# Seismic performance of accelerated bridge construction (ABC) precast bulb-tee girder-to-bent cap connection

**Seismic performance of accelerated bridge construction (ABC) precast bulb-tee  
girder-to-bent cap connection**

A thesis submitted to the graduate faculty  
in partial fulfillment of the requirements for the degree of  
**MASTER OF SCIENCE**

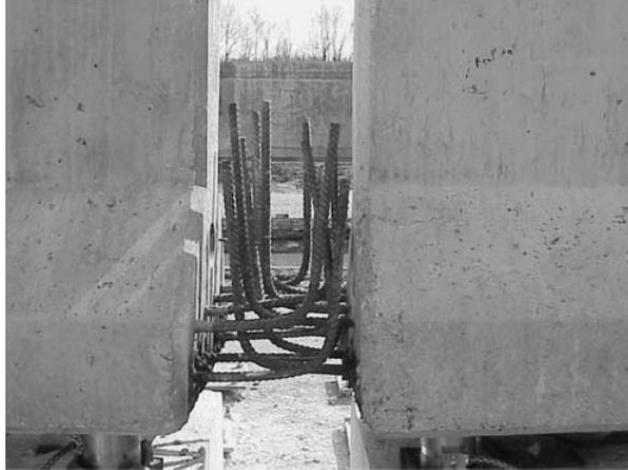
*Figure 2-15 Congestion within Connection Region due to the Use of Bent Bars (Miller et al., 2004)*

Additional reinforcement that is required in order to develop the continuity resulting in congestion within the connection region as shown in *Figure 2-15*. The congestion of reinforcement induces the consolidating concerns for connection resulting from the use of small spacing between reinforcement. The honeycombs surrounding reinforcement may cause a weak bonding and result in the reduction of effective strength of reinforcement. The bent bars are difficult to use in construction, labor intensive, and are often asymmetrical, which can lead to uneven stresses and failure in the interface between the precast girders and bent cap (Miller et al., 2004). Also, the extended bars are likely damaged or fractured during fabrication and transportation. In the event of damaged bars, holes must be drilled into the girder ends through which the new bars are embedded and anchored with epoxy.

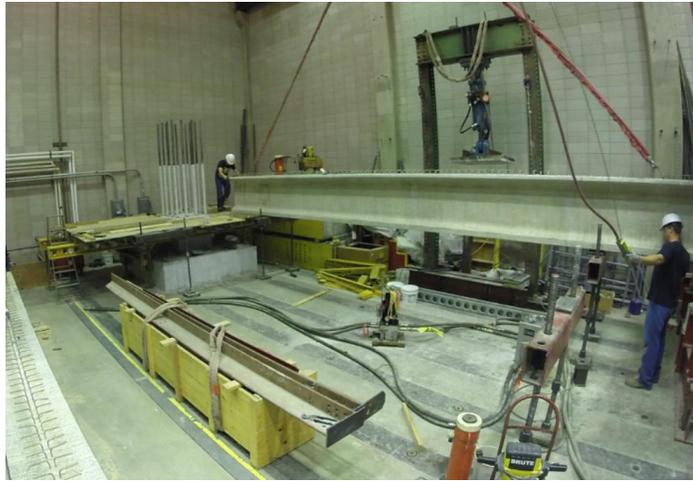
***Figure 4-1*** Place the Girder on Temporary Falsework

The construction of the test unit took place in the Iowa State University structural laboratory. The footing and column were reused from the test unit constructed for the second set of connection tests. The falsework was initially placed surrounding the column to support the bent cap throughout the construction process. Two bulb-tee girders precast at Cretex Concrete Products in Iowa Falls, IA were then placed on the bent cap falsework and temporary support throughout the construction of the test unit as shown in *Figure 4-1*.

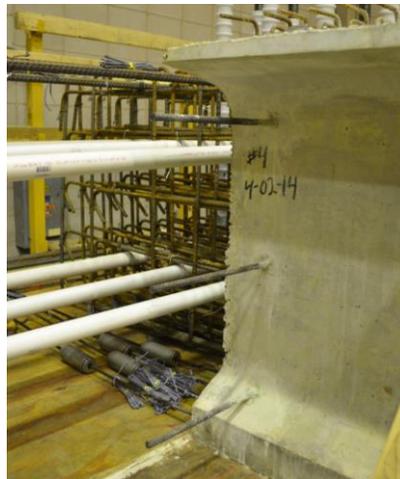
***Figure 4-2*** Dowel Bars Inserted through the Web of Girder

The precast girders arrived at ISU laboratory with six of the ten girder strands extending 8 ft from each girder. Since only four strands were required to be embedded into the bent cap, the strands in the upper row were cut. Before the fabrication of the bent cap, the dowel bars were inserted through the holes blocked out transversely through the web of the girders, and grouted in place as shown in *Figure 4-2*. The reinforcement cage for the bent cap and the pier diaphragm were tied on the falsework, and the extended girder strands

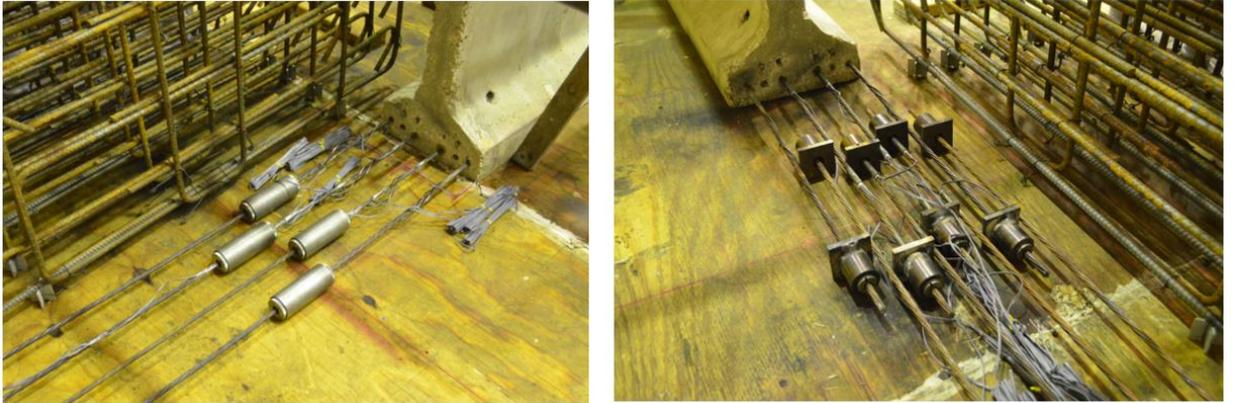
*Figure 4-3 Extended Girder Strands in the ESMS and ESL Connections*

were spliced according to each connection details. The mechanical splice chucks were used in the ESMS connection to splice the strands extended from the precast girder with the strands added on the back of the bent cap as shown in *Figure 4-3*. The strands located at the back of the bent cap with the external anchorage were added in order to simulate the strands extended from an opposite girder. For the ESLS connection, the strands with strand chucks were also lap spliced with strands at the back side of the bent cap as shown in *Figure 4-3*. The post-tensioning ducts were inserted longitudinally through the bent cap for the cap post-tensioning. At the same time with the fabrication of the bent cap, the deck reinforcing steel was placed over the girder on the formwork constructed by bridge hangars, brackets, and plywood as shown in *Figure 4-4*. The formwork for bent cap was fabricated and set into place. The bent cap and deck concrete with BASF M100 micro fiber added at 0.5 lbs. per cubic yard and BASF MAC MATRIX macro fibers added at 3.0 lbs. per cubic yard was then placed in one continuous pour and allowed to cure. The finished test unit is showed in *Figure 4-5*.

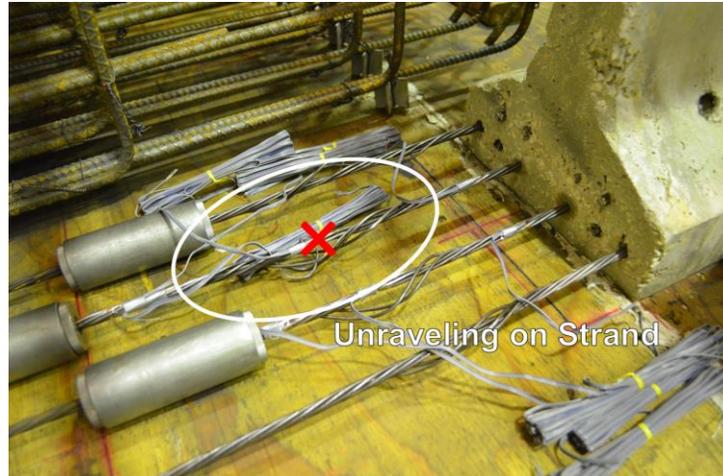
**Figure 4-14** Placement of Strain Gauge on Unraveled Portion of a Strand in the ESMS Connection

Two of four strands extended from the girder were instrumented in the ESMS connection, and the strain gauges were placed 2 in. from the girder-to-cap interface and 1 in. from the ends of the splice chuck. Two additional strain gauges were placed at the midpoint between the girder-to-cap interface and the splice chuck. Moreover, in order to verify the continuity developed by the spliced strands, two strain gauges were installed on the spliced strands at 9.25 in. and 19.25 in. from the end of splice chuck. The unraveled region was instrumented with an additional strain gage to investigate the effect of unraveling on the strand behavior as shown in *Figure 4-14*.

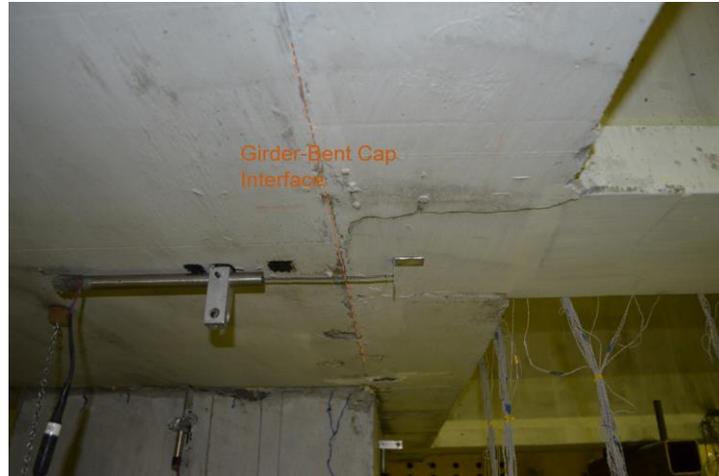
**Figure 4-19** Location of LVDT on Girder-to-cap interface

It is important to instrument the opening between the precast girder and the bent cap. In addition, the deformation of the deck over the connection region was essential to investigate the performance of the precast bulb-tee girder-to-bent cap connection. Therefore, LVDTs were mounted on both the deck and girder-to-cap interface as shown in *Figure 4-18* and *Figure 4-19*. Note that the deck deformation was instrumented at the edge of the diaphragm and the girder-to-cap interface.

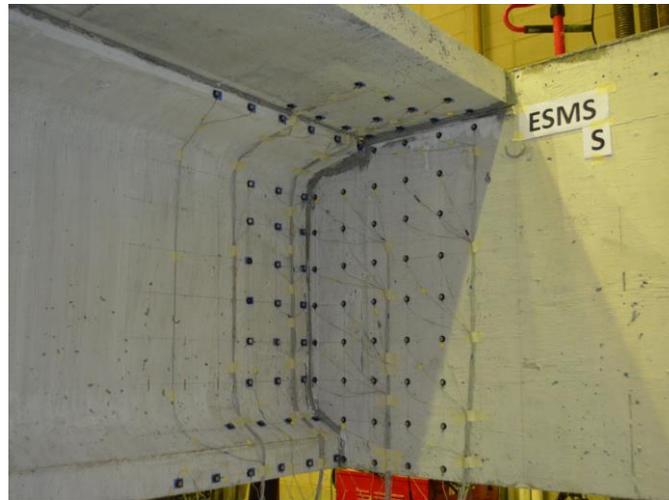
The Optotrak system provided a reliable and convenient motion capture solution with an accuracy of up to 0.04 in. (0.1 mm). With a space digitization camera, the location of each marker can be tracked and recorded. A total of 86 markers were mounted as the 4 in. by 4 in. grid on the connection region consisting of the diaphragm, precast girder, and deck. As the marker layout shown in *Figure 4-20*, the deformation of the connection region and the relative displacement between each of the components were captured by a number of markers.

**Figure 4-20** Optotrak System Marker Layout

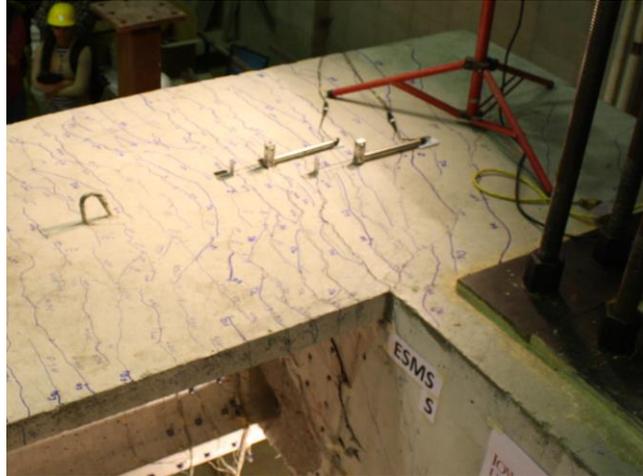
**Figure 5-2** Flexural Cracks on Deck of the ESMS Connection

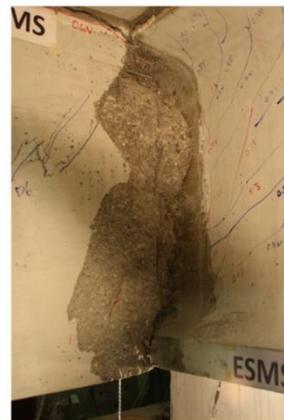
**Figure 5-4** (a) Separation between Girder End and Bent Cap; (b) Penetration Cracks on Diaphragm; (c) Diaphragm Region where the Spalling of Concrete Was Observed

girder pulling out subsequently appeared on the diaphragm next to the girder at the load equivalent to the summation of gravity, horizontal seismic load, and 0.7g vertical acceleration effects as shown in *Figure 5-4* (b). At 4.5 in. of vertical displacement measured at the black actuator location 28.5 ft from the girder-to-cap interface, the concrete adjacent to the girder on the front diaphragm surface began to spall. As shown in *Figure 5-4* (c), a large portion of the diaphragm next to girder spalled off and separated from the girder after the vertical displacement reached 7.5 in.. The compressed strands at negative moments were stretched and straightened when the positive moments were applied on the connection, but the extended strands did not fracture during the entire test.

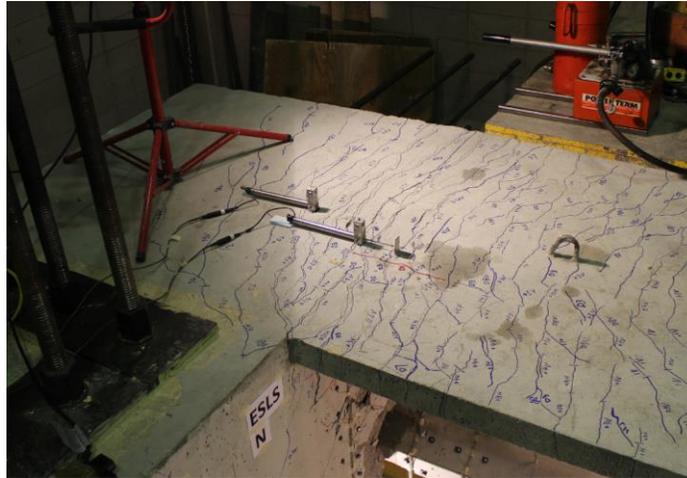
*Figure 5-6 Cracks on Deck of the ESLS Connection*

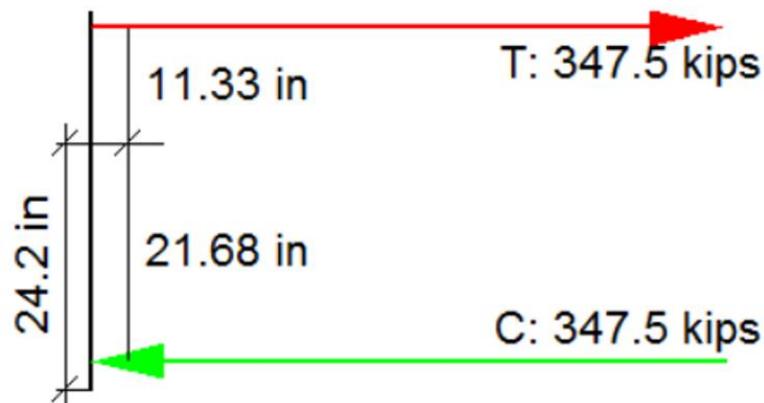
(b) Internal Forces at Idealized Yield Condition

**Figure 6-2** Results of Sectional Analysis

The sectional analysis for the composite cross-section can be performed and a moment-curvature response showing the idealized yield and ultimate moment resistance of the section can be estimated. The corresponding tension force developed in the deck reinforcement can also be easily calculated (*Figure 6-2*).
