**Local calibration of the MEPDG prediction models for pavement rehabilitation and
evaluation of top-down cracking for Oregon Roadways**

A dissertation submitted to the graduate faculty
in partial fulfillment of the requirements for the degree of
DOCTOR OF PHILOSOPHY

Major: Civil Engineering (Civil Engineering Materials)

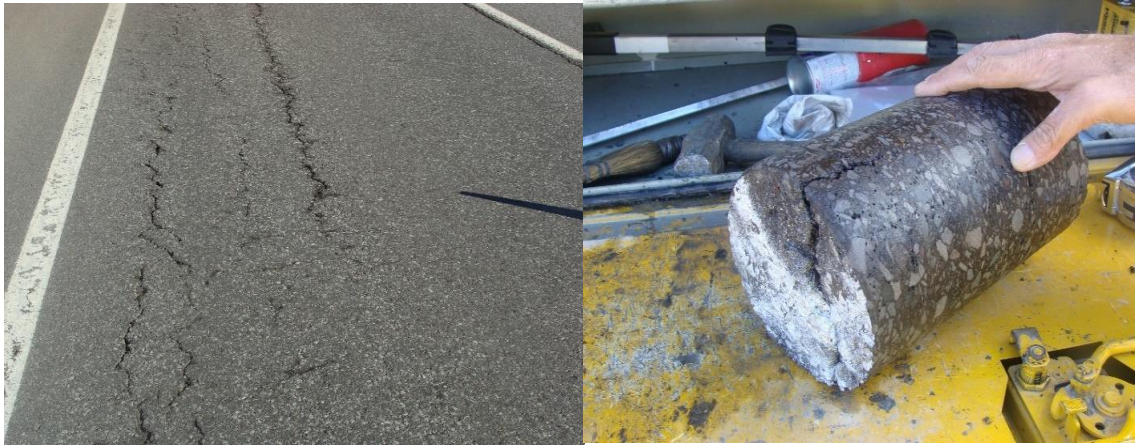
Figure 1-1 Pictures showing the development of top-down cracking

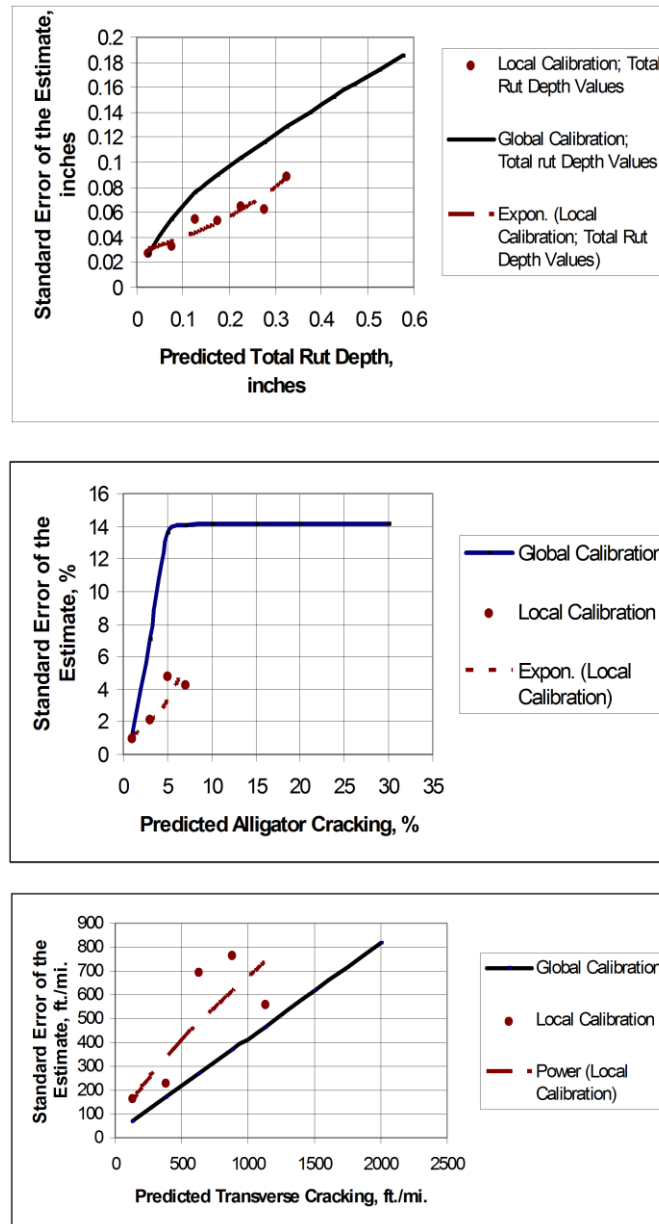
Figure 2-8 Comparison of the standard error of the estimate for the global-calibrated and local-calibrated transfer function in KSDOT study (NCHRP, 2009)

After the bias is reduced or eliminated for each of the transfer functions, the standard error of the estimate (SEE, S_e) from the local calibration is evaluated in comparison to the SEE from the global calibration. The standard error of the estimate for each globally calibrated transfer function is included under the “Tools” section of the MEPDG software. Figure 2-8 illustrates the comparison of the SEE for the globally calibrated transfer functions to the SEE for the locally calibrated transfer functions.

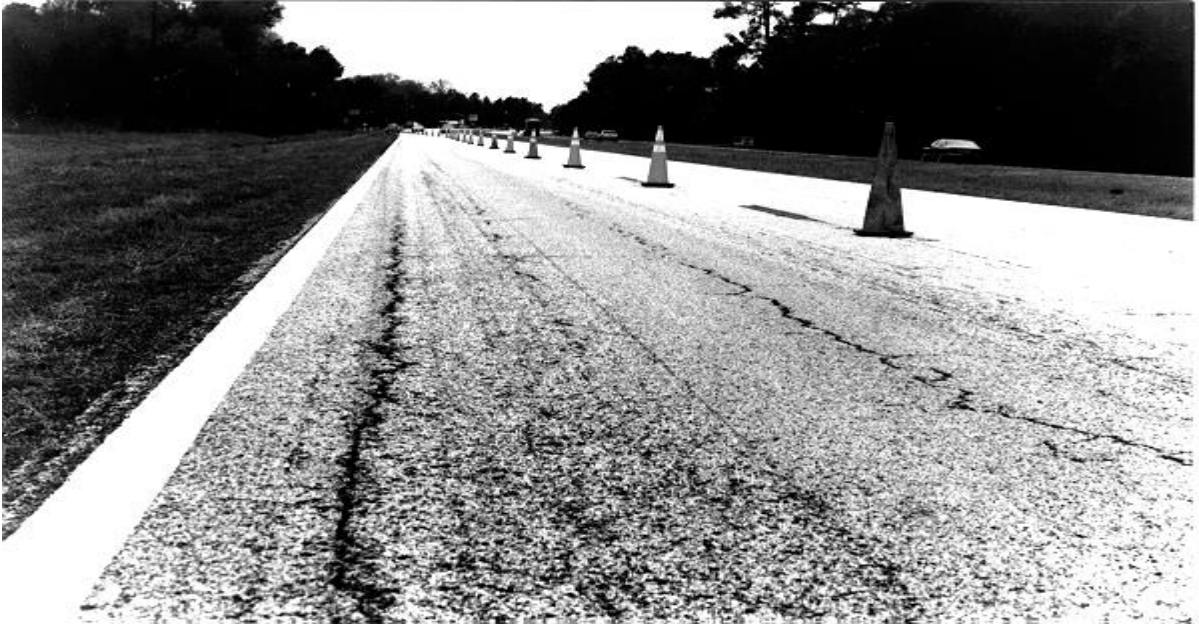
Figure 2-10 Lane exhibiting surface initiated top-down cracking in both wheelpaths (Myers et al., 2000)

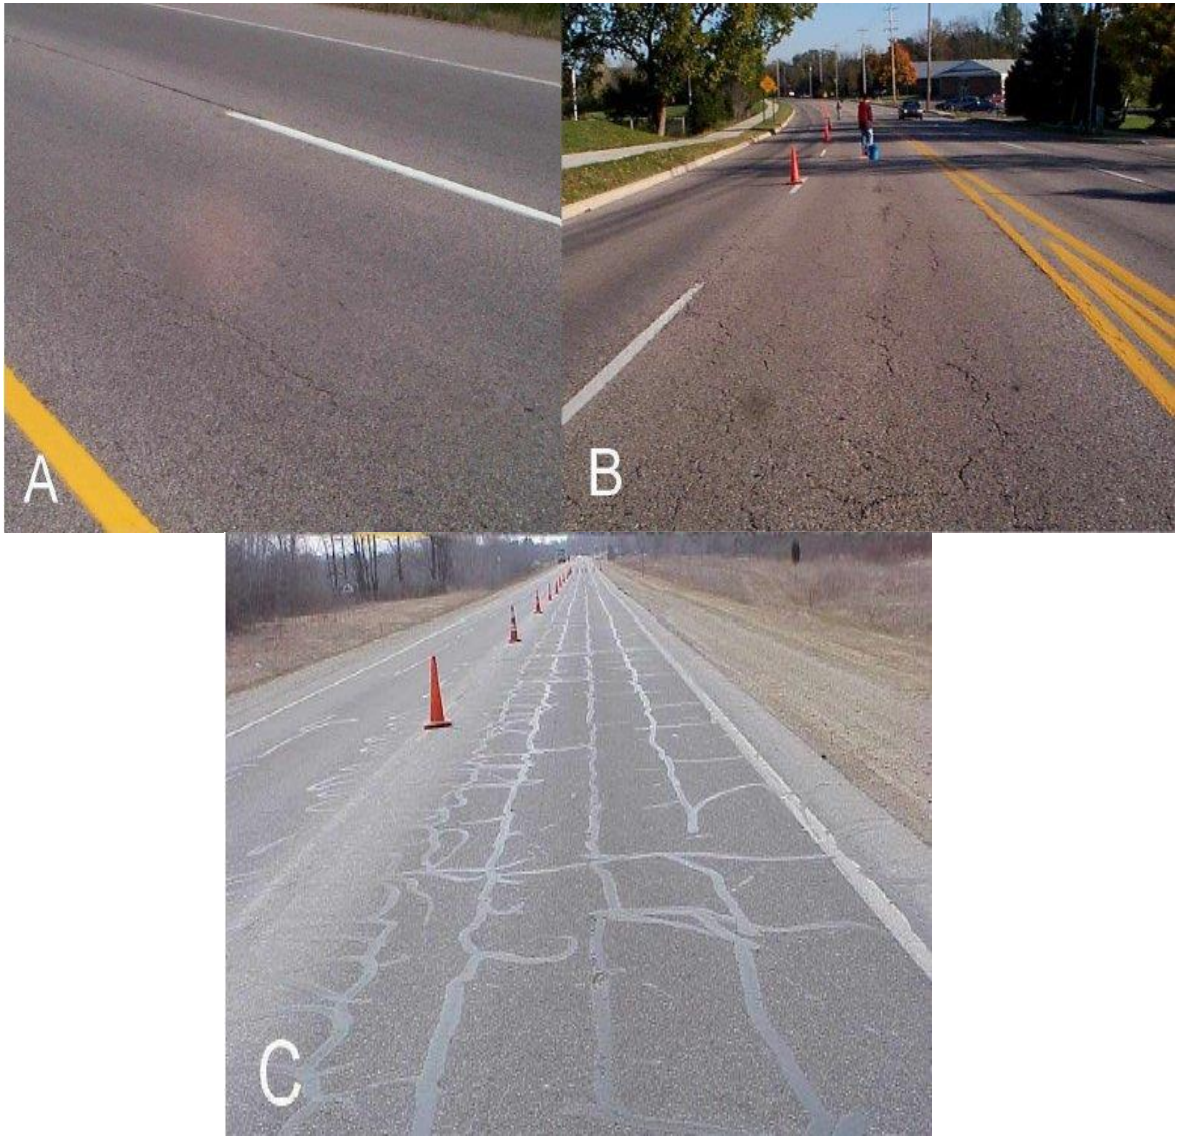
*Figure 2-12 Photographs illustrating the development of top-down cracking
(Svasdisant et al., 2002)*

- Most top down cracking are observed just outside the wheelpaths and progress in three stages.
- Surface radial tensile stress induced by wheel load and enhanced by differential stiffness due to construction (poor compaction and segregation), temperature and aging can cause top down cracking,
- Aging of asphalt binder reduces the tensile strength and tensile strain at failure of the asphalt mixture, and
- The locations of the maximum surface tensile stress predicted by the mechanistic analysis correspond very well to the locations of the field observed top down cracking.

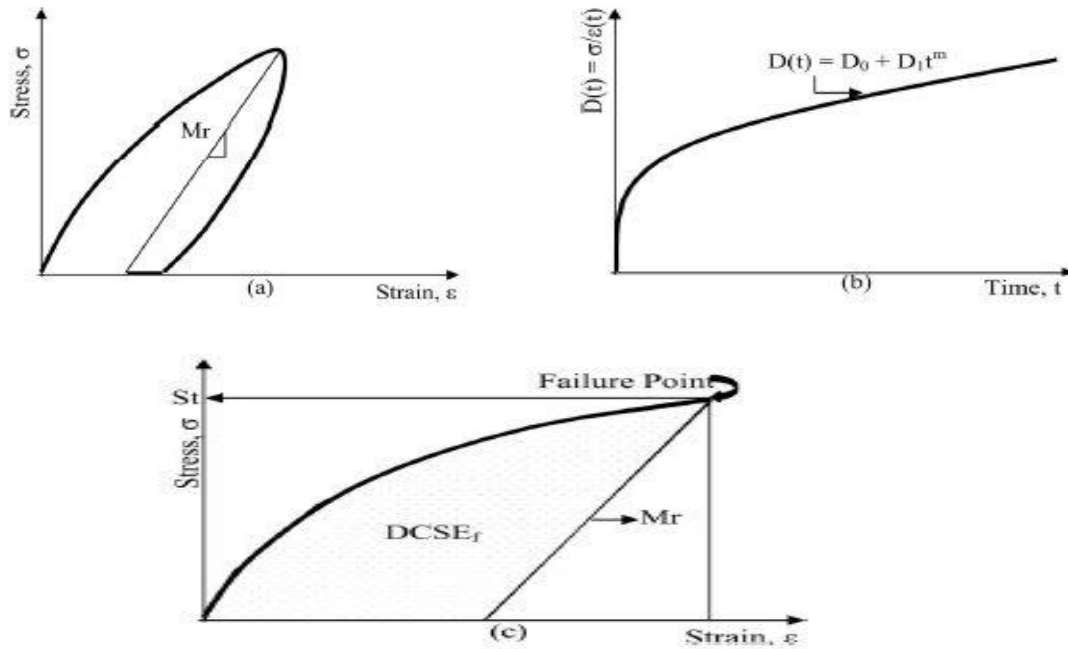
Figure 2-16 Description of parameters obtained from (a) resilient modulus, (b) creep compliance, and (c) strength tests (Kim et al., 2009)

Where $DCSE_f$ is dissipated creep strain energy at failure, σ is the tensile stress obtained at the bottom of the asphalt layer using elastic layer analysis, m and D_1 are power function parameters. The parameters required for the top down cracking model can be obtained from resilient modulus, creep compliance and tensile strength tests. The resilient modulus, M_r is determined from the stress-strain curve obtained in resilient modulus test. The power function parameters are obtained by fitting the creep compliance curve performed using a constant load control load. The tensile strength and dissipated creep strain energy at failure are determined from the stress-strain curve of a given mixture from the strength test. Figure 2-16 shows the description of parameters determined for top down cracking model.

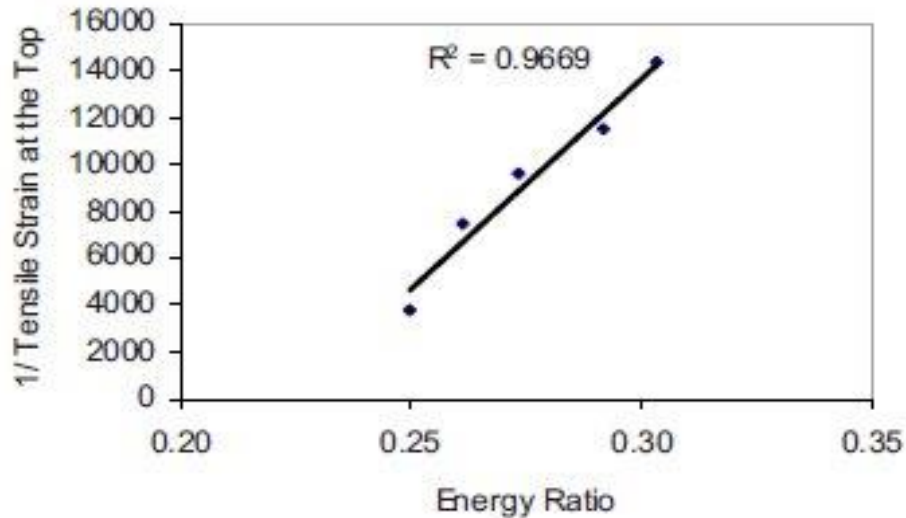
*Figure 2-17 Inverse tensile strain at top of the asphalt layer versus energy ratio
(Kim et al., 2009)*

Kim et al. (2009) found that tensile strain obtained at the top is inversely related to energy ratio, if the identified tensile strain at top is a primary cause of top down cracking. Figure 2-17 shows the linear relationship between energy ratio and inverse tensile strain at top at the 50-loading cycle. The study indicated that the tensile strain at the top of asphalt layer is a primary factor affecting the top down cracking performance.
