Evaluation of the need for longitudinal median joints in bridge decks on dual structures

MASTER OF SCIENCE

Major: Civil Engineering (Structural Engineering)

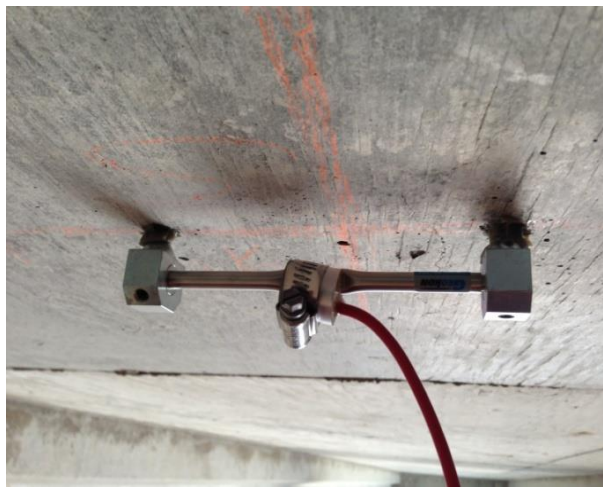
Figure 16. Vibrating wire strain gauge at the bottom of deck

Figure 16 shows a photograph vibrating strain gauge mounted to the bottom of concrete deck prior to the installation of the protective cover.

During long-term testing, Geokon Model 4000 vibrating strain gauges were used to measure the load-induced strain on the bottom of the deck. For the strain gauges instrumentation, three sections - abutment section, middle-span section and pier section were selected to capture the strain data. The abutment section (Figure 13) is 54 in. from the surface of the south abutment. Six bays near the east side of the bridge were selected to install the strain gauges. In each bay the strain gauge was attached in the middle of the bay between the two girders. The middle-span section (Figure 14) is located in the middle of the first span on the south side of the bridge. The pier section (Figure 15) is 54 in. from the south side of the first pier in the south side of the bridge. In both the middle span section and the pier section, the vibrating strain gauges were attached in the 1st bay, 3rd bay and 5th bay on the east side of the bridge.

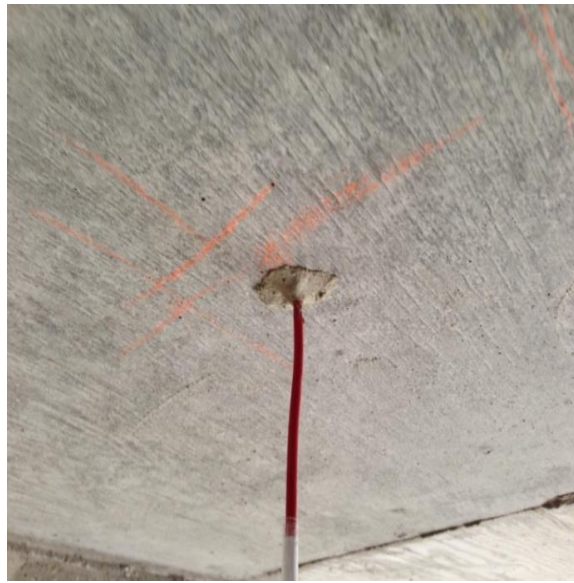
Figure 21. Thermistors at the bottom of deck

During long-term testing, five such thermistors were installed into the deck and 54 in. from the surface of the abutment (shown in Figure 20). Figure 21 shows a photograph of a thermistor attached within the deck. The locations of the four thermistors installed in the abutment are shown in Figure 20.

In addition to the temperature at the bottom surface of the deck, the temperature inside the deck and within the abutment were also measured using a Geokon 3800 thermistor placed at mid-depth of the deck and just below the surface of the abutment. The relative position between the cover of the vibrating strain gauge and Geokon 3800 thermistors is shown in Figure 19.

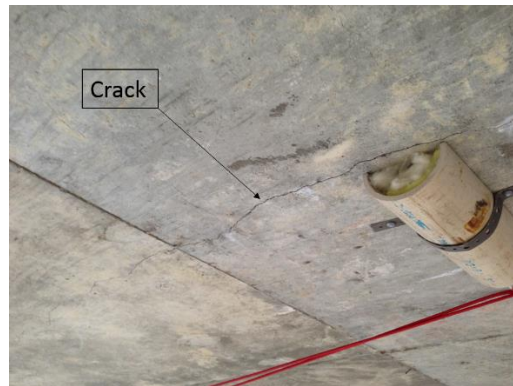
Figure 45. Relative position between crack and strain gauge in the fifth bay

For the fifth bay, a crack parallel to the girders was found at the bottom of the deck within one inch from one side of the strain gauge (shown in Figure 45). The strain gauge is near the edge of the crack and perpendicular to the crack; thus, the reading from the strain gauge will be reduced due to stress release near the edge of the crack. A similar situation was also observed in the third bay where a crack developed close to the mounting block of the strain gauge, which resulted in an irregular strain vs. temperature relation.

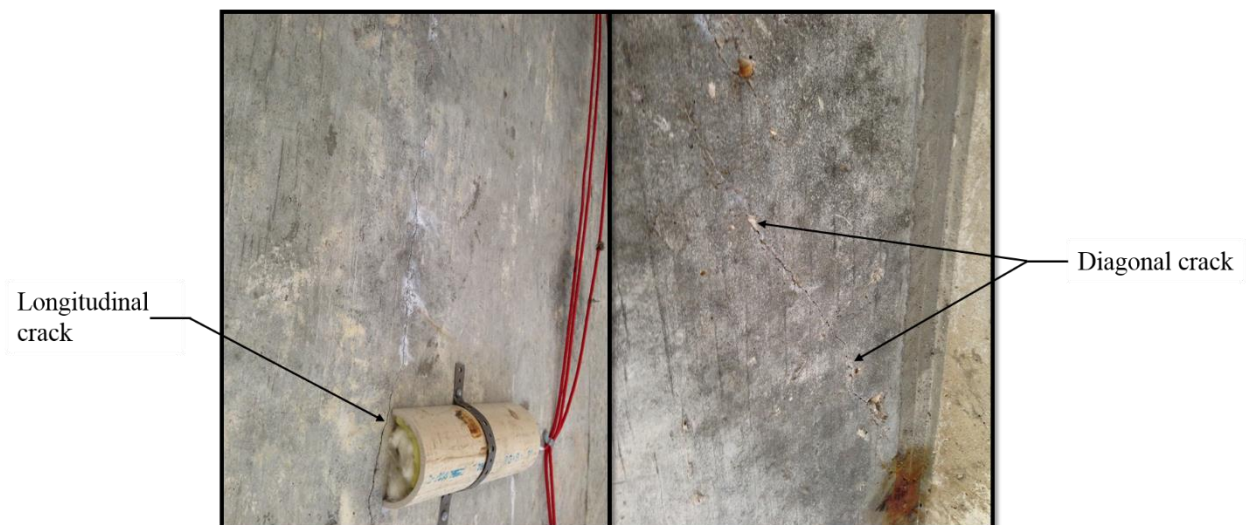
Figure 111. Typical longitudinal and diagonal cracks at the bottom of deck

Bridge inspection experience indicated that the opening width of diagonal cracks at the corner of the deck is usually larger than the width of longitudinal cracks at the middle of the deck. The leaking problem through those diagonal cracks is more severe than it is on the longitudinal cracks. Furthermore, on the integral abutment bridge, the diagonal cracks are more prevalent than the longitudinal cracks. Figure 111 compares a longitudinal crack with a diagonal crack at the bottom of the deck on bridge #605220 in Waterloo. The inspection results on newly constructed bridges revealed that often, when longitudinal cracks have not yet occurred, diagonal cracks have already existed.
