**Development, evaluation and implementation of sensor techniques for bridges
critical to the national transportation system**

A dissertation submitted to the graduate faculty
in partial fulfillment of the requirements for the degree of
DOCTOR OF PHILOSOPHY

Major: Civil Engineering (Structural Engineering)

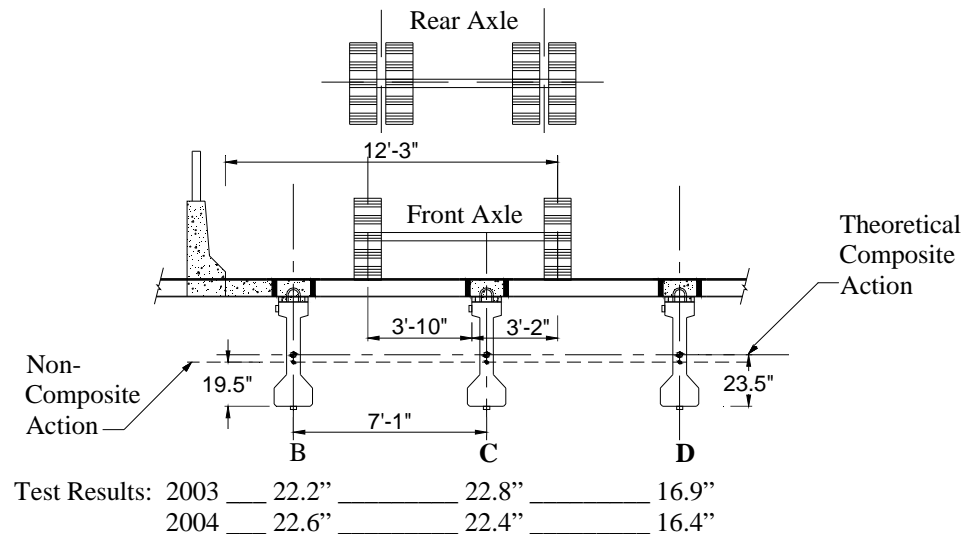
Figure 4.6. Neutral Axis of FRP Deck Span – Path Y1

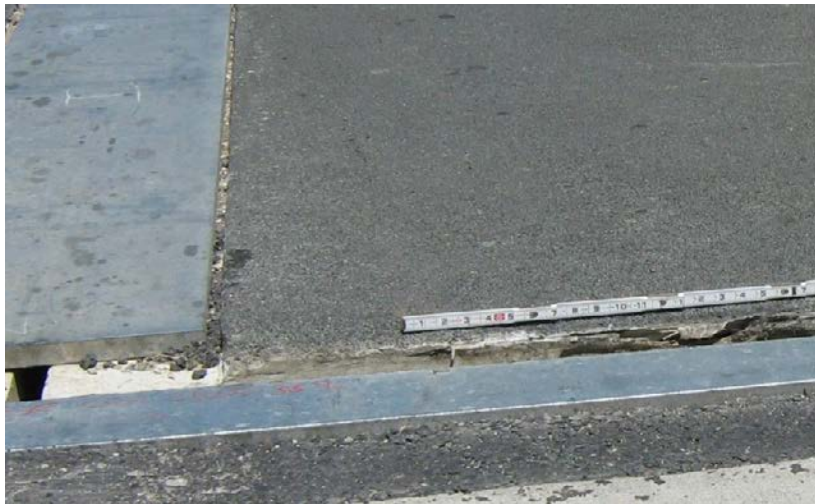
(b) Deterioration at end of deck panel

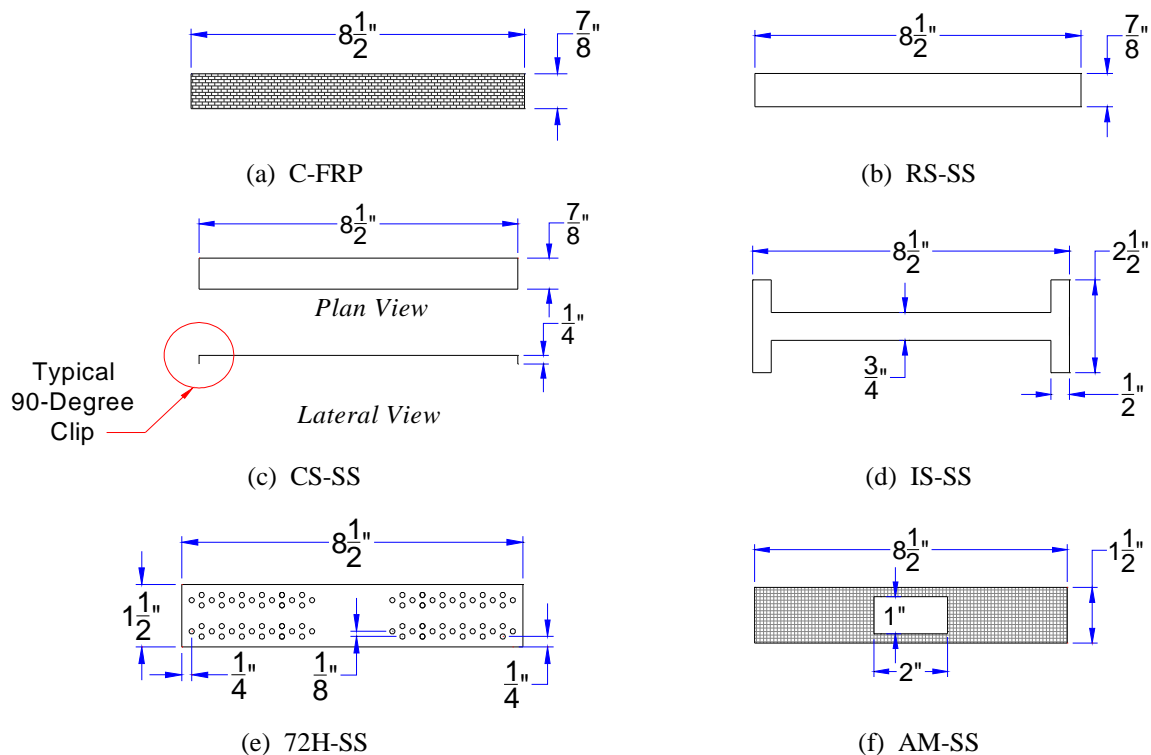
**Figure 6.5. Structural Packages: Backing Material Geometry**

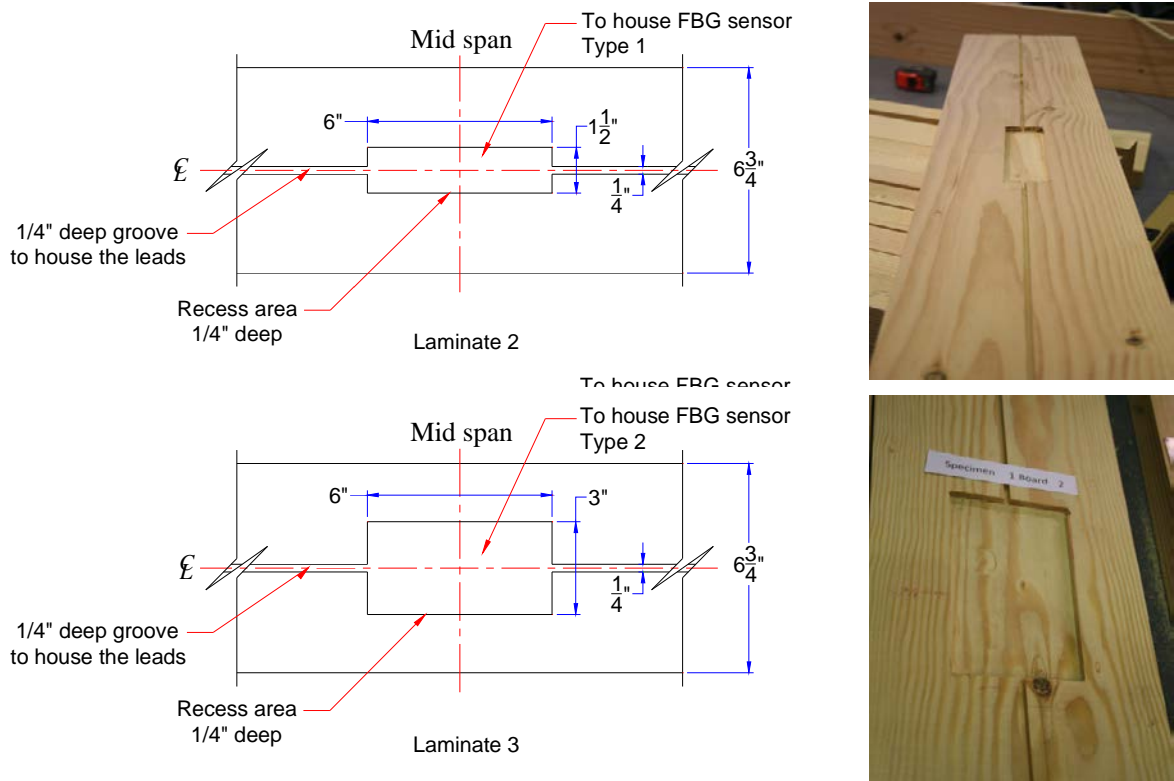
Figure 6.15. Non-Structural Package: Location and Dimensions of the Recess Area to House the FBG Sensors

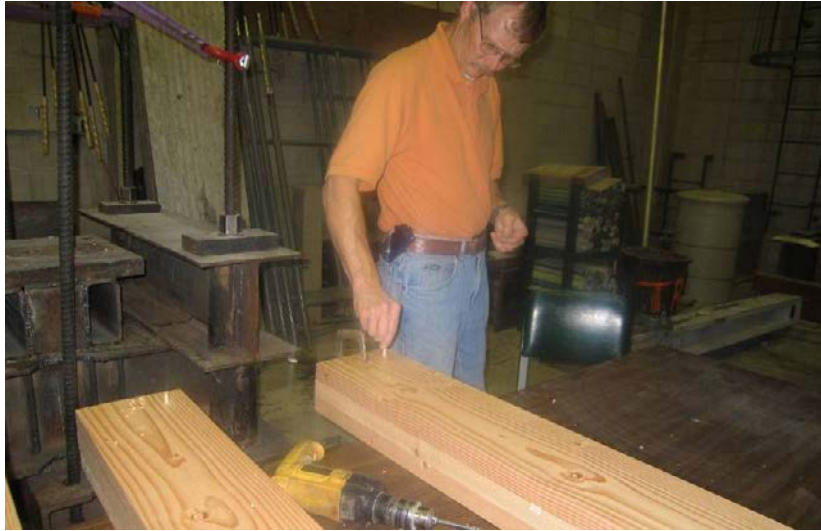
Figure 6.21. Assembly of the Glulam Specimens with Non-Structural Packages: Insertion of the Wooden Dowels

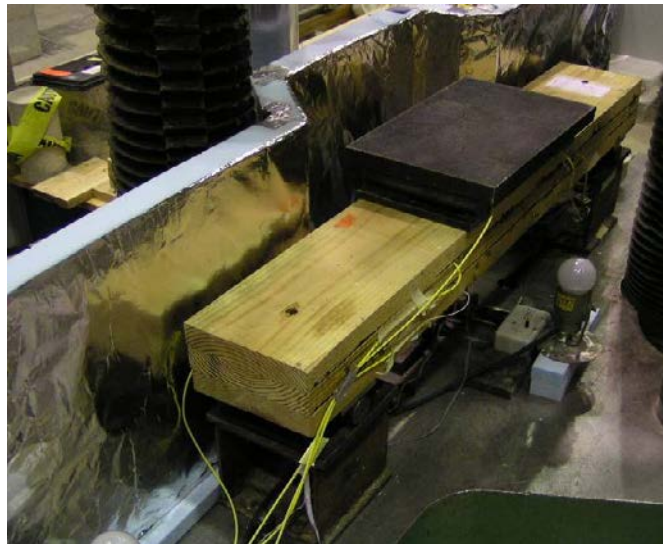
Figure 6.27. Heat and Sustained Loading Test: Assembling of the Heat Box

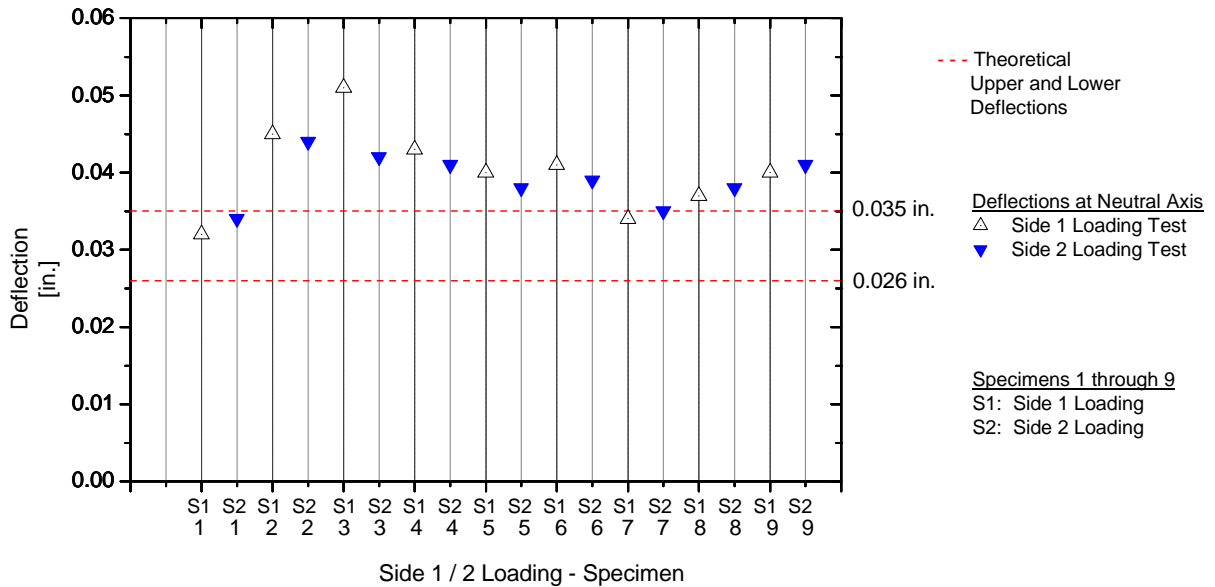
Figure 6.45. Bending Test: Comparison of Maximum Theoretical vs. Experimental Deflection at Mid Span for Specimens 1 through 9, Side 1 and 2 Loadings
