Corrosion Evaluation and Durability Estimation of Aluminized Steel Drainage Pipes

A dissertation submitted in partial fulfillment
of the requirements for the degree of
Doctor of Philosophy
Department of Civil and Environmental Engineering
College of Engineering
University of South Florida

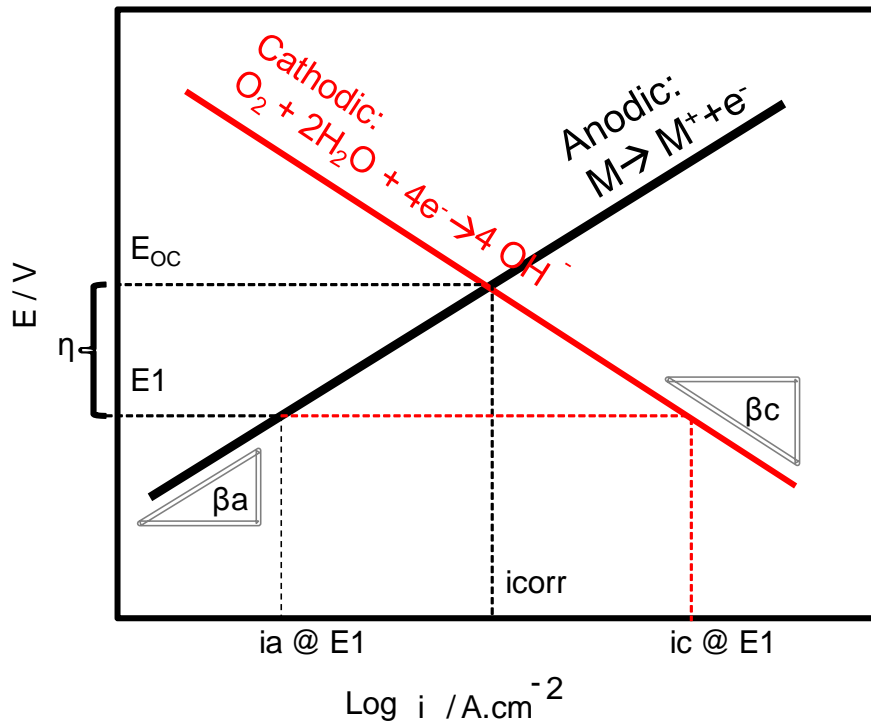
Figure 4: Simple polarization diagram showing anodic polarization functions and corrosion potential.

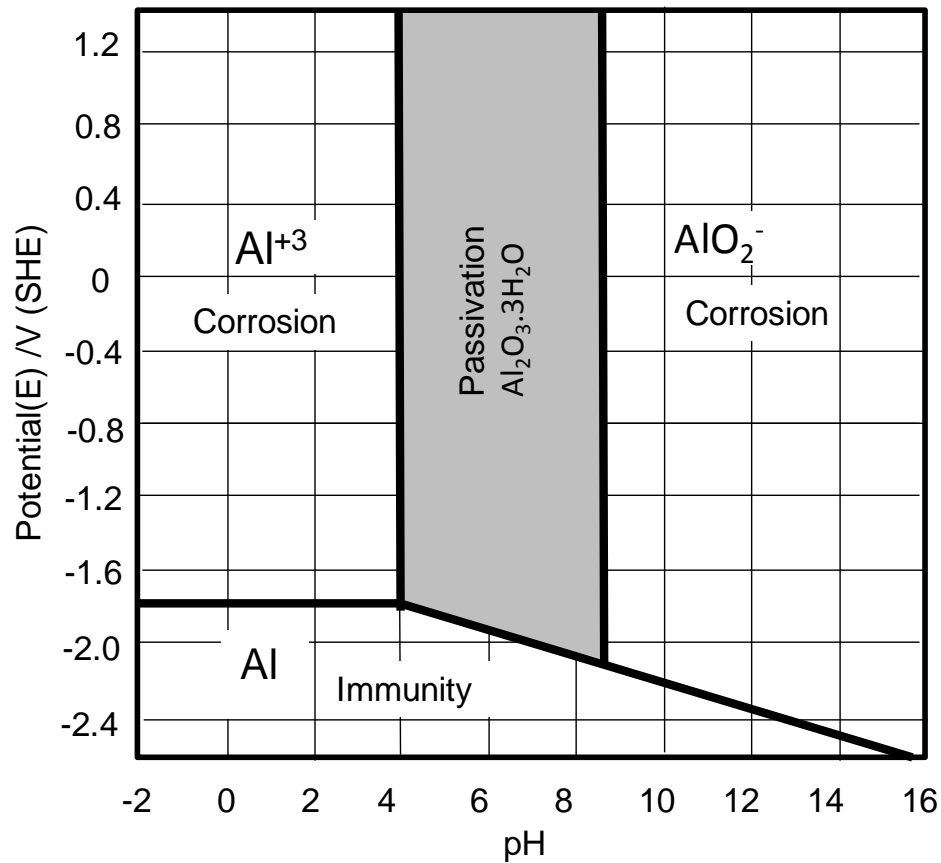
Figure 7: Pourbaix diagram for aluminum at 25°C

According to Figure 7, aluminum is passive (not corroding) in the pH range of about 4 to 8.5 (precise values depend on the concentration of the ionic species in the solution). Beyond this range aluminum corrodes and dissolves as Al^{3+} in acid and AlO_2^- , aluminate, in a basic environment (Davis, 2000). Pourbaix diagrams, however, do not consider the presence of aggressive ions, such as chloride, which attack and break the passive film and cause pitting corrosion.

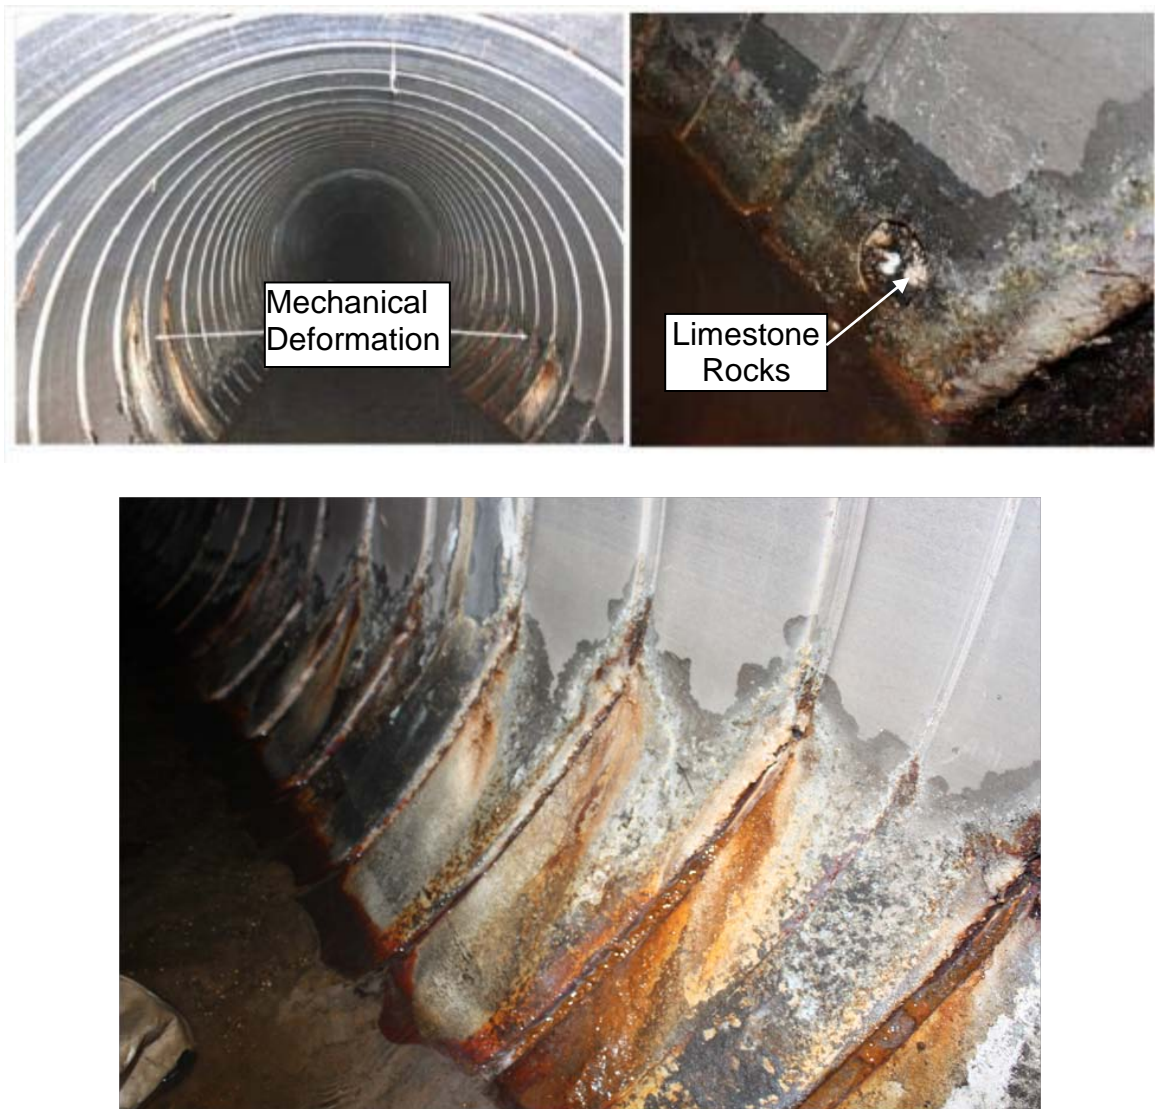
Figure 15: Photograph of in situ pipe located in Jacksonville, near Highland Glen and Beach Blvd. Mechanical damage (Top-left and bottom). Limestone rocks present beneath the bore location (Top-right).

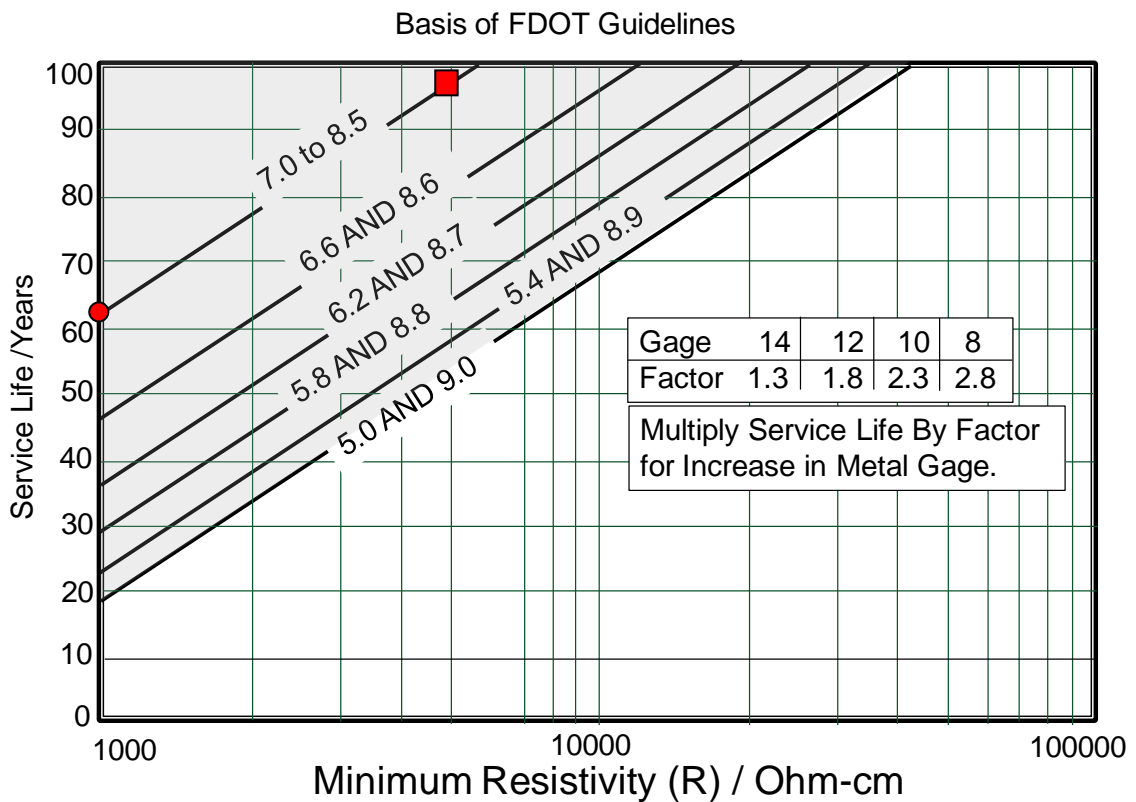
Figure 21: The FDOT chart for estimation of years to perforation of 16-gage aluminized steel Type 2 culvert pipes (solid lines). Light shaded triangle illustrates the service life functionality envelope. The circle and the square indicate the conditions for solution S+ and S respectively.

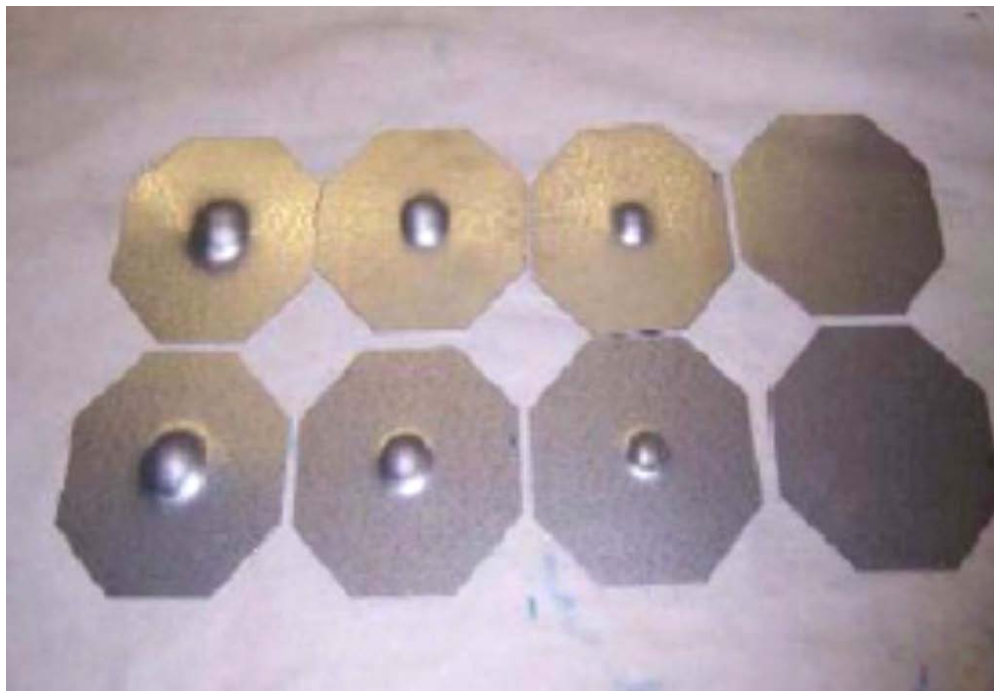
An indented Teflon plate was used to protect the convex face of the sample until nominally full hemispheric penetration was achieved. The convex face was the one later exposed to the test solution. After forming, the specimens were cleaned with ethanol and acetone and stored in a desiccator prior to immersion exposure to the test solution with a circular exposed area of 82 cm^2 (12.6 in^2) centered on the dimple (Figure 23).

Figure 23: Dimple specimens (Exposed Surface Area: 82 cm^2).

The dimple configuration, with flat surroundings, permitted placement in the test cell with a flat gasketed joint that avoided leaking and minimized the risk of crevice corrosion at an unevenly sealed joint. Control flat specimens without surface indentations, with similar exposed surface areas, were used for comparison. Specimens were tested in duplicate.

Immediately after exposure, corrosion was observed at high strain areas around the indentations (yellow shade). As time progressed the shaded region of corrosion product grew wider and became darker and various tuberculation occurred at the formed zones. SEM and EDS results confirmed that the corrosion product was iron oxide (Figure 26).

The results showed that aluminized steel that was strongly formed by spherical indentation was susceptible to early corrosion development. In contrast, undeformed aluminized surfaces showed much less deterioration during the same test interval.

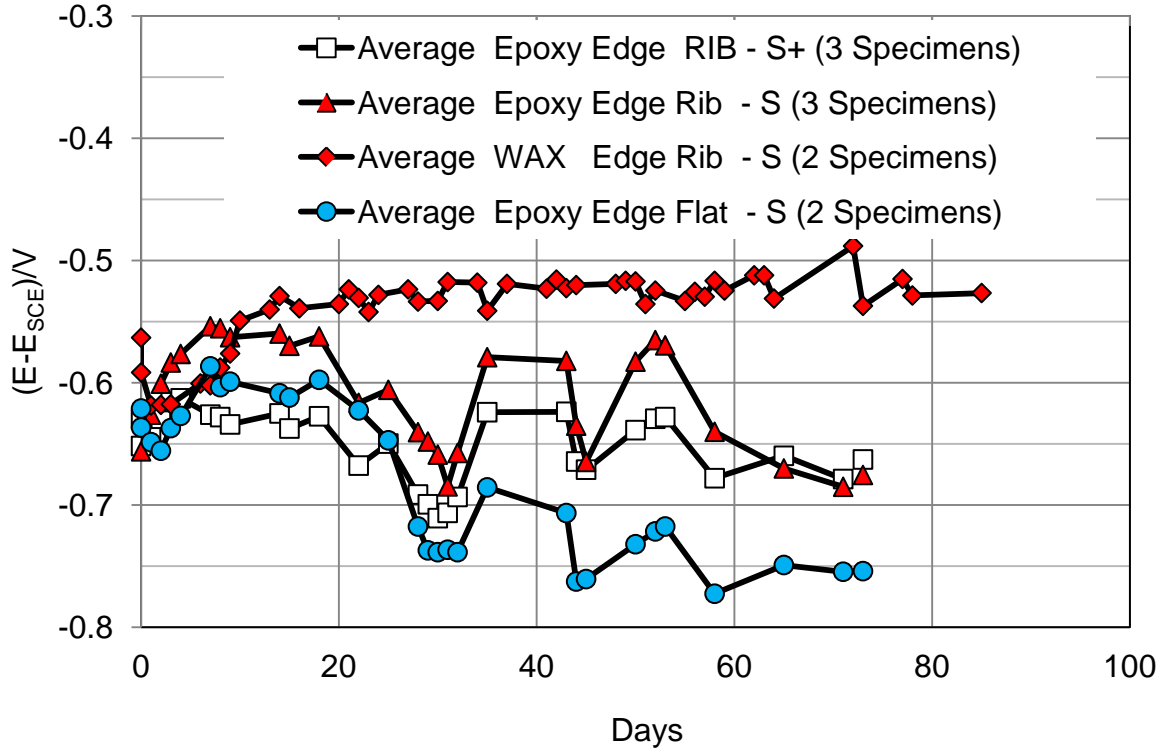
Figure 29: Average E_{OC} for small size SRAP specimens (Typical replicate variability: 41 mV).

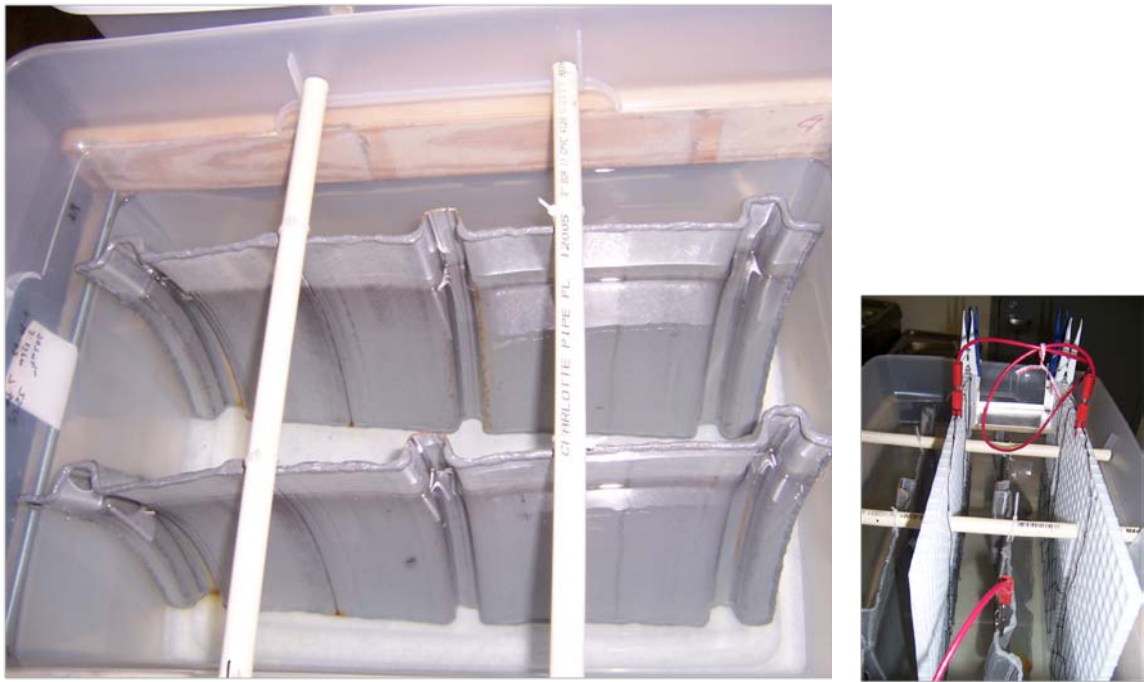
Figure 30: Large SRAP specimens in a large bin (Left). Up to 5 cm of the top of the specimens were not immersed. Counter electrode inserted during EIS tests (Right).

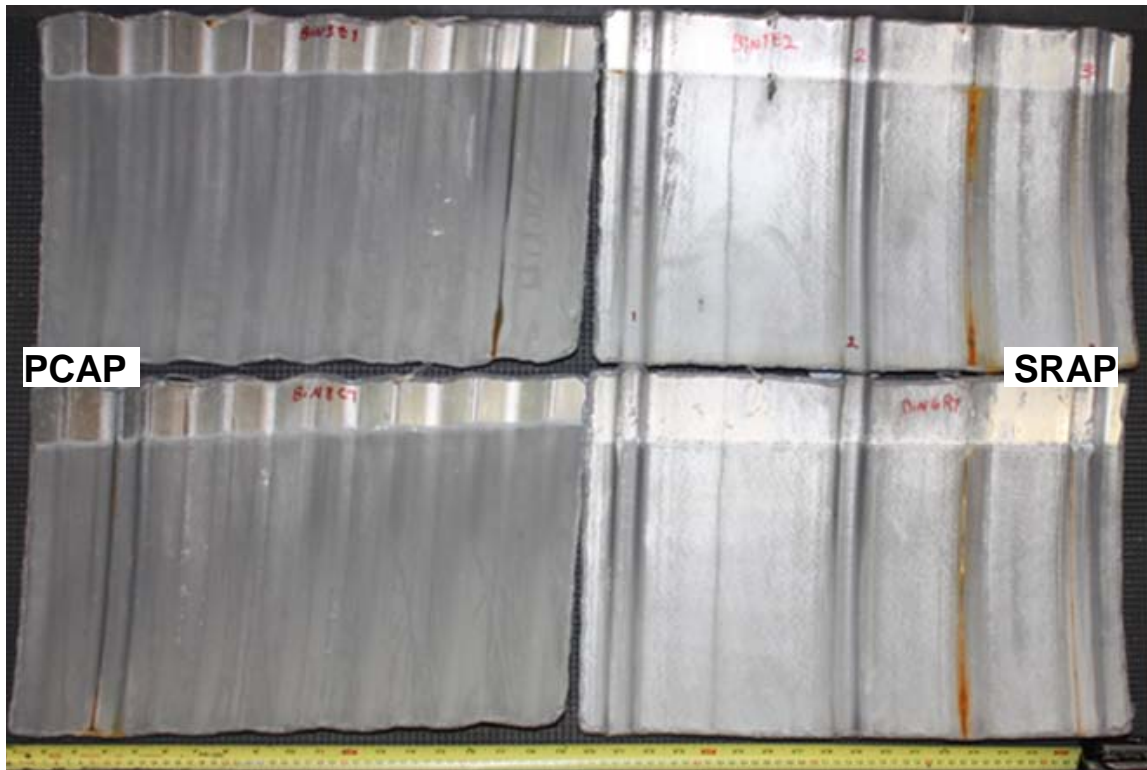
Figure 31: PCAP and SRAP specimens in solution S (Top) and S⁺ (Bottom) after ~700 days of exposure (specimens internal ID code: Bin 1 E2 (Top-right), Bin 6 R7 (Bottom-right), Bin 3 E1 (Top-left) and Bin 8 C7 (Bottom-left)).

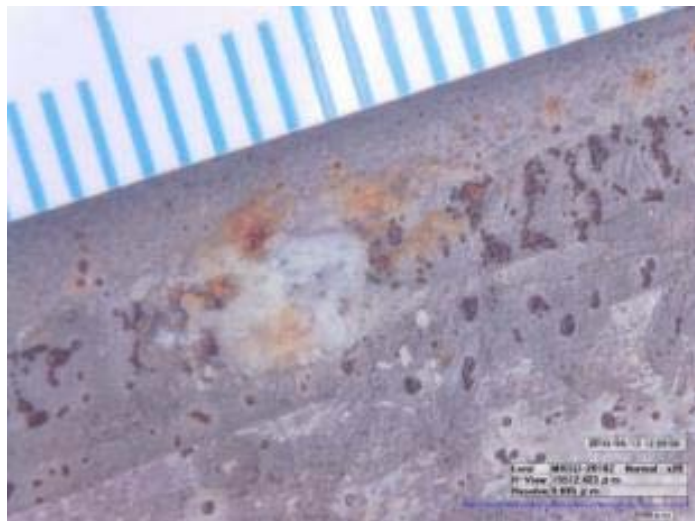
Figure 32: Pits and corrosion product at ribbed regions of an in-situ SRAP specimen in S⁺ solution after ~300 days of exposure. 1 mm markers (specimen internal ID code: Bin 7 R8).

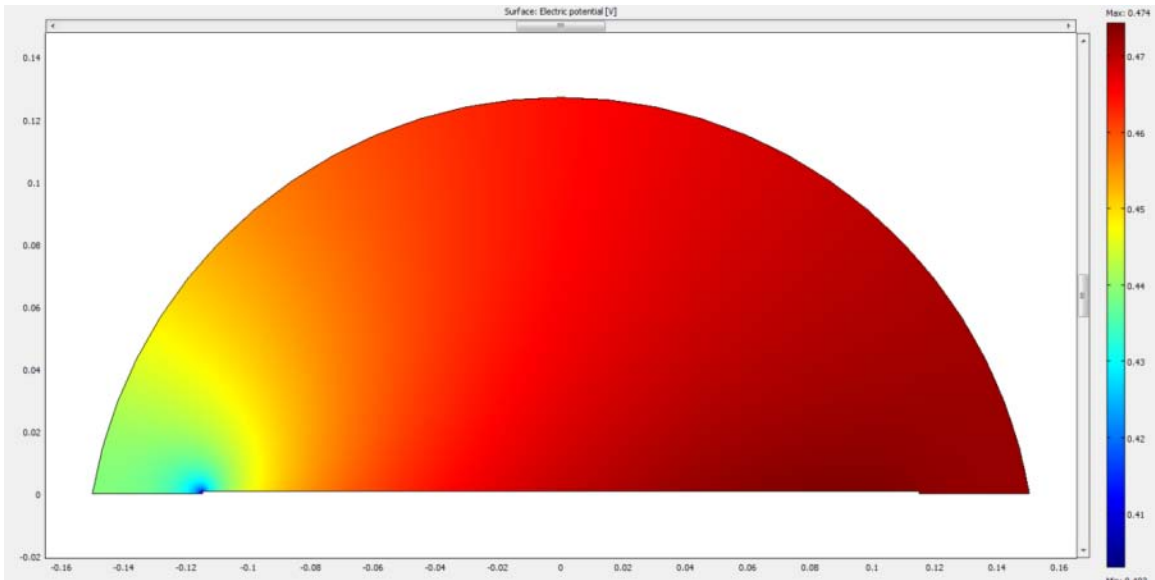
Figure 47: Computer model for potential distribution (Blue 0.40V, Red 0.47V) (0.5mm coating lost).

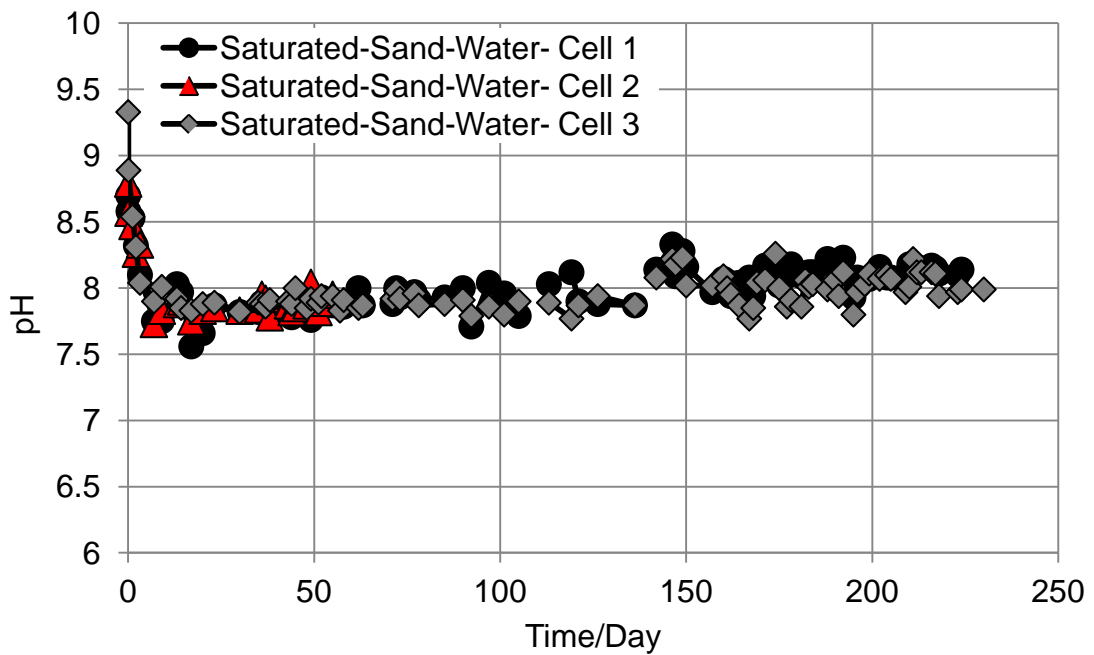
Figure 52: pH measured for triplicate specimens in saturated sand experiment.

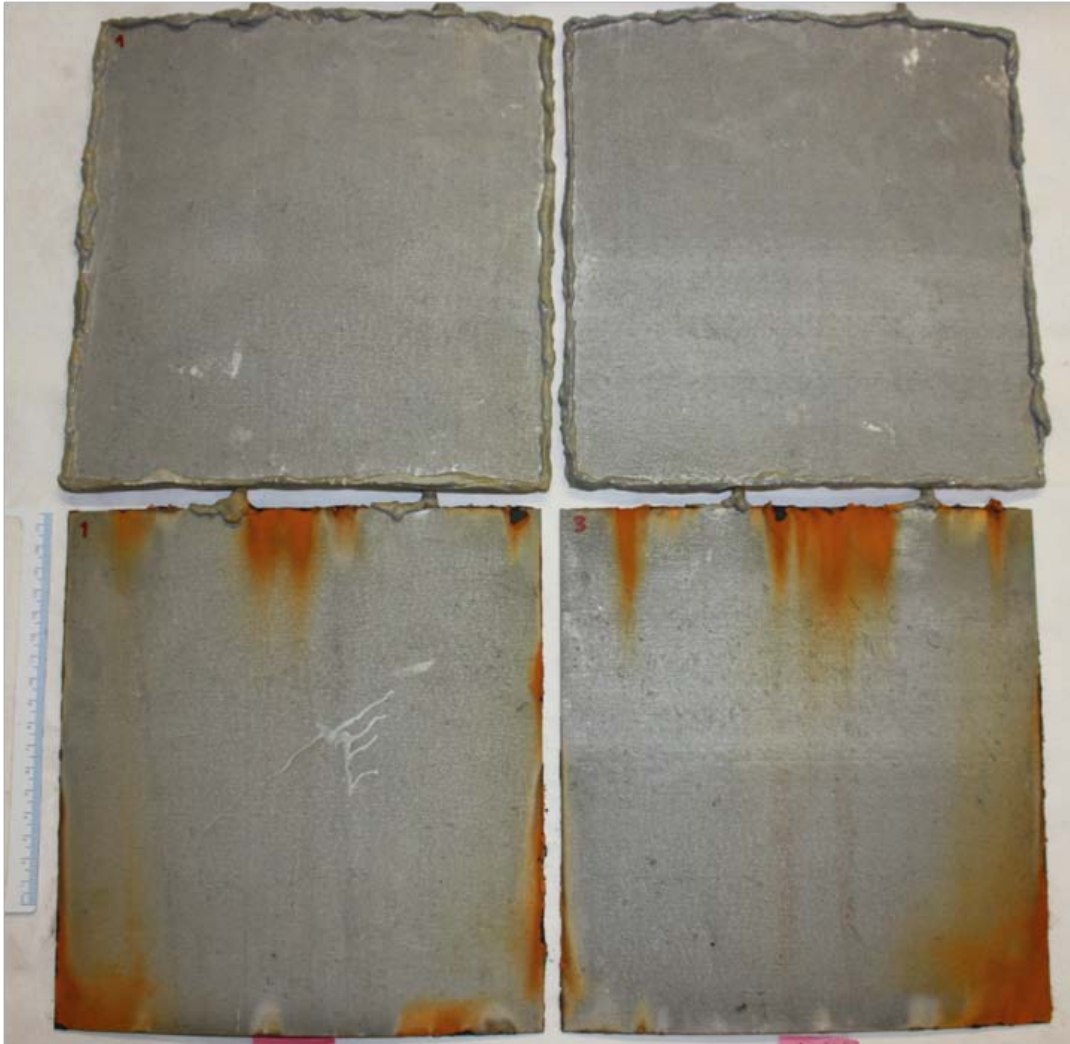
Figure A-9: Specimens with exposed edges (Bottom) and their counterpart specimen (Top) (two years of exposure). Specimens on the left side were exposed to solution S (Cell#1) and specimens on right side were exposed to solution S+ (Cell#3).
