Corrosion assessment of mechanically formed aluminized steel

Corrosion Assessment of Mechanically Formed Aluminized Steel

A thesis submitted in partial fulfillment
of the requirements for the degree of
Master of Science in Civil Engineering
Department of Civil & Environmental Engineering
College of Engineering
University of South Florida

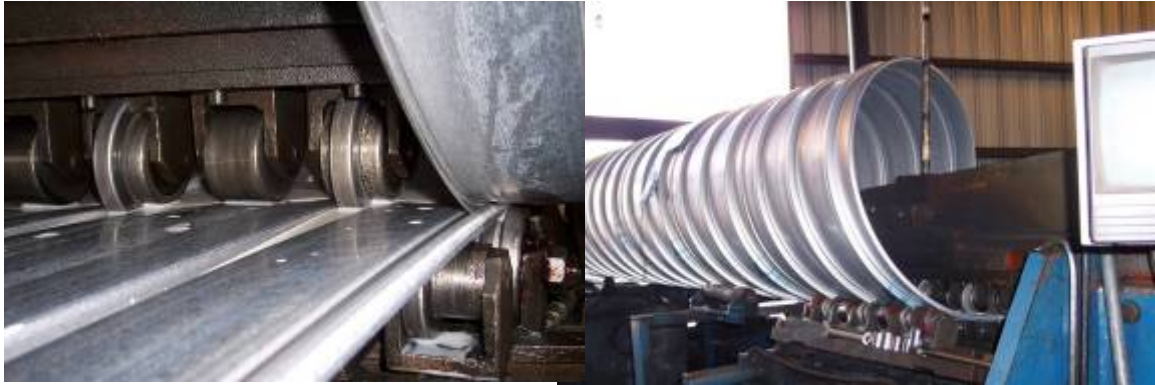
Figure 1-2. Spiral Rib Pipe Manufacturing Process (Dies Used to Form Rib (Left), Forming Spiral Pipe (Right)). [Photograph by the Author]

The ASTM 760 specification applies to the fabrication of ribbed pipes. The general process used to form the spiral ribs are as follows: The stock aluminized sheet is rolled over a series of press dies while it is lubricated with a soapy solution in order to decrease friction. Such construction creates open type ribs. Interlocking folds are formed in the opposite side of the sheet. As the pipe is rolled into the spiral, the interlocking fold connects with a corresponding fold on the rib. These formed, not-welded interlocks are called lock-seams and join the segments of spiral pipes.

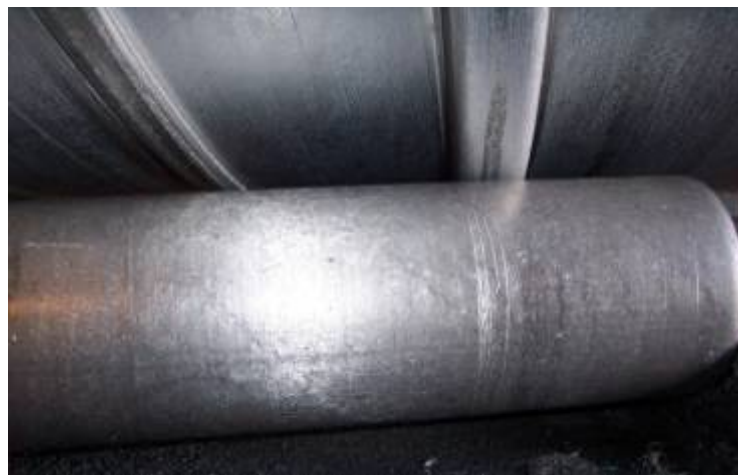
Figure 1-3. Minor Scratches During Fabrication Spiral Rib Pipe. [Photograph by the Author].

During the fabrication of pipes, minor scratches and surface blemishes due to the rolling process and handling of the pipes are normal. As shown in Figure 1-3, aluminized stock rolls over against other metal components during the forming process, and signs of minor scratching are readily observed.

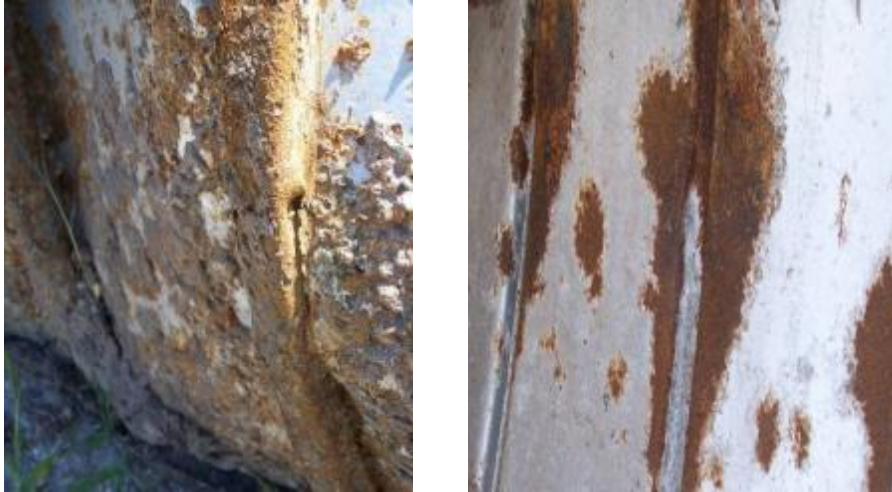
Figure 1-4. Corroded Pipe from the Curlew Rd. Site, Pinellas County, Fla. (2007)
[Photograph by the Author].

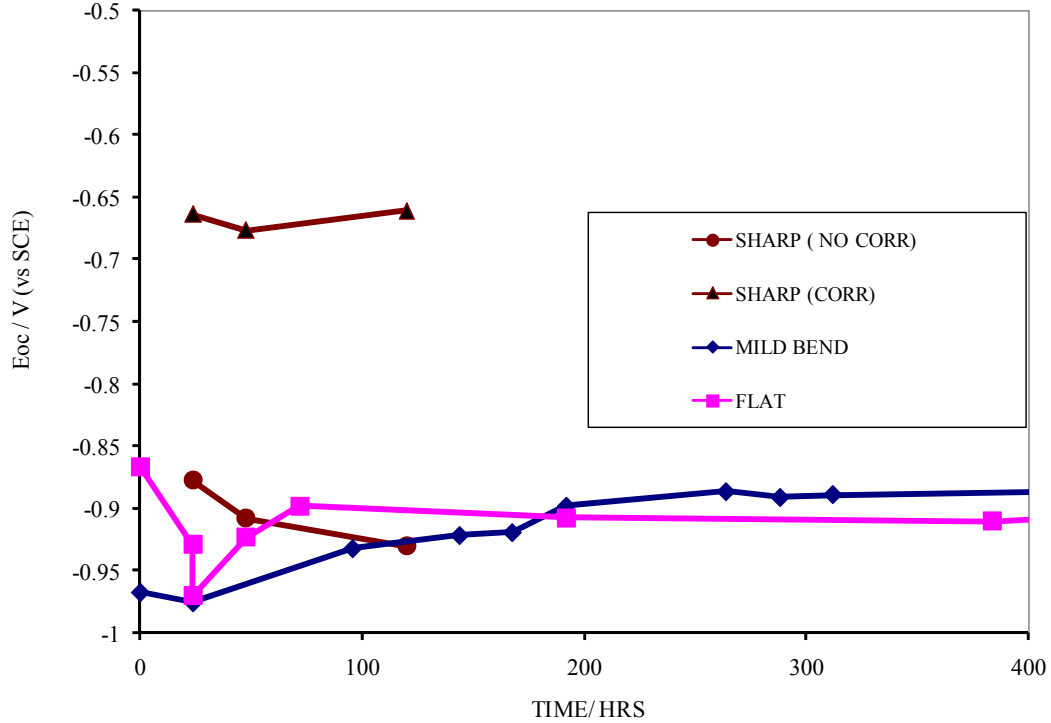
Figure 2-8. E_{OC} Trends with Exposure Time in Immersion-Cell System

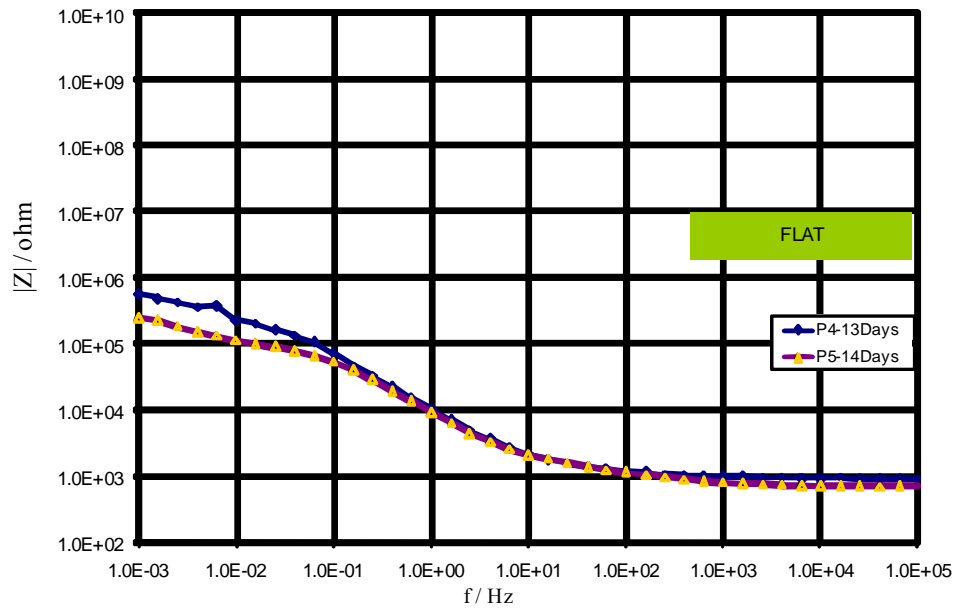
Figure 2-9. EIS Behavior of Flat Specimens in Sponge-Cell System

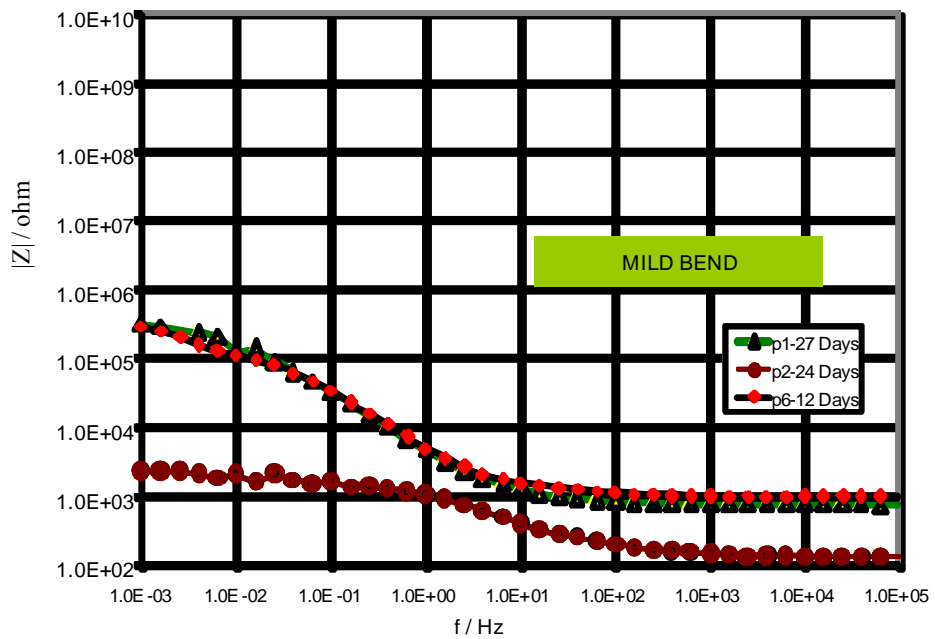
Figure 2-10. EIS Behavior of Mild Bent Specimens in Sponge-Cell System

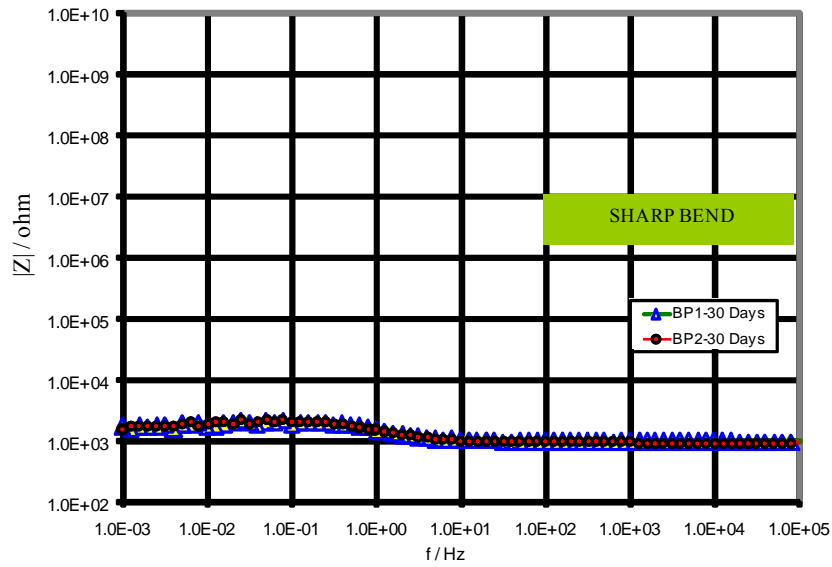
Figure 2-11. EIS Behavior of Sharp Bent Specimens in Sponge-Cell System

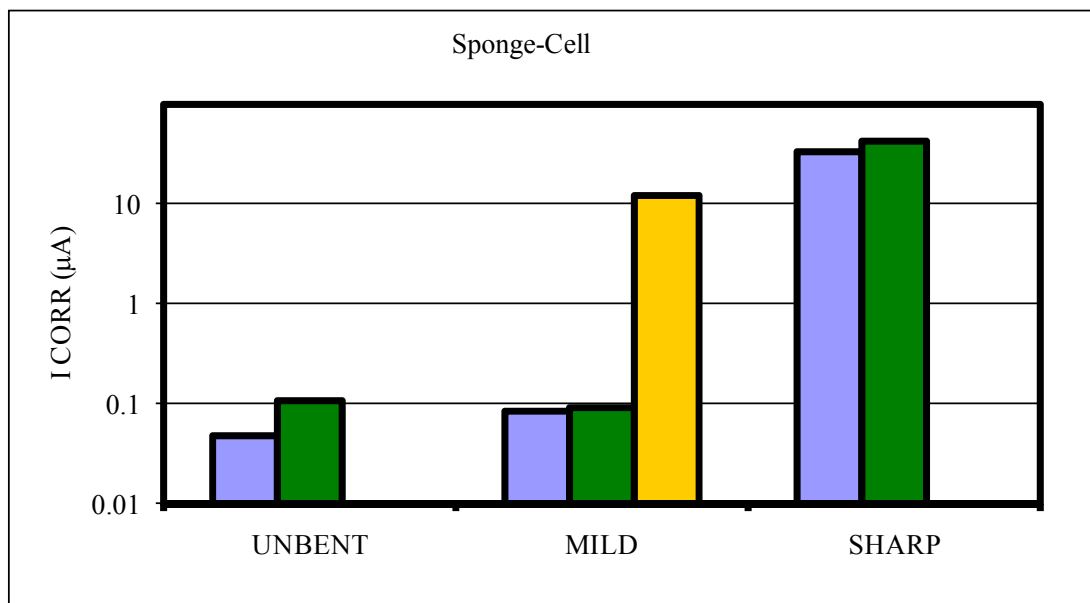
Figure 2-12. I_{Corr} Trend of Specimens with Various Radii in Sponge-Cell System

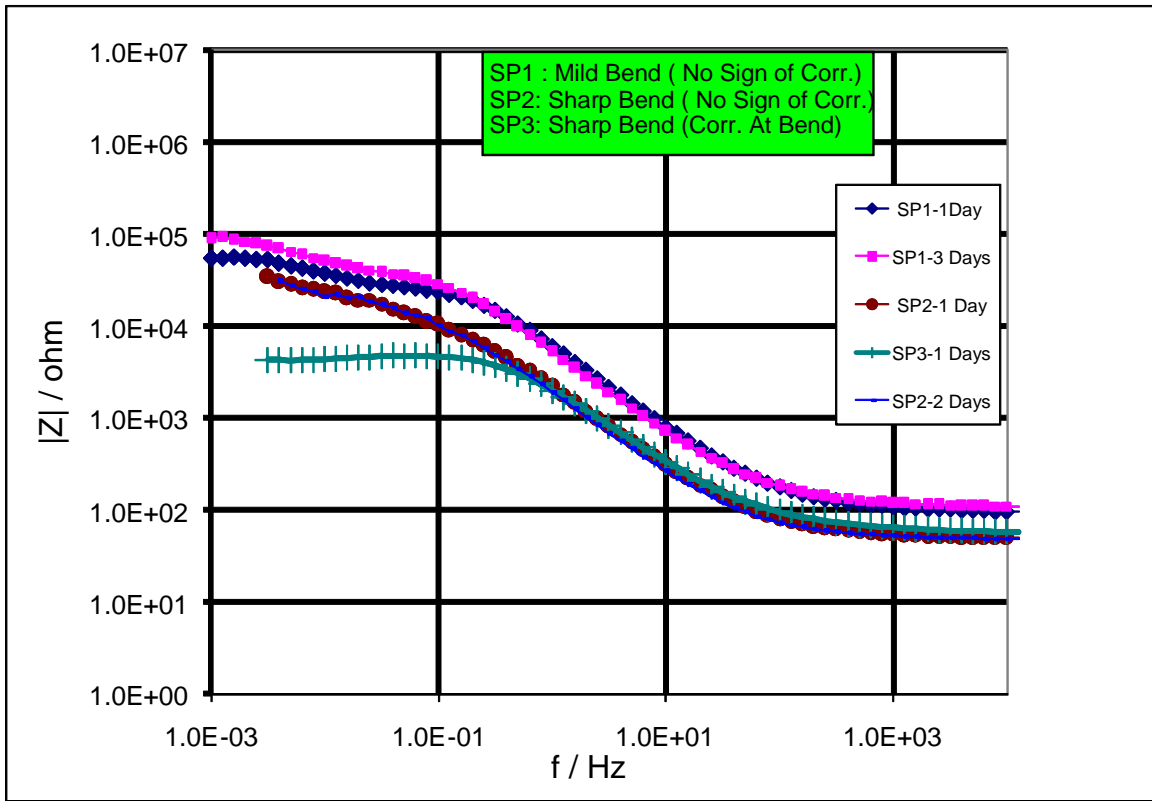
Figure 2-13. EIS Behavior of Bent Specimens in Immersion-Cell System

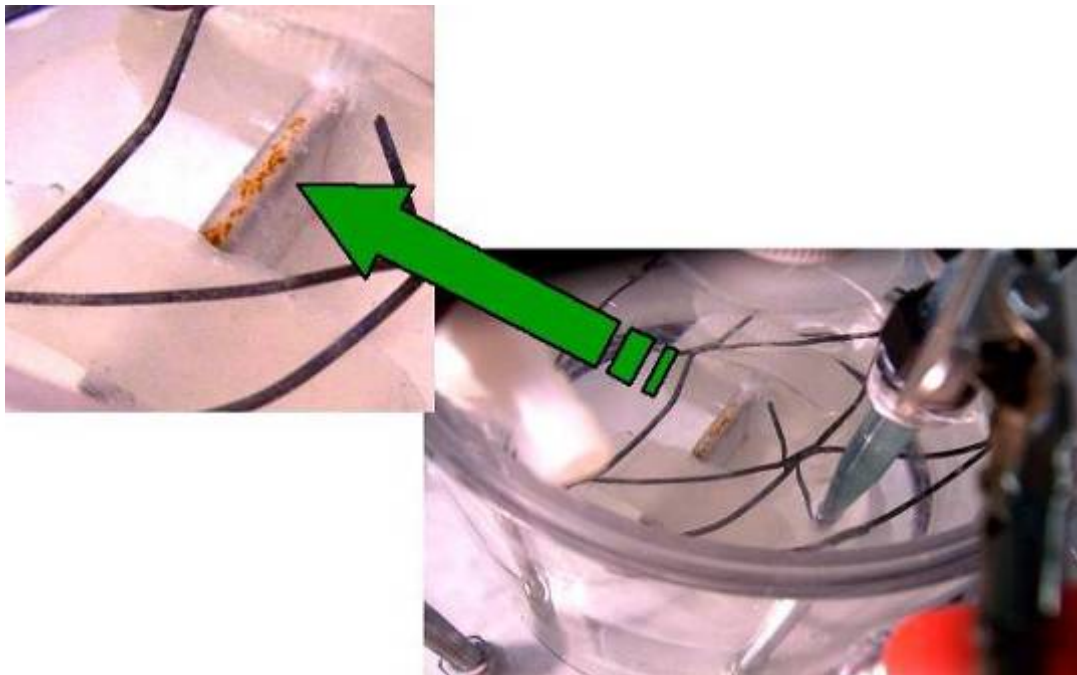
Figure 2-15. Immediate Sign of Corrosion at Bend Region in Immersion-Cell Samples

The bend region was covered in the sponge-cell specimens so it was not amenable for direct examination early in the test. sponge-cell specimens were not opened until late in the test exposure when extensive corrosion had taken place, so those results will not be considered. In the immersion-cell system, no crevice corrosion was observed in any of the samples. A sharp-bend specimen clearly showed corrosion signs (red rust) at the bend region soon after exposure began.

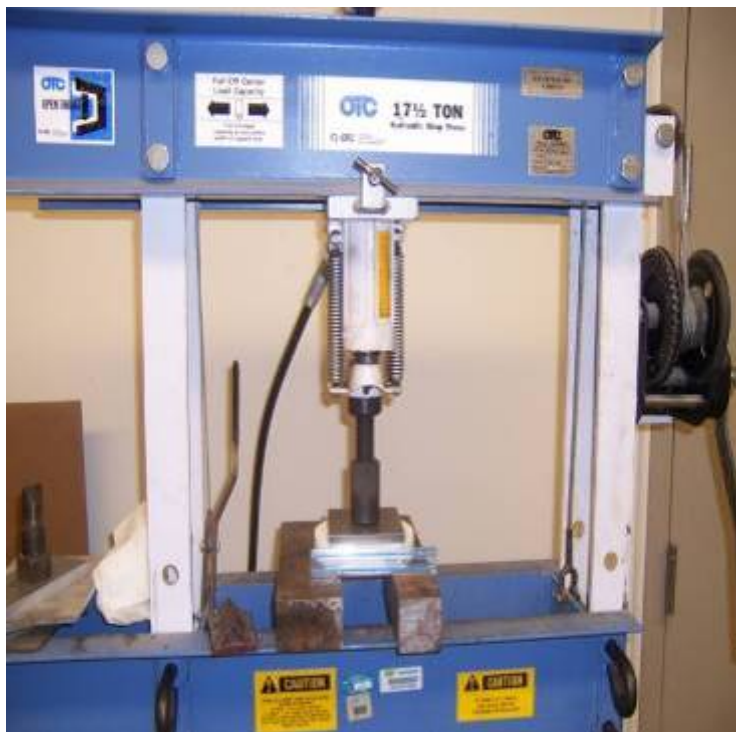
Figure 3-1. Dimpling Specimens Using a Press-Sketch Shows Dimensions for the 1-in Ball Case.

Circular 16-gage aluminized steel specimens with exposed area of 12.56 in² (82 cm²), and with minimal as-received surface distress were hemispherically indented at the center using stainless steel ball-bearing balls with diameters of 1 in (2.54 cm) , 3/4 in (1.90 cm), or 9/16 in (1.43 cm) as shown in Figure 3-1. The indentation was made by pressing the bearing ball, socketed in a steel plate into the initially flat specimen. An indented Teflon plate was used to protect the convex face of sample until full hemispheric penetration was achieved. The convex face was the one later exposed to the test solution. Afterwards, the specimens were cleaned with ethanol and acetone, and stored in a desiccator prior to immersion. Figure 3-3 shows the appearance of the dimpled specimens. Control flat specimens without surface indentation were also used for comparison. Multiple specimens were prepared for duplicate testing.

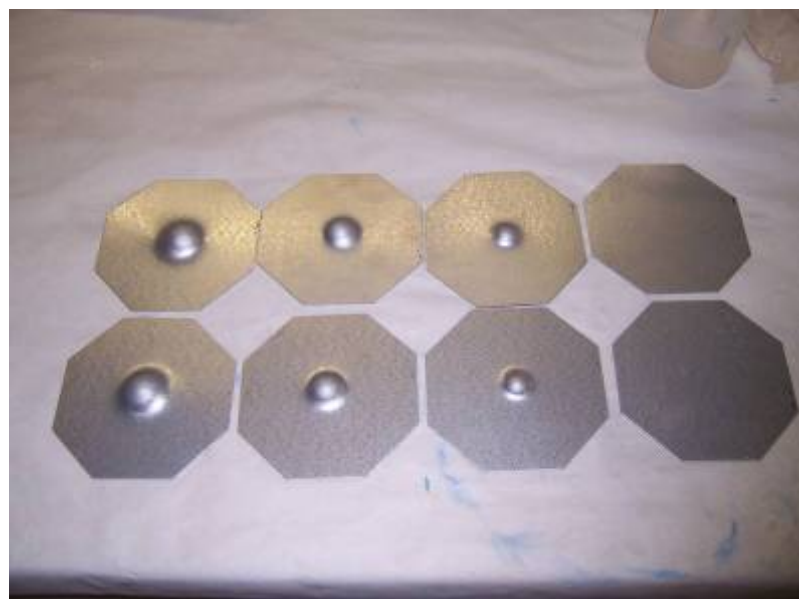
Figure 3-3. Duplicate Aluminized Steel Specimens (Left to Right) 1-in, $\frac{3}{4}$ -in, 9/16-in, and Flat

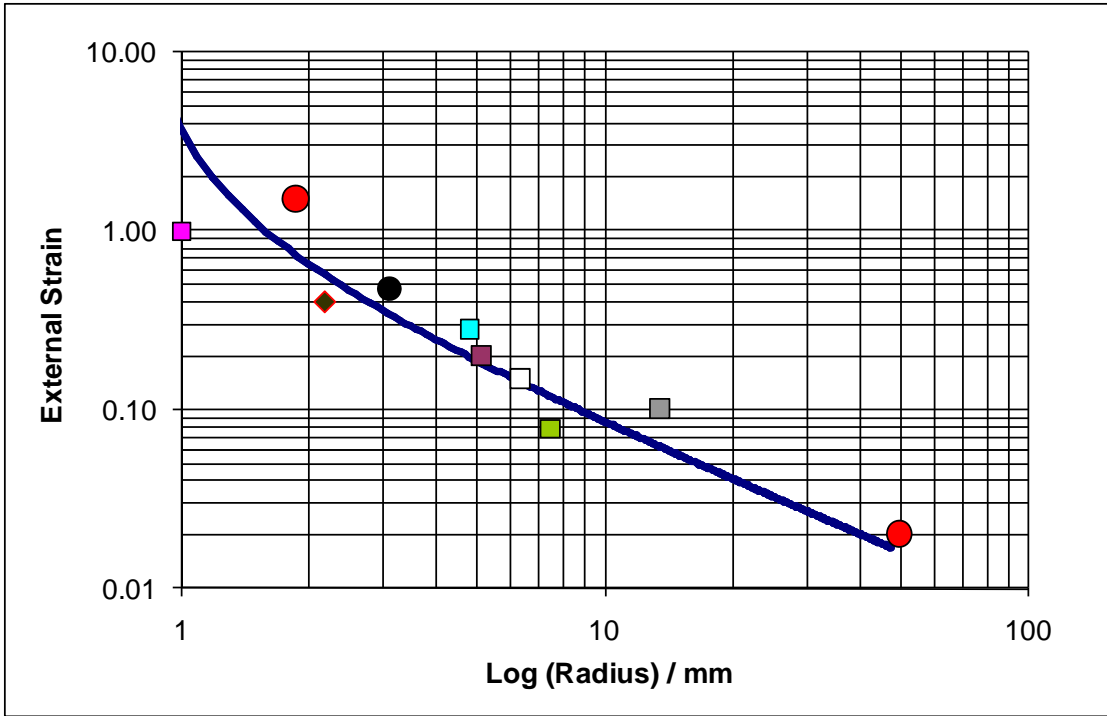
Figure 4-3. Outer Strain (ϵ_1 per Eq(1), solid line) and ϵ_M per Micrographic Analysis of Intermetallic Layer gaps, symbols) as Function of Radius of Curvature for Several Samples

Figure 4-2 compares the values of ideal outer fiber strain computed per Eq(1) from the radius of curvature (determined for various specimens from the low magnification micrographs) and the sheet thickness, and ε_M from the micrographic analysis of the intermetallic layer (Figure 4-5). Flat samples were assigned a radius > 50 mm in the graph. The results show good agreement between measured and expected strain, supporting the hypothesis of nearly completely brittle behavior for the inner intermetallic layer. Tests in progress address behavior of specimens bent by spherical indenting and ductile fracture of the outer layer, which will be reported in the future.

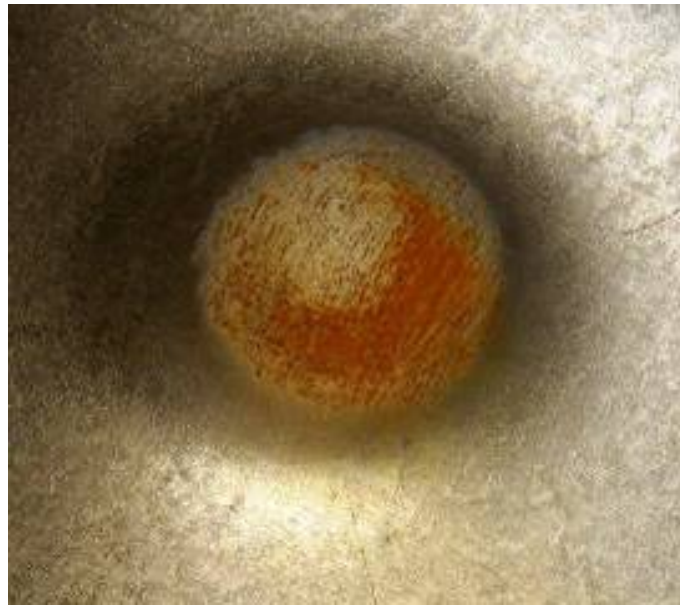
Figure 4-5. Severe Corrosion at a 1-in Convex Dimple Exposed to Solution C. (Picture shows immersed sample surface at 19 days exposure).

Symptoms were more severe in solution C (low alkalinity and hardness, with no precipitating tendency), where strong reddish discoloration was first noted early on the convex indentation of all dimpled specimens, and gradually propagating covering the entire indentation surface (Figure 4-5).

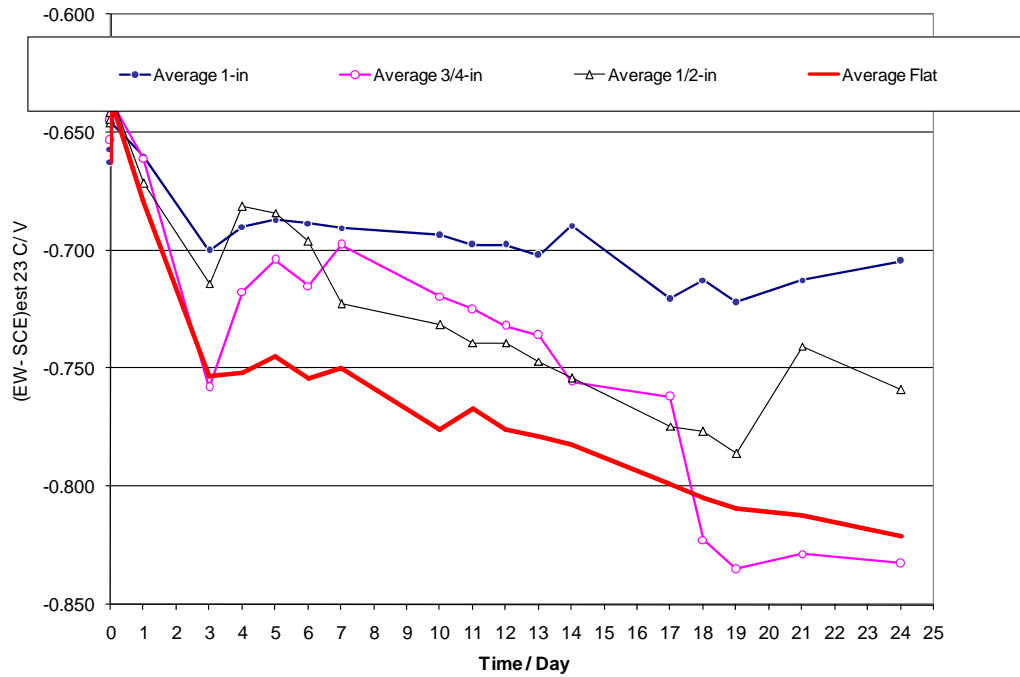
Figure 4-7. E_{OC} Trends versus Exposure Time in Solution C

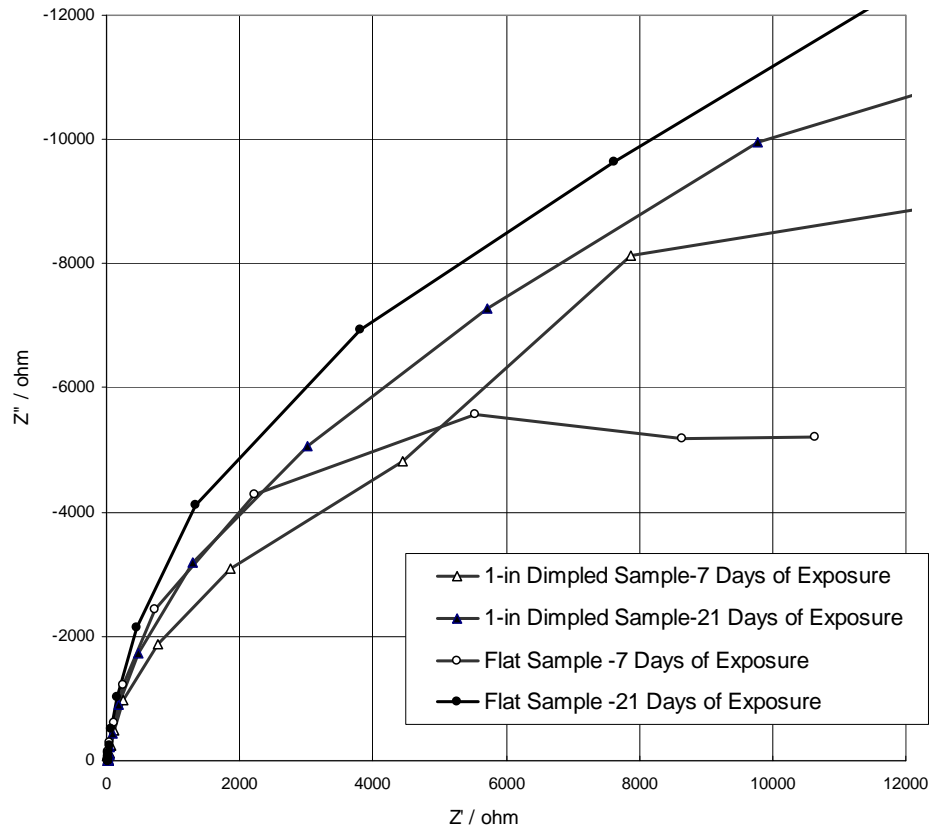
Figure 4-11. EIS Results of the Flat and 1-in Indentation Specimens Exposed to Solution P. Bode Diagram Is Presented in Appendix C.

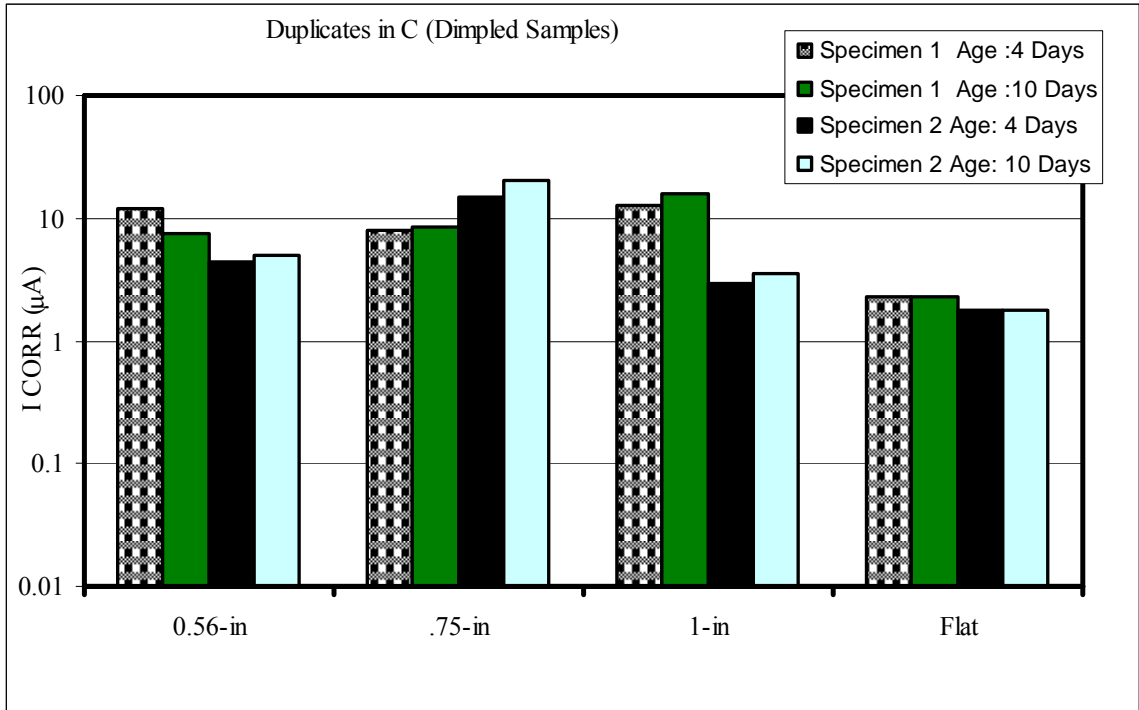
Figure 4-14. I_{Corr} Trend of Deep Drawn Specimens with Various Radii in Solution C

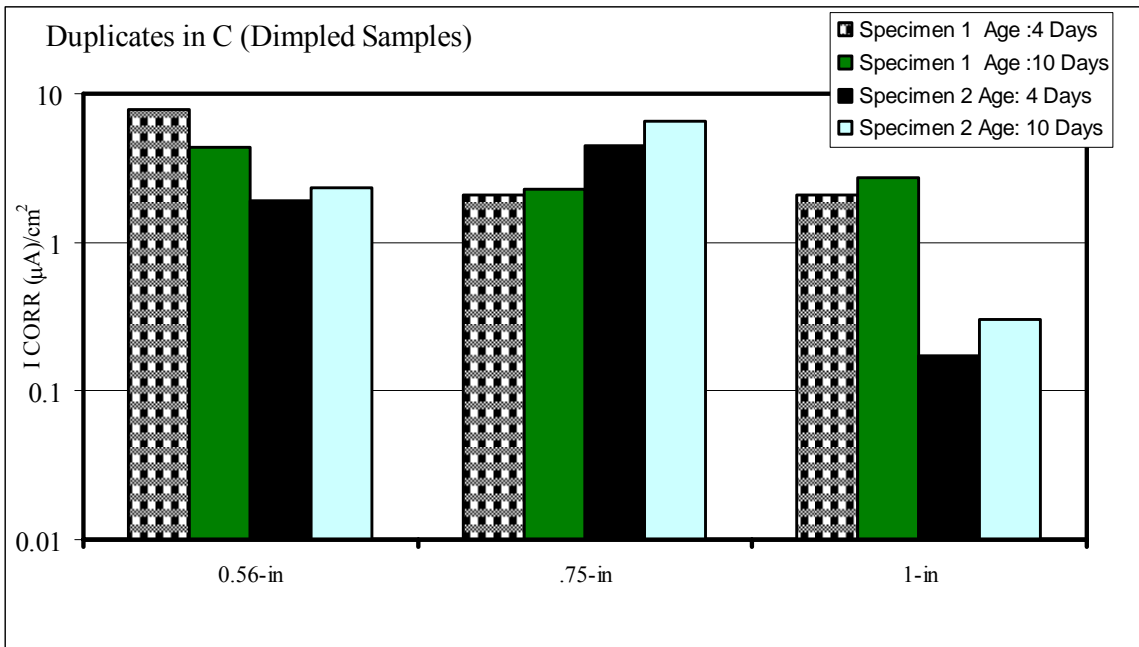
Figure 4-16. i_{CORR} (Nominal Current Density) Trend of Deep Drawn Specimens with Various Radii in Solution C

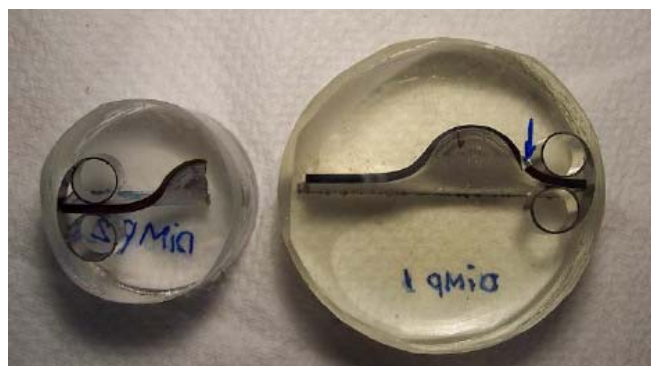
Figure D-3. Metallographic Dimpled Samples
