Operational and safety effects of signage and lighting configurations for public transit buses in Florida

A thesis submitted in partial fulfillment of the requirements for the degree of Master of Science in Civil Engineering Department of Civil and Environmental Engineering College of Engineering University of South Florida

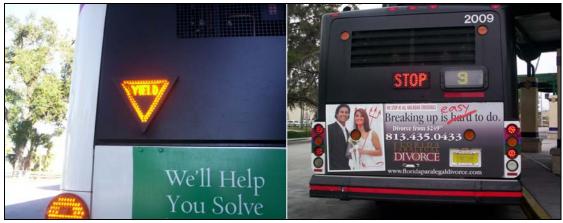
Figure 2 YIELD and STOP LED Lights

Additional light emitting diode (LED) lights and deceleration lights are sometimes added to improve bus safety. Options available in LED lights include lights that spell the word STOP and YIELD (Figure 2). Transit agencies may also change the positions of amber and red lights and increase the size of the lights. Reflective tape is also used to increase the conspicuity of buses. Other lighting used to improve the conspicuity of the bus includes daytime running lights, additional lights around the bus, and strobe lights. LED lights have additional benefits as they are said to have a useful life approximately 100 times greater than incandescent bulbs. Incandescent lights have been traditionally used for the external lighting on buses.

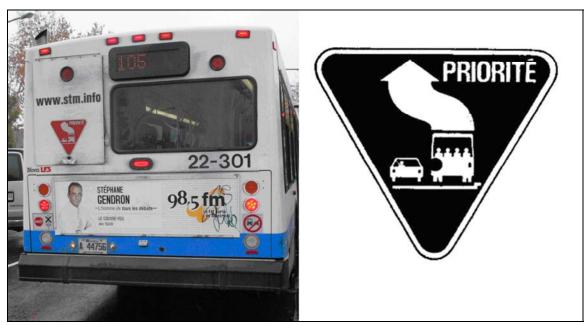
Figure 5 Société de Transport à Montréal Bus in Montreal, Canada

Yield-to-Bus legislation has been in effect in Quebec since 1982. The law was drafted similar to the European laws. A decal is placed on the lower-left corner of the rear window of the bus. The decal consists of an inverted equilateral triangle with sides 38 cm and a red message on a white back ground (Figure 5).

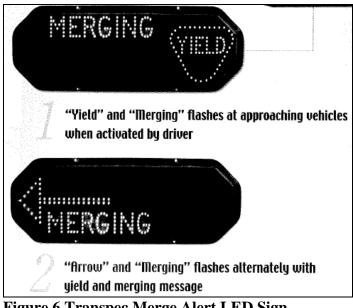
Figure 6 Transpec Merge Alert LED Sign

Other signage directly related to YTB programs includes light emitting diode (LED) signs. These LED signs generally consist of a flashing "YIELD" sign activated by the bus operator when he or she attempts to re-enter the traffic lane. In 2006, Transpec Worldwide introduced a new LED flashing sign for the YTB programs. The new Transpec Merge Alert motorist warning device has been developed to assist with motorist education of YTB laws. The merge Alert delivers a highly-visible, high-brightness LED message that the bus is merging back into traffic. The device flashes a "Yield" sign, along with the word "MERGING," and then alternates to a flashing, left pointing "ARROW" along with a second "MERGING" text (Figure 6). In transit operations tests, the Merge Alert significantly reduces difficulty in the bus reentering traffic and reducing rear-end collisions.

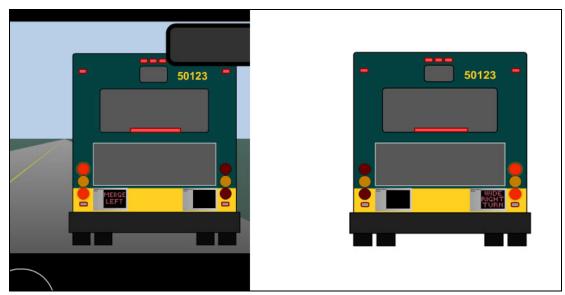
Figure 7 Advanced Safety Wheel and Hubs Alert System

Another company developed a merge alert and wide-turn alert system. The Advance Safety Wheel and Hubs, LLC company has been developed a system to prevent accidents from wide right turns and assisting the operator to re-enter traffic a stop. For this concept, two safety control boards are placed on the back of transit buses, parallel to each other (Figure 7). On the left side, rear end of the bus, the control board is activated by the left turn signal. The message "Merging Left" flashes, then strolling arrows pointing left, and then the message "Thank You" when the turn signal is turned off. On the right side rear end of the bus, the control board is activated by the right turn signal activating the message "Wide-Right Turn", then strolling arrows pointing right. A "Thank You" message appears when turn signal is turned off.

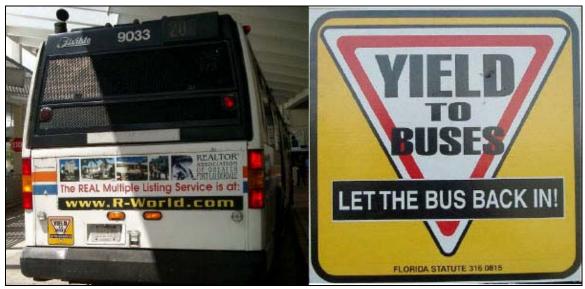
Figure 8 BCT Decal

Broward County Transit (BCT) in Florida uses a reflective Yield-to-Bus (YTB) decal on the lower-left rear corner above the bumper of the bus. The decal is an equilateral triangle with sides approximately 18 inches in length as shown in Figure 8 (King 2003). The triangle is red on a yellow background with white words on a black background. BCT also considered using an electronic flashing yield sign but they were concerned with electrical power load (King 2003).

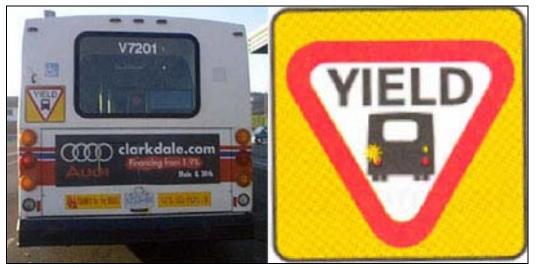
Figure 9 CMBC Decal

Coast Mountain Bus Company (CMBC) in Canada uses a reflective square decal with sides approximately 10 inches in length. Inside the square is a red equilateral triangle on a yellow background as shown in Figure 9 (King 2003). Inside the triangle is white with "Yield" written in black letters and the silhouette of a bus below it. The decal is located to the left of the rear window on the back of the bus. A decal was chosen over the electronic yield sign because the decal was significantly less expensive; however, some CMBC buses that operate in West Vancouver use LED yield sign in combination with the decal. On the rear bumper, CMBC also includes YTB-related decal signs that say "Thanks for the Brake" and "Please Yield it's the Law", as shown in Figure 10 (King 2003).

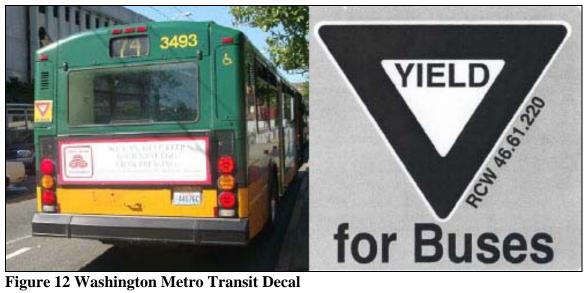
Figure 12 Washington Metro Transit Decal

Metro Transit uses a reflective decal located to the left of the rear window on the back of the bus. They chose this location because a lower location was believed to be too difficult for the second and third following vehicle to see. The decal consists of a red triangle on a yellow back ground. Inside the triangle is white with the word "Yield" inside and "For Buses" directly below the triangle as shown in Figure 12 (King 2003).

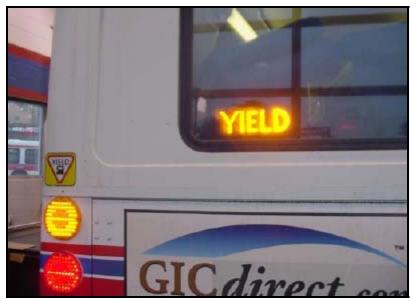
Figure 13 British Columbia Transit YTB Decal and Yield LED Sign

British Columbia (BC) Transit uses a six inch square reflective yield decal and a LED yield sign. Inside the square is a red equilateral triangle on a yellow background. Inside the triangle is white with "Yield" written in black letters and the figure of a bus below it. This decal is used throughout British Columbia and is similar to the CMBC decal. The LED yield sign is located in the lower-left corner of the rear window as shown in Figure 13 (King 2003).

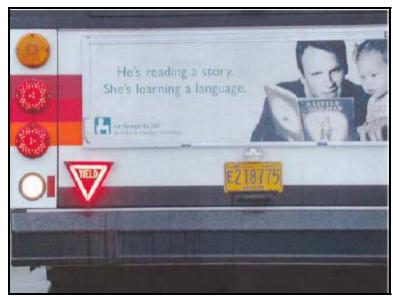
Figure 14 Tri-Met LED Yield Sign

In Oregon, specifications have been developed by the Oregon Transportation Commission for a yield sign that includes a 6.75 tall triangle with the word "Yield" inside. Both the triangle and yield message must be red when flashing. Tri-County Metropolitan Transportation District (Tri-Met) uses a red LED flashing yield sign with a triangle that is approximately eight inches on each side as shown in Figure 13 (King 2003). The flashing yield sign is located on the lower-left corner above the bumper. A control switch is used by the bus operator to activate the yield sign. The operator first activates the amber turn signal then the yield sign. The yield sign is deactivated when the left turn signal switch is released.

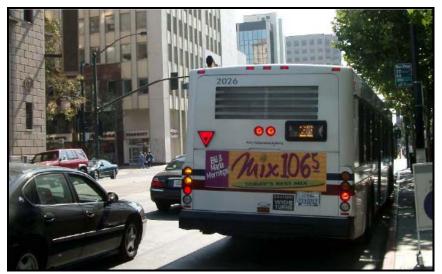
Figure 17 Santa Clara Valley Transportation Authority Bus with LED Yield Sign

California law requires that buses be equipped with a yield right-of-way sign on the left rear of the bus. The sign must be illuminated by a flashing light when the bus is signaling to enter a traffic lane. The Santa Clara Valley Transportation Authority (VTA) and the Santa Cruz Metropolitan Transit District use the same flashing yield sign as Oregon, mounted on the rear left of the bus above the engine access door as shown in Figures 17 and 18 (King 2003). The yield sign is activated first, followed by the left turn signal and both signals will stop when the left turn signal is turned off. Arming the yield signal first allows the bus operator to have both hands on the steering wheel when pulling out from a stop. After 10 to 15 seconds, the yield sign deactivates therefore if the operator cannot move before then, the left turn signal must be released and the yield control button pushed again.

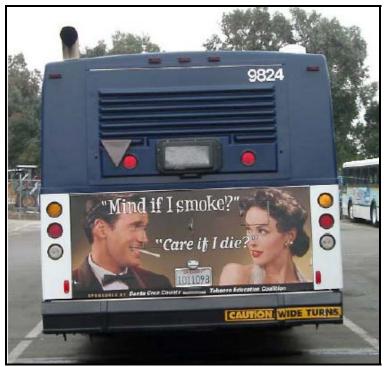
Figure 18 Santa Cruz Metropolitan Transit Bus with Yield LED Sign

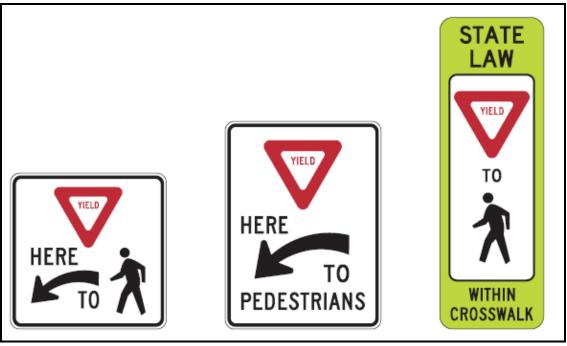
Figure 24 MUTCD Yield to Pedestrians Signs

The yield line consists of individual triangles with a base of 300 to 600 mm (12 to 24 in) wide and a height equal to 1.5 times the base. The space between the triangles should be 75 to 300 mm (3 to 12 in). Yield lines may be used to indicate the point behind which vehicles are required to yield in compliance with a yield sign (Figure 23) or a "Yield Here to Pedestrians" (Figure 24) sign. Yield lines are placed a minimum of 1.2 m (4 ft) in advance of the nearest crosswalk line at controlled intersections, except for yield lines at roundabout intersections and at midblock crosswalks. In the absence of a marked crosswalk, the stop line or yield line is placed at the desired stopping or yielding point, but should be placed no more than 9 m (30 ft) nor less than 1.2 m (4 ft) from the nearest edge of the intersecting traveled way. If used at an unsignalized midblock crosswalk, yield lines are placed adjacent to the "Yield Here to Pedestrians" sign located 6.1 to 15 m (20 to 50 ft) in advance of the nearest crosswalk line, and parking should be prohibited in

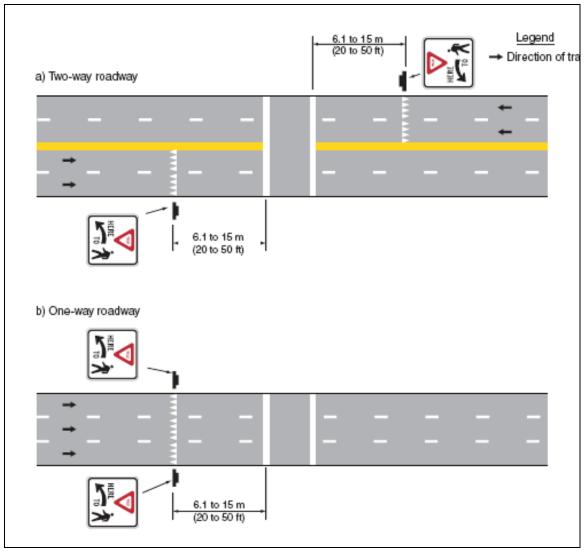
Figure 25: MUTCD Placement of Yield Markings

the area between the yield line and the crosswalk (Figure 25). Drivers who yield too close to crosswalks on multi-lane approaches place pedestrians at risk by blocking other drivers' views of pedestrians. Yield lines are shown in Figure 26.

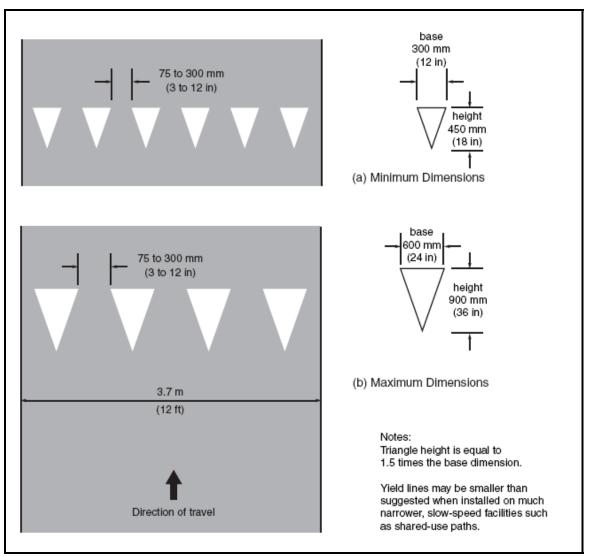
Figure 26 MUTCD Yield Pavement Markings

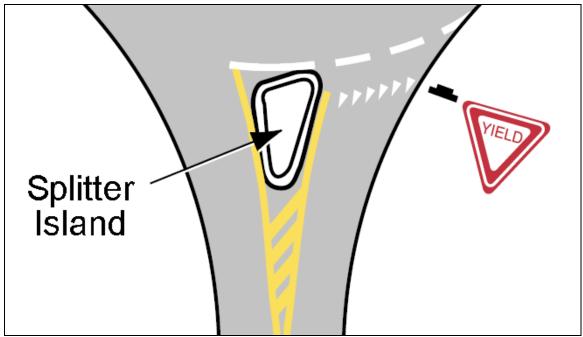
Figure 27 MUTCD Yield Marking for Roundabout

At roundabout intersections, a yield line (Figure 27) may be used to indicate the point behind which vehicles are required to yield at the entrance to a roundabout intersection (US Department of Transportation Federal Highway Administration 2002).

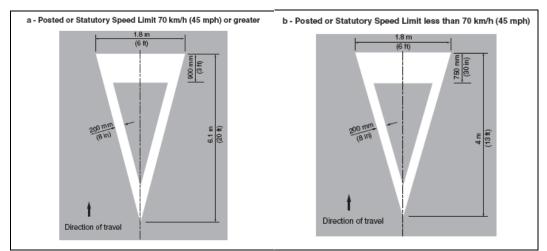
Figure 28 MUTCD Yield Ahead Triangle

A yield-ahead triangle symbol (Figure 28) or "Yield Ahead" word pavement marking may be used on approaches to intersections where the approaching traffic will encounter a yield sign at the intersection. The yield-ahead triangle symbol or "Yield Ahead" word pavement marking cannot be used unless a yield sign is in place at the intersection.

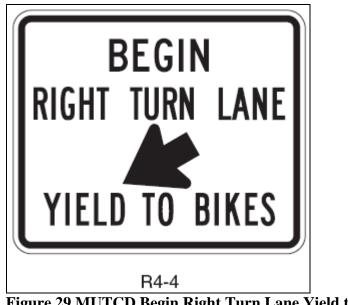
Figure 29 MUTCD Begin Right Turn Lane Yield to Bikes Sign

Other yield signs available are for yielding to bicyclists. The sign is 900 mm by 750 mm. The sign is used where motor vehicles entering an exclusive right-turn lane must weave across bicycle lanes; the "Begin Right Turn Lane Yield to Bikes" (R4-4) sign (Figure 29) may be used to inform both the motorist and the bicyclist of this weaving maneuver.

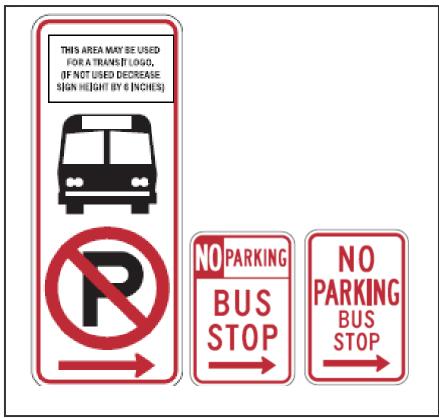
Figure 30 MUTCD No Parking Signs Related to Transit Stops

The MUTCD also does not have any standard signs to warn road users of the possibility of vehicles unexpectedly stopped in the travel lane but they do have general guidelines for signs governing the parking, stopping, and standing of vehicles. Discussions of parking signs and parking regulations in Section 2B.40 of the MUTCD apply to parking and stopping. Prohibitive signs should have a red legend and border on a white background while permissive signs should have a green legend and border on a white background. Alternate designs may include, on a single panel, a transit logo, an approved bus symbol, the words "Bus Stop", and an arrow. The preferred bus symbol color is black, but other dark colors may be used. Additionally, the transit logo may be shown on the bus face in the appropriate colors instead of placing the logo separately. The reverse side of the sign may contain bus routing information. Parking prohibition signs around bus stops are illustrated in this section of the MUTCD (Figure 30).

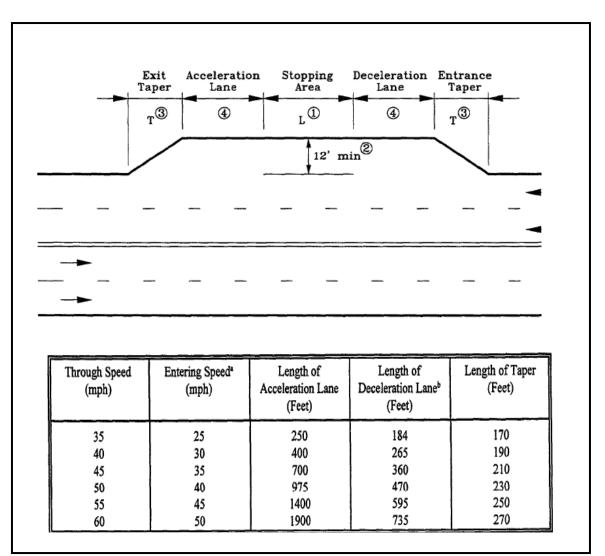
Figure 31 Bus Bay Configuration

TCRP Report 19 contains the factors which would lead to the construction of bus bays. Bus bays should be considered on roads where curb lane traffic exceeds 250 vehicles during the peak hour but bus drivers will not use bus bays when traffic volumes exceed 1000 vehicles per hour per lane. Heavy volumes make it very hard for buses to merge back into the flow of traffic. Acceleration lanes, signal priority, or far-side placements are potential solutions for this. Bus bays are ideal where traffic speeds exceed 40 miles per hour, where vehicles are prone to collide with the rear end of a stopped bus and locations with high passenger volumes or where the dwell time exceeds 30-seconds during peak hours. Areas where there are extended layover times and high volumes of buses at peak hours are also ideal for bus bays. Bus bays should be designed to reduce automobile-bus conflict, provide greater separation between traffic and pedestrians waiting for the bus, and allow the bus to quickly regain its travel speed upon re-entry into the traffic (Florida Planning and Development Lab 2004). The total length of a bus bay consists of an entrance taper, deceleration length, stopping area and acceleration length. Figure 31 shows the bus bay dimensions based on through speed and entering speed (Florida Planning and Development Lab 2004).

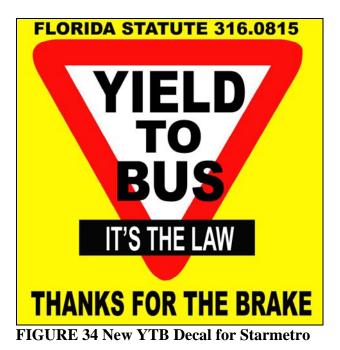
Based on the results of the literature review and preliminary bus operator surveys, a new YTB decal was designed by the Center for Urban Transportation Research and produced by Next Day Signs to be tested on Starmetro buses in Tallahassee. The new decal was made larger than the average decal in Florida to see if the larger sign has any effect on a transit system that previously never employed any YTB signage or lighting. Ten decals were made using reflective vinyl. The decal was made as an 18 inch square with the Florida Statute listed (Figure 34). The design of the new decal was based on results from the literature review, bus operator survey and the MUTCD yield sign. In the narrative portion of the questionnaire, some bus operators recommended a larger YTB decal; therefore the new test decal was made larger than the typical decals seen in Florida. The red triangle, which is the sign used in the MUTCD was also made brighter and more like the MUTCD yield sign. The basic elements of the YTB decal were made similar to other YTB decals used in Florida. Initially, a large 69 inch decal, similar to the one used by Lynx in Orlando was considered but Starmetro did not want this larger decal to conflict with advertising on the back of the bus.

The Starmetro bus fleet consisted of 68 buses and the maintenance personnel were instructed to put the decals in the upper-left corner of the rear door panel of 10 buses.

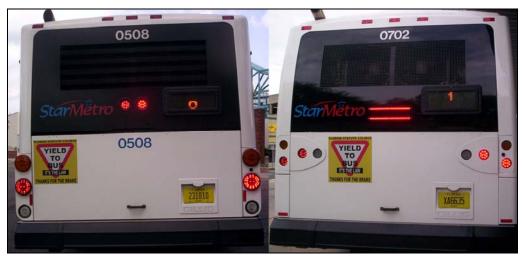
Figure 39 Starmetro Decal Placements

No significant findings were obtained from video data of the new decal used at Starmetro possibly because the video was take the same day the new decals were implemented. During the hours of data collection there was no significant difference in motorists' behavior around buses with and without the new decal. Video data was collected the morning after the new decals were implemented therefore the motorists possibly did not have a chance to react to the new signs. Operator questionnaires were then distributed 2 weeks after the new decals were implemented to see if they noticed any difference in motorists' behavior after 2 weeks. Forty-one percent of operators said there was a noticeable difference in yield behavior but a few operators commented in the narrative section that they are still not used to the new decals. The decals were restricted to buses that did not have advertising on the back and also to the newer Gillig buses since the older RTS models did not have adequate space to accommodate an 18 inch decal. The lighting configuration on the back of the buses constrained the exact location of the decal. On the older Gillig buses, the decal could be placed in the corner of the rear door panel but on the newer Gillig models, the decal had to be placed closer to the center to avoid the rear lights. Figure 39 shows the locations where the new test decals were placed on the Starmetro Gillig buses.

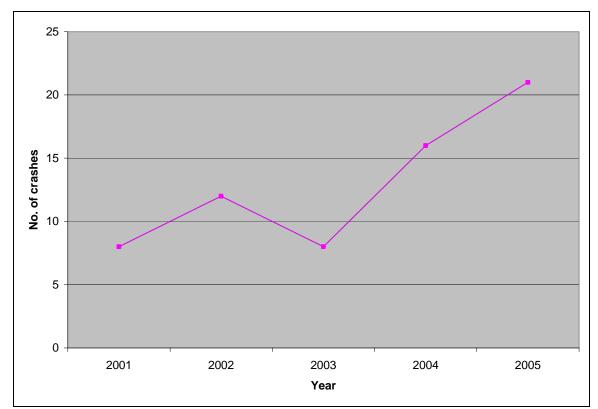
Figure 40 Hillsborough Bus Side-swipe and Rear-end Collisions

The 2003 to 2005 Hillsborough crash data shows that 34 percent of bus crashes were rear-end collisions, 23 percent were angle collisions and 24 per cent were sideswipe collisions. The bus was at fault in only 25 percent of bus crashes. There was an increase in bus accidents between 2001 and 2005 as shown in Figure 40. The HART decals were installed between 2001 and 2002 therefore they do not seem to have any effect on bus crashes.

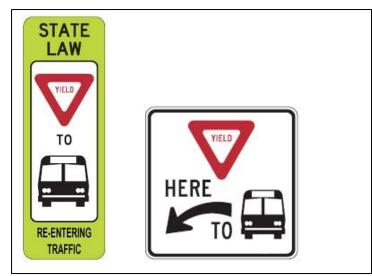
Figure 41 Yield-to-Bus Roadway Signs

Since the MUTCD currently has no signage or pavement markings for the YTB law, new signage and pavement markings can be developed based on the existing practices for yielding to pedestrians and bicyclists. A concern would be that adding more to the MUTCD may only add to driver confusion. Many roads are already congested with roadway signs and pavement markings that give drivers more information than they are able to digest. Additional signs and pavement marking for the YTB law would therefore have to be used under strict engineering judgment in areas where many conflicts are observed. Figure 39 shows possible YTB roadway signs that can be added to the MUTCD.

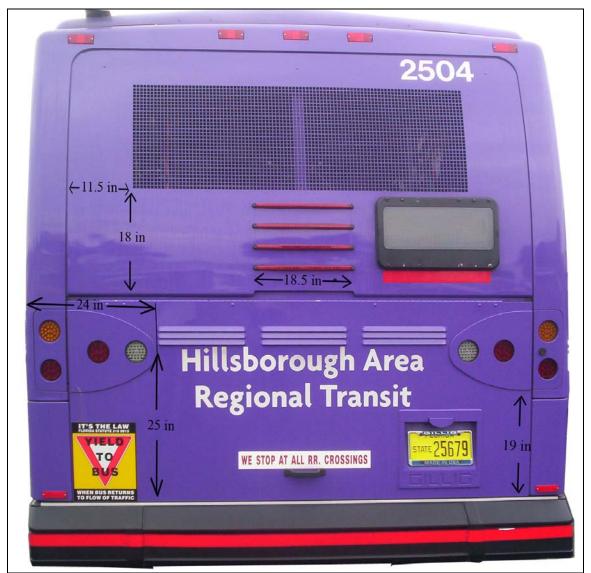
Figure 52 HART Bus with YTB Decal and Dimensions
