Fluvial erosion measurements of streambank using Photo-Electronic Erosion Pins (PEEP)

FLUVIAL EROSION MEASUREMENTS OF STREAMBANK
USING PHOTO-ELECTRONIC EROSION PINS (PEEP)

A thesis submitted in partial fulfillment
of the requirements for the Master of
Science degree in Civil and Environmental Engineering
in the Graduate College of
The University of Iowa

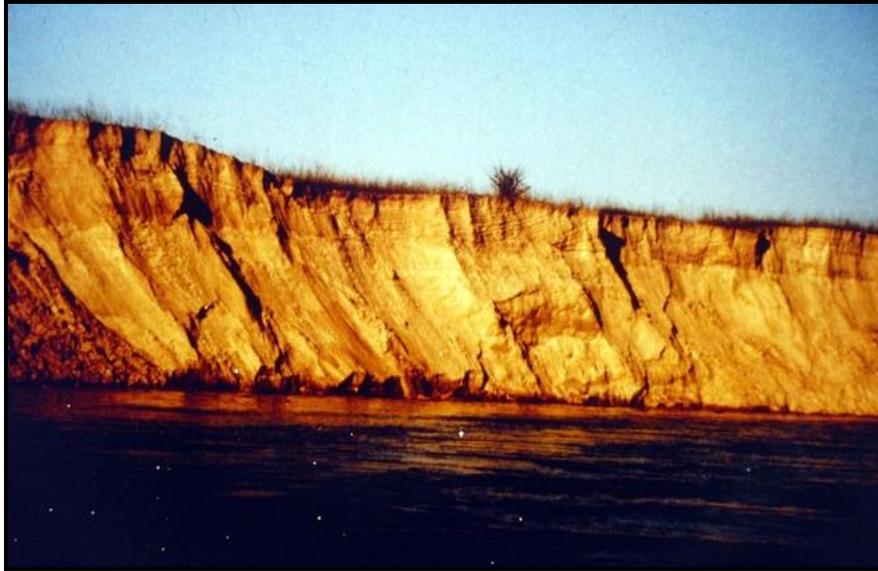
Figure 1.2 : Planar failure (Thorne et al., 1997)

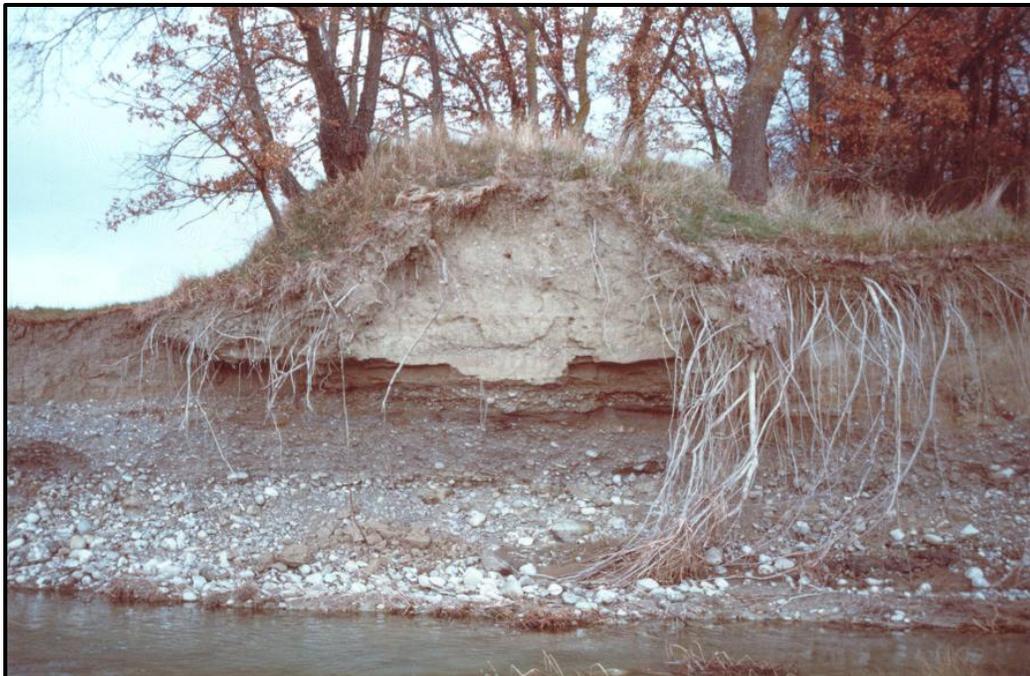
Figure 1.3: Cantilever blocks reinforced by roots in Cecina River Italy (Papanicolaou et al., 2006)

The removal of the riparian vegetation affects the bank soil properties (e.g., moisture, porous structure) and reduces the critical erosional strength of soil by a factor of 3 making the bank soil more susceptible to the action of the hydraulic forces (i.e., drag and lift forces) (Millar, 2000; Papanicolaou and Hilldale, 2001). It is the pioneering work of Wolman (1959) which demonstrated the interconnection between bank vegetation and soil properties. The modification of the vegetation patterns affects the soil properties of banks (such as soil wetness) and makes the impacts of the freeze/thaw cycle (discussed in section 1.2.4) on the reduction of soil strength more pronounced (Van Klaveren and McCool, 1998). Figure 1.3 shows cantilever blocks reinforced by the presence of roots in the Cecina River (Italy).

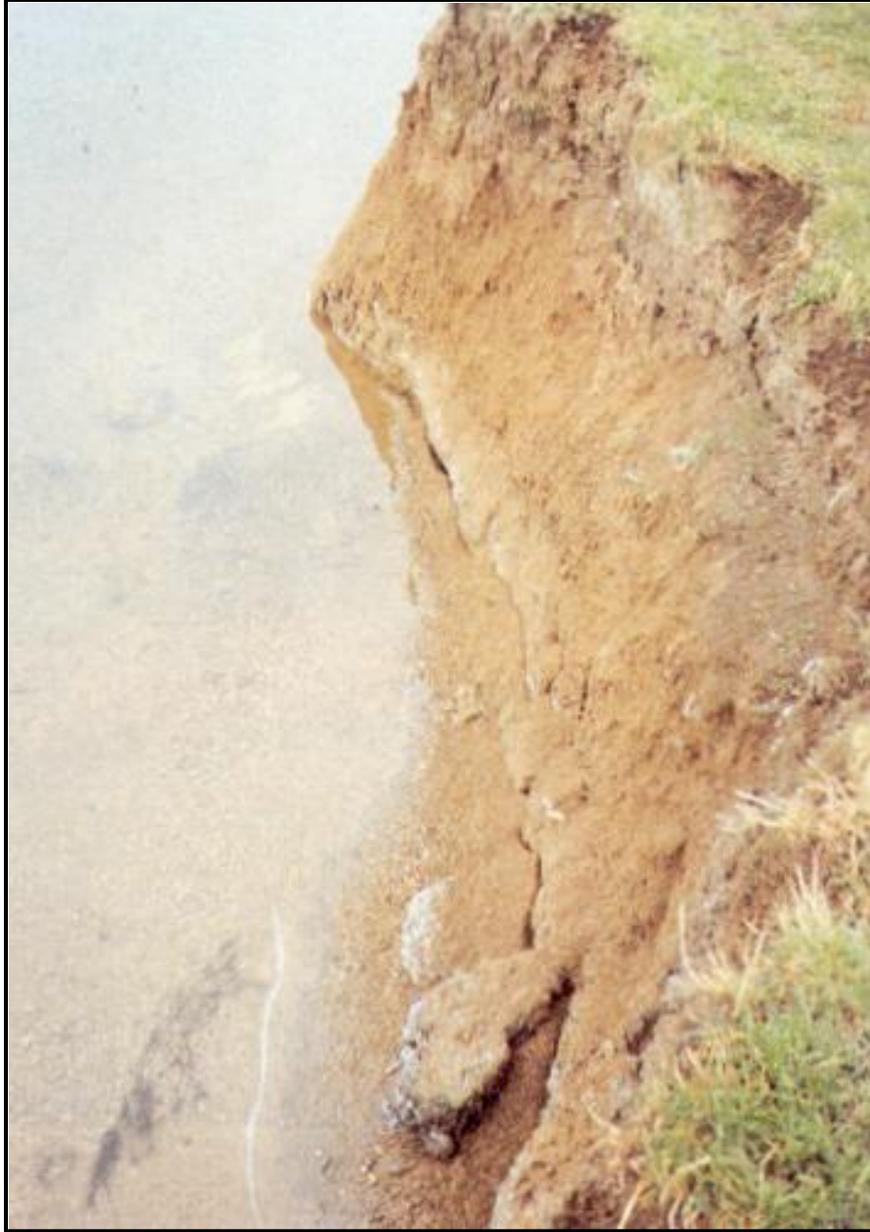
Figure 1.4: Sub-aerial processes: freeze/thaw (Thorne et al., 1997)

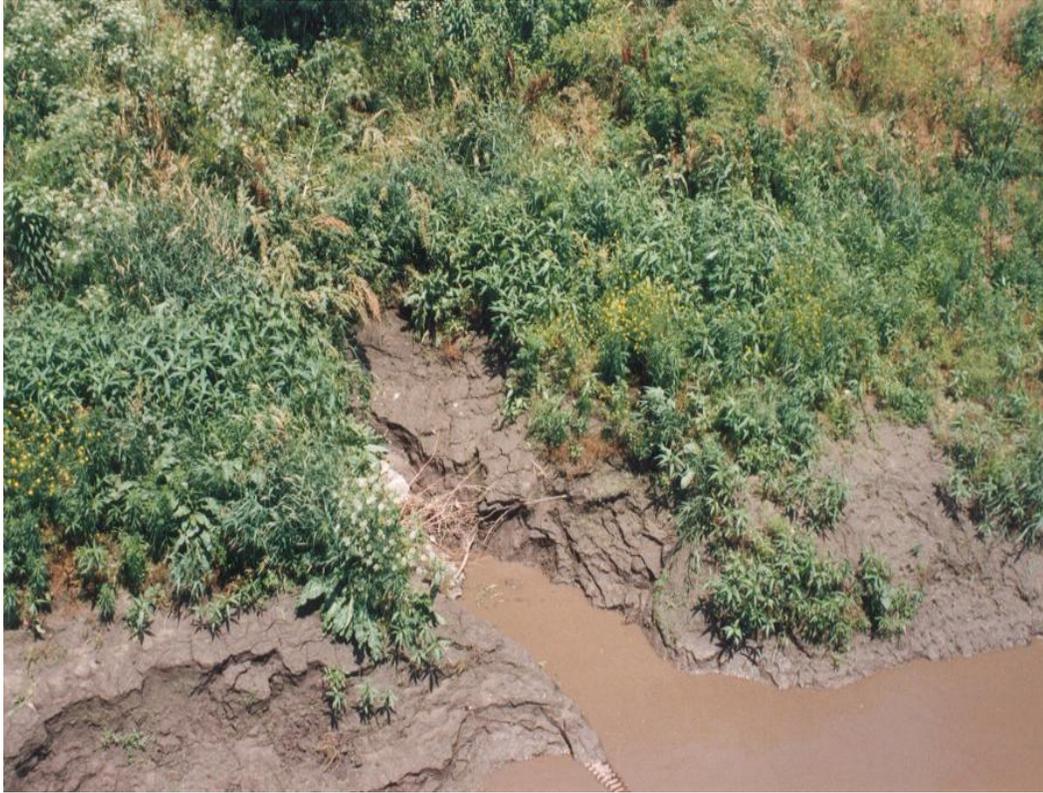
Figure 1.5: Pop-out failure in a cohesive lower bank (Midwestern US) (Papanicolaou et al., 2006)

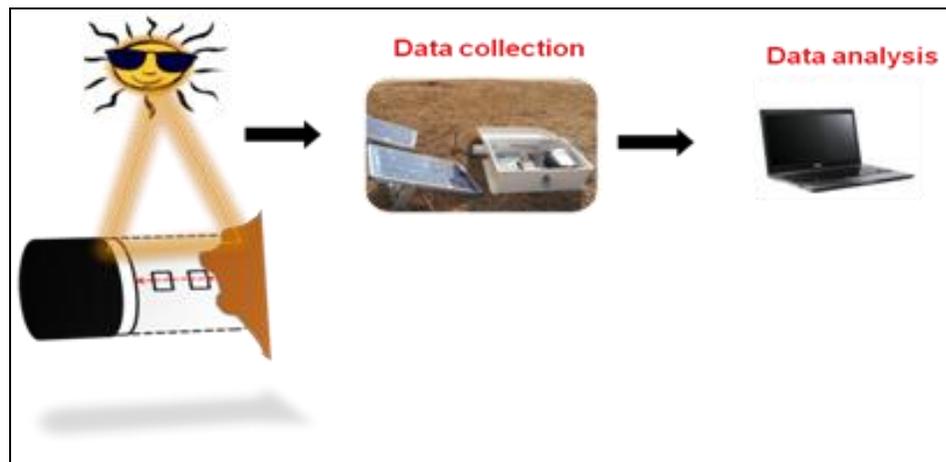
Figure 3.8: Illustration of the principle of operation of the PEEP.

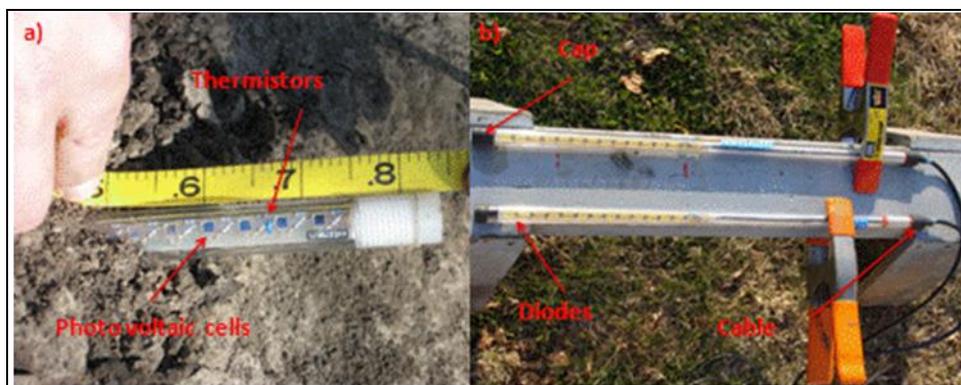
Figure 3.9: Picture of the PEEP sensors.
 (a) Photovoltaic sensor
 (b) Photo resistance sensor

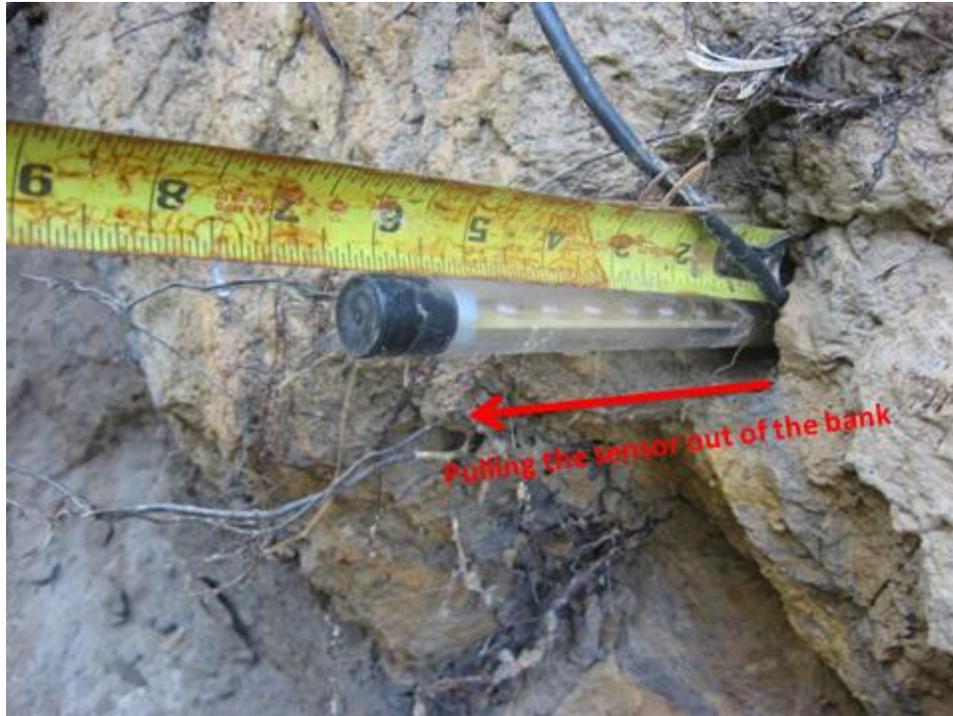
Figure 3.11: In-bank calibration of the PEEP.

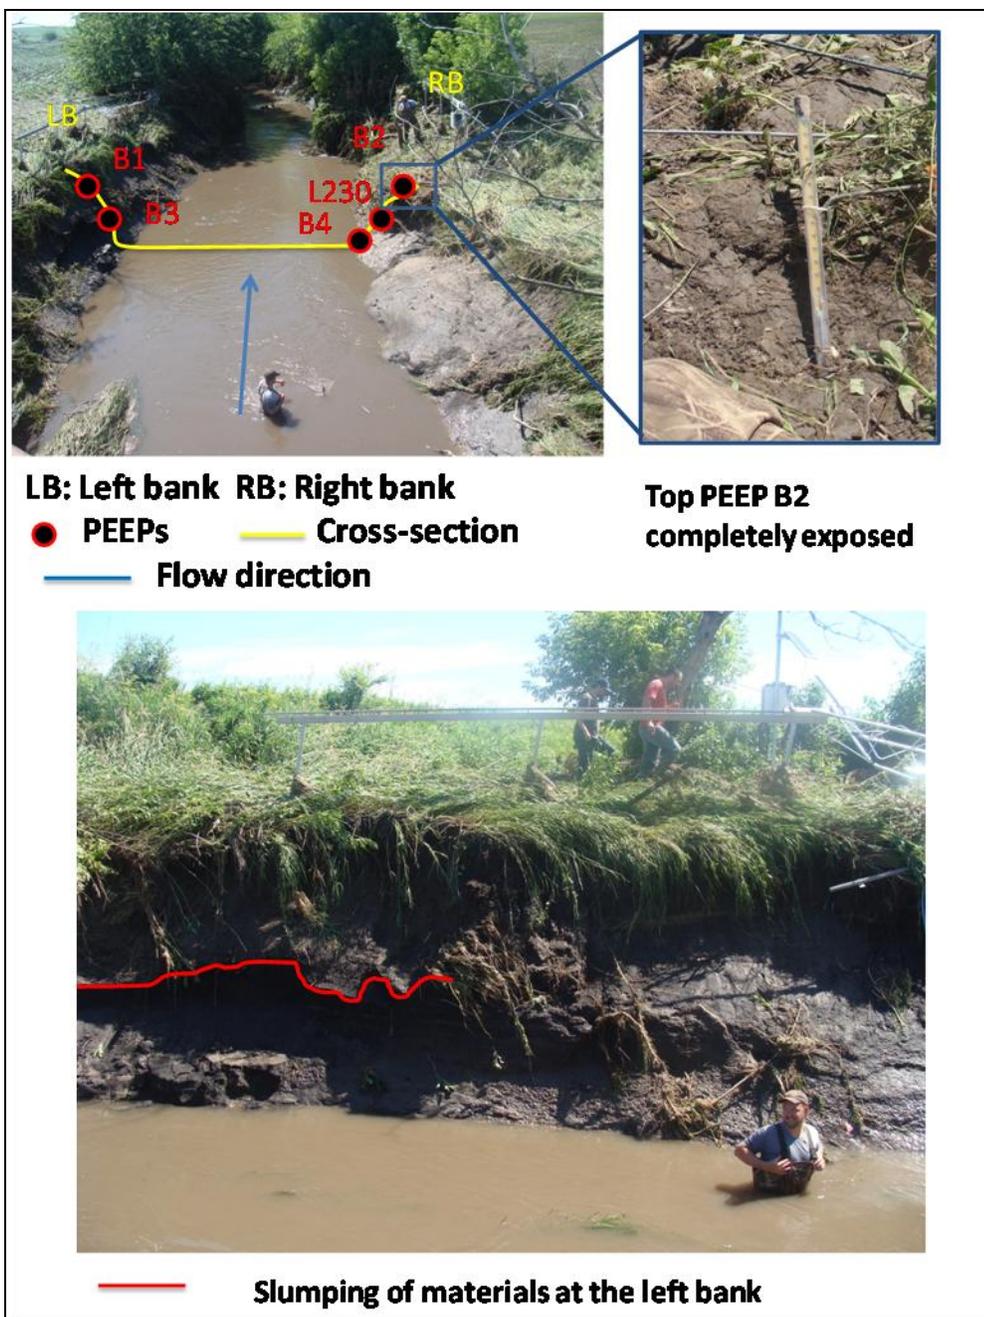
Figure 3.12: Site 1 study reach showing the location of the PEEPs.

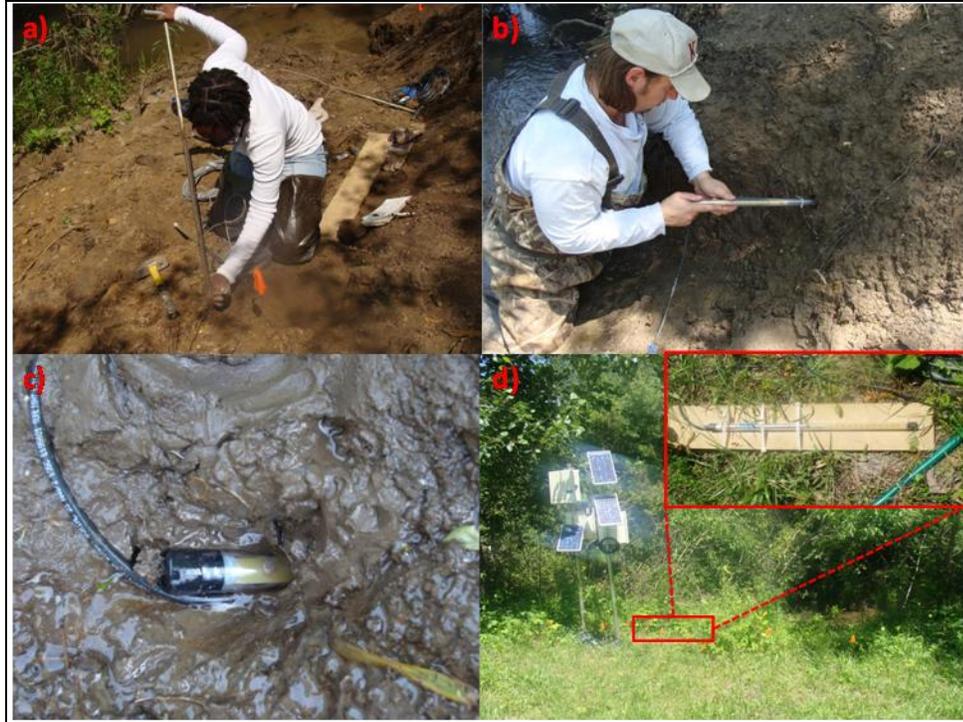
Figure 3.13: Installation procedure for the PEEPs.

The recommended procedure for installing the PEEPs calls for drilling two 16-mm diameter holes. The first hole is into the bank face, parallel to the water surface. The second hole must be vertical from the top of bank some distance from the edge to avoid disturbing the bank. The two holes must intersect perfectly so that the PEEP cable can be passed through the holes. This technique proved difficult and was modified.

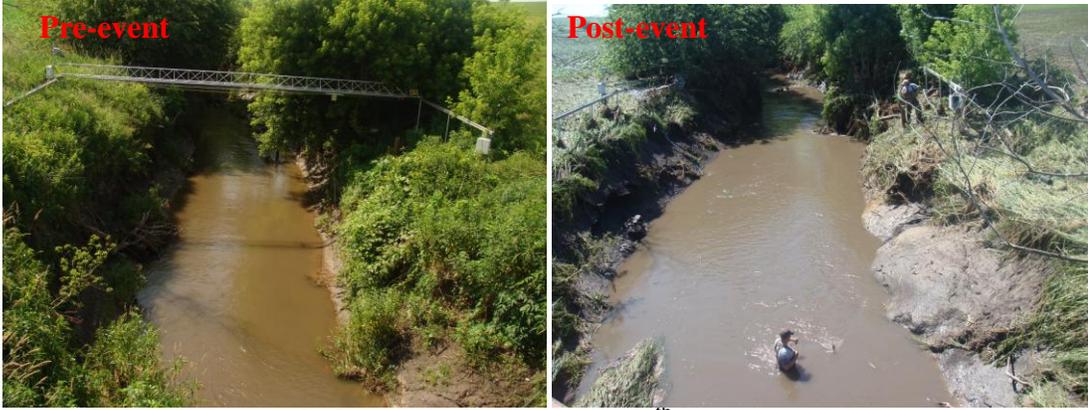
b) Picture of the PEEPs cross-section pre- and post event

Figure 4.3: South Amana before and after the June 19th event.
(a) PEEP cross-section pre-event and post-event. The bank profile is delimited using the survey data of May 28th and June 23rd 2009.
(b) Plan view of the study reach pre- event and post- event. Facing downstream, “RB” stands for Right bank and “LB” for left bank.
