Laboratory and field testing and evaluation of precast bridge elements

A thesis submitted to the graduate faculty
in partial fulfillment of the requirements for the degree of
MASTER OF SCIENCE

Major: Civil Engineering (Structural Engineering)

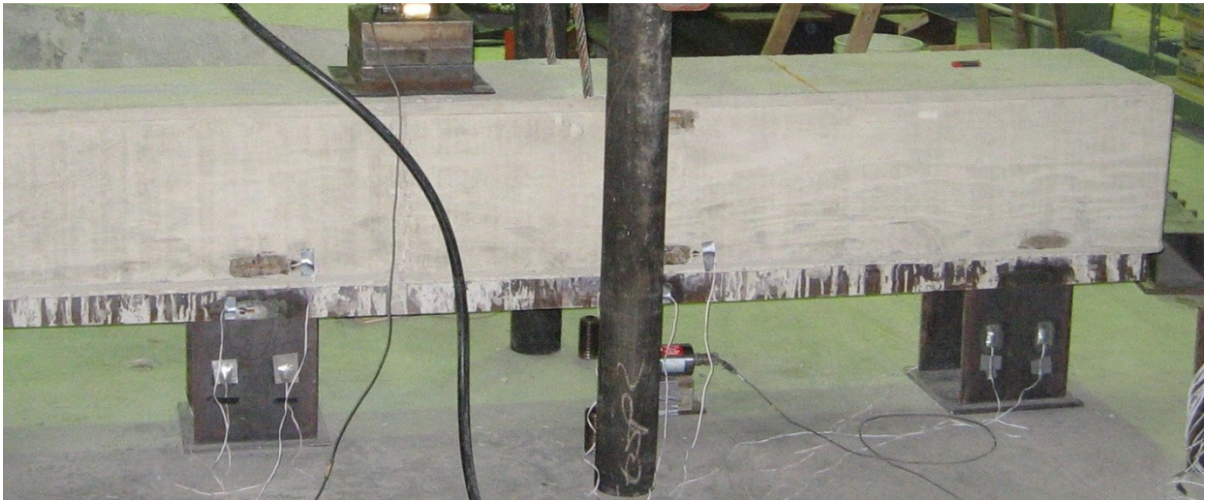
b) Cap 2 fabricated with W12x26

The abutment caps designed by Black Hawk County Engineering Department were fabricated at the Black Hawk County yard by county forces. After fabrication, the abutment caps were shipped to the ISU structures laboratory for service and ultimate strength testing. Two abutment caps were tested; the first abutment cap (Cap 1) was fabricated using a W12x65 steel section (Figure 5a), and the second abutment cap (Cap 2) was fabricated with a W12x26 section (Figure 5b).

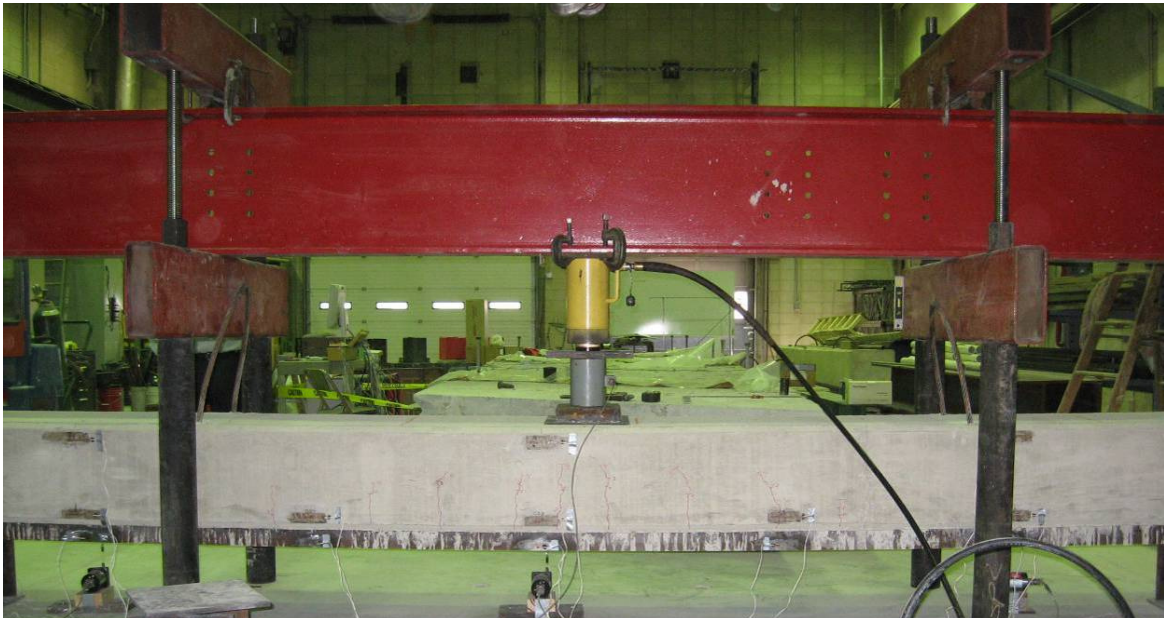
a) Strength test dimensions

b) Photograph of test

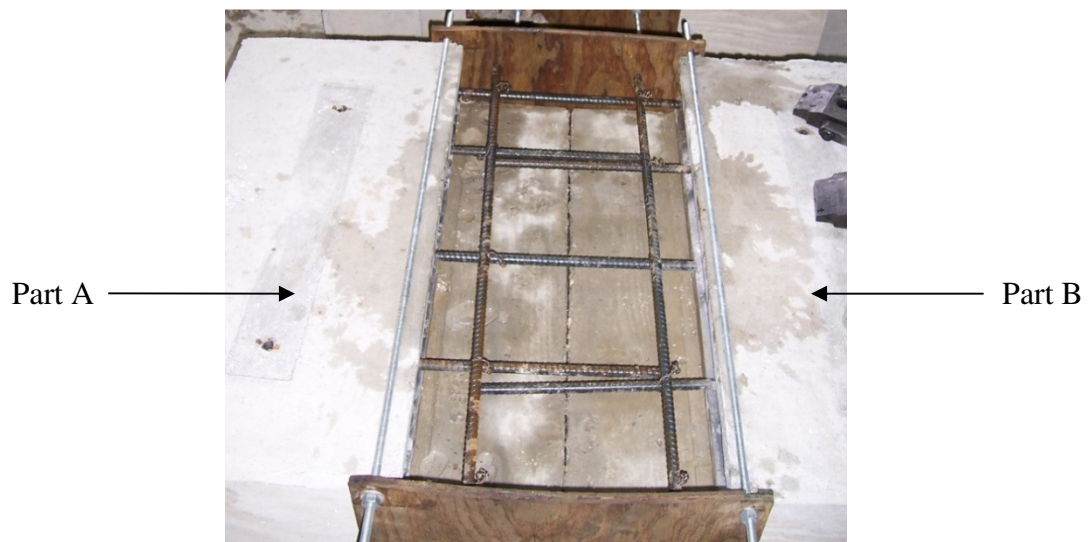
Figure 20. Position of reinforcing bar before closure.

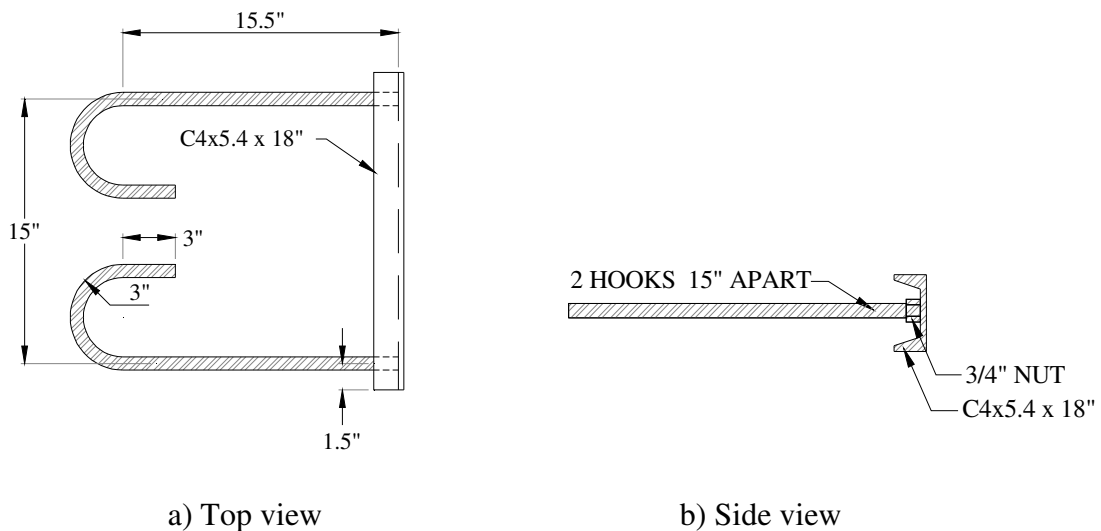
Figure 23. Type 2 connection reinforcing detail.

Welding the two #6 reinforcing bars to the C-channels provides the connection between the channels and the panels. The reinforcing bars were cut to 28 in. and were bent into 180 degree hooks with a minimum radius and tail length of 3 in. Preparation for the welding of the #6 bars to the C-channels included grinding off rust on the reinforcing bar, and the welding of a ⁷/₈ in. nut to the end of the rebar for the purpose of increasing the weld

area between the reinforcing bars and the channels (C4x5.4 18 in. long). The center of the #6 bars were positioned at a distance of 1.5 in. from the end of the C-channel, and welded in place. Chairs were cut to a vertical height of 11 in. to provide support for the #6 bars at the desired location 5.5 in. from the top of the connection. Details of the reinforcement for the Type 2 Connection are shown in Figure 23.

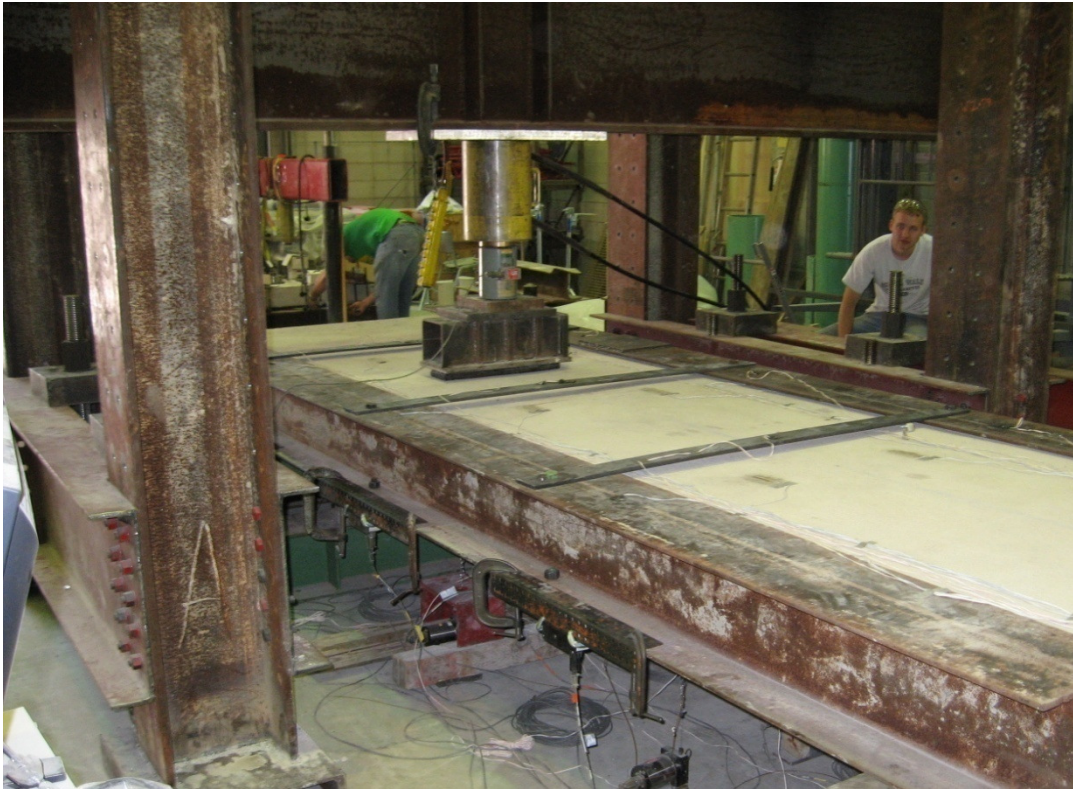
a) Location of load for strength test

Figure 44. Strength test of the precast abutment backwall.

b) Photograph of test in progress

The position of the load in the ultimate strength test is 61.4 in. from the bottom of the wall, as shown in Figure 44. This location corresponds to the location of the resultant force due to worst case soil loading and five 5-ton axles spaced at 4.25' on the abutment. Load was applied at this location until the wall was unable to support the load.

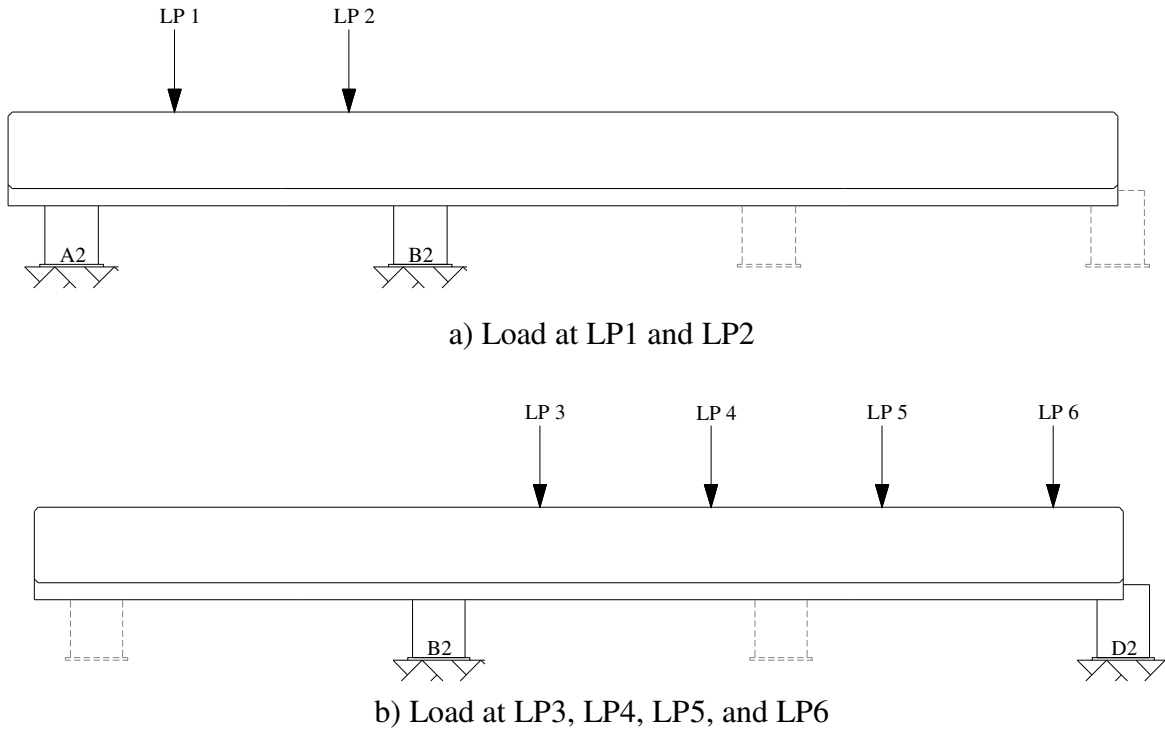
Figure 48. Support conditions for Cap 2 for each load point.

In the early tests, it was observed that bearing was not achieved on all the piles for the service level testing. This was due to two reasons. Firstly, the cut and grind method used to fabricate the pile sections made it difficult to produce pile sections that were exactly the same length. Secondly, the elevation of the laboratory floor was not constant. Due to these factors, only two piles were supporting each cap during the testing. Despite the fact that the load at each point was increased up to 40 kips, there was never any point where more than two supports were being utilized. Also, the pile sections supporting the caps were not the same for all the tests as the load was moved across the length of the cap. Deflection data from the testing show which piles were supporting the cap for the load at the various load points. Figure 47 illustrates which piles were reactive for each load point for Cap 1, while Figure 48 illustrates the support conditions for each load point for Cap 2. Presented in Figure 49 and Figure 50 are the deflection profiles for Cap 1 and Cap 2, respectively. The data presented

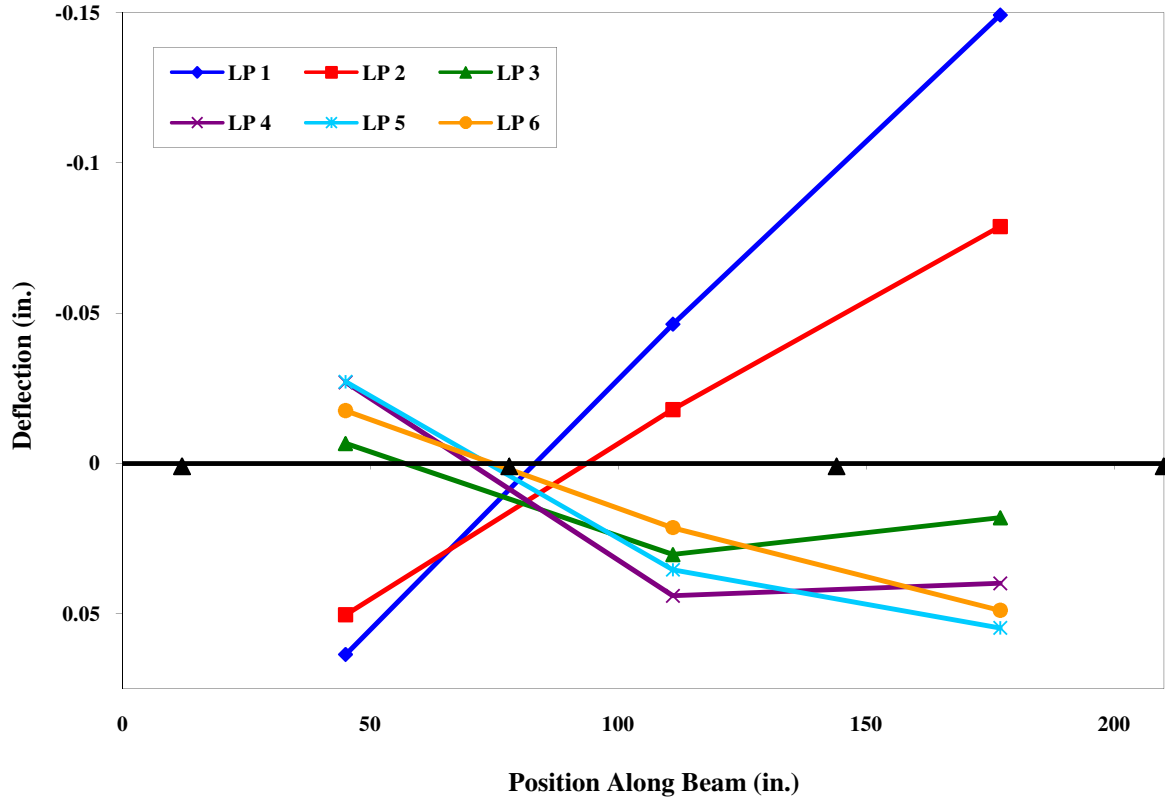
Figure 50. Deflection profile for Cap 2 for the six load points used.

show the deflection of the abutment cap for a load of 40 kips at each load point; with positive deflections indicating movement downward (towards the floor) and negative deflections indicating movement upward (away from the floor). In each graph, the black triangles indicate the location of the pile supports. It can be seen for Cap 1 that Piles A1 and C1 support the cap for Load Points 1 through 3, and Piles C1 and E1 support the cap for Load Points 4 through 7. For Cap 2, Piles A2 and B2 support the cap for Load Points 1 and 2, while Piles B2 and D2 support the cap for Load Points 3 through 6. The location and magnitude of the maximum deflections (both upward and downward) for both abutment caps are presented in Table 1.

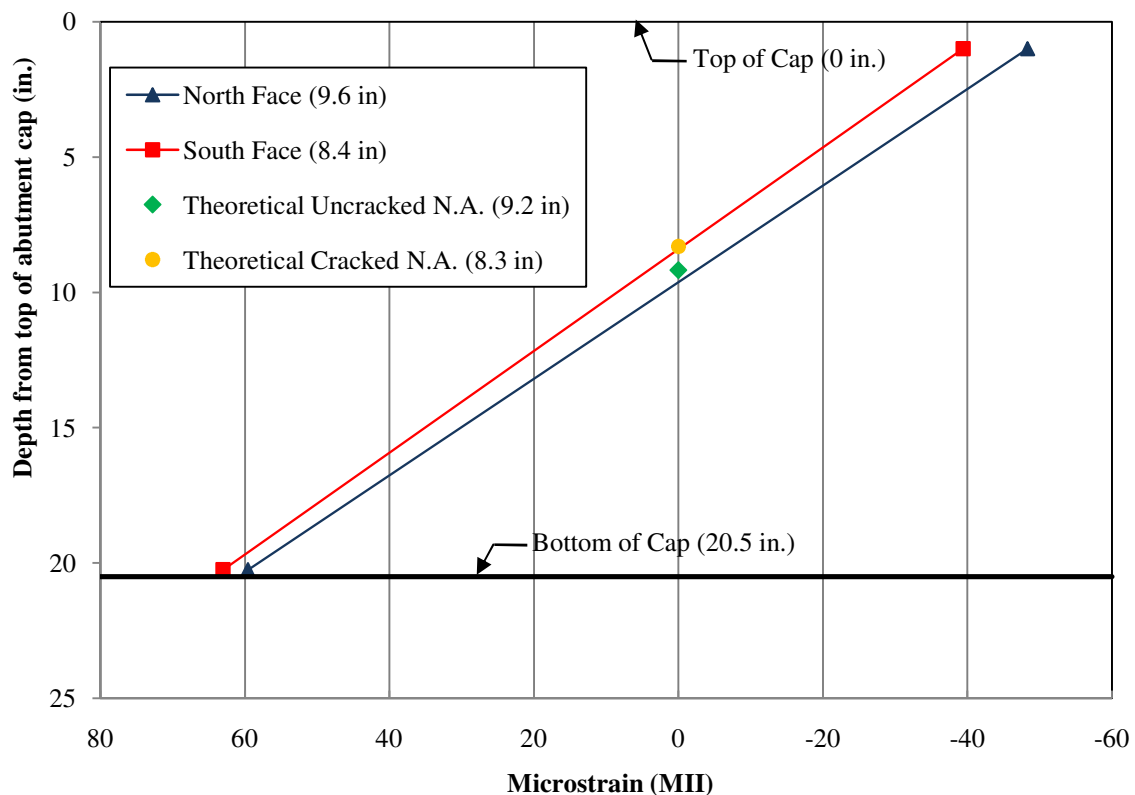
Figure 53. Cap 1 neutral axis at Section 2, Load Position 1, 40 kip load.

axis at Section 2 for both the north and south faces of Cap 1 while the load was at the second load position is shown in Figure 53. Note that the top gages are 1 in. below the top of the cap. Both the theoretical cracked and uncracked neutral axis locations are also plotted on this graph. Taking experimental error into account, the laboratory results are in moderately good agreement with the theoretical data points. From Figure 53 and Figure 54, it appears that there is some eccentricity being developed in the system in that the north face neutral axis is approximately 1 in. lower than the south face neutral axis. A possible explanation for this discrepancy is the uneven bearing on the pile supports or the loading was applied off center.

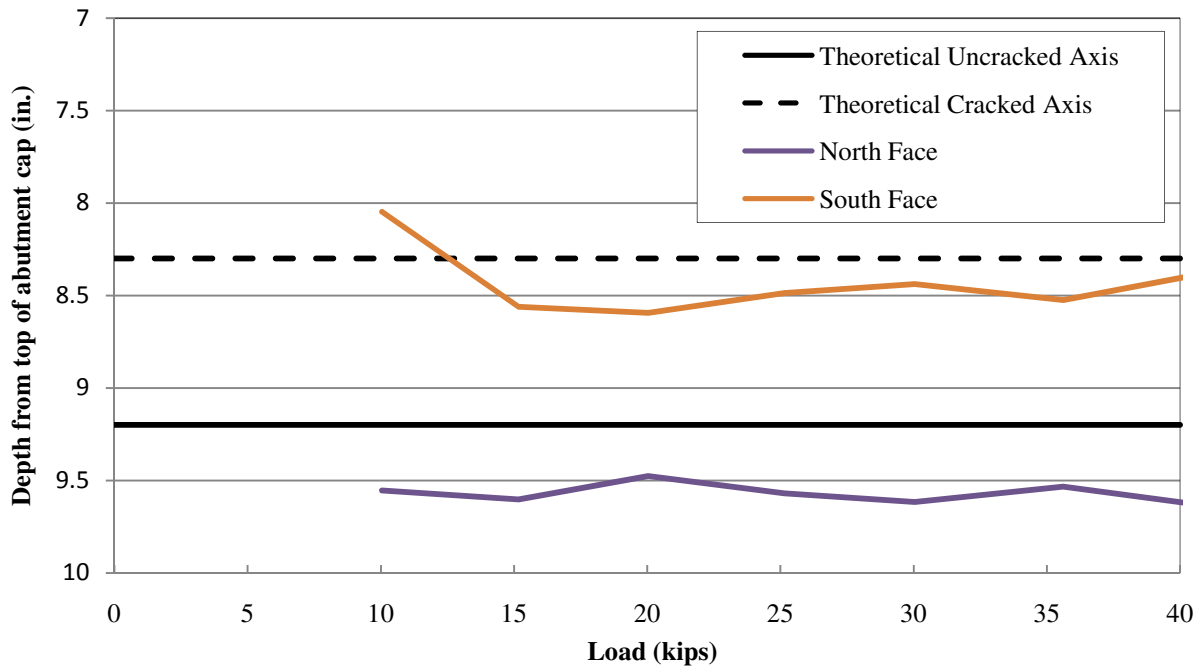
Figure 54. Cap 1 neutral axis at Section 2 plotted against load.

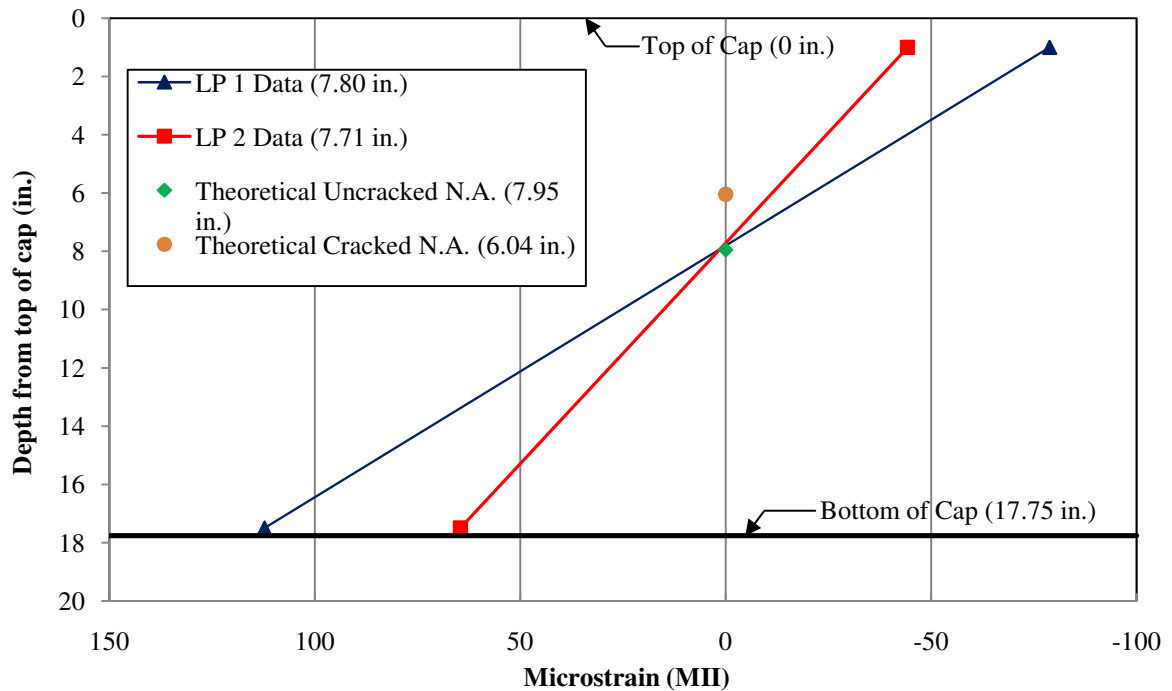
**Figure 55. Cap 2 neutral axis at Section 1, Load Positions 1 and 2, at 40 kips.**

The neutral axis calculated from the service testing of Cap 2 and also the theoretical cracked and uncracked axes locations are presented in Figure 55. The lines were drawn using the data from the first and second load positions, using the top concrete strain gage and the steel gage at Section 1. Both the theoretical cracked and uncracked neutral axis locations are plotted on the graph (6.04 in. and 7.95 in. from the top of the cap, respectively), as can be seen the experimental axes are within experimental error of the uncracked axis.

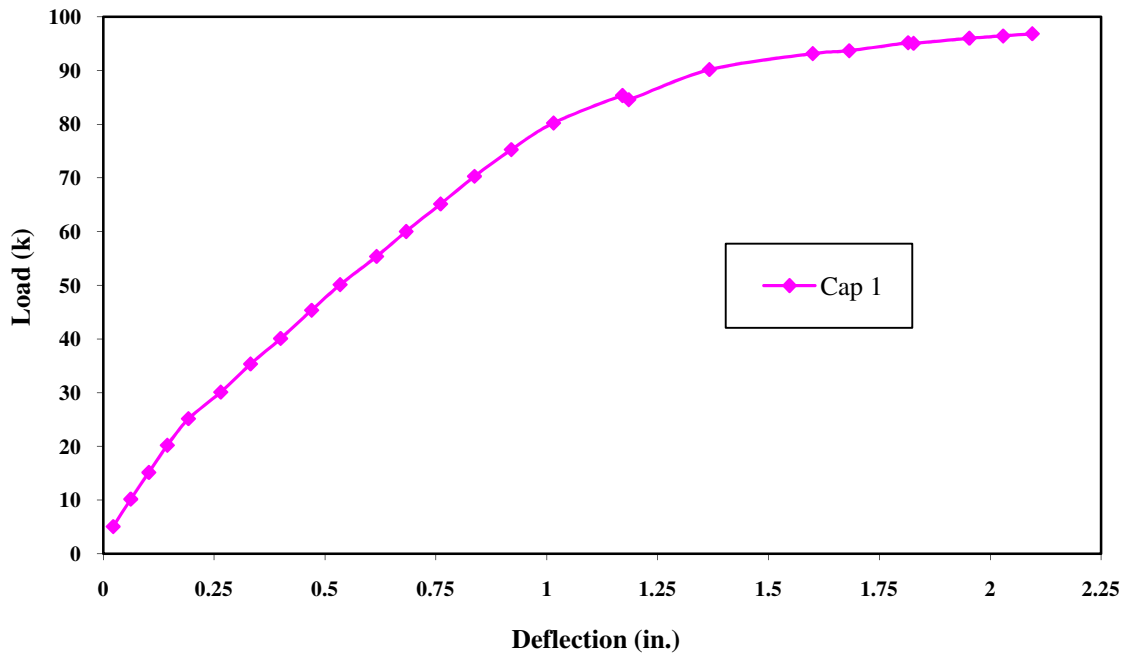
Figure 57. Plot of load vs. deflection for negative capacity test of Cap 1.

Cap 2 was not tested for negative moment capacity due to the damage sustained during the positive capacity test. The load-deflection curve for the negative moment capacity test for Cap 1 is shown in Figure 57. As is clearly seen, Cap 1 experienced a ductile failure at 97 kips, which induced a moment of 363 kip-ft in, deflecting 2.1 in. Factored

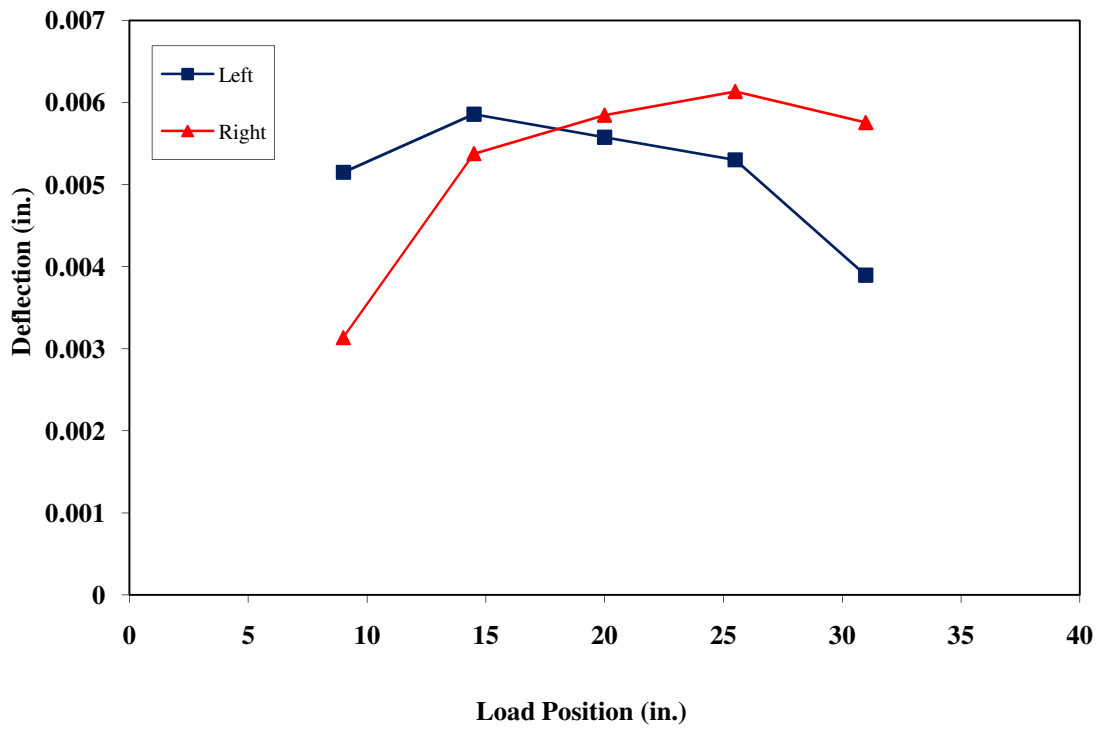
Figure 58. Type 1 Connection service deflections.

Results from the service level testing show that all three connection details were able to transmit the 5 kip load across the joint. Figure 58, Figure 59, and Figure 60 show deflections for each connection type for both the left and right sides of the specimen. In these figures, the service loading started on the left side, and moved to the right side. For the Type 1 and Type 3 Connections, the side of the specimen that is carrying the load deflects more than the other side, as is expected since there is no positive connection between the instrumented areas (see Figure 32 for deflection instrumentation locations). The Type 2 Connection deflections show continuity between the two sides of the specimen. This was expected as the welded plates create a positive connection in the Type 2 Connection. The instrumentation labeling for the concrete gages on the top surface of the specimens is shown in Figure 61. Table 6 presents the highest compressive strains that occurred in these strain gages for all three connection types.

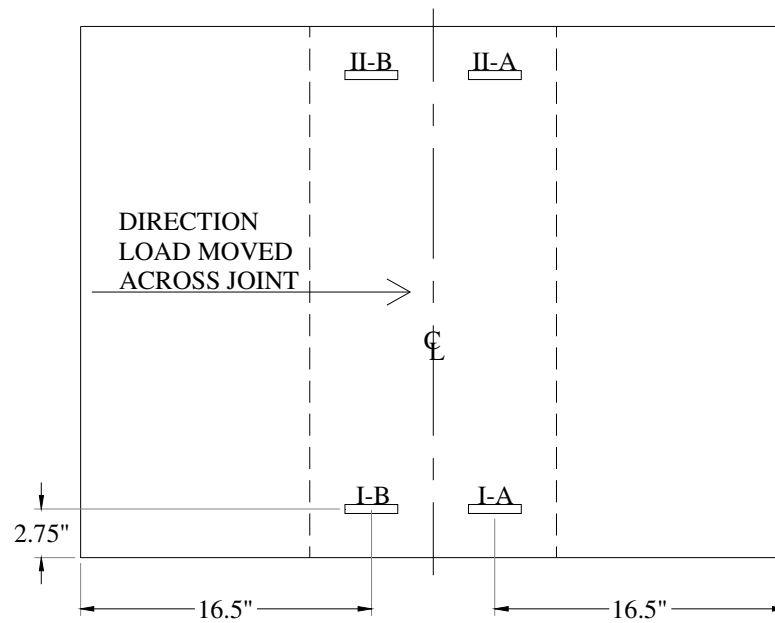
Figure 61. Labeling for top concrete strain gages.

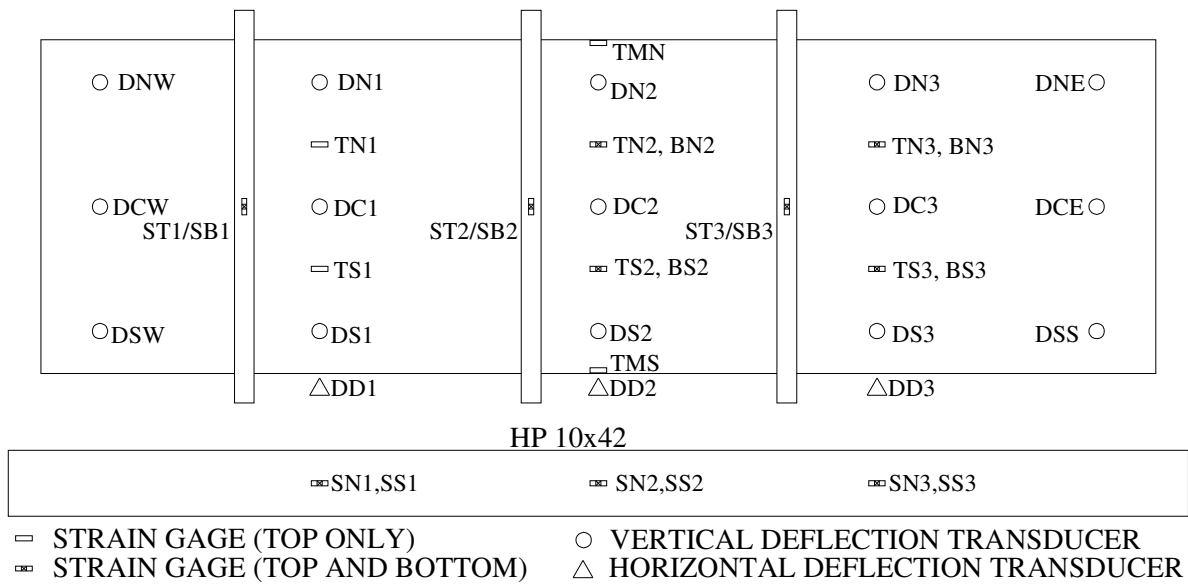
Figure 62. Labels for the abutment backwall instrumentation.

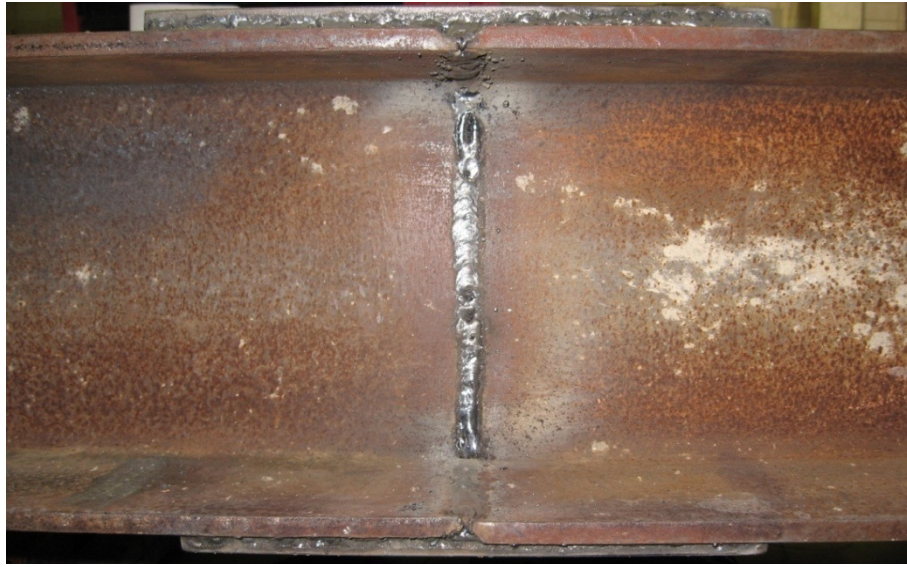
Figure 64. Repaired H-pile splice.

After the repair, the test was performed again, and the slab was still able to resist a point load of 100 kips. The load-deflection curves at DC2, both before and after the H-pile break, are shown in Figure 65. The failed backwall specimen is shown in Figure 66; the pattern of the cracking suggests that punching shear was the mode of failure. During the strength testing, the stress induced in the steel straps was less than 2.7 ksi for the top straps and less than 1.1 ksi for the bottom straps. The expected resultant load from both a 5-axle, 10 tons per axle truck over the abutment and the lateral earth pressure from an undrained clay under worst-case conditions is approximately 63 kips. Even in its weakened state, the backwall system provided a factor of safety of 1.6 against failure.

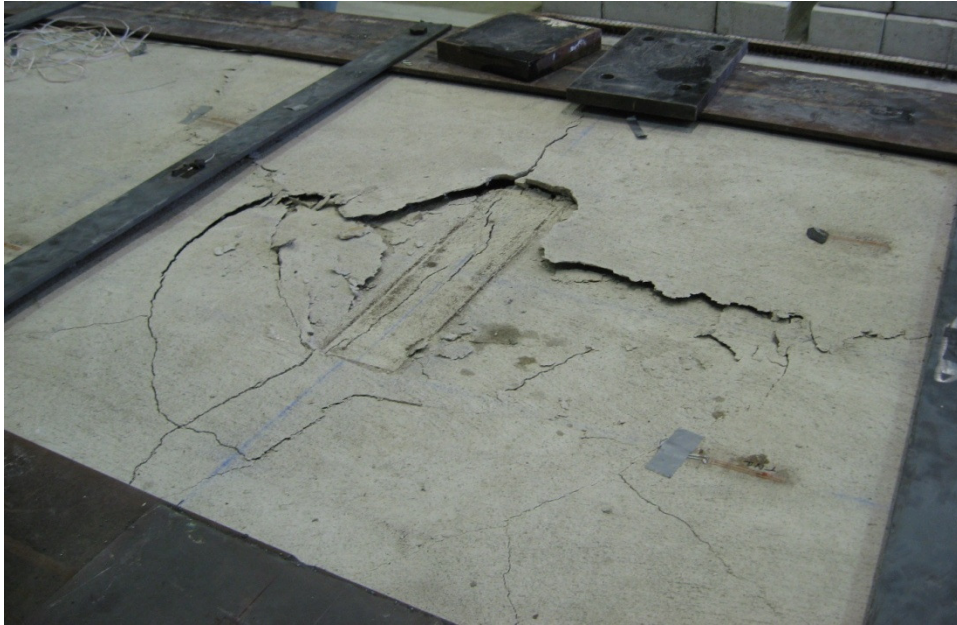
Figure 66. Failed abutment backwall specimen.

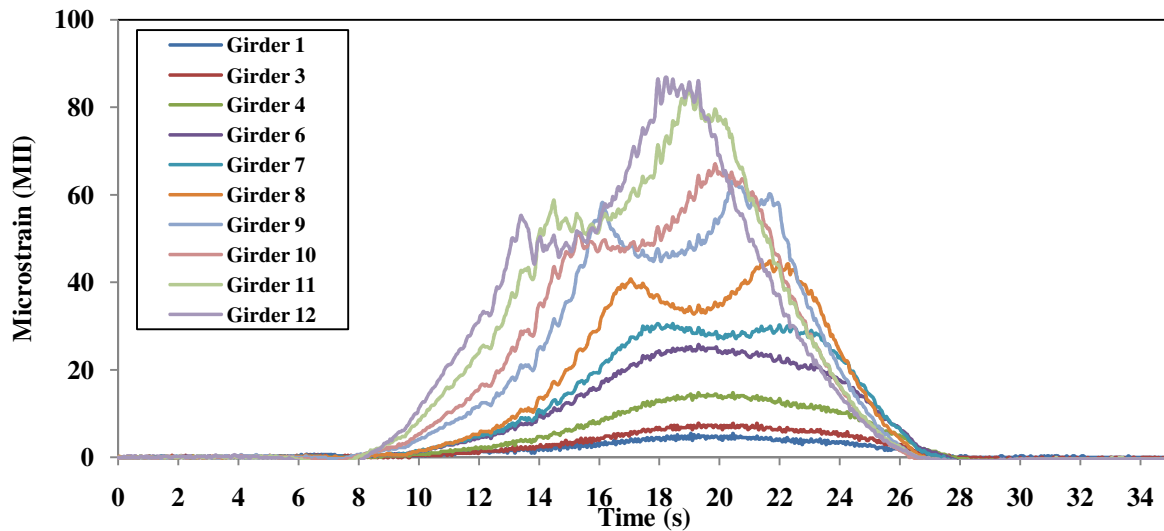
Figure 86. Midspan strain history for Test 5.1.

The maximum midspan tensile and compressive strains due to the field tests were converted to a stress (assuming $E_s=29,000$ ksi and $E_c=4,030$ ksi). The maximum tensile stress in the steel was 2.5 ksi and occurred during Test 5.1 in Girder 12, while the maximum compressive stress in the concrete was 0.27 ksi, also occurring during Test 5.1. Allowable stress for the steel used in the design of the panel was 27.5 ksi ($.55f_y$), and for the concrete was 2 ksi ($0.4f'_c$); these allowable values were determined from the AASHTO Standard Specification. Since the test vehicle isn't as heavy as the AASHTO vehicle (72 kips), the stresses need to be factored accordingly in order to compare to the AASHTO allowable stresses. After factoring, the maximum steel stress is 3.2 ksi and the maximum concrete stress is 0.35 ksi. Dead load stresses were determined from the BHC design spreadsheet, which shows the steel stress as 9.4 ksi and the concrete stress as 0.45 ksi. Therefore, the total steel stress is 11.9 ksi, and the total concrete stress is 0.69 ksi, which are much lower than what is allowed. Thus, the MVRB meets the AASHTO design criteria.

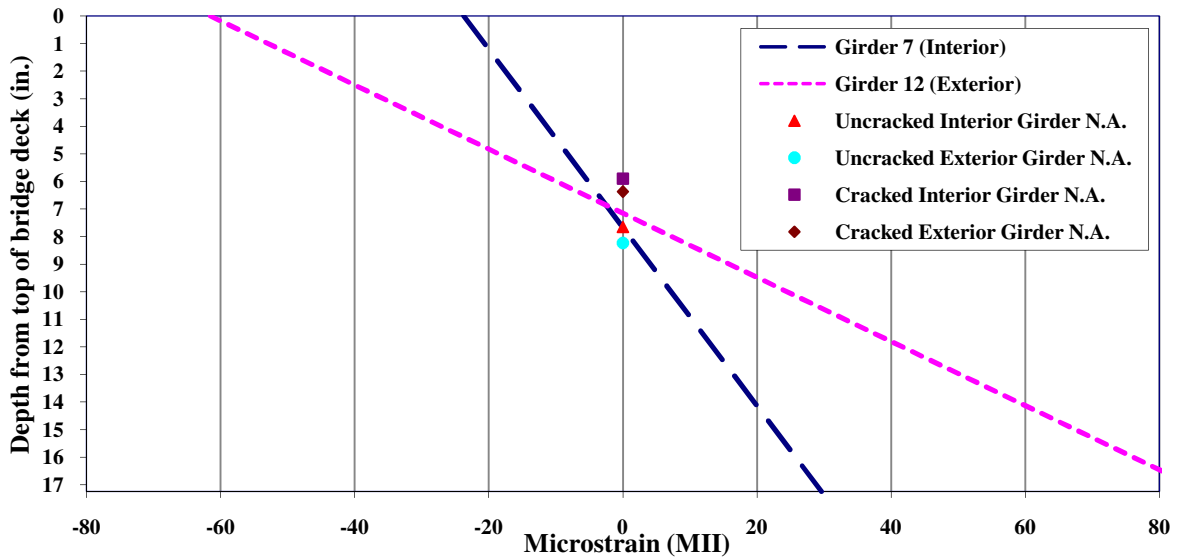
Figure 88. Test 5.1 neutral axes.

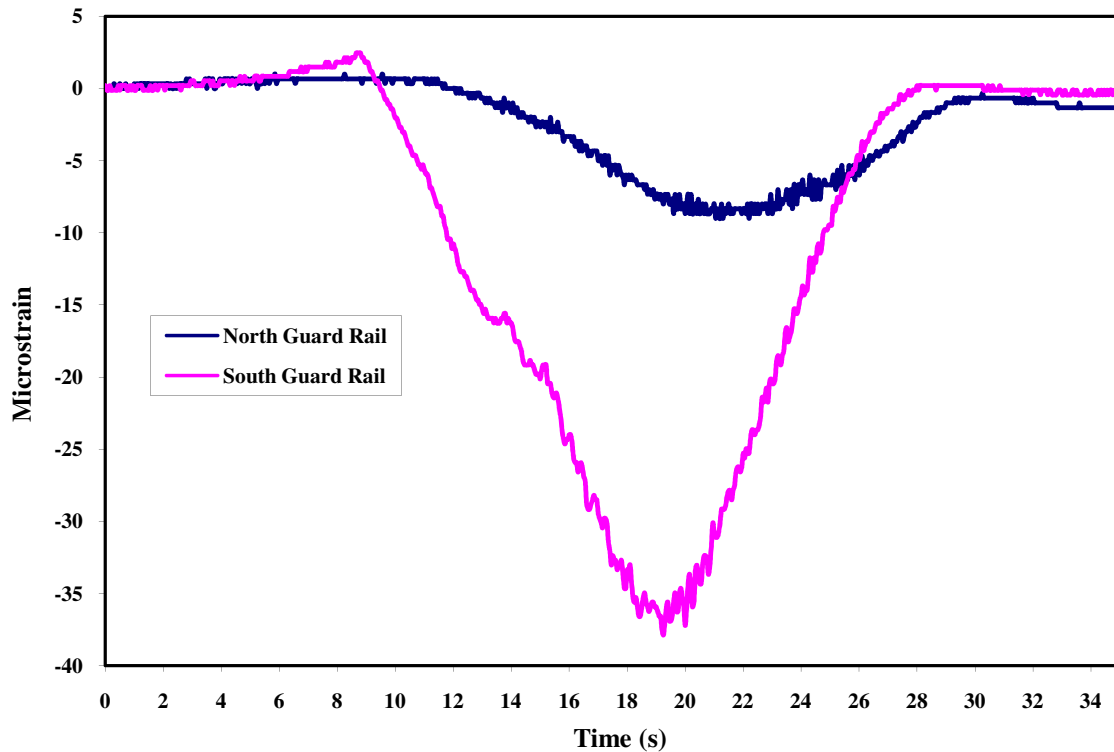
Figure 89. Guardrail strains for Test 4.1.

guardrail, indicating that the guard rail contributes to the flexural resistance of the PMBISB system. The contribution of the guard rails varies, depending on the location of the truck. The contribution increased when the truck was closer to the rails, and decreased as the truck moved away from the rails.

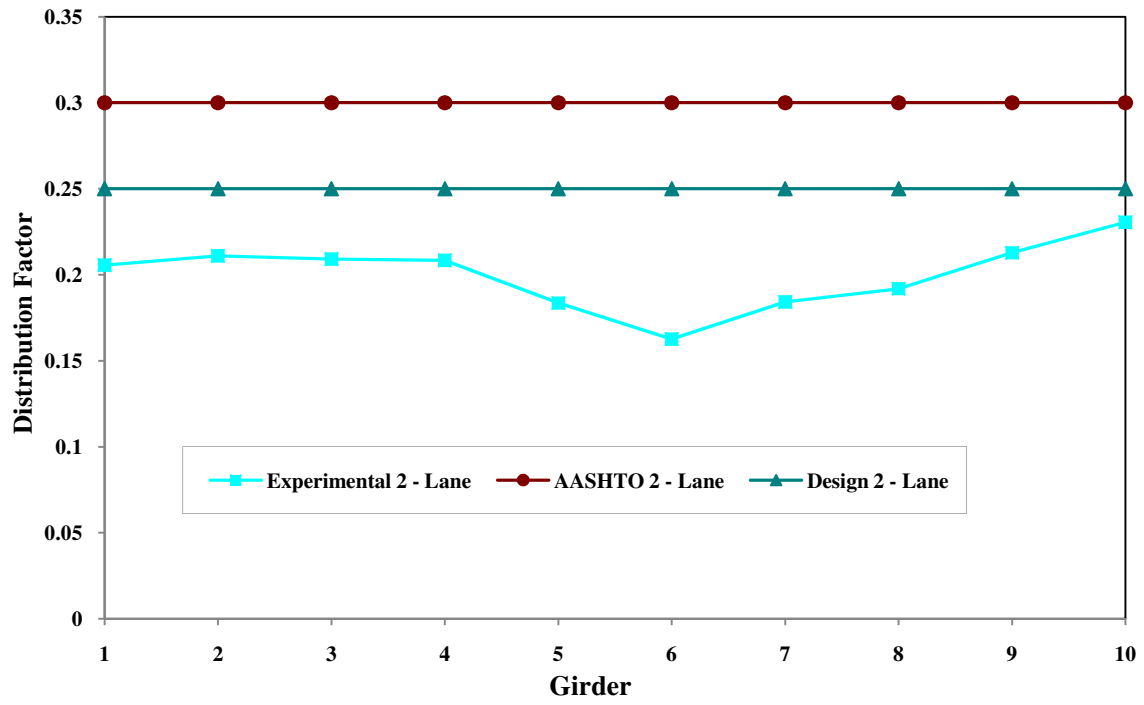
Figure 99. Two lane DF from strains.
