The effectiveness of Iowa's automated red light running enforcement programs

A thesis submitted to the graduate faculty
in partial fulfillment of the requirements for the degree of
MASTER OF SCIENCE

Major: Civil Engineering (Transportation Engineering)

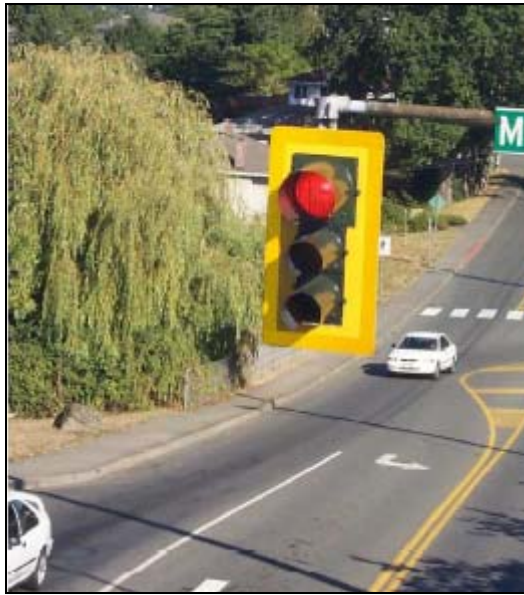
Figure 2. Signal with high intensity yellow retroreflective tape on backplate (23).

In 1998, a research study conducted in British Columbia, Canada by Miska, de Leur, and Sayed investigated the effects of installing yellow reflective tape on the edge of the backplates to combat various claims of not being able to visually see the traffic signals at studied intersection. As shown below in Figure 1, a 75mm reflective 3M tape border was installed on single heads of six traffic signals at six intersections. The cost of installation was minimal at \$35 per signal and around \$420 per intersections. Miska, de Leur, and Sayed concluded that the numbers of claims were reduced up to 60% (23, 24).

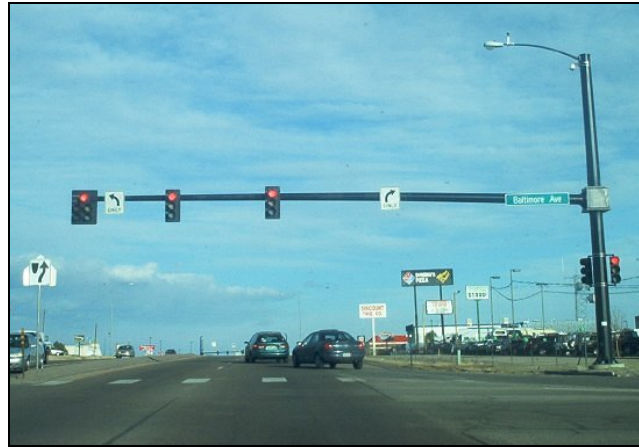
Figure 3. CDOT specified high-speed intersection traffic signal (25).

- *Placement:* Although the MUTCD does not specify or require that the traffic signals be over each lane and be attached to a pole, studies in Iowa and Missouri have shown 32 and 25 percent reductions in crashes at intersections with traffic signals attached to mast and poles (16). An FHWA report states that traffic signals located above each lane overcome three important obstacles that median or roadside traffic signals have: (1) they generally do not provide good conspicuity, (2) mounting locations may not provide a display with clear meaning and (3) motorists' line-of-sight blockage to the signal head due to other vehicles, particularly trucks, in the traffic stream (16). Shown below in Figure 3 is a typical high speed intersection in Colorado where 12" diameter traffic signal heads are located over each travel lane. Also note the 8" diameter

pole mounted signal head to aid vehicles that cannot see the overhead traffic signals due to blockage from trucks or other large vehicles.

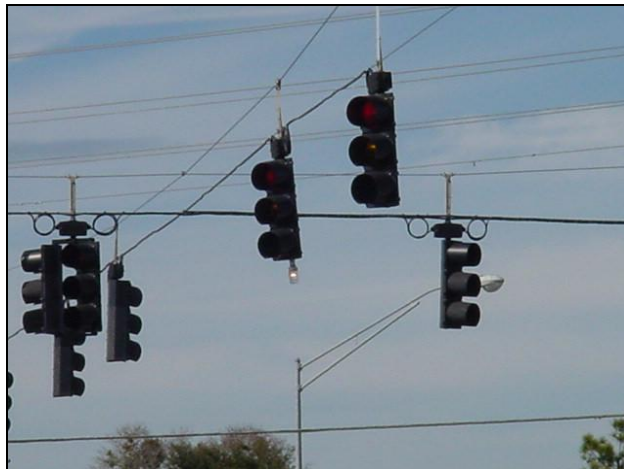
Figure 5. White enforcement light in Hillsborough County, Florida (28).

“Rat Boxes”, “White Light Enforcement”, or also referred to as “The Tattler” are a form of enforcement that are simple and cost effective and can be integrated into an existing traffic signal system. Constructed for about \$100, a rat box consists of a small LED or incandescent light that is placed on the backside or underneath a traffic signal as shown in Figure 5. Once the approach traffic signal turns red, the light will activate and will turn off during the green and yellow interval. The system is designed so that a single police officer can sit downstream of the intersection and catch RLR violators while watching each approach stop bar when its designated traffic signal turns red and the rat box illuminates.

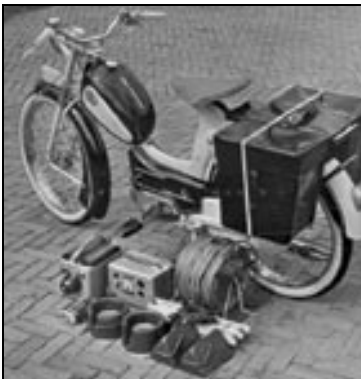
Figure 6. First mobile Gatsometer (31).

Maurice Gatsonides' first invention to capture drivers was the speed camera system, shown in Figure 6. First tested in 1958, it later proved to be the most reliable in the industry. Comprised of a moped, camera, two road tubes, and a mechanical stopwatch, the system was moved easily to different intersections or road segments depending on the client's need. The original intent of this system was to develop a technology to show Gatsonides his speed as his car raced around a corner using the pneumatic road tubes. After the photo camera was activated by a human, a fast speed study was performed by a mechanical stopwatch, which used the pulses from the road tubes at intersections. Gatsometer's second breakthrough product is shown in Figure 7, which were the first speed flash camera invented in 1971, using radar technology to capture RLR and speeding violators. Later, this same technology would be implemented into a camera system that would capture vehicles running a red light based on its approach speed. Gatsometer has been a leader in the RLR camera technology, having made great progress in automated enforcement including mobile cameras, hidden camera technologies, toll booth enforcement, and cameras to capture the driver's face as shown in Figure 8 and Figure 9.

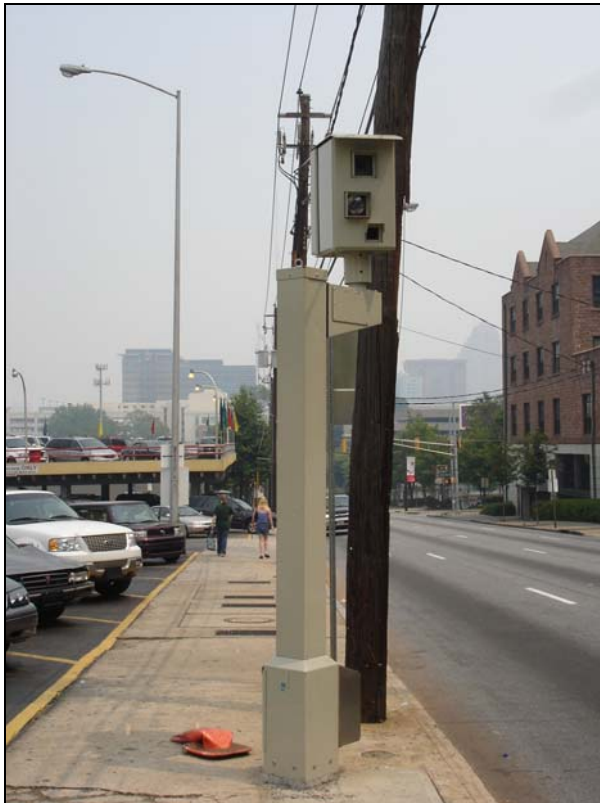
Figure 10. Gatso RLR camera system (Atlanta, GA).

RLR cameras are located typically in weatherproof, vandalism-protected metal boxes. Placed close to the intersection on hinged poles or fixed onto a traffic signal structure, these boxes are mounted 10-15 feet in the air as shown in Figure 10. Other RLR camera systems are integrated into the existing traffic signal hardware as shown in Figure 11. The red light camera system is typically connected both to the traffic signal controller and to dedicated inductive loops in the pavement at or before the stop bars or to the auto scopes at the intersection. Although many traffic equipment vendors claim one automated enforcement camera system can monitor four lanes of traffic, studies performed in New York City have shown accurate photography can only

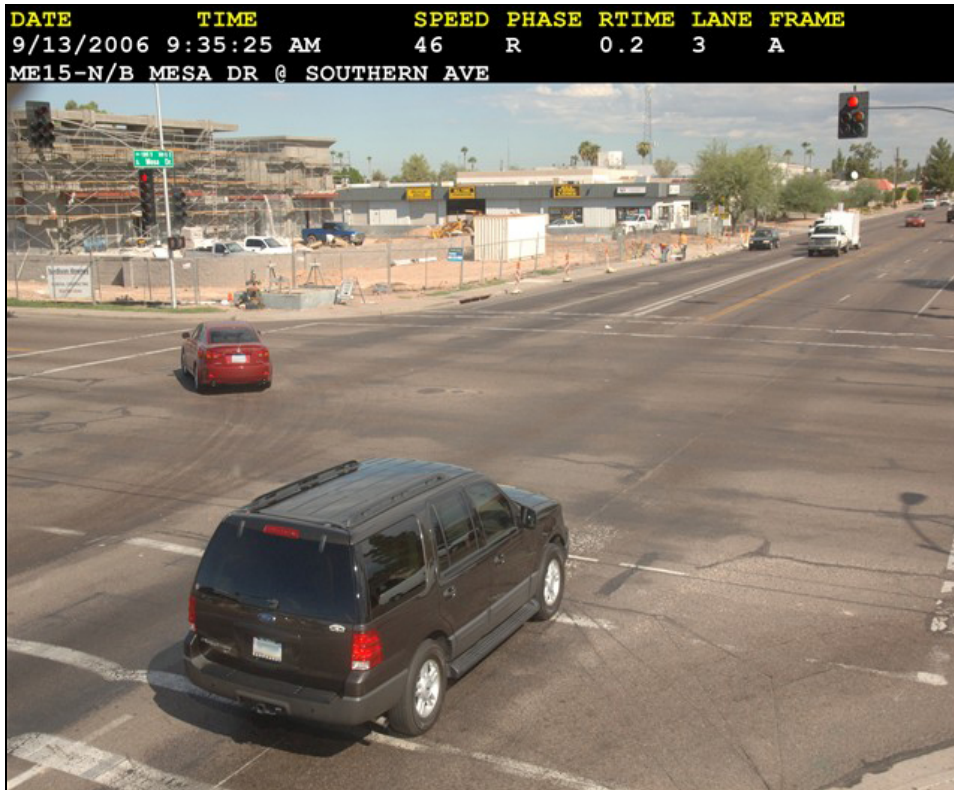
Figure 12. First picture taken by an automated RLR enforcement camera (Mesa, AZ).

Figure 12 shows the sport utility vehicle (SUV) has clearly passed the stop bar and is currently proceeding through the crosswalk. The black bar at the top of the photo displays current information about the picture frame. The date, time, and location are current to the image. The recorded speed is shown at 46 mph, and the current signal phase is "R" or red. RTIME, short for "red time," is shown as 0.2 or two-tenths seconds after the traffic signal had turned red. Also shown is the lane number; this number tells which lane the offending vehicle is in. Typically the lanes are counted from the inside out in one direction if more than one camera is present. Lastly, the frame tells the reader which picture is being shown; for example frame A equals picture 1, while frame B equals picture 2.

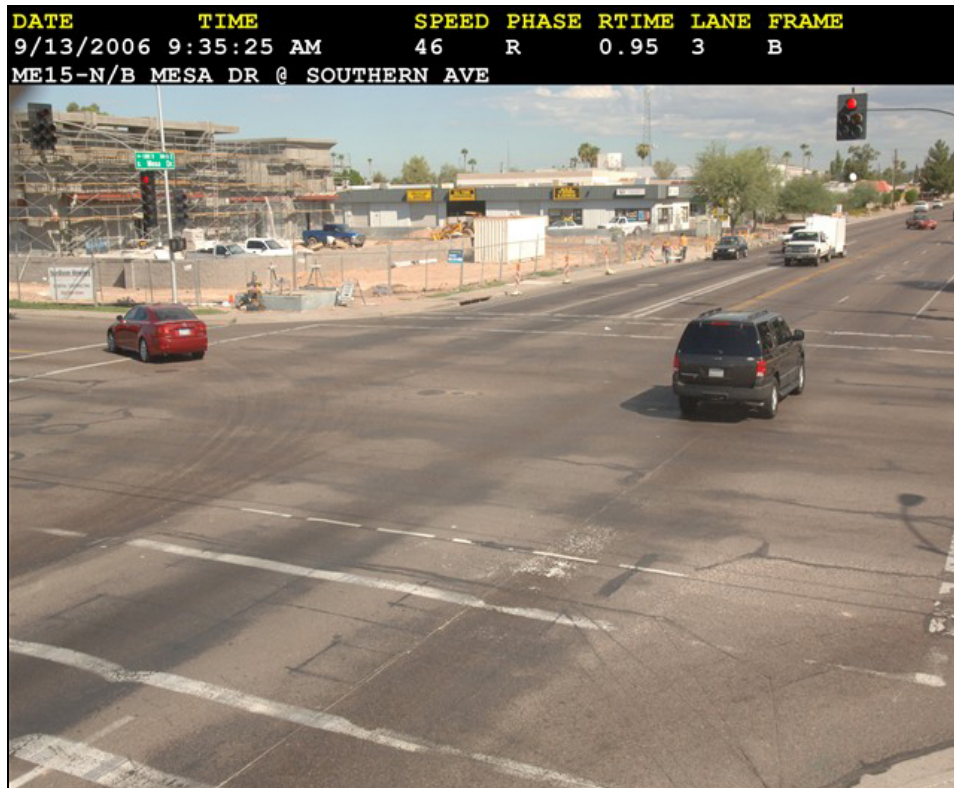
Figure 13. Second picture taken by an automated RLR enforcement camera (Mesa, AZ).

Figure 13 is the second photo taken by the Mesa, Arizona red light enforcement system, showing the SUV clearly inside the intersection. As shown in the photo's black box at the top, much of the information has remained constant except the time and the red time, which is currently at 0.95 seconds. By viewing both Figures 6 and 7, a Mesa, Arizona police officer can conclude that the SUV entered the intersection illegally 0.2 seconds after the traffic signal had turned red.

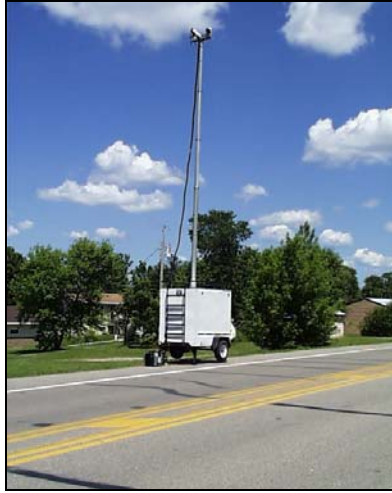
Figure 14. Mobile Autoscope trailer (CTRE, Iowa State University).

Autoscope technology was first introduced in the early 1970’s by University of Minnesota researchers as proposed video technology to study traffic flow, automatic surveillance, incident management, and signal control (55). Mass production of Autoscope technology started as a joint venture between the University of Minnesota and Econolite Control products in 1984, and advanced software packages were created as a computer overlay program to video taken in the field to evaluate speed, counts, and even operate traffic signal at intersections (55). In a violation study performed by Kamyab and McDonald in 2000, two methods of video recording were tested, including a trailer-mounted Autoscope and a wireless Autoscope system. As shown below in Figure 14, two Autoscope cameras were mounted on a 35 foot pneumatic mast pole and were connected to recording devices located inside the trailer (4j).

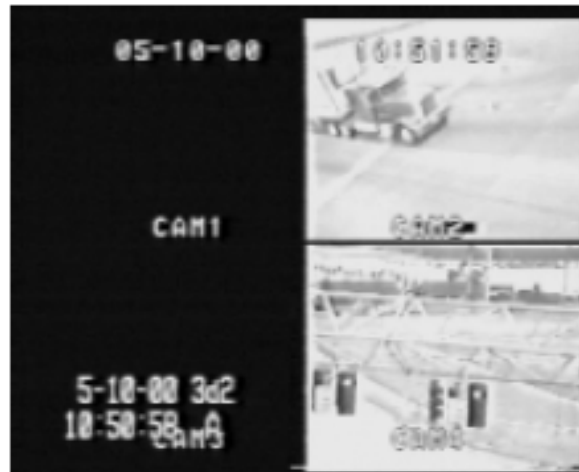
Figure 16. Direct monitoring combined camera view (CTRE, Iowa State University).

The Direct Monitoring Method is considered the most precise evaluation method available, but can be time-consuming and mistakes can be easily made by the evaluator depending on his or her judgment of a violation (57). Shown below in Figure 16, from the Center for Transportation Research and Education at Iowa State University, a split screen was used to record RLR violations. The top picture shows a truck crossing the stop bar while the traffic signal shown below the picture is red. The research team recorded the time movement of each violation (4j).

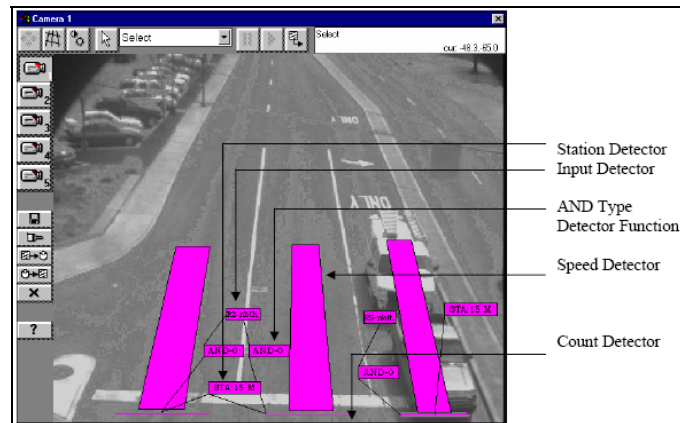
Figure 17. RLR Autoscope computer program approach overlay (57).

The machine-aided monitoring method’s objective is to reduce the time needed to evaluate an approach with the sacrifice of minimal errors in the evaluation (57). As shown below in Figure 17, Purdue University researchers used Autoscope software to detected RLR vehicles at a single intersection approach while determining entering vehicle counts and approaching vehicle speeds. Tarko et al. concluded that all violations occurred during the first 2 seconds of the red phase. Although this method proved to save considerable time extracting violations, it was determined that the video data needed to be screened a second time to verify that the software captured the violations (57).

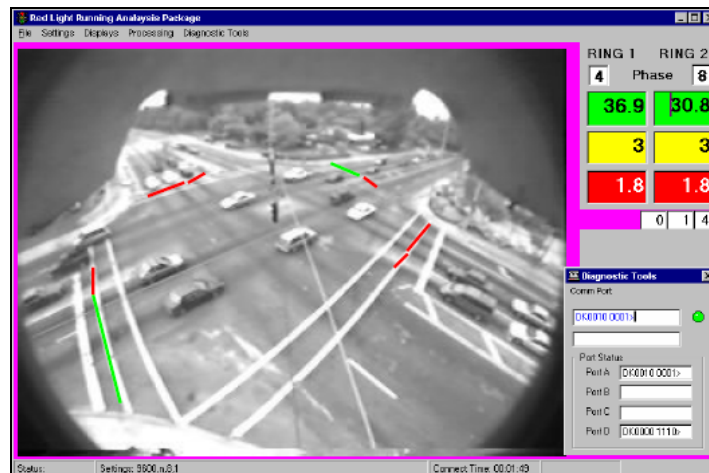
Figure 18. RLRAP monitoring an intersection (58).

In a research project conducted by Washburn and Courage at the University of Florida, a third method to evaluate RLR violators was created. Red Light Running Analysis Package (RLRAP) was developed to enable users to monitor two items simultaneously, vehicles entering the intersection and the current signal status, displayed using colors while only using one video feed of the entire intersection as shown in Figure 18.

Although the RLRAP software package does not include a counting program similar to that used in the Purdue study, the goal of this project was to measure the accuracy of phase timing measurements and the repeatability of those measurements over multiple playbacks of the videotape (58).

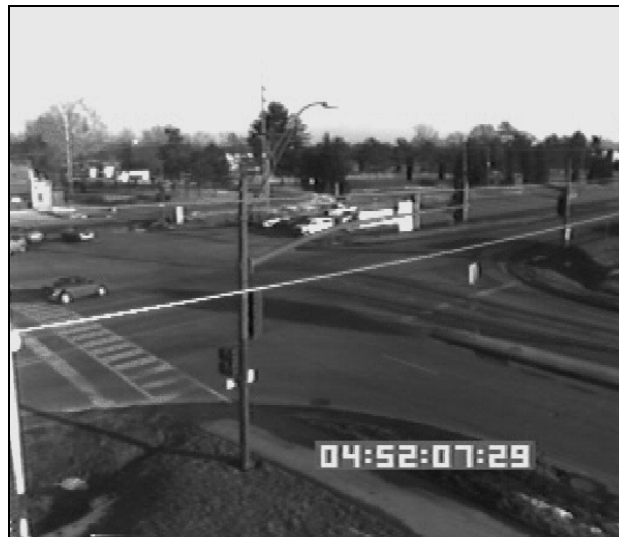
Black and white video was recorded for the three peak hours of 7:00 AM – 9:00 AM, 11:00 AM – 1:00 PM, and 4:00 PM – 6:00 PM, and the mast was lowered between recording sessions. The eastbound and southbound approaches were the only approaches studied. The videos were post-processed the following day. Shown in Figure 43 and Figure 44 are the respective 4:00 PM – 6:00 PM and 11:00 AM – 1:00 PM resulting video images.

Figure 43. Autoscope image of test location in Ames looking eastbound at 4:52 PM.

As shown in Figure 43 and Figure 44, it was nearly impossible to view the traffic signal phase for the entire day because of sun glare, shadows, wind, and the type of equipment. Additionally, the trailer/camera/mast arm configuration is rather obvious and it was not certain whether the data collection equipment would affect driver behavior. As a result, the research team decided to use ground level wide-angle Digital Versatile Disc (DVD) cameras instead. In addition to these cameras being less obvious to drivers, they can be positioned to minimize glare and shadows and also detect the color of the traffic signal quite easy.

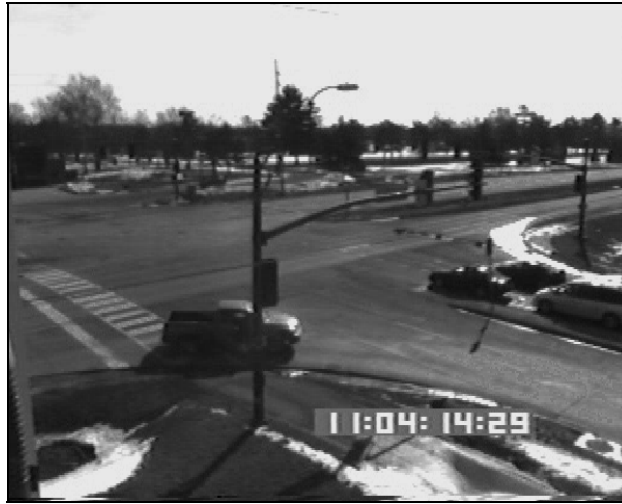
Figure 44. Autoscope image of test location in Ames, looking eastbound at 11:04 AM.

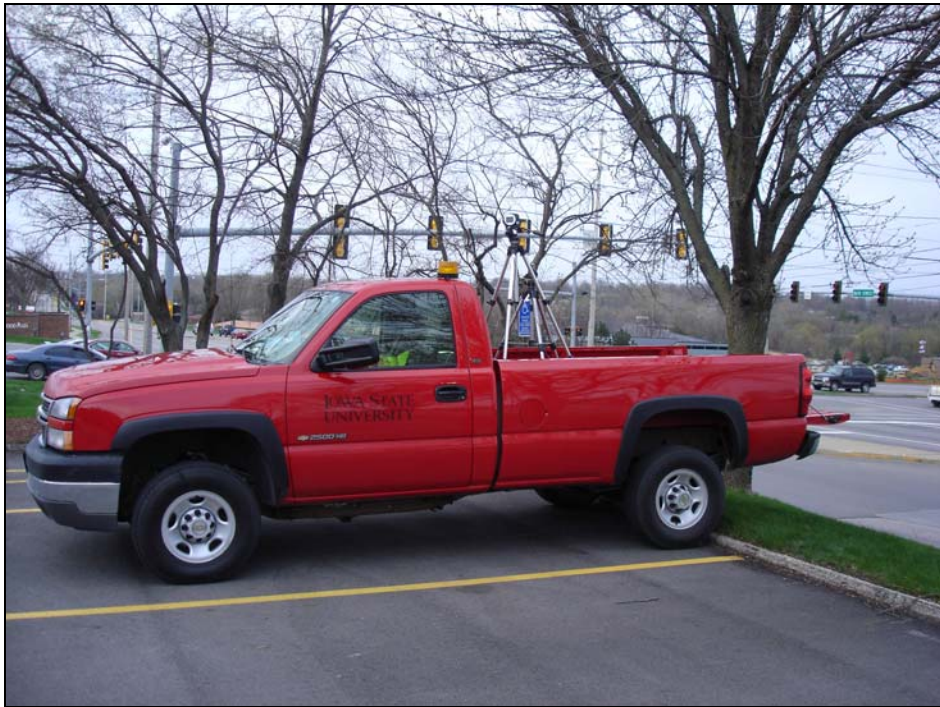
Figure 45. Collecting data at 86th Street and Douglas Avenue.

Video was taken using two DVD-R digital cameras mounted on two tripods in the bed of an Iowa State University pickup truck as shown in Figure 45.

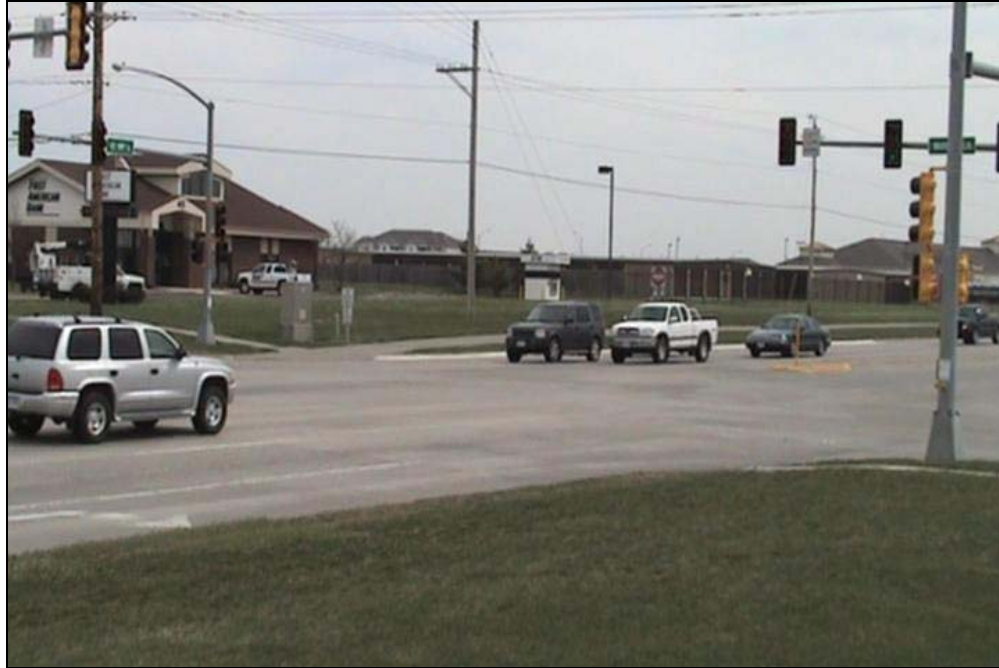
Figure 46. Captured video of N. Warrior Lane and Hickman Road.

DVDs were viewed using the computer program Power DVD where zoom and frame-by-frame capabilities could be used to determine if a red light running violation occurred. Although the frame-by-frame feature added a more exact way to measure car position in relevance to the yellow and red light, some experimental error was expected. Shown in Figure 46 is a frame of the DVD video of the recorded intersection.

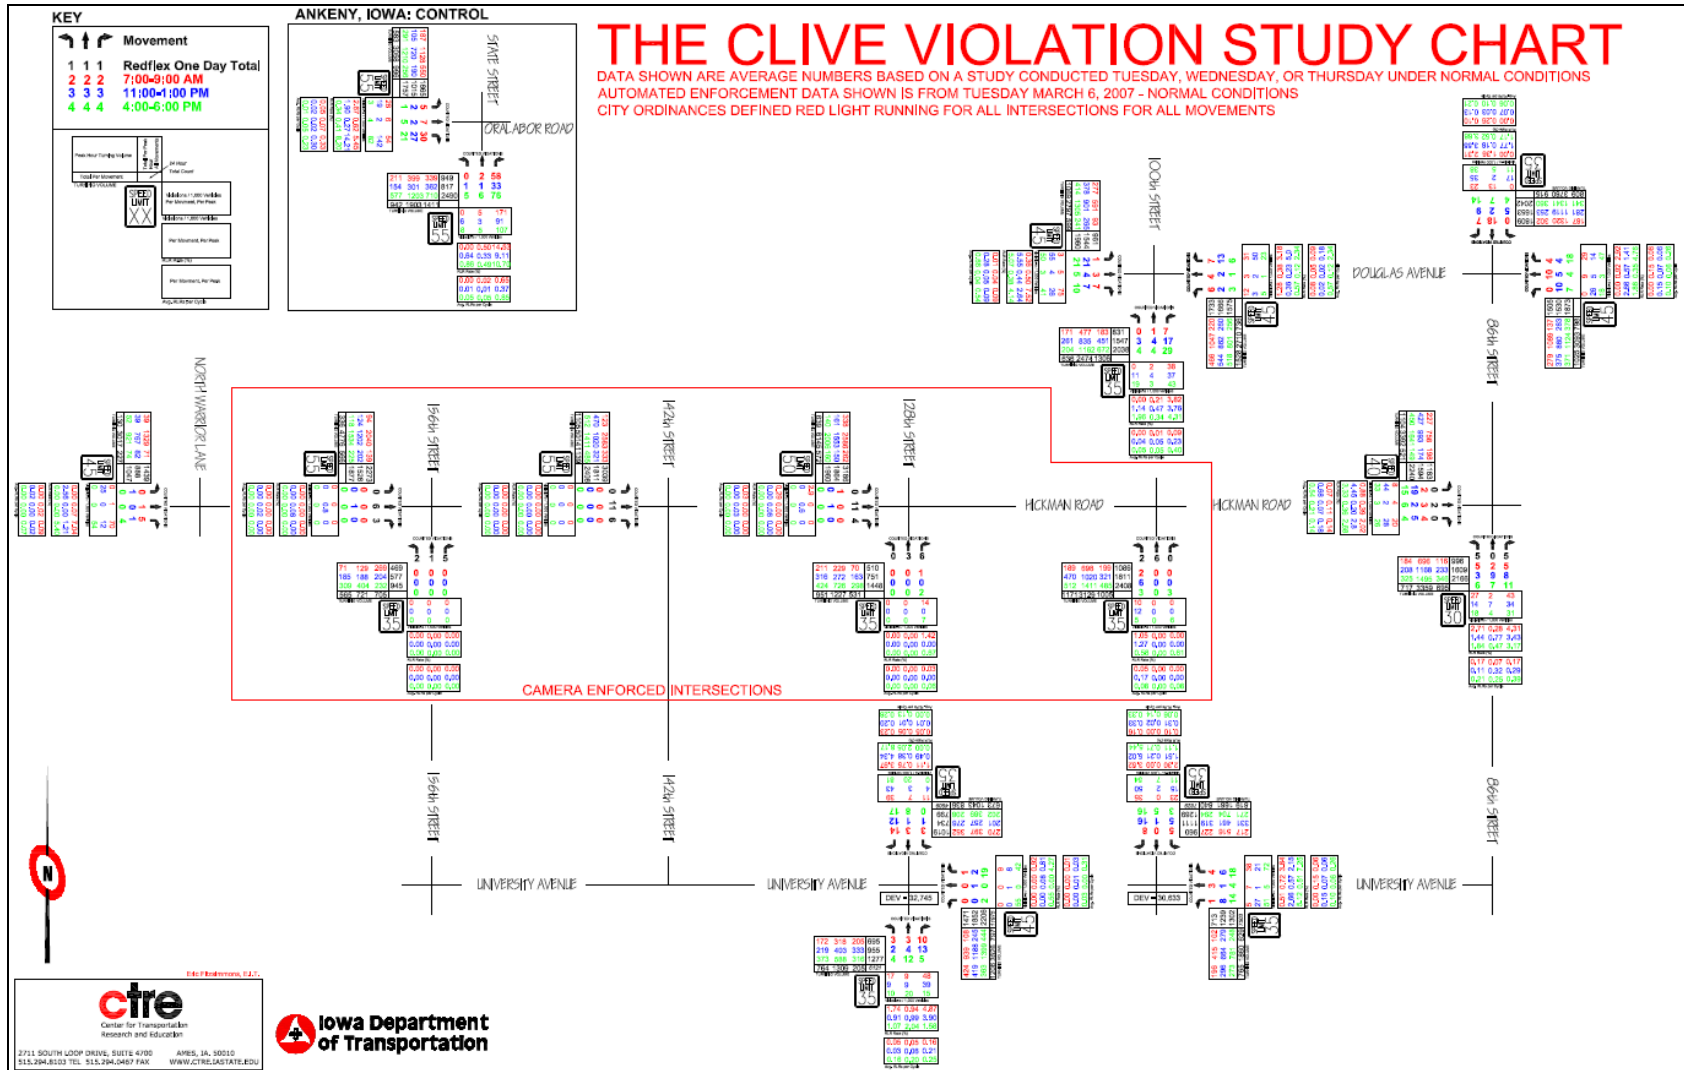
Figure 47. Violation study map and results per intersection.

In addition to performing a study looking solely into violations at camera enforced intersections and control intersections, the research team was interested as to what kind of data was behind each violation at the camera enforced intersections. Along with the actual violation count for the entire enforcement period, day of the week data were also obtained from the Clive police records via Redflex as to what day of the week violations occurred the most. A common misconception by many media outlets is that RLR occurs most frequently on the weekends when drivers are away from the office; however, contrary to this theory, RLR studies have concluded that RLR violations occur most frequently during the working days of the week when traffic volumes are higher and schedules are tighter. Using RLR data obtained from the Clive Police Department, TABLE 43 lists the total number of violations for the entire enforcement period per day of the week and the rank of each day depending on this value for all of the intersections in Clive with RLR cameras.

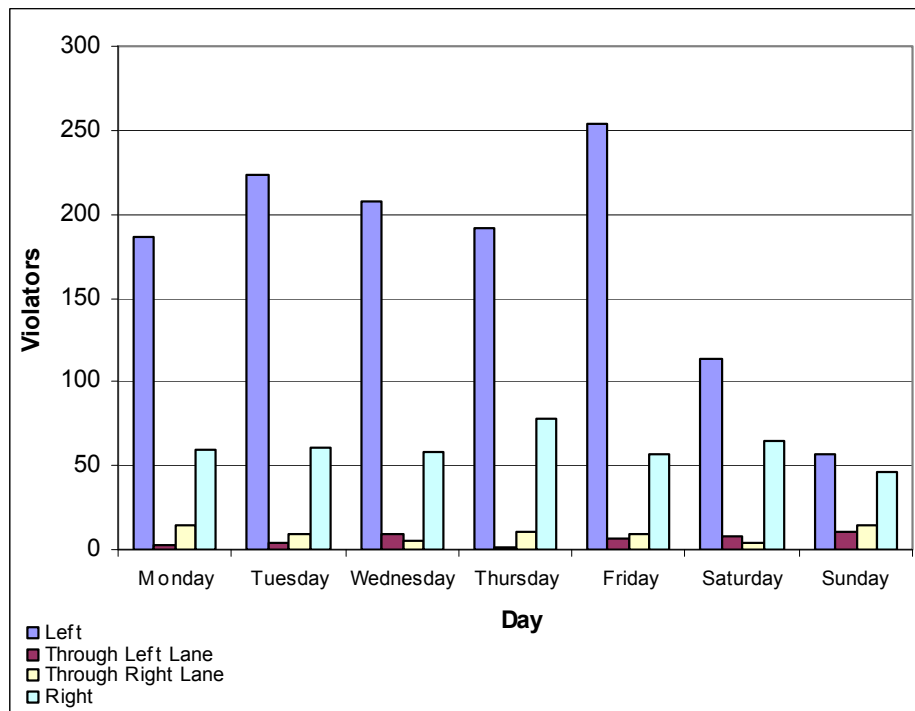
Figure 49. Total violations per day of the week at 100th St. northbound and Hickman Rd.

Figure 49 illustrates the number of violators per day of the week for the northbound approach at the intersection of 100th Street and Hickman Road. As shown, the left turn movement had the highest number of violators each day of the week with the highest number of violations occurring on Friday. The number of through movement violations stayed consistent throughout the week, the right turning movement had its highest number of violations on Thursday.

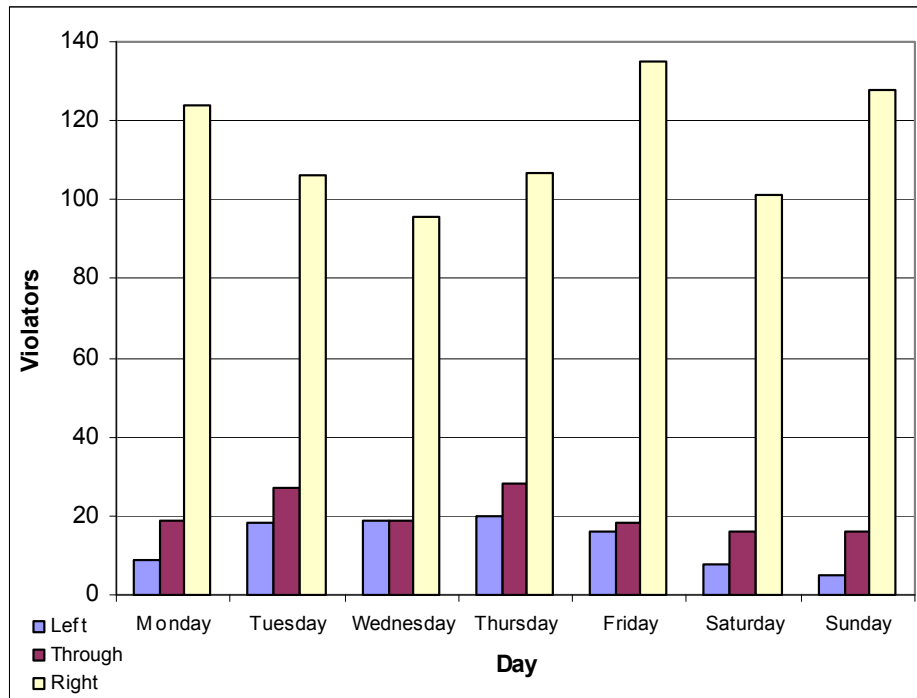
Figure 50. Total violations per day of the week per lane at 128th St. northbound and Hickman Rd.

As shown in Figure 50, the northbound approach at the intersection of 128th Street and Hickman Road had its highest violation total on Friday. Also, Figure 50 illustrates that the right turning movement had the highest number of violation each day of the week.

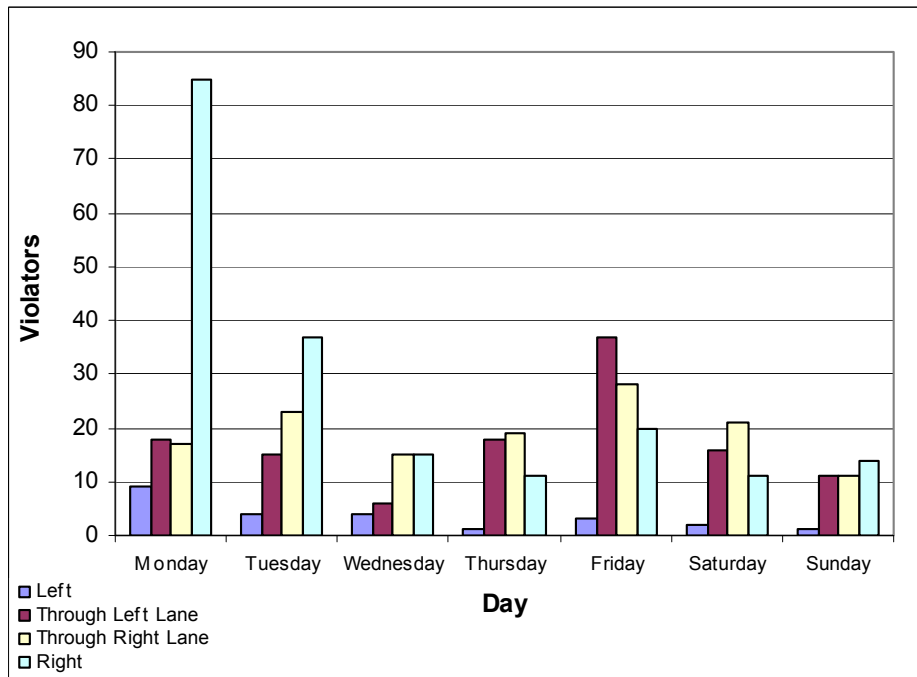
Figure 54. Total violations per day of the week per lane at 156th St. eastbound and Hickman Rd.

As shown in Figure 54 and listed in TABLE 43, the eastbound approach at the intersection of 156th Street and Hickman Road had the highest total number of violations on Monday, as the right turning movement on Monday was extremely high compared to the through and left turning movements for the entire week. The through movement had the highest number of violations on Friday, while the left turning movement had its highest number of violators on Monday.

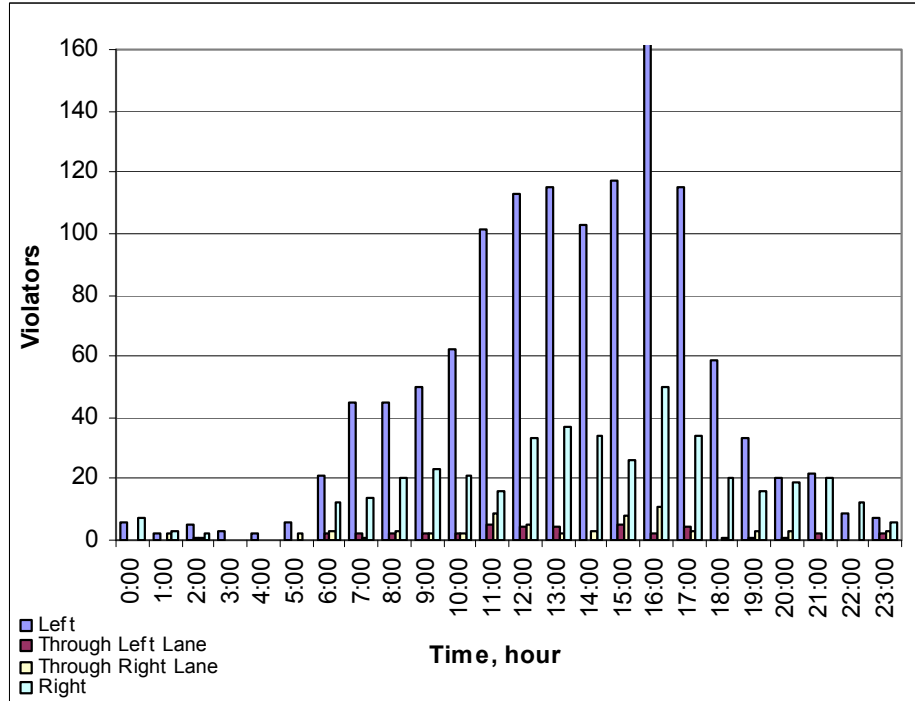
Figure 57. Total violations at northbound 100th Street and Hickman Road over a 24 hour period.

Figure 57 illustrates the total number of violations per hour of day for each northbound movement at 100th Street and Hickman Road. As shown, the left lane had the highest number of violations from 6:00 AM to 9:00 PM. Due to surrounding businesses and location of this camera, it is believed that most of the vehicles running the left turn were either commercial vehicles or private vehicles heading towards Interstate 80, located west (left turning movement) of 100th Street and Hickman Road. The right turning movement had the second highest number of violators and its trend follows closely that of the left turning movement at a lower number of total violations.

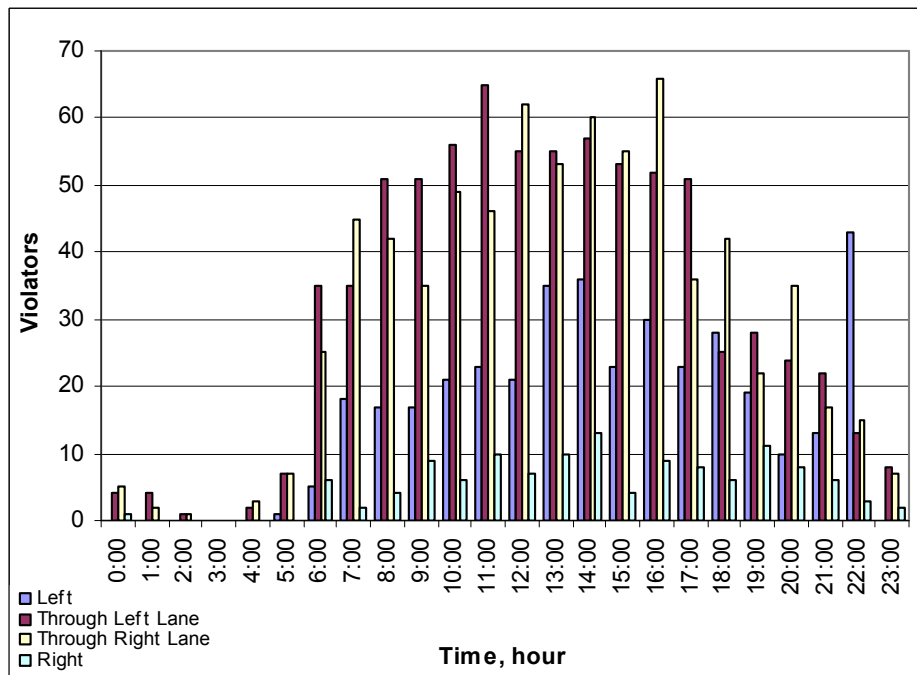
Figure 59. Total violations at eastbound 128th Street and Hickman Road over a 24 hour period.

Figure 59 illustrates the total number of violations per hour of day for each eastbound movement at 128th Street and Hickman Road. As shown, the majority of the RLR violations happened between 6:00 AM and 11:00 PM, with both through movements having the highest number of violations. Also shown, the left turning movement had an unusually high number of violations at 10:00 to 11:00 PM compared to the trend of all other movements.

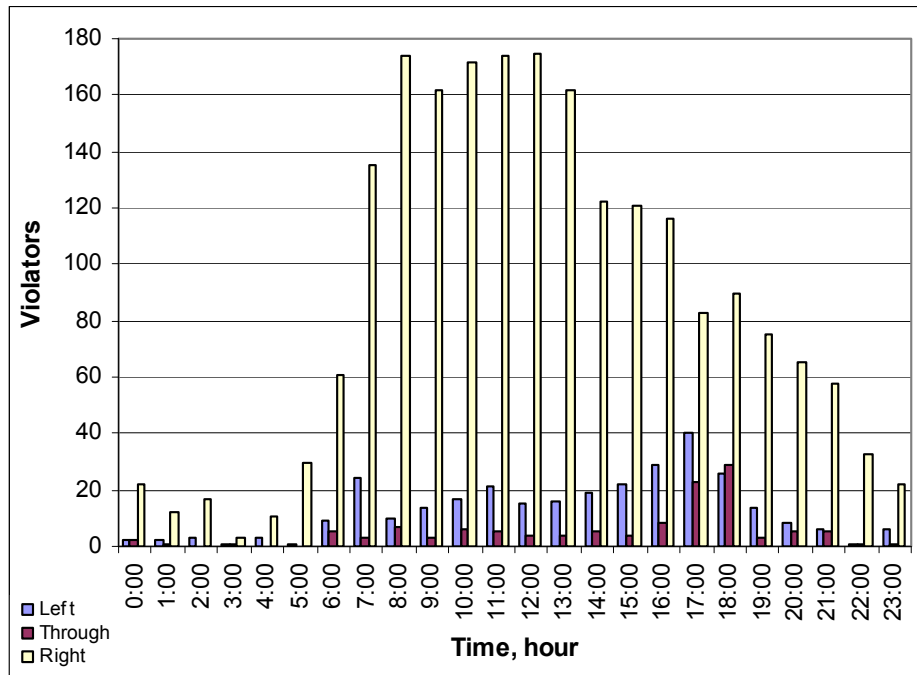
Figure 61. Total violations at northbound 156th Street and Hickman Road over a 24 hour period.

Figure 61 illustrates the total number of violations per hour of day for each northbound movement at 156th Street and Hickman Road. As shown, the right turning movements had the highest number of violators over all of the 24 hours, but were especially high between 8:00 AM and 1:00 PM. One possible reason for this might be the Dahl’s grocery store that has an access point on northbound 156th Street, and these times might correlate to when people go to the grocery store. Also shown, left and through movements had a gradual increase in RLR during the hours of 12:00 PM through 6:00 PM, likely due to commuters running a red light on their way home from work.

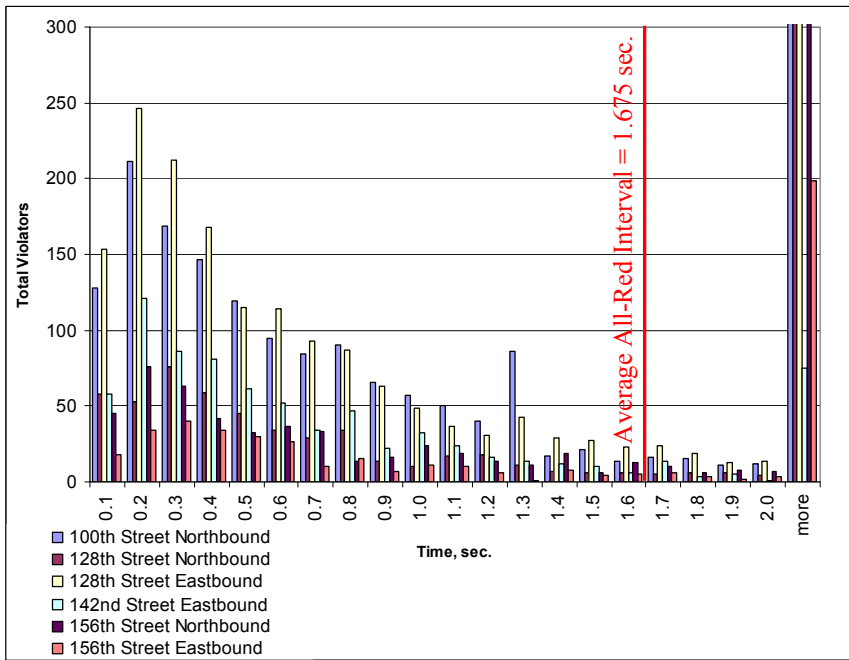
Figure 63. RLR severity Totals at all camera enforced intersections.

Although many violators ran the red light during the 1.675 average all-red phases, a majority of the RLR occurred after 2.1+ seconds on the red phase as shown in Figure 63. The highest number of 2.1+ second violators occurred at northbound 156th Street with over 1900 violations happening at 2.1+ seconds. To explore the reason behind why drivers might enter the intersection so late in the red phase, each movement for each intersection was studied in order to find an explanation or movement that contributed to when the driver entered the intersection. Figure 64 through Figure 69 present the times for each lane of the enforced approaches in Clive. As illustrated in Figure 64, the left and right turning movements had the highest number of violators for all of the measured times after the onset of the all-red phase at the intersection of 100th Street and Hickman Road. This intersection had the longest all-red clearance interval of Clive's camera enforced intersections. It was also found that this approach had the second highest number of violators between 0.1 and 2.0 seconds, but just the fourth highest number of violators that entered the intersection after 2.1+ seconds. Figure 65 and Figure 66 illustrate the RLR severity at the intersection of 128th Street and Hickman Road

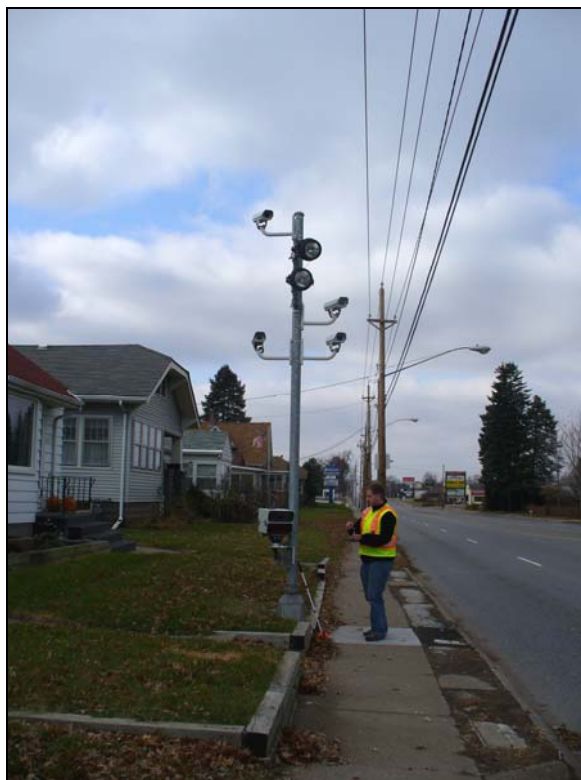
Figure 89. Davenport RLR and Automated Speed Camera System.

Unlike the camera systems in Council Bluffs and Clive, individual lanes are monitored by a single video camera and flash as shown in Figure 89. Advance warning signs with orange flags alert approaching vehicles of automated enforcement. Video is constantly dumped by the computer system until a violating vehicle's speed is detected by inductive loops (or the video detection system) triggering the video capturing sequence. There is no grace time built into the system and no approaching vehicle threshold speed to give the benefit of doubt to the driver. Short videos that are captured are transmitted to Transol in Arizona via a dedicated T1 phone line and are processed and filtered before sending images back to the Davenport Police Department for approval. Once a police officer has reviewed the video and license plate photo, approved violations are sent back to Transol and mailed to the owner of the vehicle. Unlike Clive, Davenport does not have a driver nomination ordinance to ticket the drivers of the registered vehicle.
