Pavement Condition Index and Cost of Ownership Analysis on Preventative Maintenance Projects in Kentucky

Dominic J. Michels

University of Kentucky, dmichels57@hotmail.com

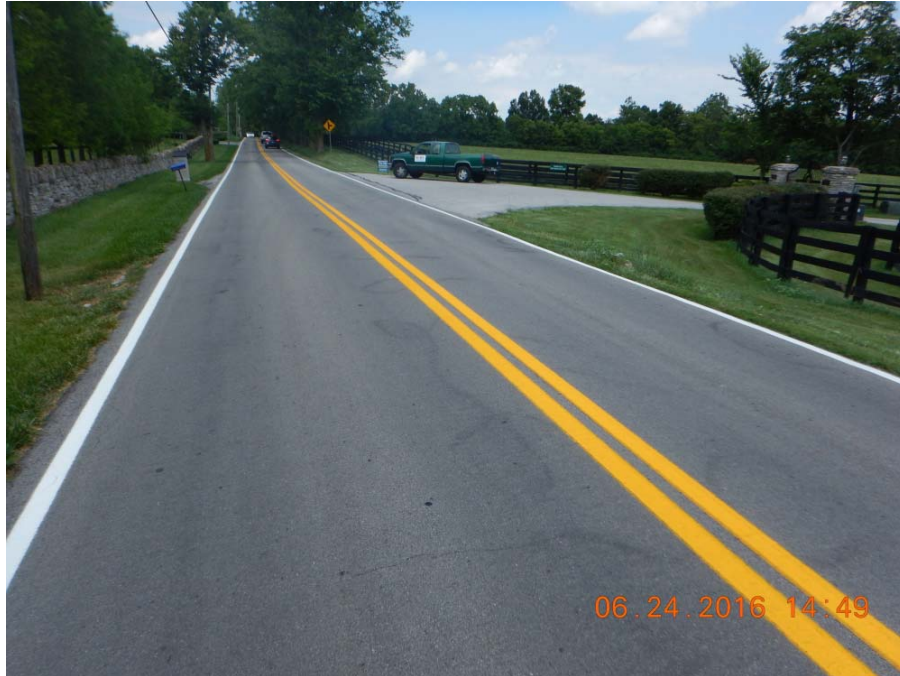
Figure 7.1: Fayette County, Bleeding Distress

Microsurfacing was found to be more susceptible to liquid asphalt bleeding than Thinlay. The bleeding would primarily originate from the presence of crack sealing material underneath the surface. While this distress did not contribute much numerically to the PCI difference, its commonality with Microsurfacing is worth noting. Some examples of this distress are shown below.

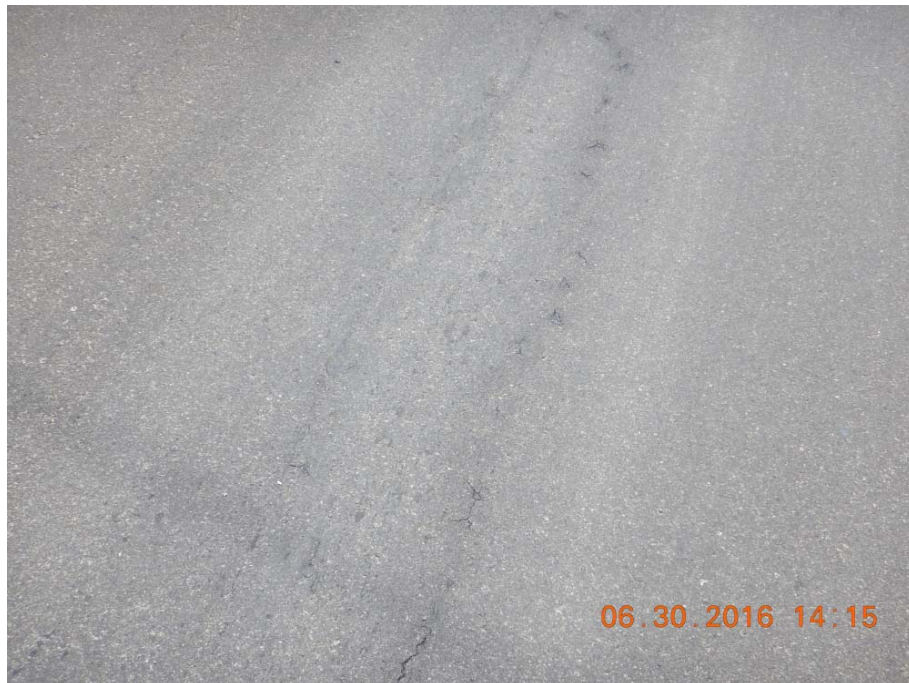
Figure 7.2: Morgan County, Bleeding Distress, Brand New Surface

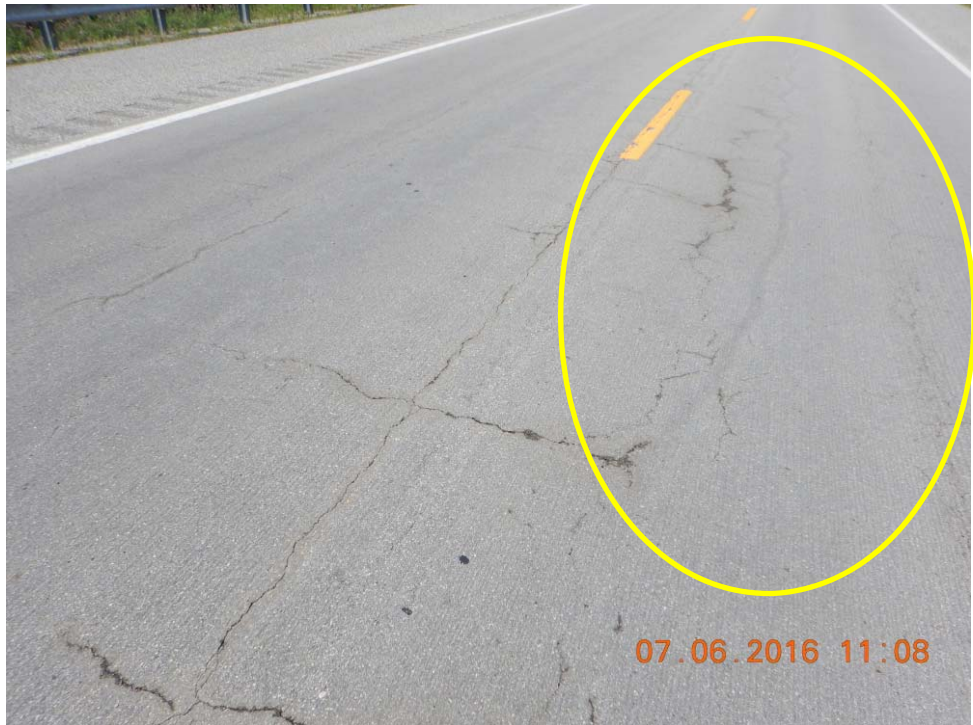
Figure 7.8: Greenup County, Alligator Cracking, Microsurfacing

Alligator Cracking was a common distress encountered during the pavement evaluations. This distress is caused by repeated traffic loading that eventually causes the pavement to crack and break apart in a pattern similar to chicken wire or alligator skin. It is a symptom that there is structural damage occurring in the pavement, and that the cracks are forming from the bottom to the top. Alligator Cracking appeared to be more common amongst Microsurfacing sites than Thinlay. There are a number of factors that may have contributed to this observation, including the thin layer thickness of Microsurfacing, or the possibility that the pre-existing pavement already had structural damage. If Microsurfacing or a Thinlay is applied to a surface with such structural damage, sub-par performance is expected of either product. Within the ASTM deduct value curves, alligator cracking is a very sensitive parameter, and can significantly reduce the PCI with a relatively small density. Therefore, the presence of more alligator cracking in Microsurfacing significantly contributed to its low PCI values. Some visual examples of this distress are shown below. These images, as well as the vast majority of recorded alligator distress, represent low severity, before the cracking patterns into alligator skin.

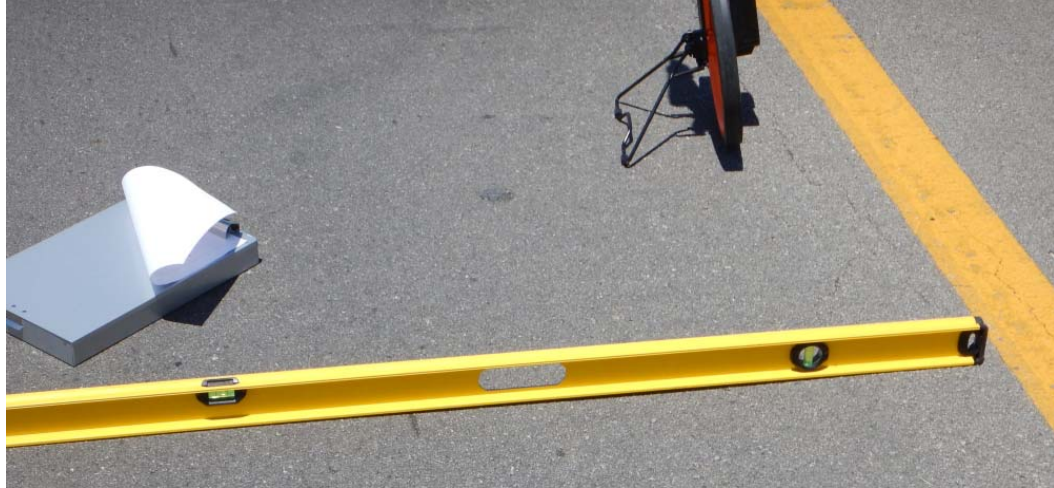
Figure 7.11: Nelson County, Rutting, Microsurfacing

The distress within the ASTM method that most significantly contributed to PCI loss was rutting, which is longitudinal deformation caused by wheel loading. It was found that Microsurfacing recorded significantly more cases of rutting than Thinlay. All rutting recorded was found to be low severity, which means that the maximum depth was between ¼” and ½”. It could be that Microsurfacing is too thin to properly correct for even minor rutting, or that physical wearing in the wheel path is creating the rut. Some examples are shown below.

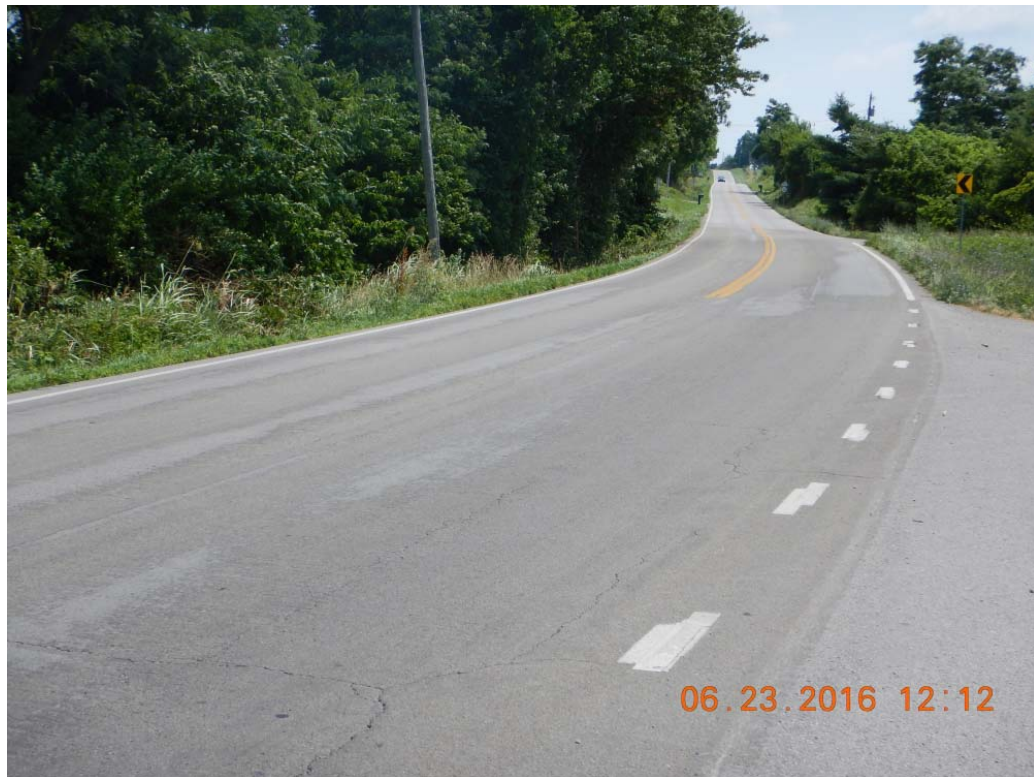
Figure 7.12: Boyle County, Surface Wearing, Microsurfacing

In certain Microsurfacing sites, it was found that the material was visibly wearing away and the underlying pavement layer was visible. While this severe wearing was not common to every site, it is worth noting as a distress unique to Microsurfacing, and was never seen on a Thinlay product. The notable occurrences were at the Fayette County and Boyle County Sites, as shown below.
