# Water Resources and Reuse for Remote Arctic Communities

Master of Science

Department of Environmental Engineering

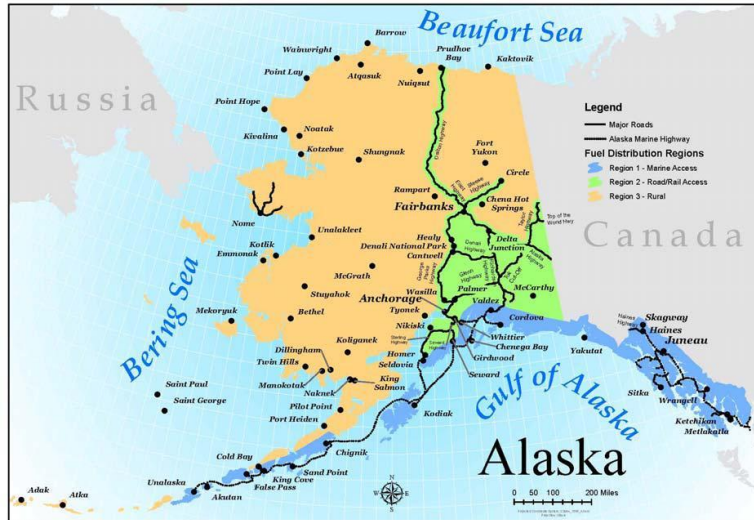
Figure 2: The road system and fuel distribution areas of the state of Alaska. Only region 2 (in green) has road and rail access. Region 1 (blue) is served primarily by the Alaska Marine Highway and air services. Region 3 (yellow) is exclusively accessible by coastal or river boat or barge, air services, and off-road trail or snow vehicles (Alaska Department of Environmental Conservation 2017a).

barge and all-terrain vehicles in the warmer months, and snow machine in the colder months (Figure 2). Because jobs and other economic opportunities are scarce in the remote rural areas, poverty is widespread and reliance on government jobs and public assistance programs is very common (Goldsmith 2008).

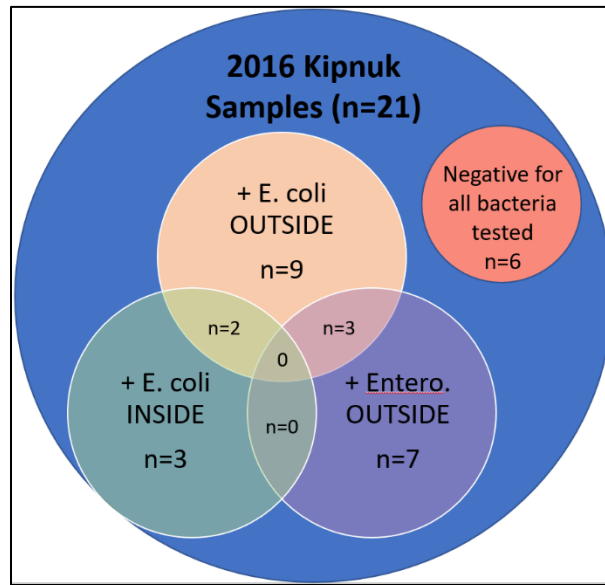
*Figure 4: Bacteria results from Kipnuk rainwater catchments that were sampled for *E. coli* in indoor and outdoor containers and for Enterococci in outdoor containers. Out of 21 total samples, 6 were negative on all three bacteria tests. Nine homes tested positive for *E. coli* in the outside sample, two of which were also positive for *E. coli* inside and three of which were also positive for Enterococci outside. One additional sample only tested positive for *E. coli* inside the home and four additional samples only tested positive for Enterococci in the outside sample. No homes tested positive on all three bacteria tests.*

Fourteen out of 21 Kipnuk samples (Figure 4) and four out of eight Koyukuk samples (Figure 5) from 2016 tested positive for bacteria. Twenty out of 21 Kipnuk homes sampled and four out of eight Koyukuk homes sampled consented to collection of an indoor sample of stored rainwater in addition to the outdoor sample. Nine samples from outside rain catchments in

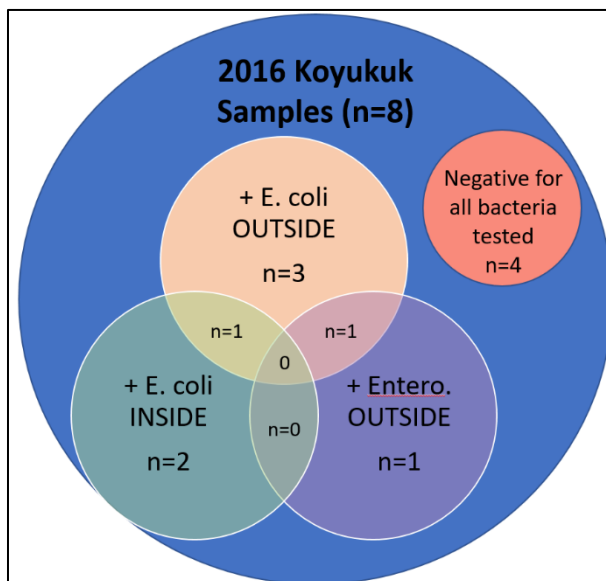
Figure 5: Bacteria results from Koyukuk rainwater catchments that were sampled for *E. coli* in indoor and outdoor containers and for Enterococci in outdoor containers. Eight homes were sampled and four were negative for all three bacteria tests. Three households were positive for *E. coli* in the outside sample taken, one of which was also positive for *E. coli* inside and one of which was also positive for Enterococci in the outside sample. One additional sample tested positive for *E. coli* indoors only. No homes tested positive on all three bacteria tests.

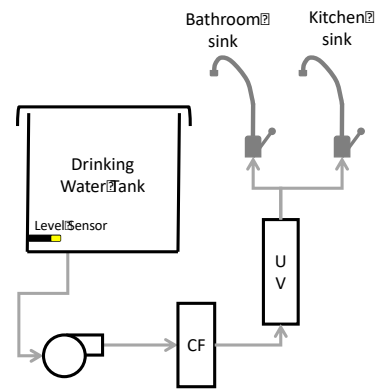
*Figure 6: Drinking water treatment schematic*

The drinking water system was designed to use the best quality source water and produce the highest quality water within the pilot system. Source water of the homeowner's choosing is poured into a 6-gallon drinking water tank for pre-treatment storage and then is pumped on demand at 1.1 gallons per minute (GPM) through a 1 micron cartridge

filter to remove debris. After filtration, the water is pushed through a low-pressure ultraviolet disinfection unit and dosed with at least 40 mJ/cm<sup>2</sup> (milli-Joules per centimeter squared) of UV light before being dispensed through a specified and separate drinking water faucet (Figure 6).

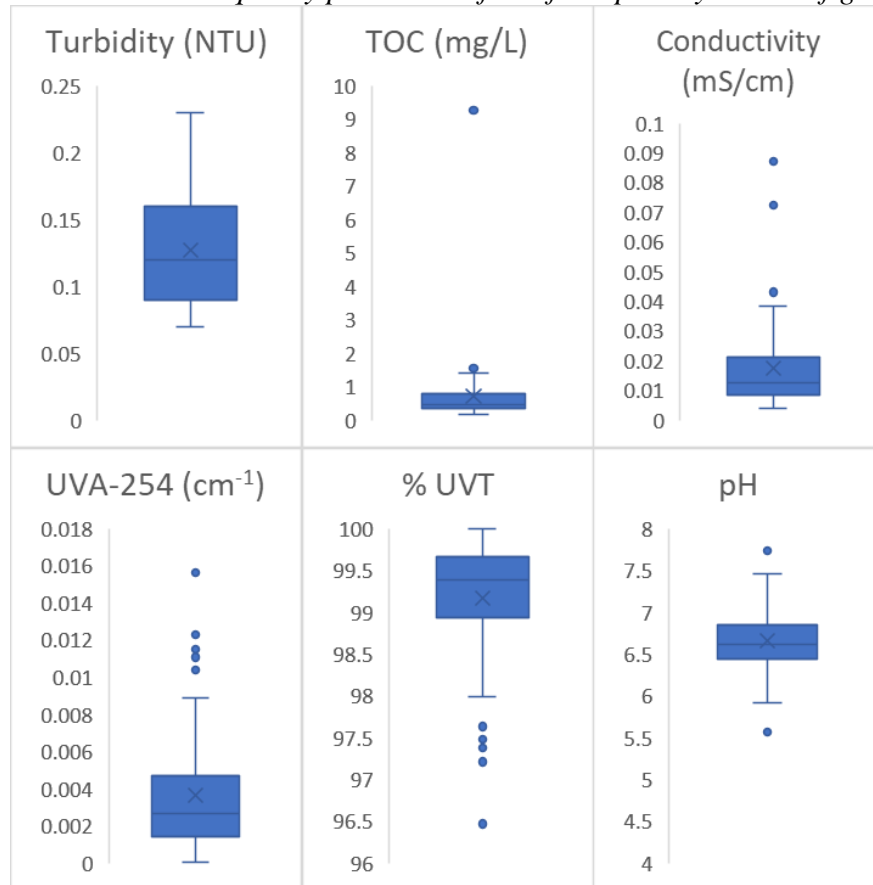
Figure 8: Wash water quality parameters from final pilot system configuration.

The changing of RO membranes was associated with abnormally high TOC (9.62 mg/L) in at least one instance. The ozone component of the system was added to ensure that bacteria regrowth did not affect stored wash water and to improve odor with higher water age if the

system was unused for several days. While the system operated at desired water quality specifications most days without ozone, two positive bacteria samples and two positive odor detections were seen when the ozone was turned off.

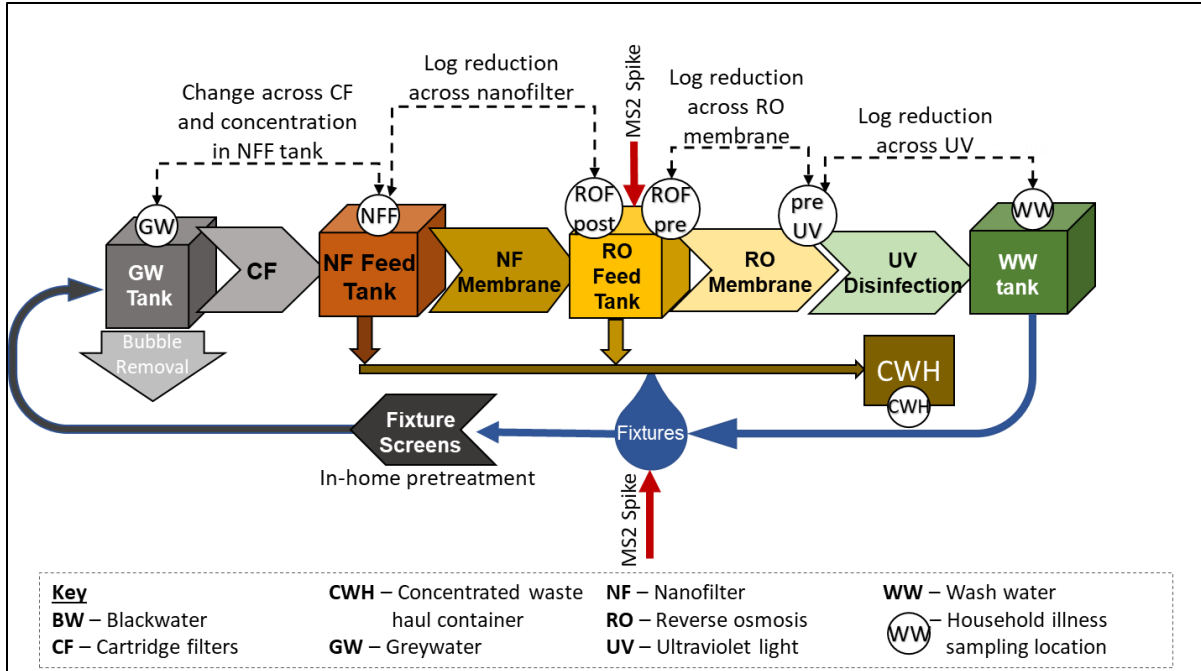
Figure 9: Household virus challenge spike and sampling schematic

Prior to the virus challenge, the stability of MS2 was examined in water from each of the four water treatment tanks (GW, NFF, ROF and WW) over a 24-hour period. During the virus challenge, 10<sup>11</sup> PFU/mL (plaque-forming units per mL) MS2 was spiked daily into the fixture drains (185 mL into the shower, 55 mL into the kitchen sink, and 65 mL into the bathroom sink)

from day 0-6 (Figures 9-10). Each day, approximately 60 gallons (230 liters) of wash water and synthetic greywater concentrate also flowed into the fixture drains through 50-mesh stainless steel screens during normal operation of the pilot system (see above), accumulating in the greywater tank over a 12-hour period. The GW and ROF tanks (“ROFpre” samples) were sampled approximately 20 hours after the daily spike and before the daily batch treatment began. The nanofilter feed tank was sampled one hour later after the first treatment step was complete and the NFF tank was full. The pre-UV samples were collected during the second treatment step while water was being treated from the ROF tank across the RO membrane and through the UV unit from a plastic valve sterilized with 70% ethanol and wiped down with a clean cloth. While pre-UV samples were being collected, a valve connecting the RO membrane effluent line to the UV unit was closed to ensure that no UV-treated water back-flowed into the sample container. The ROF (“ROFpost” samples) and WW tanks were sampled immediately after treatment when they were full each day (Figure 9). All samples except pre-UV were collected via metal taps that drained from the bottom of the tanks and were sterilized with 70% ethanol and wiped with a clean cloth. Although the wash water system is designed to have two UV reactors in series and periodic ozone dosing of the WW tank during normal operation, only a single UV unit was turned on during the whole household virus challenge and the ozone was turned off. Microbiological samples were collected in sterile HDPE sample bottles and other water quality samples were collected in furnaced glass vials.

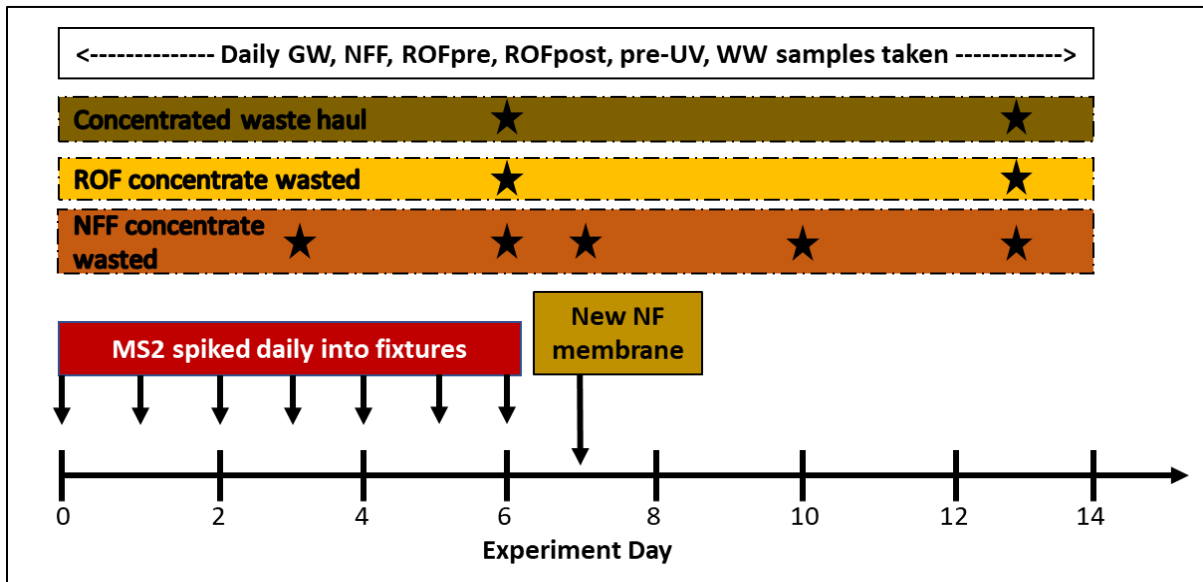
Figure 10: Household virus challenge timeline

After the seven-day spiking period, samples continued to be taken from all sample locations on the same schedule as described above daily from days 7-13 to monitor virus persistence within the reuse system after the loading period ended. The concentrated waste haul tank was sampled on the designated haul days during the testing period (day 6 and 13) to examine the virus concentration within the hauled waste.

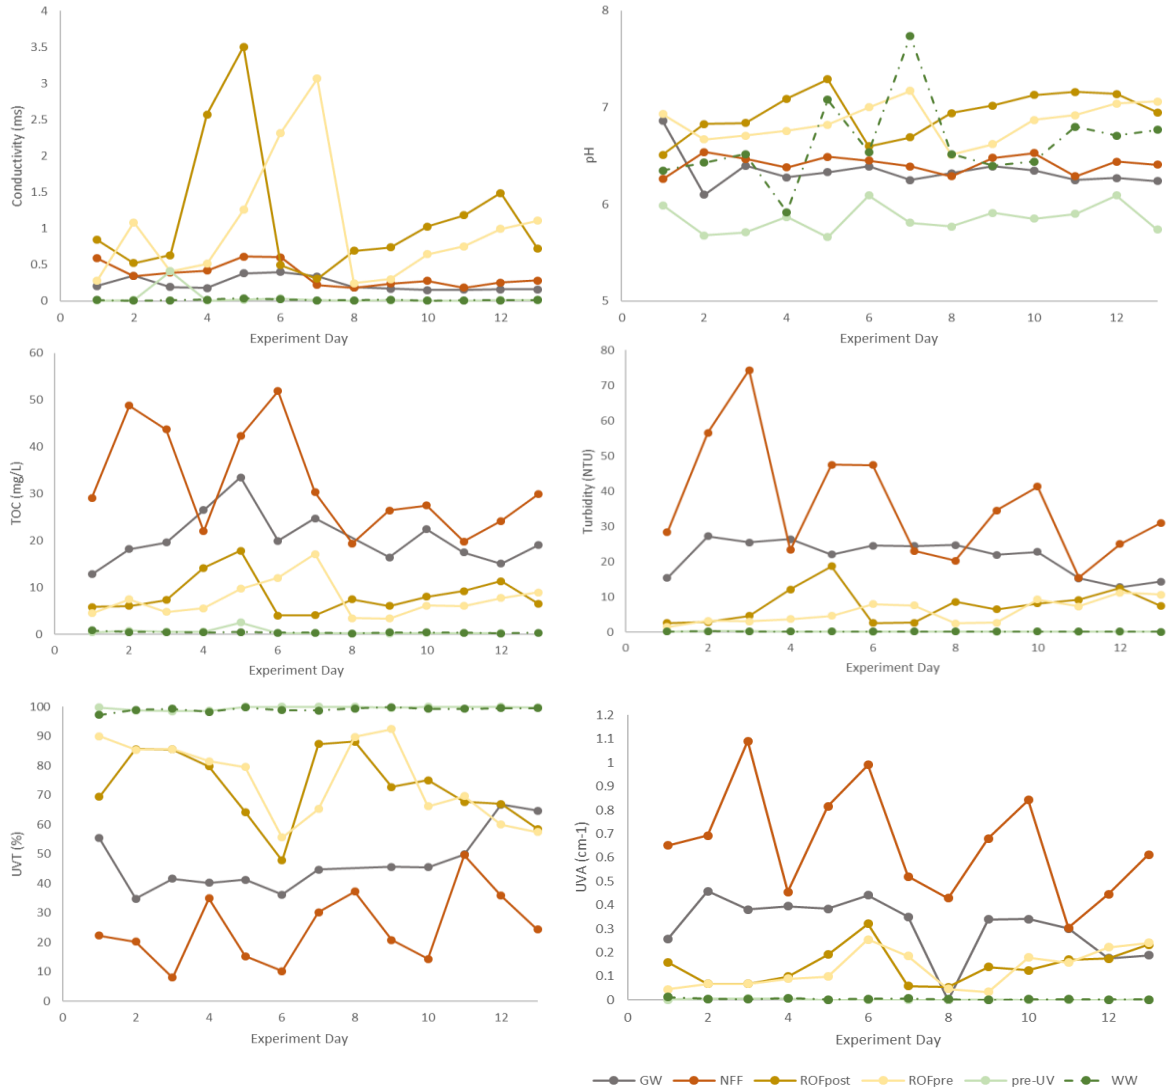
Figure 11: Conductivity, pH, TOC, turbidity, UVT and UVA in samples from six different points in the wash water treatment system during the whole household viral challenge with MS2.

The GW tank, pre-UV, and WW tank water quality samples were consistent over time for all parameters except for a large day-to-day variation in the WW tank pH (Figure 11). The NFF tank parameters fluctuated predictably every 3-4 days coinciding with the NF concentrate wasting day (day 3, 6, 7, 10, 13): turbidity and TOC would decrease and UVT would increase immediately after the wasting day, while conductivity and pH stayed consistent throughout the wasting cycle. The ROFpre and ROFpost samples also showed weekly fluctuations with conductivity, turbidity, TOC and pH decreasing after the wasting day (day 6 and 13) and UVT increasing. The ROFpre tank showed these changes one day after the ROFpost tank due to the timing of the concentrate wasting versus sample collection times (Figure 7).

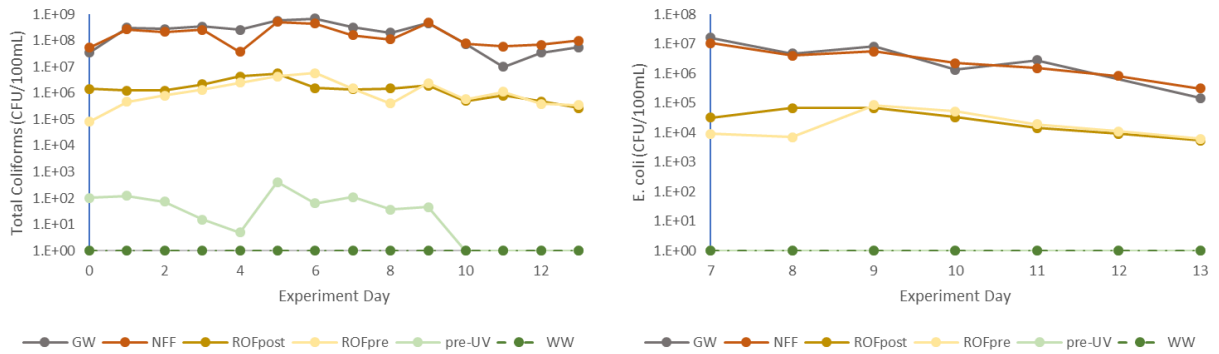
Figure 12: Total coliform (left) and *E. coli* (right) concentrations at six different sampling points in the wash water treatment system show relative stability in bacteria concentrations within each tank over time.

Total Coliforms and *E. coli* were consistent in each tank throughout the experiment, with some small daily fluctuations (Figure 12). Total Coliforms occurred in the synthetic greywater on the order of  $10^8$  CFU/100mL and *E. coli* occurred at  $10^6$ - $10^7$  CFU/100mL. No consistent and significant decrease in either indicator occurred between the GW tank and the NF feed tank because of regrowth and the concentrated waste that accumulates in the NF feed tank. Nearly 2-

log<sub>10</sub> reduction of both TC (total coliforms) and *E. coli* occurred across the nanofilter, and >4- log<sub>10</sub> reduction of both TC and *E. coli* occurred across the reverse osmosis membrane. Less than 10<sup>2</sup> CFU/100mL of Total Coliforms and no *E. coli* were detected in the pre-UV samples, so log<sub>10</sub> reduction could not be accurately measured across the UV unit.

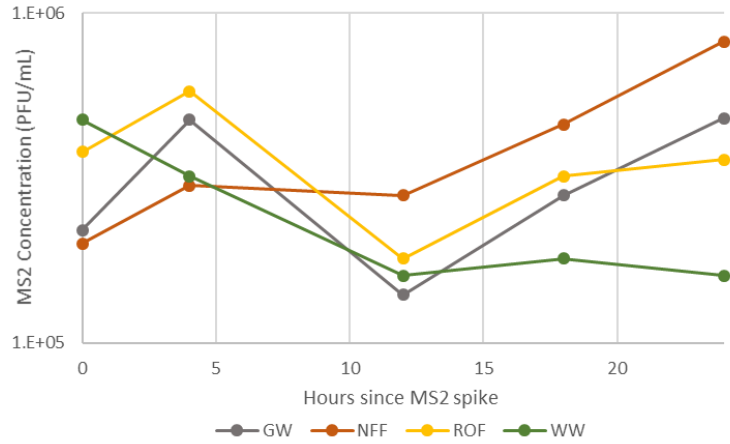
Figure 13: Concentration of MS2 in sample water from each tank in the treatment process over 24 hours during a bench-scale stability test.

MS2 fluctuated less than one log and was therefore considered stable in water from each of the treatment tanks for at least 24 hours (Figure 13). The concentrations of MS2 at each sampling point over the entire experiment are shown in Figure 14. An initial concentration of > 10<sup>7</sup> PFU/mL of MS2 was achieved in the GW tank on each day of fixture spiking. During the seven-day spiking period, this concentration was maintained from the GW tank to the NFF tank. After the fixture spike period ended, the concentration of MS2 in the GW tank dropped to 10<sup>4</sup> PFU/mL over two days and slowly decreased on subsequent days. Because of the waste being concentrated in the NFF tank, after spiking, the NFF MS2 concentration dropped much more slowly to 10<sup>5</sup> PFU/mL after seven more days.

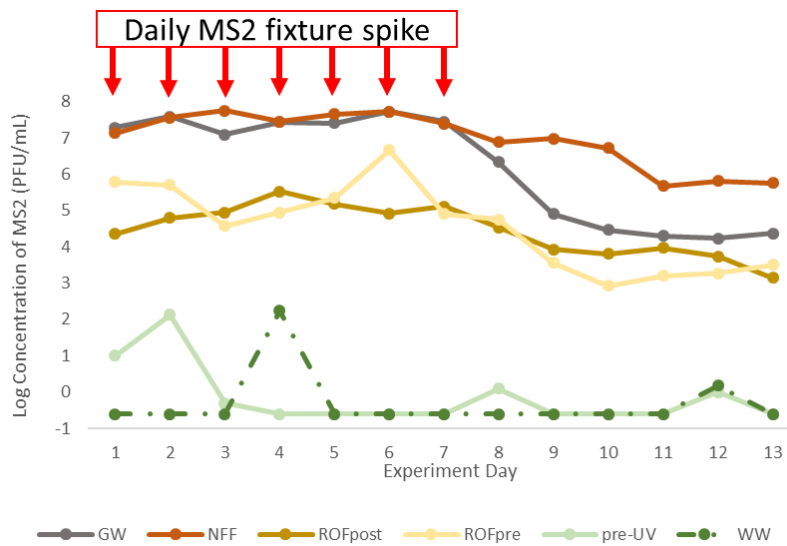
Figure 14: MS2 concentration within the treatment system during the seven-day fixture spike experiment and for seven days after daily MS2 spiking ended.

The nanofiltration membrane averaged 2.5- $\log_{10}$  reduction of MS2 over the 14-day test period. Average concentrations of MS2 in the ROF tank were  $>10^5$  PFU/mL during the spike period, but dropped to slightly over  $10^3$  PFU/mL by the end of the experiment. Preliminary

MS2 concentrations in the GW, NFF and ROF tanks declined slowly after the seven-day spiking period ended. MS2 was detected at low levels in four pre-UV sample during the entire experiment, and only two WW samples were above the detection limit (Figure 14).

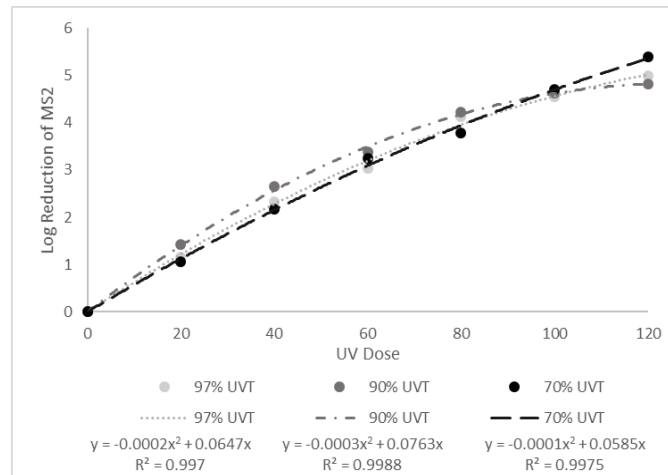
Figure 15:  $\log_{10}$  reduction curves of MS2 in a low-pressure UV collimated beam reactor for waters with three different UVTs.

UV disinfection were applied to water immediately after nanofiltration but without with RO treatment step, the UVT would be 71-76% and the reduction equivalent dose would be less than 100 mJ/cm<sup>2</sup> (Figures 15-16).

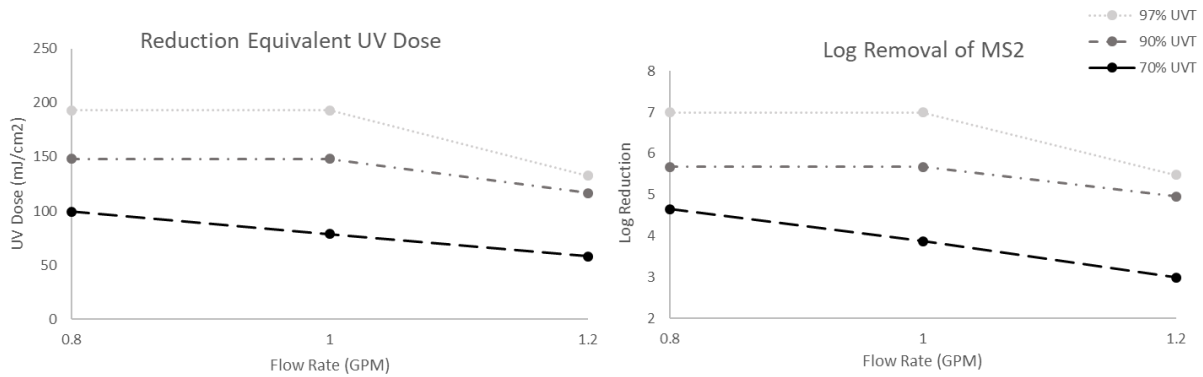
Figure 16: Reduction equivalent dose and log<sub>10</sub> reduction of MS2 for the Viqua VH200 UV component of the wash water treatment system.

The Viqua VH200 system demonstrated a 5.5 to 7- $\log_{10}$  reduction of MS2 at 97% UVT and a flow rate of 0.8-1.2 GPM (Figure 16).  $\log_{10}$  reduction decreased to 5-5.7  $\log_{10}$  of MS2 at 90% UVT and to 3-4.6  $\log_{10}$  of MS2 at 70% UVT (Figure 16). The average UVT of treated water immediately before UV disinfection (pre-UV) in the pilot system is  $>99\%$  (Table 7). At this UVT and 1.0 GPM flow rate, a single Viqua VH200 system is expected to deliver approximately 200  $\text{mJ}/\text{cm}^2$  (Figures 15-16) of low-pressure ultraviolet radiation to disinfect the wash water before use. This dose decreases as UVT decreases or as flow rate increases. If the
