The Relationship between Seismic Hazard Vulnerability and Stage of Economic Development: Illustration for Three Countries

**THE RELATIONSHIP BETWEEN SEISMIC HAZARD VULNERABILITY AND
STAGE OF ECONOMIC DEVELOPMENT:
ILLUSTRATION FOR THREE COUNTRIES**

Master of Engineering

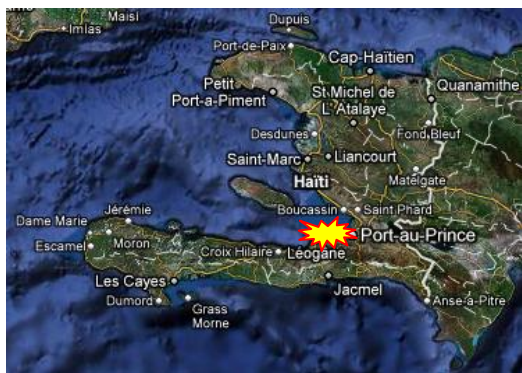
Figure 2-1. Location of Haiti's earthquake epicenter.

The earthquake that struck Haiti happened at 04:53 PM local time (21:53 Coordinated Universal Time (UTC)). The main shock epicenter was located about 25 km west-southwest of the city of Port-au Prince, 130 km east of Les Cayes, 150 km South of Cap-Haitien in Haiti and 1125 km south-east of Miami, Florida as shown in Figure 2-1. Within two weeks after the primary shock, there were 59 aftershocks with magnitudes 4.5 or greater (USGS, 2010a).

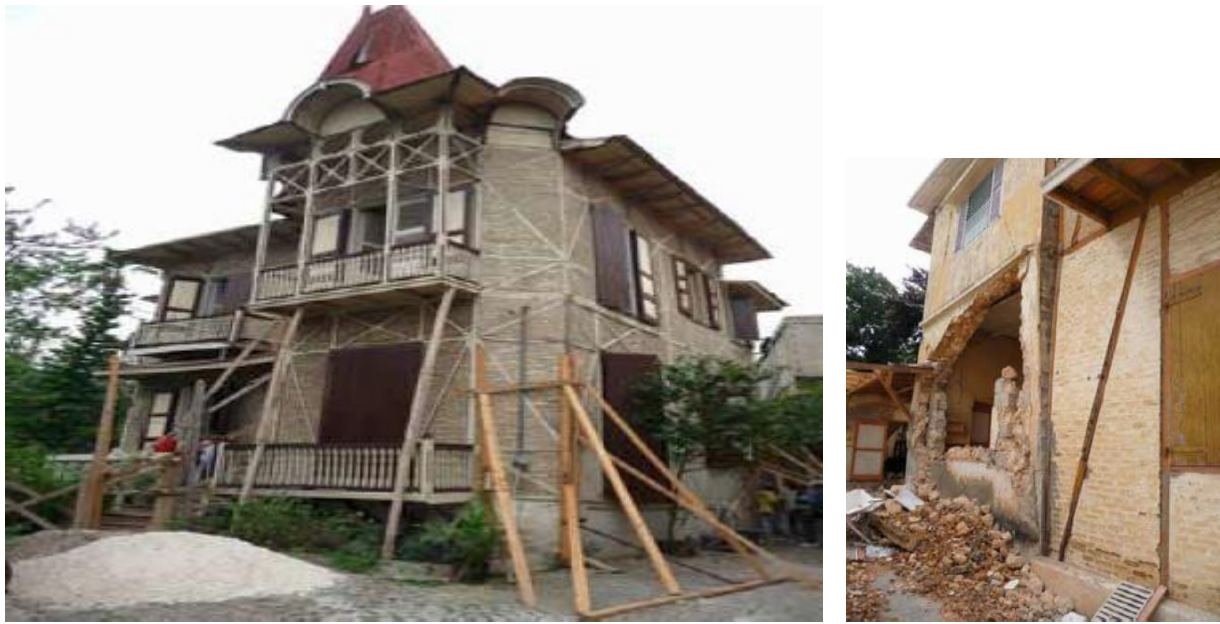
Figure 2-4. a. Gingerbread wooden house (Badley, 2010). 4b. Unreinforced masonry building(Hammer, 2010)

In general, timber frame buildings performed well under the seismic load (EERI, 2010a). In Bois Verna, a neighborhood of Port-au-Prince, 200 wooden houses known as 'gingerbread' houses withstood the earthquake shown in Figure 2-4a below (Bradley, 2010). Wood buildings in these types of timber frame structures are light and flexible, with diagonal members and interior wooden planks spanning horizontally across the wall framing, providing lateral structural strength. In many cases, however, serious damage was caused due to the deterioration of wood members from termites or rot, thus weakening the members.

Unreinforced masonry failed under the earthquake load, with damage ranging from diagonal cracking in wall sections to collapse (see Figure 2-4b). Failures can be attributed to the lack of brick ties or brick headers between brick wythes, lack of reinforcement, weak stone at critical points, poor quality due to poor aggregate quality, inadequate cement or lime, and poor maintenance.

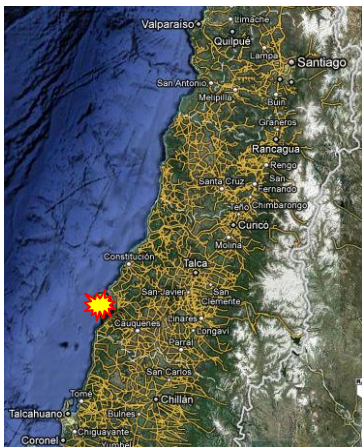
Figure 3-1. Location of the epicenter in Chile earthquake.

On February 27, 2010, an earthquake with magnitude Mw 8.8 hit the central region of Chile. The main tremor occurred off the coast of the country at 3:34 am local time (6:34 UTC). Following the primary shock, over 300 aftershocks occurred with magnitudes of 5.0 or greater over the period of two months. In fact, twenty-one of these were at magnitudes 6.0 or greater (USGS, 2010). The epicenter of the 2010 earthquake was 105 km (65 miles) north-northwest of Concepción off the coast of the country shown in Figure 3-1. As the main earthquake occurred, the ocean floor warped and caused a destructive tsunami (Universidad de Chile, 2010). The earthquake moved the city of Concepción three meters (ten feet) to the west of its previous location, and moved the capital, Santiago, about 28 centimeters (11 inches) to the west-southwest (AON Benfield, 2010).

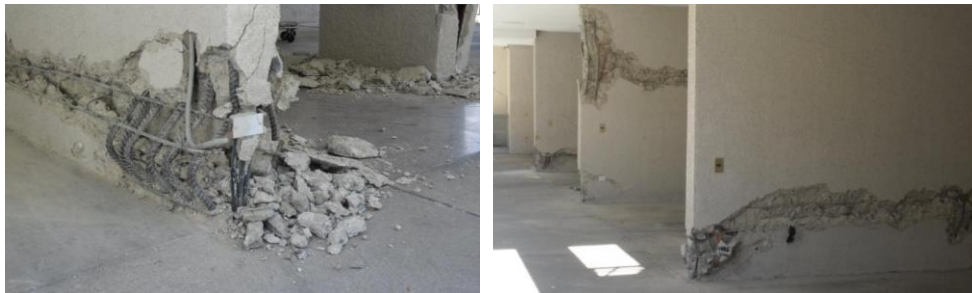
Figure 3-5. Damage due to concentration of vertical steel bars at end of walls (Leon, 2010)

the seismic response coefficient C (Moehle, 2010), as compared to the limitation of seismic shear force calculation that referenced ASCE7-05. Nor does NCh433 require the provisions of ACI that address boundary elements in walls. Because of this, what was found in many walls that failed were concentrations of vertical bars at both ends, and widely spaced bars in the middle, as shown in Figure 3-5 below (Leon, 2010). With tensile strength of the wall concentrated at the ends, the steel could not reach yield, and brittle crushing of concrete occurred as seen in the following picture. In contrast, ACI requires hooks or U-stirrups to resist buckling of vertical edge reinforcement (ACI 318, 1995).

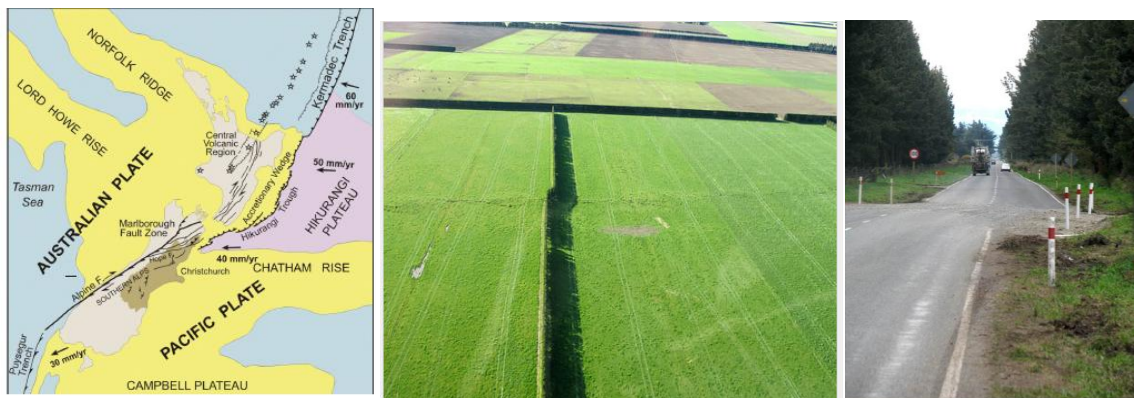
Figure 4-1.a. Fault zone in New Zealand. 1b. Greendale fault 1c. Road offset due to fault (Jongens et al., and Begg, 2010)

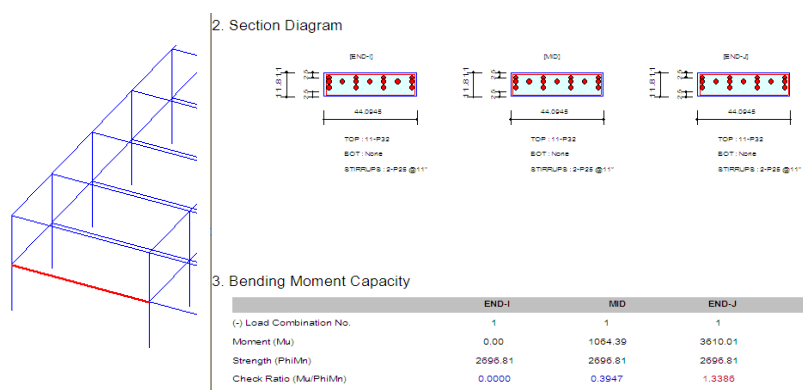
Figure 5-5. Random capacity check of a beam member

Since the two results are close to each other at this point, it is not necessary to further obtain all the calculations by hand. At the time of the evaluation, J R Harris Co had included the concrete walls as well as the steel panels in their analysis, and the impact of these wall added a significant rigidity to the building. The fact that the building experienced only minor damage means it must have received some help from these walls. Yet, when modeling this building, all the walls were taken out so that the analysis was solely focused on the frame structure itself. Consequently, as a result of this simplification, the displacement check for the frame did not meet the code requirement. Although, it appears that the safety factor when the building was built had also helped the building as well, based on the fact that it was only subjected to minor damage. Seen in Figure 5-5 below is one of the capacity checks of a beam member chosen at random.

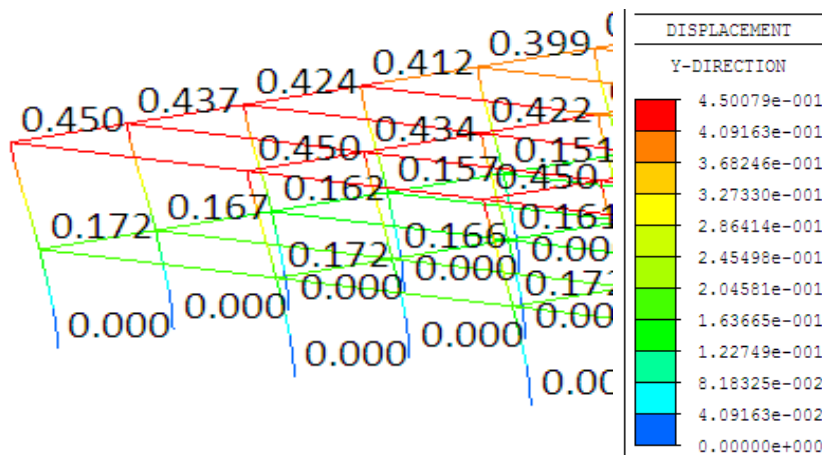
Figure 5-6. Displacements for story drift check

Shown in Appendix 6 and 7 are the reinforced design for beams and columns. A challenge in the design is that the story drift was large after amplifying by $C_d=5.5$. Because of this, the members selected are rather large in order to withstand the earthquake. MIDAS has an option that checks the story drift for each trial of the selection, as seen in Figure 5-6 and Table 5-15 below. These parameters are matched with the code requirement of the allowable drift. Strong column-weak beam requirements are also checked in Appendix 8 prior to the selection.

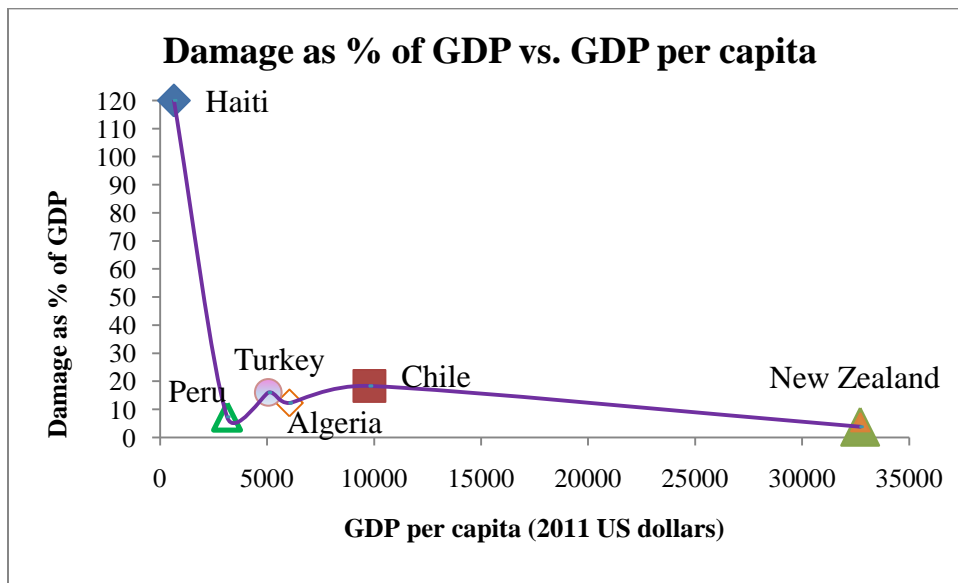
Figure 6-3. Damage as percentage of GDP versus GDP per capita with the additional information of earthquakes in Peru (1970), Algeria (1980), and Turkey (1999).

earthquake in Algeria caused 5.2 billion US dollars in damage (EM-DAT, 2011). The damage from the earthquakes in Peru, Turkey, and Algeria were then adjusted for inflation so that one can easily compare the results in the different countries. These three values were added onto the chart to see if there is a relationship, and the results can be seen in Figure 6-3. By adding more data to the chart, one can more clearly see the relationship between the result of the natural hazard and the various stages of economic development. Despite the fact that the damage in Peru, Turkey, and Algeria earthquakes were lower as a percentage of the country's GDP compared to Haiti's earthquake, it is worth pointing out here that the assessment of hazard damage in general is difficult. There were many earthquakes that were considered as destructive, but their corresponding damages in terms of number of dollars can only cover part of the description. As many others involved issues, such as: damages in surrounding areas, destruction of towns, destruction of community, and dislocation of numerous people, which are difficult to quantify in monetary terms.

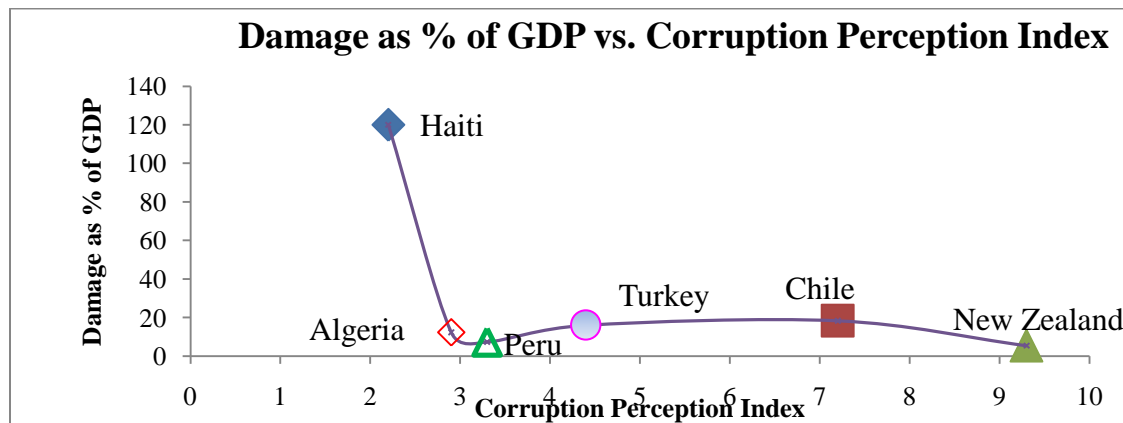
Figure 6-7. Damage as percentage of GDP versus Corruption Perception Index with addition data.

As mentioned in Section 6.2, comparison is needed to include more data. Therefore, three additional countries were added in between the portion of Haiti and Chile. Again, one can see the relationship of social's issue to the vulnerability stage of a country as in Figure 6-7.

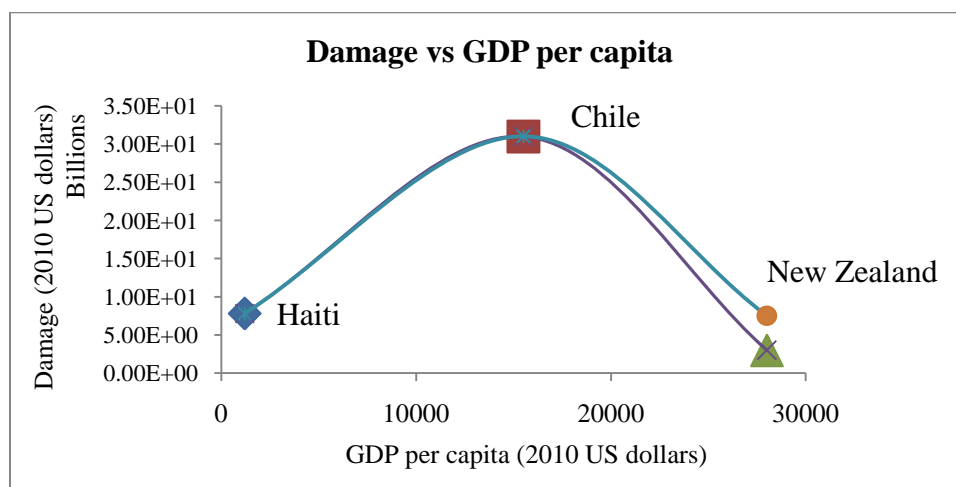
Figure 6-13. Damage as a total amount versus GDP per capita

Damage during the earthquakes has been expressed up to this point as a fraction of the economy of the country, which is assumed to reflect the development of that country in terms of infrastructure. The premise is that the larger the amount of damage as a fraction of GDP, the worse preparation the country had. Similar to the number of loss of lives, however, an alternative approach is to consider the absolute value of the damage. For Chile the amount of damage during the earthquake was about 31 billion US dollars, which is the highest number compared to the other countries. The reason is not from poor preparation of the country prior to the natural hazard; instead it is in terms of the high value of the existing infrastructure. As shown in Figure 6-13 below, the three countries' damages scatter instead of correlating in a certain order.

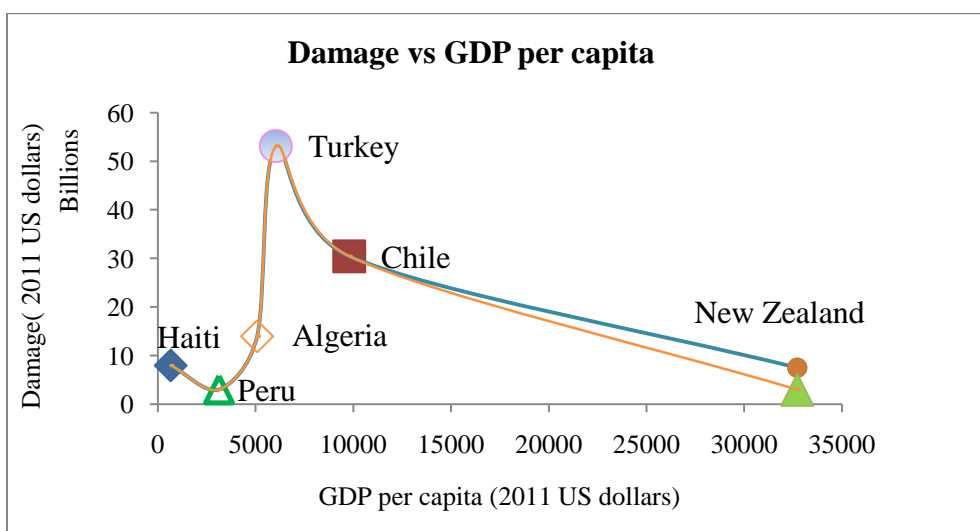
Figure 6-14. Damage as total amount versus GDP per capita (2011 US dollars).

To stay consistent with previous parts, the total damage once again is plotted in terms of the value of structures only. Here, in Figure 6-14, the amount of damage in Haiti, Peru, and Algeria implies the possible destruction of the earthquake to the available infrastructure, in Turkey and Chile, the dollar value of damage was much higher since there were more structures built. New Zealand again stayed out of this range since the economy of the country is much more developed than the other four countries and its building code was more enhanced.

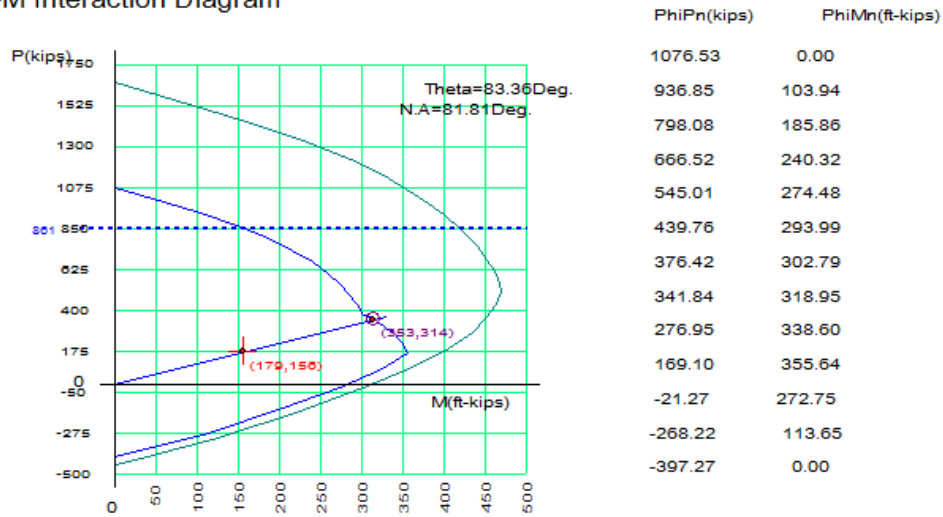
4. P-M Interaction Diagram

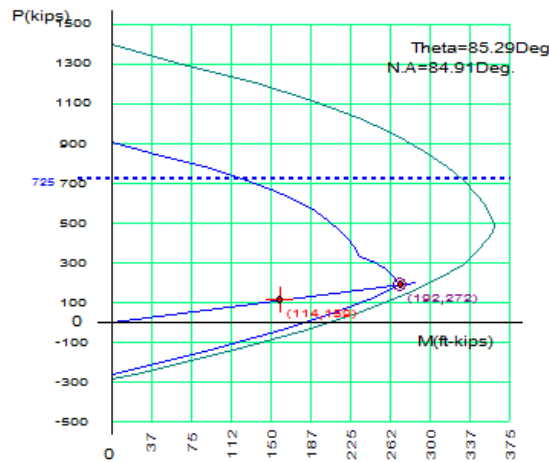
4. P-M Interaction Diagram

ΦP_n (kips)	ΦM_n (ft-kips)
906.51	0.00
783.82	87.82
669.42	151.02
562.58	191.46
465.51	215.33
383.97	228.24
335.61	233.50
312.22	244.38
270.12	258.13
197.70	271.56
53.39	211.95
-126.08	98.89
-254.25	0.00
