# Chemical and Acoustic Emission Evaluation Studies of Concrete Bridge in Marine Environment

A DISSERTATION

A field investigation of the Fair Isle Bridge, Miami, Florida consists of a nondestructive evaluation program including physical and acoustic emission (AE) assessment. The bridge is situated in a marine environment and its deck consists of PC and RC sections. Chemical evaluation is performed prior to strengthening with CFRP laminates and consists of visual inspection, carbonation, pH evaluation, chloride content, and steel corrosion detection by half-cell potential. After repair, three additional physical assessments are performed: crack mapping, thermography, and AE. These combined techniques provide sufficient information to create layered maps to evaluate the condition of the bridge structure. Within the maps, areas of interest are explored and compared for high probability of corrosion and concrete damage. Through spatial analysis of physical and chemical evaluation data, areas with significant potential difference are identified. These areas are the focus of a load test while monitoring strain, load and AE. The AE program components consist of in-service traffic monito

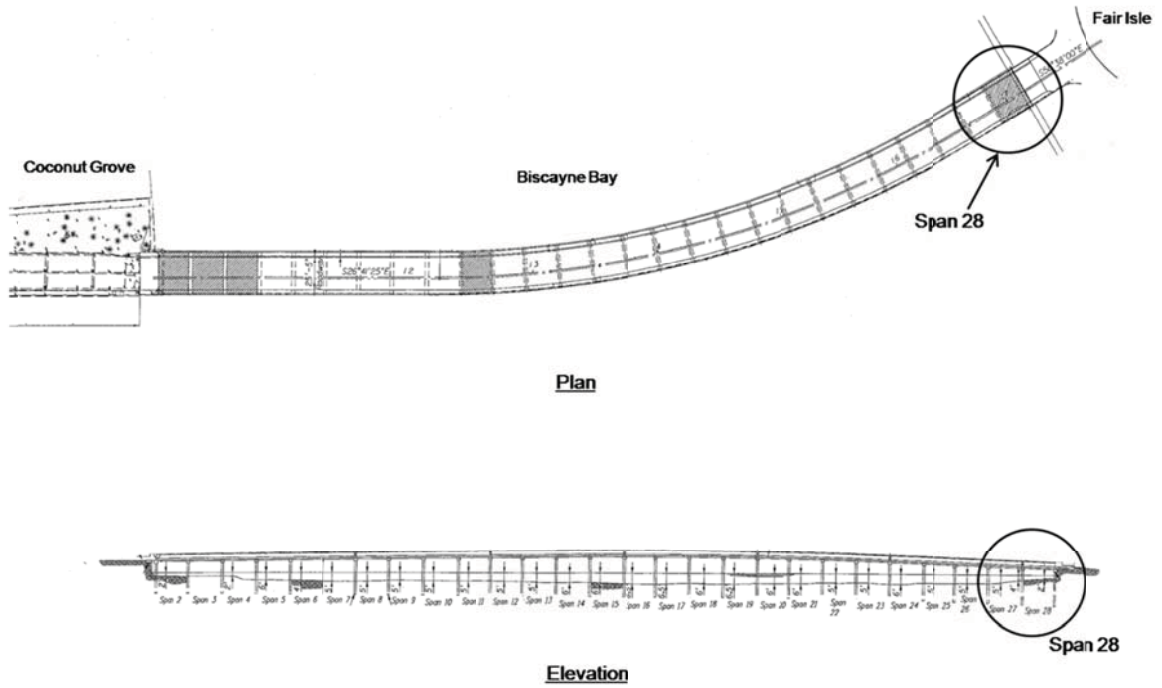
Figure 2.1 - Adopted plan and elevation of Fair Isle Bridge

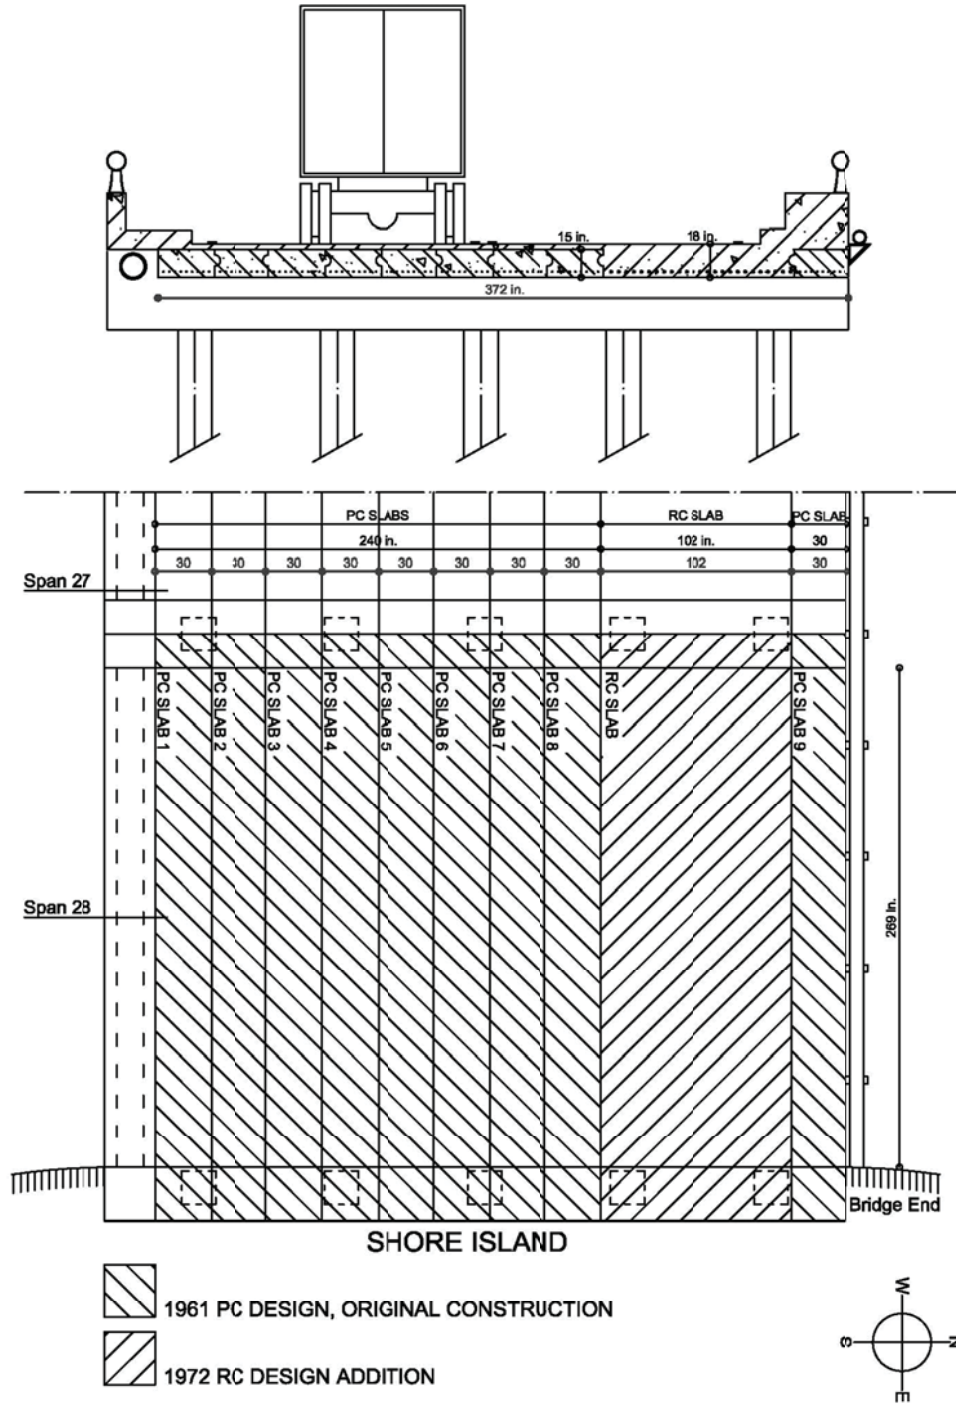
Figure 2.3 - Cross section and plan of PC and RC section

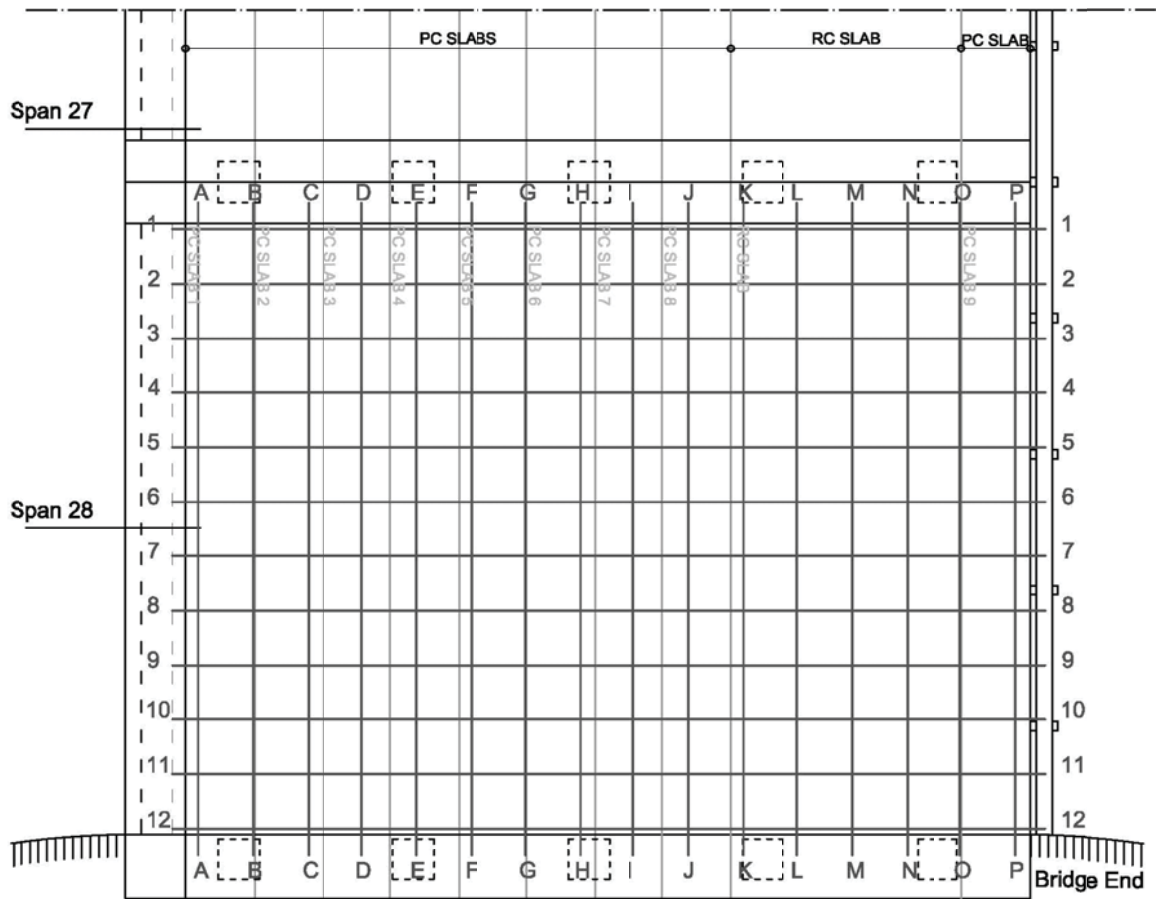
Figure 2.4 - 24 by 24 in. [610 by 610 mm] grid on deck soffit

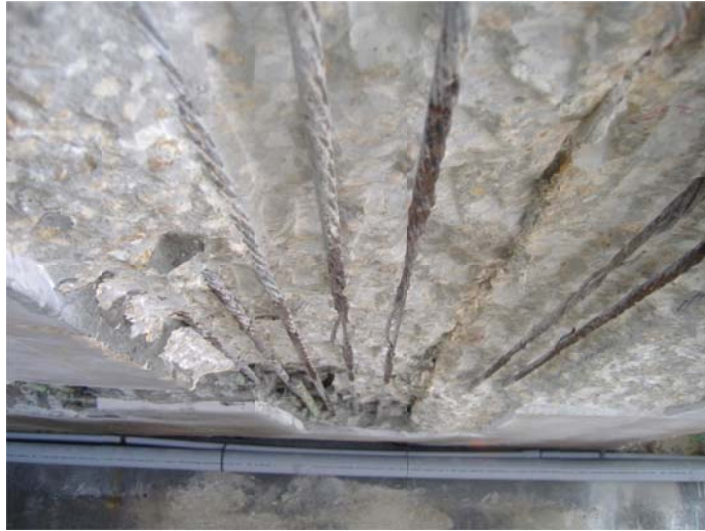
Figure 2.6 - Areas with spalled concrete and damaged strands

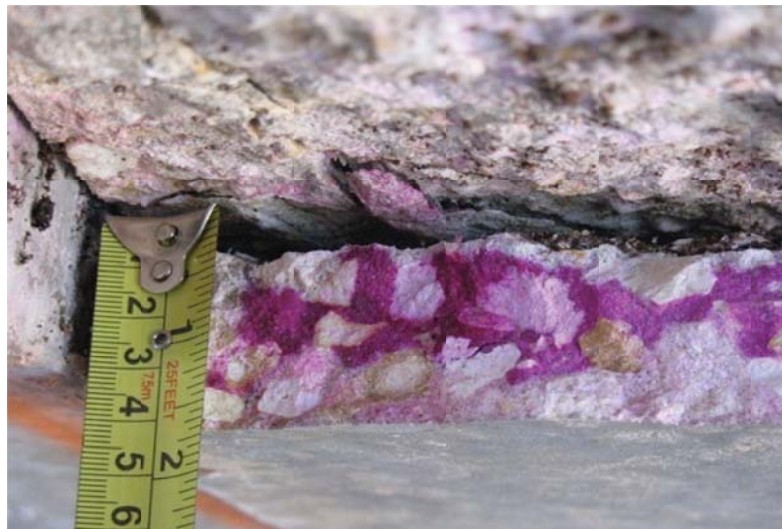
Figure 2.7 - Field exploration for carbonation detection

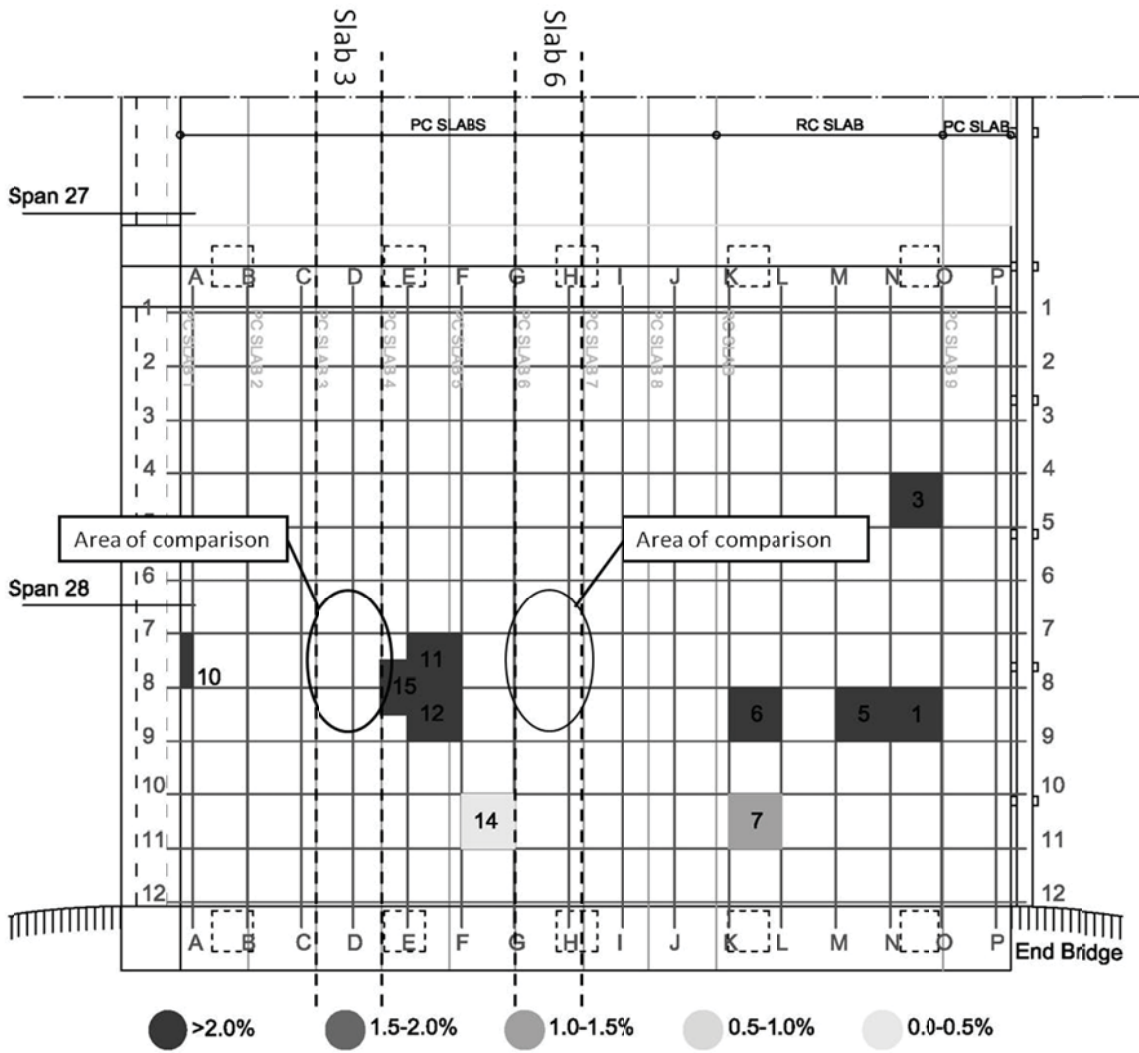
Figure 2.11 - Layer (E): Chloride content map

(E) Chloride content – Chloride content results were mapped for ten grid points in the fifth layered map (E) (Figure 2.11). All samples have chloride content above 2% of concrete mass, except sample 7 from the East side of the RC area, and sample 14 from PC slab 5. Results for material type, temperature of prepared specimen and chloride content are reported in Appendix I.B and are in agreement with case studies [Thomas, 2004; Lindvall, 2007], where values ranging from 2.0-3.5% were reported for samples taken at a depth of less than 0.4 in. [10 mm] with marine exposure for more than 10 years and tested at a temperature of about 62°F [20°C]. The resulting map contains a smaller number of samples compared to the other layered maps. This partial information doesn't contradict the collected data in the other assessments and confirms its location with high concentrations of chloride exposure. Samples in this case study showed comparable results at a depth of 3.0 in. [76.2 mm]. No samples were taken from slab 3 and 6 before repair.

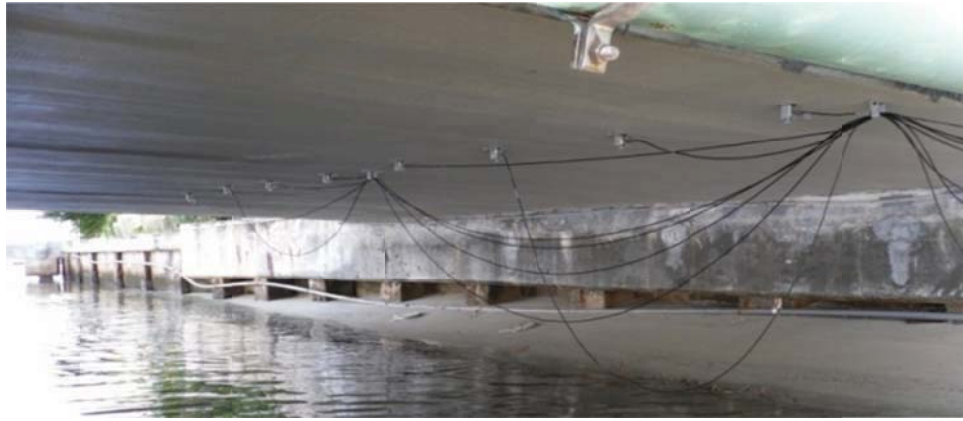
Figure 2.12 - AE sensors on deck soffit of the bridge

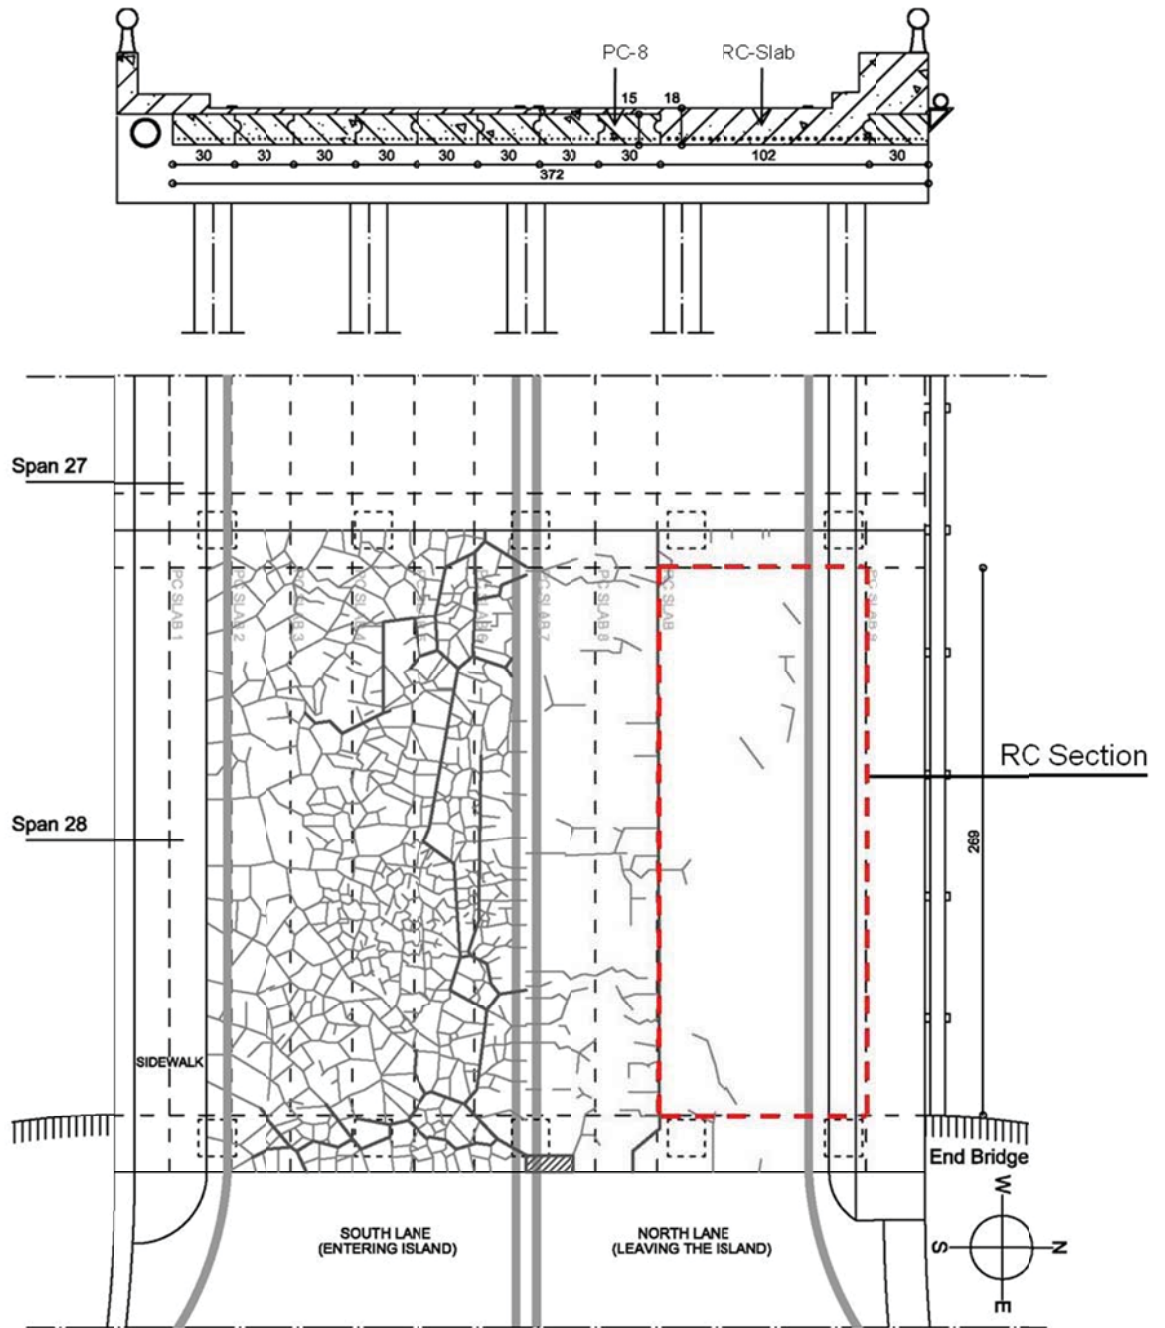
Figure 3.1 - Plan view and deck cracks

(E) Cracks in Deck Surface - The bridge deck consist of a North and South lane as illustrated in Figure 3.1, where the RC portion is marked by a dashed square. Deck cracking can be due to a number of effects such as temperature shrinkage or loading paths in relation to the thickness of the 18 in. [457 mm] solid poured concrete element [Hadidi et al., 2005; ACI 224R, 2008]. A layered map of deck cracks (F) is created to assess crack density and to verify the separation crack between the PC and RC sections. Visual cracks in the RC section were documented in x-y coordinates and mapped. Figure 3.1 shows that the South lane has far more cracks than the North lane. Overlay decks are known to suffer increased crack propagation compared to monolith bridge decks [Darwin et al., 2004]. A major crack in the North lane evidently illustrates separation between prestressed beam PC-8 and the monolith RC slab. Cracking occurring in this section has structural impact as these cracks may provide access to chloride containing air and water to the steel reinforcement. Although cracks on the deck soffit are more recognizable as structural defects, cracks in the top surface should be taken into account for identification of areas of concern for corrosion damage.

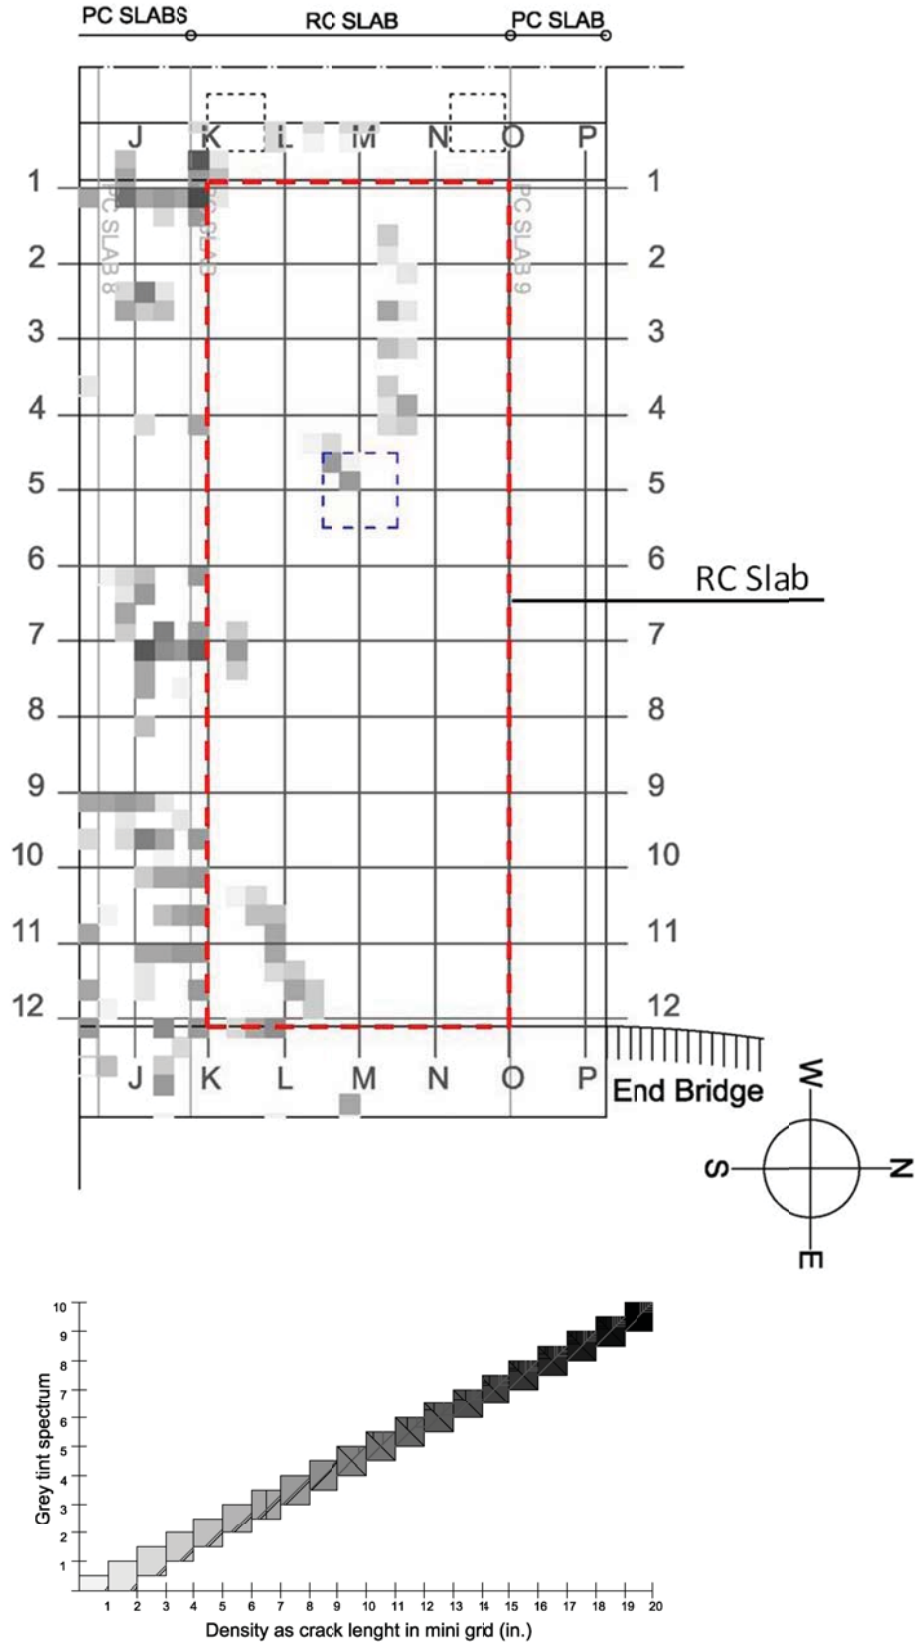
Figure 3.2 - Layer (F): Density specified deck cracks map

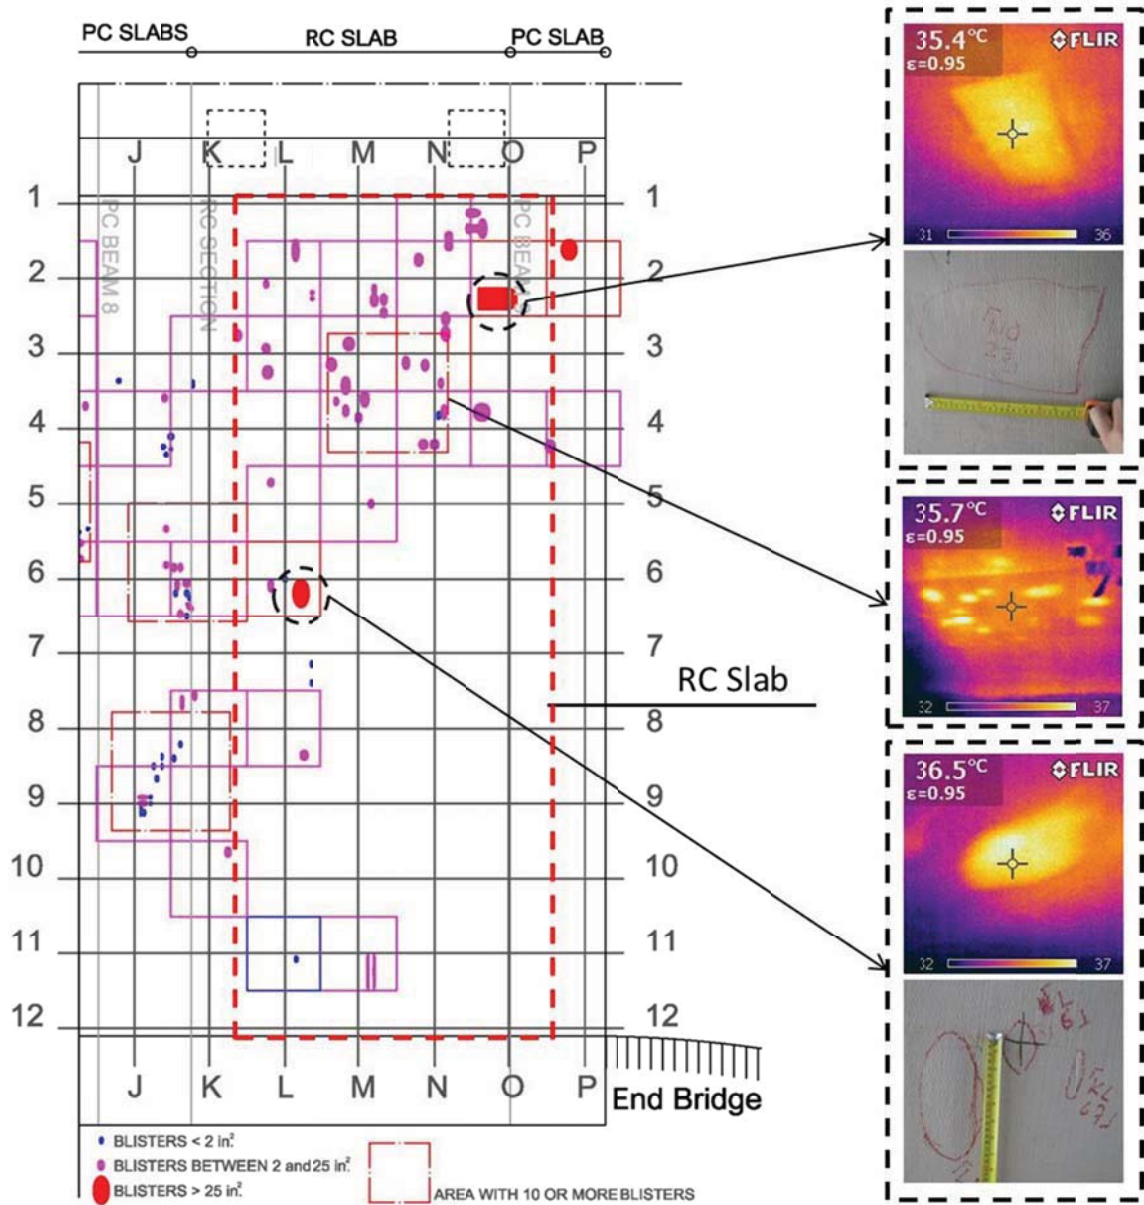
Figure 3.3 - Layer (G): Air voids under CFRP laminates map

(F) Air Voids under CFRP Laminates - An assessment layer with mapped air voids under the CFRP laminates is included as one of the layers for spatial analysis. Even though air voids are not a result of physical degradation, but rather an application defect, the layer is included to overall evaluate for future maintenance and repair. Investigation is performed 18 months after application by Infrared Flash Thermography [ASTM E2582, 2007]. Detection is performed by heating a square for several second in the 24 by 24 in. [610 by 610 mm] grid on the double layered laminate bottom surface. For this investigation, two Revlon RV484 blowers with a performance of 1875 Watt, 125 VAC and 60 Hz were used simultaneously. The FLIR Hand Held Infrared Thermal Imager monitors the surface, while it cools, to discover areas with high heat radiation.

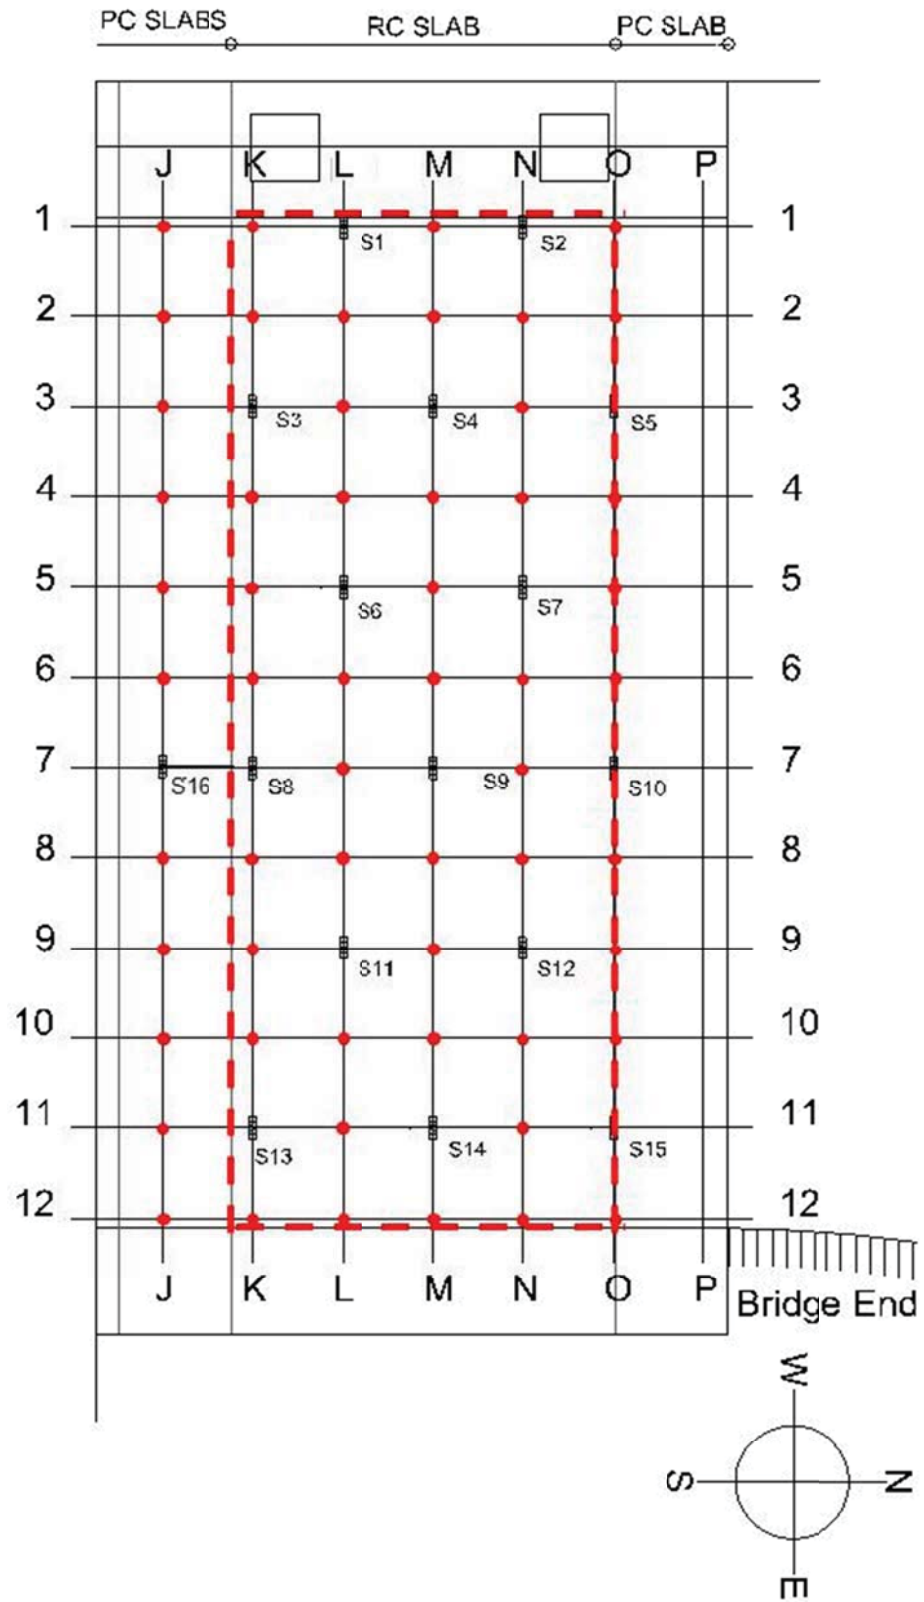
Figure 3.4 - AE sensor and pencil lead break locations

A total of 15 AE sensors were placed on the RC slab while the 16<sup>th</sup> control sensor was placed on neighboring PC slab 8; 20.5 in. [508 mm] South of sensor 8. RC slab sensors had a minimum spacing of 48 in. [1219 mm] and maximum 53.7 in. [1364 mm]. All AE sensors made contact to the CFRP interface with the same aluminum brackets and vacuum grease contact agent as previously used in Study I (see also Figure 3.20).

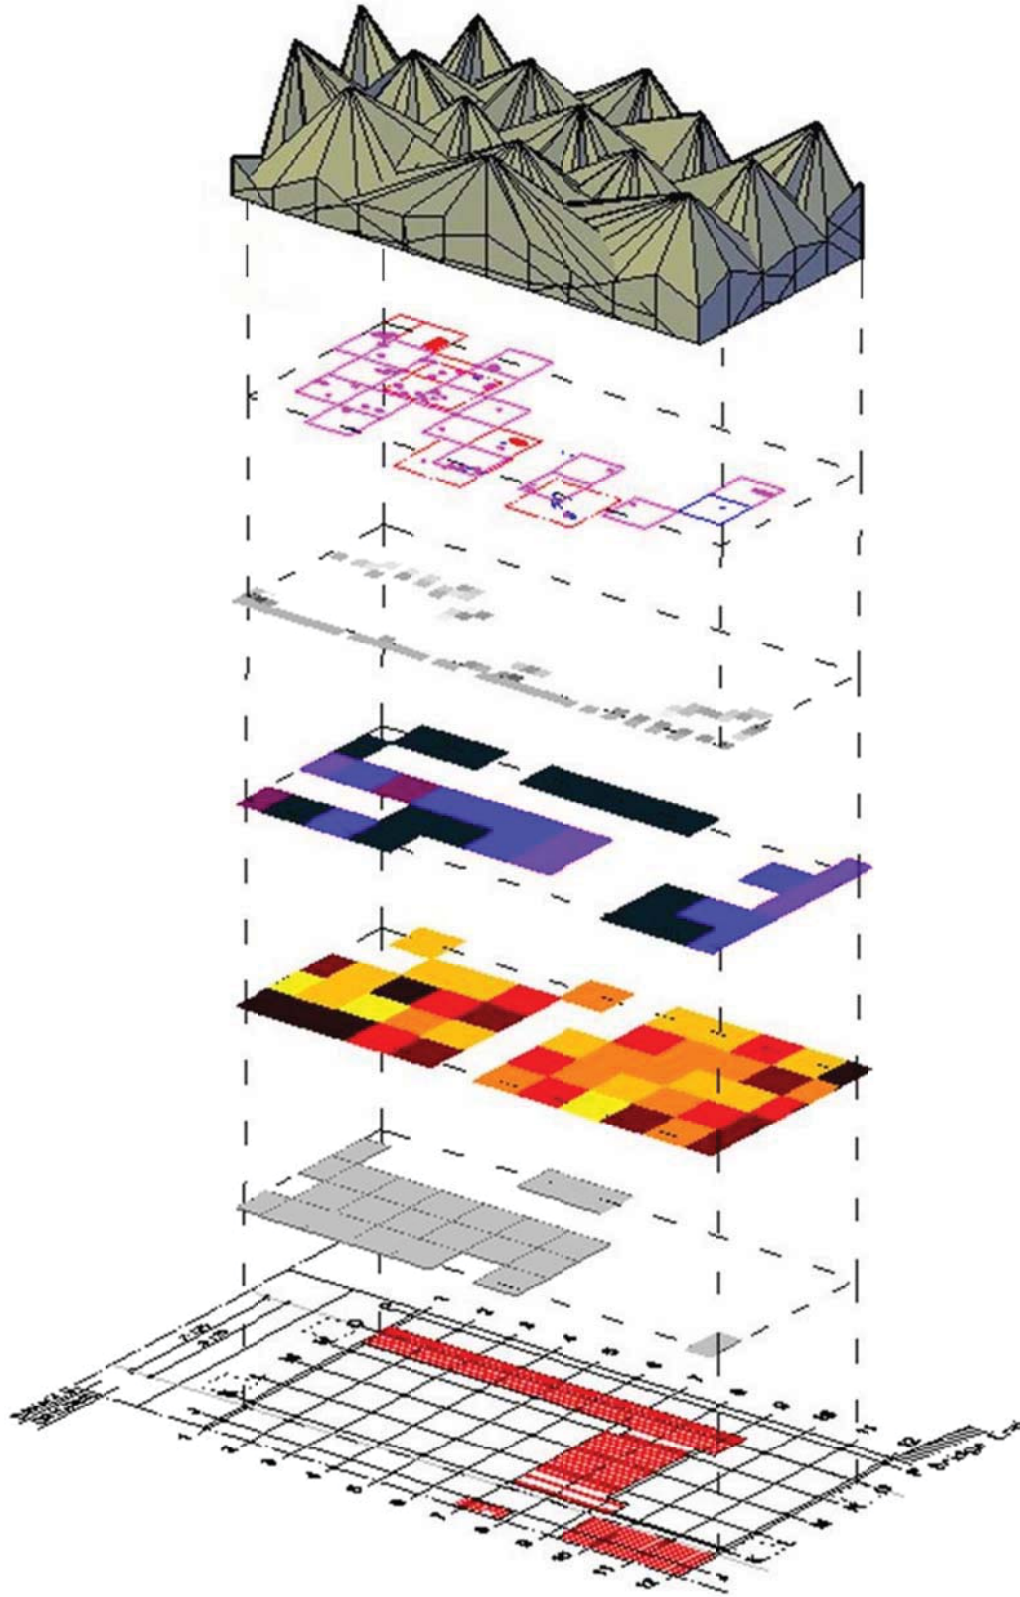
Figure 3.9 - Layered maps before and after repair, (A) to (H)

The method followed in the numerical spatial analysis is block statistics. Before comparison takes place, each layer is translated into a normalized identity for every grid point to indicate the degree of damage in relation to the specific parameter. Reason to not include the Chloride Content layer (E) is that measurements could only be taken at a few grid points, which offers only partial information of the RC slab. To maintain an equivalent measurement, each layer ought to have complete coverage of all grid points in the selected area. Chloride content measurements confirm with bridge condition and aggressive environment in Study I.

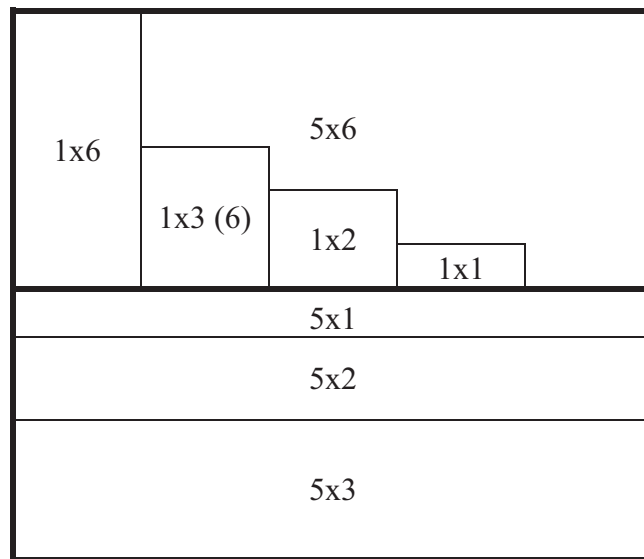
Figure 3.10 - Deviation RC deck for Blocking Statistics

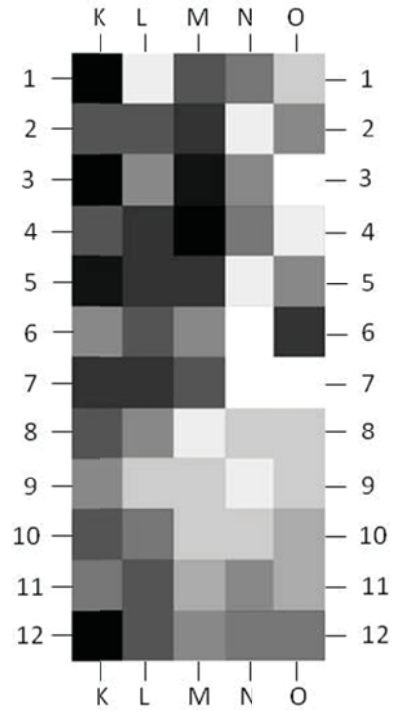
Figure 3.13 - ArcGIS output before and after repair combined

In conclusion, it was found from Figures 3.13 to 3.16 that cell K-12 and the region from column K to M to rows 1 to 5 have the highest damage probability, which are both found in the unrepaired areas of the bridge span. These regions will be the focus of the load testing of the bridge.

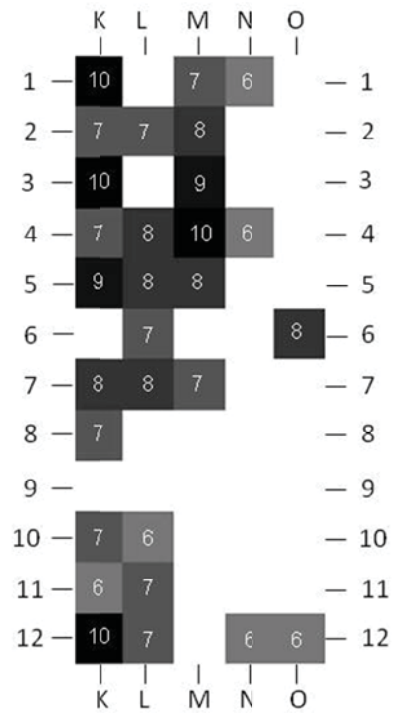
Figure 3.14 - ArcGIS output 10 class reclassification (6 to 10)

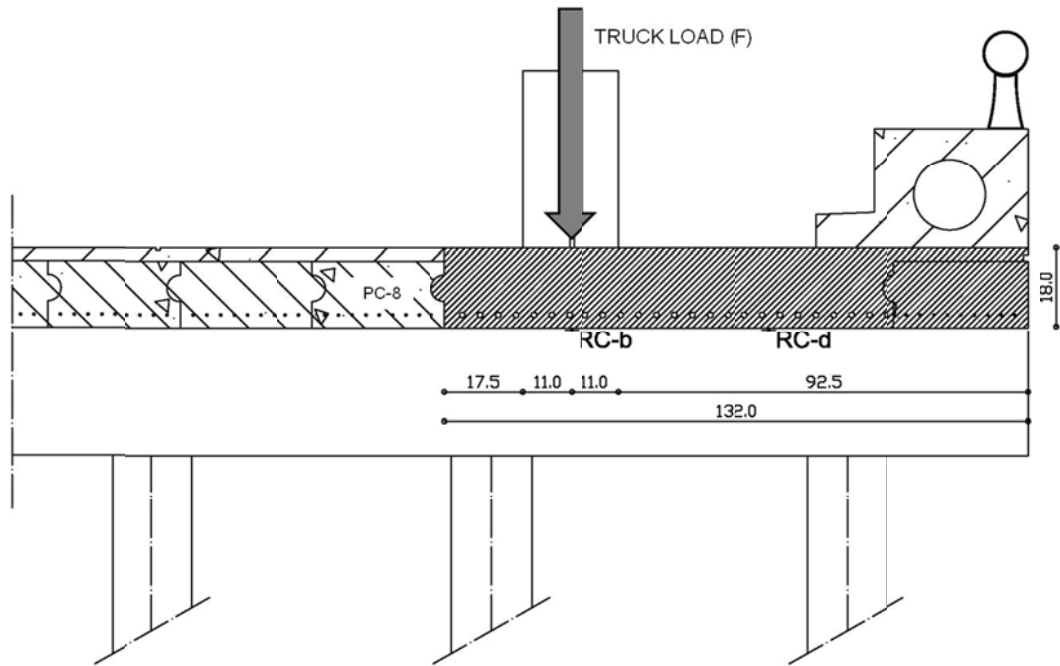
Figure 3.20 - Slab section and load position

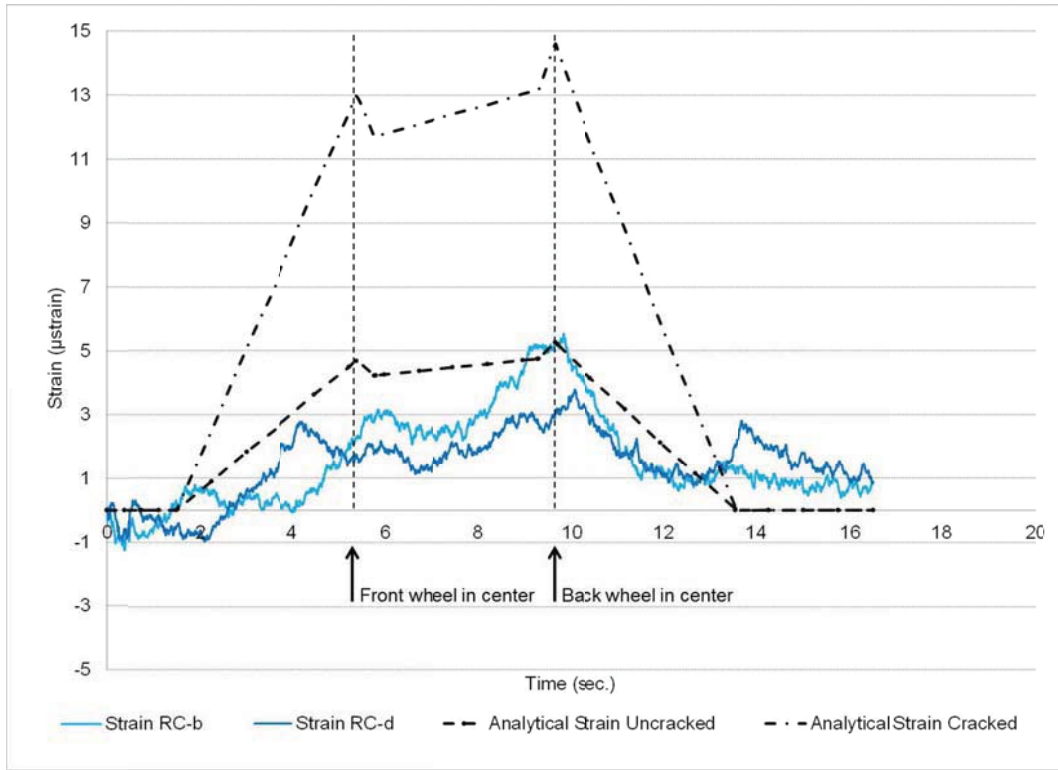
Figure 3.22 - Measured and analytical strains (N-B2a)

Significant correlation between the analytical and measured strains is observed in Figure 3.22. The light blue line represents the strain measured directly under the truck load path which shows most correlation in terms of strain magnitude, especially in the second and highest peak. The strains measured in the other tests are given in Appendix II.K which show similar results and all stay in the range of 0 to 7  $\mu$ -strain.

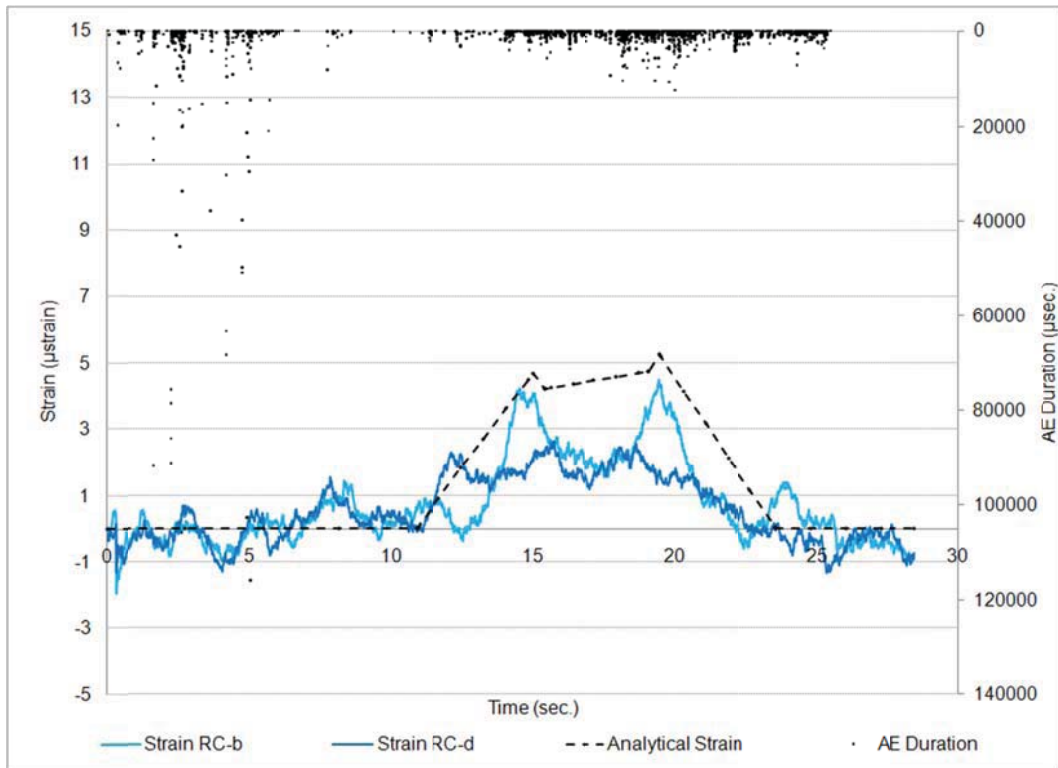
Figure 3.23 - Strains and unfiltered AE Duration (N-B1b)

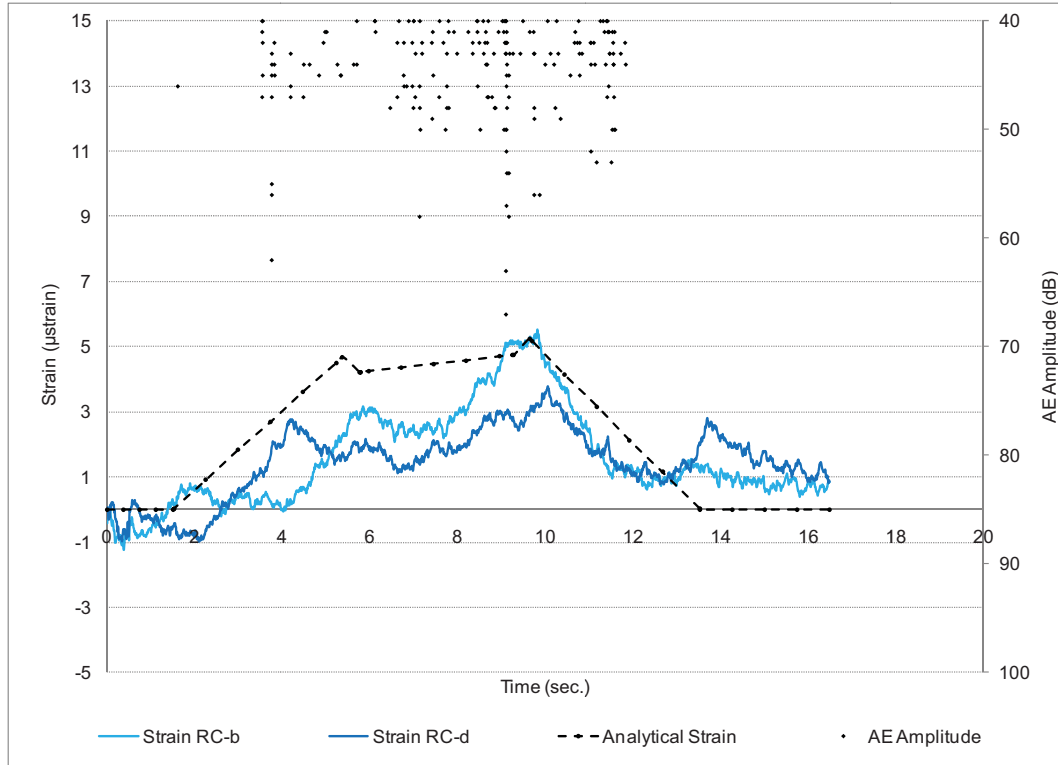
Figure 3.24 - Strain and AE Amplitude (N-B2a)

The magnitude of Amplitude gives the impression of being relatively low compared to laboratory conducted beam tests (Study III). Concrete bridge field tests of Golaski et al. [2002] and Nair and Cai [2007] conclude that AE Amplitudes recorded on field bridges below 55 dB indicates no danger for the structural integrity while strong AE hits exceeding 80 dB indicate a critical value for danger. All crawl tests performed recorded peak Amplitudes higher than 55 dB and lower than 80 dB, except Test N-B1b with a hit of 80 dB at  $t=19.98$  sec. Results of Amplitude and strain of all tests show similar results and are given in Appendix II.K.

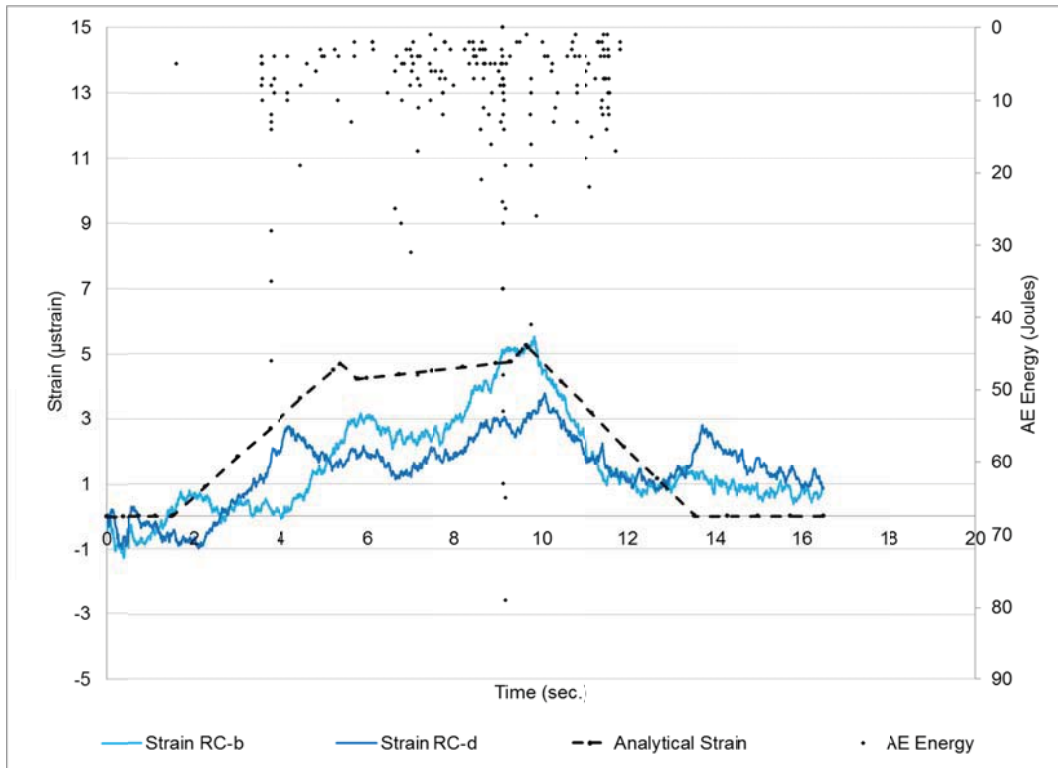
Figure 3.25 - Strain and AE Energy (N-B2a)

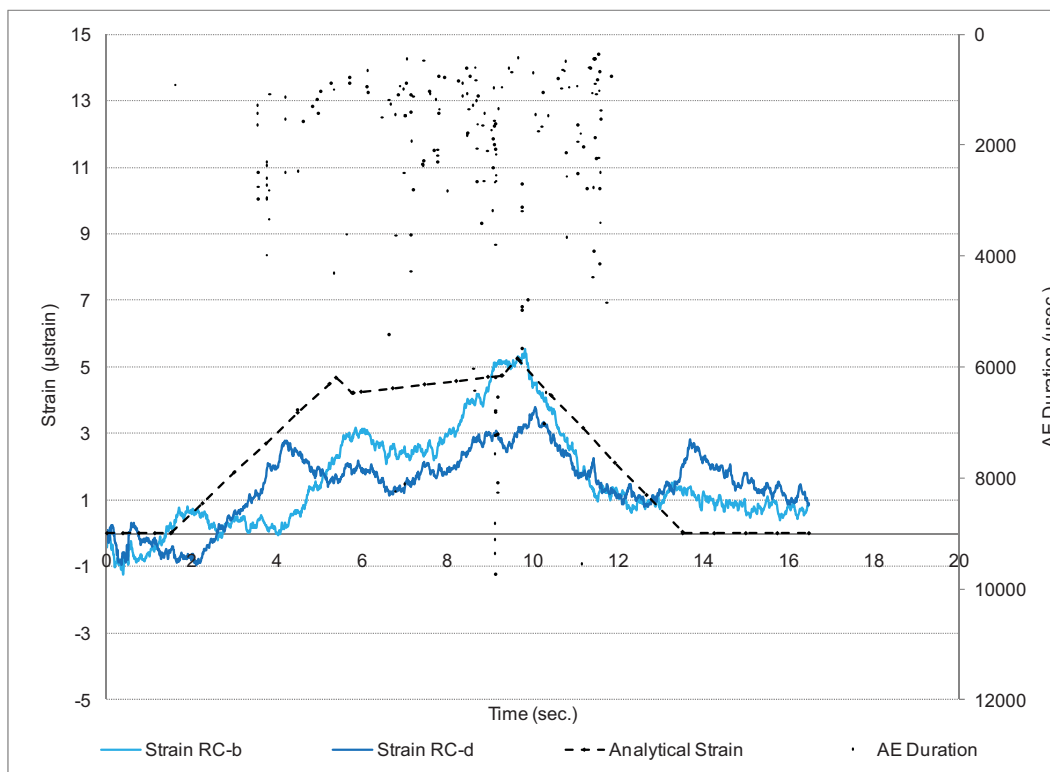
Figure 3.26 - Strain and AE Duration (N-B2a)

The duration of AE hits is given in Figure 3.26. where the same concept of graph interpretation is used with the AE Duration on the right side axis expressed in  $\mu$ -seconds. Comparing this graph with Amplitude recording (Figure 3.24) and Energy (Figure 3.25), a relationship can be found between high Amplitude, high Energy and long Duration of the event at  $t=9.11$  seconds. When all three parameters have relatively high values, it is likely that an event with high intensity took place and is most likely a primary event from within the structure. Primary events occurring within the structure may come from different possible sources, such as concrete cracking, crack opening and closing, crack propagation, concrete patch movement in separation cracks, CFRP laminate debonding, CFRP fiber stretching or moving friction, resin cracking or local yielding, or resin slip. Some are more likely to occur than others considering the load magnitude.

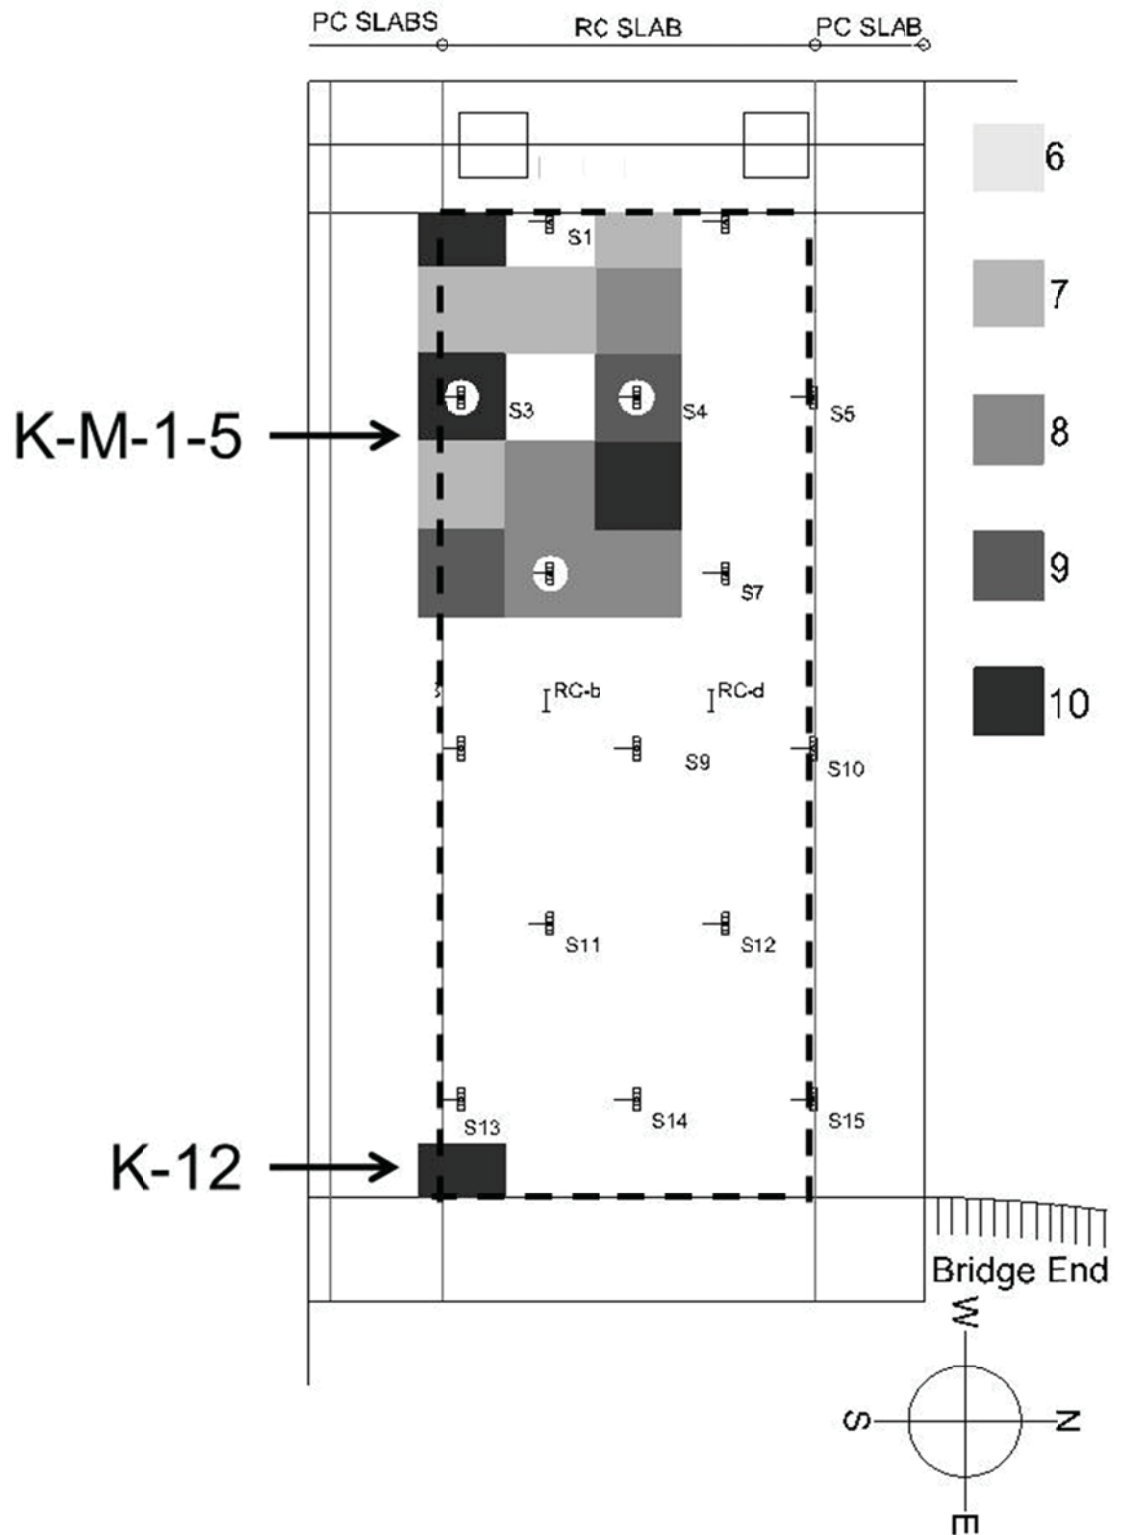
Figure 3.29 - Potential damaged areas and sensor locations
