# Chemical and Acoustic Emission Evaluation Studies of Concrete Bridge in Marine Environment

A DISSERTATION

A field investigation of the Fair Isle Bridge, Miami, Florida consists of a nondestructive evaluation program including physical and acoustic emission (AE) assessment. The bridge is situated in a marine environment and its deck consists of PC and RC sections. Chemical evaluation is performed prior to strengthening with CFRP laminates and consists of visual inspection, carbonation, pH evaluation, chloride content, and steel corrosion detection by half-cell potential. After repair, three additional physical assessments are performed: crack mapping, thermography, and AE. These combined techniques provide sufficient information to create layered maps to evaluate the condition of the bridge structure. Within the maps, areas of interest are explored and compared for high probability of corrosion and concrete damage. Through spatial analysis of physical and chemical evaluation data, areas with significant potential difference are identified. These areas are the focus of a load test while monitoring strain, load and AE. The AE program components consist of in-service traffic monito

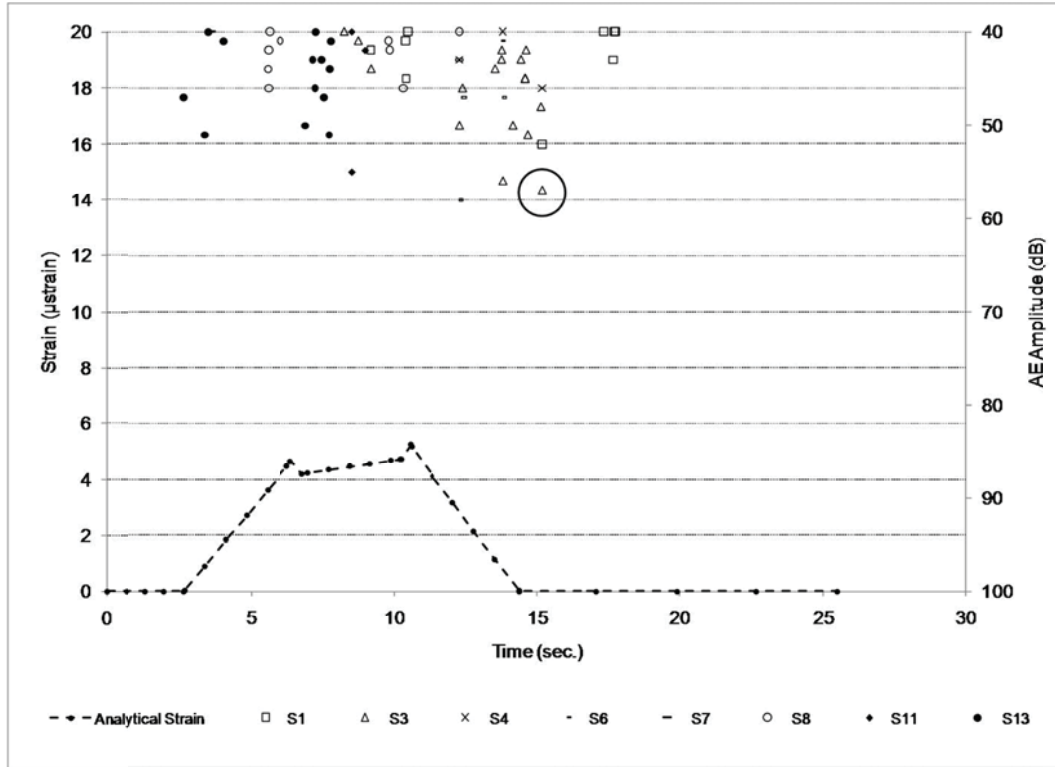
Figure 3.30 - AE Amplitude hits per sensor (N-B3a)

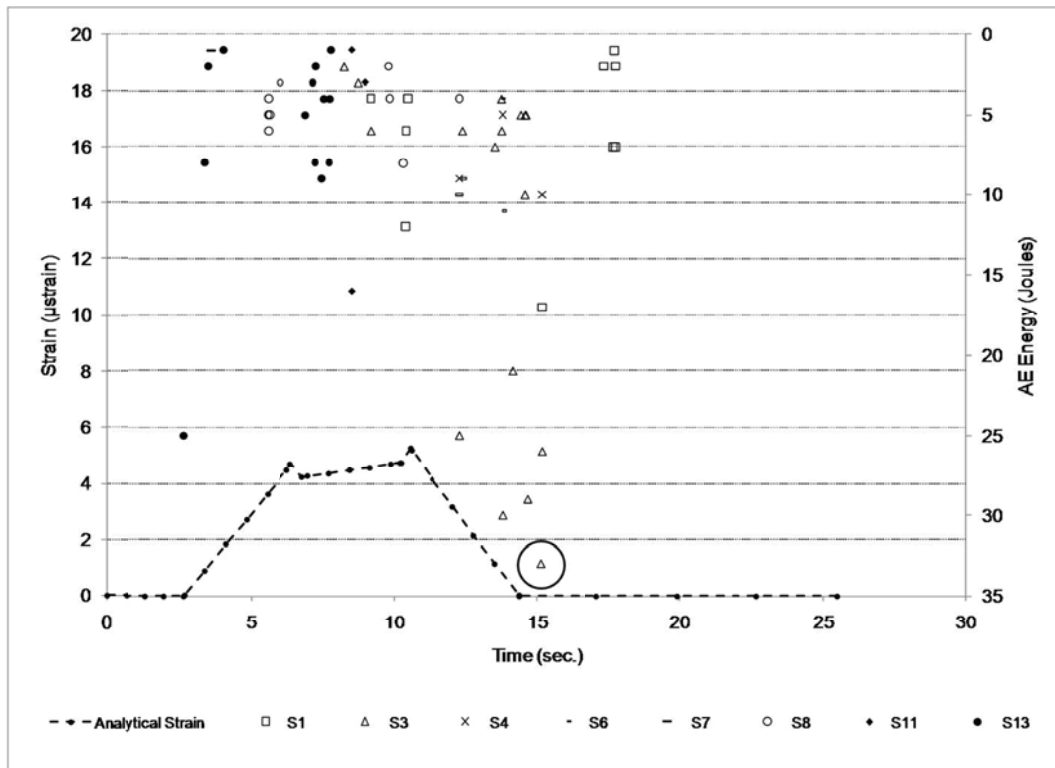
Figure 3.31 - AE Energy hits per sensor (N-B3a)

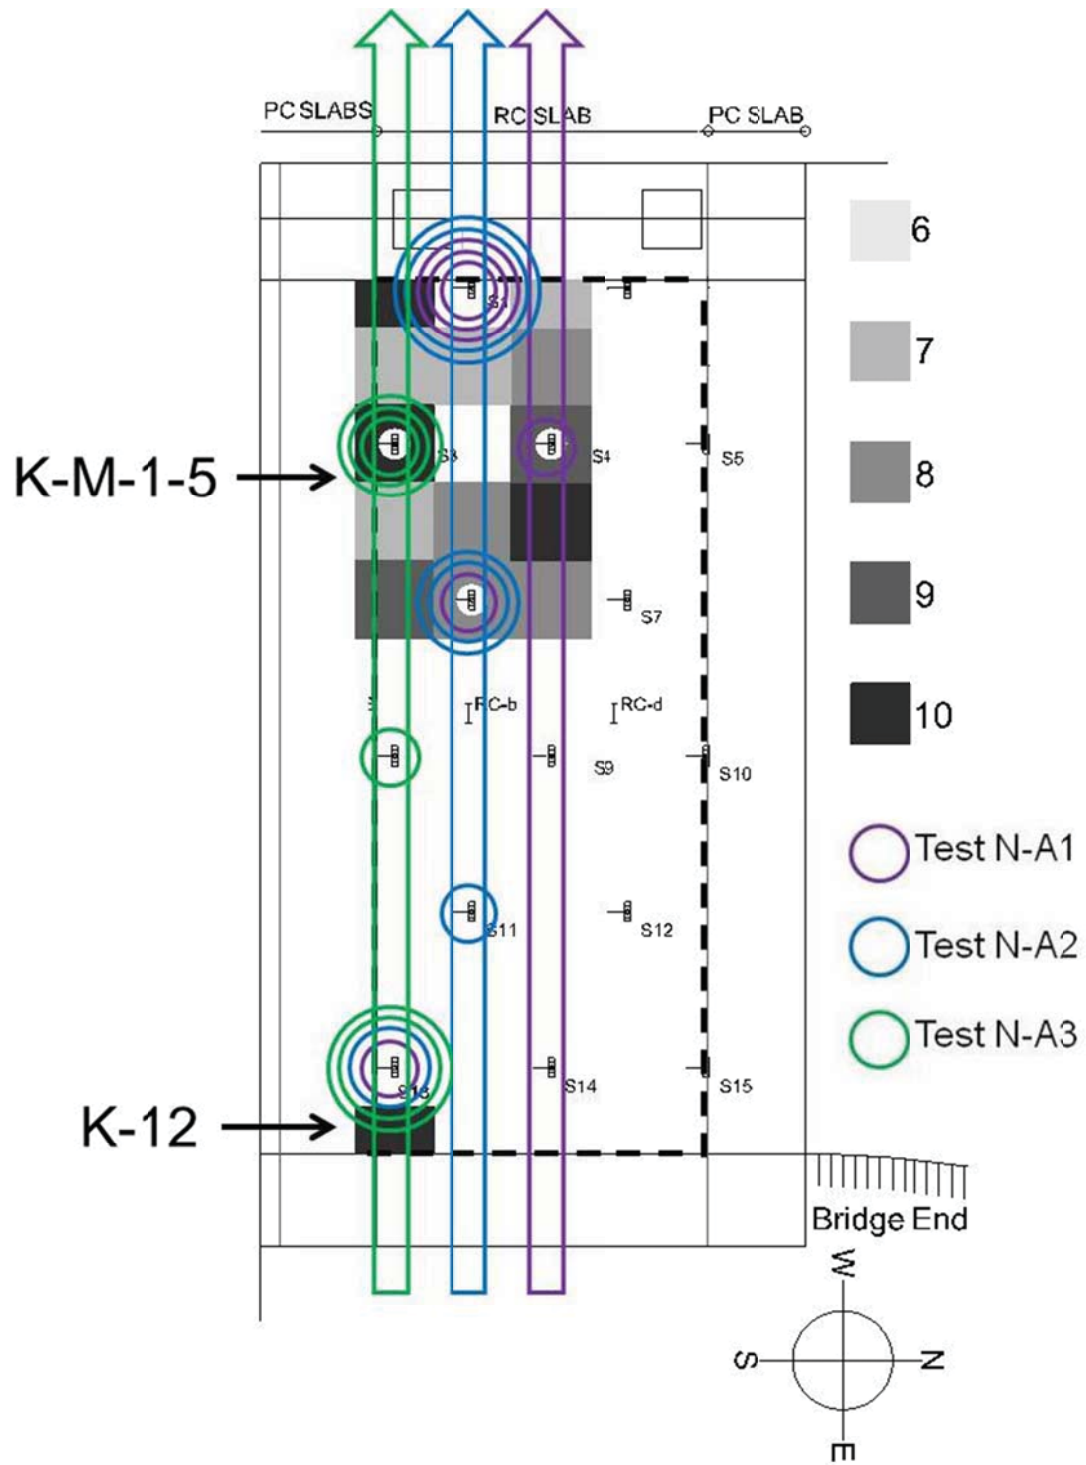
Figure 3.32 - Most active sensors per crawl speed test

In overall perspective, the figure shows that with three equal travel paths at different locations, most activity was found in the clustered area K-M-1-5. Sensors 3 and 4 are on top of cells ranked at level 9 and 10 on scale 1 to 10 for damage potential where sensor 4 is the only sensor with high activity in the travel path going over sensor 4, 9 and 14.

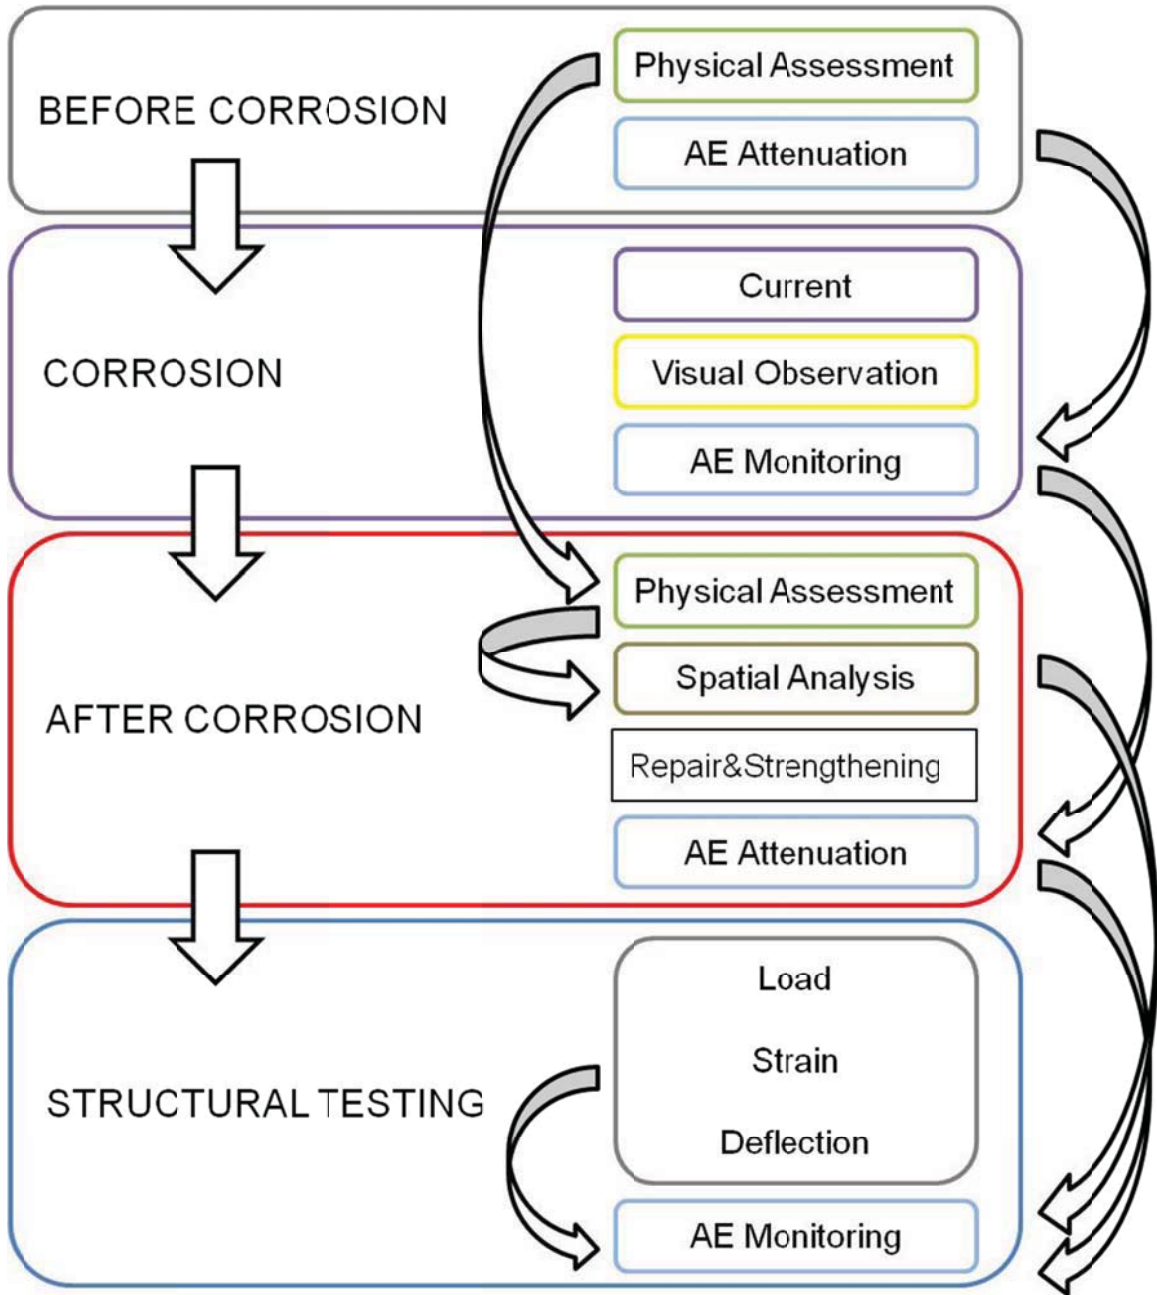
Figure 4.1 - Structure of Study III

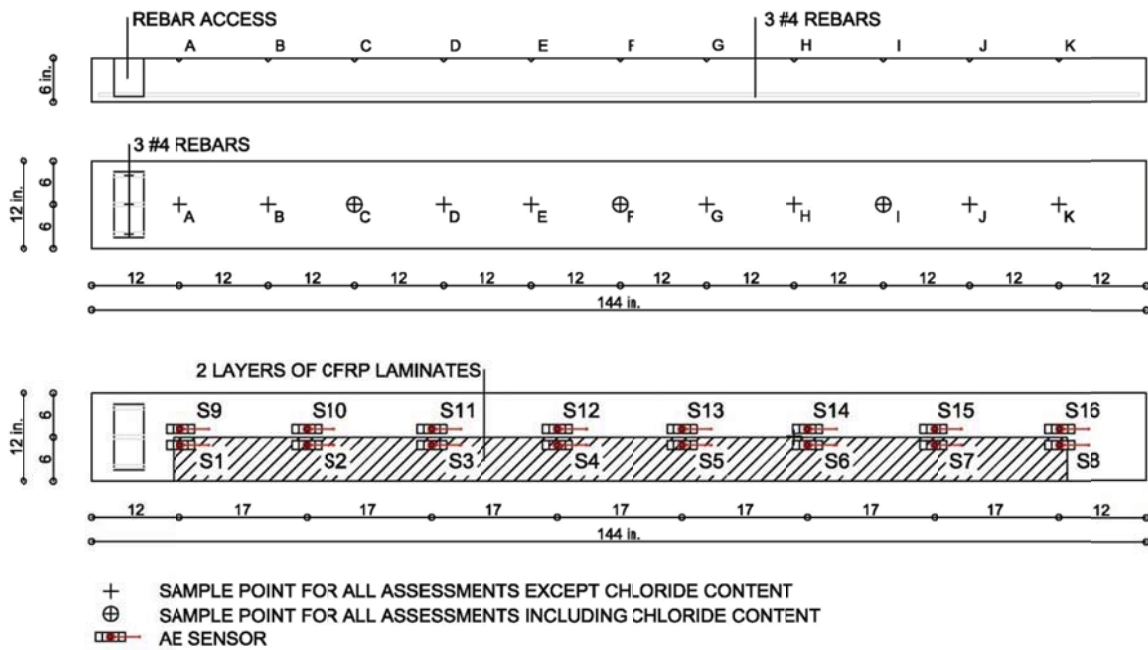
Figure 4.2 - Physical assessment and AE sample points (in.)

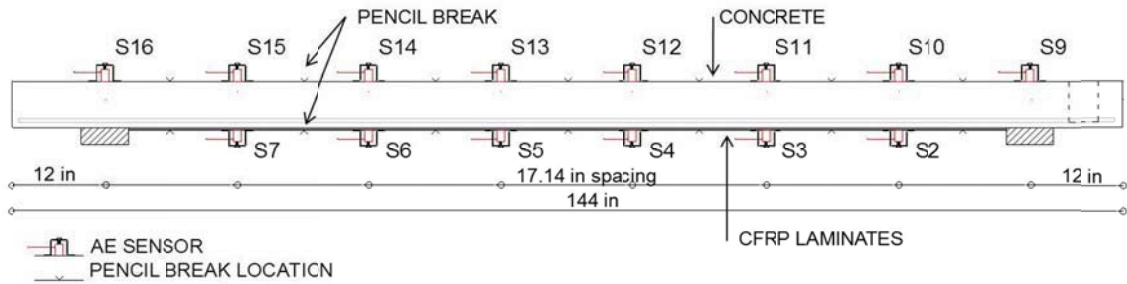
Figure 4.4 - AE attenuation test plan

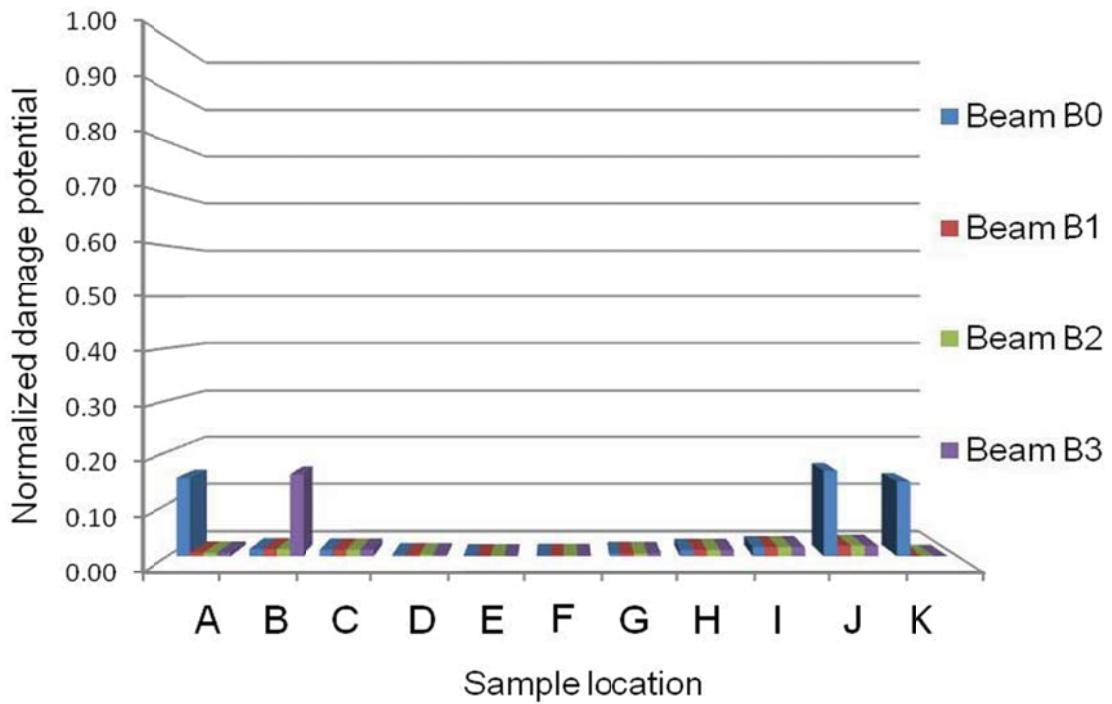
Figure 4.5 - Combined normalized results before corrosion

Visual inspection (A) before corrosion is limited to the observation that the beams are undamaged and show no visual cracks (F). No evidence for concrete carbonation (B) by 1% phenolphthalein in ethanol solution was detected. pH level measurement (C) was performed from three 5 mg powder samples from 1 in. [25 mm] deep drilled holes. pH level measurements result in values above 9.0, except for location B0-A, B0-J, and B0-K. The detection of active corrosion potential (D) was performed three times. The lowest average potential was found on location B1-A for -289 mV. Chloride samples were collected from the same drill holes and tested at an average temperature of 71.8 F [22.1°C], providing a mean value of 0.028% with standard deviation 0.0175%. All values are below 0.2% [ACI 222.3R, 2003]. AE Amplitude attenuation in relation to distance is translated by counting a maximum of seven recorded hits at each sensor location with a threshold of 40 dB (Figure 4.4). The least conductivity was found at B0-J where one out of seven signals was not recorded. Mean value of deterioration condition in terms of conductivity is 0.06 with standard deviation 0.049 on a normalized scale between 0 and 1. The combined results of physical assessment layers are normalized according to standards introduced in Table 3.3 to 3.9 in Study II. Figure 4.5 shows the combined normalized results of the four beams which, as expected, show a low corrosion damage probability (peak<0.17) before corrosion. Physical assessment results are reported in Appendix III.B.

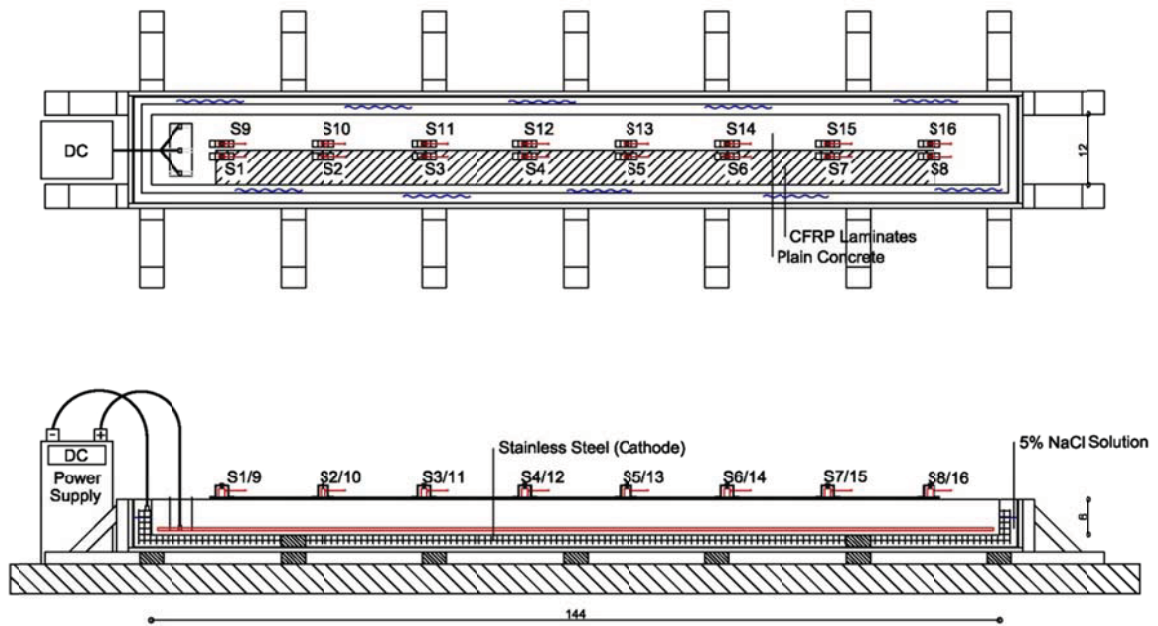
Figure 4.6 - Top and side view test setup corrosion conditioning

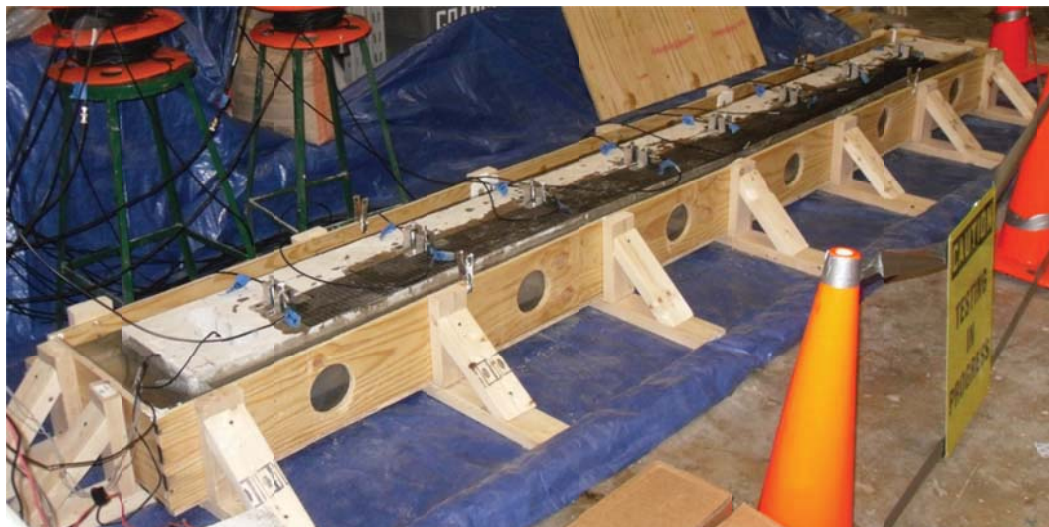
Figure 4.7 - Corrosion conditioning setup

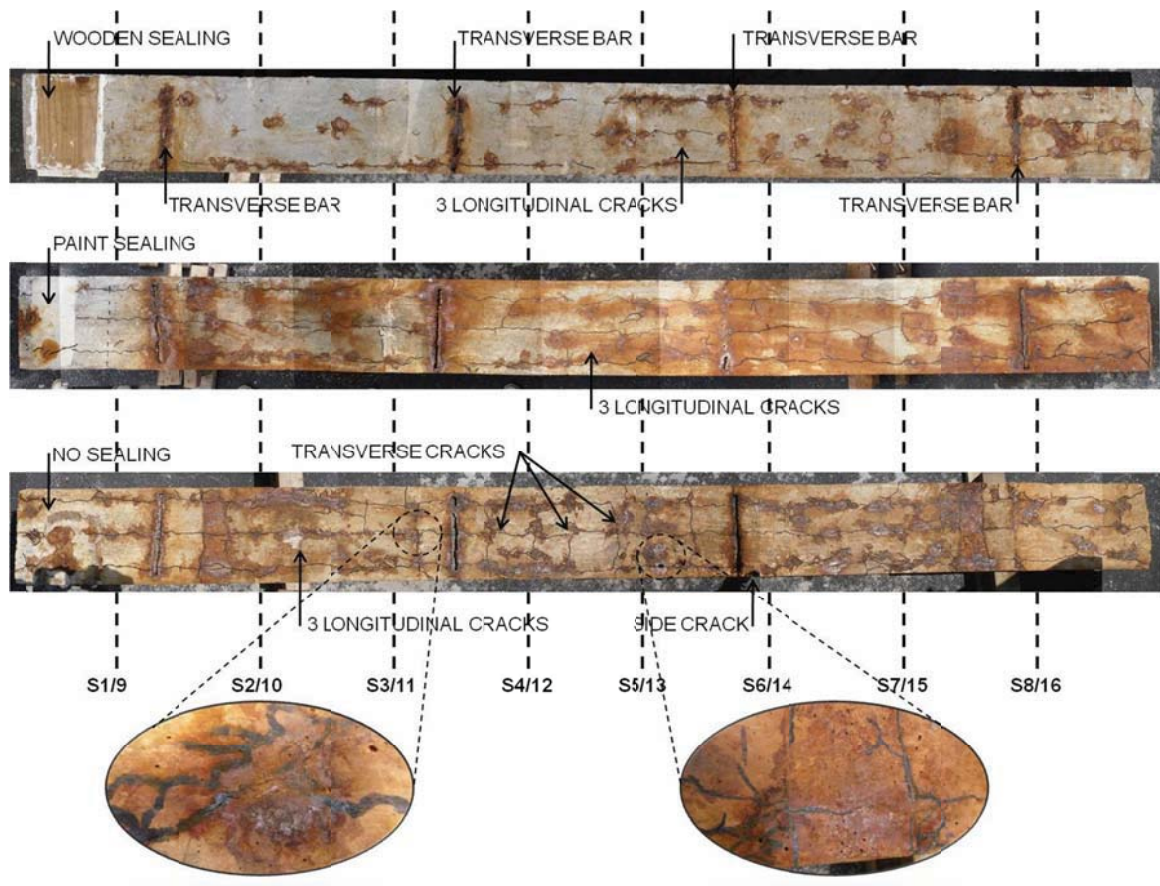
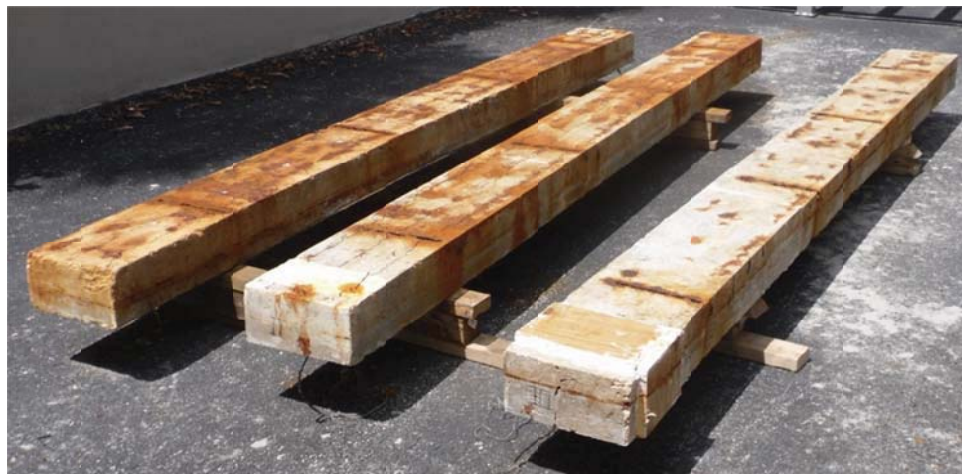
Figure 4.8 - Visual inspection after corrosion (B1 to B3)

Each beam is visually inspected after corrosion conditioning. Surfaces were cleaned and rust removed to inspect for cracks. Figure 4.8 shows in order Beam B1 with 7.24%, Beam B2 with 12.14% and at the bottom Beam B3 with 19.90% steel mass loss. The specimens show transverse cracking and spall at the location of four transverse bars. The worst corrosion occurred on Beam B3 which shows longitudinal cracks throughout its length and transverse cracks at midspan. Focusing on Beam B3, sensor locations S11 and S14 were recognized with the highest AE Amplitude and Number of Hits. At sensor S14, the most severe corrosion was discovered and spall at the side surface showed that steel reinforcement was locally completely consumed. The transverse bar had more than half of its diameter dissolved and lay loose in the spall gap.

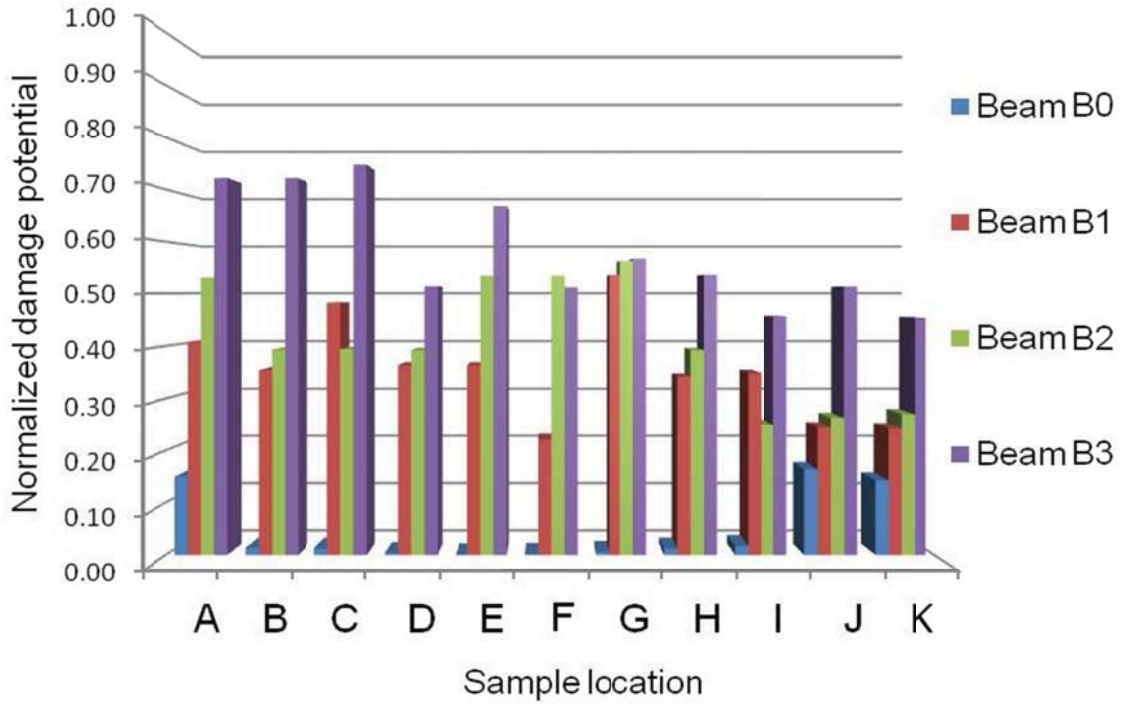
Figure 4.10 - Damage potential combined layers after corrosion

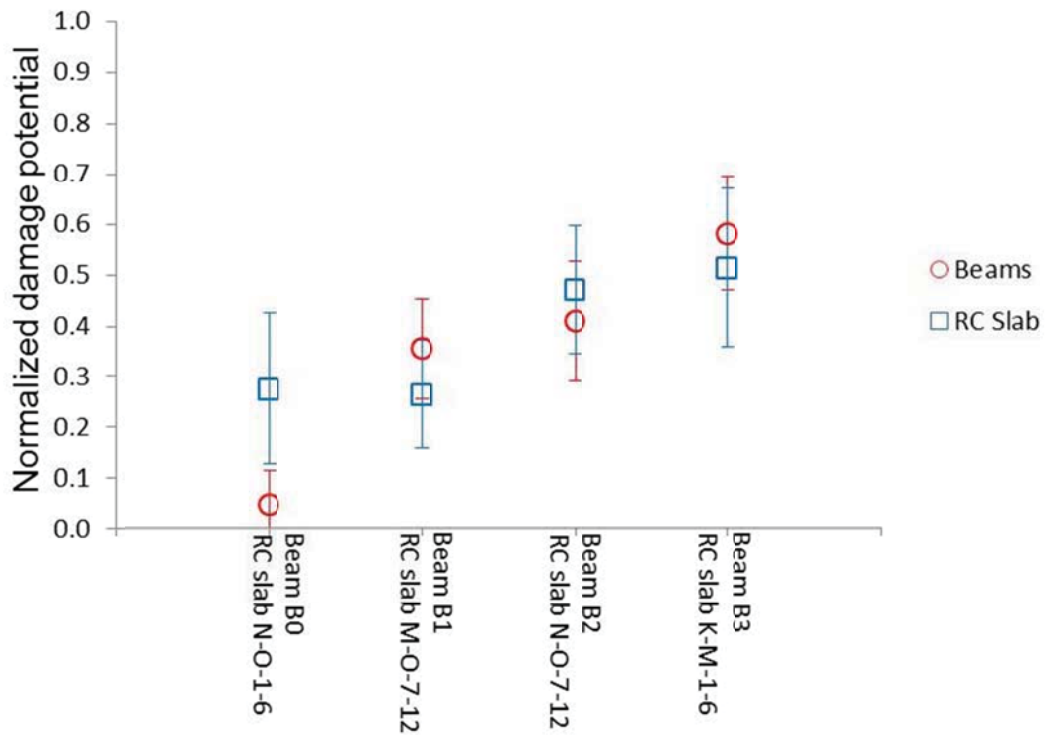
Figure 4.11 - Damage comparison RC slab and beams

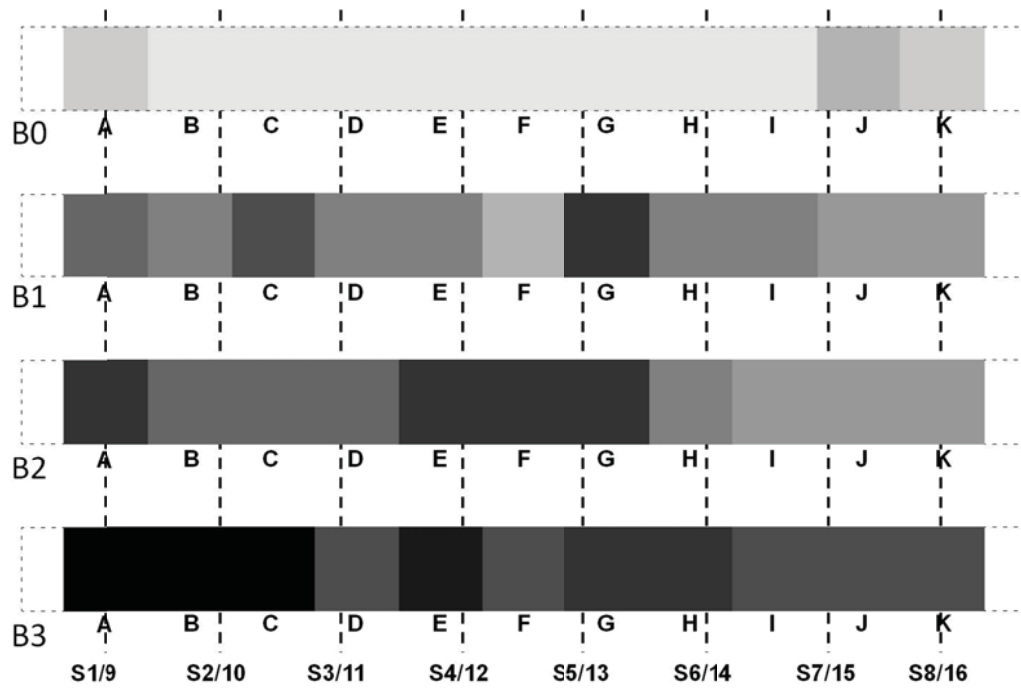
(a) Relative to all specimens

Figure 4.12a shows the classification of the first approach in a perspective of all specimens. The scale from 0 to 10 is dominated by the highly damaged condition of Beam B3. The cell's gray scales can be directly related to Figure 3.15 in Study II. By visual estimation, concrete and corrosion damage potential estimates of beam specimens with outcomes of the RC slab can be compared.

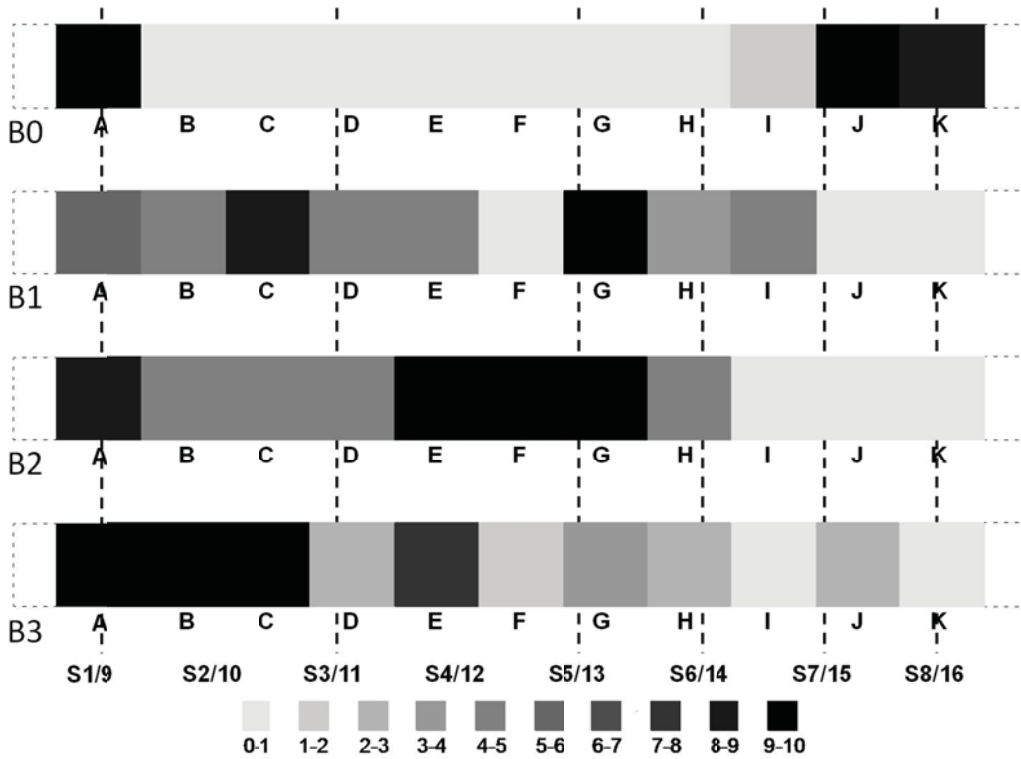
(b) Relative to each specimen

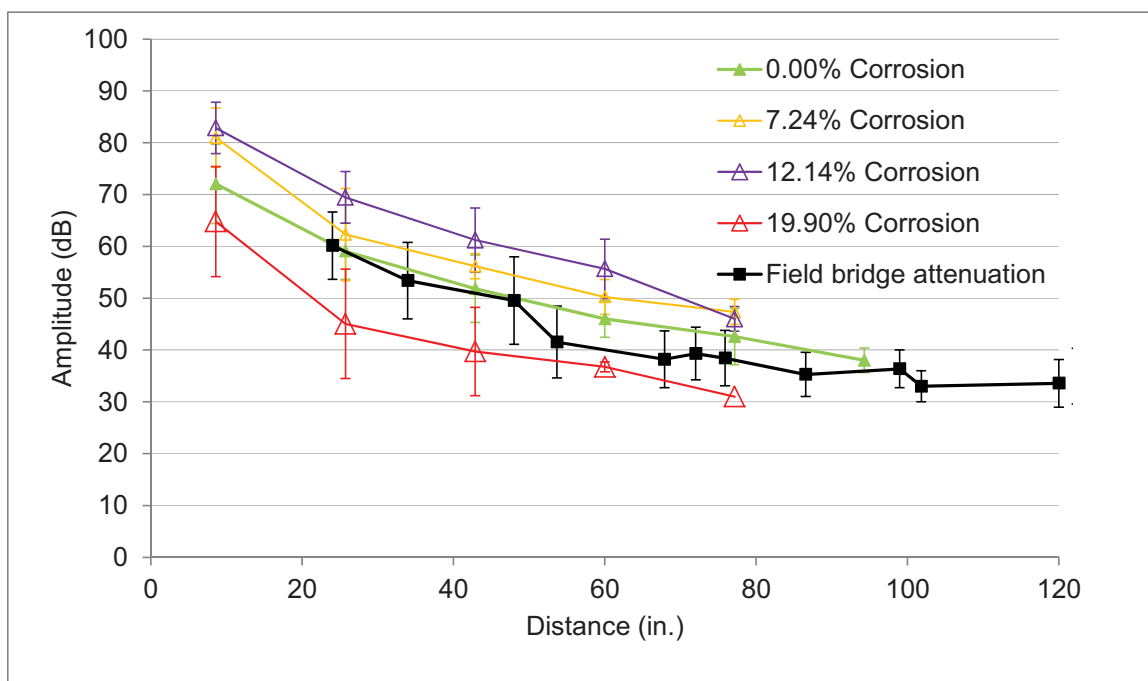
Figure 4.13 - Attenuation, sensors and breaks on CFRP

Collected attenuation data has been expressed in three sample average Amplitude (dB) against distance (in.) in Figure 4.13 to show the relationship between uncorroded, corroded at different levels, and the unknown damage level of the field bridge from sensors recording on CFRP. Figure 3.13 shows the results from breaks performed on the CFRP, while Figure 4.14 shows the results from breaks on the concrete surface. The graphs show that the most corroded Beam B3 has the highest attenuation, while Beam B2 has the lowest attenuation, but like the other specimens doesn't record signals from a larger distance than 77 in. [1.96m]. Only the uncorroded Beam B0 is able to record from greater distances.

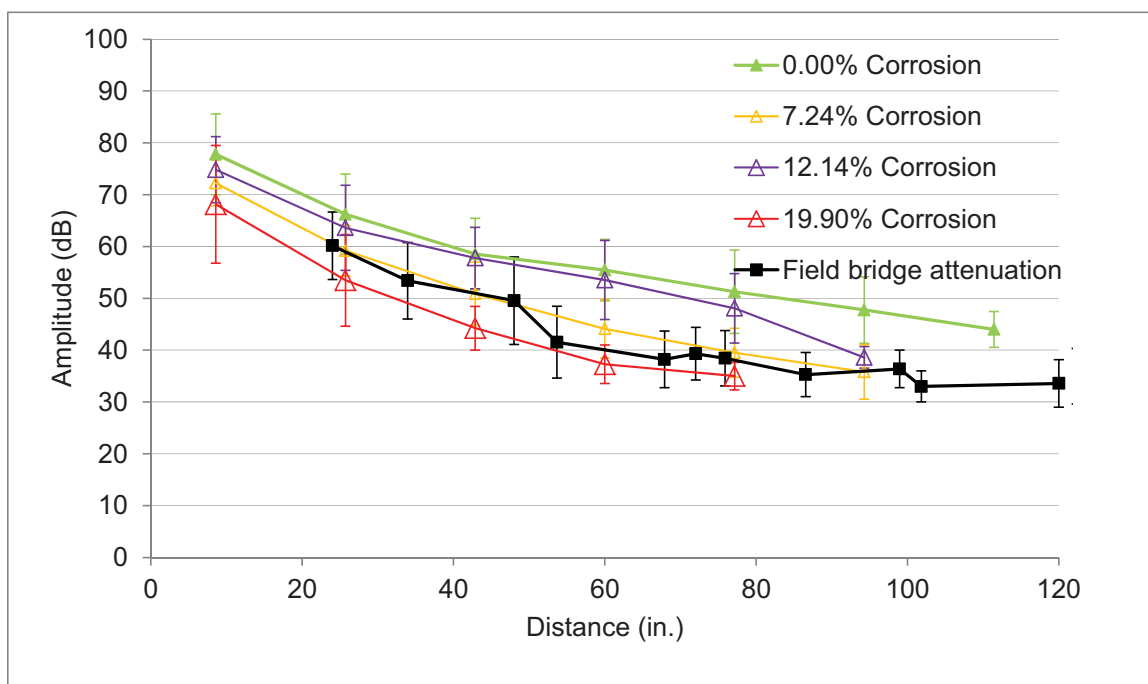
Figure 4.14 - Attenuation, sensors on concrete, breaks on CFRP

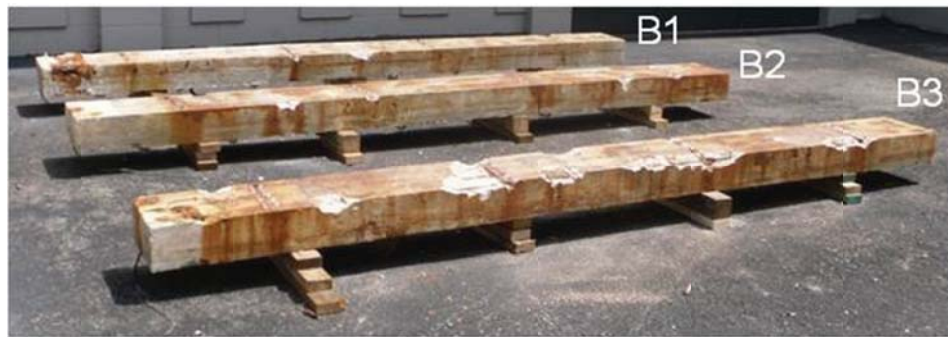
Figure 4.15 - Local removal of concrete cover (B1 to B3)

Repair and strengthening is performed after the visual inspection for spall of concrete cover, crack density and deterioration of concrete. Local removal of the concrete cover is done by impacting [Concrete Repair Manual, 1999]. Figure 4.15 shows local chipping on Beam B1, B2 and B3. Figure 4.16 shows locations of concrete cracks with corrosion bleeding and locations where steel reinforcement has been completely consumed. Specimens are prepared for repair by cleaning the remaining steel reinforcement and removing all attached concrete where the cover was locally removed as per ACI 220.3R [2003]. Immediately after cleaning procedures, the removed concrete cover is patched with cementitious grout (Figure 4.17). Troweling and dry packing of 1 in. [25 mm] deep areas is performed using grout placement technique. After 7 days of curing, the entire surface of the specimens is prepared for CFRP laminate strengthening as per ACI 440.2R [2008]. Material specifications of the CFRP laminates can be found in Table 4.1.

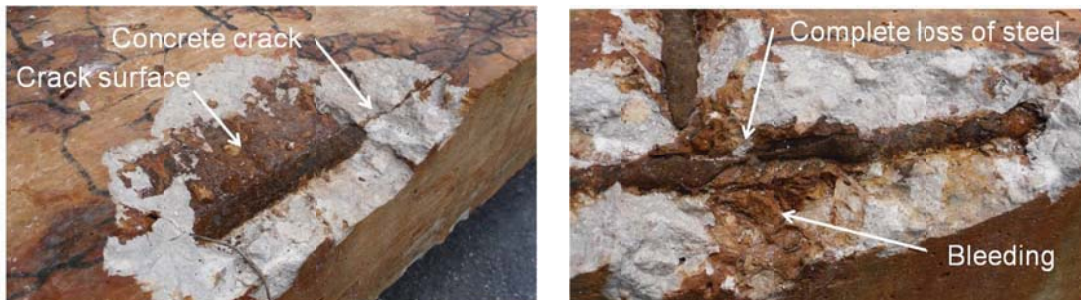
(a) Crack in concrete cover with bleeding surface

Figure 4.16 - Corrosion observations

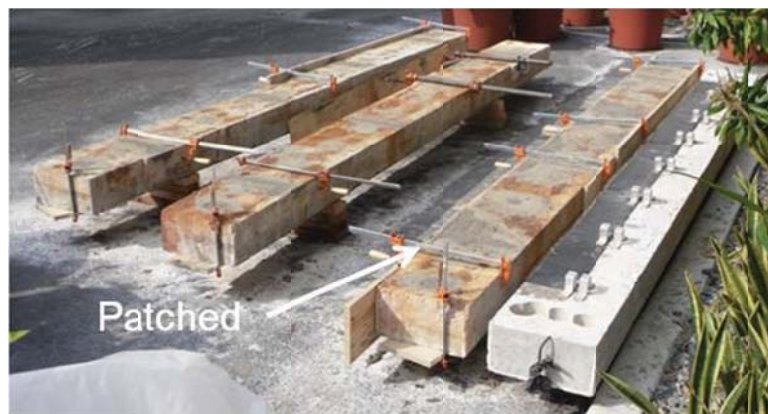
Figure 4.17 - Concrete patching chipped areas (B1 to B3)

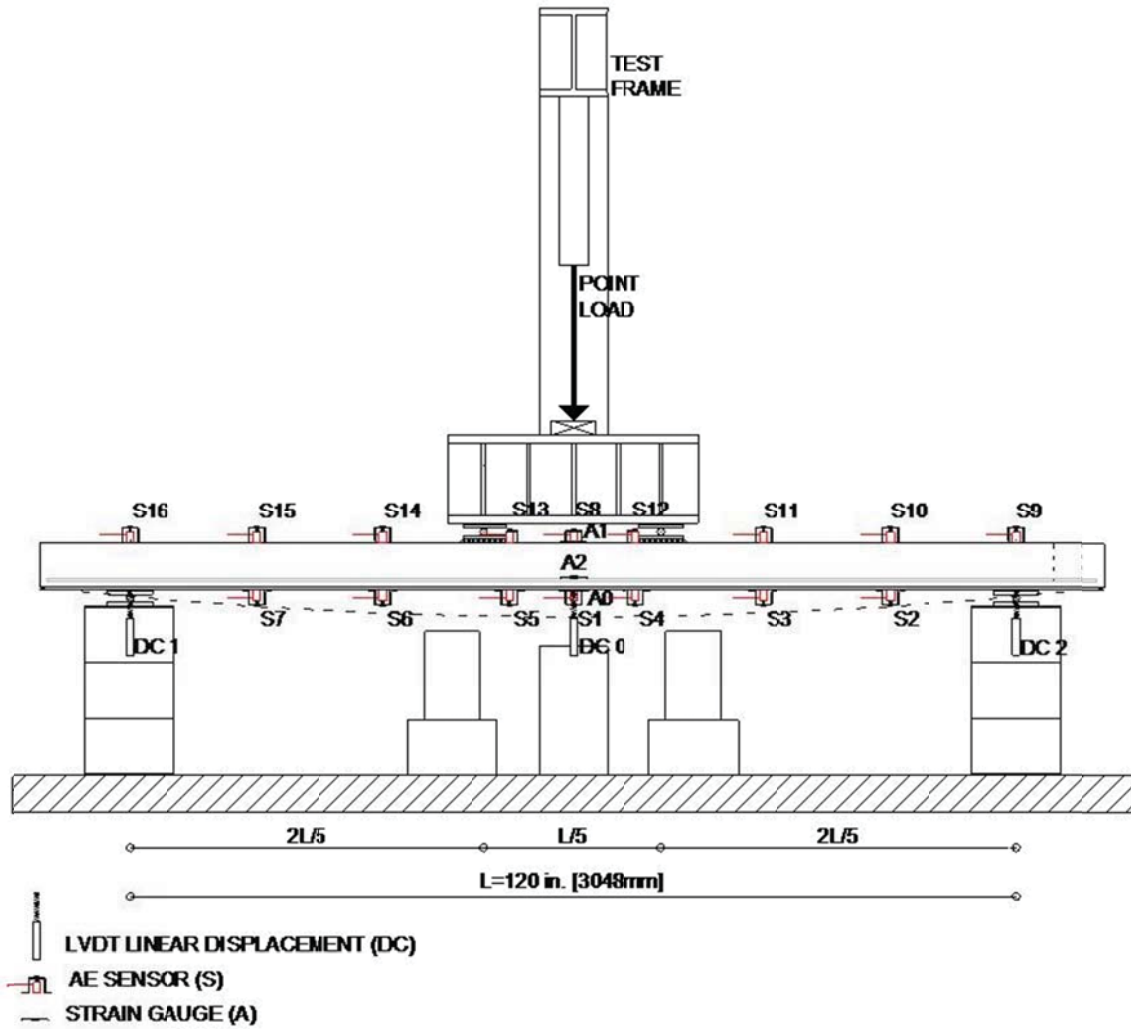
Figure 4.18 - Four-point bending test setup

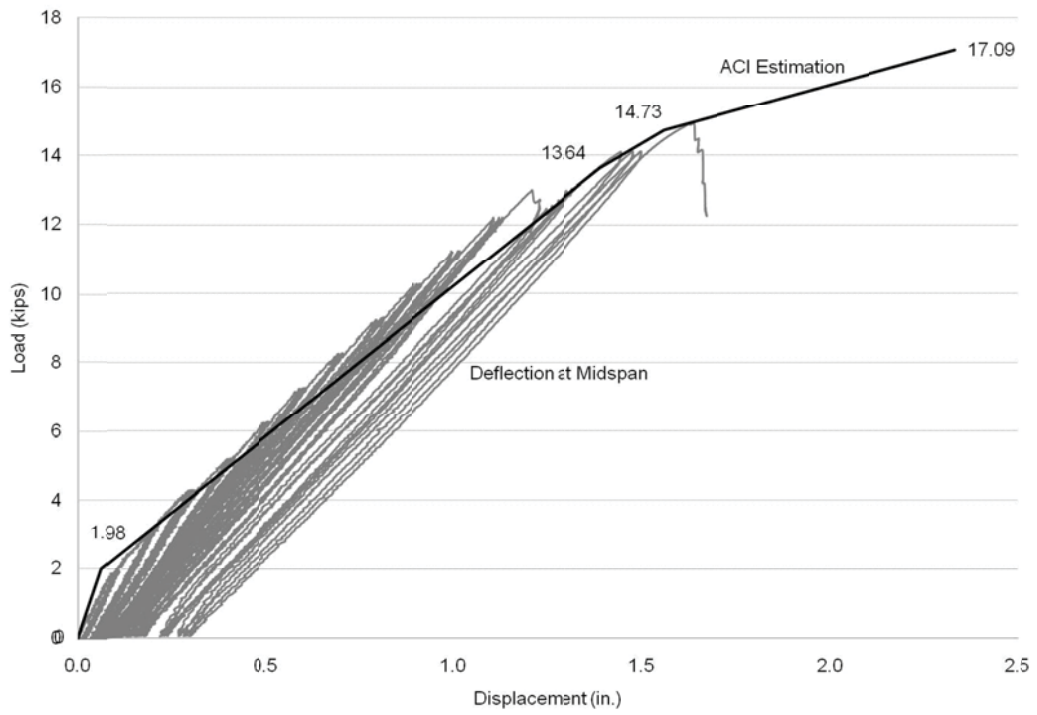
Figure 4.20 - Load-displacement (B0)

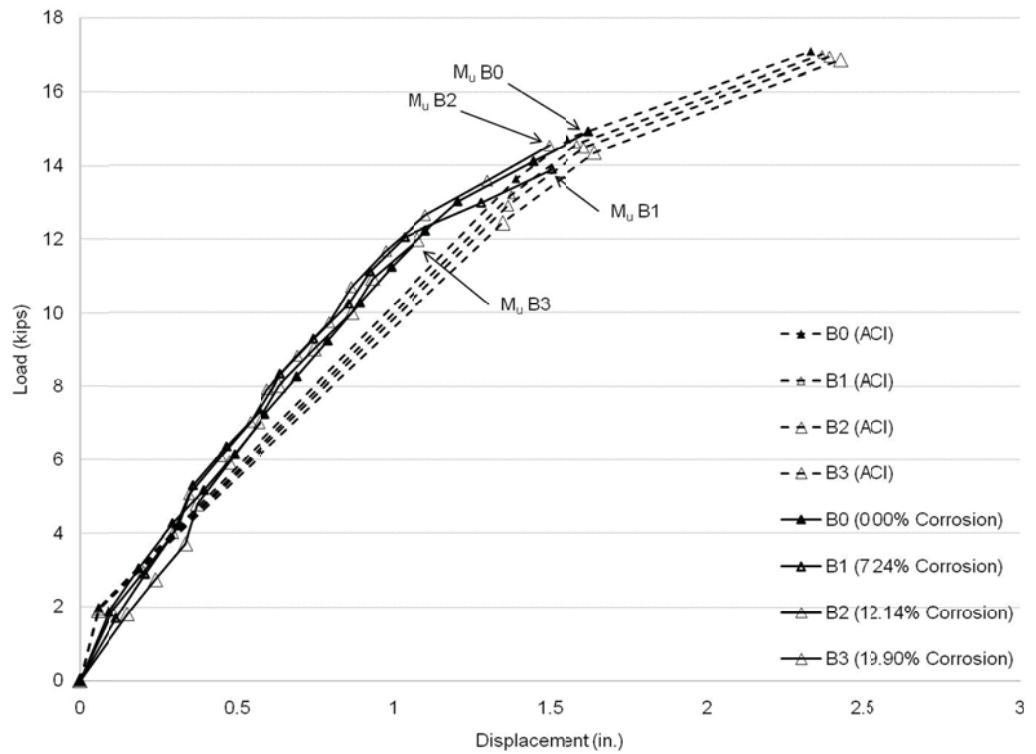
Figure 4.23 - Load-displacement (B0 to B3)

Strain behavior as a function of applied moment on the vertical axis shows two groups of strain envelope lines in Figure 4.22. The group with the highest increase is the positively expressed concrete strain which shows correlation with different corrosion levels. Strain is higher in order of corrosion level. The envelope line of experimental load-displacement relation of Beam B0 has a close relationship with the analytical evolution of Beam B0 in Figure 4.23.

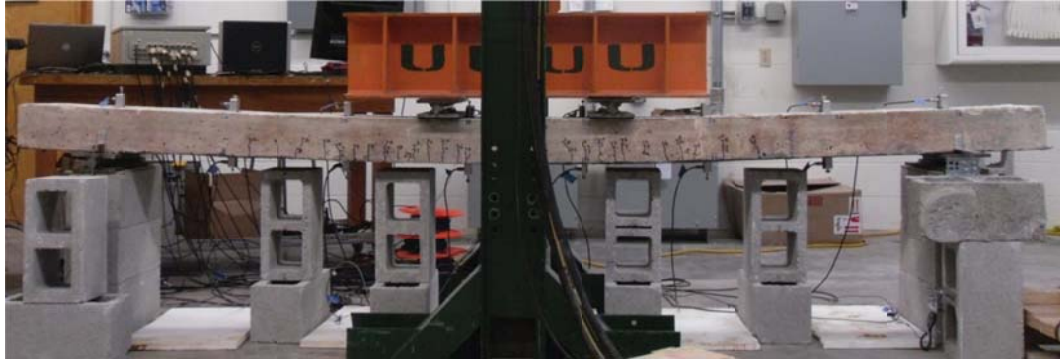
Figure 4.24 - Test setup with bended specimen close to failure

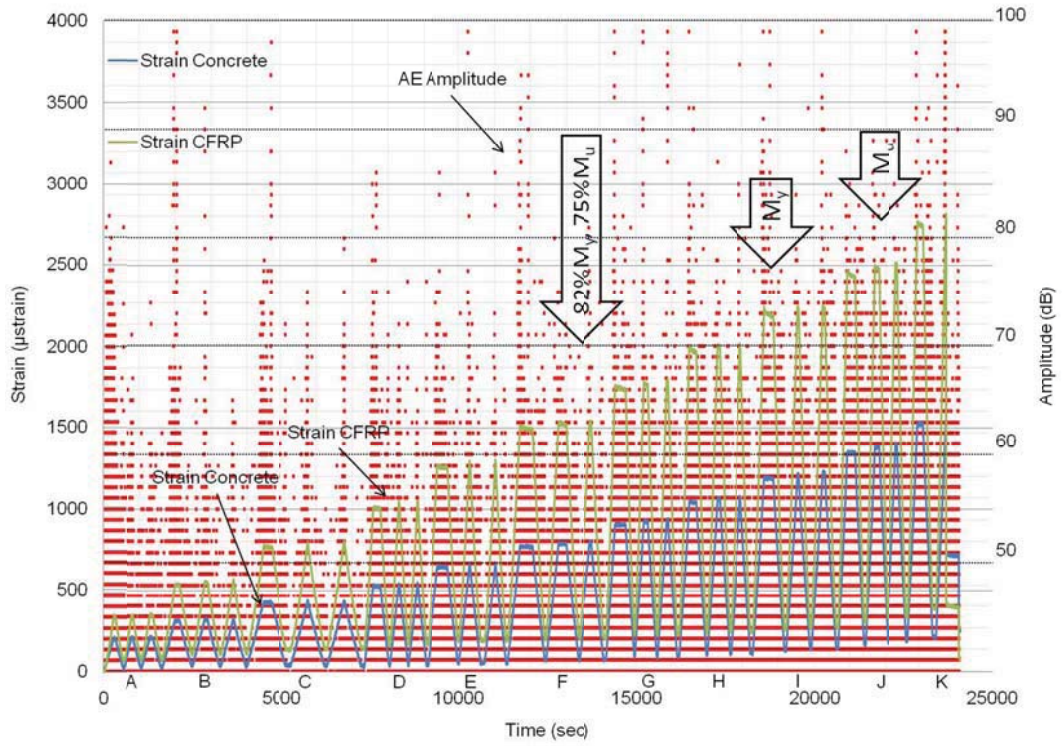
Figure 4.26 - Strain and AE Amplitude in time, complete test B3

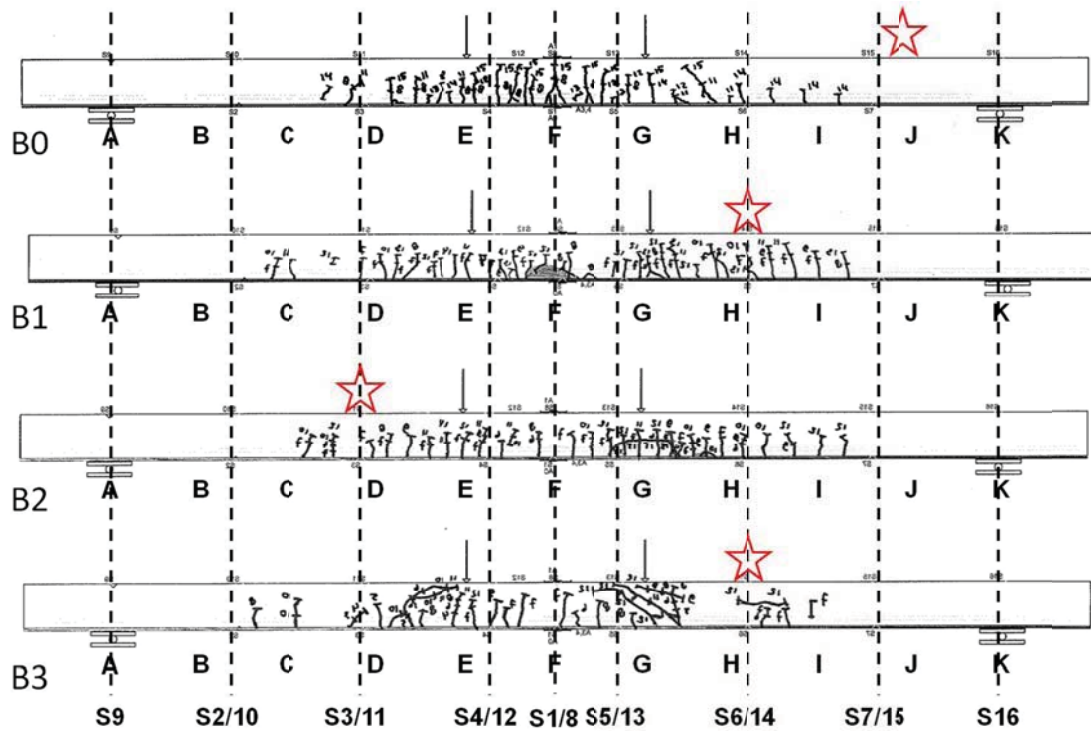
Figure 4.35 - Crack map with failure and AE sensor locations

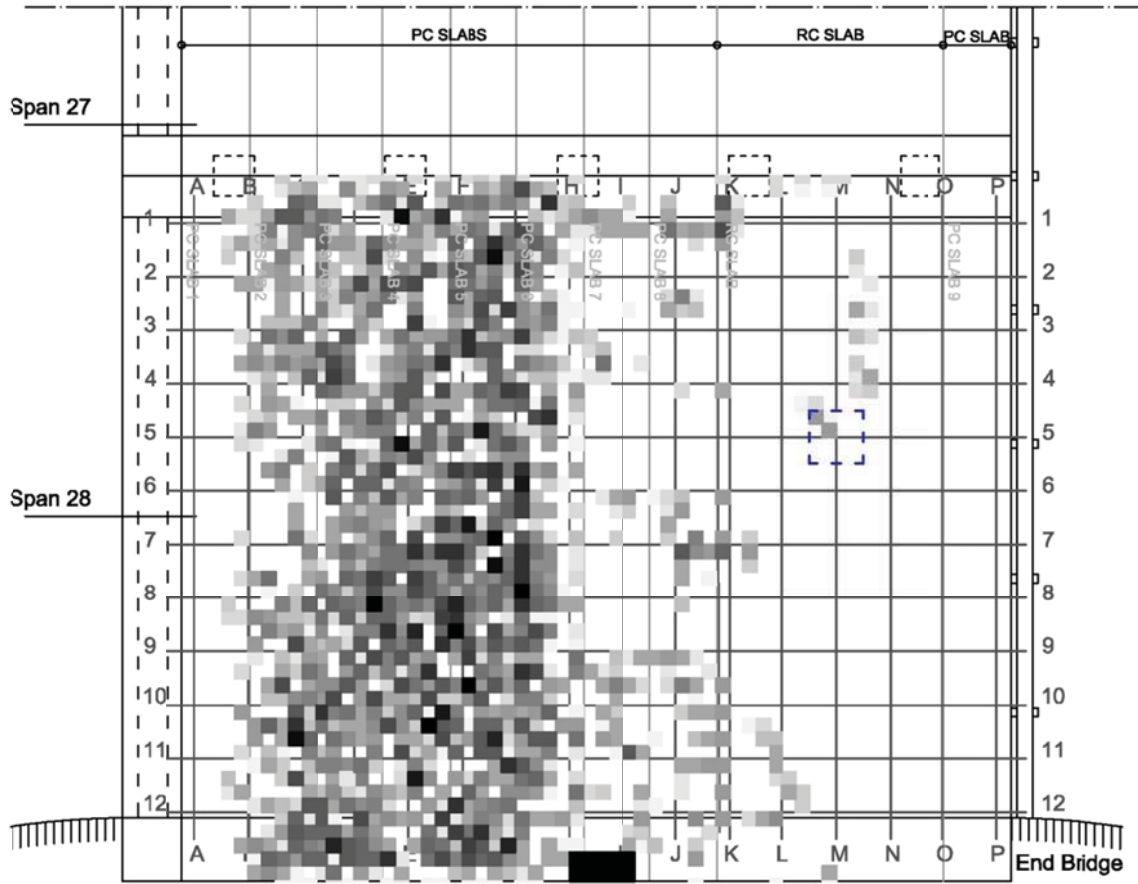
Figure II.A1 - Crack density map Fair Isle Bridge
