# Chemical and Acoustic Emission Evaluation Studies of Concrete Bridge in Marine Environment

A DISSERTATION

A field investigation of the Fair Isle Bridge, Miami, Florida consists of a nondestructive evaluation program including physical and acoustic emission (AE) assessment. The bridge is situated in a marine environment and its deck consists of PC and RC sections. Chemical evaluation is performed prior to strengthening with CFRP laminates and consists of visual inspection, carbonation, pH evaluation, chloride content, and steel corrosion detection by half-cell potential. After repair, three additional physical assessments are performed: crack mapping, thermography, and AE. These combined techniques provide sufficient information to create layered maps to evaluate the condition of the bridge structure. Within the maps, areas of interest are explored and compared for high probability of corrosion and concrete damage. Through spatial analysis of physical and chemical evaluation data, areas with significant potential difference are identified. These areas are the focus of a load test while monitoring strain, load and AE. The AE program components consist of in-service traffic monito

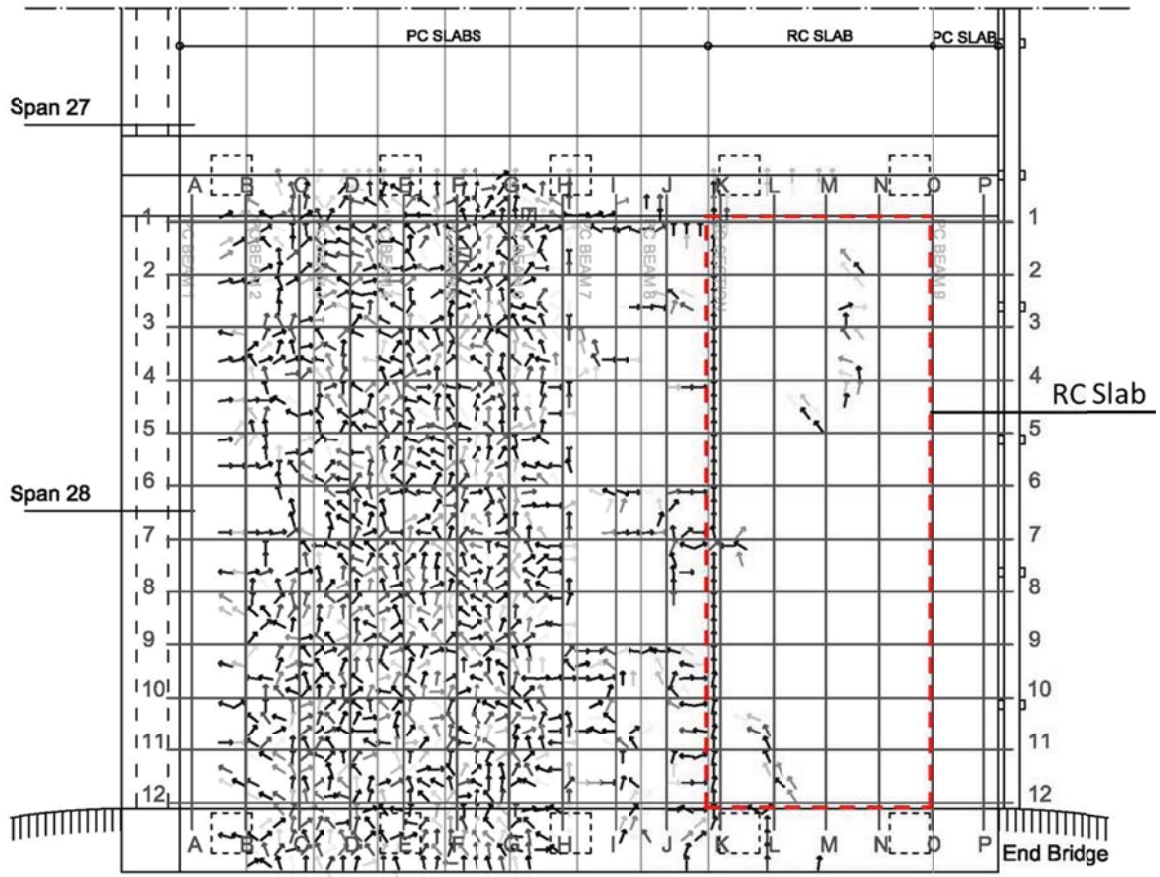
Figure II.A2 - Crack direction map of Fair Isle Bridge

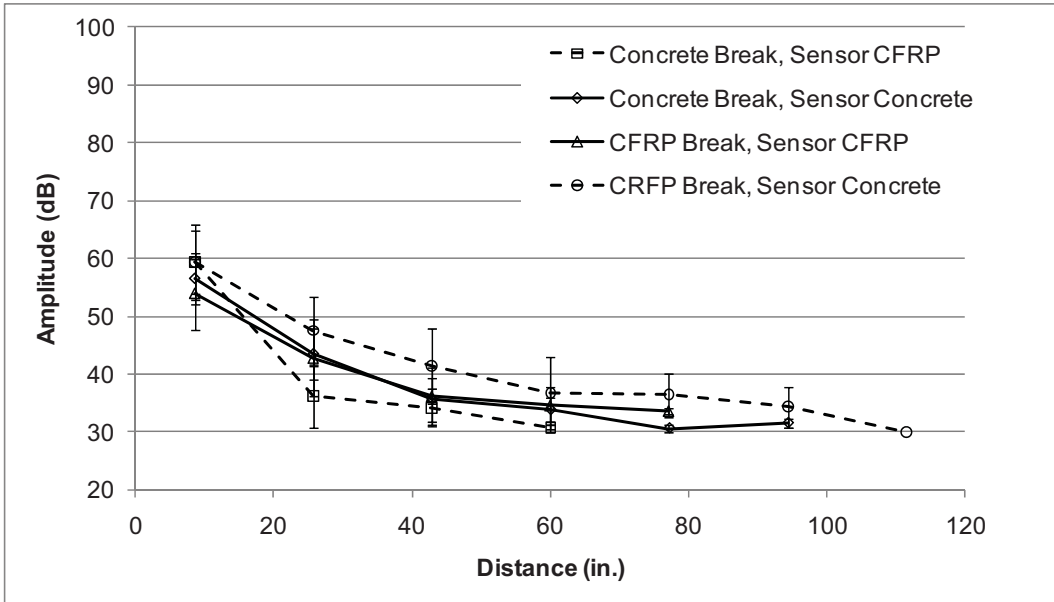
Figure III.A.1 - Attenuation results Beam B1

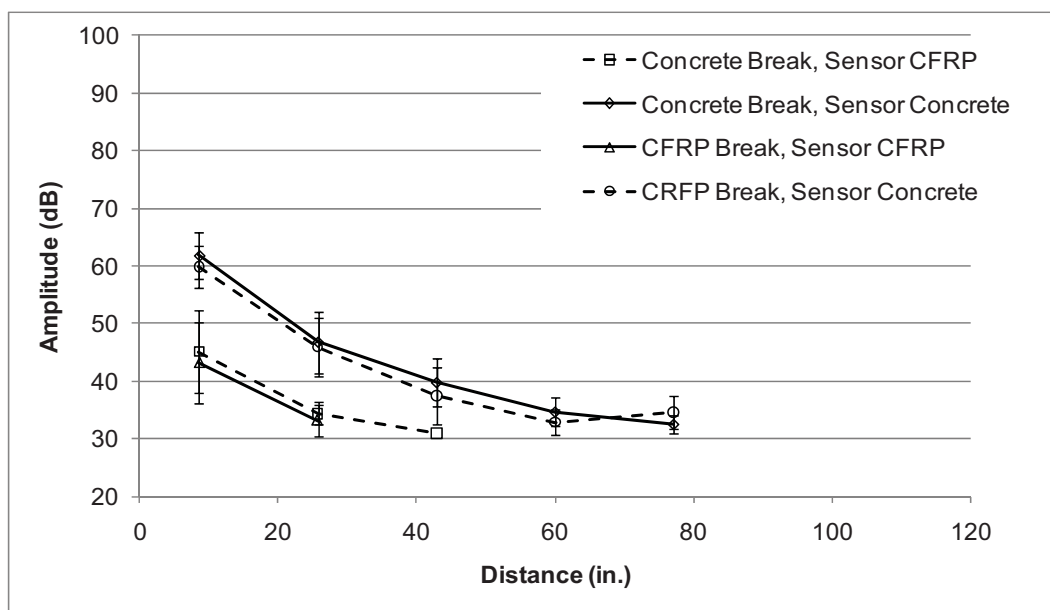
Figure III.A.3 - Attenuation results Beam B3

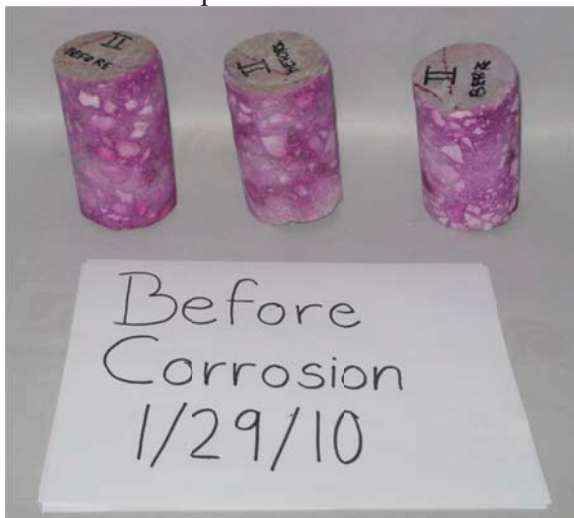
Figure III.D.2 - Core evaluation of concrete carbonation before corrosion

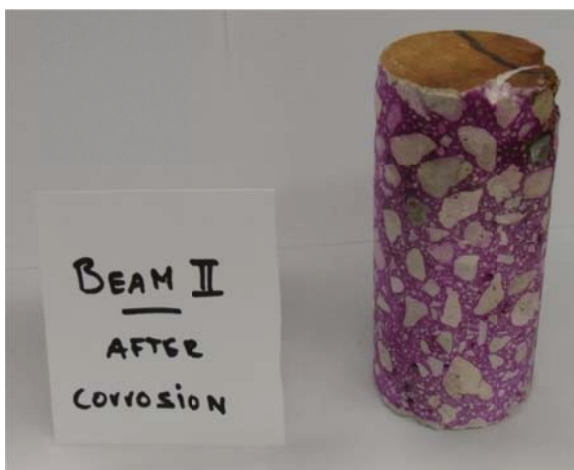
Figure III.D.3 - Core evaluation of concrete carbonation after corrosion
