Experimental Evaluation of Full Scale I-Section Reinforced Concrete Beams with CFRP-Shear Reinforcement

EXPERIMENTAL EVALUATION OF FULL SCALE I-SECTION REINFORCED
CONCRETE BEAMS WITH CFRP-SHEAR REINFORCEMENT

A THESIS

(M.S., Civil Engineering)
(December 2008)

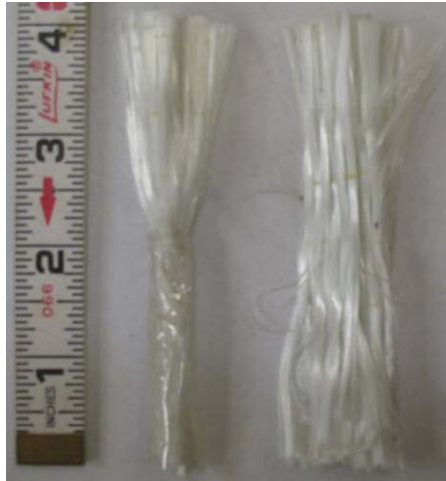
The second anchorage configuration consisted of inserting GFRP spikes through the CFRP laminates used for shear reinforcement. This time, the laminates were bonded to the sides of the beam rather than all the way around forming a U-wrap. The spikes were made with a total length of 4 inches (101.6 mm) and a diameter of $\frac{1}{2}$ inch (12.7 mm) (75% of final diameter) before being saturated with resin and a final saturated diameter of $\frac{11}{16}$ inch (17.46 mm). Of the 4 inches (101.6 mm), only 2 inches (50.8 mm) was saturated and cured before installation. To achieve the desired diameter and length, the bundle of fibers was first passed through a wooden block with a $\frac{1}{2}$ inch (12.7 mm) diameter hole. Then, 2 inches (50.8 mm) were covered with tape so that only half the length of the fibers would be saturated as shown in Figure 5.8.

Figure 5.8 – Prepping of Glass Fibers

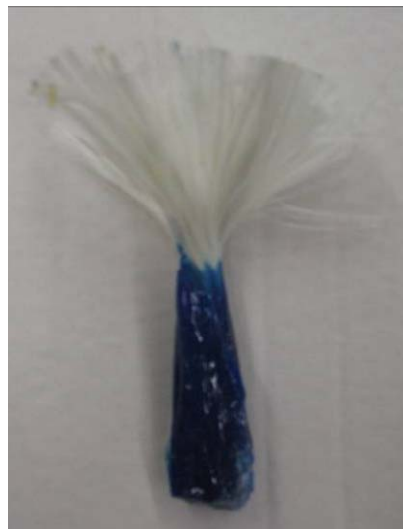
The loose end of the fibers was then saturated using MBrace Saturant and passed through a wooden block with an 11/16 inch (17.46 mm) diameter hole in order to achieve a uniform diameter. The spikes were then hung instead of being placed on a table in order to avoid the saturated end from flattening out. After curing for 24 hours, the tape was removed and any deformities such as loose fibers or excess resin that had dripped and cured were removed with a blade. Figure 5.9 shows an example of a finished GFRP spike.

Figure 5.9 – Finished GFRP Spike

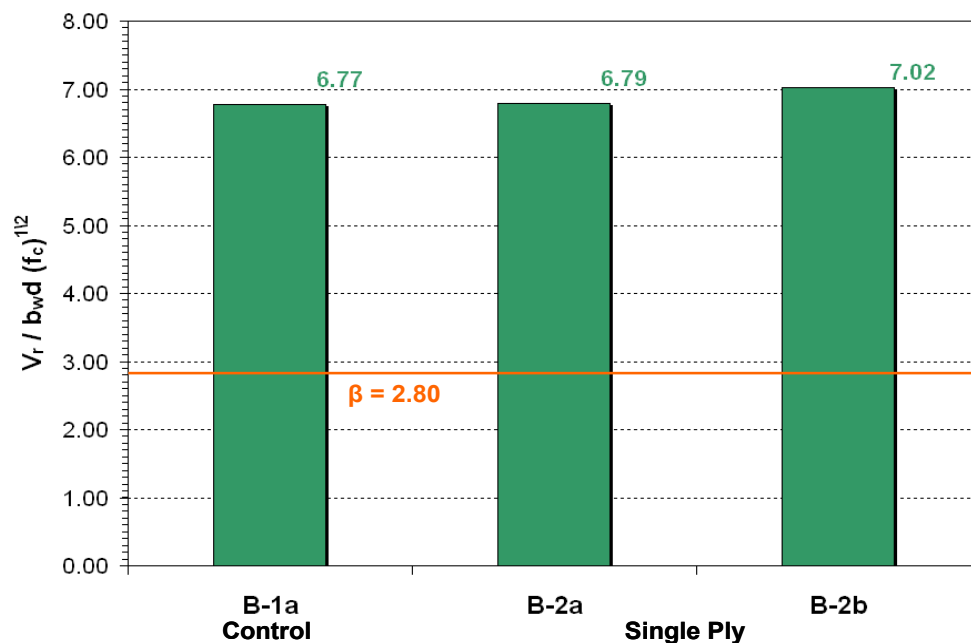
Figure 7.1 – Normalization of Results

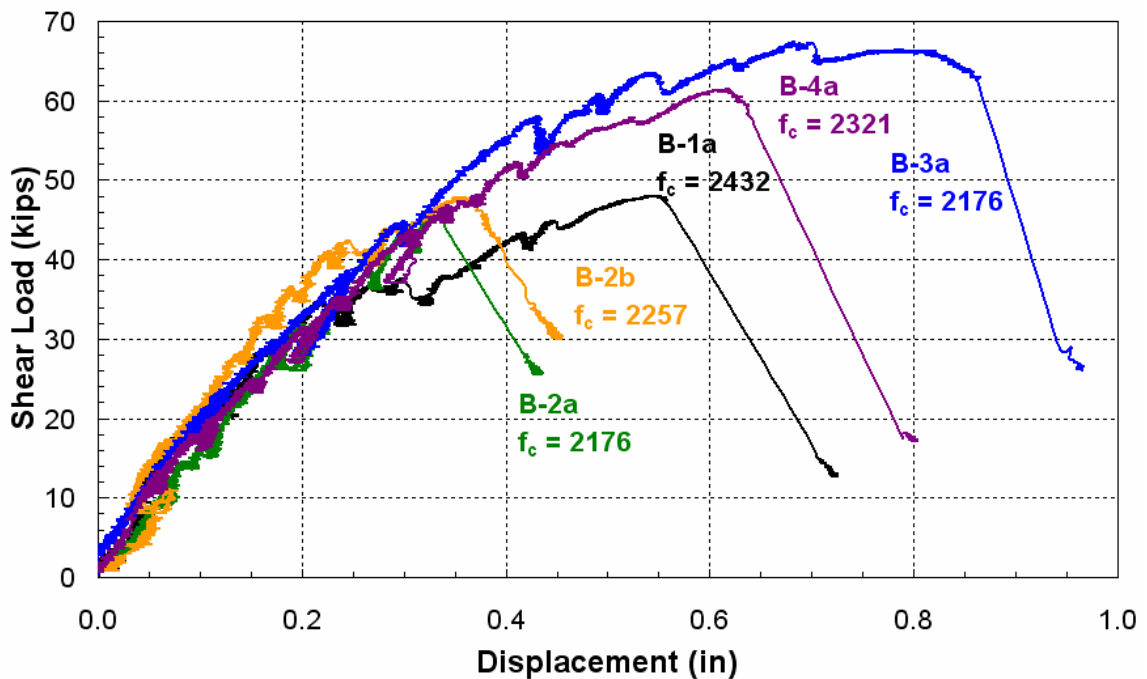
In Figure 7.2, the load – deflection plot of each of the specimens along with their respective f_c is shown. It can be observed that all of the plots closely overlap (due to the similarity in relative stiffness) each other up to the range of about 22 kips (97.8 kN) and net deflection of 0.15 inches (3.81 mm) and four of the five plots closely overlap each other up to the range of 30 kips (133.4 kN) and 0.2 inches (5.08 mm). After this common point, the four reinforced specimens began to show greater stiffness per load applied when compared with the control specimen, B-1a. It was not the intention of this project to provide ductility. Shear failure still occurred.

Figure 7.2 – Load-Deflection for Specimens Tested

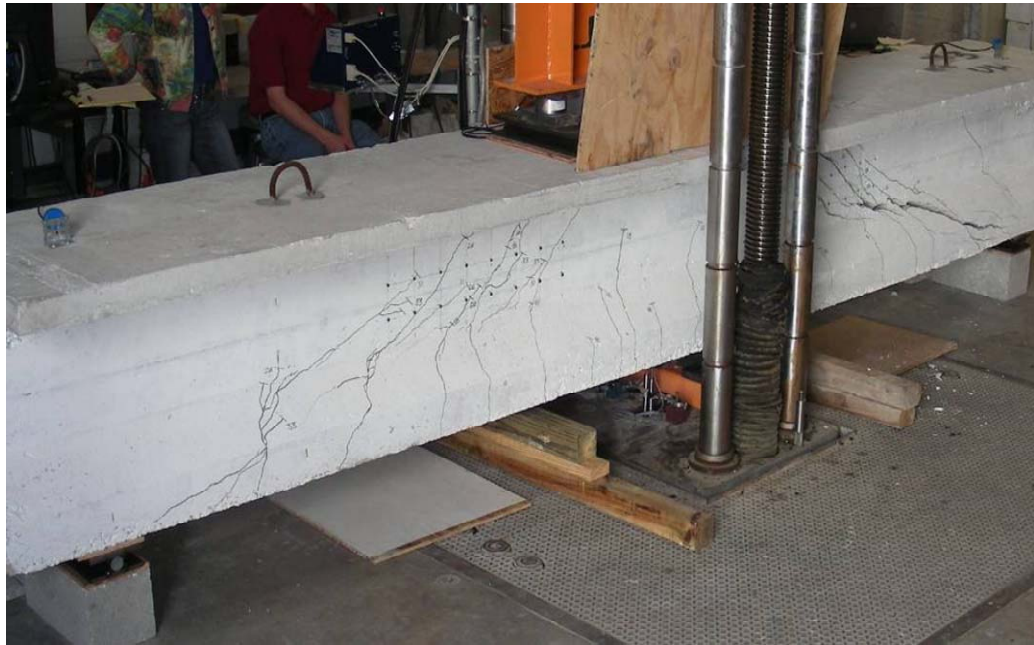
Figure 7.5 – B-1a

Figure 7.6 – B-1a Failed Section

In Figure 7.3, the load-deflection diagram clearly shows every time a major crack formed. Figure 7.4 shows the crack pattern of the beam and Figures 7.5 and 7.6 shows the specimen once it has failed. See Appendix B for the map of sensors and the pi-gauges strain data at midspan.

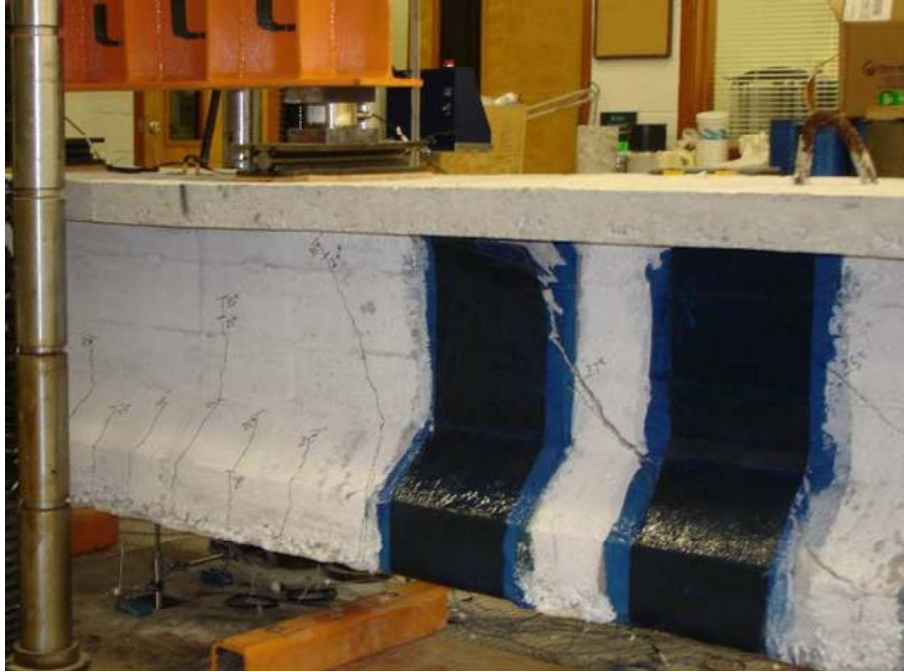
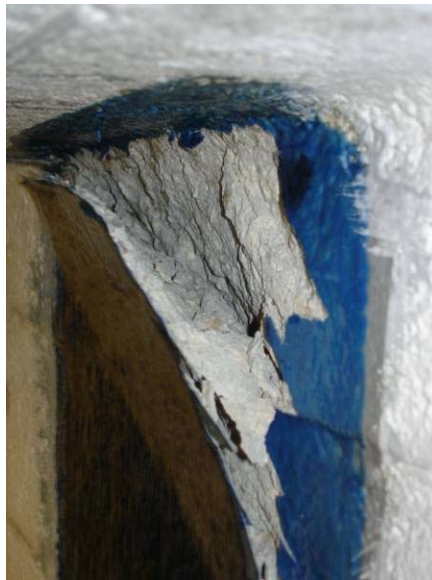
The reduction in deflection is due to the high stiffness characteristic of the CFRP. Also, the laminates acted as a form of confinement which in a sense “hold” the beam and keep it from severely deflecting. Failure of the laminate occurred due to straightening of the center laminate followed simultaneously by peeling of the laminate closest to the loading point. As described in Chapter 1, this straightening was caused by a peeling force which acts perpendicular to the laminate. In the area where the laminate peeled, a layer of about ½ inch (12.7 mm) of concrete was observed to have been peeled off along with the laminate. This failure illustrates that the reinforcement is bond critical and that failure occurs in the concrete substrate and not in the CFRP laminate. These failure modes are illustrated in Figures 7.8, 7.9 and 7.10.

Figure 7.8 – B-2a Failed Section

Figure 7.9 – B-2a Peeling of Laminate

Figure 7.10 – B-2a Straightening of Laminate

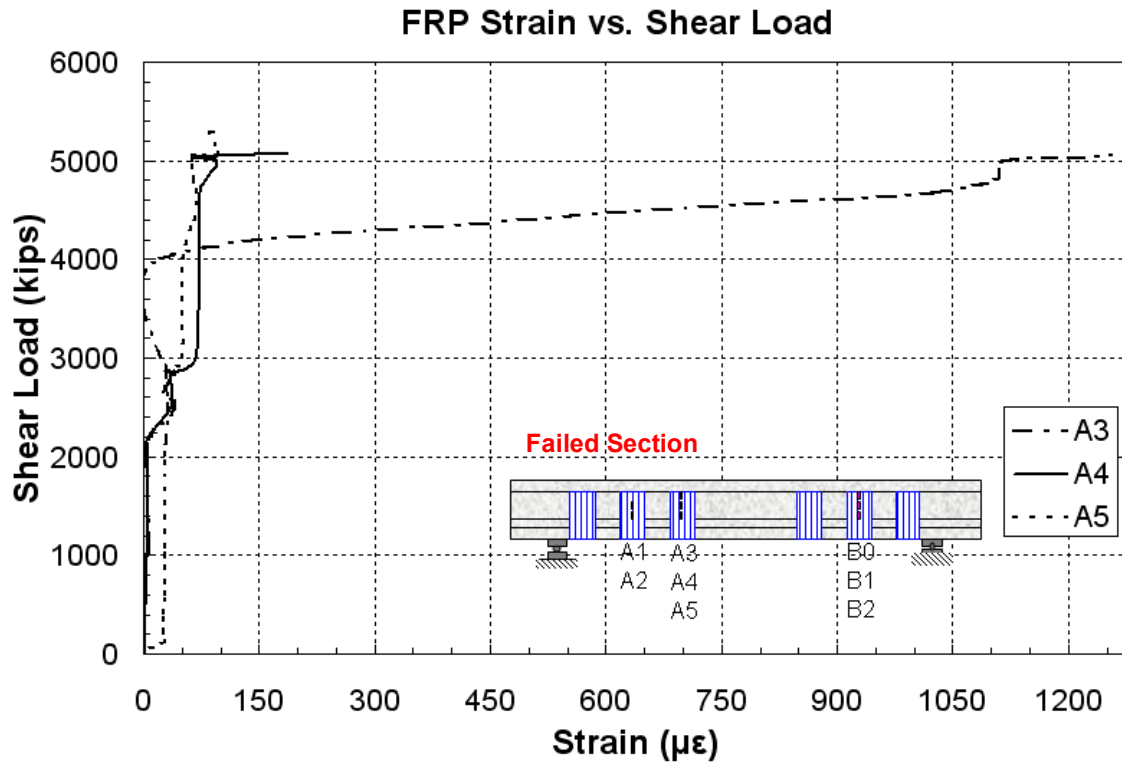
Figure 7.13 – B-2a Strain in CFRP (Gauges A3, A4, & A5)

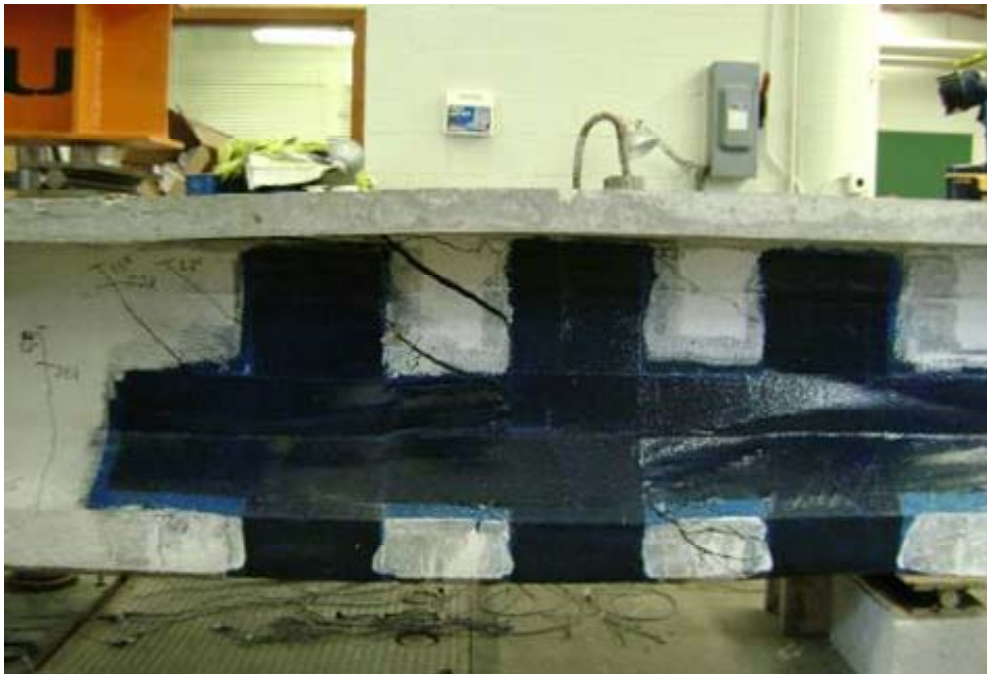
As the shear cracks continued to grow and debonding began in the horizontal laminate, the strength could be observed to decrease somewhat and then increase a small amount until complete debonding and failure occurred. This can be seen in Figure 7.23 within the deflection range of 0.5 and 0.7 inches (12.7 and 17.8 mm). Splitting of the horizontal laminate was also observed. This was due to the fact that the fibers in the horizontal laminate were unidirectional which does not allow it to resist shear forces that are perpendicular to the fiber orientation. Figures 7.25 through 7.27 show the beam after failure.

Figure 7.25 – B-3a Failed Section 1

Figure 7.26 – B-3a Failed Section 2

Figure 7.27 – Close-up of Horizontal Anchorage

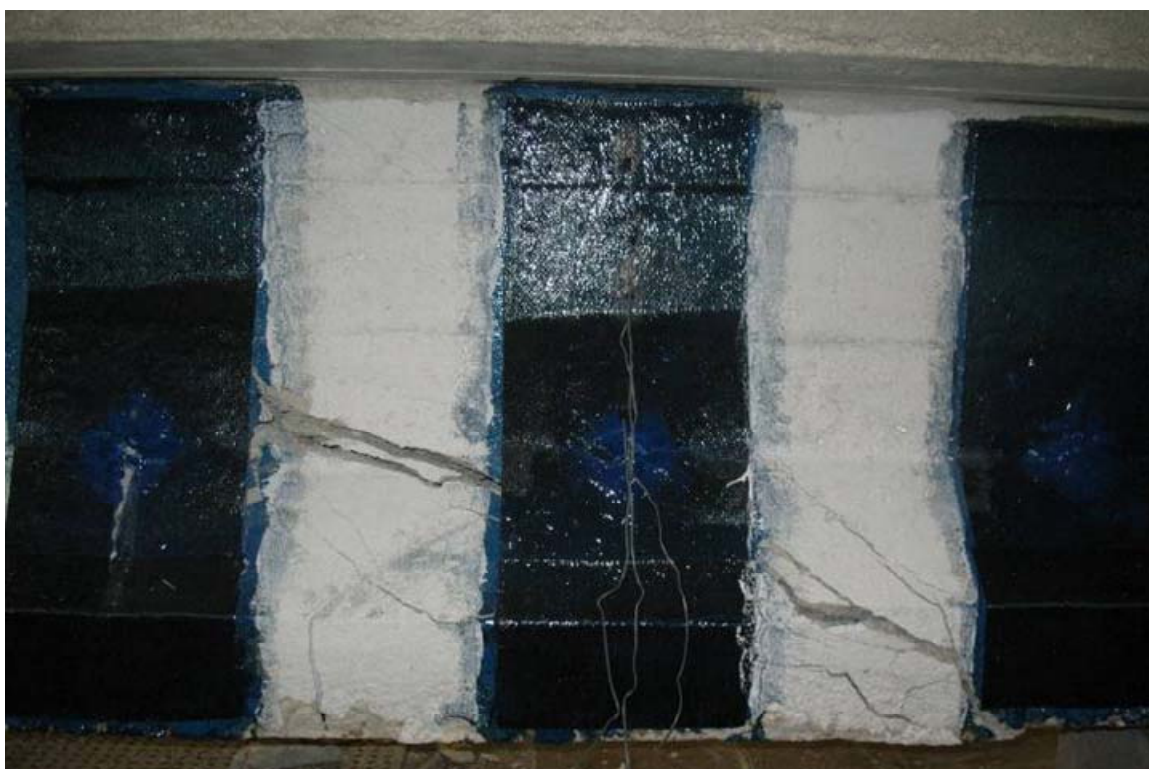
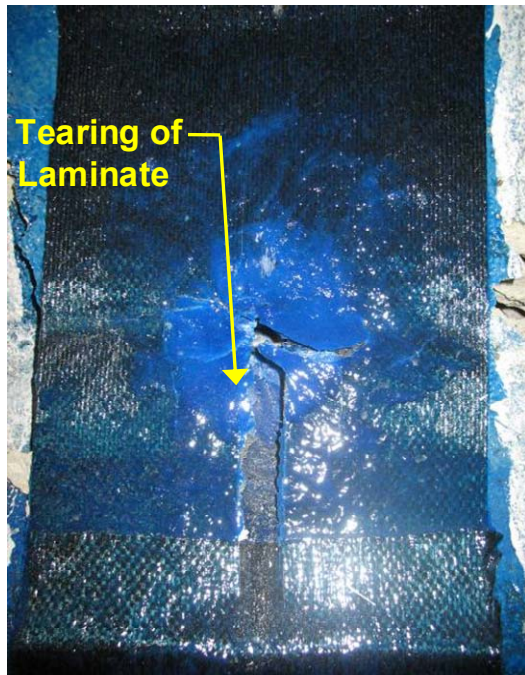
Failure of the specimen occurred due to straightening of the laminate and rupture of the GFRP spike at the flared end. During the test, straightening of the laminate was observed to have initiated along its edge and continued until it reached the general area of the GFRP spike. This was observed in both sides of the beam. Failure finally occurred once the maximum strain in the spike was reached causing it to rupture. Splitting, or tearing, of the two laminates closest to the loading point was also observed along with rupture of the spike. The reason for this was because since the spike ruptured at the flared end, part of the spike stayed attached to the laminate keeping it from debonding whereas the parts that broke free allowed the laminate to debond. This shows that failure of the laminate (and as a result the beam) is dependent on the rupture strength of the spike at the flared end. Figure 7.33 shows the crack pattern and Figures 7.34 through 7.36 illustrate the failure mode encountered.

Figure 7.34 – B-4a Failed Section

Figure 7.35 – B-4a Failed Laminate

Figure 7.36 – B-4a Spike Failure

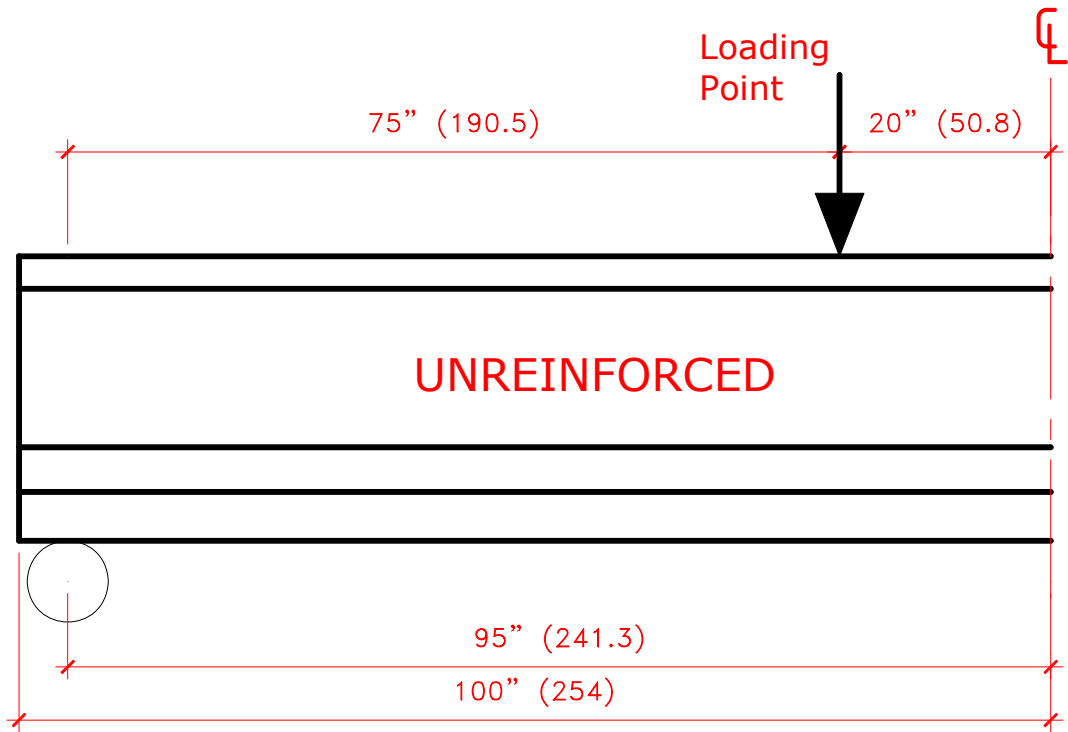
Figure A.1 – Beam Elevation
Note (SI conversion in cm)

All of the beams were reinforced with two rows of four #7 (22.2 mm diameter) steel rebar in the tension region. 90 degrees bent #5 (15.9 mm diameter) steel rebar with a length of 8 in. (203.2 mm) and spaced at 12 in (304.8 mm) O.C. is used to insure load transfer between the flange and web of the beam. The flange is reinforced with 3 x 3 in. (76.2 mm x 76.2 mm) and 3/8 in. (9.53 mm) diameter steel wire mesh. Figure 3.1 shows a typical cross section of the beams being tested. Units are presented in inches. Full construction details are provided in Appendix A.

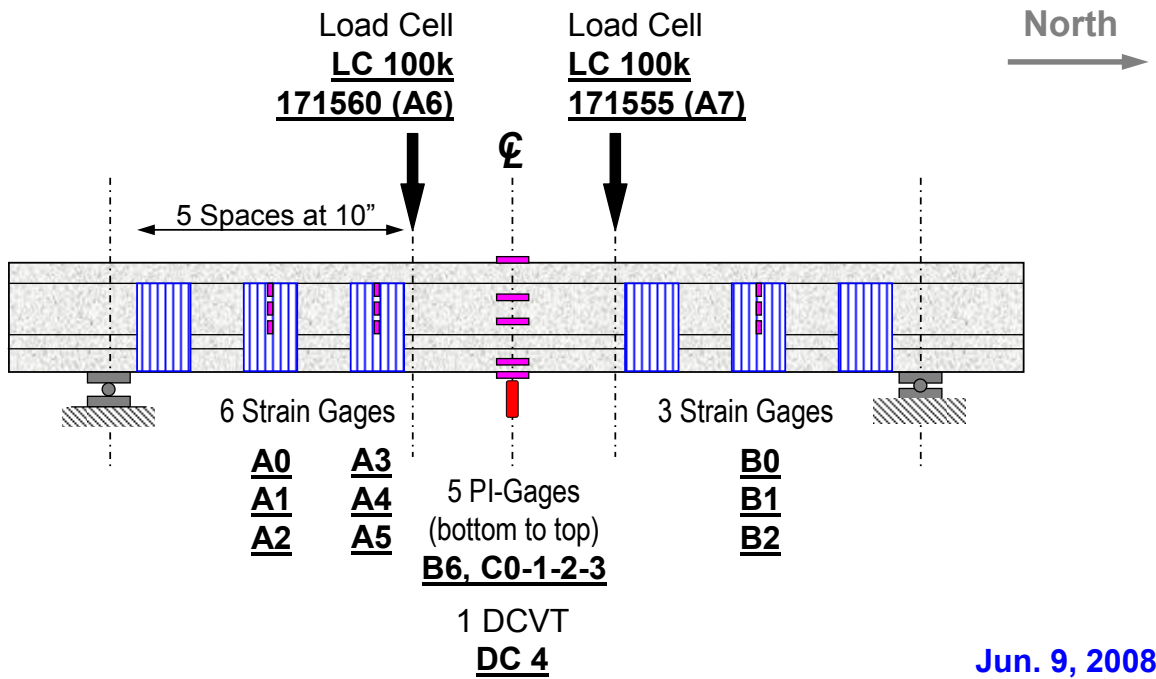
Figure B.2 – B-2a & B-2b Map of Sensors

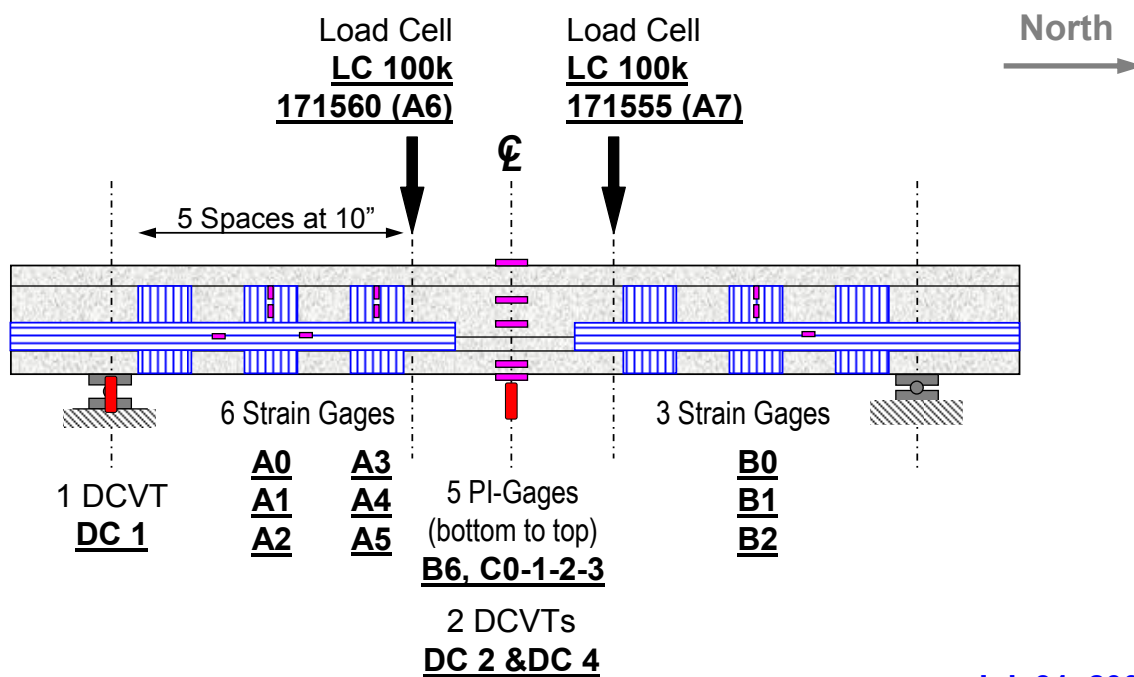
Figure B.3 – B-3a Map of Sensors

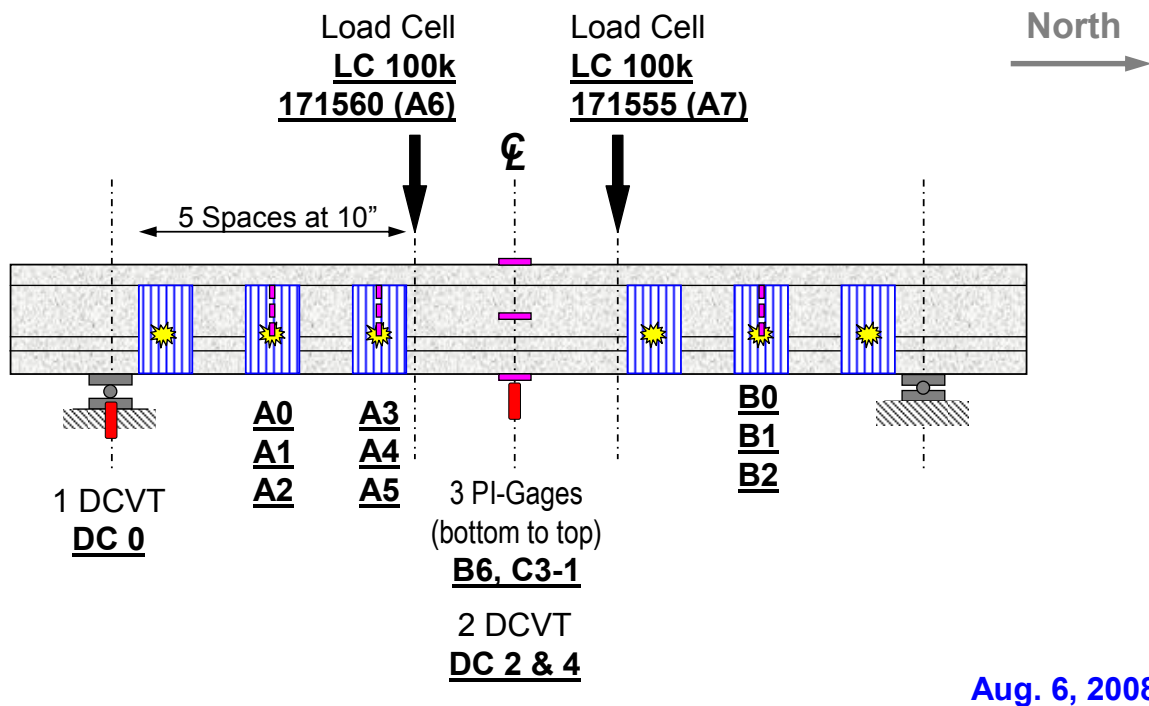
Figure B.4 – B-4a Map of Sensors

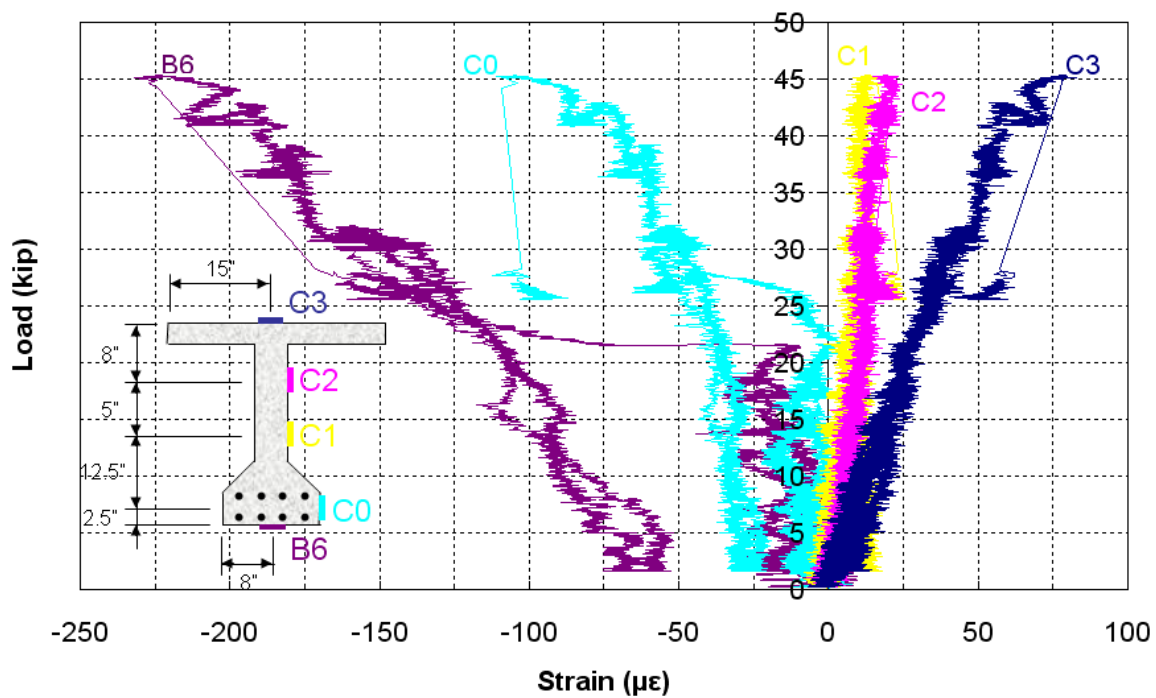
Figure B.6 – B-2a Pi-Gauge Strain Data

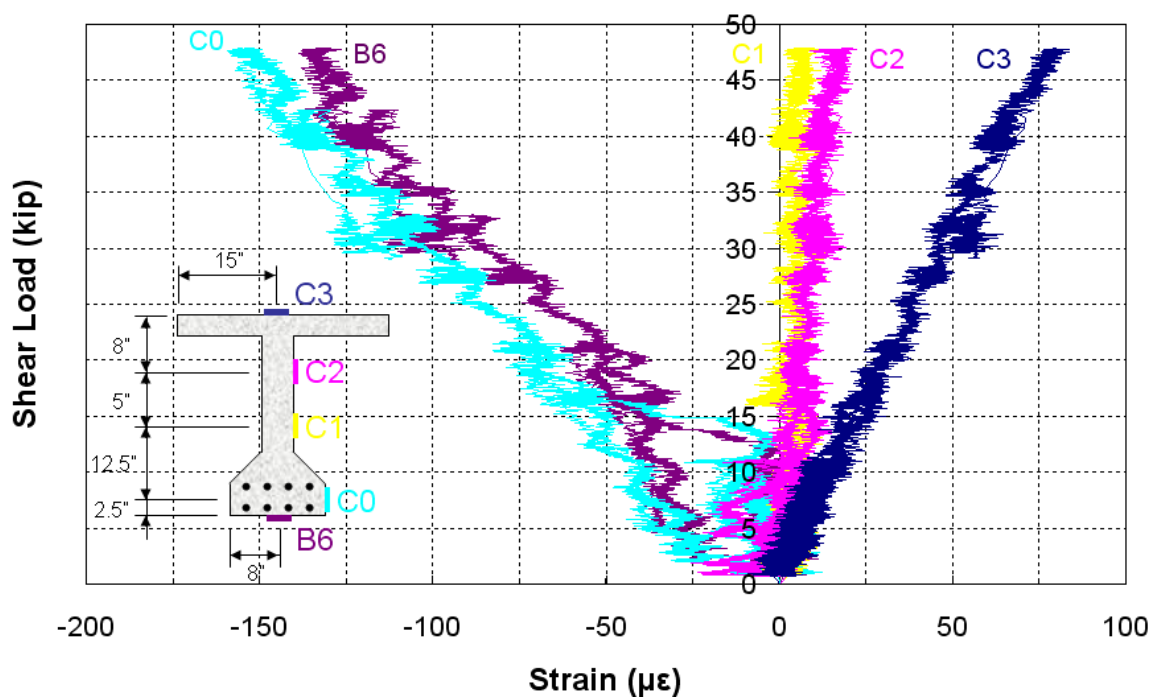
Figure B.7 – B-2b Pi-Gauge Strain Data
