# Mitigation and Evaluation of Alkali-Silica Reaction (ASR) and Freezing and Thawing in Concrete Transportation Structures

A dissertation submitted in partial fulfillment  
of the requirements for the degree of  
Doctor of Philosophy in Engineering  
with a Concentration in Civil Engineering

August 2017  
University of Arkansas

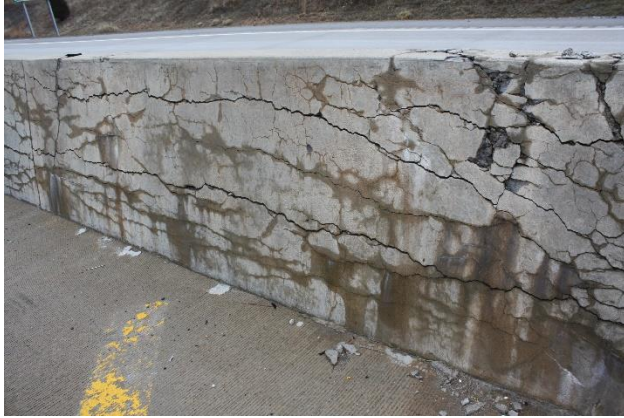
**Fig. 1.1-1**–Typical deterioration in concrete barriers due to F/T and ASR (by Richard Deschenes Jr.).

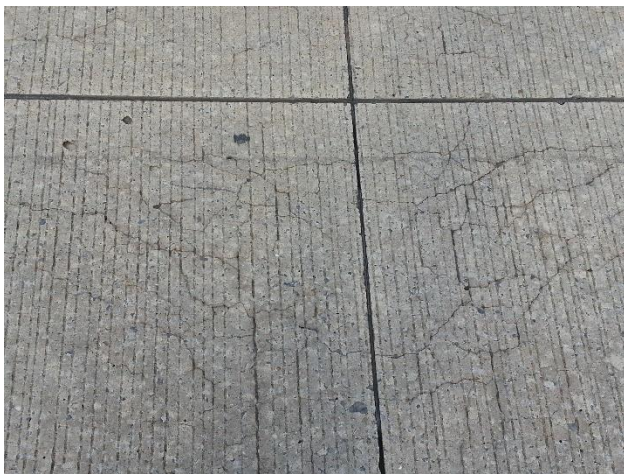
**Fig. 1.1-2**–Typical deterioration in concrete pavements due to F/T and ASR (by Richard Deschenes Jr.).

Deterioration can also occur if D-cracking susceptible coarse aggregate particles become critically saturated, and water is expelled on cooling. The water may be expelled too quickly to dissipate safely into the surrounding cement paste and air-voids. Therefore, the cement paste in the interfacial transition zone (ITZ) deteriorates. Deterioration occurs first as microcracks within the ITZ, on repeated cycles of F/T, the cracks propagate and interconnect forming a network. The cracks often appear at the exposed surfaces of concrete adjacent to joints. In air-entrained concrete pavements, the cracks curve along the joints at corners forming a typical D pattern known as D-cracking. An example of D-cracking is shown in **Fig. 1.1-2**.

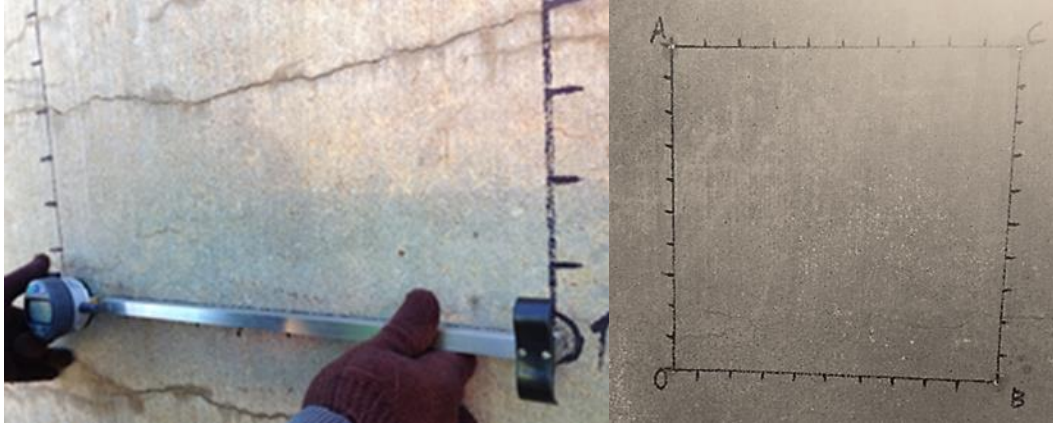
**Fig. 1.3-1**–Typical DEMEC gauge measurement and grid (by Richard Deschenes Jr.).

Multiple measurements along each axis provides reduced error and redundancy if a pin is damaged. Typical DEMEC gauges provide an accuracy of  $\pm 0.001$  mm, or  $\pm 0.0002\%$  strain. A typical grid for measuring expansion and CI is shown in **Fig. 1.3-1** along with a 500-mm DEMEC gauge.

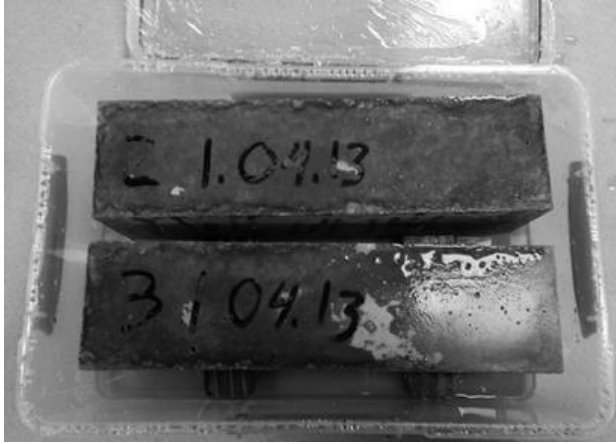
**Fig. 2.2-1**—Typical CPT containers (by Richard Deschenes Jr.).

One of the limitation of the CPT method is alkalis leached from the sample during testing. The standard containers limit the amount of water precipitated onto the surface of the prisms, reducing the transport of alkalis from the concrete. During the cooling period, moisture within the containers condenses and precipitates onto the surface of the prisms. The water then provided an avenue for alkalis to be leached from the concrete and into the water at the bottom of the containers. The smaller containers led to higher alkali leaching than typical for ASTM C1293 recommended CPT container. This caused lower expansion than observed when using the recommended container. A typical container, as shown in **Fig. 2.2-1**, contains two prisms. Six prisms were cast for each aggregate evaluated, and although the prisms were stored in separate containers, the expansion results were consistent between containers.

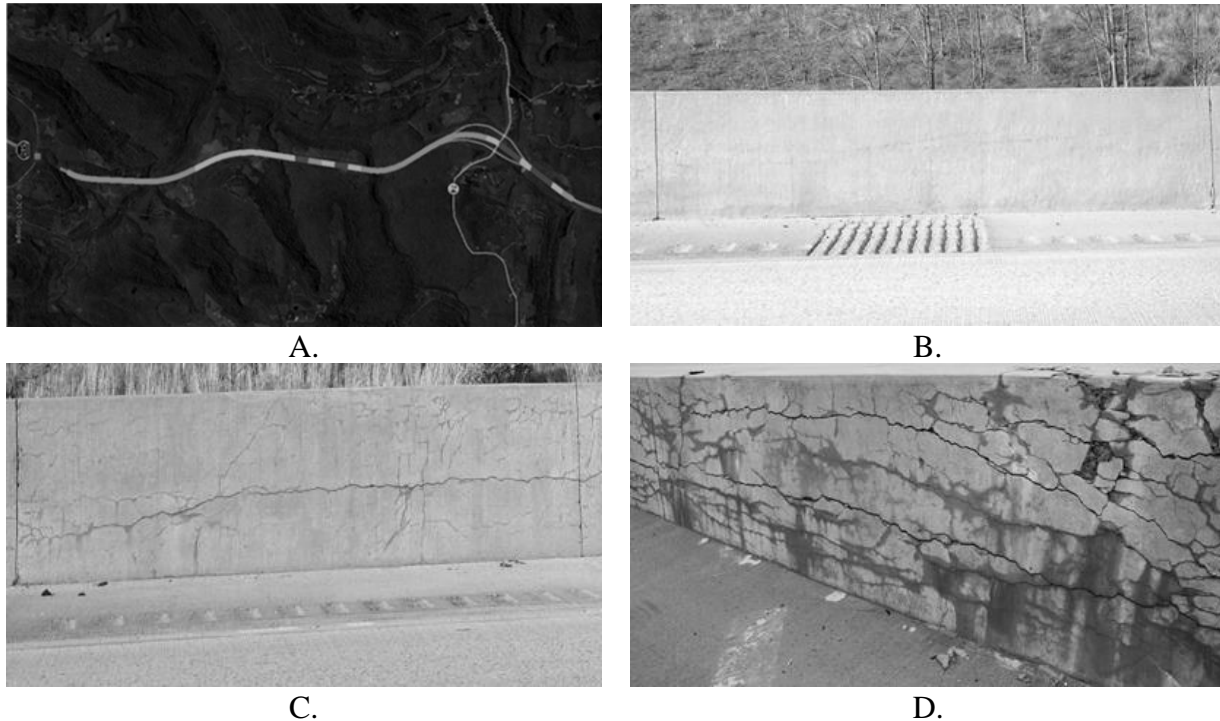
**Fig. 2.2-2**—A. Interstate wall map view. B. Minimal damage. C. Moderate damage. D. Severe damage (by Richard Deschenes Jr).

cracking and multiple wide longitudinal cracks, to severe crushing and spalling. In addition, gel exudation and precipitation are present along the surface near larger cracks. The joints have completely closed, and in several places the crushing has caused large pieces of concrete to separate from the wall. The multiple longitudinal cracks are up to 6 mm wide at the surface [Fig. 2.2-2 (d)].

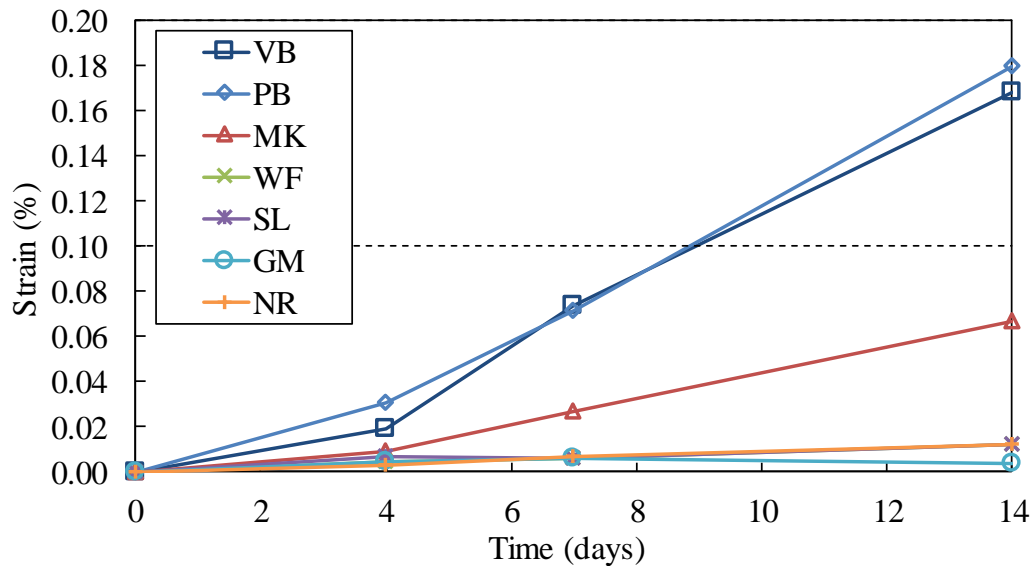
**Fig. 2.3-1**—ASTM C1260 (AMBT) results.

Additional fine aggregate from an Arkansas River source in MK was evaluated. However, this aggregate developed a 14-day expansion of 0.07%, and was classified as inert (**Fig. 2.3-1**). No instances of ASR have been reported in concrete containing aggregate from this aggregate source.

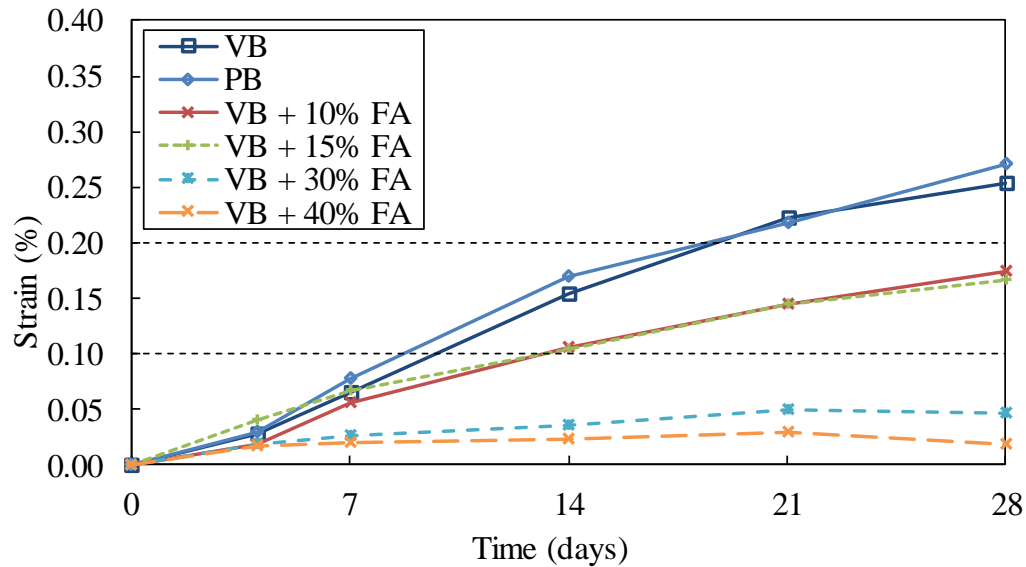
Fig. 2.3-2–ASTM C1567 (AMBT) results.

(Fig. 2.3-2). For the prevention of ASR, recommended replacement rates for Class C fly ash are between 40 and 50% (ACI, 1998; Shehata and Thomas, 2000). This range is often necessary for highly reactive aggregates. However, the rate of replacement is conservative for slowly reactive aggregates such as VB sand. As indicated in Fig. 2.3-2, a replacement rate of 30% is adequate, and the sample passes the ASTM C1567 test with a 28-day expansion of 0.05%.

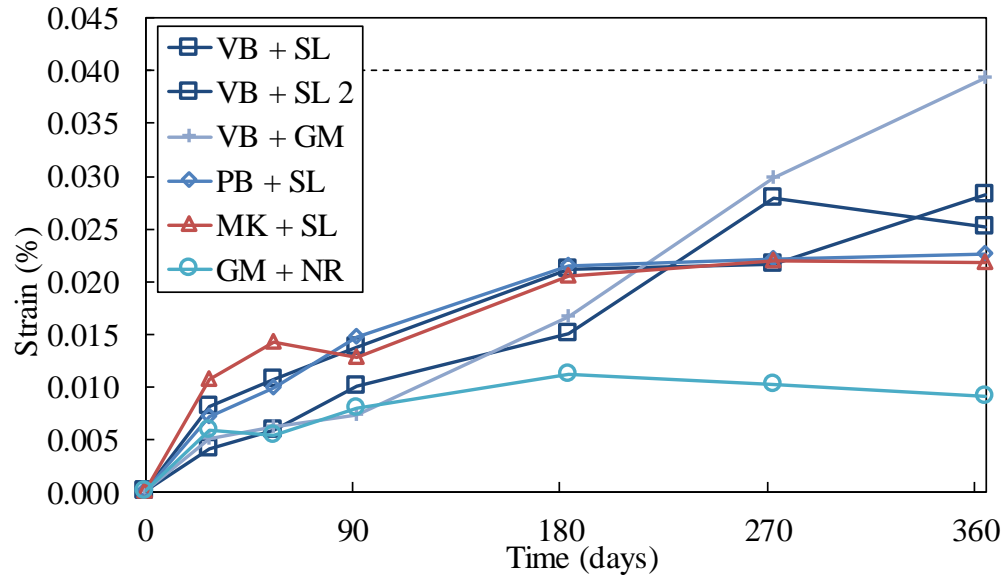
**Fig. 2.3-3**—ASTM C1293 (CPT) results.

The VB aggregate was evaluated following ASTM C1293 (CPT). The prisms, containing VB fine aggregate and the nonreactive SL, developed a one-year average expansion of 0.03%. The CPT is used to evaluate either a potentially reactive fine or coarse aggregate, and a nonreactive companion aggregate is required to produce a concrete mixture. Prisms containing river sand from PB and SL had a one-year expansion of 0.02%. Both sands were classified as inert, per ASTM C1293 (Fig. 2.3-3). However, this classification is in contradiction with the petrographic analysis and AMBT results and is discussed in the synthesis of results.

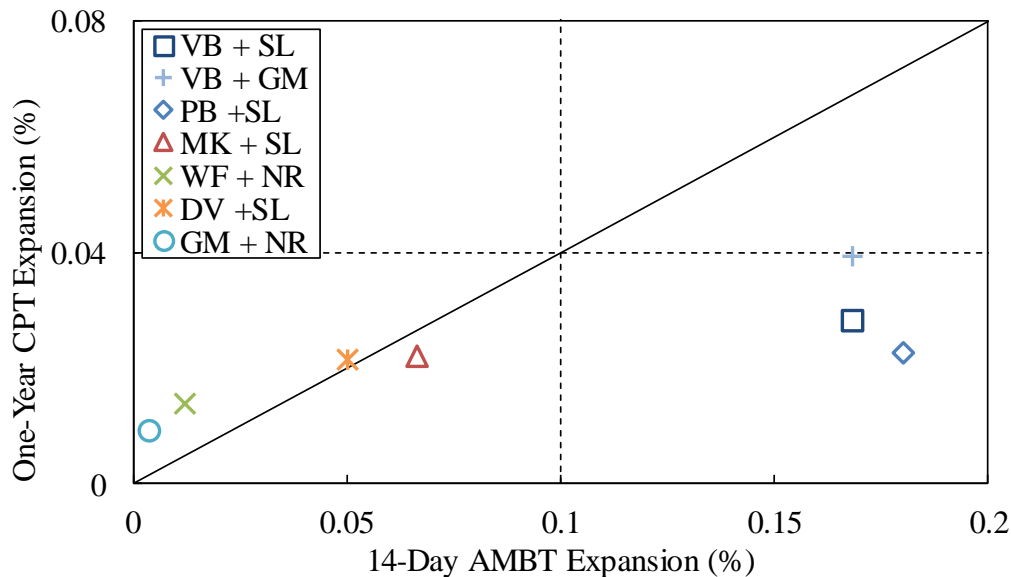
**Fig. 2.3-4**—Comparison of 14-day AMBT and one-year CPT results.

A comparison between the AMBT and CPT results is provided in **Fig. 2.3-4**, similarly to the manner presented in Fournier and Bérubé (2000). The six aggregates evaluated showed a majority of the local aggregates to be inert in both test methods. The VB and PB fine aggregates are potentially deleteriously reactive as indicated by ASTM C1260 results and petrographic analysis results for core samples from the wall containing the aggregate from the Arkansas River VB source. The VB and PB fine aggregates fall into the false negative category for the one-year CPT results, because they do not react deleteriously in CPT tests, while reacting deleteriously in AMBT tests.

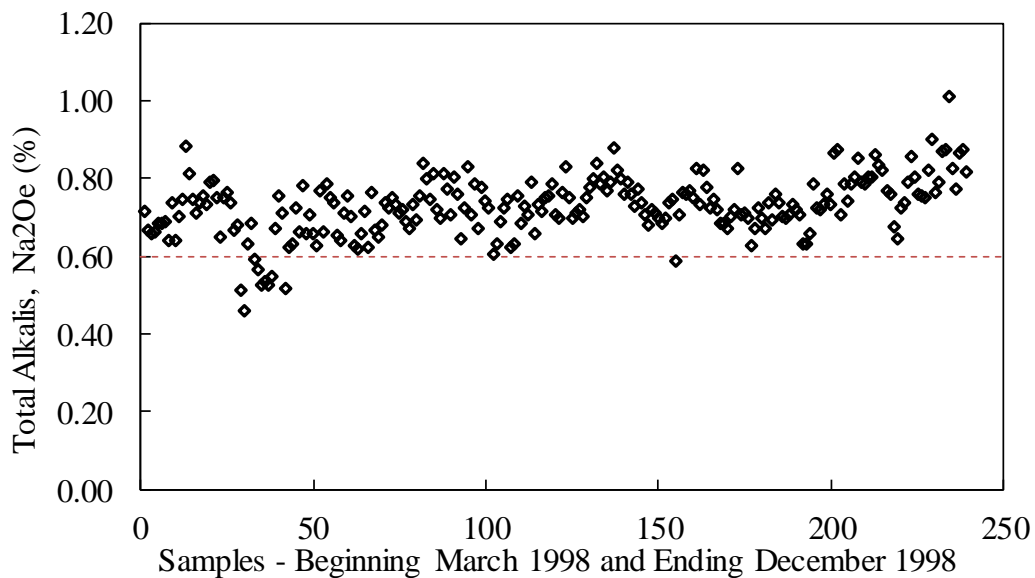
**Fig. 2.3-5**—Portland cement alkali content with respect to time.

The cement alkalis varied throughout the duration of construction of the wall. The cement was manufactured between 1997 and 1998. The average cement alkali content was 0.73%  $\text{Na}_2\text{O}_{\text{eq}}$ . However, the alkali content changed by as much as 0.19% from one day to the next. This variability was due to the manufacturing process and material properties of the limestone in use at the time. This variation partly explains the erratic damage level between sections of the wall. The high alkali content caused the development of ASR in concrete containing the slowly reactive Arkansas River sand. Conversely, when the alkali content dropped below a safe level, no alkali-silica reaction developed. Data from the cement manufacturer reveal the considerable variation in cement alkalis from day to day (Fig. 2.3-5).

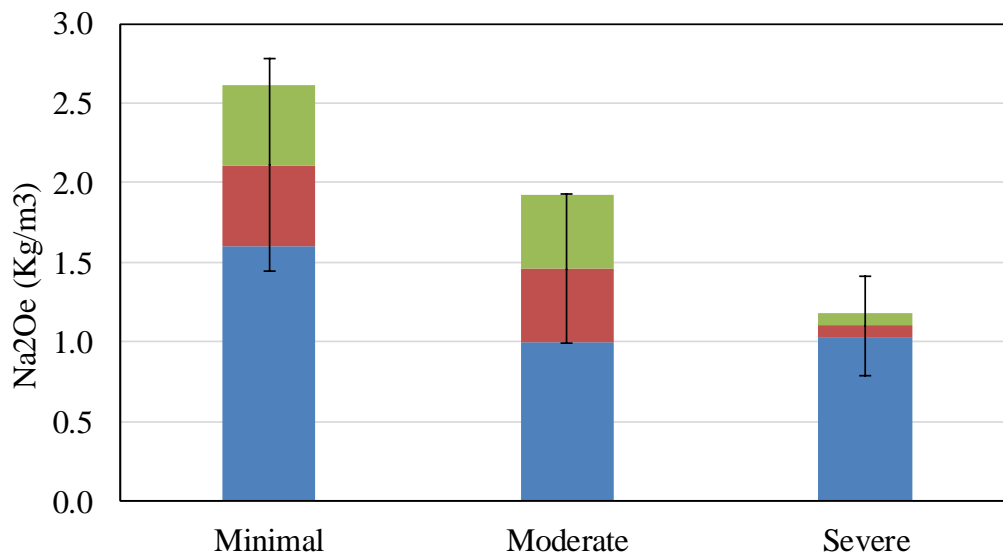
**Fig. 2.3-6**—Concrete barrier wall alkali content for wall sections of minimal, moderate, and severe deterioration.

six tests were used in determining the average soluble alkali content at each damage level. The bar graph shows the lowest result, the average, and the highest result, along with error bars indicating the standard deviation of the results. The average soluble alkali contents were 2.11, 1.46, and 1.10 kg/m<sup>3</sup> for the minimal, moderate, and severe damage sections, respectively. The soluble alkali content consisted only of alkalis that have not been leached out of the concrete or adsorbed into insoluble reaction products. Therefore, the alkali content at the time of construction was likely greater, for all damage classification, than measured using alkali extraction, and greater than the suggested limit of 3 kg/m<sup>3</sup> (ACI 1998; Fournier and Bérubé 2000). The concentration decreases as the damage level increases. It is hypothesized that this occurs due to alkalis adsorbed into insoluble reaction products, and additional alkalis leached from the severely damaged concrete. It is impossible to know the original alkali content in the severely and moderately damaged sections as compared to the minimally damaged sections. However, an increase in alkalinity increases the likelihood of siliceous minerals dissolving and forming ASR.

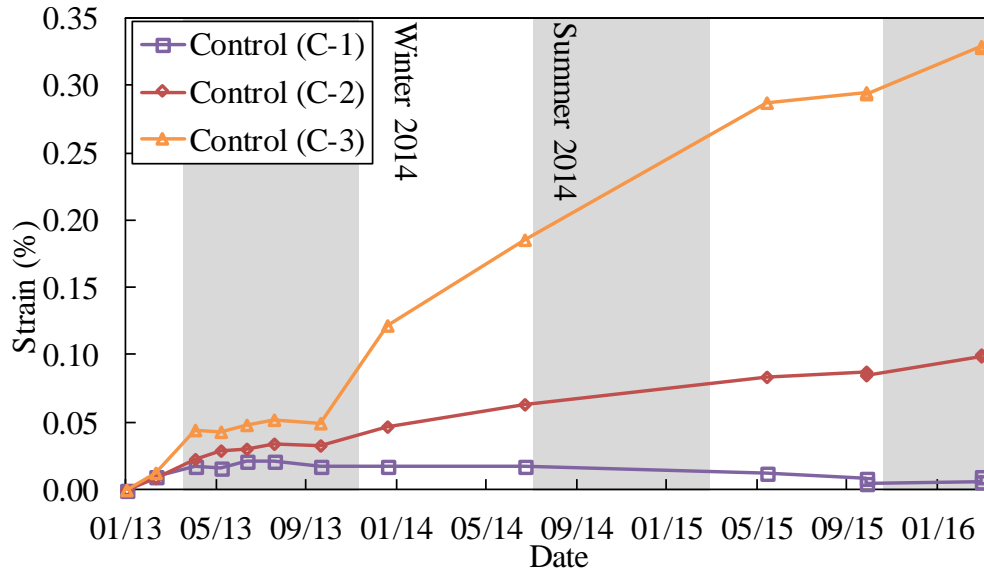
**Fig. 2.3-7**–Barrier wall normalized vertical strain.

The section with minimal damage has, on average, not expanded or contracted over two years, whereas the sections of moderate and severe damage are expanding 0.04 and 0.11% per year, respectively. Ideker et al. (2012) reported that unrestrained concrete would develop visible cracking when expansion exceeded 0.04%. Therefore, the sections of moderate and severe damage expand enough in a single year to produce visible cracks in the concrete.

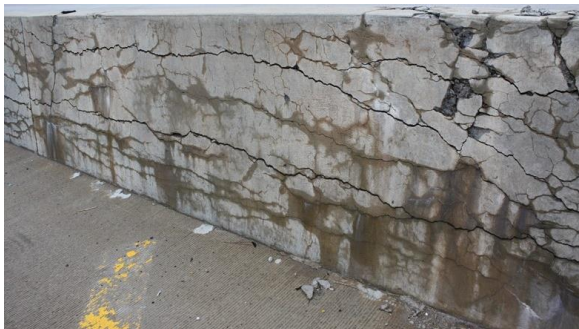
**Fig. 3.3-1**—Typical barrier section with severe damage (by Richard Deschenes Jr.).

Premature deterioration was noted in several sections of interstate median barrier in Northwest Arkansas during a 2012 inspection. A sample of concrete was sent for petrographic analysis and the presence of ASR and freezing and thawing damage was noted. The degree of damage varied considerably throughout the 4.4 mile (7.1 km) length of median barrier. Approximately 2.3 miles (3.7 km) of the median barrier showed minimal visible damage, 1.4 miles (2.3 km) had moderate damage, and 0.7 miles (1.1 km) showed severe damage (**Fig. 3.3-1**). An experimental program was initiated in January 2013 to evaluate methods for mitigating the ASR. Several surface treatments were evaluated to slow the progress of ASR and freezing and thawing, for sections of minimal, moderate, or severe damage.

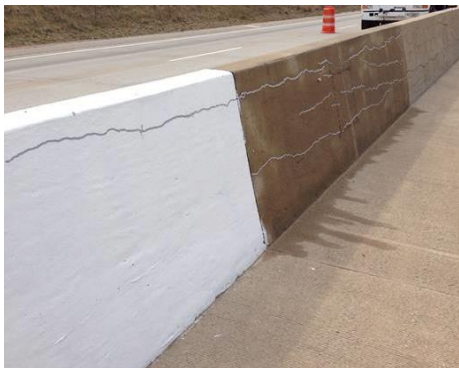
**Fig. 3.3-2**—Barrier sections treated with elastomeric paint (left) and silane (right) (by Richard Deschenes Jr.).

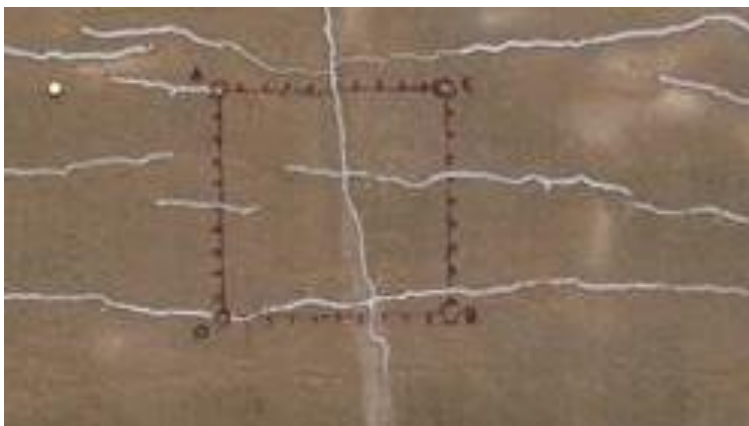
**Fig. 3.3-3**—Typical strain measurement grid on barrier section after treatment with silane (by Richard Deschenes Jr.).

A port was drilled alongside the strain measurement grid (**Fig. 3.3-3**) for inserting a portable humidity probe. The port was drilled to a depth of 6 in. (150 mm) with an inside diameter of 33/64 in. (13.1 mm). A 2 in. (50 mm) long, 1/2 in. (12.7 mm) nominal-diameter polyvinyl chloride (PVC) pipe was epoxied into this hole to allow the humidity probe to fit securely. The port was closed off between measurements using an airtight cap. Portable humidity probes were used for internal-RH and temperature measurements.

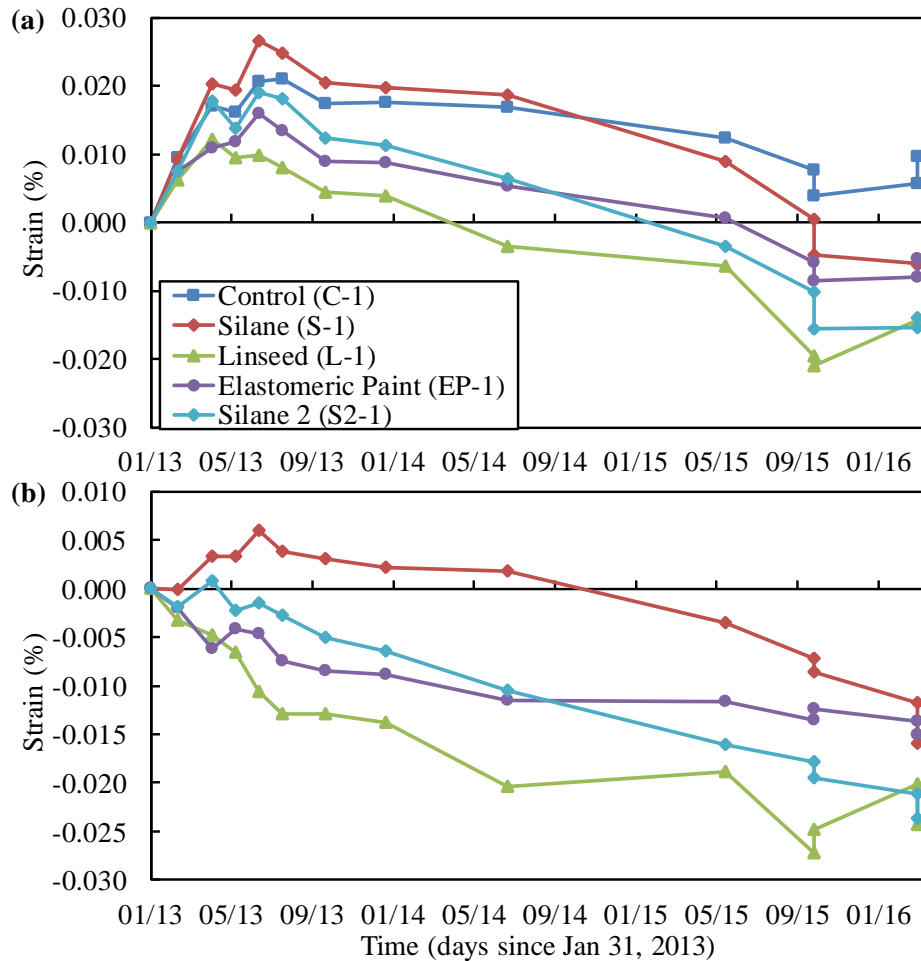
**Fig. 3.5-1**—Temperature-normalized vertical strain (%) with respect to: (a) time (date); and (b) differential strain for sections of minimal damage.

The differential strain for sections of minimal damage is provided in **Fig. 3.5-1 (b)**, which again has strain (%) on the ordinate and time (date) on the abscissa. The sections treated with boiled linseed oil, elastomeric paint, and the second section treated with silane fared better than the untreated control. The section treated with linseed oil (L-1) had a final strain 0.021% lower than the control section, which suggests that there was a beneficial reduction in expansion as compared to the control. The section treated with elastomeric paint (EP-1) and the second section treated with silane (S2-1) had 0.012 and 0.021% less strain than the control, respectively. In the second year after treatment, the section treated with silane (S-1) began to contract faster than the control section and had 0.012% less expansion than the untreated control section at the end of monitoring. The single application of silane took longer to slow the rate of expansion than the section treated with two applications; however, silane provided a beneficial reduction in expansion in both silane treated sections.

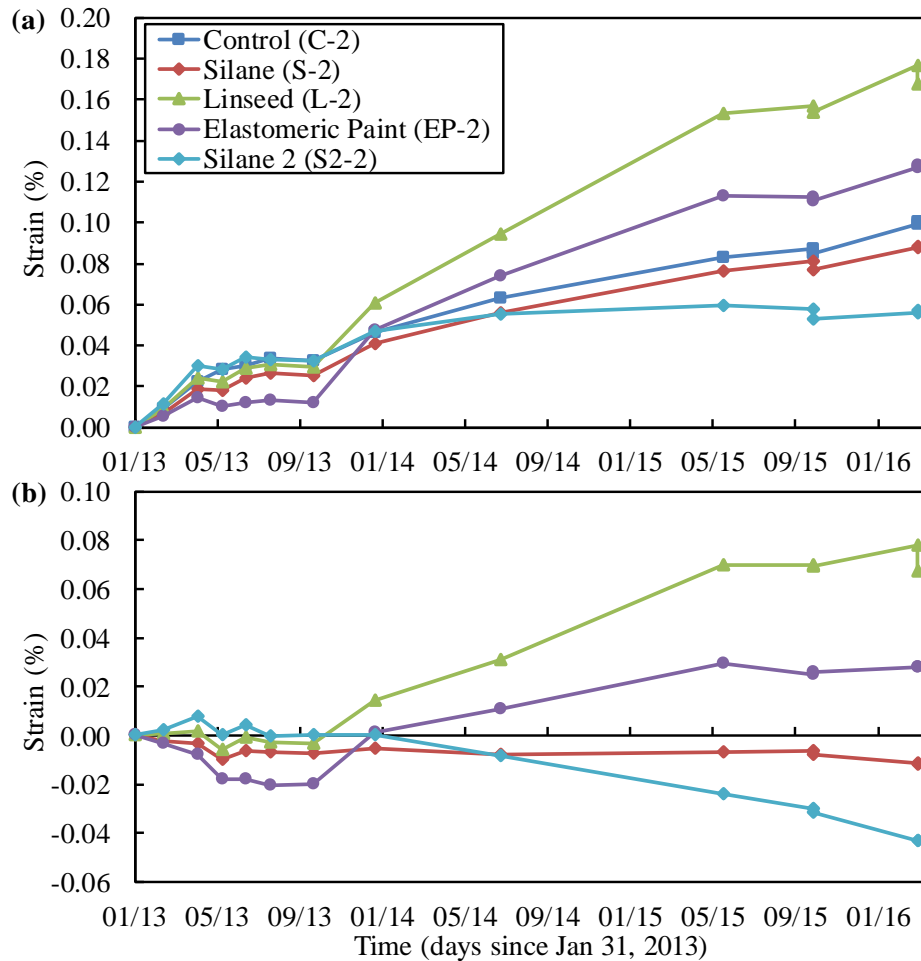
**Fig. 3.5-2**—Temperature-normalized vertical strain (%) with respect to: (a) time (date); and (b) differential strain for sections of moderate damage.

The section treated with elastomeric paint (EP-2) had a reduced rate of expansion during the first summer with expansion below that of the control (C-2). However, the expansion rate rapidly increased during the winter and was greater than the control section. The sections treated with silane (S-2 and S2-2) exhibited a reduction in expansion, which continued throughout the monitoring period. The silane-treated sections S-2 and S2-2 had final expansions of 0.087% and 0.056%, respectively. The sections had expansion 0.011% and 0.043% less than that of the control section, respectively (**Fig. 3.5-2(b)**). However, the sections treated with boiled linseed oil (L-2) or elastomeric paint (EP-2) did not exhibit any reduction in expansion, and fared worse than the control during the winter months. Both sections had a final expansion greater than that of the control section. This result is counterintuitive and may be due to the reduced mobility of moisture both into and out of the concrete caused by the surface treatment. Water could not escape from the concrete during freezing, leading to increased damage during freezing and thawing.

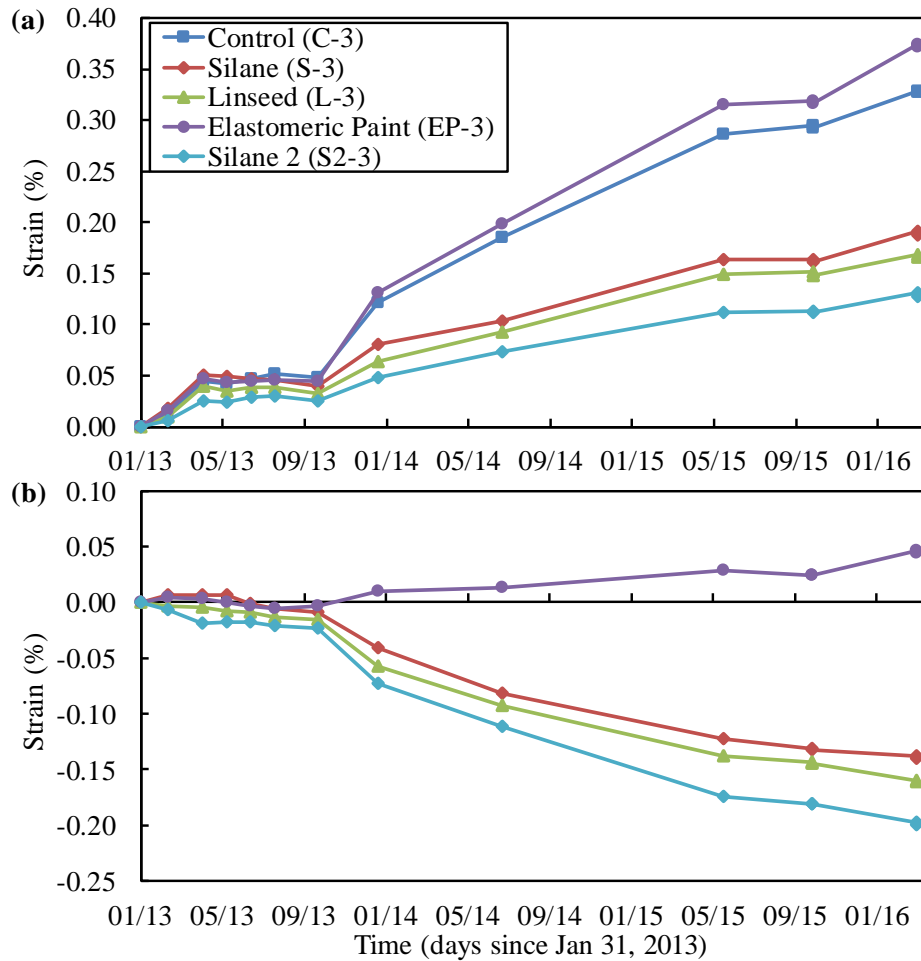
**Fig. 3.5-3**—Temperature-normalized vertical strain (%) with respect to: (a) time (date); and (b) differential strain for sections of severe damage.

Except for the section treated with two applications of silane (S2-3), all the sections of severe damage had similar expansion throughout the first 9 months. However, during the winter months, the control section (C-3) and elastomeric paint treated section (EP-3) experienced a severe increase in expansion. Meanwhile, the sections treated with silane (S-3 and S2-3) and linseed oil (L-3) exhibited less expansion. The differential strains at 3 years for the silane-treated sections (S2-3) and (S-3) were 0.20% and 0.14%, respectively, and 0.16% in the section treated with linseed oil (L-3). Although these strains are considerably lower than that of the control section, the rate of expansion is still sufficient to cause failure in only a few years.

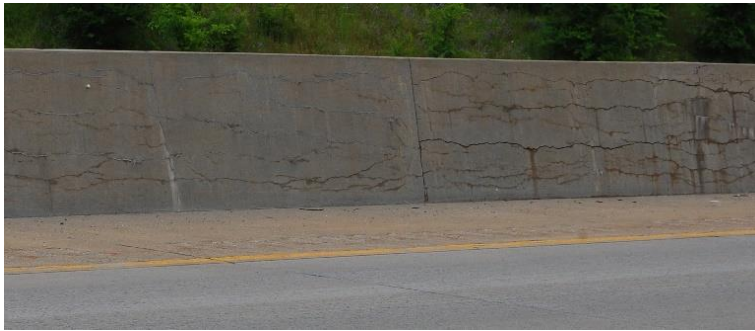
**Fig. 3.5-4**—Silane-treated section (left) as compared to untreated section (right) (by Richard Deschenes Jr.).

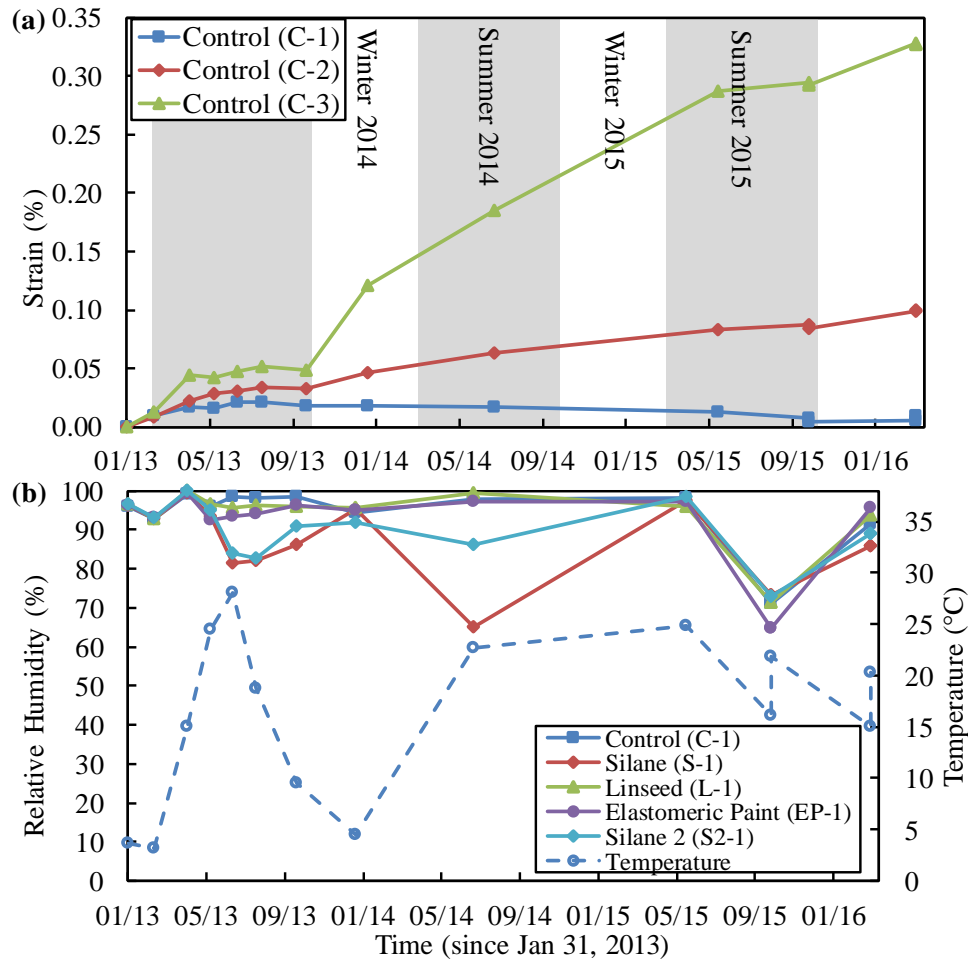
**Fig. 3.5-5**–Temperature-normalized vertical strain (%) with respect to: (a) time (date) for control sections with seasons highlighted; and (b) internal relative humidity (%) with respect to time (date) for sections of minimal damage.

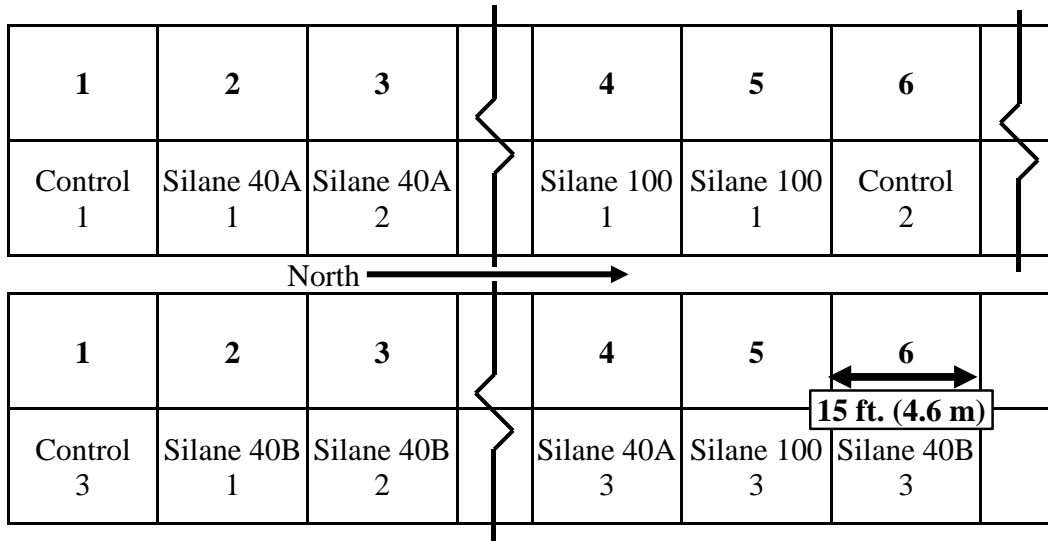
**Fig. 4.3-1** –Diagram of Interstate 49 test sections. Three commercially available silanes were applied to the indicated test panels, and three sections remained untreated as control samples.

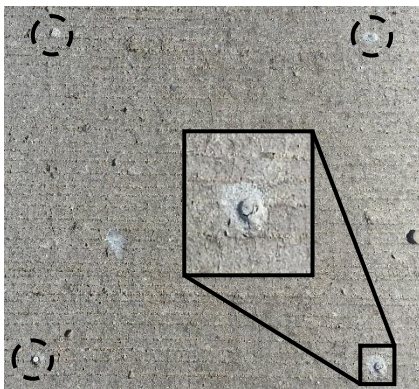
**Fig. 4.3-2**–Panel with pins for strain measurements (by Richard Deschenes Jr.).

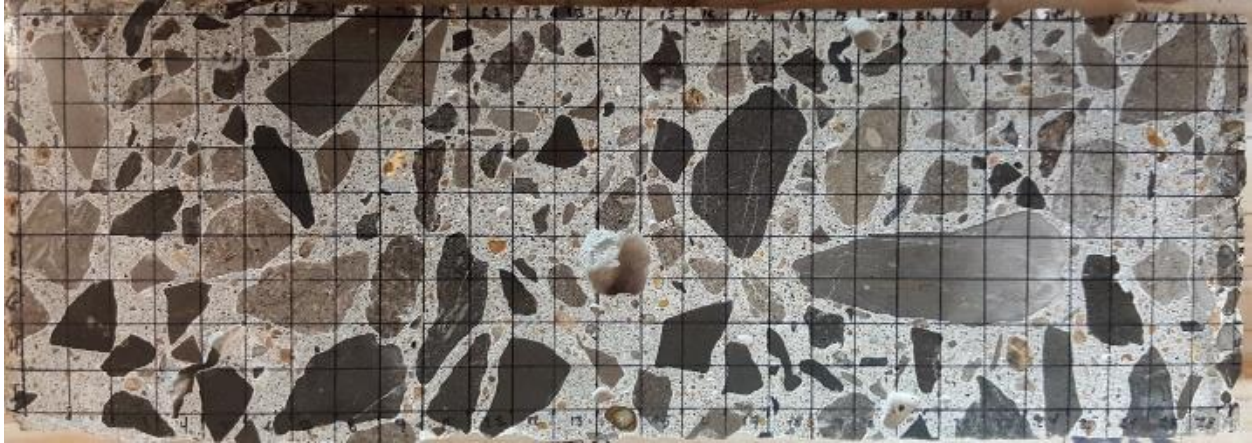
**Fig. 4.3-3**—Typical DRI sample with reference grid (by Richard Deschenes Jr.).

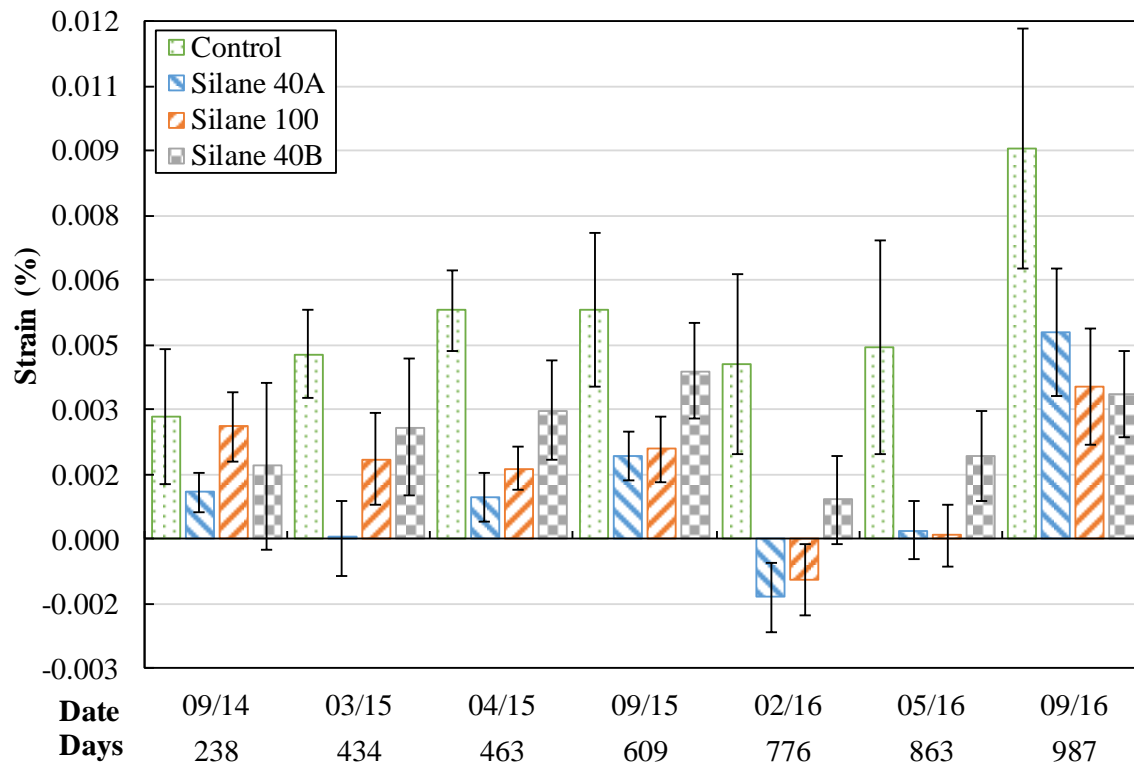
**Fig. 4.5-1**—Temperature-corrected strain (%) measured in the travel direction for control and silane-treated pavement panels. Error bars represent the 90% confidence of the mean.

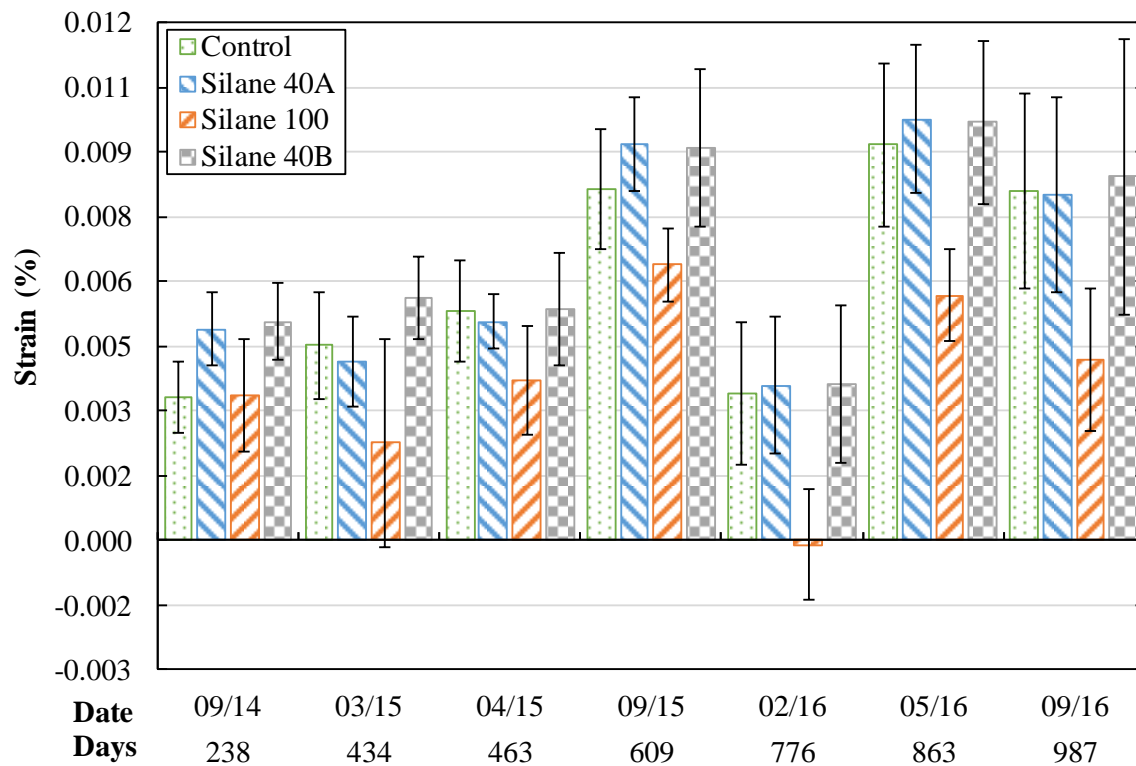
**Fig. 4.5-2**—Temperature-corrected strain (%) measured in the transverse direction for control and silane-treated pavement panels. Error bars represent the 90% confidence of the mean.

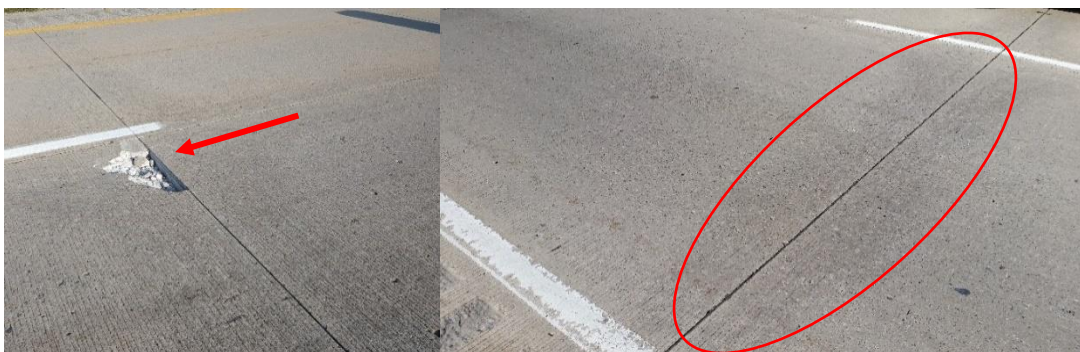
**Fig. 4.5-3**–Joint spalling (left) and discoloration (right) (by Richard A. Deschenes).

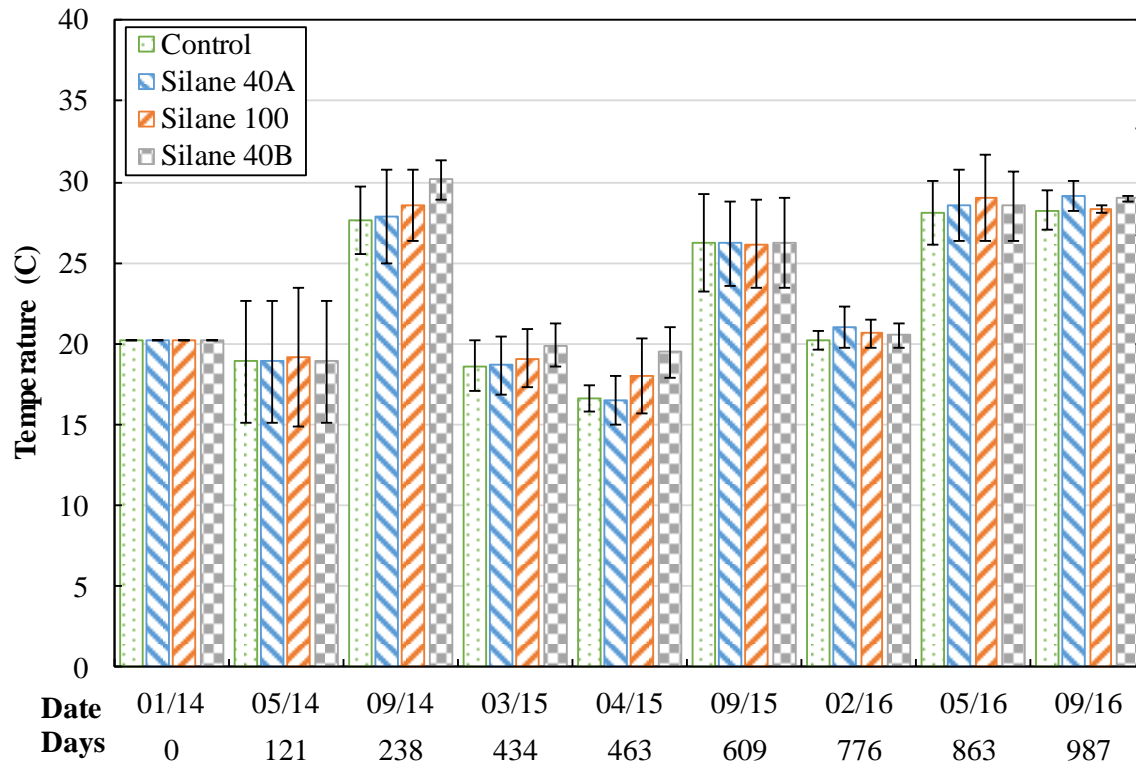
**Fig. 4.5-4**—Temperature (°C) with respect to date, error bars indicate 90% confidence of the mean, Interstate 49.

The error bars indicate the difference in temperature between the tested panels, which was within  $\pm 3.0$  °C.

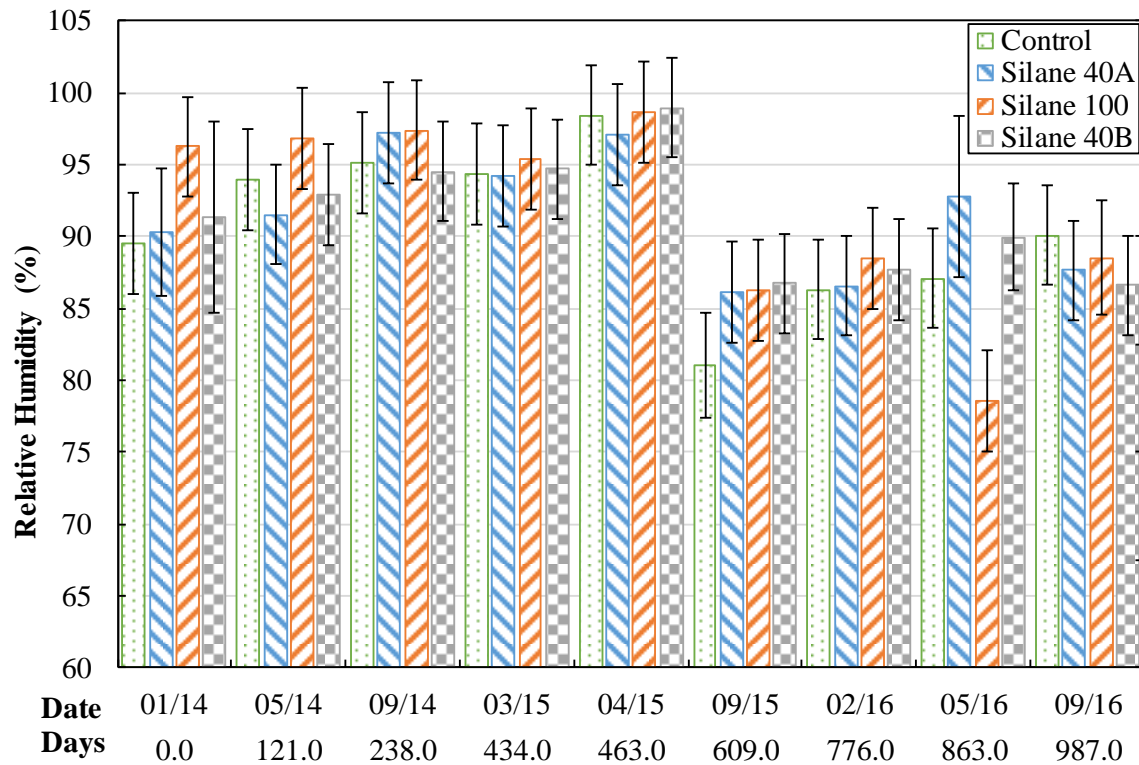
**Fig. 4.5-5**– Internal-RH (%) with respect to time, error bars indicate 90% confidence of the mean, Interstate 49.

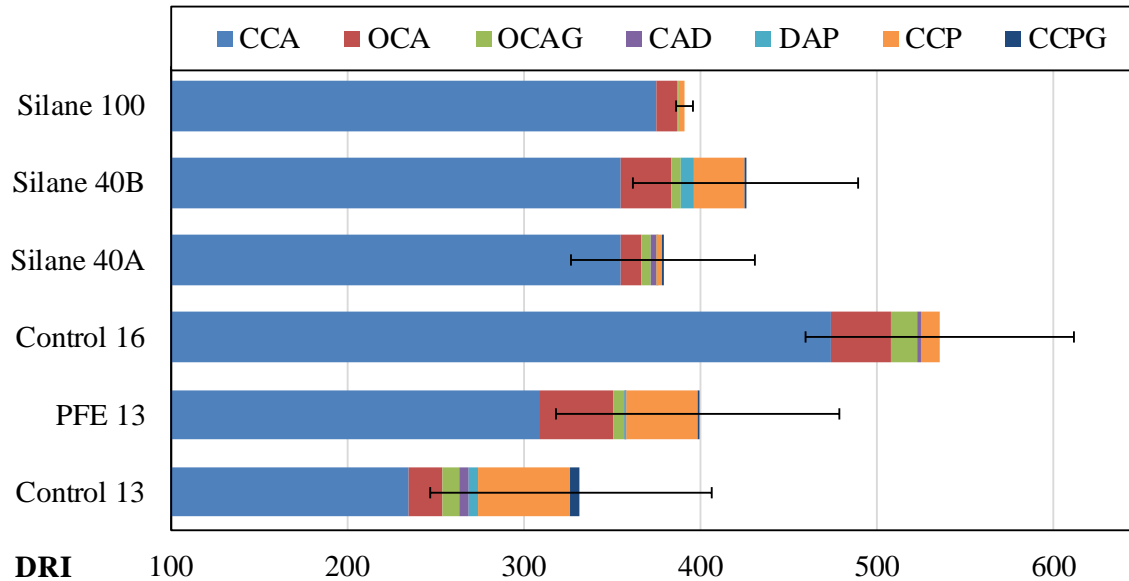
**Fig. 4.5-6**–DRI for core samples taken from pavement panels, error bars represent standard deviation, Interstate 49.

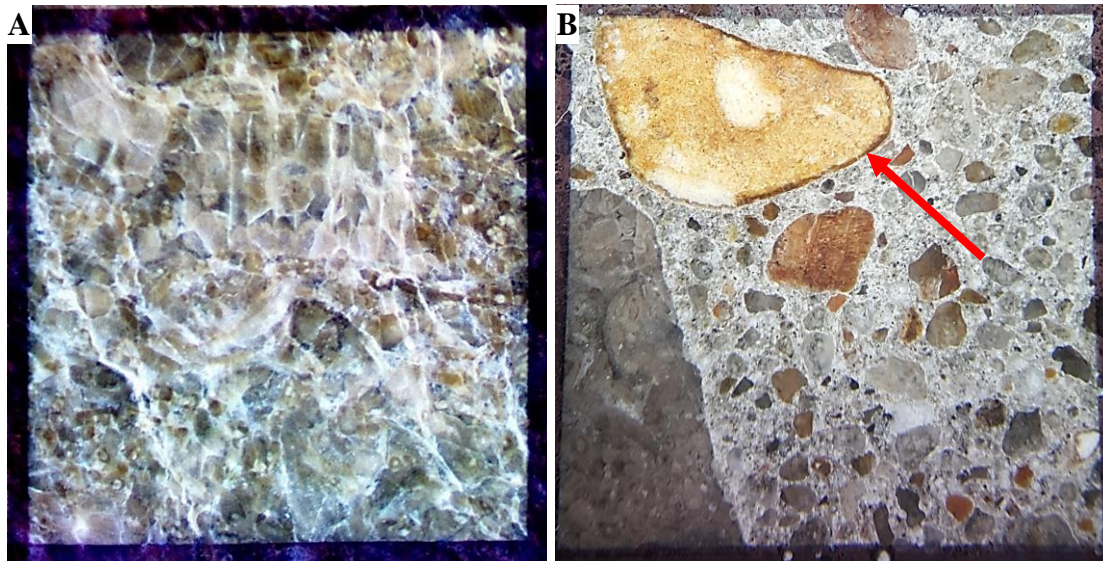
**Fig. 4.5-7**–Photomicrograph of coarse-aggregate particle with microcracking (A) and corroded aggregate particles, indicated by red arrow (B). Field of view is 10.0 mm x 10.0 mm (15X magnification) (by Richard Deschenes Jr.).

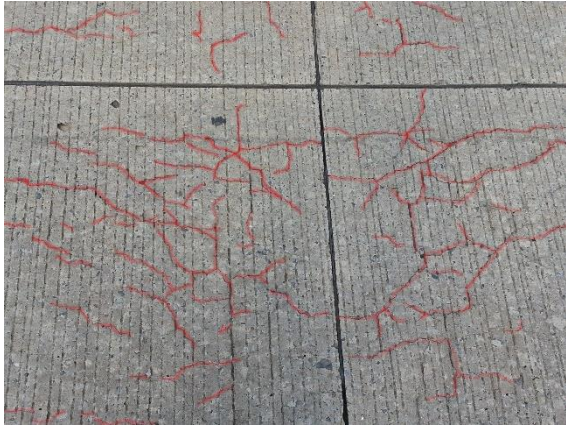
**Fig. 5.1-1-D-Cracking in concrete pavement, Interstate 49 (by Richard Deschenes Jr.).**
