# Mitigation and Evaluation of Alkali-Silica Reaction (ASR) and Freezing and Thawing in Concrete Transportation Structures

A dissertation submitted in partial fulfillment  
of the requirements for the degree of  
Doctor of Philosophy in Engineering  
with a Concentration in Civil Engineering

August 2017  
University of Arkansas

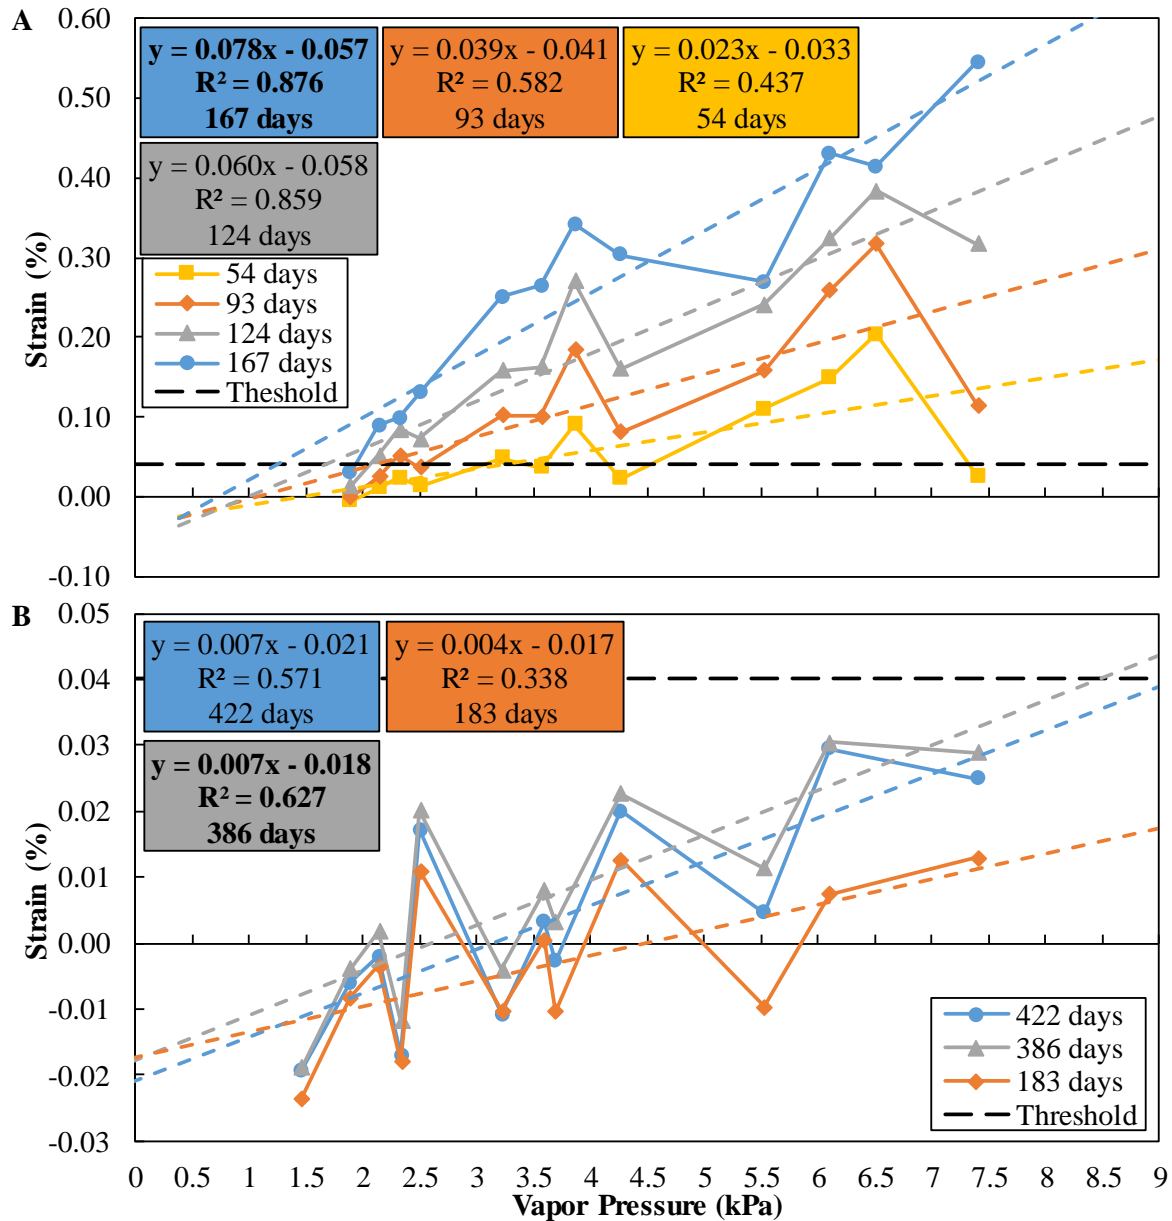
**Fig. 5.4-2**–Strain (%) with respect to VP (kPa), highly-reactive aggregate (A) and moderately-reactive aggregate (B).

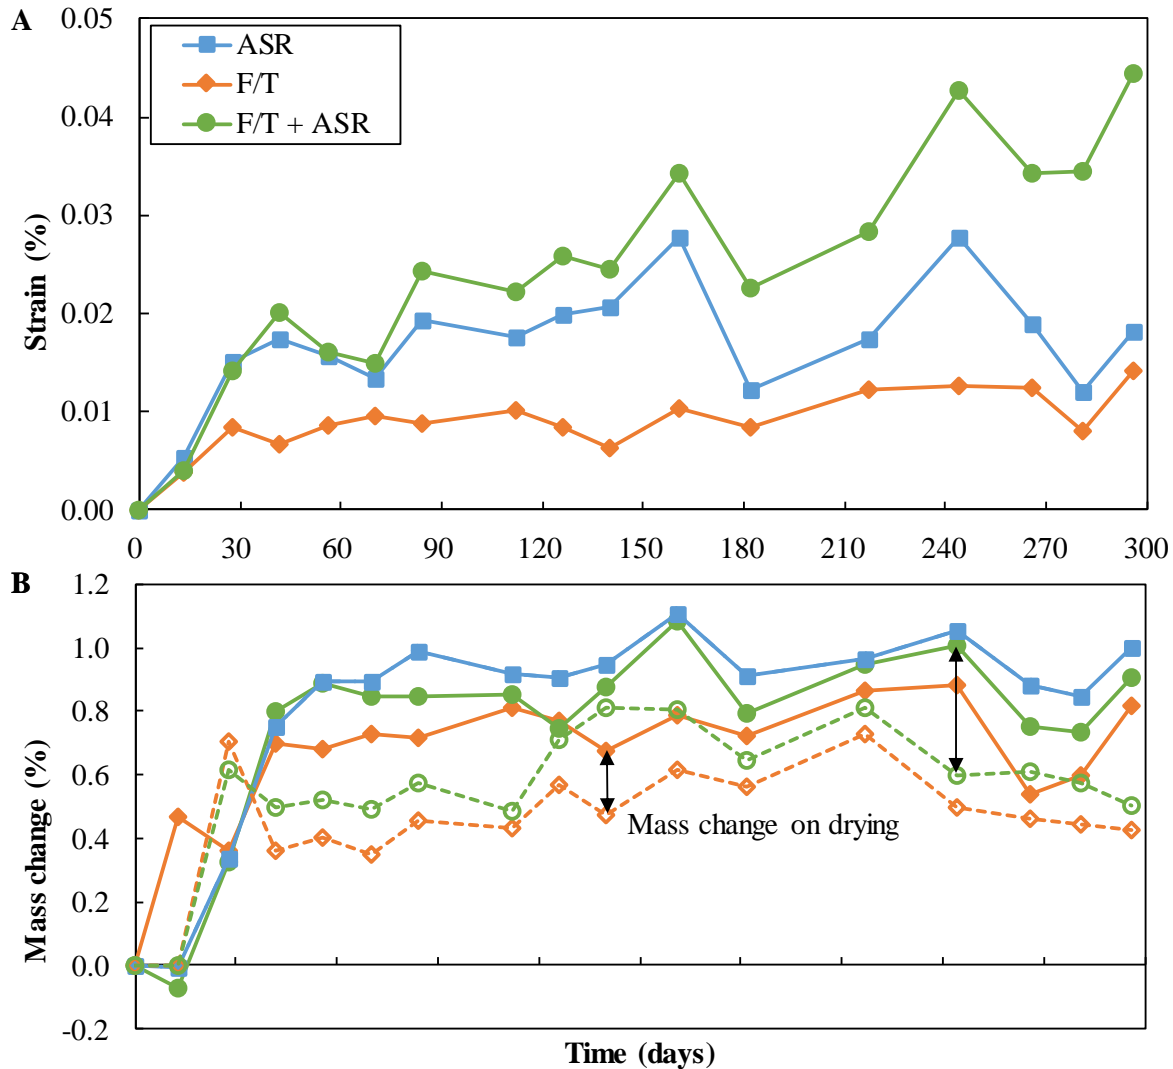
**Fig. 5.4-3**– Strain (%) (A) and mass change (B) with respect to time (days), concrete prisms exposed to conditions which promote ASR, F/T, or ASR and F/T.

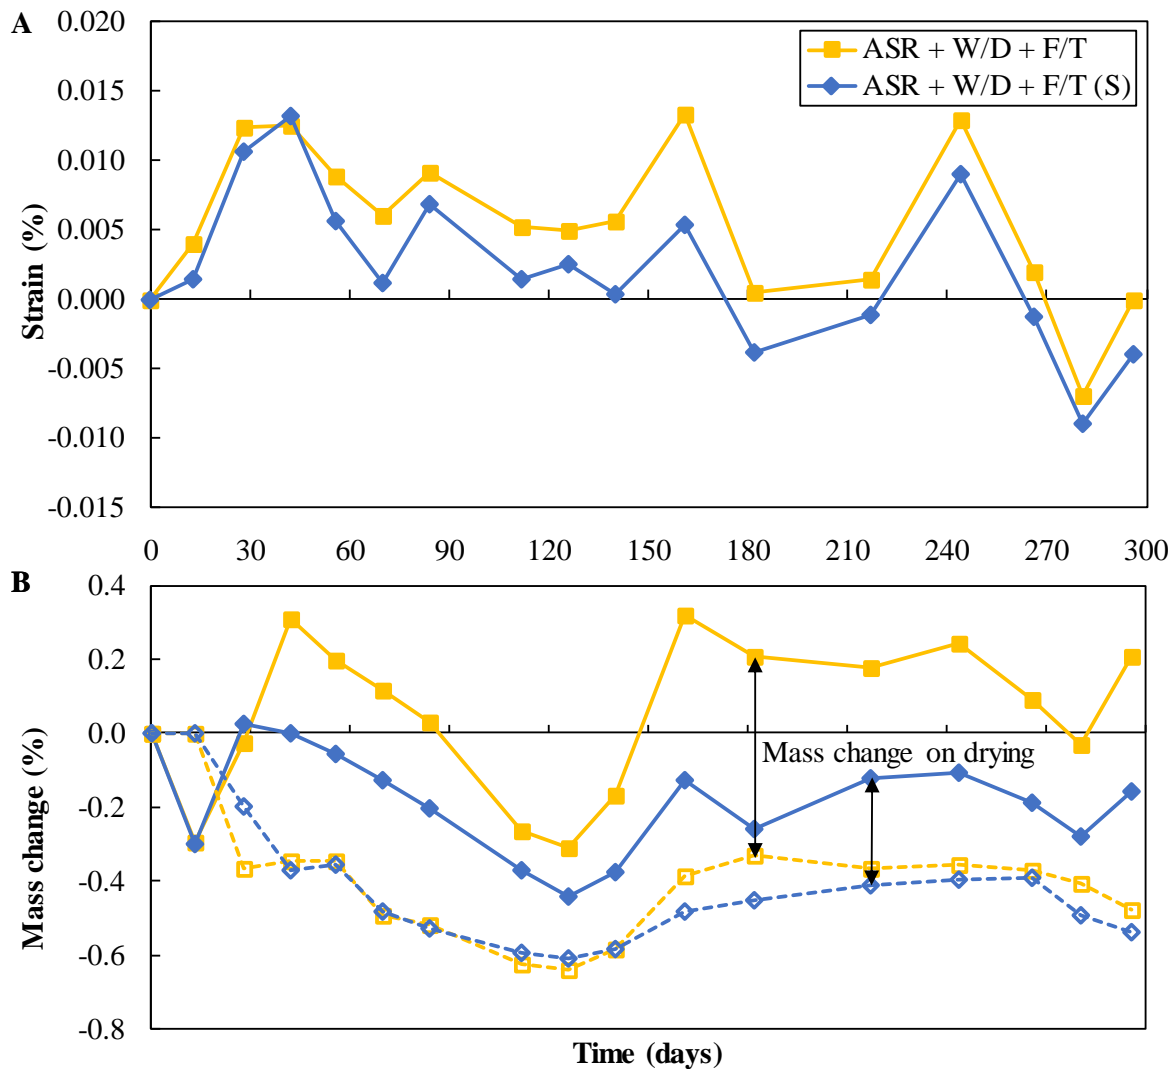
**Fig. 5.4-4**— Strain (%) (A) and mass change (B) with respect to time (days), concrete prisms exposed to conditions which promote a combination of ASR and F/T.

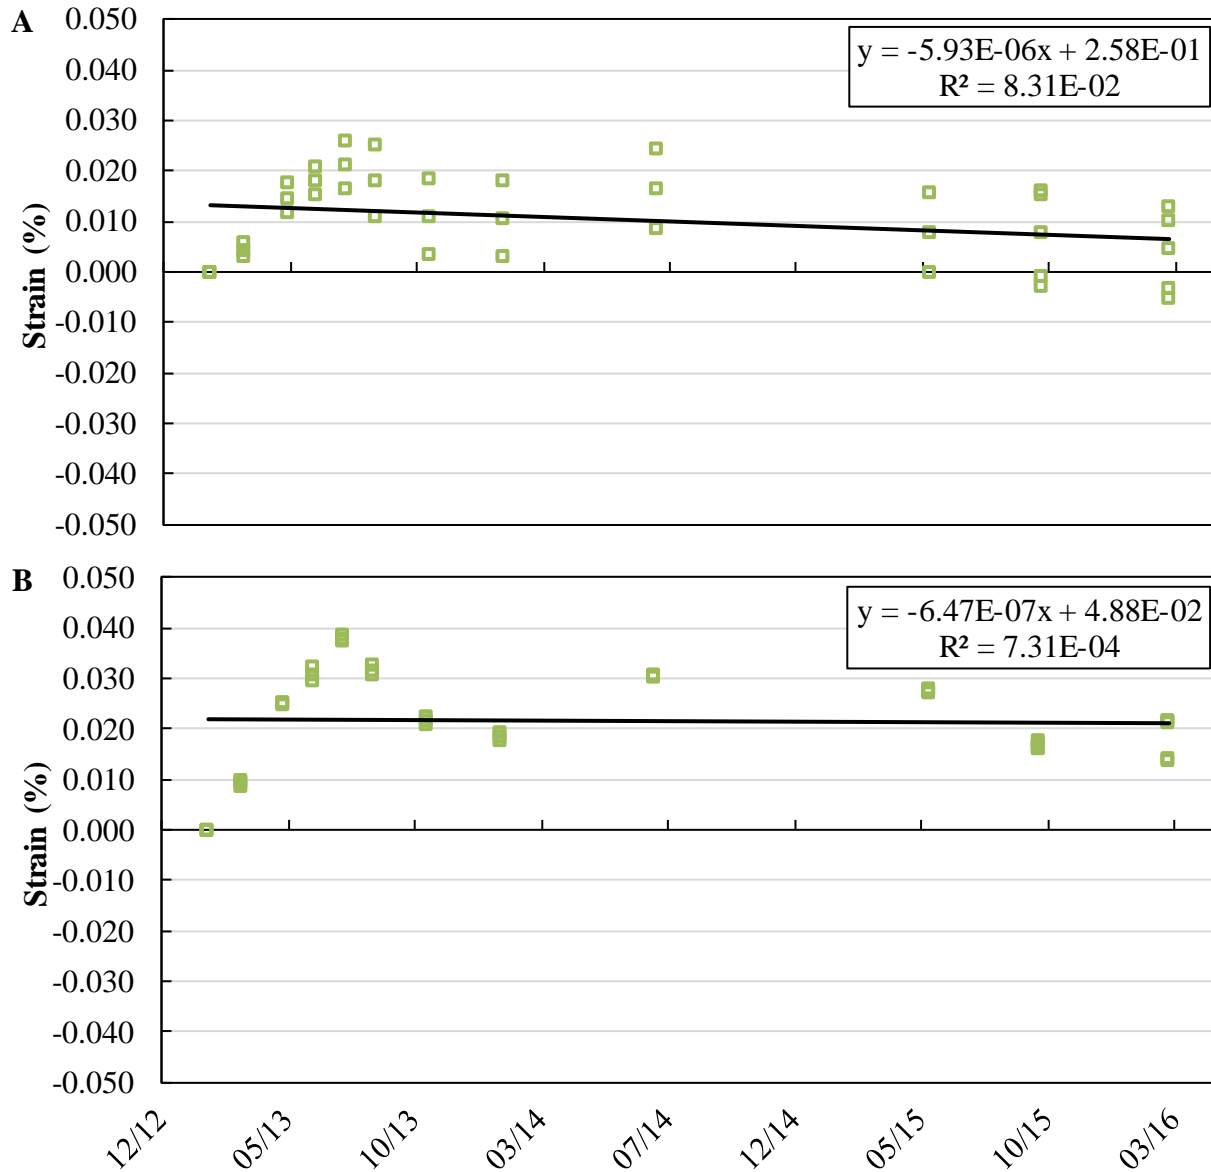
**Fig. 8.1-1**–Horizontal (A) and vertical (B) strain (%) with respect to date, Interstate 49 barrier wall exhibiting minimal deterioration, control section (C-1).

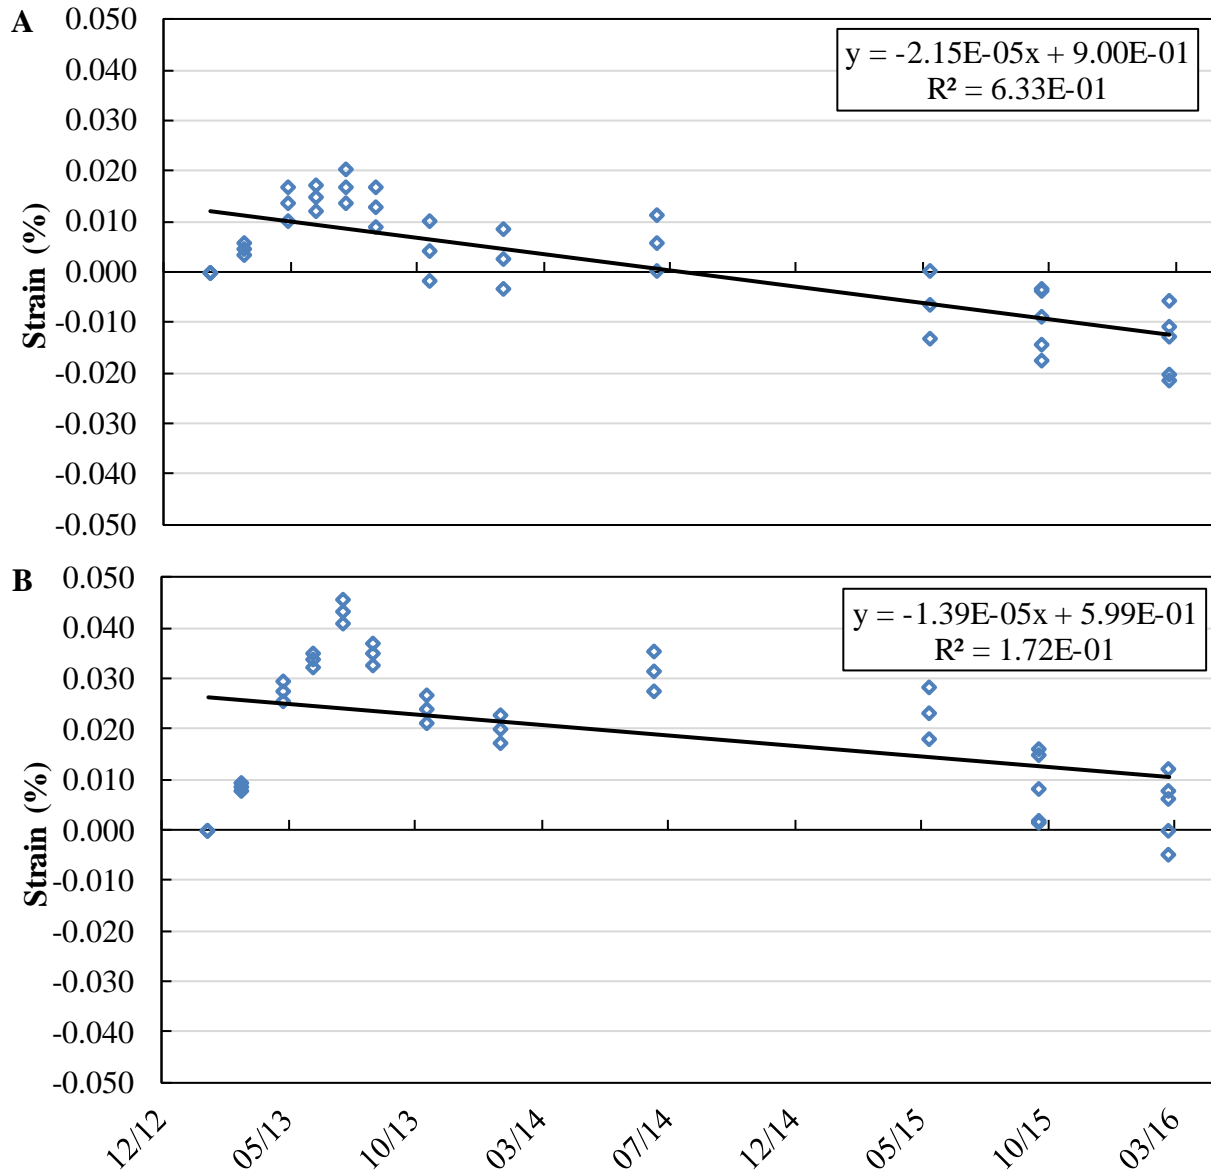
**Fig. 8.1-2**–Horizontal (A) and vertical (B) strain (%) with respect to date, Interstate 49 barrier wall exhibiting minimal deterioration, silane section (S-1).

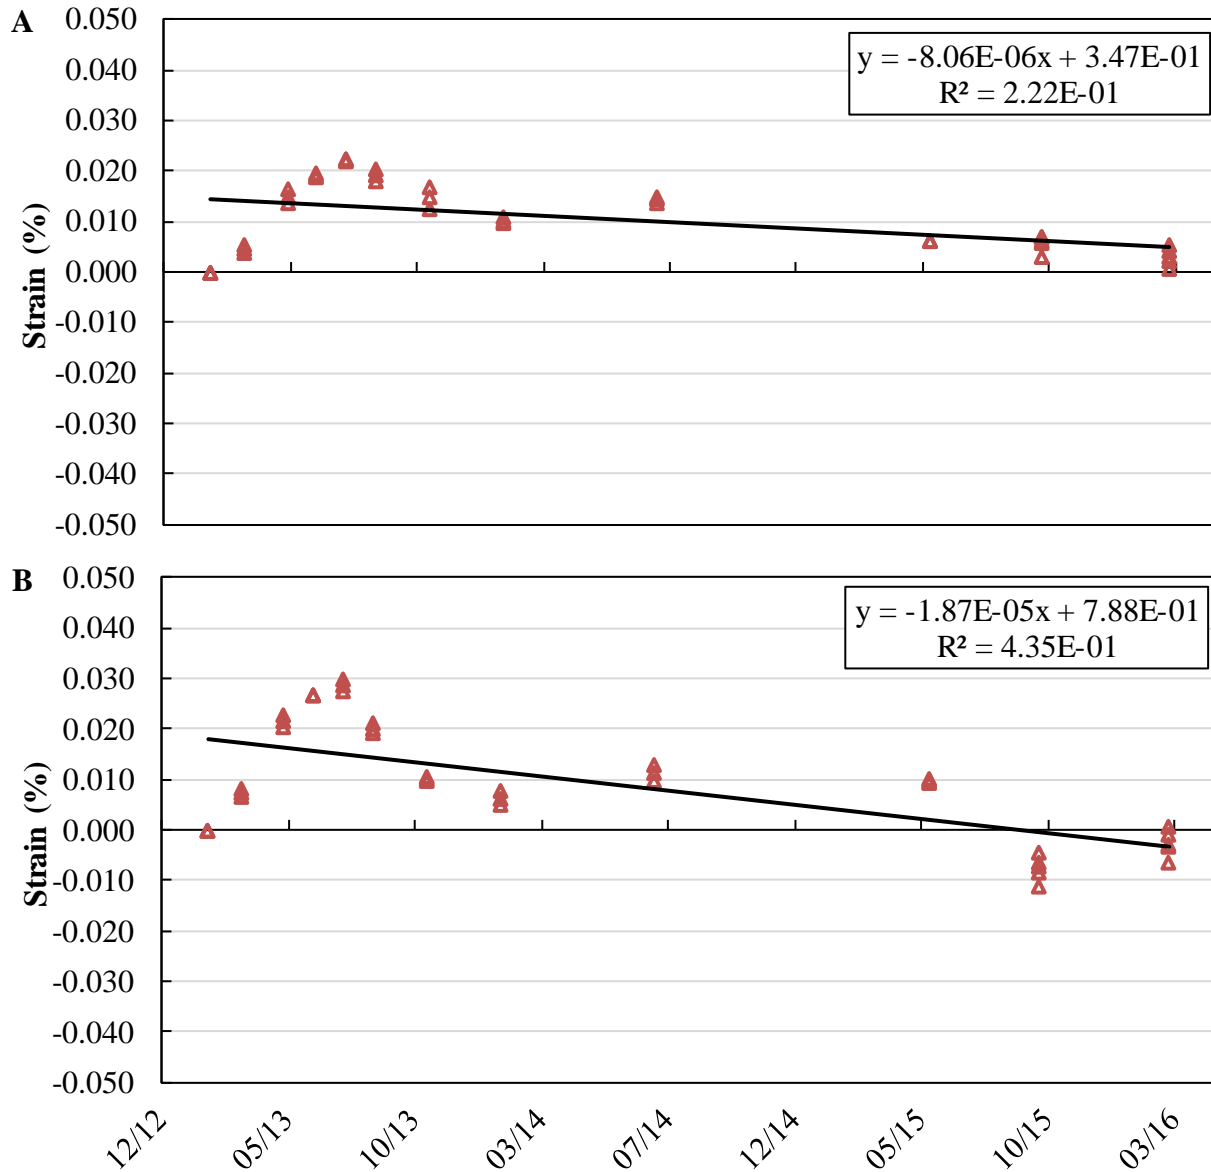
**Fig. 8.1-3**—Horizontal (A) and vertical (B) strain (%) with respect to date, Interstate 49 barrier wall exhibiting minimal deterioration, linseed section (L-1).

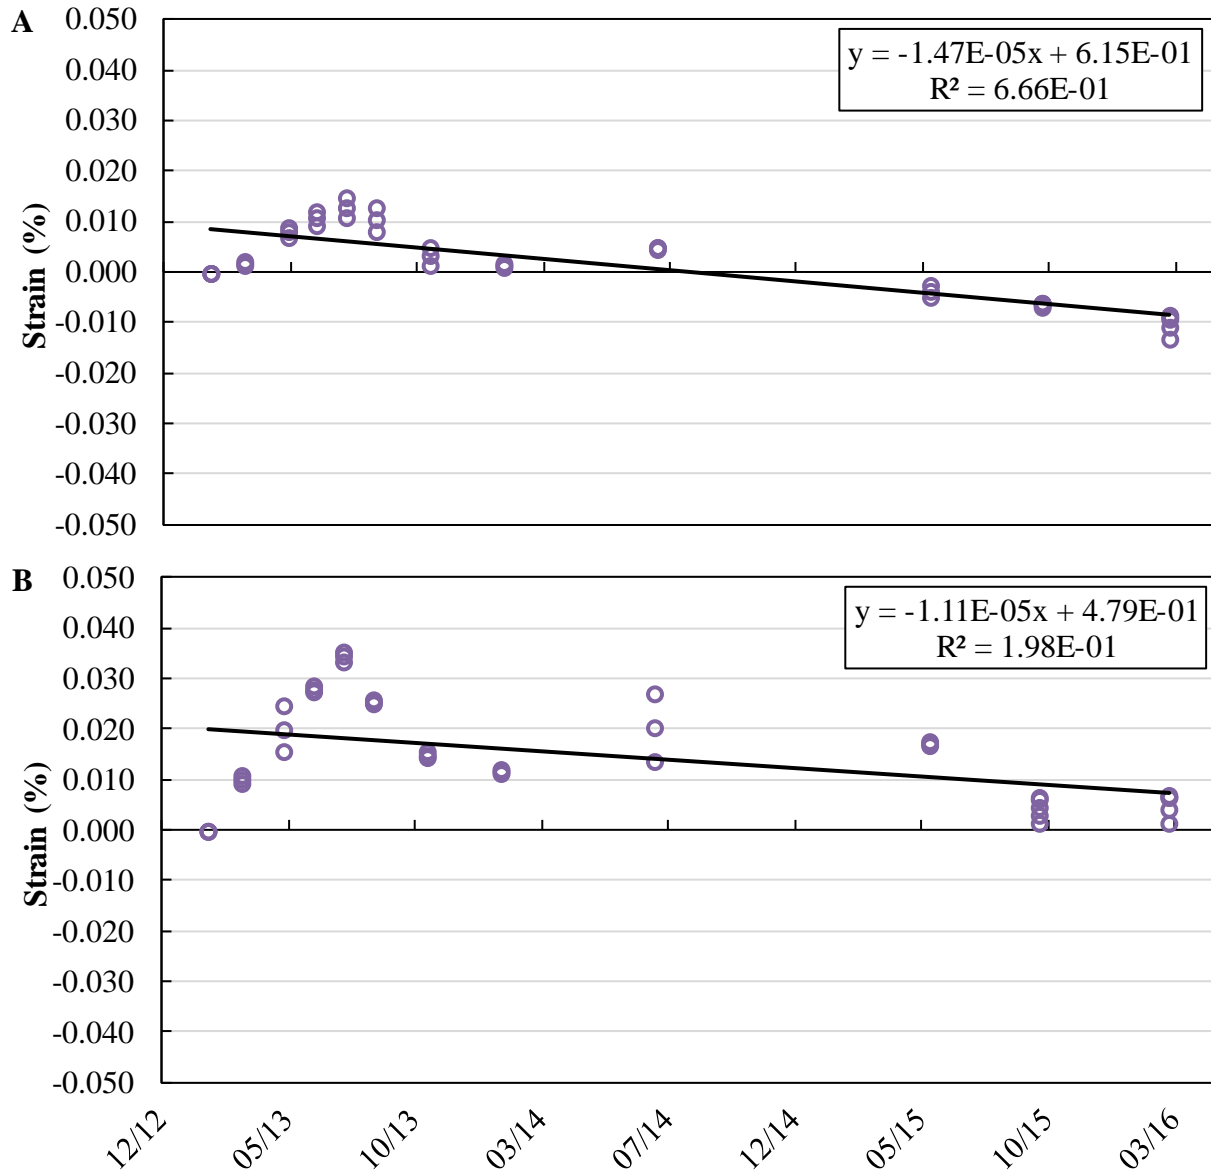
**Fig. 8.1-4**—Horizontal (A) and vertical (B) strain (%) with respect to date, Interstate 49 barrier wall exhibiting minimal deterioration, elastomeric paint section (EP-1).

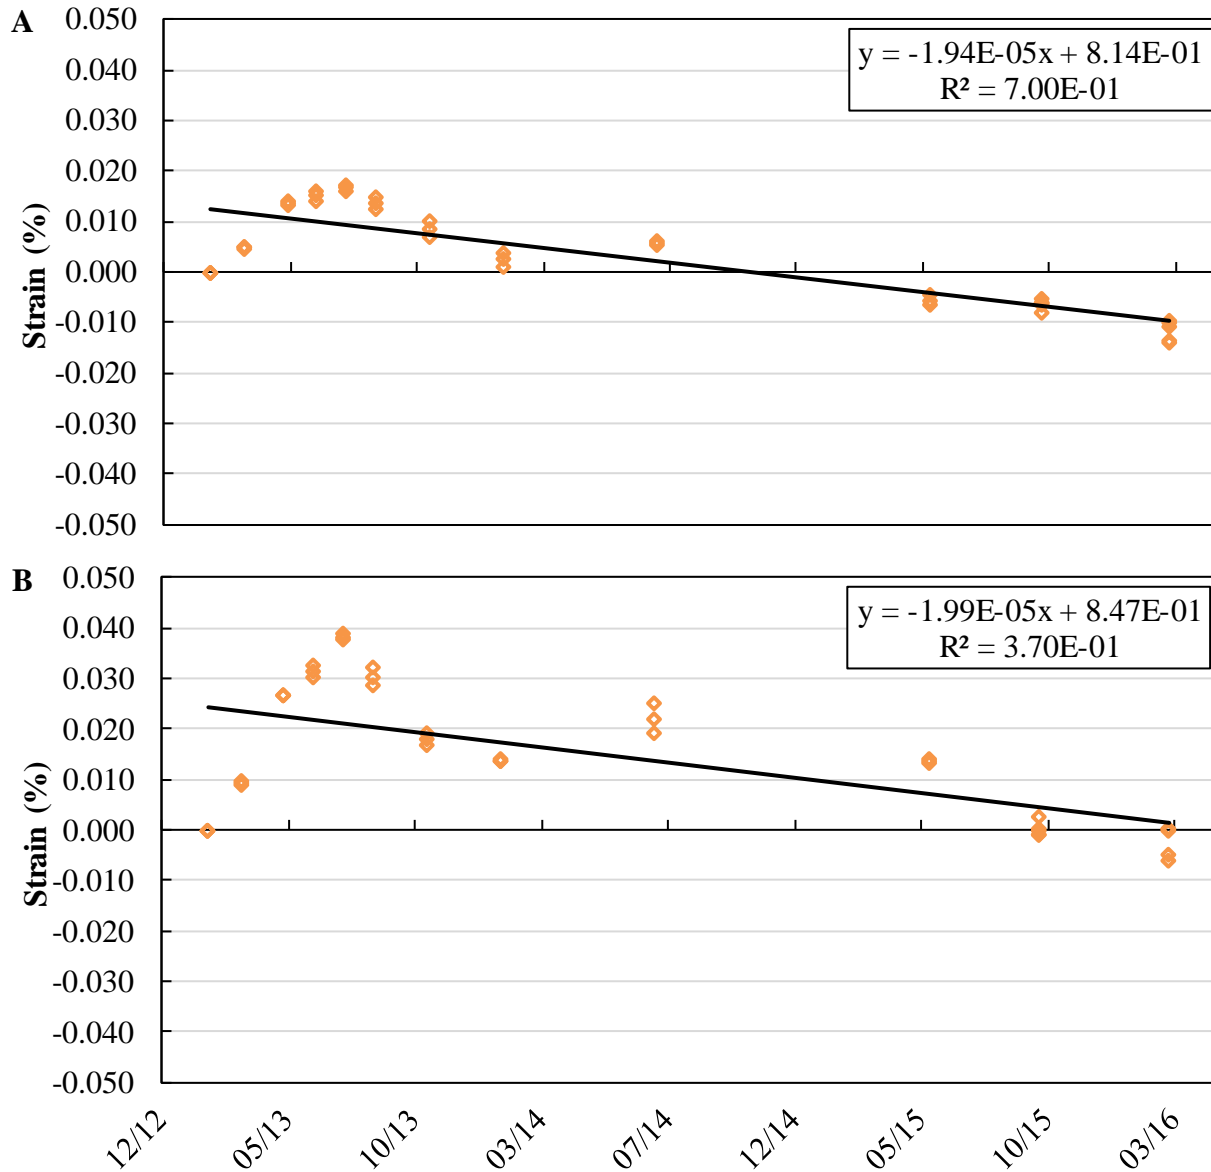
**Fig. 8.1-5**–Horizontal (A) and vertical (B) strain (%) with respect to date, Interstate 49 barrier wall exhibiting minimal deterioration, silane 2 section (S2-1).

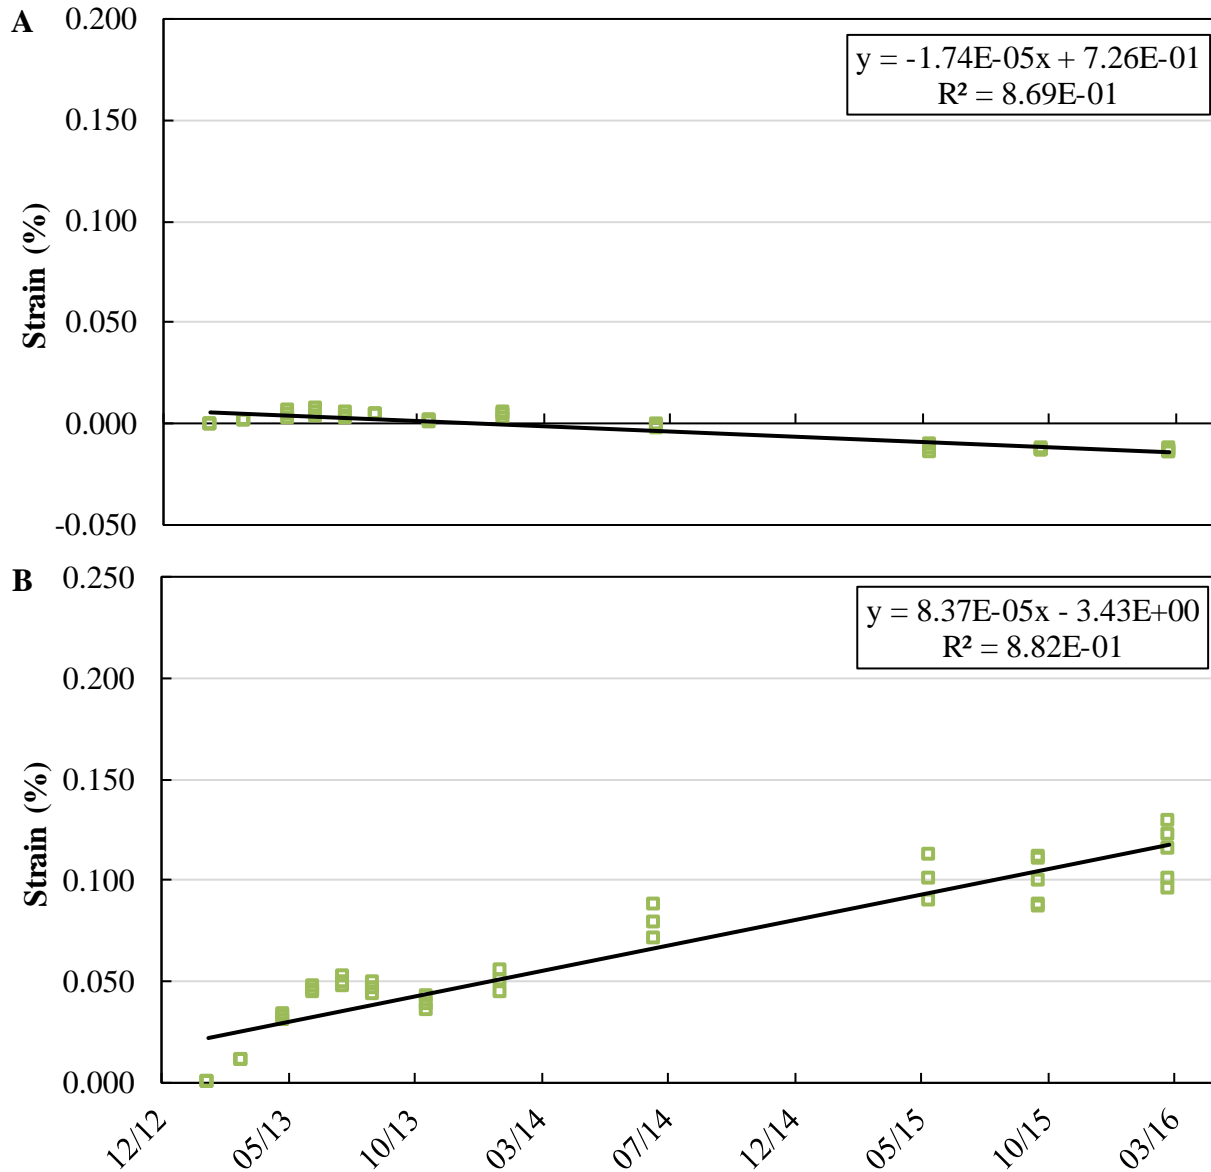
**Fig. 8.1-6**–Horizontal (A) and vertical (B) strain (%) with respect to date, Interstate 49 barrier wall exhibiting moderate deterioration, control section (C-2).

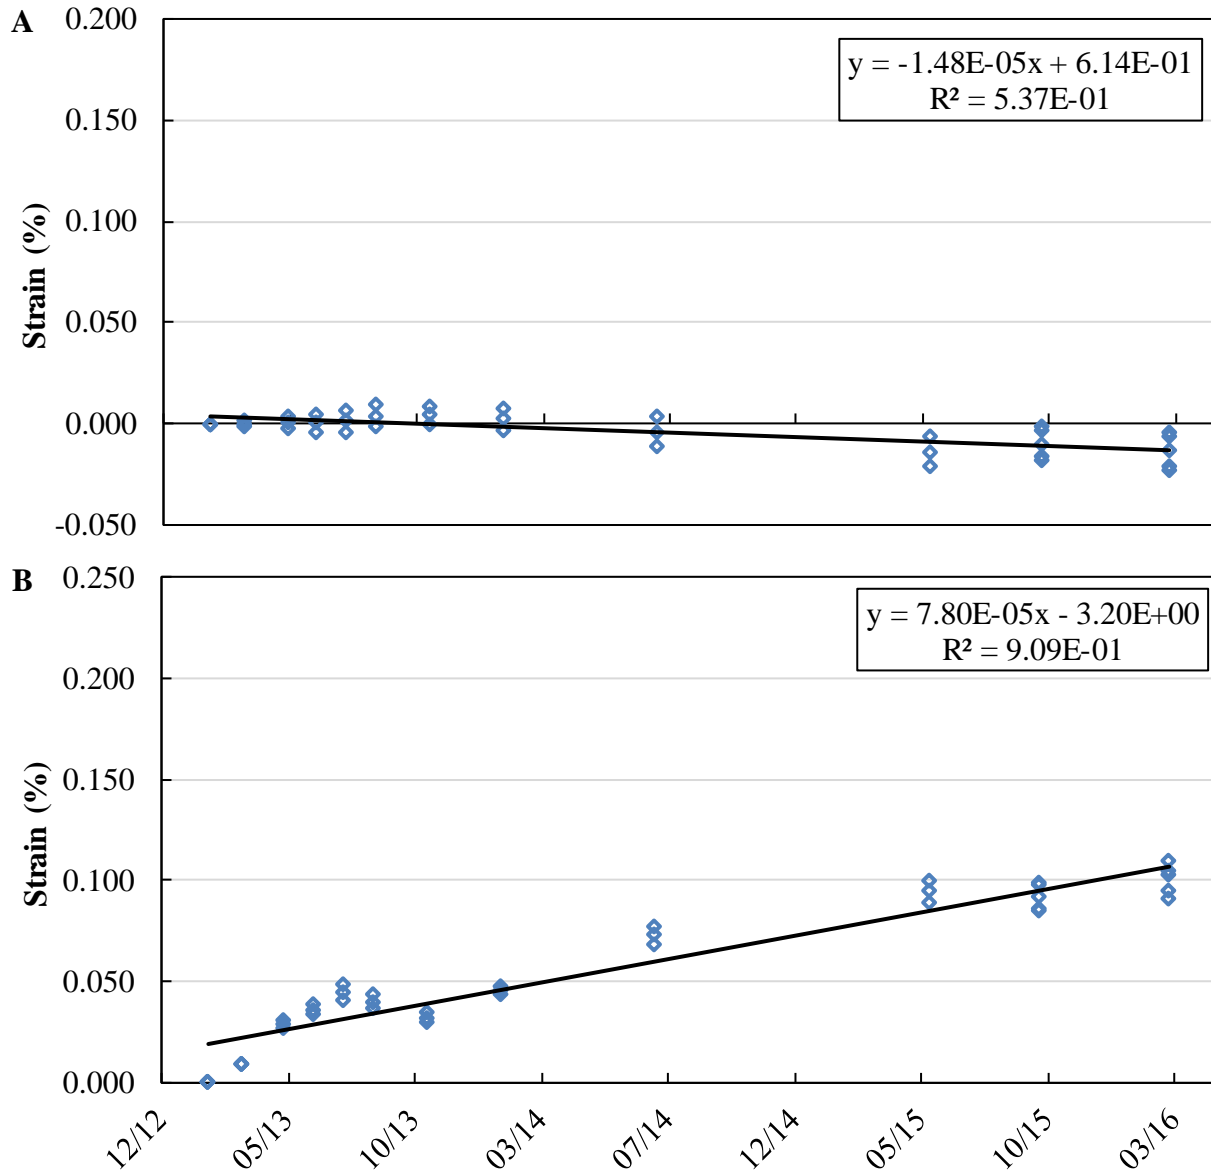
**Fig. 8.1-7**–Horizontal (A) and vertical (B) strain (%) with respect to date, Interstate 49 barrier wall exhibiting moderate deterioration, silane section (S-2).

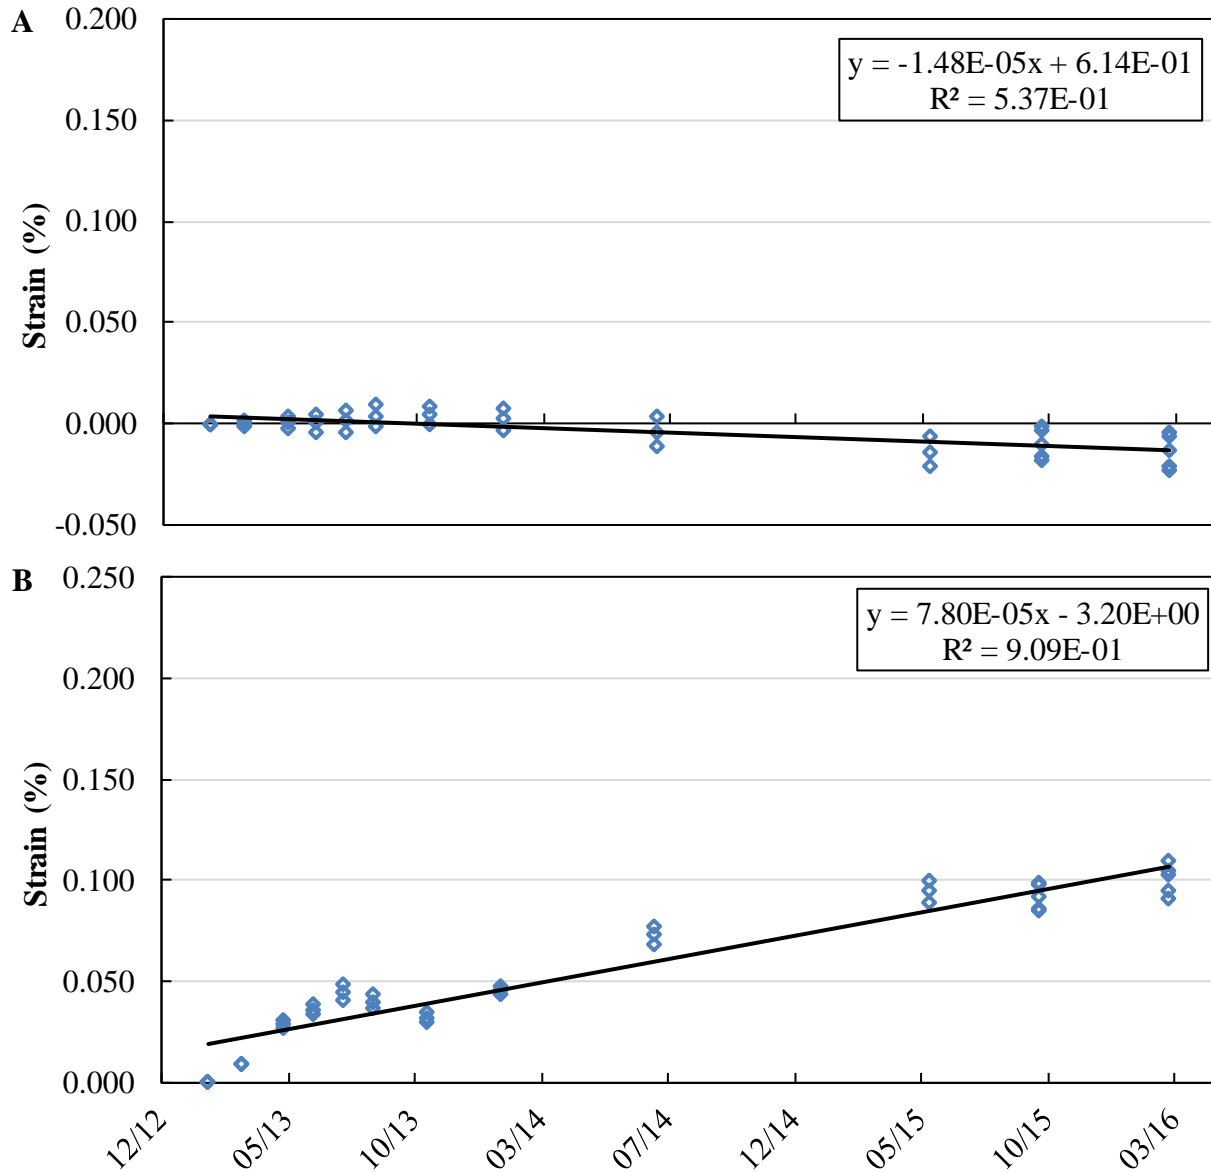
**Fig. 8.1-8**–Horizontal (A) and vertical (B) strain (%) with respect to date, Interstate 49 barrier wall exhibiting moderate deterioration, linseed section (L-2).

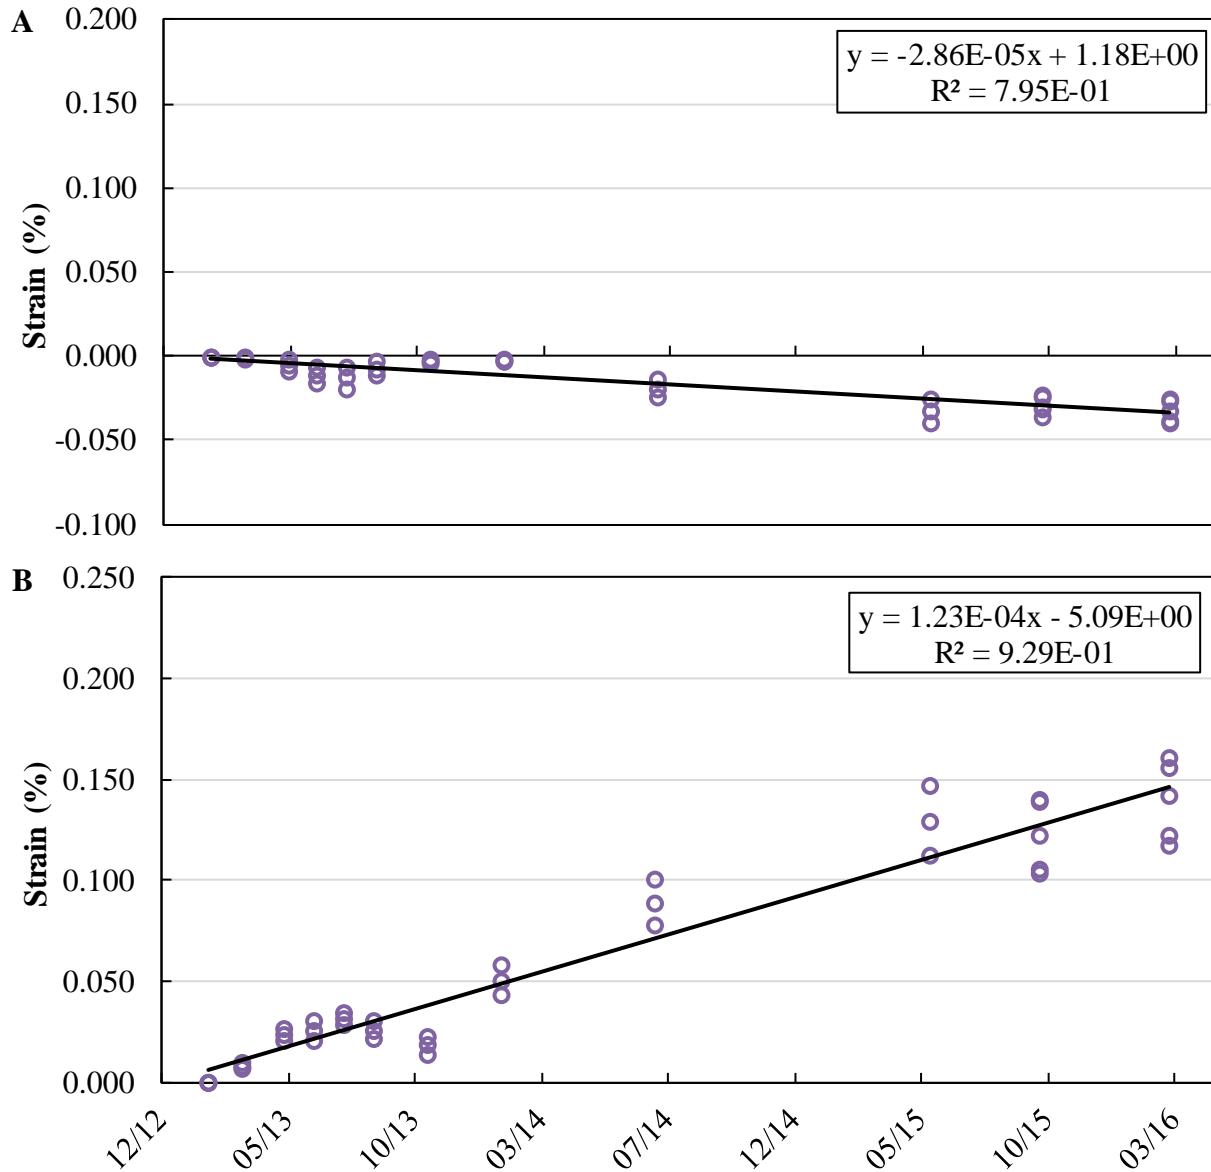
**Fig. 8.1-9**–Horizontal (A) and vertical (B) strain (%) with respect to date, Interstate 49 barrier wall exhibiting moderate deterioration, elastomeric paint section (EP-2).

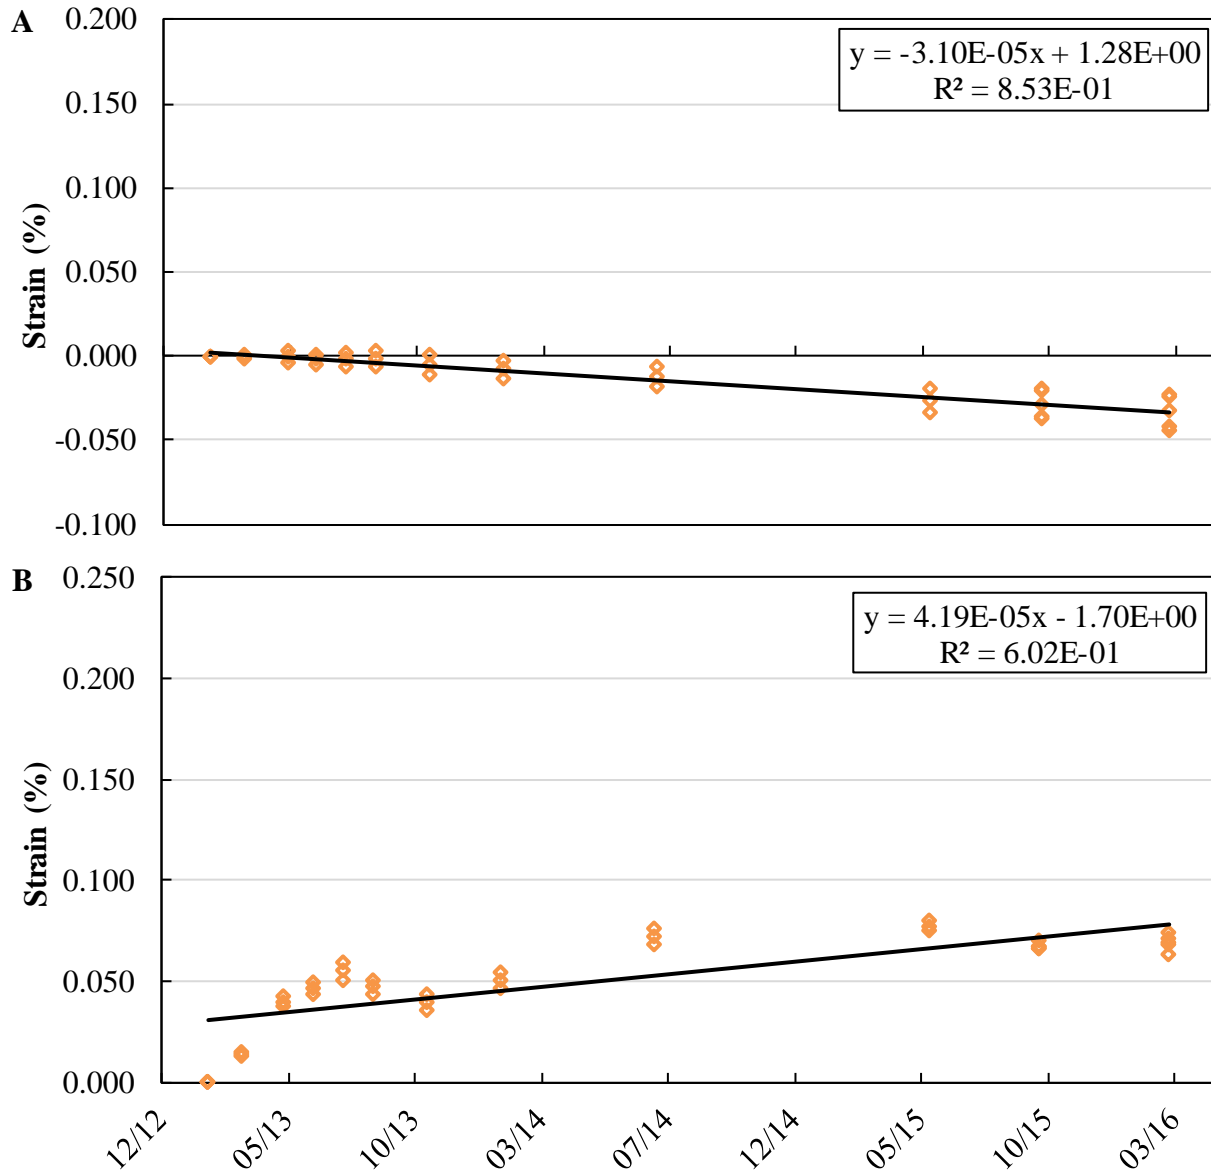
**Fig. 8.1-10**–Horizontal (A) and vertical (B) strain (%) with respect to date, Interstate 49 barrier wall exhibiting moderate deterioration, silane 2 section (S2-2).

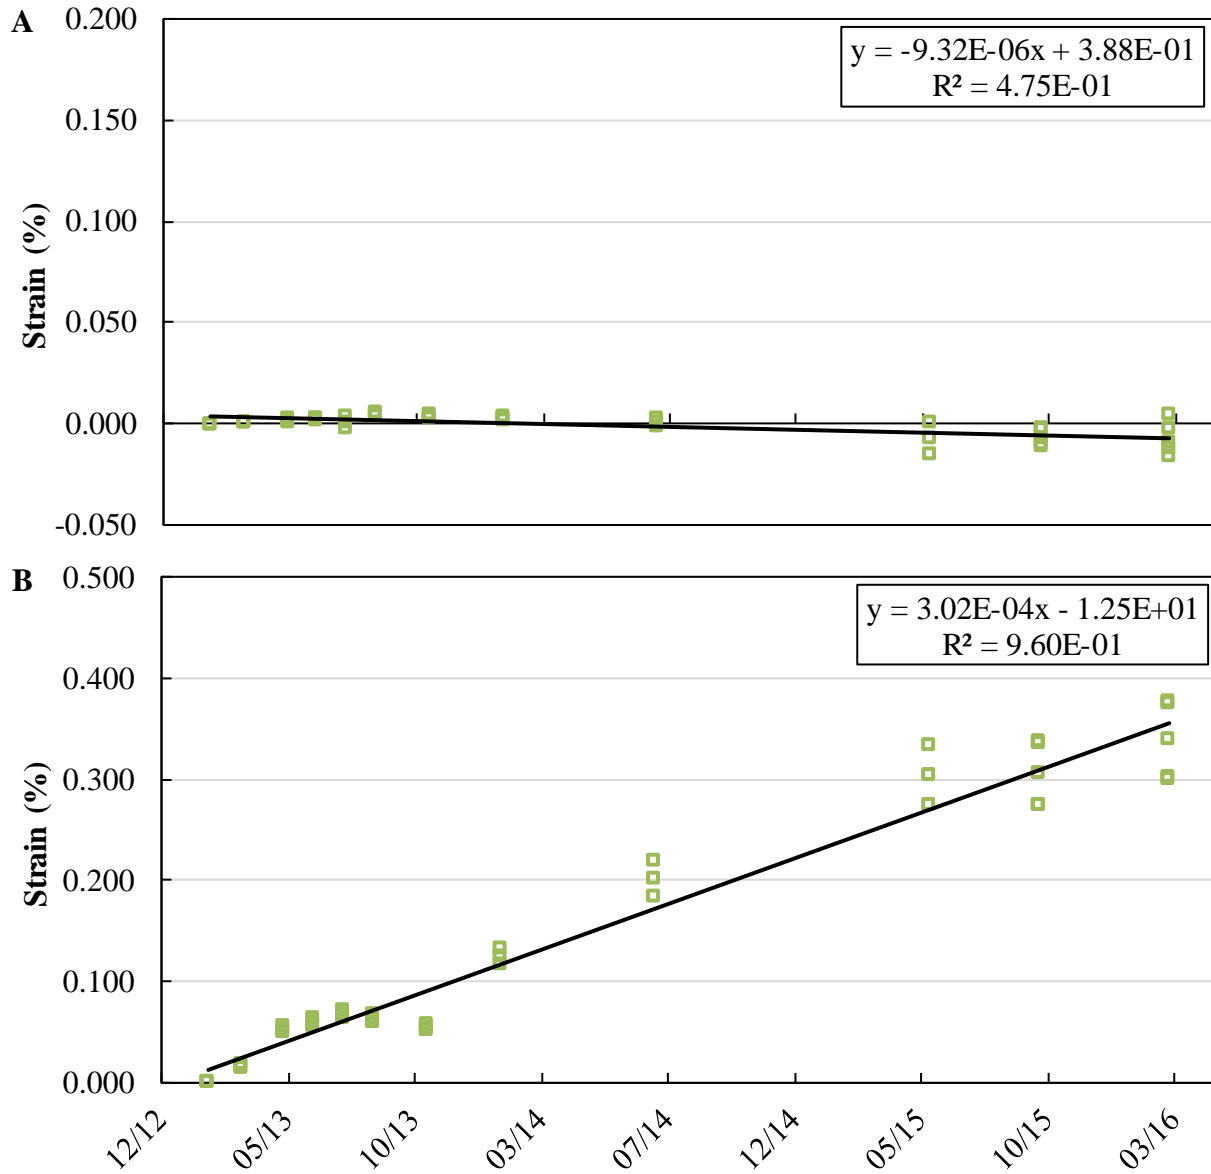
**Fig. 8.1-11**—Horizontal (A) and vertical (B) strain (%) with respect to date, Interstate 49 barrier wall exhibiting severe deterioration, control section (C-3).

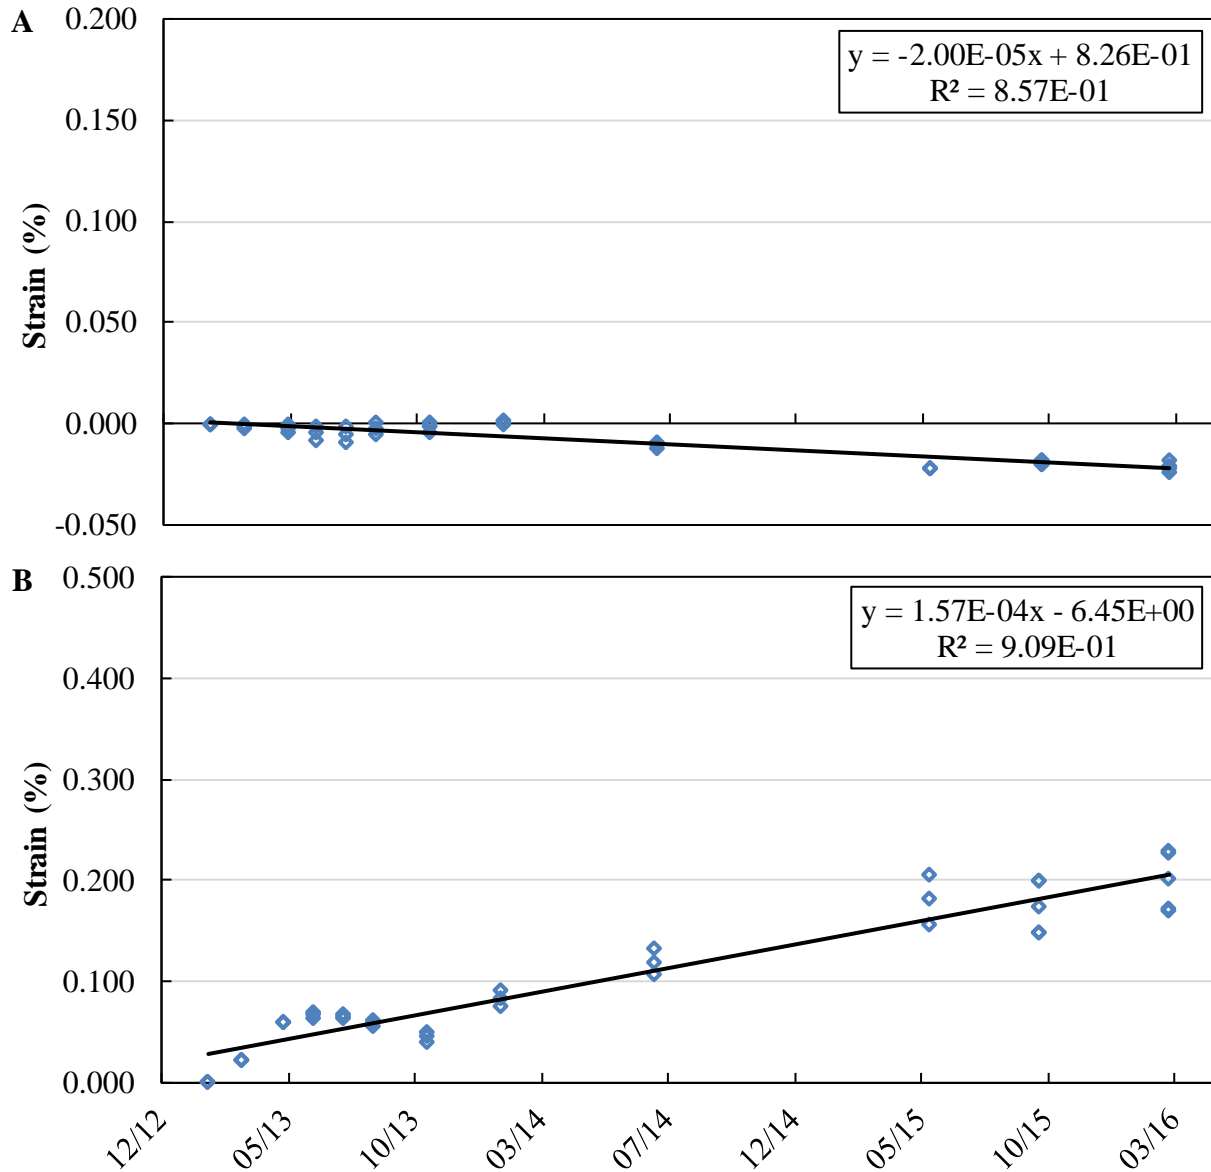
**Fig. 8.1-12**–Horizontal (A) and vertical (B) strain (%) with respect to date, Interstate 49 barrier wall exhibiting severe deterioration, silane section (S-3).

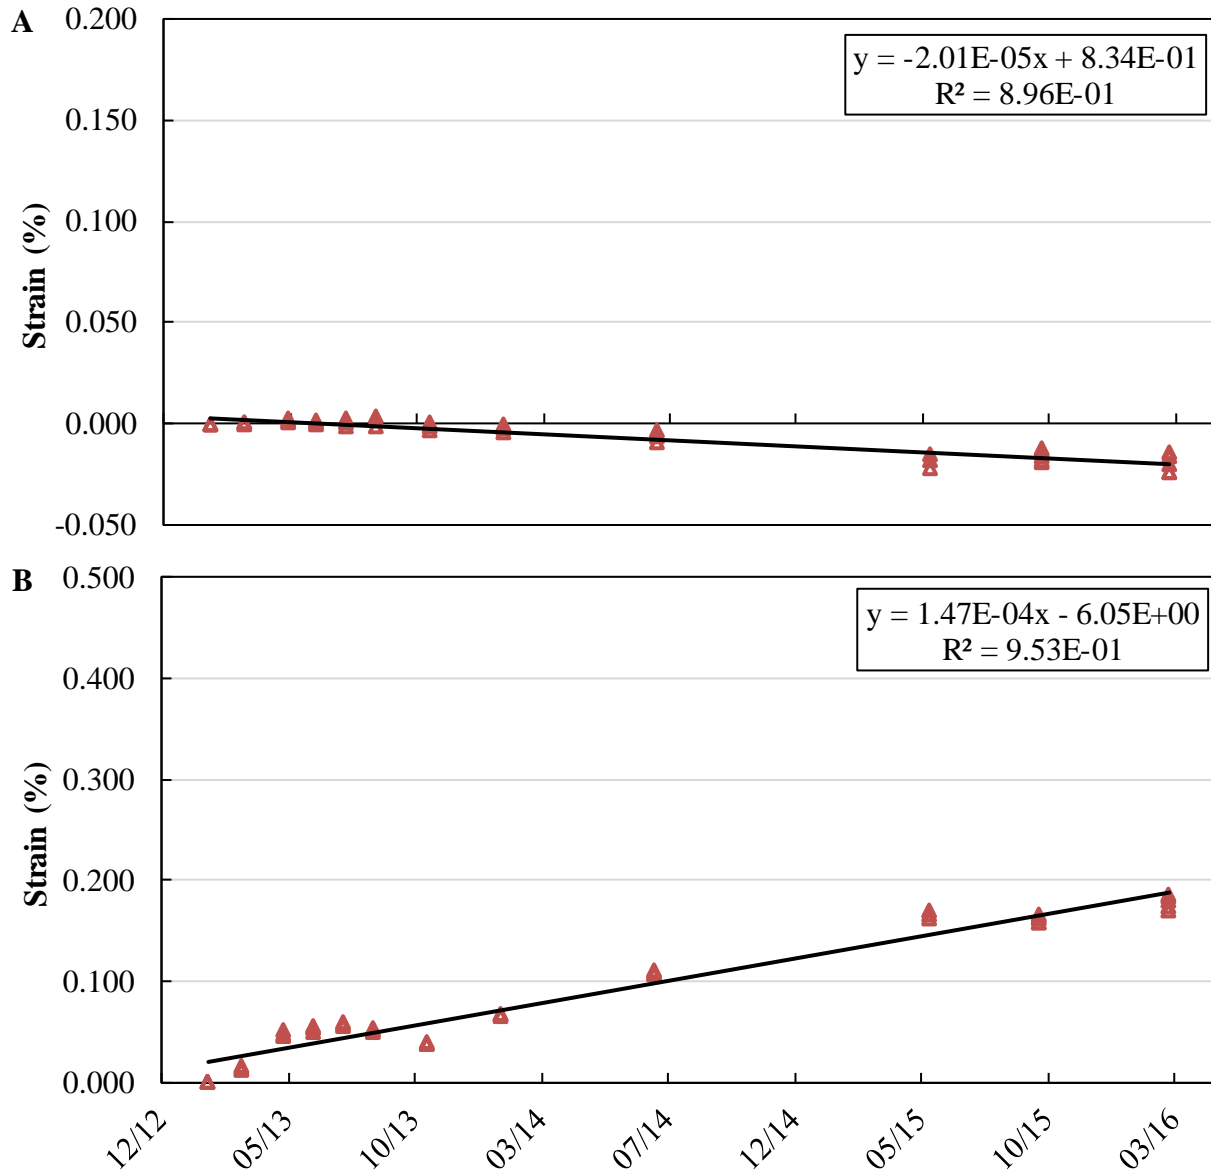
**Fig. 8.1-13**—Horizontal (A) and vertical (B) strain (%) with respect to date, Interstate 49 barrier wall exhibiting severe deterioration, linseed section (L-3).
