# Mitigation and Evaluation of Alkali-Silica Reaction (ASR) and Freezing and Thawing in Concrete Transportation Structures

A dissertation submitted in partial fulfillment  
of the requirements for the degree of  
Doctor of Philosophy in Engineering  
with a Concentration in Civil Engineering

August 2017  
University of Arkansas

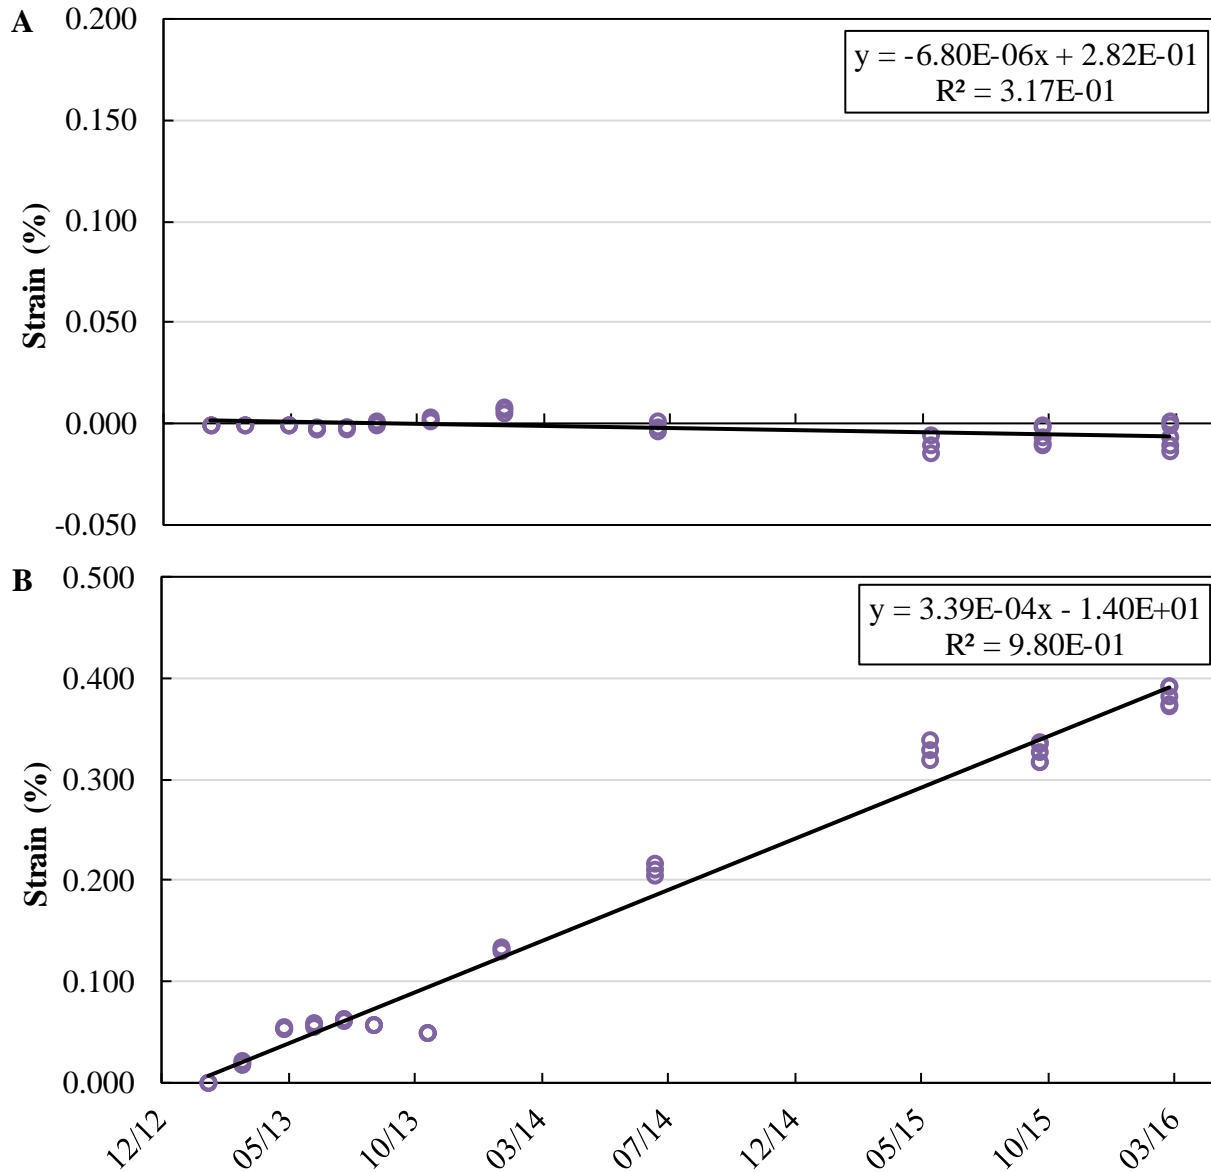
**Fig. 8.1-14**—Horizontal (A) and vertical (B) strain (%) with respect to date, Interstate 49 barrier wall exhibiting severe deterioration, elastomeric paint (EP-3).

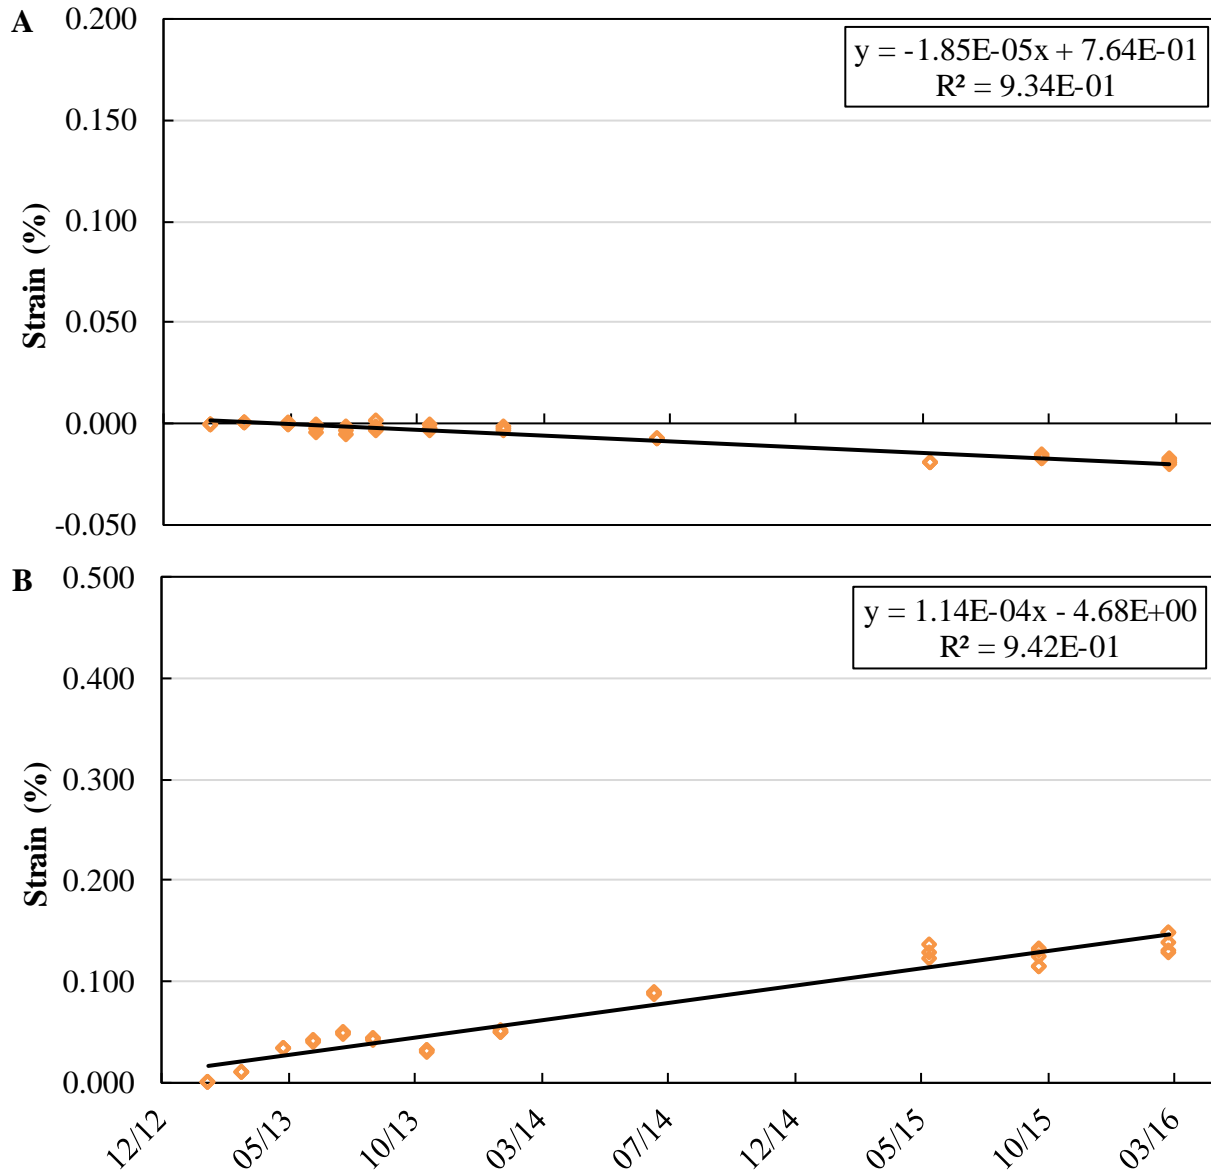
**Fig. 8.1-15**—Horizontal (A) and vertical (B) strain (%) with respect to date, Interstate 49 barrier wall exhibiting severe deterioration, silane 2 section (S2-3).

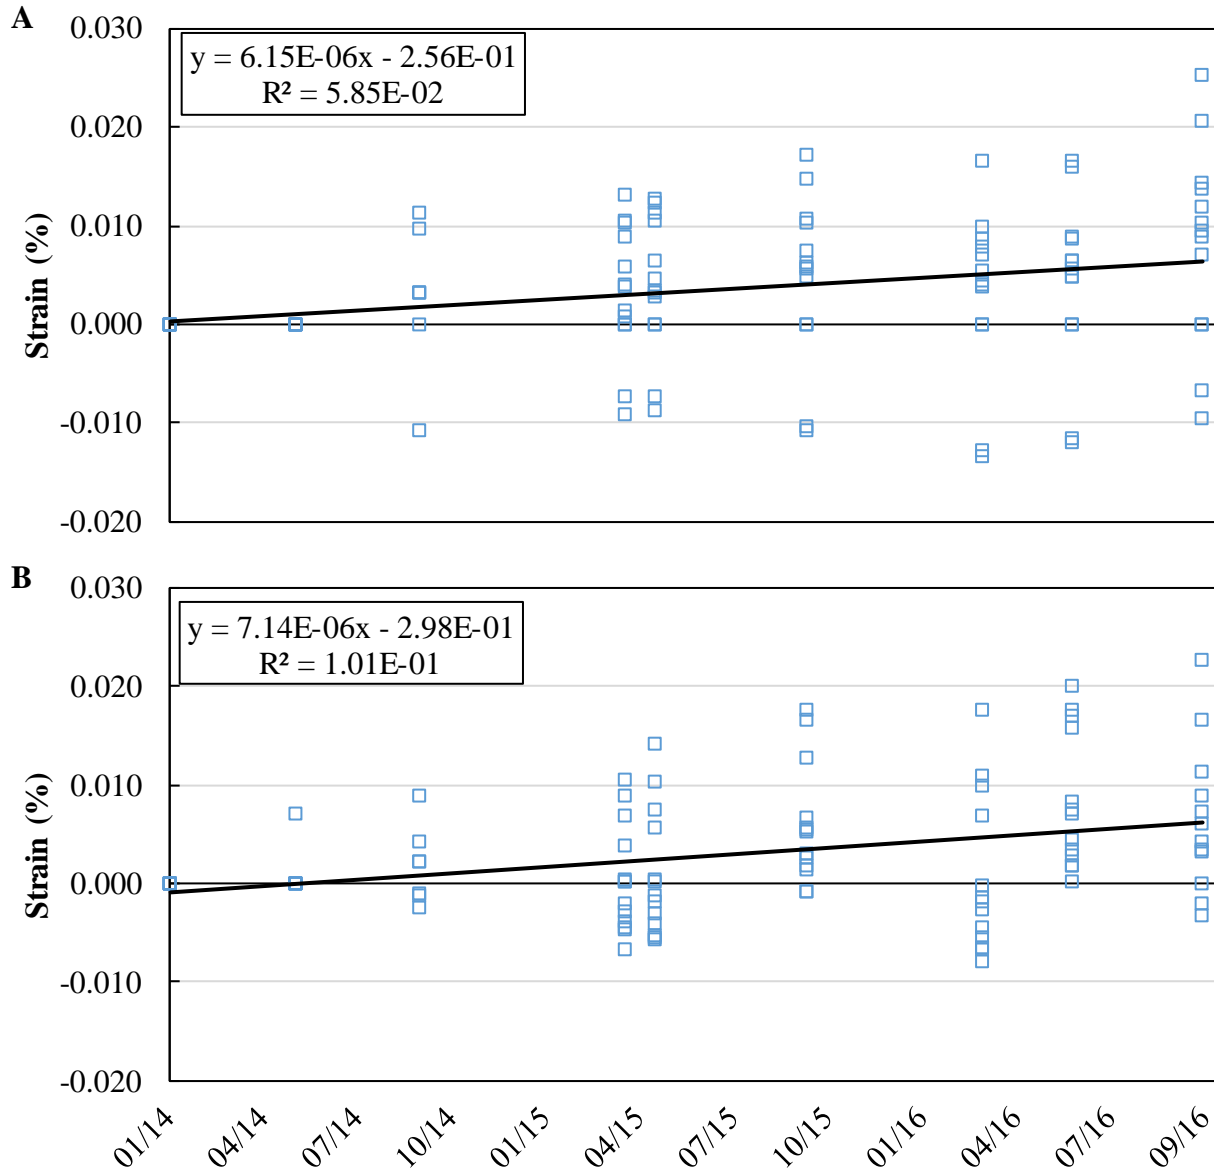
**Fig. 8.2-1**—Strain (%) with respect to time for Interstate 49 control panels, travel (A) and transverse (B).

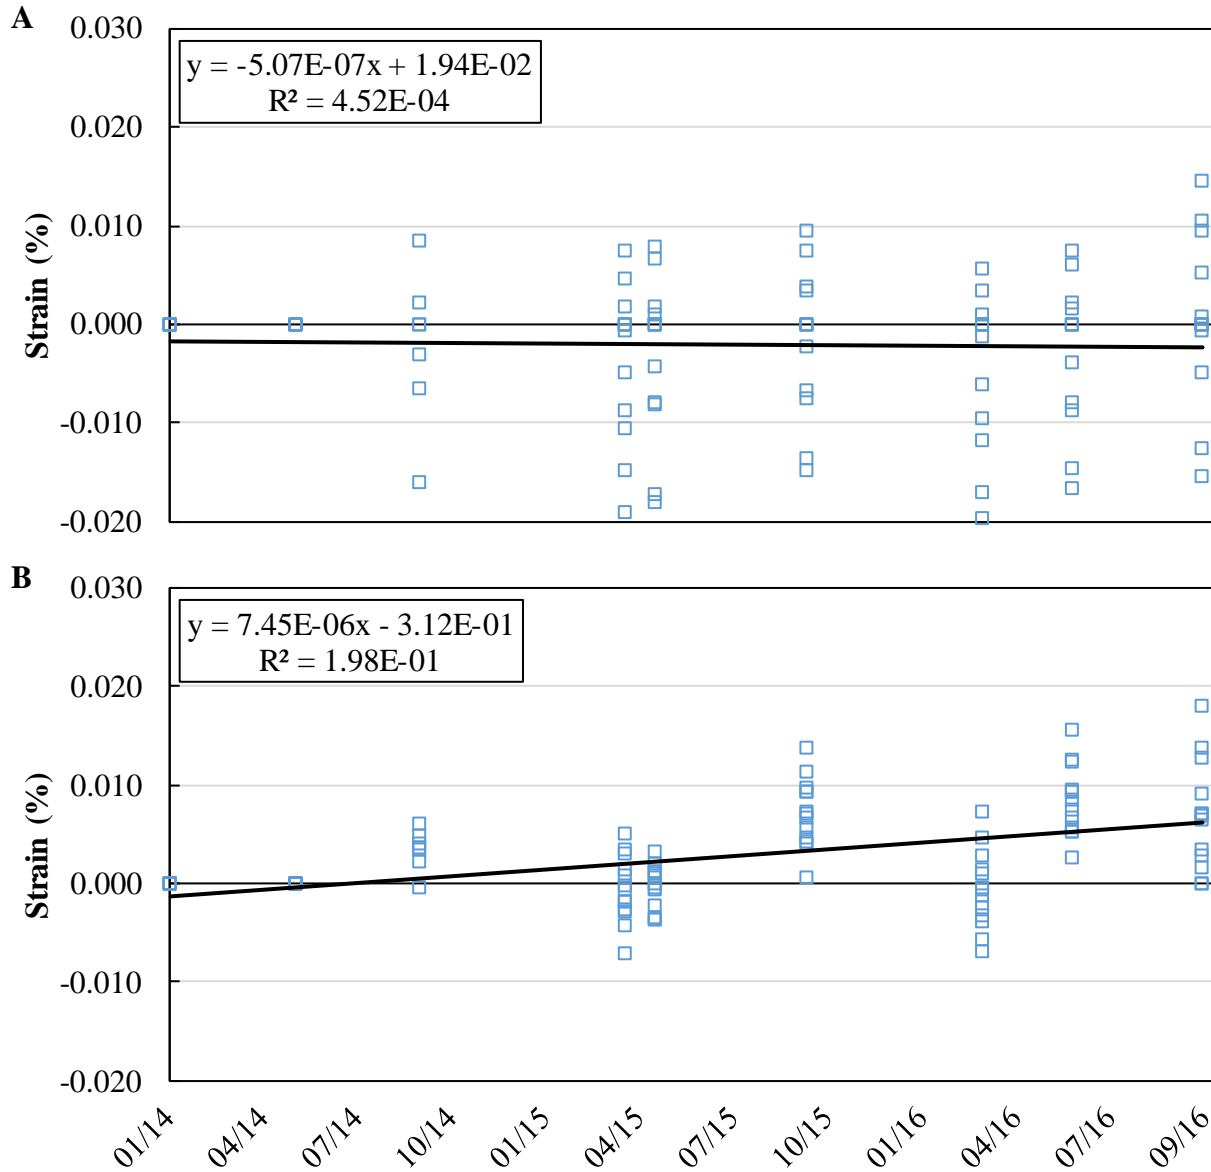
**Fig. 8.2-2**—Strain (%) with respect to time for Interstate 49 Silane 40A panels, travel (A) and transverse (B).

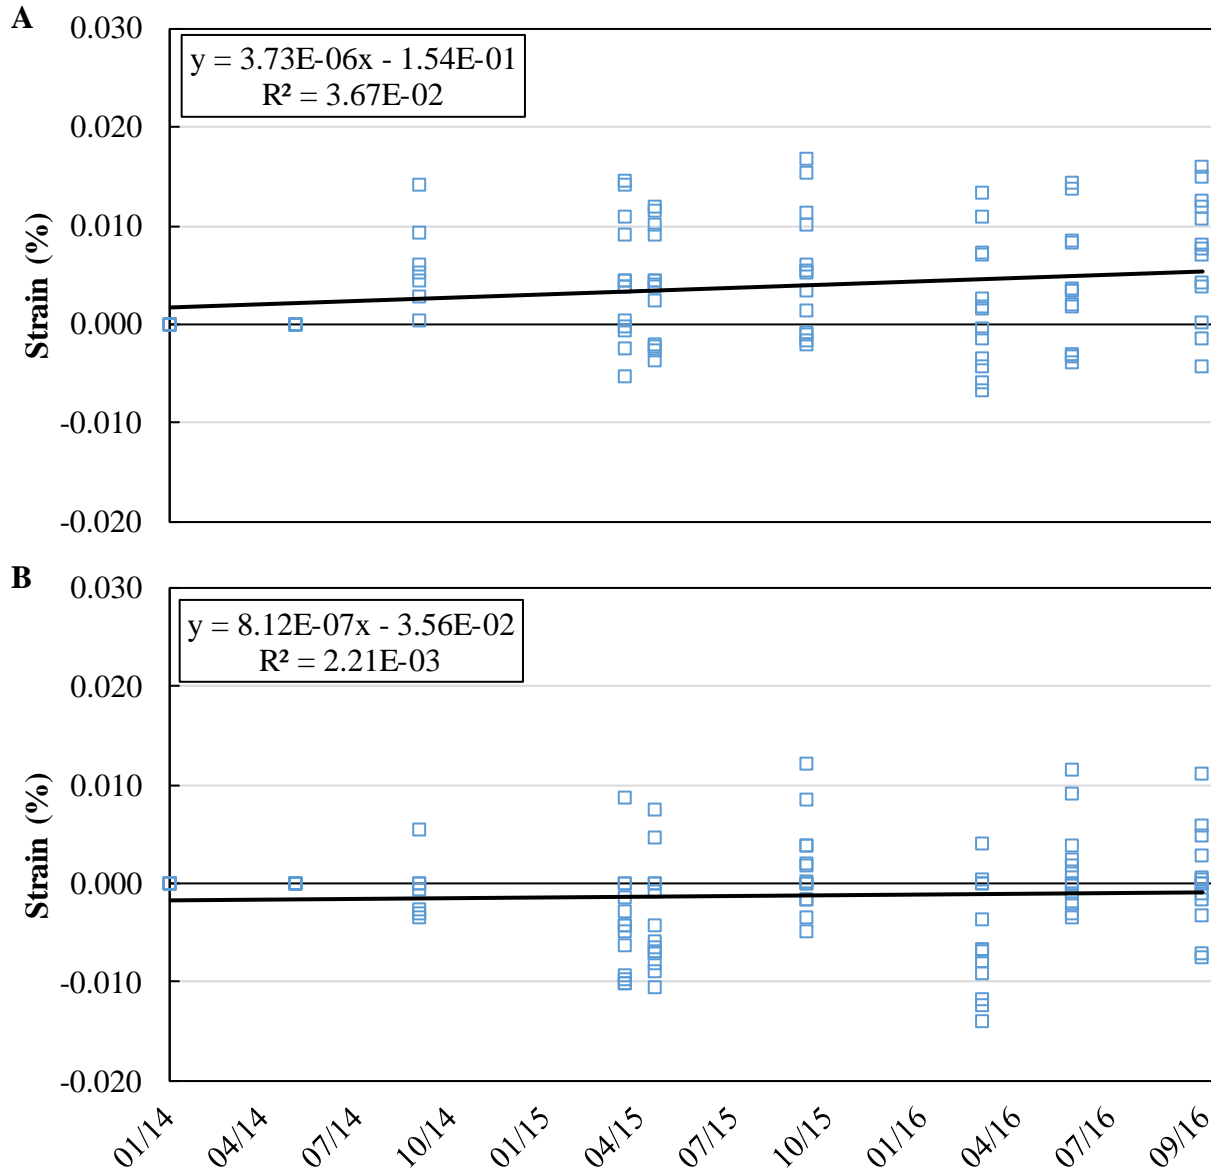
**Fig. 8.2-3**— Strain (%) with respect to time for Interstate 49 Silane 100 panels, travel (A) and transverse (B).

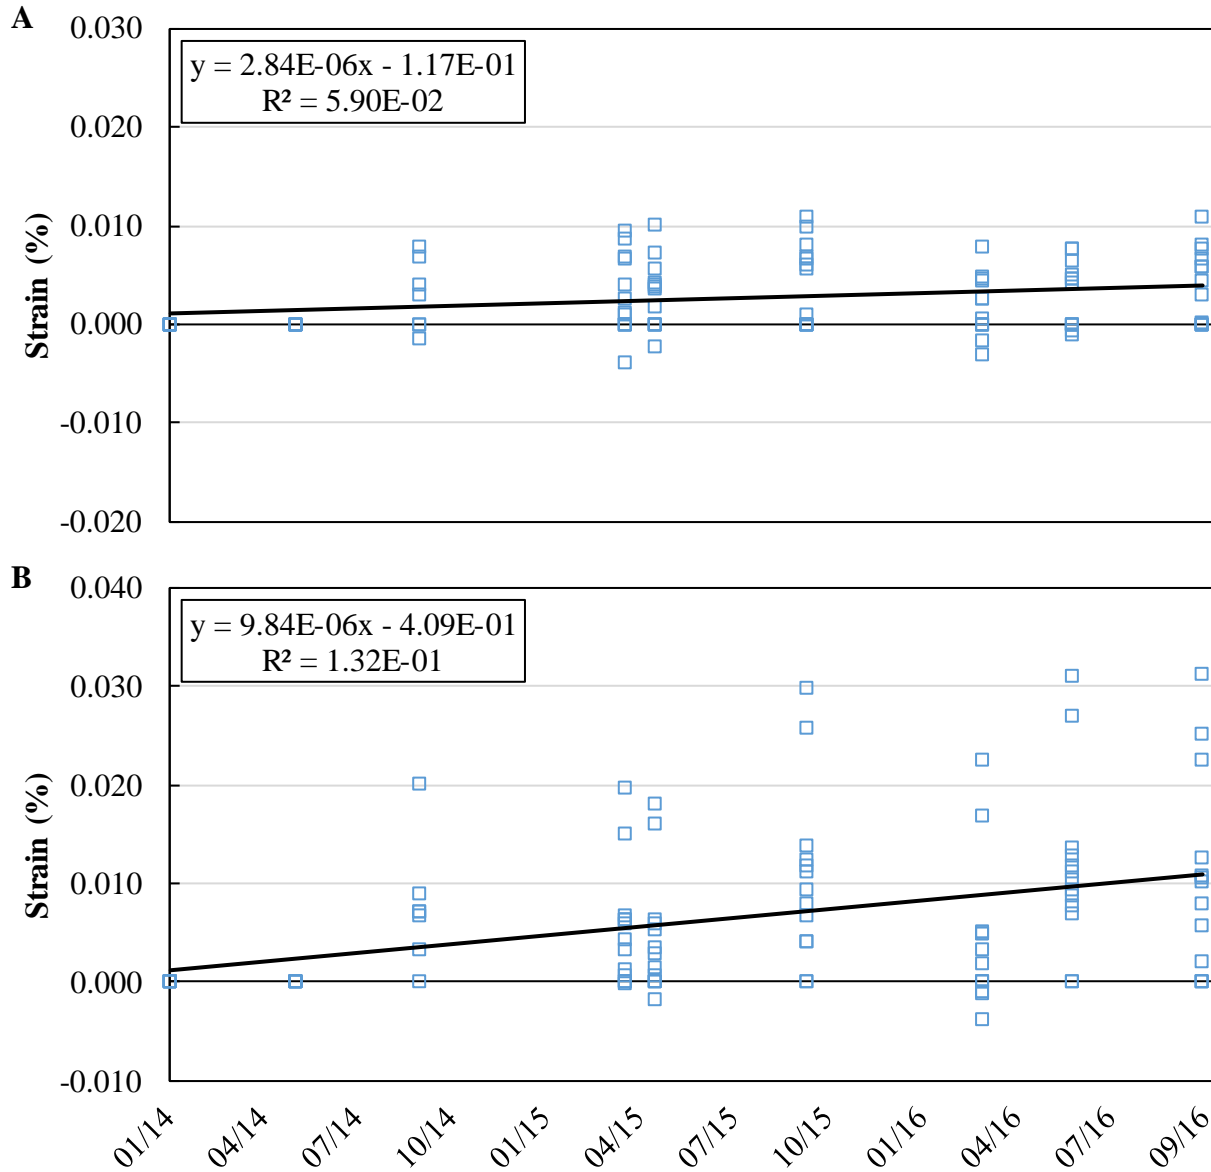
**Fig. 8.2-4**—Strain (%) with respect to time for Interstate 49 Silane 40B panels, travel (A) and transverse (B).
