Asbestos Cement Pipe Condition Assessment and Remaining Service Life Prediction

A thesis submitted in partial fulfillment
of the requirements for the degree of
Master of Science in Civil Engineering

August 2016
University of Arkansas

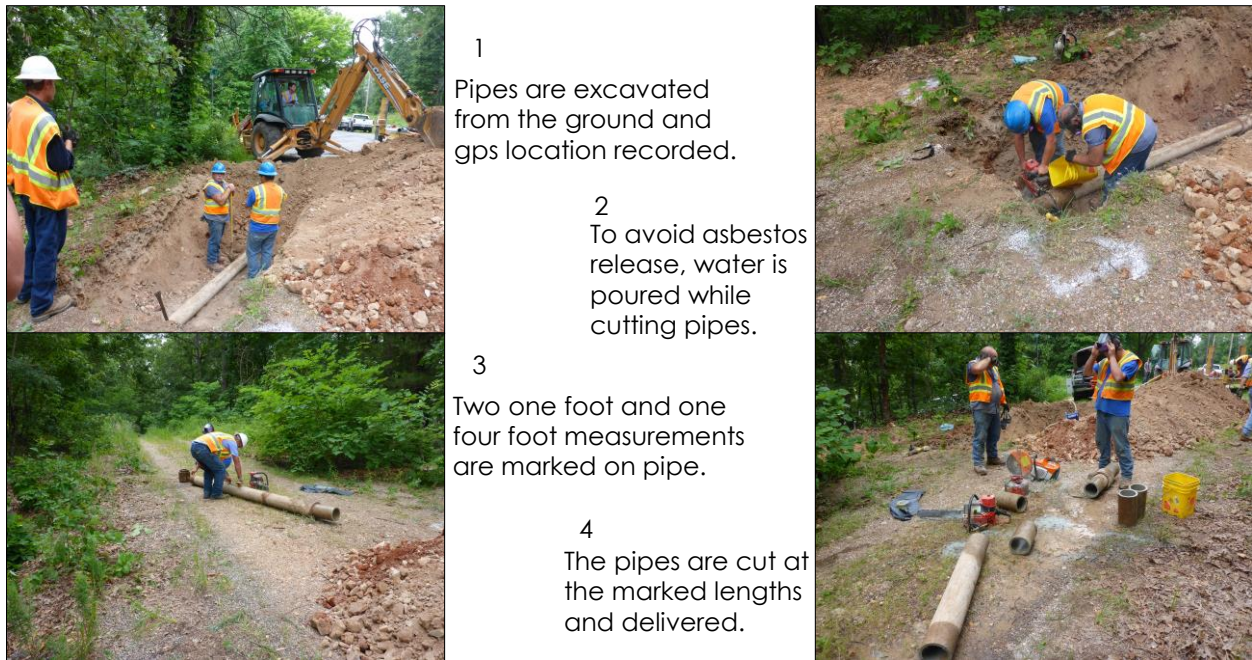
Figure 3-3. AC pipe sampling procedure

While there are no special licenses required to conduct AC pipe sampling, there are special trainings given to the technicians conducting the removal of these samples to ensure proper safety procedures. Although, AC pipes are considered non-friable, the sampling process presented in Figure 3-3 below can release asbestos fibers into the air.

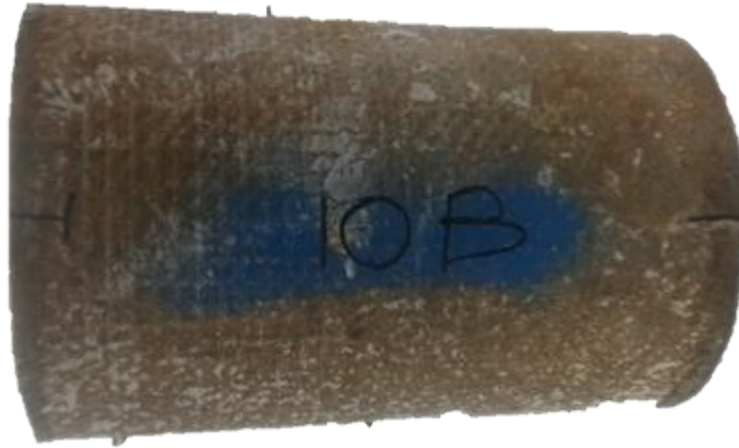
Figure 5-1. Sample 10B depicting the external surface of AC pipe

pattern is part of the manufacturing process of AC pipe. There were no samples with obvious signs of degradation that were visible to the naked eye.

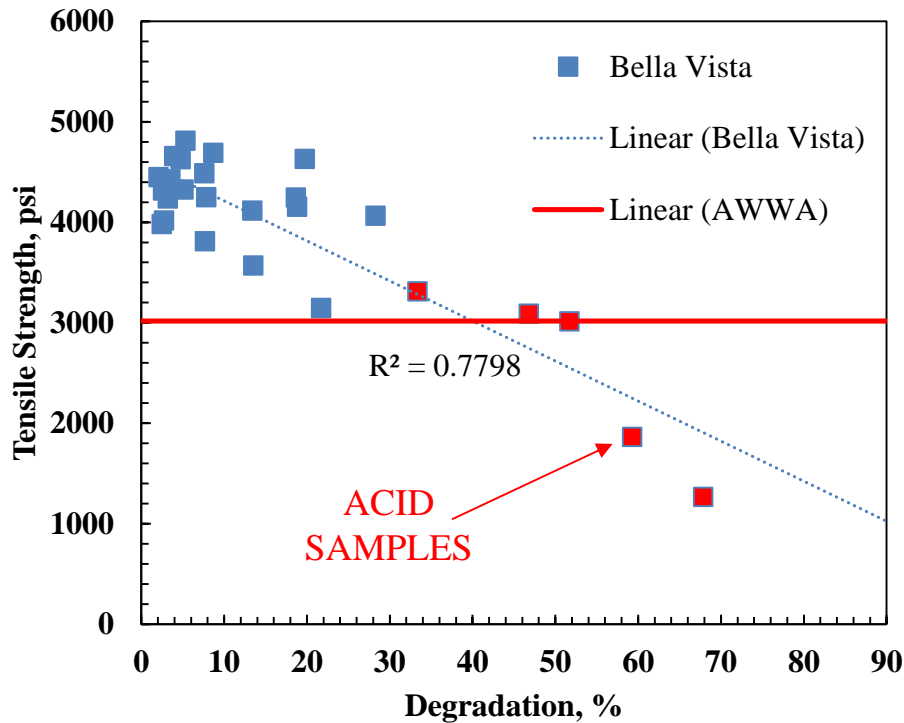
Figure 5-15. Tensile strength calculated from hydrostatic data which accounts for differences in pipe thickness and diameter

Where P is the Hydrostatic bursting pressure in psi, d is the internal diameter of sample in inches and t is the thickness of pipe in inches. Sample 9 from Stevenson Drive falls just below the AWWA line when taking the diameter and thickness into consideration. However, the sample is still over 4 times the reported operating pressure.

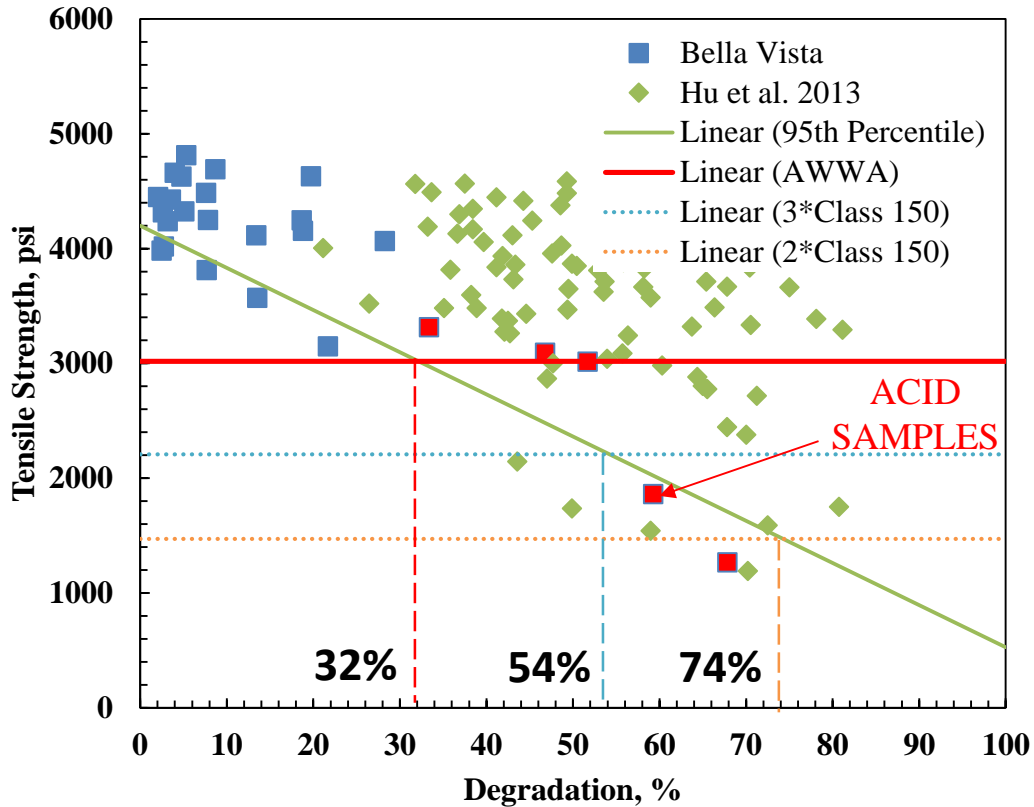
Figure 5-16. Tensile strength from Hu et al. (2013) and Bella Vista with AWWA and 95th percentile intersection shown

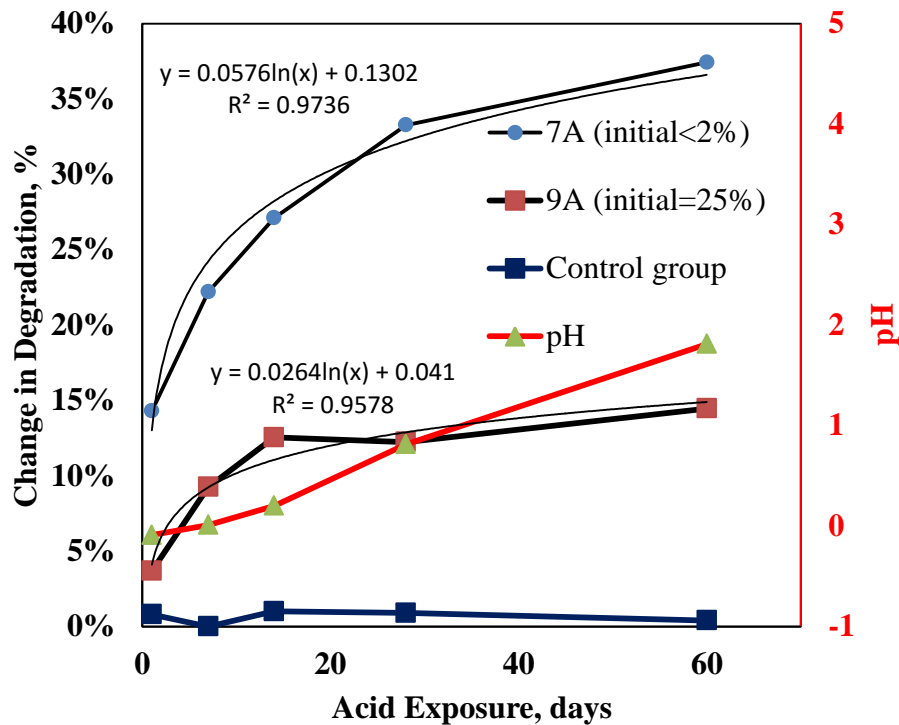
Figure 6-1. Rate of degradation from Phase I acid testing

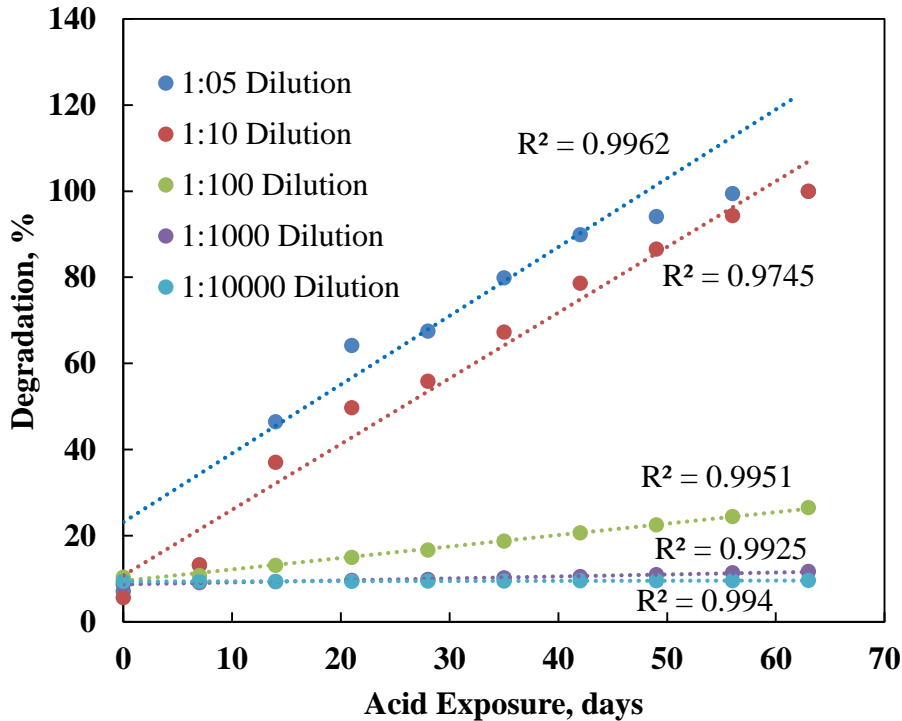
Figure 6-5. Phase III acid test results showing linear rate of degradation for all dilutions
