Identifying Damage, Predicting Expansion, and Determining the Effectiveness of Sealers on Concrete Affected by Alkali-Silica Reaction and Freeze-Thaw

A thesis submitted in partial fulfillment
of the requirements for the degree of
Master of Science in Civil Engineering

Matthew Waidner
University of Arkansas
Bachelor of Science in Civil Engineering, 2015

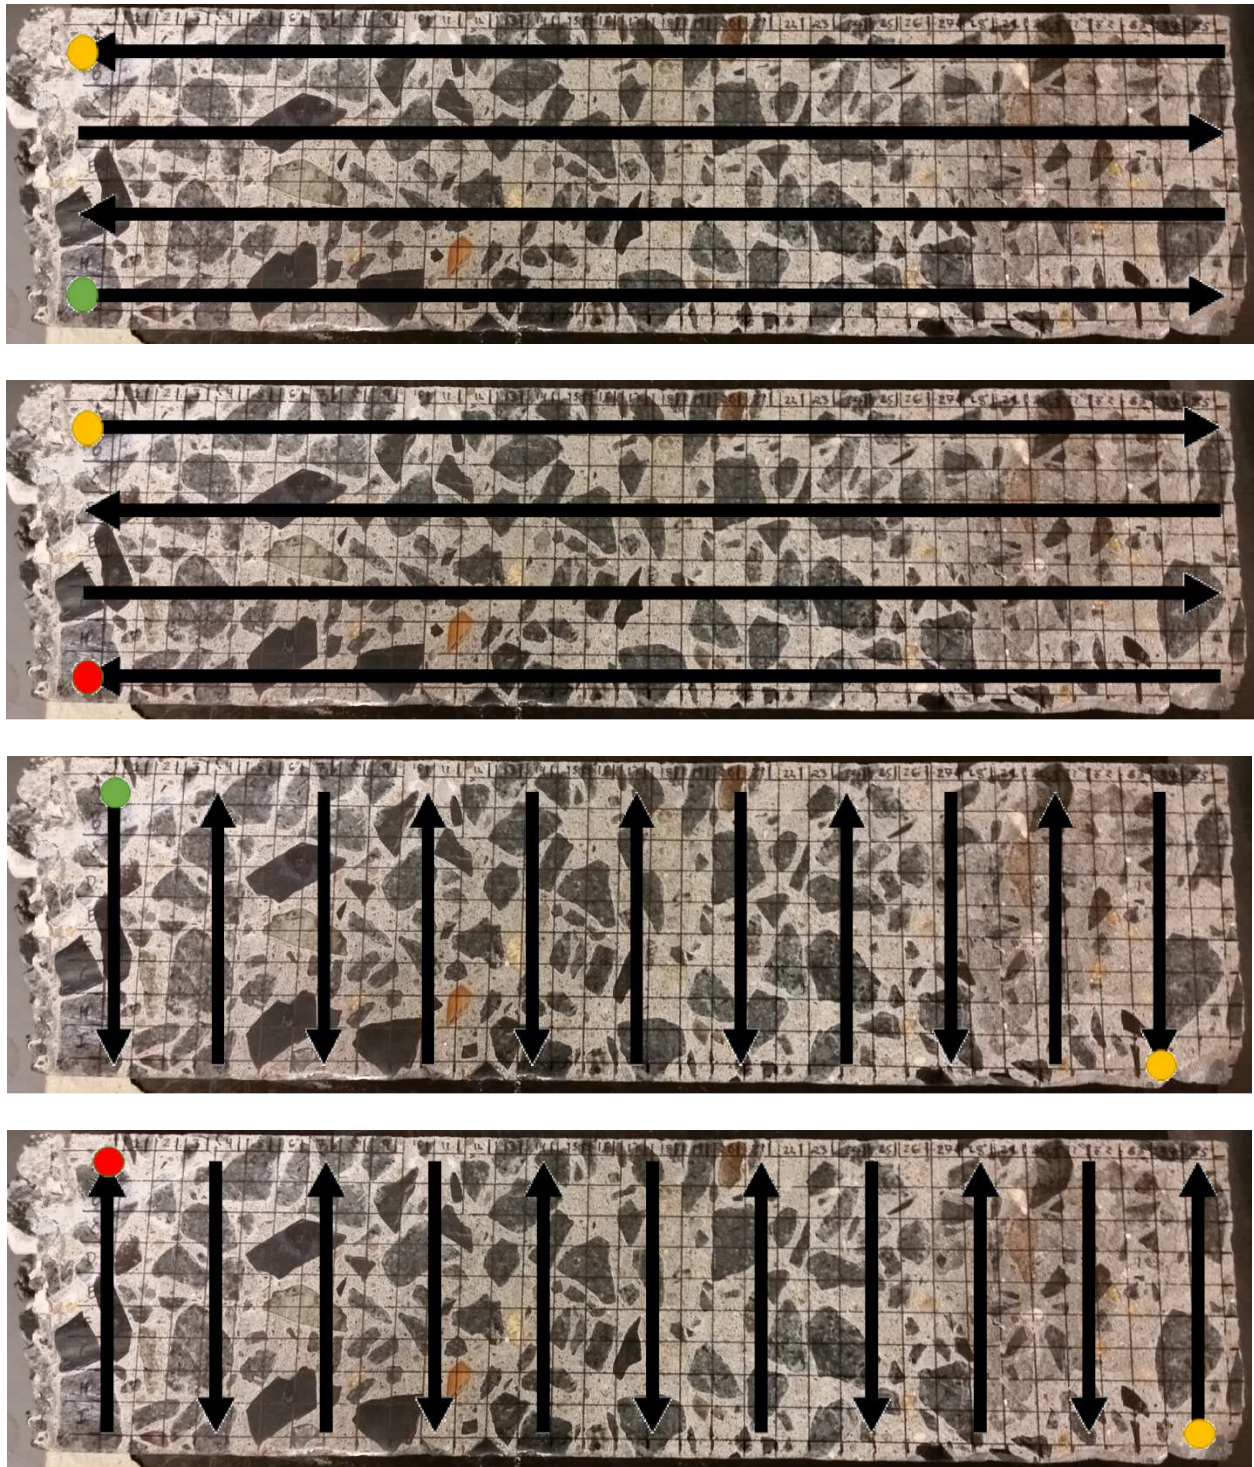
Figure 3.1. Polishing Patterns

During polishing, two patterns were employed to avoid creating grooves in the surface of the core. Figure 3.1 shows the two patterns used, in which the green dot represents the start, the yellow dot represents turning around, and the red dot represents the stopping place. Each pattern was performed three to four times before switching to the other pattern. Patterns were also started from the right side of the core just in case starting from one side created grooves or affected the smoothness. Overlapping passes in each pattern helped to reduce grooving and improve smoothness.

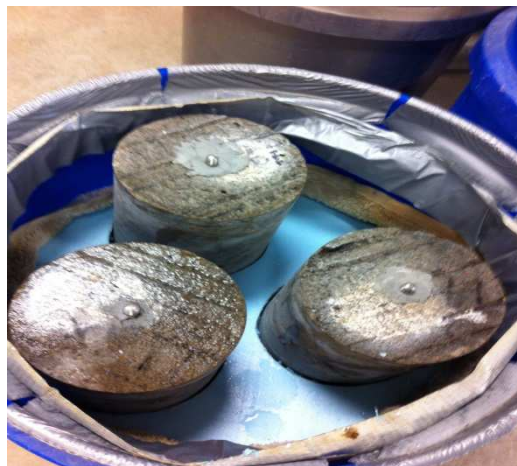
Figure 3.2. Bucket with Cores over Water

Normally, three-five gallon buckets would be used to store the nine cores in a water bath, but due to a lack of Styrofoam, three-6 in by 12 in cylinder molds were used for the 1N NaOH solution cores. The first-five gallon bucket was fitted with two wooden blocks with 1 in height at the bottom, so that 1 in. of water at the bottom could be easily measured and maintained. Above the wooden blocks, a piece of Styrofoam was cut to fit into the bucket and rest on top of the wooden blocks. Three small holes were cut just big enough in the Styrofoam for the gage studs to fit in. The cores would rest on the Styrofoam, while the gage studs would not carry any of the weight of the cores being in the holes. Four inches from the top of the bucket another Styrofoam piece was place with three holes cut into it symmetrically about the center. These holes were made just bigger than four inches to accommodate the cores. The sides of the bucket were lined with a towel. The towel was taped to the top of the bucket, while the bottom of the towel sat above the bottom piece of Styrofoam. Figure 3.2 shows the cores in the first bucket. A lid fitting over the bucket and towel was used to create a water tight seal.

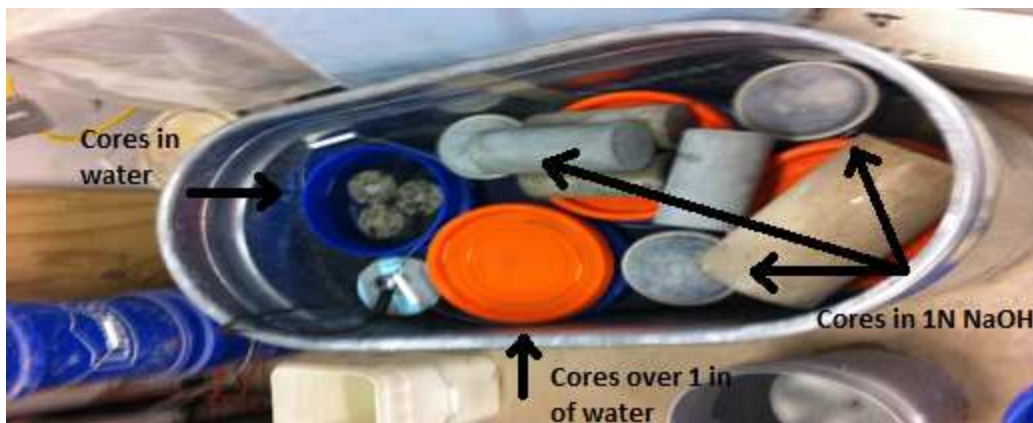
Figure 3.3. Water Bath

A water bath was prepared using a 100 gal watering trough. The water temperature was measured and controlled using an electric thermometer connected to a heater. The water bath was maintained at 100°F. All the buckets and cylinder molds were kept in the water bath throughout the testing. The buckets were not submerged in the water bath, but the water came up to just under the lid for the buckets, which is shown in Figure 3.3. The two extra buckets in Figure 3 were for another project not discussed in this paper.

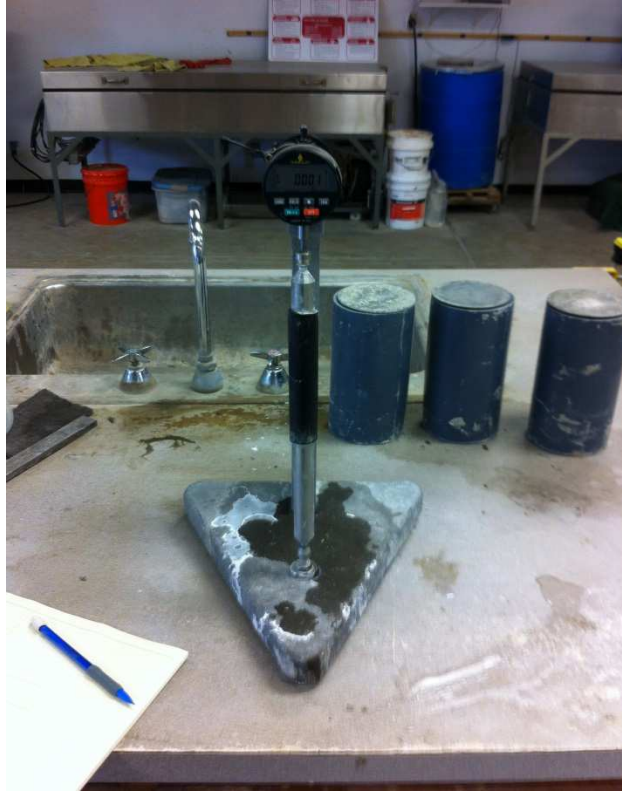
Figure 3.4. Length Change Comparator

The initial length for each core was recorded using a length change comparator which is shown in Figure 3.4. The cores were then placed into their respective buckets and placed into the water bath. Subsequent readings were taken every week for one year. Before each reading, the buckets were removed from the water bath and placed into an environmental chamber at 73°F. The buckets were allowed to cool for at least 16 hr. Each core was then removed from the buckets and measured twice using the length change comparator. The cores were measured the same way every time to ensure equivalent readings. After the lengths had been recorded, the cores were placed back in the bucket but the cylinders were flipped, so that one end of the core did not always take the weight of the core. The buckets were then returned to the water bath. At six months, the 1N NaOH solution in the cylinders was replaced.

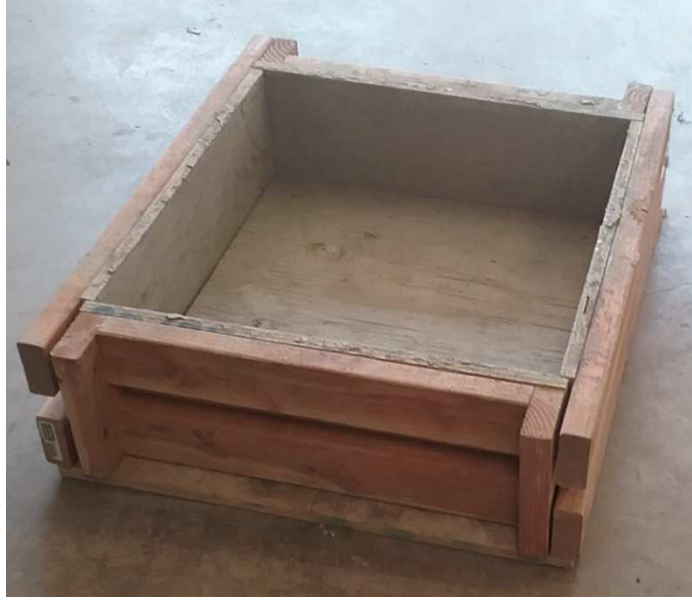
Figure 3.5. Formwork

The concrete was mixed and placed into two forms that were two feet by two feet by eight inches deep as shown in Figure 3.5. The bottom of the forms was made of plywood with four holes, so that gage studs could be placed into the concrete. As the concrete was placed into the forms, it was rodded and consolidated. After the concrete was placed, the surface was finished with a trowel.
