# Slope Stability Monitoring Using Remote Sensing Techniques

A thesis submitted in partial fulfillment  
of the requirements for the degree of  
Master of Science in Civil Engineering

Omar A. Conte Robles  
Missouri University of Science & Technology  
Bachelor of Science in Civil Engineering, 2010

May 2012  
University of Arkansas

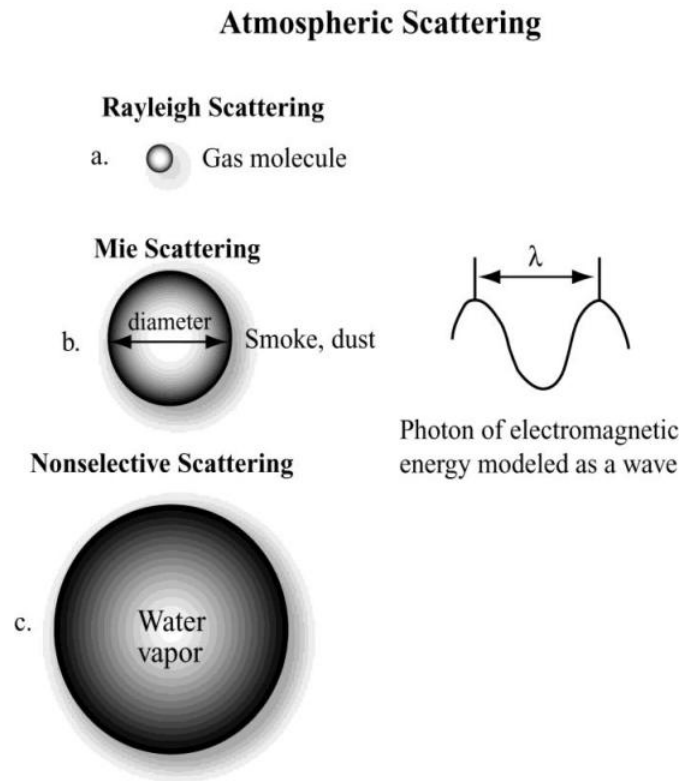
**Figure 2.2. Penetration of RADAR waves due to wavelength being larger than atmospheric molecule diameter (from Jensen, 2007).**

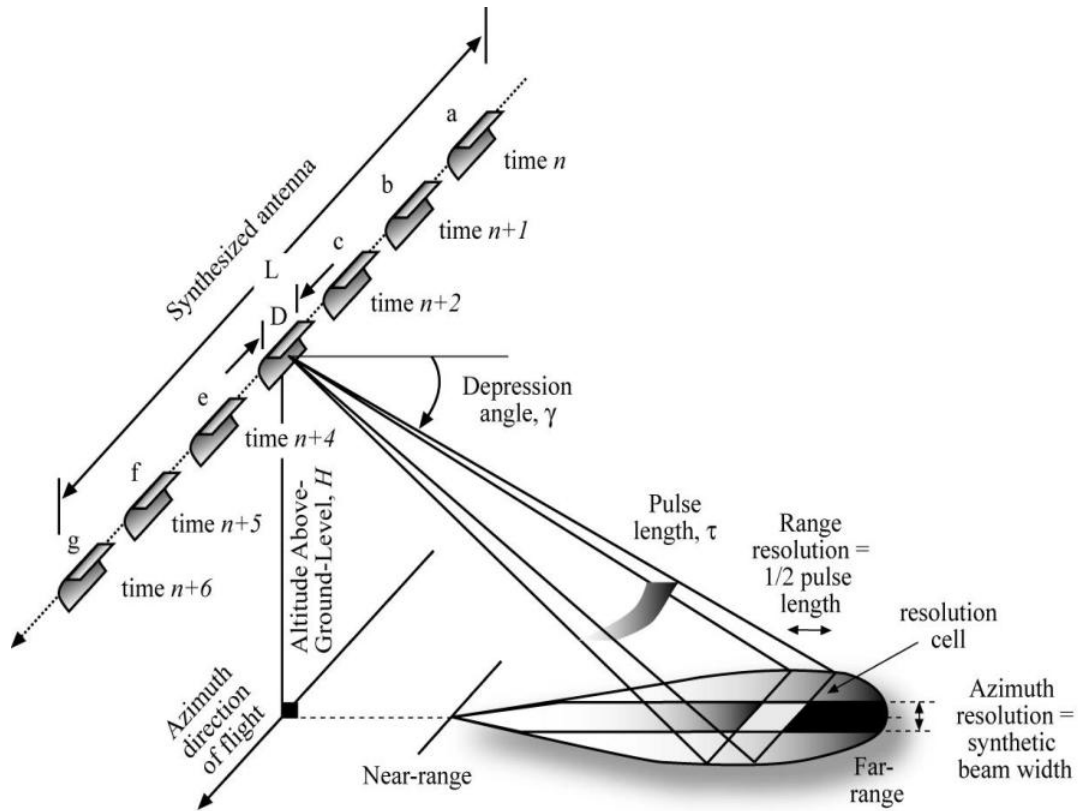
**Figure 2.4. Schematic showing satellite based synthetic aperture RADAR concept (from Jensen, 2007).**

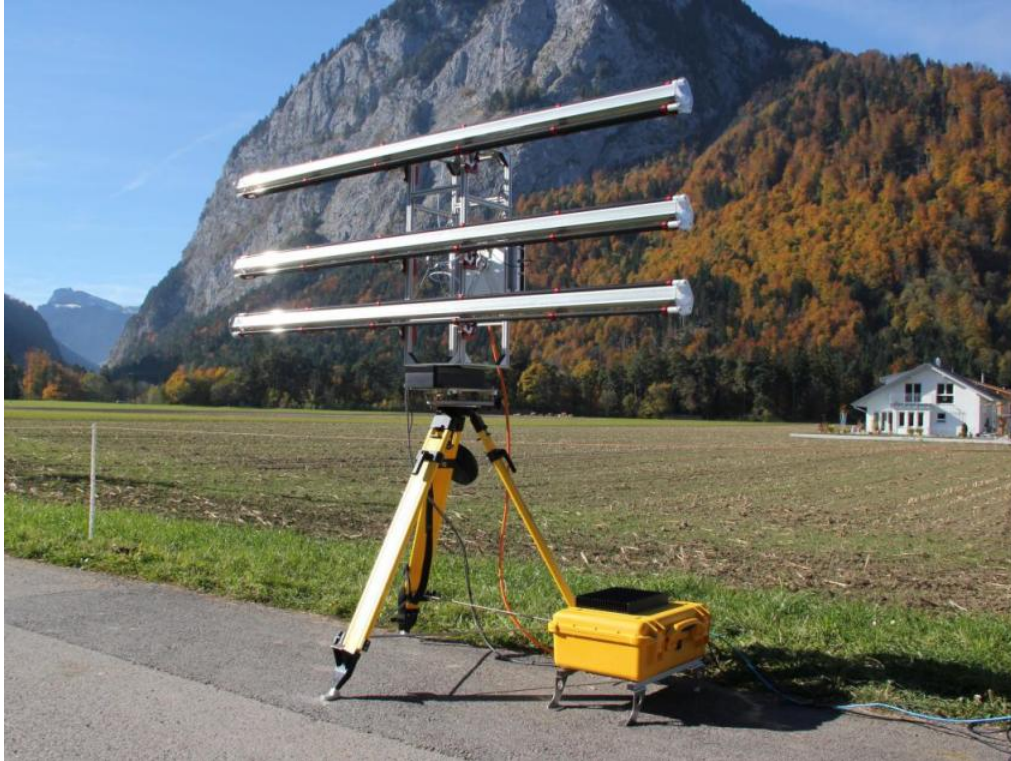
**Figure 2.5.** GPRI-II acquiring images of a mountain near Gumligen, Switzerland on October 31, 2010 (from GAMMA Remote Sensing AG, 2011).

The GPRI-II system utilizes three real-aperture antennas; two of the antennas are used to emit signals while one antenna is used to receive signals. The vertical separation between the two receiving antennas (25cm) provides different viewing geometries allowing for topography measurements to be obtained. A picture of the GPRI-II acquiring data in Switzerland in October, 2010 is presented in Figure 2.5. The high frequency of the RADAR (17.2GHz) corresponding to a long wavelength (1.74cm) allows the system to emit waves which travel through the atmosphere while also obtaining high sensitivity (sub-centimeter deformation) in the line-of-sight (LOS) direction. As stated before, the instrument is portable and is easily deployed with a minimal crew. The typical set up time for a two member crew is between 30 minutes and one hour. After the RADAR is deployed individual measurements are acquired in less than thirty-six seconds for a 360 degree field of view (Figure 2.6) to operational distances of 0.1 to 4 kilometers (GAMMA Remote Sensing AG, 2011).

The system is comprised of: the antennas (2.7kg each), the tower (8kg), the RF electronics (4kg), tribrach/stepper motor (10kg), tripod (4kg), and field computer/controller located with a pelican case (14kg), and a generator (25kg). The approximate total weight of all of the equipment is 73kg. The device is conveniently transported in three pelican boxes and a transport bag, specifically: the RF assembly and field computer are stored in one box, the tower and tribrach/stepper motor are stored in one box, the three antennas are stored in one box, and the tripod is stored in the transport bag.

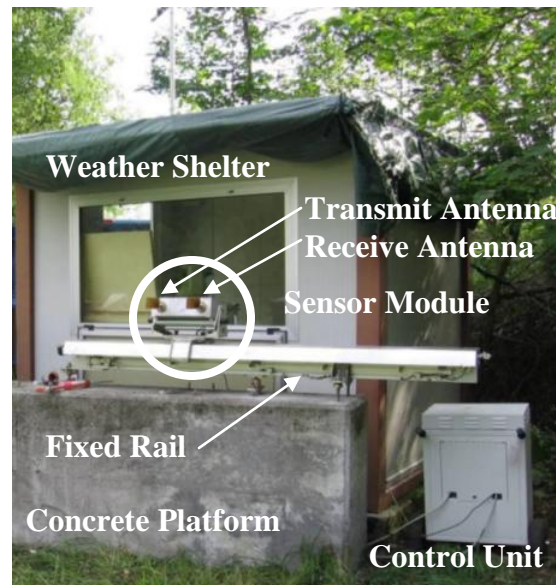
**Figure 2.7. IBIS-L system at the Tessina landslide site (modified from Ingegneria Dei Sistem Online Brochure, 2007).**

RADAR is commonly placed within or next to a weather shelter (Figure 2.7) and is specifically intended for monitoring displacements of slopes and structures.

As shown previously in Figure 2.7, the IDS IBIS-L uses a 2.5m long fixed rail bolted to a concrete platform or into bedrock. The sensor module, consisting of two horn antennas (one transmitter and one receiver) moves along the rail to acquire data (Jungner, 2009). The IBIS-L control unit is comprised of a computer with the software necessary to control this RADAR system and a battery pack necessary for powering the device. Power for the RADAR is supply by two 12V car batteries which also provides power to the computer and other external components (Jungner, 2009). A range resolution of 0.5m is obtained by sampling at a frequency of 17.1GHz ( $K_u$ -band), corresponding to a wavelength of 1.8cm. At this frequency and power, the maximum range for this system is 4.0km and data is collected for approximately five minutes to collect an image. According to Junger, 2009, this RADAR system weights approximately 170kg total (10kg sensor module, 54kg baseline rail, and 89kg power supply with computer).

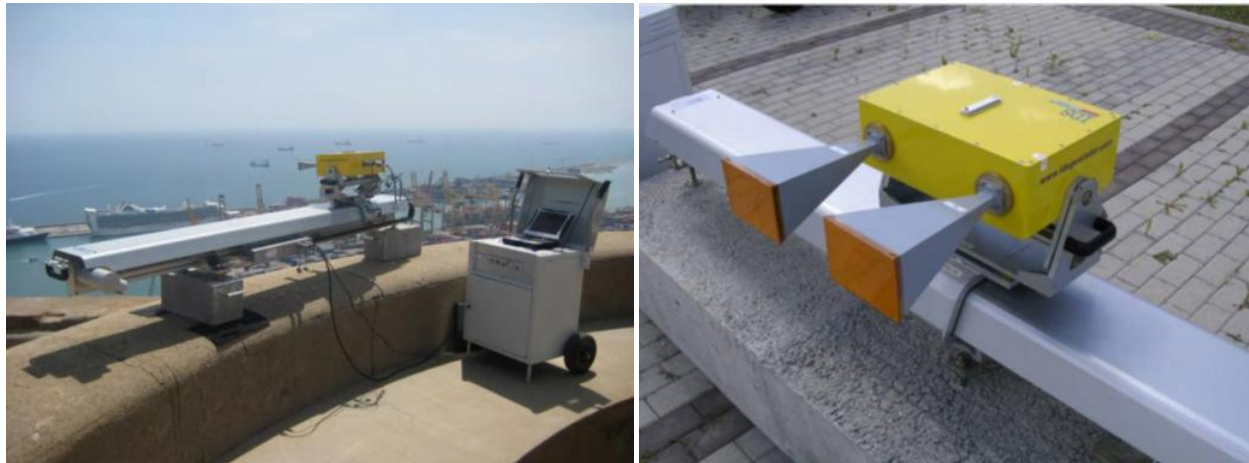
**Figure 2.8.a) IBIS-L RADAR system: rail, sensor module, and computer/power component (from (Jungner, 2009), b) IBIS-L sensor module composed of receiver and transmitter antennas (from Ingegneria Dei Sistem Website, 2012)**

In a similar fashion to satellite based sensors, the IBIS-L uses SAR technology for image acquisition and interferogram computations. The small antennas synthesize to become a 2m antenna when the system moves along the rail. The wavelength and antenna length of the IBIS-L system results in a cross range resolution of 4.5mrad (Ingegneria Dei Sistem Online Brochure, 2007). Photographs of the IBIS-L system are presented in Figure 2.8.

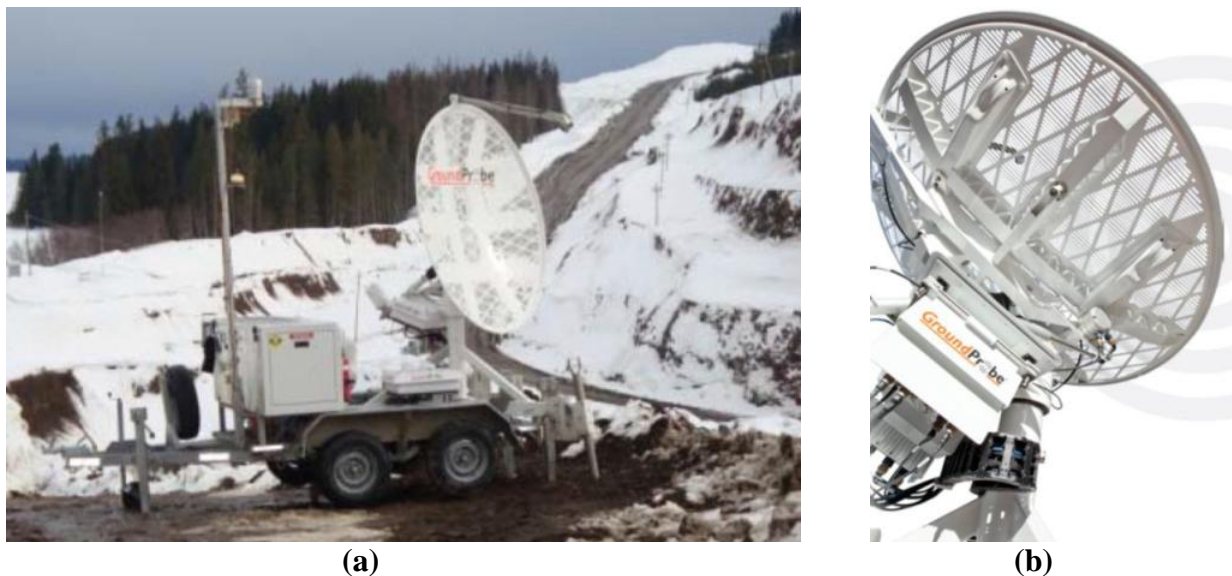
**Figure 2.9. a) Photograph of the trailer mounted GroundProbe SSR acquiring data, and b) detailed photograph of the SSR parabolic dish antenna (from GroundProbe, 2012).**

The SSR has been proven to work under extreme environmental conditions. The deployment time for the SSR is approximately 20 minutes and a typical scan repeat time is 15 minutes (GroundProbe, 2012). The maximum range is 3500m from the source of interest, measuring displacements to  $\pm 0.2\text{mm}$  without the use of reflectors (McHugh et al., 2006). Photographs of the SSR system are presented in Figure 2.9.

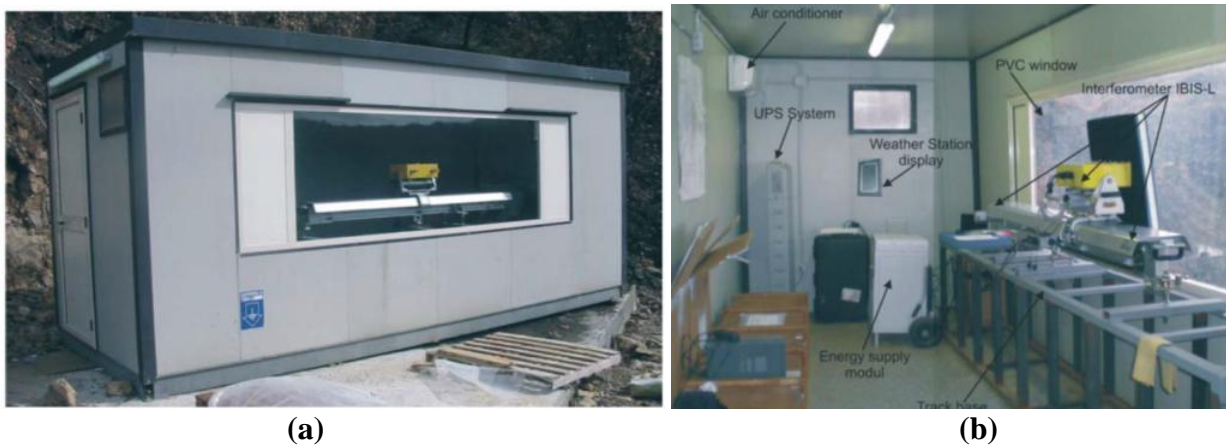
**Figure 2.13. a) Photograph of the exterior of IBIS-L platform enclosure, and b) photograph of the interior of the platform enclosure including the IBIS-L system (from Bozzano et al., 2008).**

The geology of the site consisted of sandy marine deposits with some sandy colluvial deposits on top of fractured and weathered rock. The landslide was known to have experienced a deep rotational slide with a main sliding surface in the past. This deep rotation movement and the other observed small translational movements necessitated the need for this research (Bozzano et al., 2008). A picture of the platform used in this research and the observed landslide site are presented in Figure 2.12. The exterior and interior views of the platform enclosure are presented in Figure 2.13.

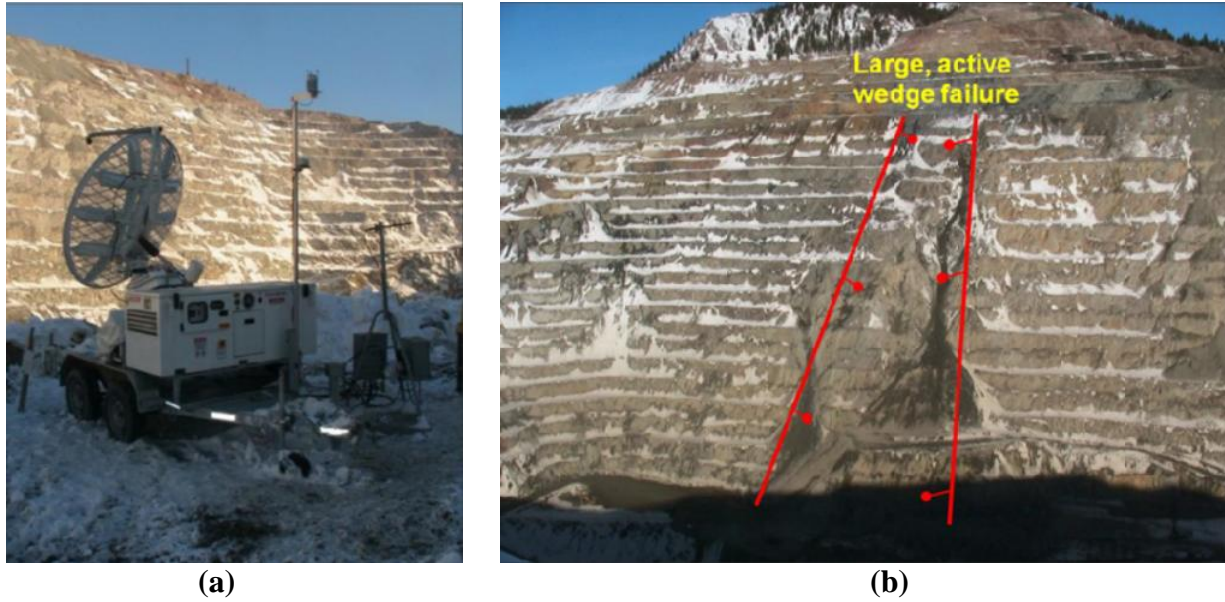
**Figure 2.14. GroundProbe SSR deployed at Thompson Creek Mine, and b) wedge failure located in the central portion of the north highwall (from Harries et al., 2009).**

Several slope accelerations, within the wedge failure, were detected using the SSR. On October 30, 2008 a significant acceleration event was recorded. For safety reasons the all personnel and equipment were cleared from the area. Four days later, on November 3rd, failure occurred. The catastrophic failure discharged about 70,000tons of material (Harries et al., 2009). Because of the use of remote sensing techniques, and the decisions made based on the data obtained from the remote sensing device, no injuries or equipment loss occurred during the failure. A picture of the SSR acquiring data at the open pit mine and the active failure wedge are presented in Figure 2.14.

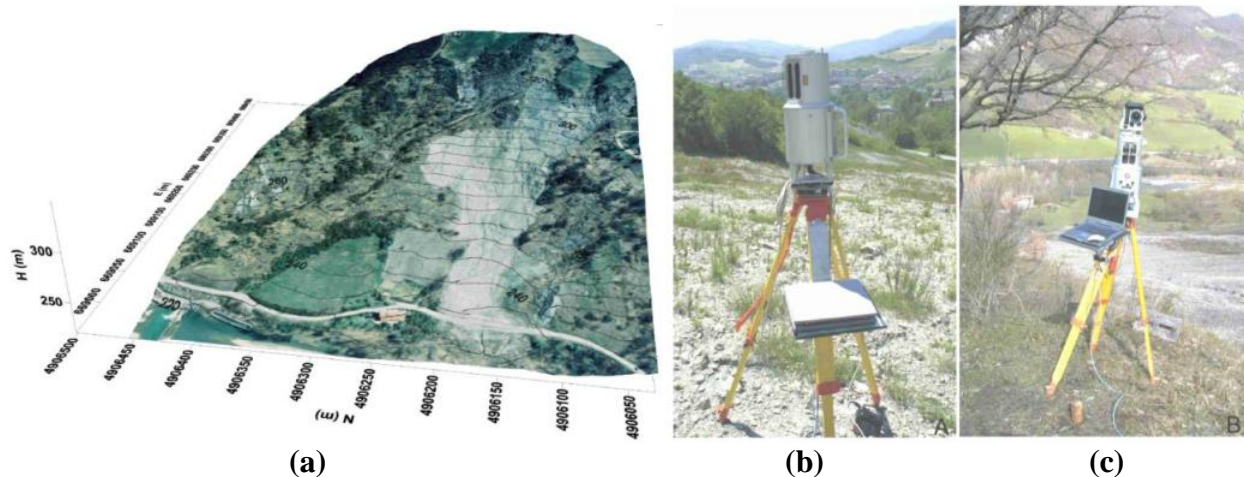
**Figure 2.19. a) Three dimensional digital elevation model created from aerial photogrammetric survey in 2000, b) Riegl LMS-Z210 on site in 2001, c) Riegl LMS-Z420i on site in 2004 (from Bitelli and Zamutta, 2004).**

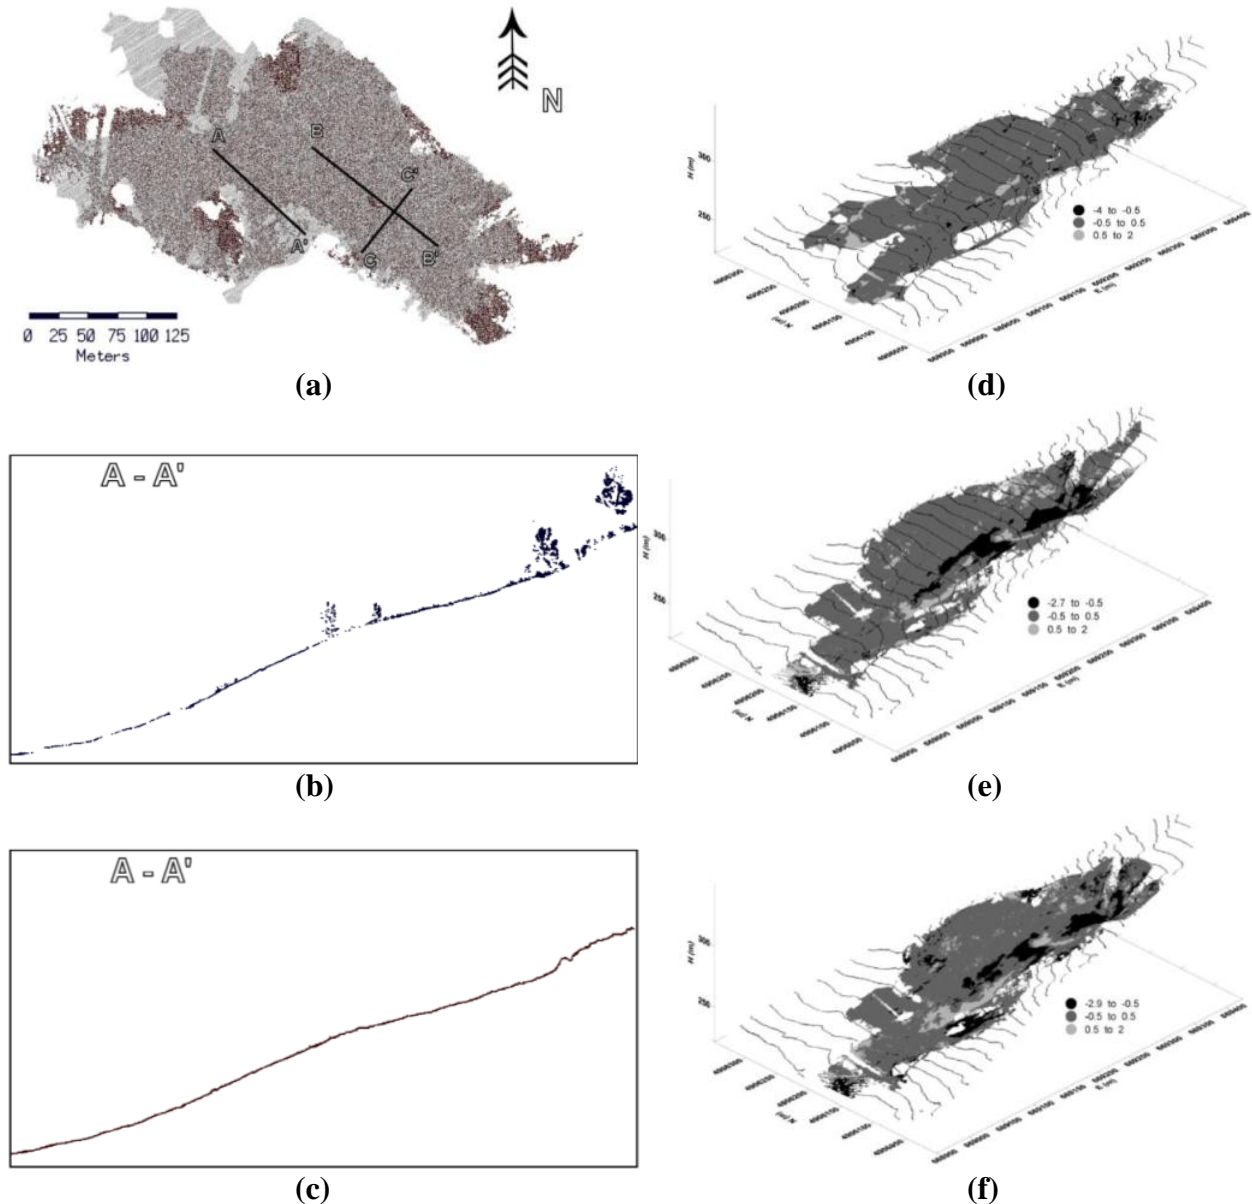
**Figure 2.20. a) Different cross-sections shown in the original point cloud, b) LIDAR cross-section before filtering, c) LIDAR cross-section after filtering and vegetation removal, d) comparison of the 2000-2001 DTMs, e) comparison of the 2000-2004 DTMs, f) comparison 2001-2004 DTMs (from Bitelli and Zamutta, 2004).**

The differences between the Digital Terrain Models (DTMs) obtained from the 2000 photogrammetric survey and the 2001 LIDAR survey were negligible. Some minor movement was observed in distinct areas, but this was attributed to effects of vegetation growth which was not properly filtered out during image processing. Conversely, significant elevation changes were observed when comparing the first two surfaces with the surface obtained from the 2004 LIDAR survey. The 2001-2004 DTM comparison revealed the greatest movements. Negative values (indicating downward movement) were located in the scarps of the landslide, as expected; however, positive values (uplifts zones) were not located at the foot of the landslide, as expected by the researchers. Cross-sections of the LIDAR point cloud before and after filtering, and comparison surfaces obtained from the three surveys are presented in Figure 2.20.

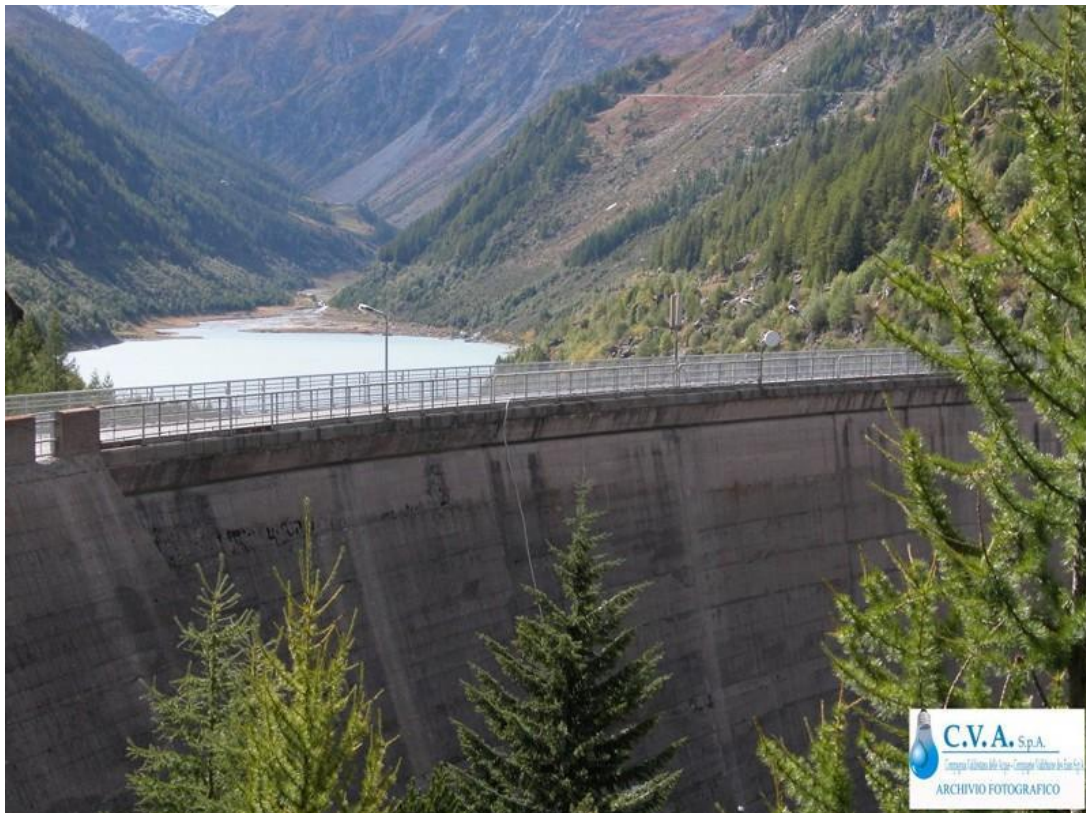
Figure 2.23. Photograph of BDSGSD site (from Valle d' Aosta Website, 2012).

Multiple instruments used for monitoring (inclinometers, GPS, extensometers) were implemented between the completion of dam construction and the commencement of the research project. In 2003, a robotic total station was installed on the south-eastern (right) slope (considered to be stable) to monitor 19 targets located in the north-western (left) slope (known to be unstable). Daily measurements were acquired at night to obtain the coordinates (x, y, z) of each point. The GBInSAR system was installed in 2008, and was also located on the south-eastern (right) slope. RADAR image acquisitions were conducted every 20 minutes for a period of four months (from June 2008 to October 2008) with a spatial resolution of 0.5m (Barla et al., 2010). All of the monitoring systems installed at the BDSGSD site are illustrated in Figure 2.22. A picture of the site and Beauregard dam is presented in Figure 2.23.

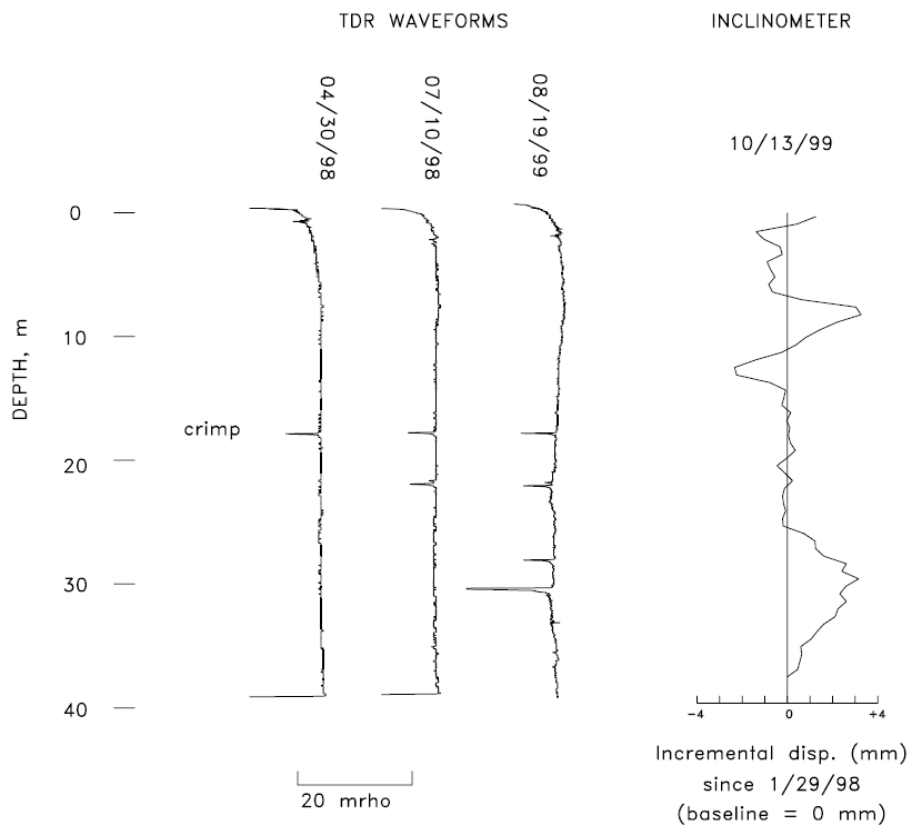
**Figure 2.27. TDR waveforms and inclinometer profile against depth for case 1 (from Dowding and Connor, 2000).**

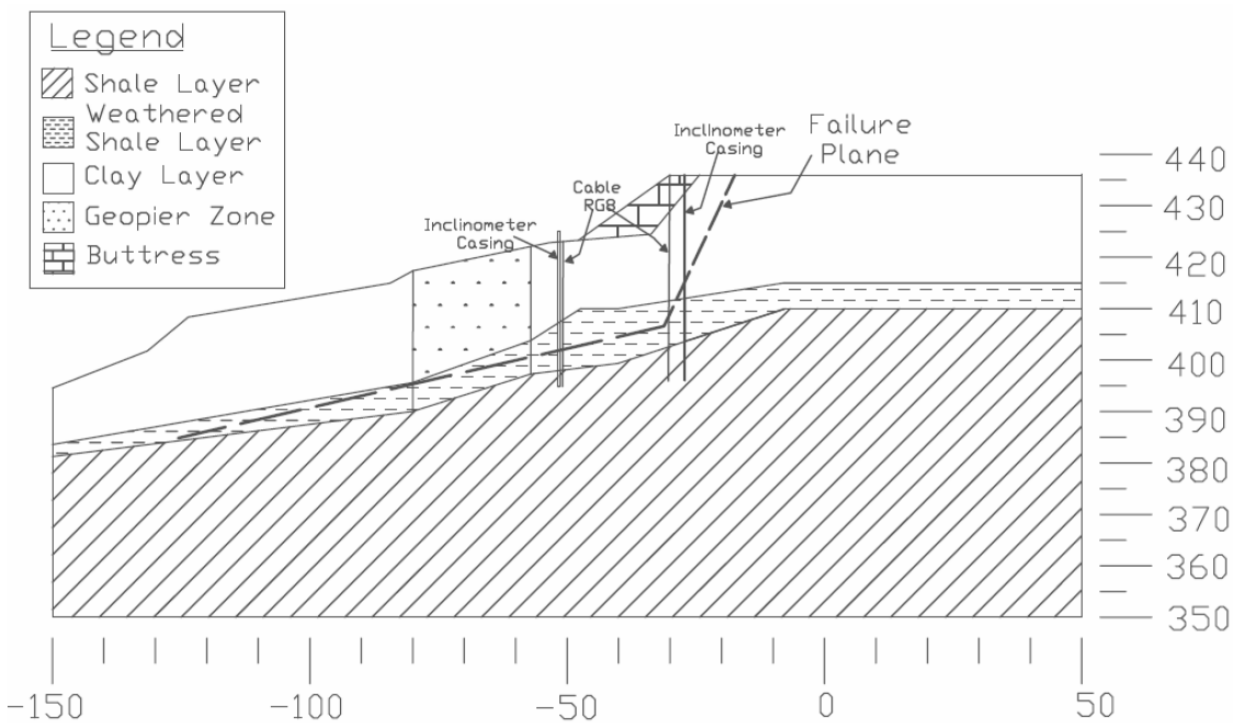
**Figure 2.29. Cross-section of the test area along Highway 167 with instrumentation used (from Dennis et al., 2006).**

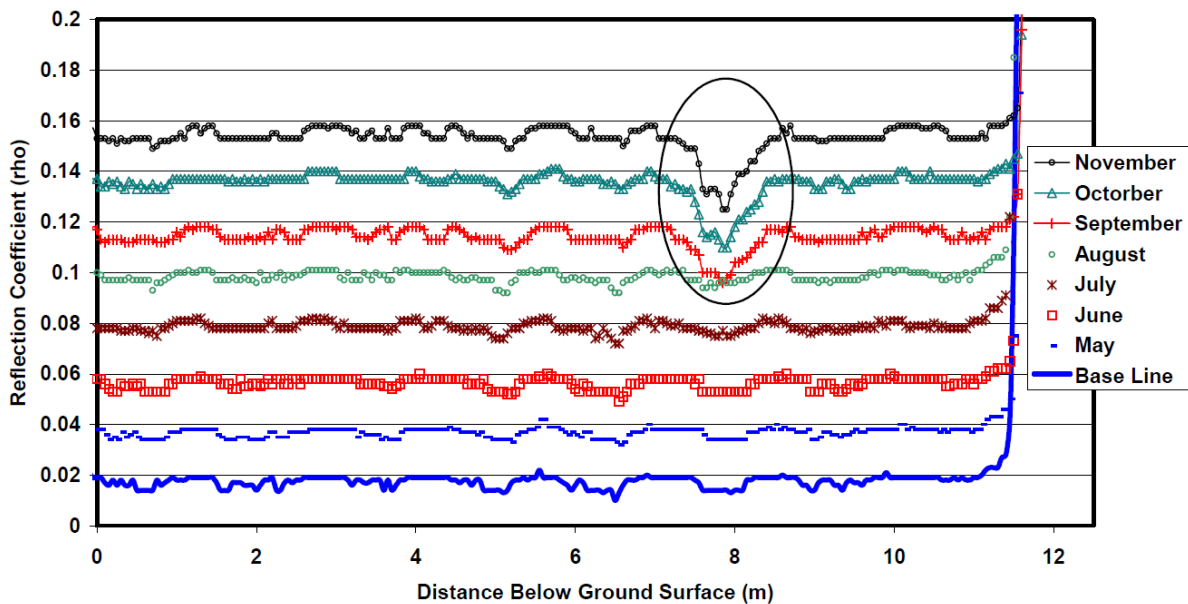
Figure 2.31. Monitoring results obtained by TDR on the Highway 167 project site (from Dennis et al., 2006).

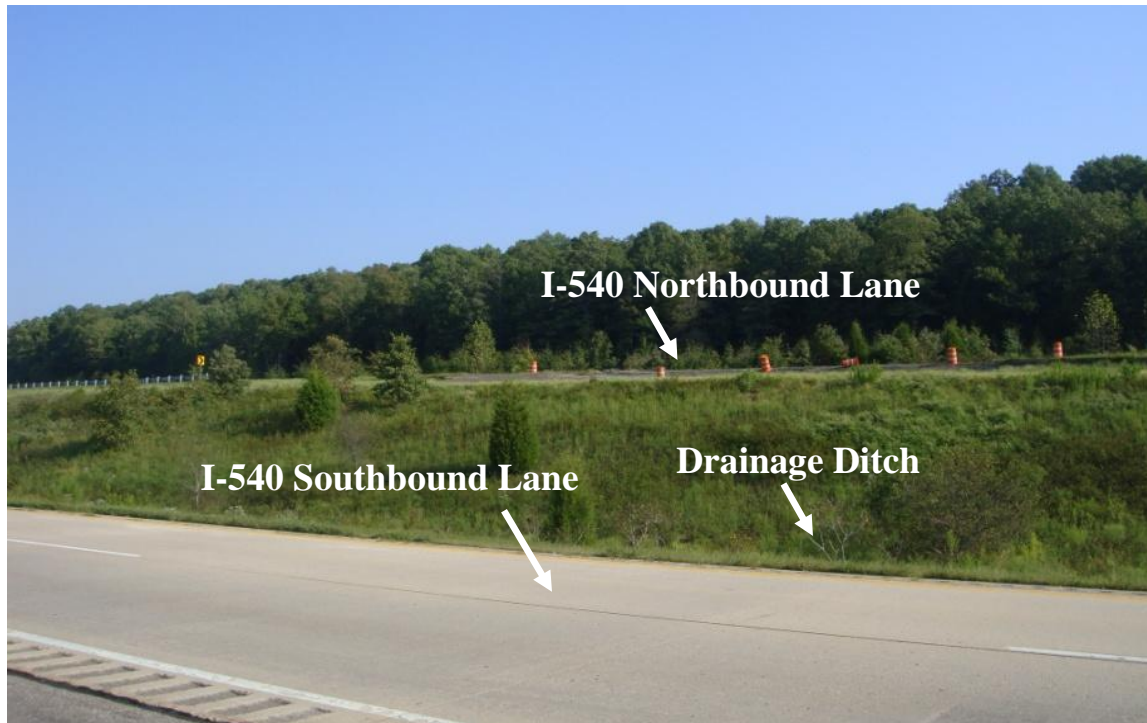
**Figure 3.2. Photograph obtained while looking northeast across southbound lane of I-540 at calibration site near Chester, Arkansas.**

The location of the calibration site was ideal for research operations due to the lack of population in the area where the slide is located; however, the slope failure is located in the median of I-540, a major transportation artery in Northwest Arkansas. The surface extents of the study area was approximately 550 feet long (in the direction of the roadway) and extend from the west shoulder of the northbound lanes to the east shoulder of the southbound lanes (transverse to the roadway). A picture of the site, as obtained from the west shoulder of the southbound lane of I-540, is presented in Figure 3.2.

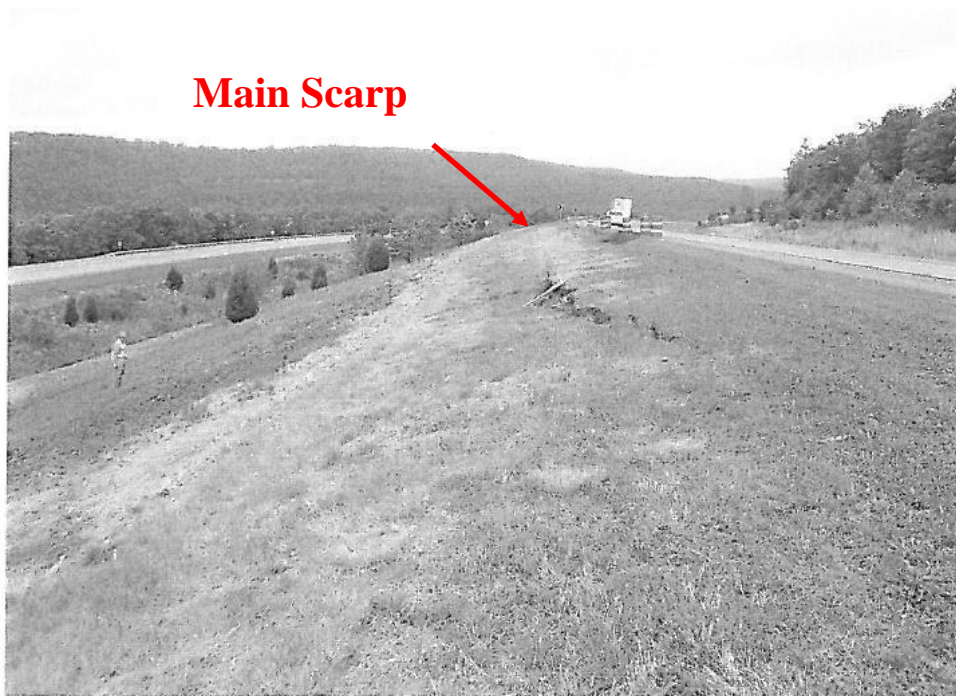
**Figure 3.3. Looking north to the main scarp at the calibration site near Chester, Arkansas in May 2010 (from AHTD, 2010).**

A geotechnical investigation conducted by AHTD in May 2010 was documented in an AHTD report in August of that year (AHTD, 2010) which summarized the findings of the investigation and suggested remediation techniques. Specifically, a rock buttress was suggested to repair of the slope failure. However, only partial reparation of the slope was performed on this site prior to the completion of this research project (TRC-1102). Photographs of the site looking north towards the main scarp during the geotechnical investigation conducted in May 2010, and a picture of the same scarp in September 2010 (during the initial visit to the site by UofA personnel) are presented in Figure 3.3 and Figure 3.4, respectively. The 18-inches of vertical movement causing the head scarp and a tension crack located in the median, as observed during the September 2010 visit, are shown in Figure 3.5.

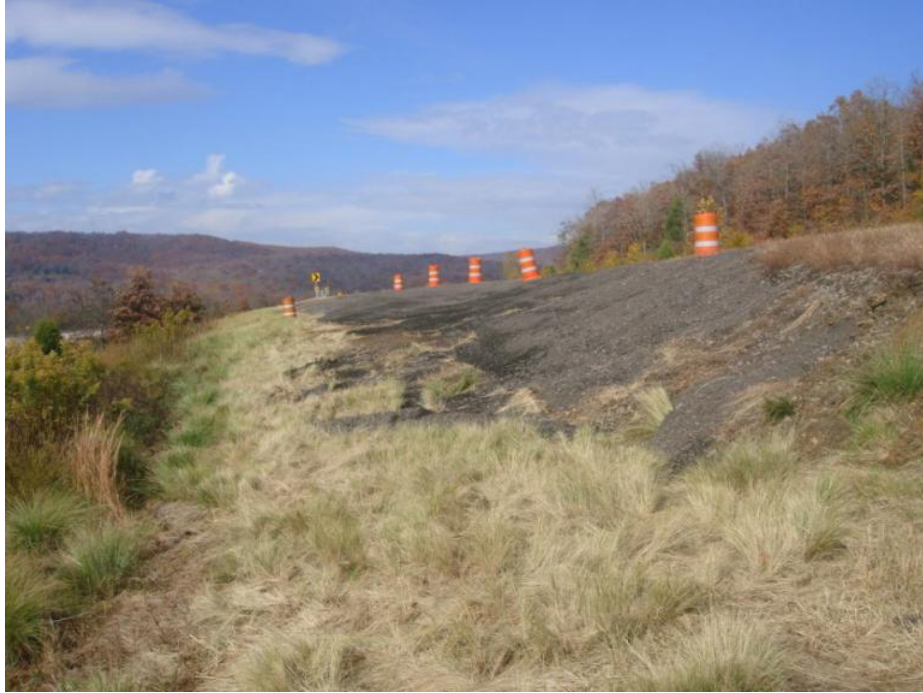
**Figure 3.4. Looking southeast to the main scarp at the calibration site near Chester, Arkansas.**

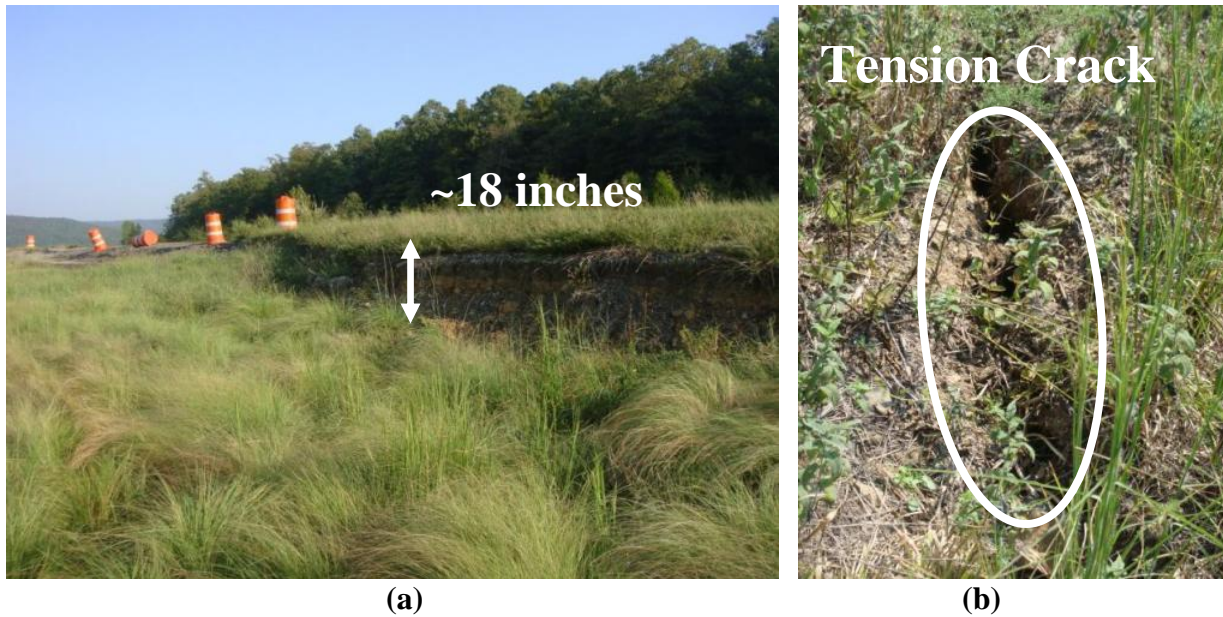
**Figure 3.5. a) Looking north, the main scarp at the calibration site located in Chester, Arkansas, and b) tension crack observed in the median of I-540.**

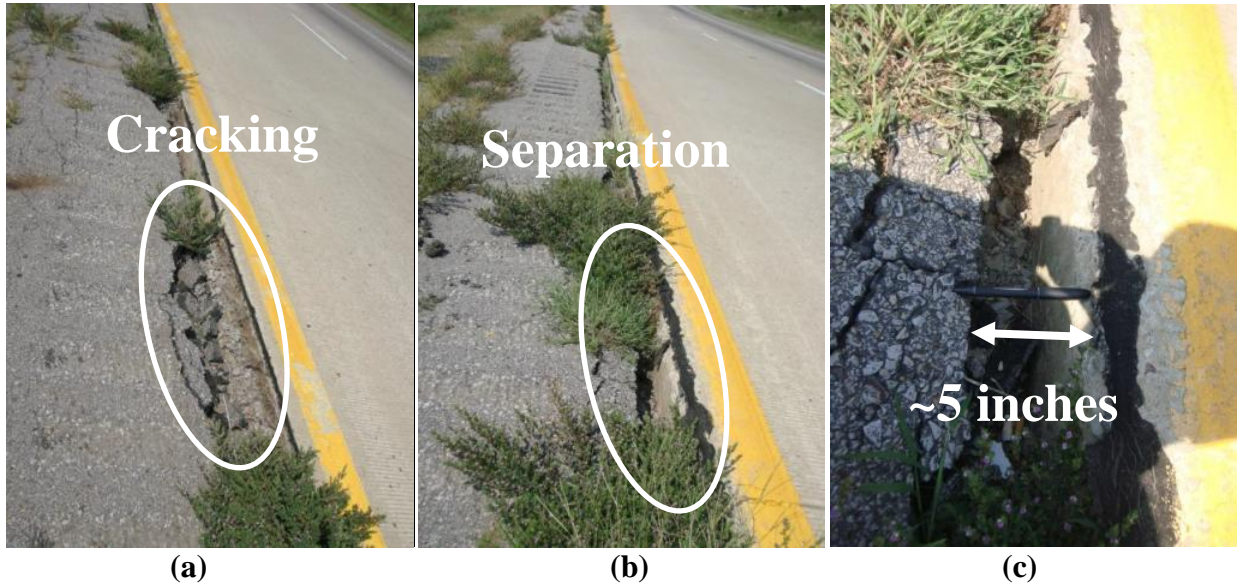
**Figure 3.6. a) Cracking in the edge of northbound lane, b) separation between the shoulder and the road on the I-540 northbound lane, and c) separation of approximately 5 inches observed during September 2010.**

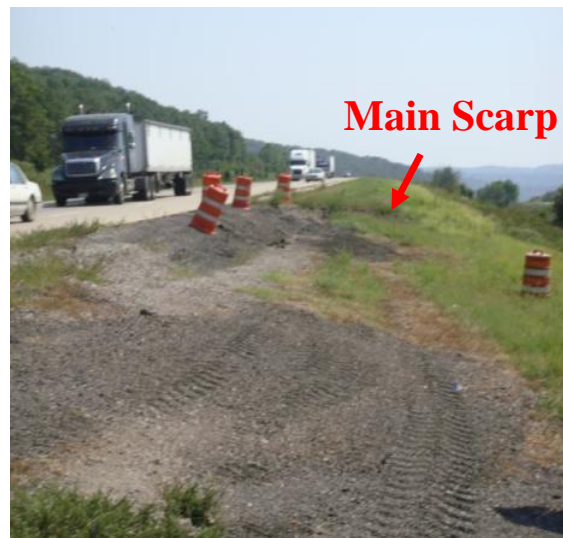
**Figure 3.7. Traffic passing next to the main scarp in calibration site near Chester, Arkansas.**

transportation road between the northwest section of the state and major cities as Fort Smith and Little Rock. In addition, this section is highly used by other traffic carrying passengers and cargo between Northwest Arkansas (Fayetteville, Bentonville, Springdale, and Rogers) and the Fort Smith/Little Rock regions. The external loads applied daily by this traffic were anticipated to have aided in the failure of the slope. A picture of traffic in the northbound lane of I-540 next to the partially repaired main scarp is shown in Figure 3.7.

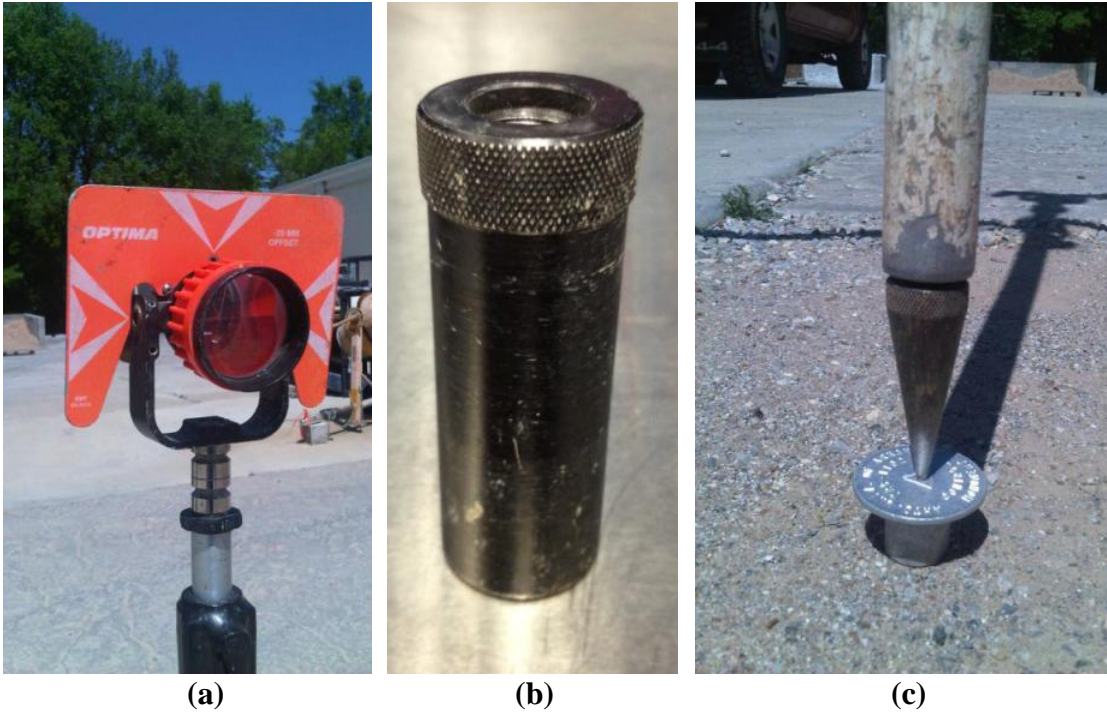
**Figure 3.9. a) Optima 30mm prism, b) flat shoe for prism pole, and c) pointed shoe on the prism pole.**

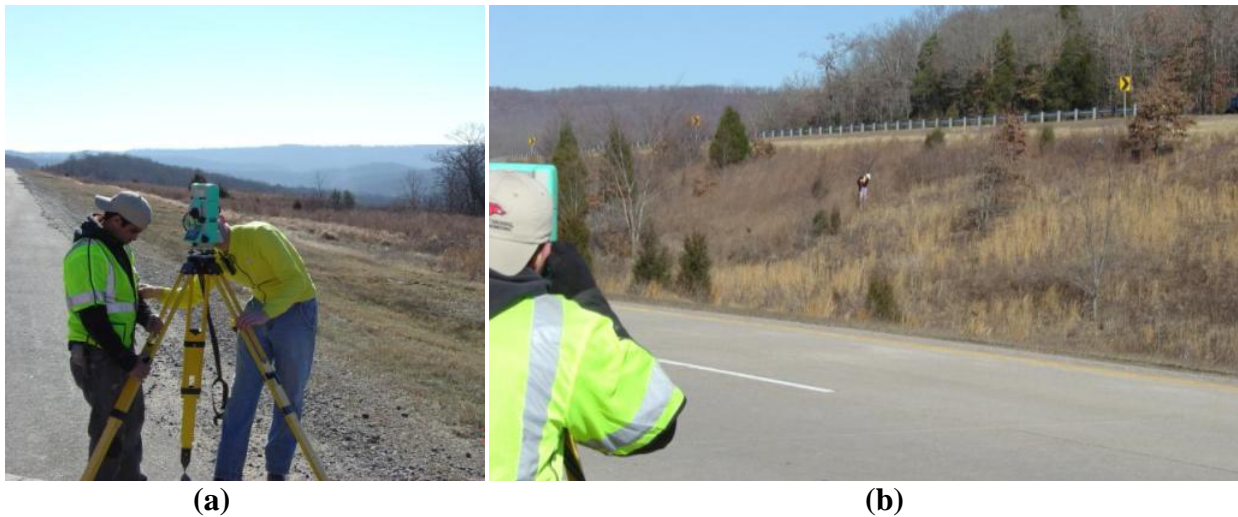
**Figure 3.10. Researchers from the UofA a) preparing the total station for data acquisition, and b) acquiring topographic data at the calibration site near Chester, Arkansas.**

A topographic survey was performed using: a Nikon DTM-520 total station, a Leica tripod, a Carlson Explorer 600+ data collector, a Sokkia prism pole with bipod legs, and a Optima 30mm offset prism (Figure 3.9). During the survey, important features of the site such as: the ditch, the edge of the lanes, tension cracks, guard rails, and the main scarp were identified. Random topographic points were also acquired using a 25 foot square grid. A flat shoe was placed on the end of the prism pole to collect the points marking the ditch, tension cracks, guard rails, main scarp, and topography points, while a pointed shoe was used to collect the points marking the edge of the lanes (Figure 3.9). Extra data was collected for the main scarp, where more than 15 points were acquired, to increase the spatial resolution of the model at this location. Photographs of researchers from the University of Arkansas (UofA) preparing the total station for data collection and acquiring data with the total station are presented in Figure 3.10.

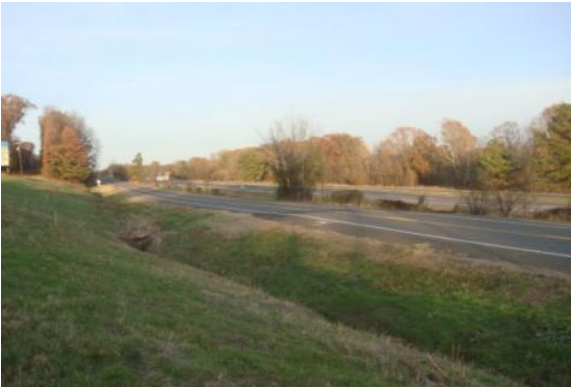
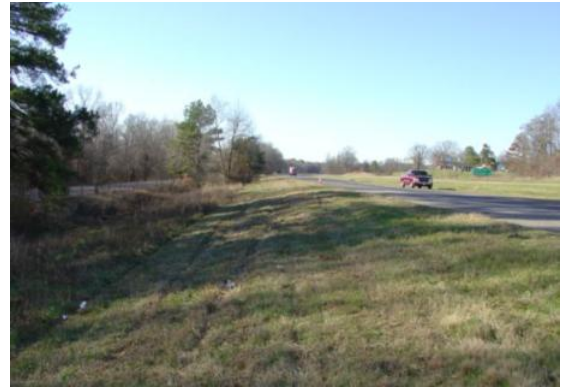
**Figure 3.15. a) Looking southwest from the hillside between Highway 84 and I-30, and b) looking west towards I-30 at the validation site near Malvern, Arkansas in December 2010.**

The landslide at this site had previously unknown extents, but its effects were noticeable along the whole site. The site is composed of private land on a hill side, a two lane highway (Highway 84), a median between Highway 84 and the interstate (Interstate 30), a median between the westbound and eastbound lanes of I-30, a median between I-30 and Haltom Road, Halton Road, and a strip of vegetation between Halton Road and the Ouachita River. The Ouachita River is believed to contribute to the instability of the site by removing the toe of the landslide. Photographs of the site, taken by UofA personnel during the site visit in December 2010, are presented in Figure 3.15.

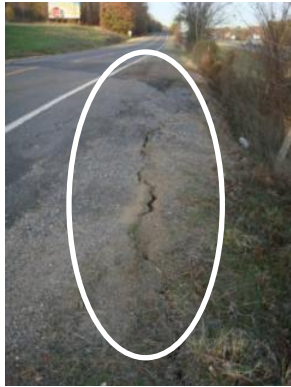
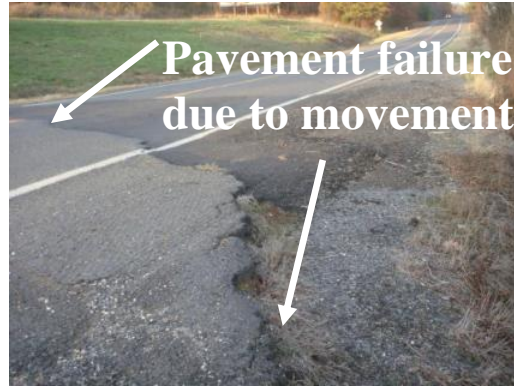
**Figure 3.17. a) Tension cracking in the shoulder of the eastbound lane of Highway 84, and b) lane cracking and settlement failure in Highway 84.**

During the first visit to the validation site by UofA personnel December 2010, several tension cracks were observed along the shoulders and in the roadway lanes; however, a visible main scarp was not detected at this site. Images of observed tension cracking are presented in Figure 3.17 and Figure 3.18

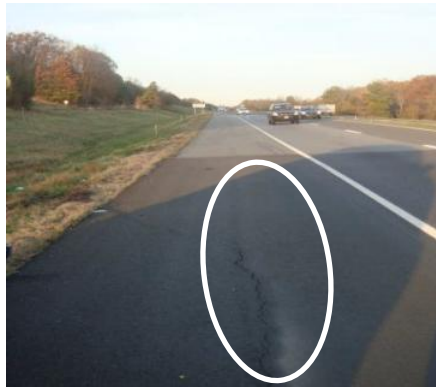
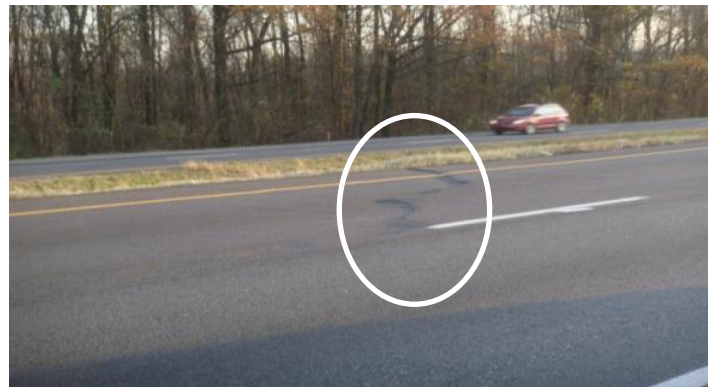
**Figure 3.18. a) Crack observed in the shoulder of the westbound lane of I-30, and b) crack in the westbound lane of I-30 in December 2010.**

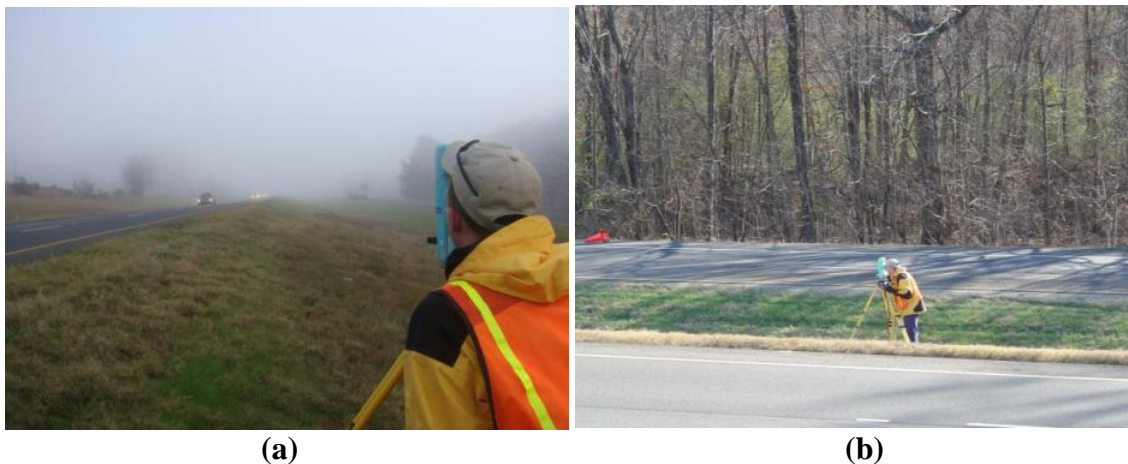
**Figure 3.21.a) University personnel acquiring points for topographic model, b) looking South to the total station set up point in validation site near Malvern, Arkansas.**

A topographic survey was performed using the same equipment used at the calibration site (as described in Section 3.2.2.1) including: a Nikon DTM-520 total station, a Leica tripod, a Carlson Explorer 600+ data collector, a Sokkia prism pole with bipod legs, and a Optima 30mm

offset prism. During the survey, important features of the site such as: the ditch, the edge of the lanes, and the tension cracks were identified. Random topographic points were also acquired using a 50 foot square grid. Photographs of researchers from the University of Arkansas (UofA) preparing the total station for data collection and acquiring data with the total station are presented in Figure 3.21.

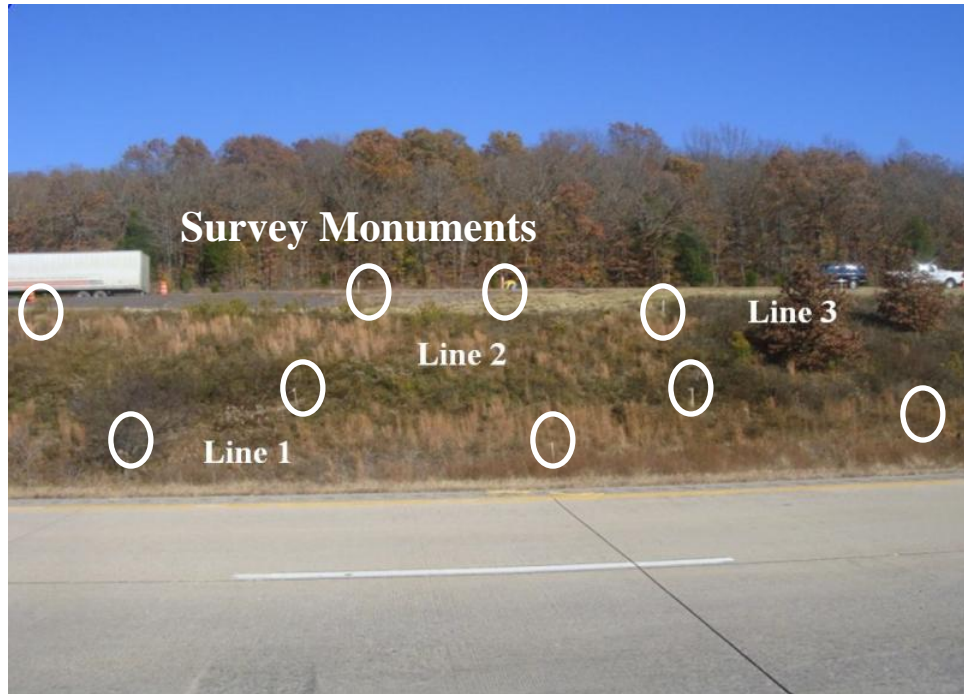
Figure 4.2. Relative positioning of survey monument lines at the calibration site (Chester, Arkansas) looking east from the Southbound lane of I-540.
