# Slope Stability Monitoring Using Remote Sensing Techniques

A thesis submitted in partial fulfillment  
of the requirements for the degree of  
Master of Science in Civil Engineering

Omar A. Conte Robles  
Missouri University of Science & Technology  
Bachelor of Science in Civil Engineering, 2010

May 2012  
University of Arkansas

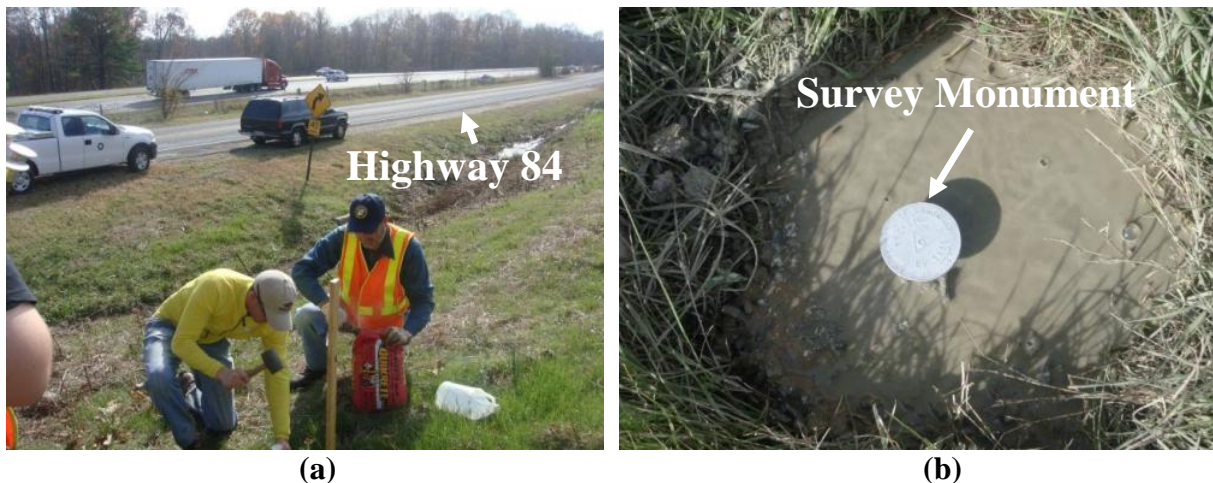
**Figure 4.5. a) Installation of survey monument in the ground by UofA and AHTD personnel, and b) survey monument installed in the ground using Quickcrete®.**

The Malvern site was instrumented with 53 survey monuments using the same procedures used at the Chester site (as described in Section 4.2.1). Forty-one monuments were installed on December 3<sup>rd</sup>, 2010 and twelve monuments were installed on January 6<sup>th</sup>, 2011. The monuments (Figure 4.5 and Figure 4.6) were installed in five lines (Figure 4.7) along the interstate (East-West direction). From North to South, the first line (6 monuments) was located north of the Highway 84; the next two lines were installed in a staggered (zigzag) pattern, and were located in the median between Highway 84 and the Westbound lane of I-30 (22 monuments); the next line (where the total station benchmark [Point 1000] was located) was in the median between the I-30 lanes (12 monuments); the fifth line was located just South of the I-30 Eastbound lane (12 monuments, these were the monuments installed on January 6<sup>th</sup>).

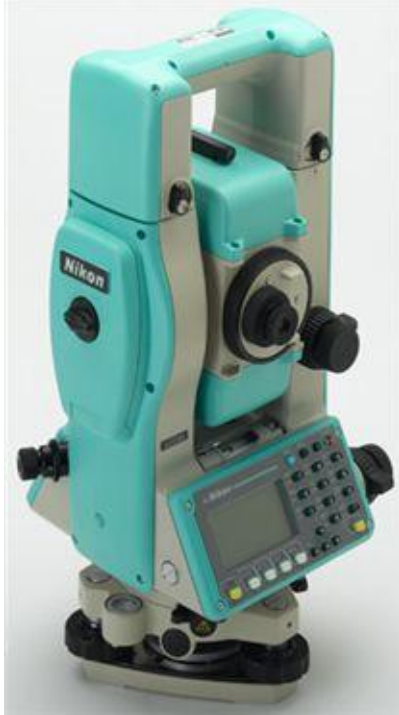
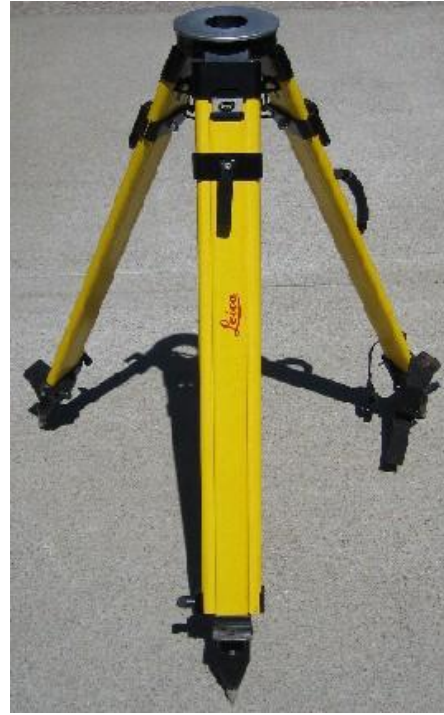
Figure 4.8. a) Nikon DTM-520 (Nikon Positioning Website, 2012), and b) Leica total station tripod utilized during this project.

One of the methods utilized for monitoring of the landslides located at the calibration and validation sites was performed using a total station. As previously discussed in Section 3.2.1.1, a Nikon DTM-520 total station mounted on a Leica tripod (Figure 4.8) was utilized for the entirety of this research project (AHTD TRC-1102). According to the Nikon Instruction Manual (2011), the maximum distance measurement using a single prism under ideal normal atmospheric conditions (ordinary haze with visibility greater than 12.5miles) is 5,300ft (1,600 m), with an accuracy of  $\pm (2 + 2\text{ppm} \times \text{distance [D]})$  mm. Furthermore, the maximum distance range under ideal good atmospheric conditions (no haze with visibility over 25miles/40km), using a single prism is 6,600ft (2,000m) (Nikon Instruction Manual, 2011). A single Optima 30mm-offset prism mounted on a Sokkia prism pole with bipod legs was utilized as a target (Figure 4.10).

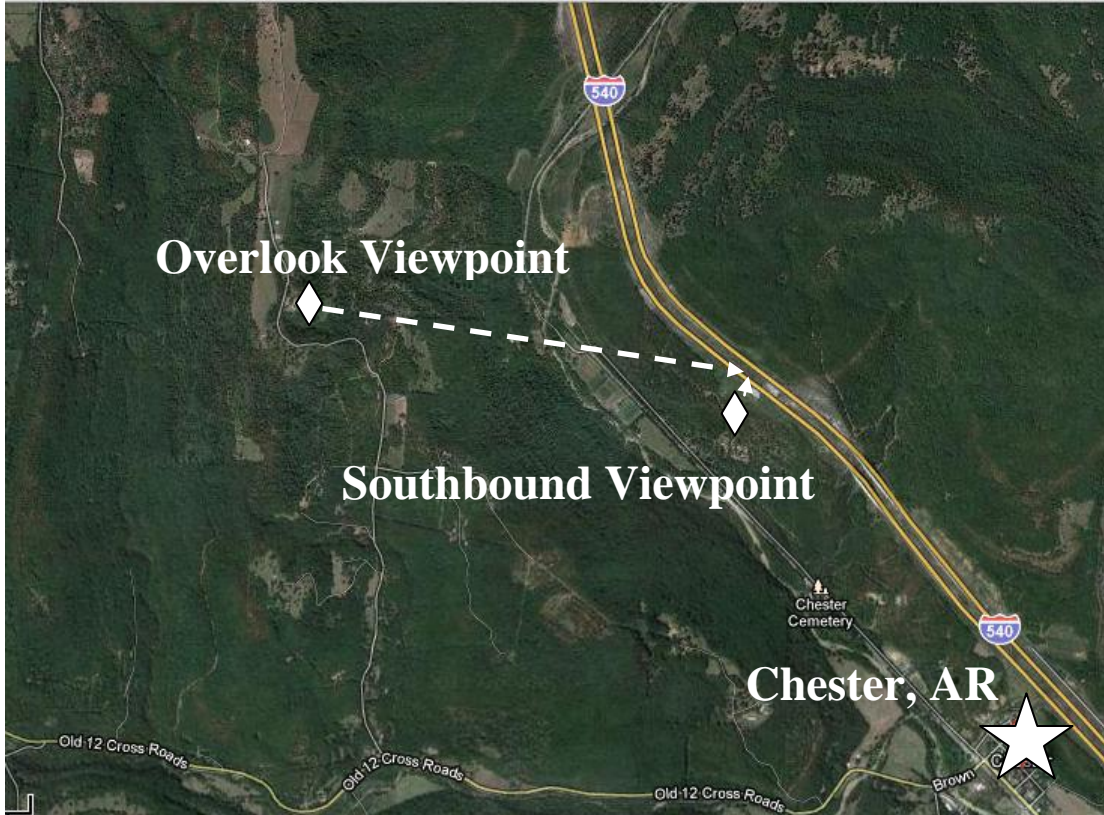
**Figure 4.16. RADAR viewpoints locations at look directions at the calibration site near Chester, Arkansas (modified from Google Maps, 2011).**

was located near the asphalt shoulder of the I-540 Southbound lane and the other was located approximately 6500 feet (2.0 km) West of the slide area. The corresponding observation points are hereinafter referred to as the southbound viewpoint and the overlook viewpoint, respectively, and the relative locations of each are presented in Figure 4.16. Photographs of the GPRI-II deployed at each site are shown in Figure 4.17.

with a short field of view (i.e. the RADAR was close to the sliding mass [approximately 100 feet]). As shown previously in Figure 4.16, the RADAR benchmark was placed due West of the center of the main scarp. Four concrete footings were utilized to deploy the GPRI-II at this viewpoint (Figure 4.18). Three concrete footings were used to secure the tripod legs to the ground using anchors, while the fourth concrete footing contained survey monument and served to align the RADAR in the same position during each visit. The setup procedure described in Section 4.4.1 was followed during each visit. Before acquiring images at the Southbound viewpoint, the GPRI-II was aligned to 4<sup>th</sup> fence wire (marked with surveying flagging) using the scope of the RADAR.

The Overlook viewpoint was selected based on the viewing geometry from this location. As shown previously in Figure 4.16, the Overlook viewpoint was located on a hillside located approximately 2km West of the calibration site. The distance from the site and the higher topographic elevation of the Overlook viewpoint, as compared with the sliding surface, permitted a panoramic view of the whole site. Only one concrete footing was place in the ground at the

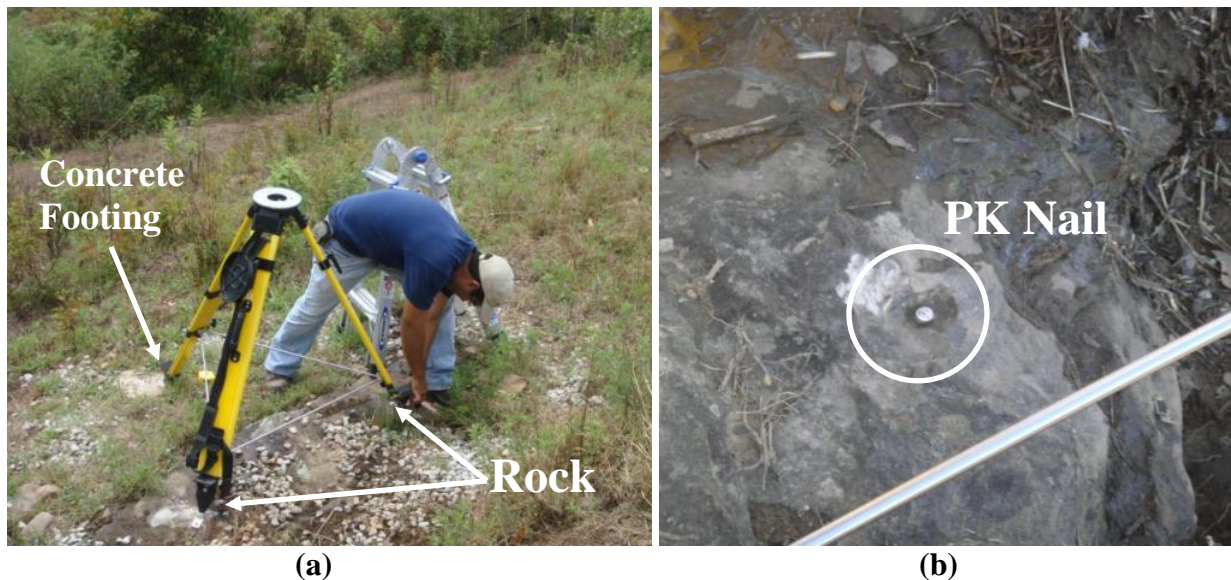
**Figure 4.19.** a) Anchoring tripod to rock at the Overlook viewpoint, and b) PK nail in rock used to center the GPRI-II at the Overlook viewpoint near Chester, Arkansas.

overlook viewpoint (supporting the downhill leg of the tripod). The other two tripod legs were anchored to surficial rock at the Overlook location. The GPRI-II was centered over a PK nail installed in the rock. The setup procedure described in Section 4.4.1 was followed during each visit to the site. The GPRI-II was aligned (using the scope) to a fence post before acquiring data in the overlook viewpoint near Chester, Arkansas. Photographs of the deployment of the GPRI-II at the Overlook viewpoint site near Chester, Arkansas are shown in Figure 4.19.

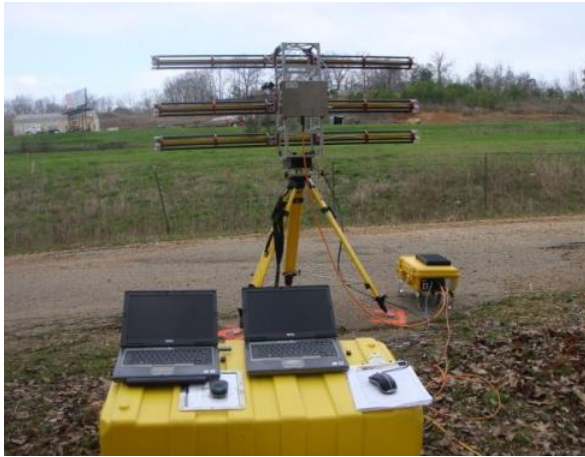
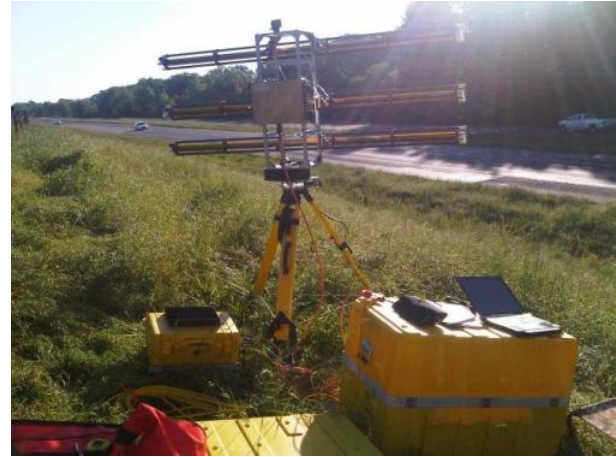
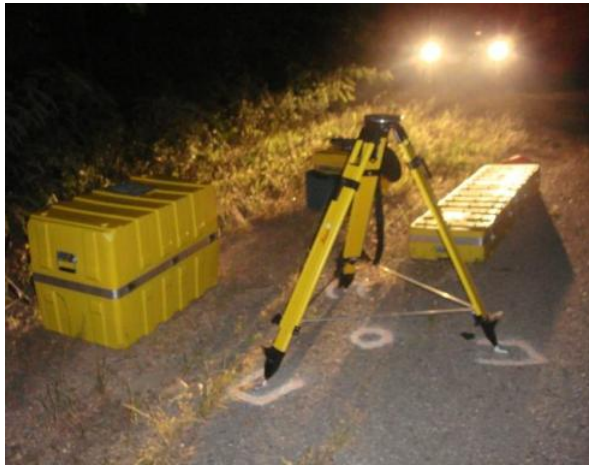
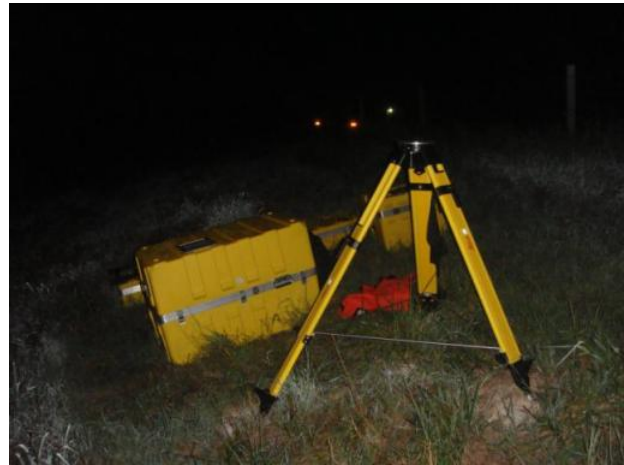
**Figure 4.21. a) GPR-II scanning at the NE viewpoint, b) GPR-II scanning at the SW viewpoint. c) deployment of the GPR-II at night at the NE viewpoint, and d) nighttime RADAR deployment at the SW viewpoint.**

30 (especially from semi-trucks), data was collected performed in the early morning hours (0000 hours-0600 hours). The location of the two viewpoints in the validation site near Malvern, Arkansas is illustrated in Figure 4.20. Additional information regarding data acquisition form the two different viewpoints at validation site near Malvern, Arkansas is discussed in the following subsections. Photographs from the two viewpoints are shown in Figure 4.21. A total of nine RADA visits were conducted to the validation site (Table 4.4).

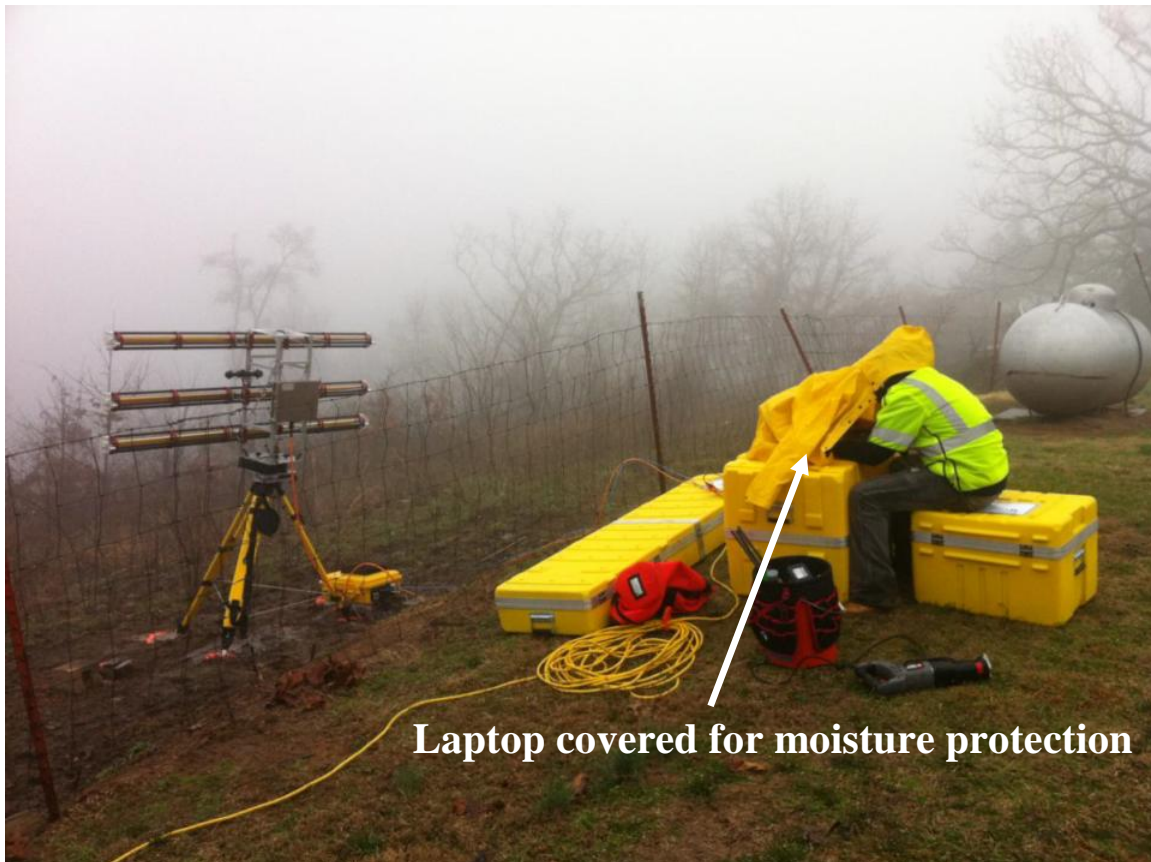
Laptop covered for moisture protection

**Figure 4.24. GPRI-II acquiring data during fog in overlook viewpoint (calibration site) near Chester, Arkansas.**

Important parameters were recorded before image acquisition during every site visit. The parameters include: weather conditions, time, GPS coordinate, Chirp Generator Assembly (CHUPA) status, and the Temperature, Stepper, Computer Controller board (TSCC) status. The CHUPA and TSCC status defined the temperature and voltages of the two hardware components. Monitoring and recording these parameters during every site visit, helped identify if a parameter was outside of the normal range of values before acquiring data. As previously explained in Section 2.3, the large microwaves wavelength generated by the GPRI-II allowed for data acquisition during a wide range of weather conditions (rain showers and fog). A picture of the GPRI-II acquiring data during rain showers and fog conditions is presented in Figure 4.24. Although all of the GPRI-II components are water proof, the laptop which serves as a terminal to control the field computer is not waterproof, thereby necessitating a cover.

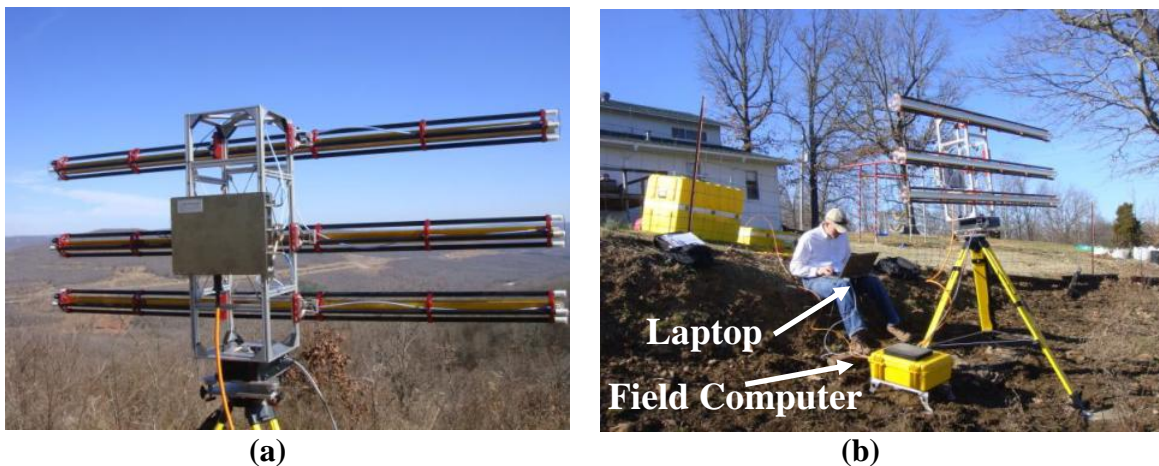
**Figure 4.26. a) Viewing geometry of the GPRI-II at overlook viewpoint, and b) University researcher acquiring data with GPRI-II.**

Traffic was not an issue while acquiring data from the outlook viewpoint because of the distance and elevation difference between the observation point and the sliding mass. A lower angular speed (5 degrees per second) was utilized at this viewpoint to obtain additional backscatter return to the sensor. At least seven images were acquired per site visit at this viewpoint (Figure 4.26) using the 2ms chirp length. The values used during data acquisition at the Overlook viewpoint are summarized in Table 4.6. The viewing geometry of the GPRI-II from the overlook viewpoint is presented in Figure 4.26.

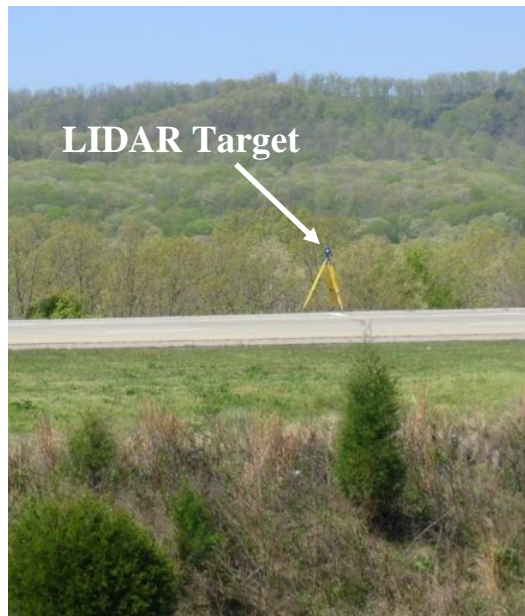
**Figure 4.31. LIDAR target positioned at the Southbound Total Station viewpoint at the calibration site near Chester, Arkansas.**

LIDAR scans were performed once a month, by AHTD personnel, at the calibration site near Chester, Arkansas (Table 4.9). Three targets were deployed with the LIDAR instrument. The targets were used to locate control points within the point cloud, to tie the scans together, and to tie the scans to geographical coordinates (Figure 4.31).

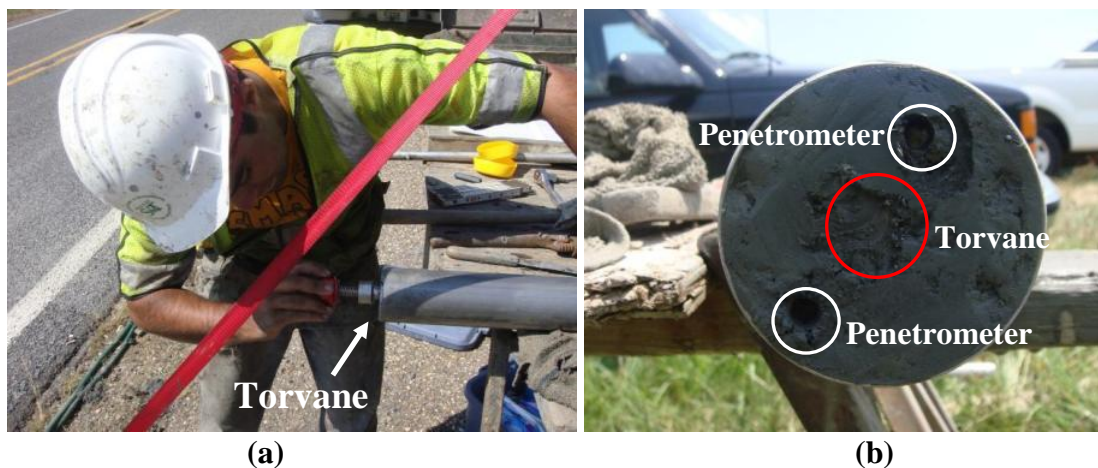
**Figure 4.34. a) Torvane test being performed on a tube, b) index test locations.**

Samples recovered during the geotechnical exploration were handled, transported, and tested by personnel from the UofA. After the amount of soil recovery was measured for each tube pocket penetrometer, torvane, and strength index tests were performed in the field to the soil in the bottom end of every ST after it was pulled from the borehole and removed from the sampling line. Index properties (as obtained from the penetrometer and torvane) were used to size the load frames used for triaxial testing of the clay samples recovered (Figure 4.34). After these tests were conducted on the end of each tube, the moisture content was acquired for the soil that was removed from the bottom two inches of the soil sample at end of the tube. The two-inches of air space created at the bottom of the tube allowed for sufficient space for the bottom gasket. A gasket was also placed in the top of the tube, hot wax was poured on top of both gaskets (top and bottom), and a plastic cap was attached to both ends in order to preserve the moisture inside the tube.

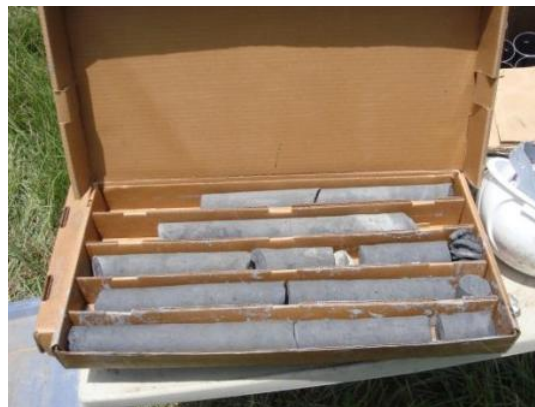
**Figure 4.35. Core rock sample box from sampling operations at validation site in Malvern, Arkansas.**

Rock coring was necessary in all of the boreholes except for Borehole B4. Rock quality designation (RQD) was measured in the field for all of the rock core runs. The rock samples were placed on core boxes and transported to the laboratory for strength testing (Figure 4.35).

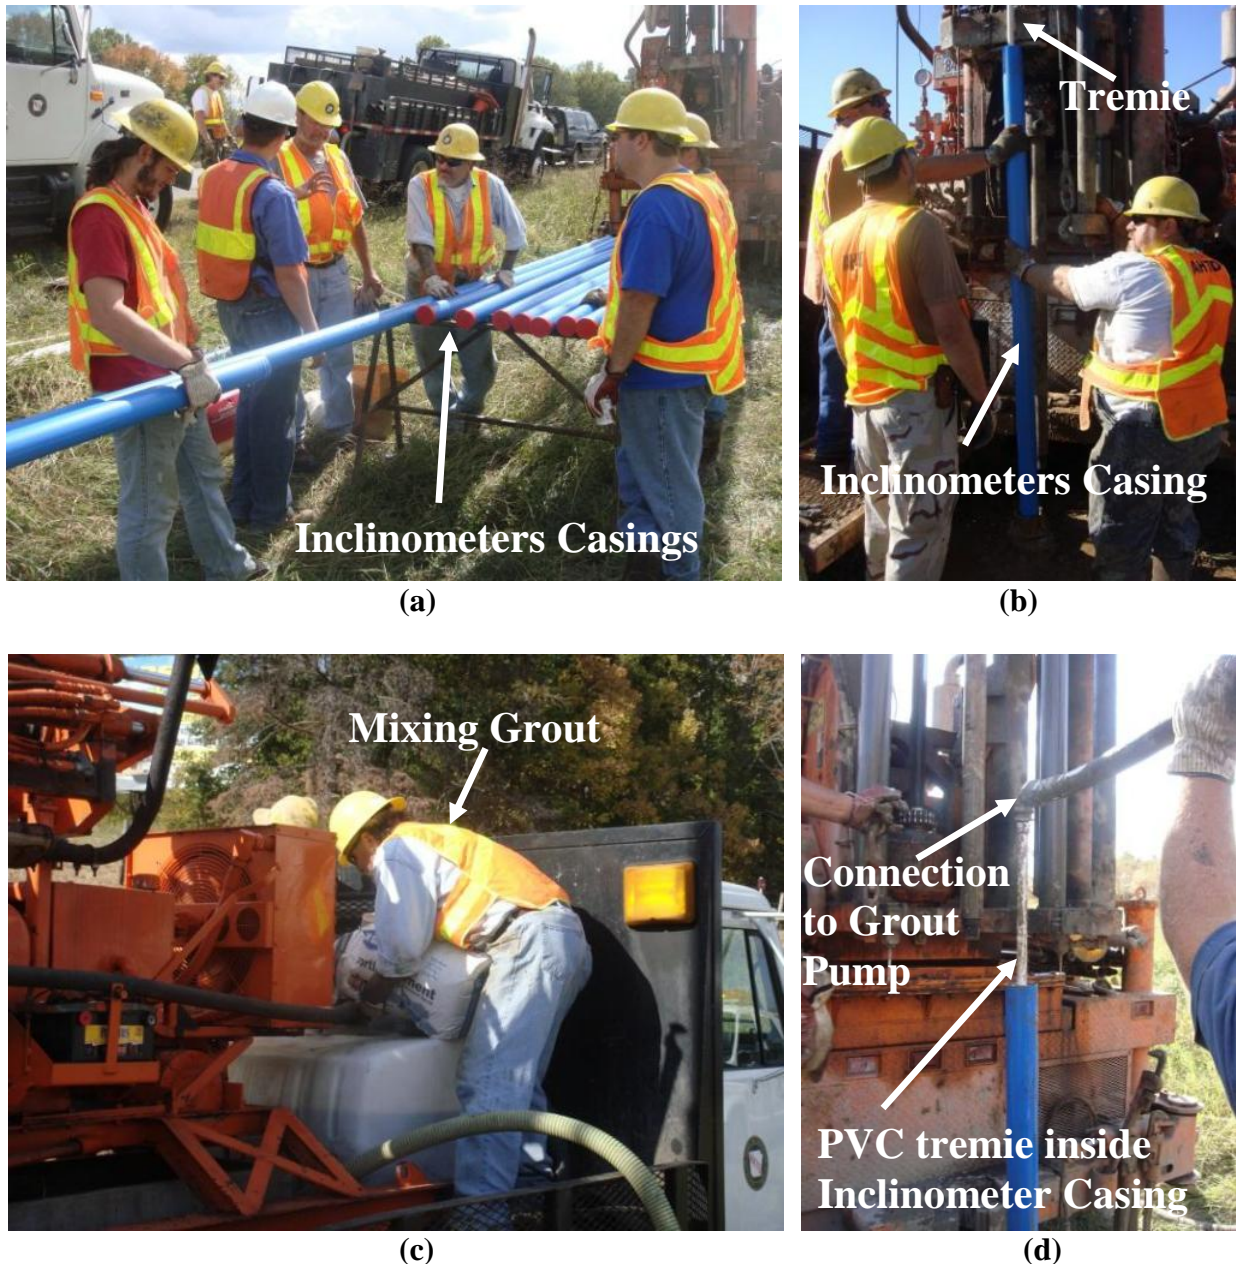
**Figure 4.36. a) Sections of inclinometer casing, b) installation of inclinometer casing, c) preparing grout mix, and d) grout connection between tremie and grout pump.**

Two months after the geotechnical exploration was conducted, the site was instrumented with four inclinometers (B-1, B-3, B4, B-6) and one vibrating piezometer (B-2). The boreholes were reopened by reaming the holes to a depth of 102 feet (to allow for the grouting connection located at depth at the end of the casing). No samples were obtained during this instrumentation and monitoring phase of the filed work. Ten-foot sections of 3.34-inch diameter Slope Indicator inclinometer casing were joined together and installed in the ground. A grout cement mix (consisting of one 94 pound bag of Portland cement, a 50 pound bag of bentonite, and 70 gallons of water) was used to secure the inclinometers in the borehole. The ground cement mix was pumped to the bottom of the inclinometer casing (and delivered to and through the one-way check valve) using a 1.5-inch diameter tremie (consisting of eleven 1.5-inch diameter Schedule 40 PVC pipes coupled together with a screw on connection at the bottom that was attached to the check valve). A summary of the inclinometer installation details is presented in Table 4.12, and the installation process for the inclinometers is illustrated in the photographs in Figure 4.36.

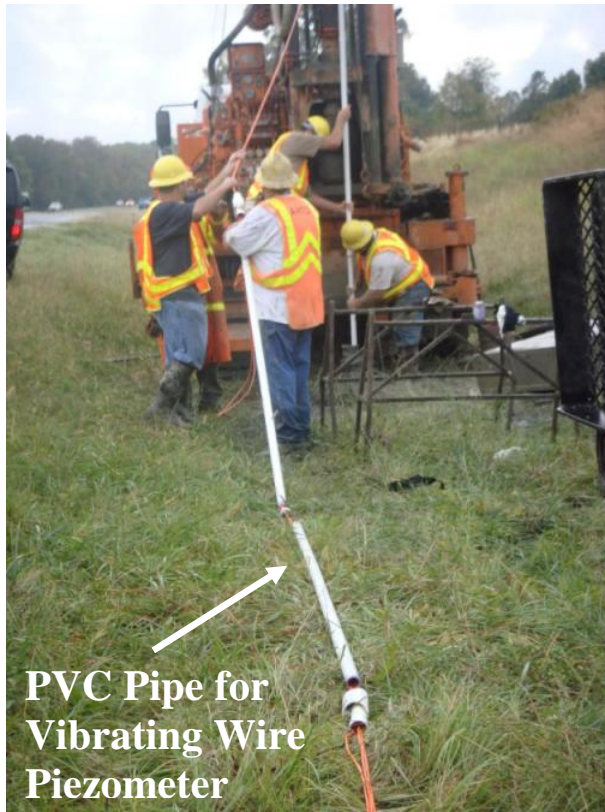
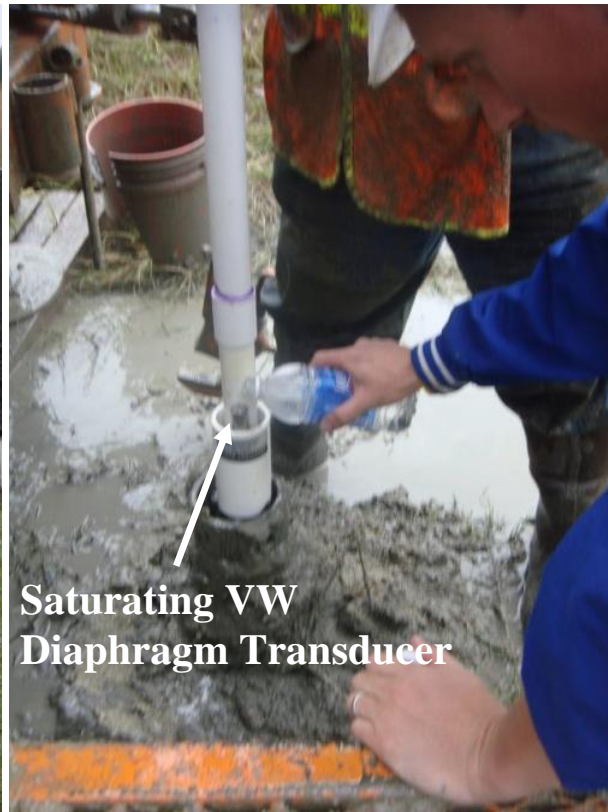
Figure 4.37. a) AHTD personnel installing nested vibrating wire piezometer in borehole B-2, and b) saturating transducers prior to placement in the hole.

A nested vibrating piezometer was installed in borehole B-2 to determine the pore water pressure fluctuation with time. The nested piezometer consists of 5 vibrating wire sensors at different depths. The transducers were placed at the following depths: 16, 37, 58, 79, and 100 feet. Implementation of the vibrating piezometer is illustrated in Figure 4.37. Pictures of the installed vibrating wire piezometer and inclinometer in the ground are shown in Figure 4.38.

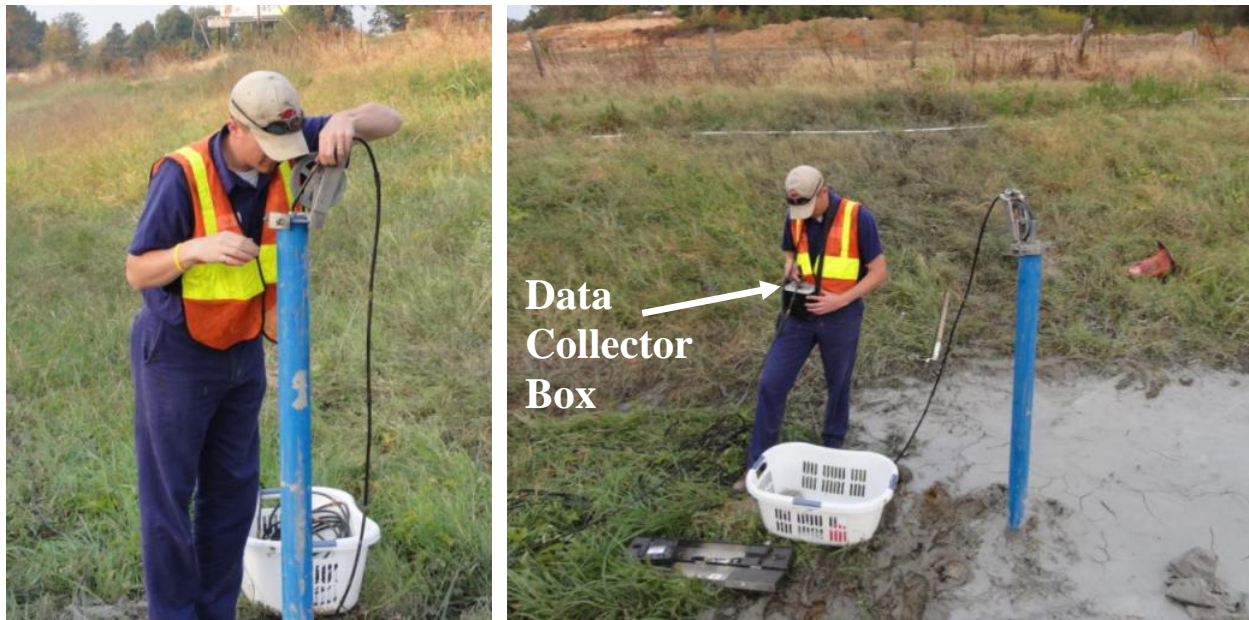
**Figure 4.39. a) Lowering probe into inclinometer casing at B-4, and b) recording slope inclinometer data using the readout box.**

Data was collected once per month using the in-situ equipment and slope inclinometer and vibrating wire piezometer tools and readout boxes. The readings were obtained in conjunction with the total station surveys and RADAR surveys at the validation site near Malvern, Arkansas. The inclinometers were monitored by lowering a probe to the bottom of the inclinometer casing (Figure 4.39). The probe was inserted to the bottom of the hole and then the probe was removed, stopping every two feet to obtain a reading using the readout box that was connected to the probe. This procedure was repeated twice, once to obtain the  $A_0$  measurements (the receiver was placed in the casing such that the upper most wheel was facing North) and again to obtain the  $A_{180}$  measurements (the receiver was placed in the casing such that the upper most wheel was facing South). During both acquisition trips up the hole, the probe measured the casing profile in two directions (North-South and West-East). The inclinometer profiles obtained during each site visit were compared to the first profile (obtained on October 13, 2011) to determine the cumulative deformation. All data was collected and stored in a Slope Inclinometer data collector box. The methods used to reduce the data collected using the Slope Inclinometer are presented in Section 5.5.1.

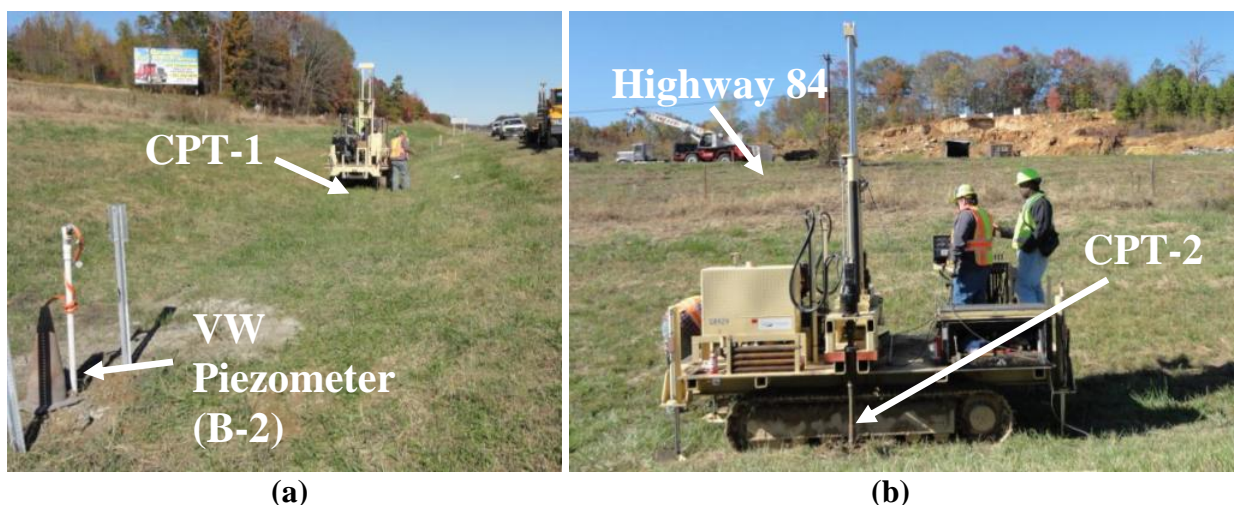
**Figure 4.41. a) Cone penetrometer test being performed at the CPT-1 location, and b) cone penetrometer rig conducting the test at CPT-2 location.**

of the boreholes location to allow for comparison of the results. Specifically, as shown previously in Figure 4.33, both CPT tests were conducted between Eastbound lane of Highway 84 and the Westbound lane of Interstate I-30 in between boring B-2 and B-3 (CPT-1), an in between borings B3-and B-4 (CPT-2). During both CPT tests the cone was pushed to refusal. Refusal was reached at 48.8 feet below ground surface for CPT-1 and at approximately 12.5 feet below ground surface for CPT-2. Photographs of the CPT rig conducting the tests at the validation site near Malvern, Arkansas are shown is Figure 4.41.

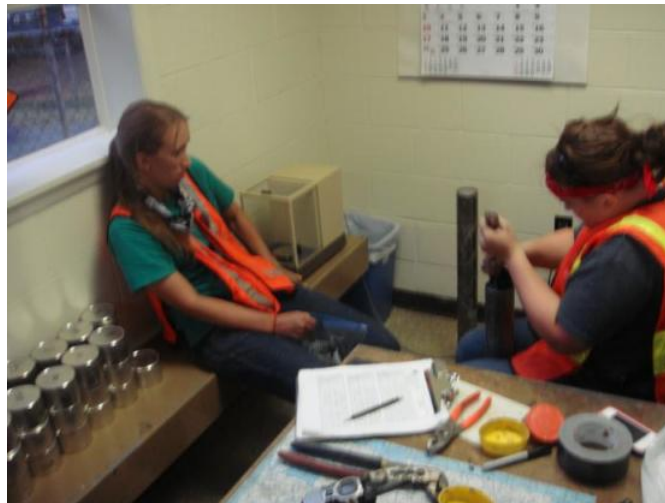
**Figure 4.42. Moisture contents being obtained at a facility nearby the validation site.**

Field moisture content was obtained from every sample obtained during the geotechnical investigation according to ASTM D2216 (2007). The water content test were performed by recording the wet weight of a moisture sample from the bottom part of a Shelby tube sample or a portion of a Standard Penetration Test (SPT) sample. In order to obtain the weight of the moisture can, an AHTD maintenance facility in the proximity to the site was used by the researches to set up a balance and used as storage for the soil samples. Samples were sampled out of the ground and immediately taken to the facility, minimizing heat exposure and loss of moisture. After water content sample was extracted from the tubes, caskets and wax were used to seal the tubes. Moisture content was also obtained from UU samples after were tested in the laboratory. A figure of the AHTD facility used for storage and weight measurements is presented in Figure 4.42.

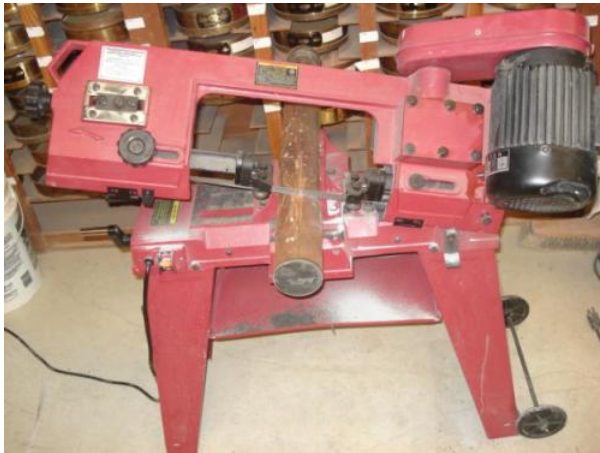
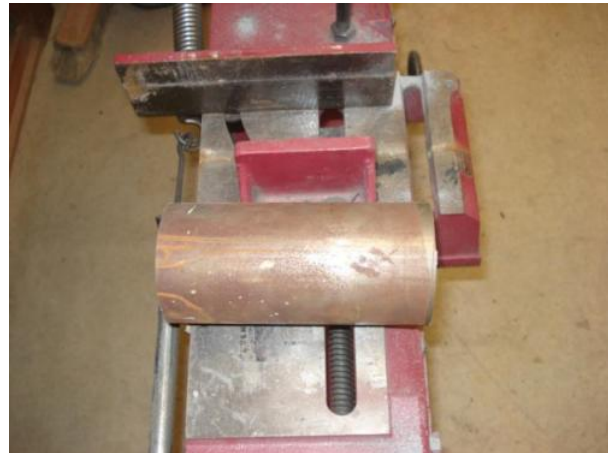
**Figure 4.43. a) Central Machinery band saw cutting Shelby tube sample for UU test, and b) six inches Shelby tube specimen for UU test.**

First, one inch was cut from the bottom of each Shelby tube sample to discard the soil disturbed by the water content and strength index test conducted in the field during sampling operations. Six inches length specimens were cut from the Shelby tube sample, the rest of the Shelby tube was securely wrap with plastic paper and covered with plastic caps to prevent the change in moisture content. The soil specimens were retrieved from the tube by splitting the tube specimens. A Dewalt circular hand saw was used first to cut an initial seam along the tube, and once the seam was close to the thickness of the tube a Dremel tool was used to carefully finish splitting the tube without disturbing the soil specimen. The procedure for UU test specimen extraction is presented in Figure 4.43 and Figure 4.44.

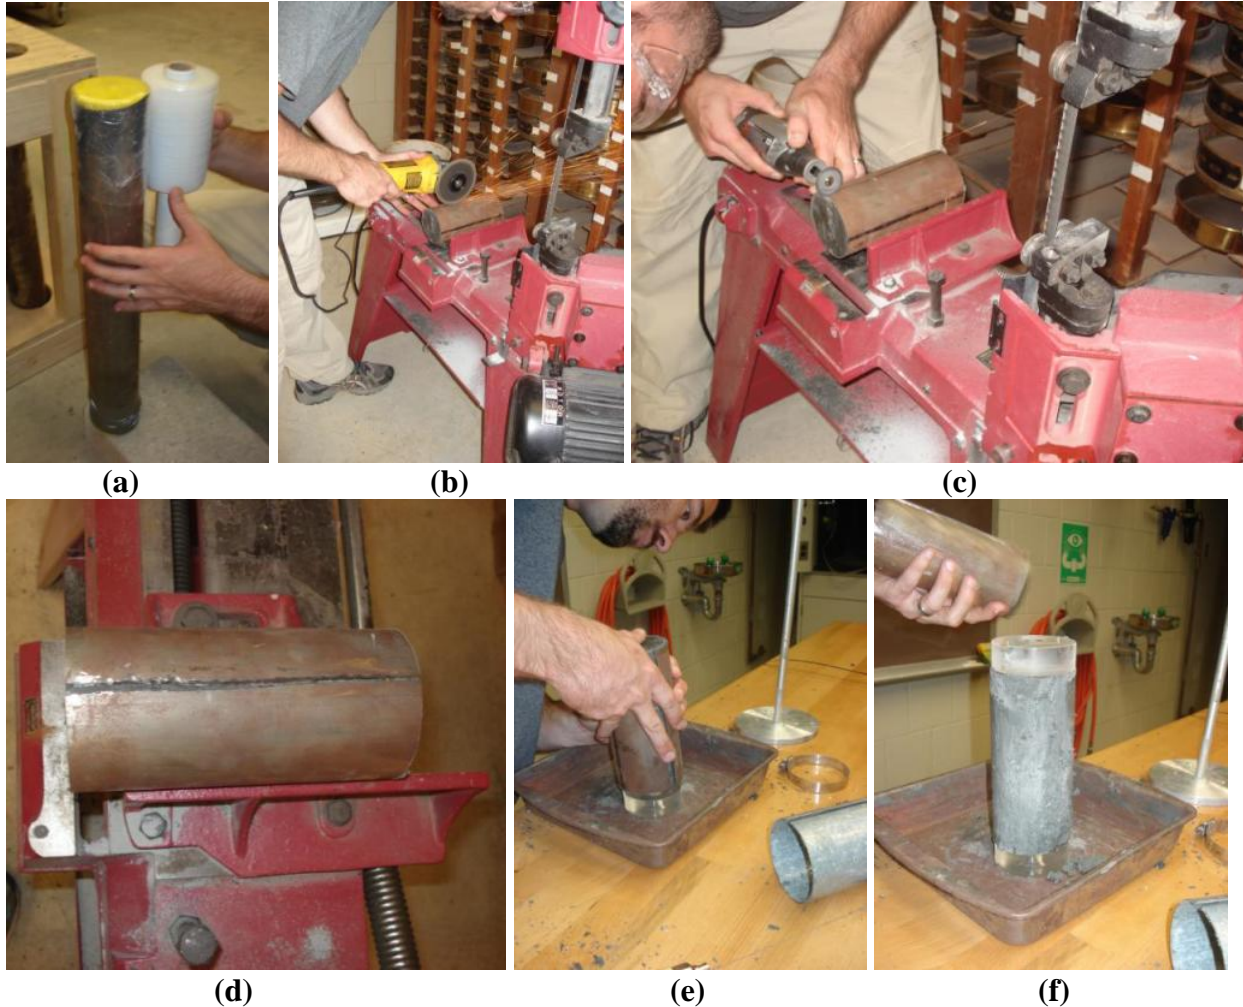
**Figure 4.44. a) Shelby tube sample wrapped to prevent moisture change, b) circular hand saw used to start splitting the Shelby tubes specimen, c) final cuts with the Dremel before splitting the Shelby tube specimen, d) Shelby tube specimen with seam parallel to tube, e) retrieving soil specimen for UU test, and f) UU test specimen after Shelby tube extraction.**

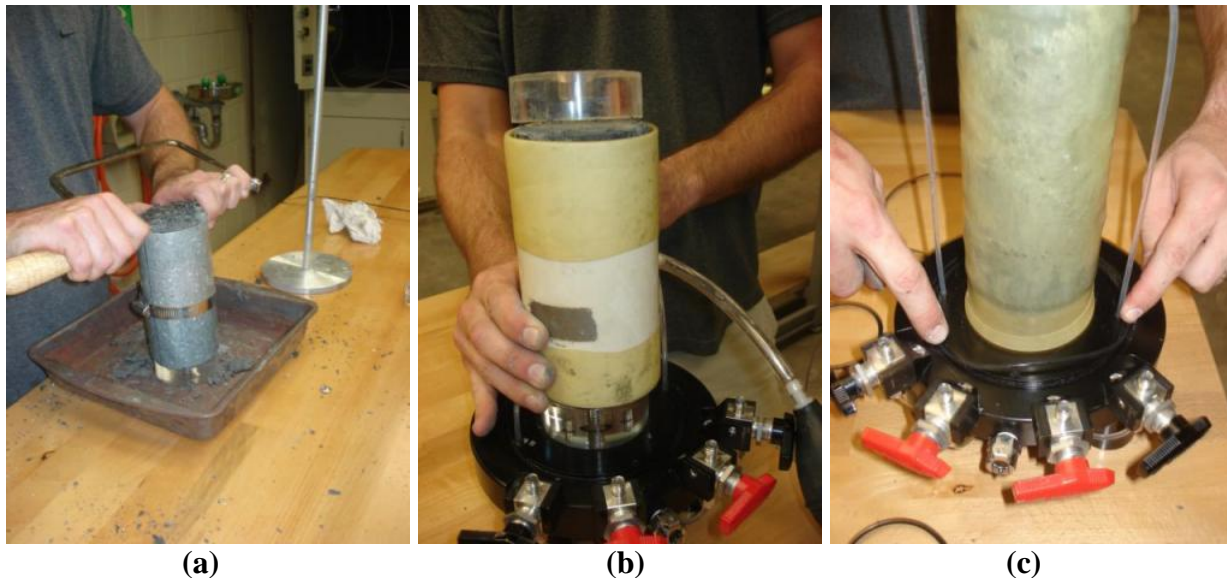
**Figure 4.46. a) Soil specimen being level to prevent concentration of stresses, b) placing membrane around the sample, and c) securing o-ring to seal the UU triaxial cell.**

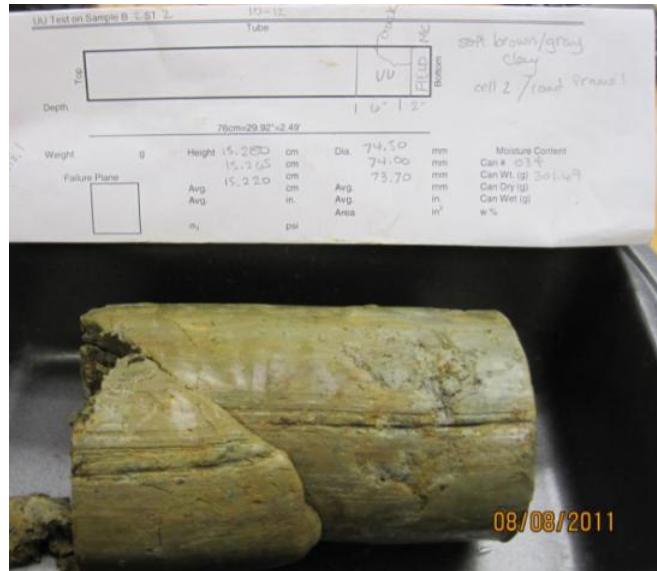
**Figure 4.48. Soil specimen B-2 ST2 after UU triaxial test, sample ready for post-test moisture content.**

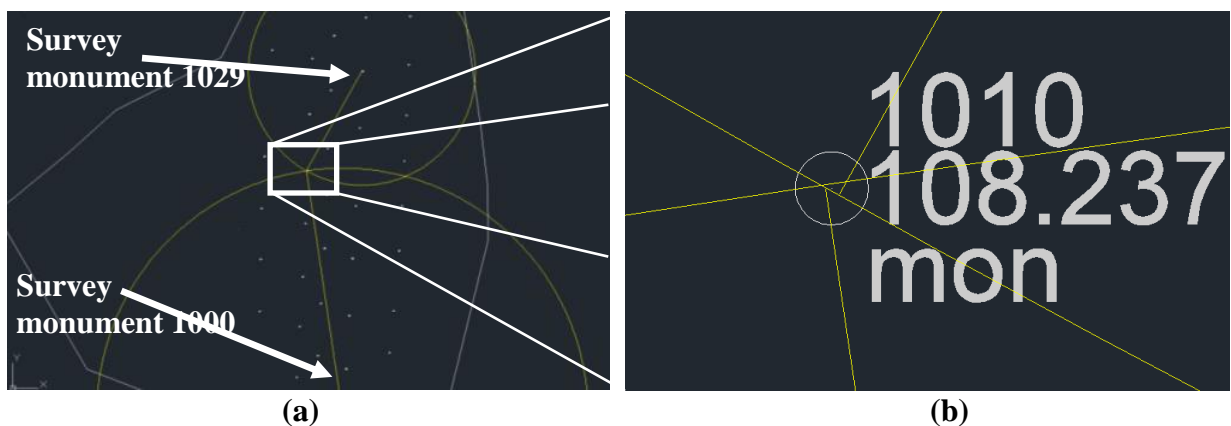
**Figure 5.3. a) Plan view of the validation site while tangent method was attempted, and b) zoomed view of the intersection between the two circles developed during the tangent method using AutoCAD Civil 3D®.**

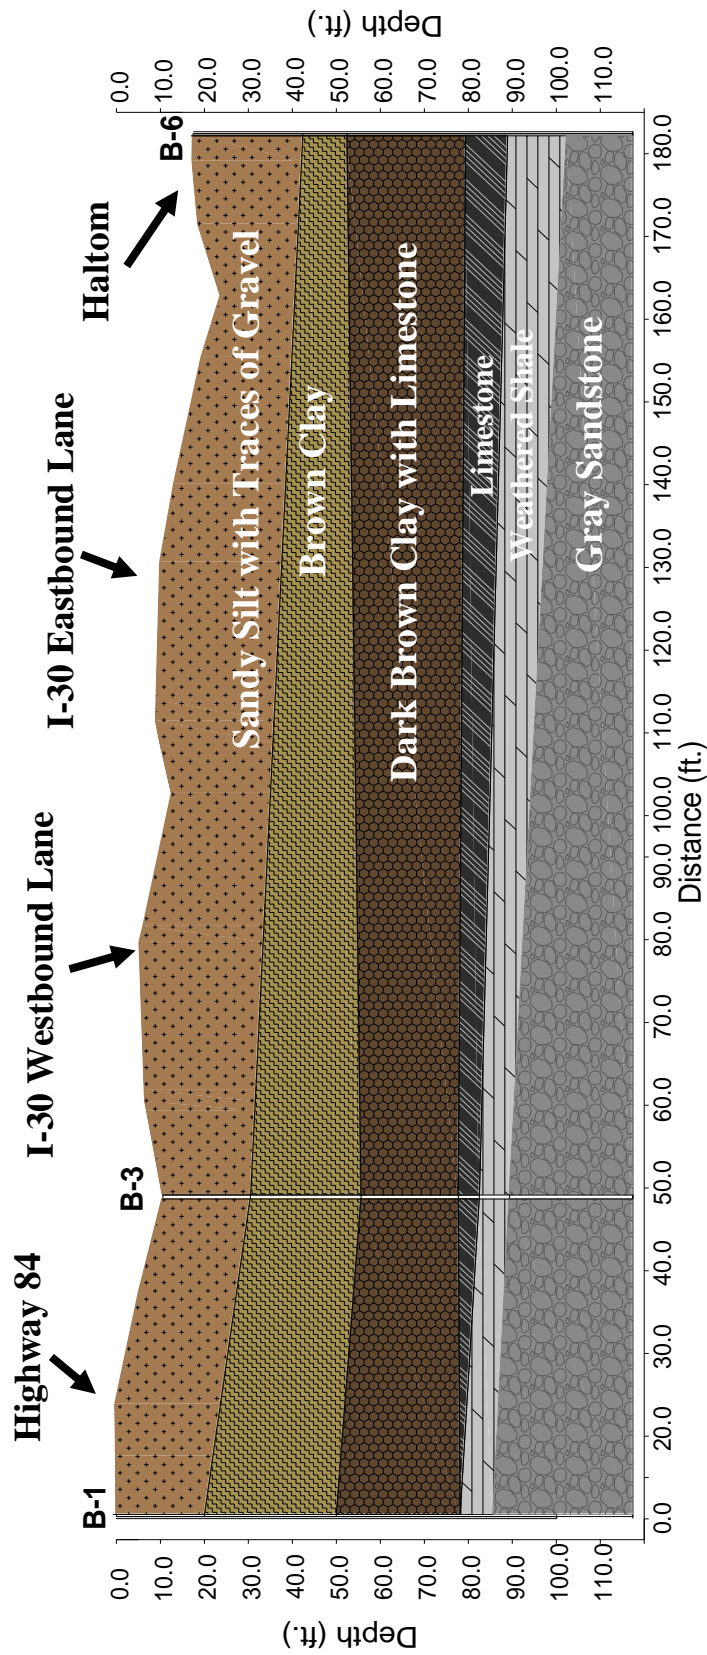
Figure 6.1. Soil strata cross-section containing boreholes B-1, B-3 and B-6 in validation site near Malvern, Arkansas.

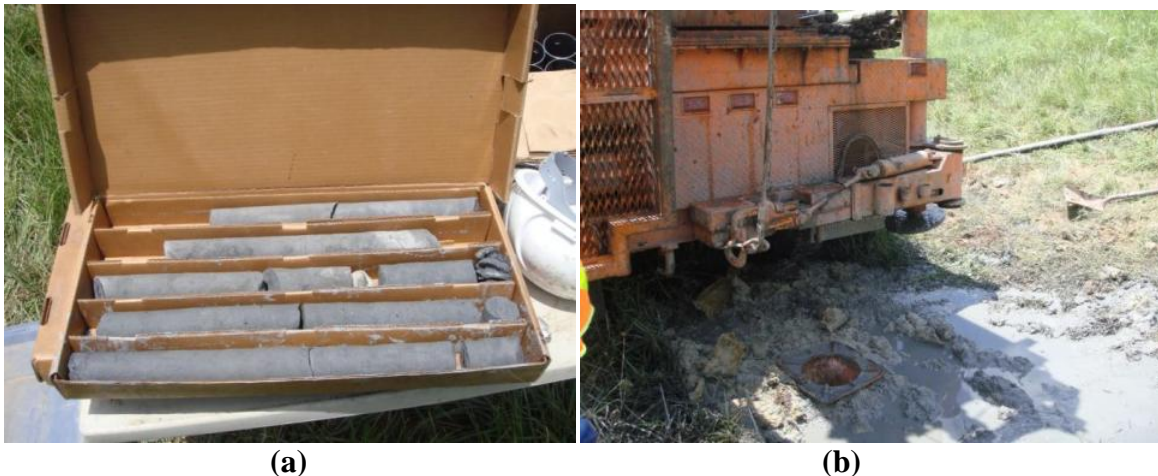
**Figure 6.3. a) Rock sample obtained coring at B-2 (validation site), and b) post-drilling conditions at B-2**

Borehole drilled between two days 07-18-2011 to 07-19-2011. At this location a layer of molted brown-gray clay was encountered until a depth of 25 feet. Rotary wash method was started at approximately 18 feet below ground surface. A 1.5 foot thick layer of limestone of was encountered at 25 feet, underlain by a thick layer of blocky hard dark clay to a depth of 40 feet. Between depth of 40 feet and 60 feet a second (softener) brown-grey clay layer with traces of limestone was encountered. From 60 feet to 68 feet a hard dark clay layer was reached. SPT refusal was occurred at a depth of 68 feet, and coring was immediately started on 5 feet intervals from a depth of 68 feet. Weathered shale layer was encountered to a depth of 78 feet. A 20 feet layer of sandstone was encountered until a depth of 98 feet with RQD ranging from 75% to 92%. Rock sample box obtained and end hole conditions presented on Figure 6.3. The boring logs for Borehole-2 (B-2) are presented in Appendix **Error! Reference source not found.**

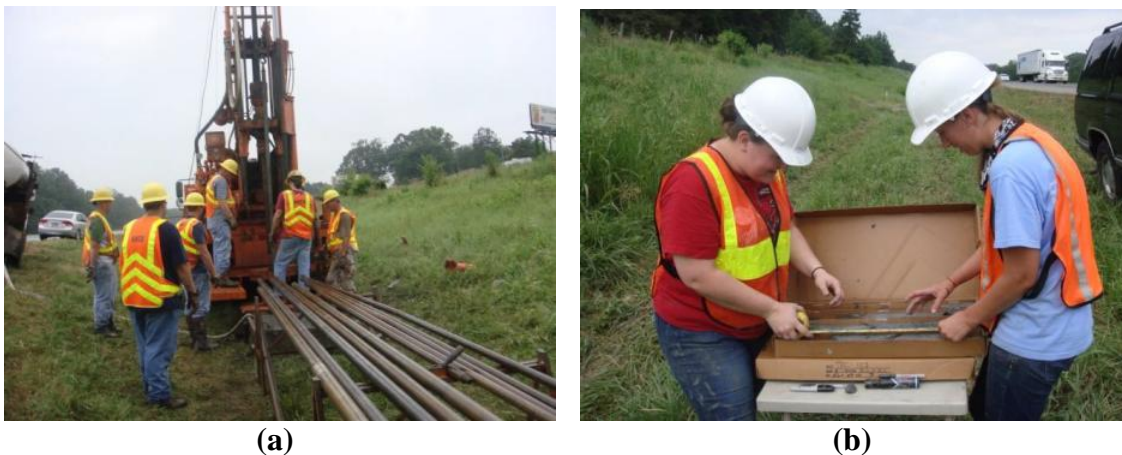
**Figure 6.4. a) Drilling operations at B-3, and b) measuring RQD of rock sample obtained from B-3.**

bottom of the layer. Approximately below 20 feet a thin layer of limestone was noticed. Drill crew changed to rotary wash at approximately 22 feet below ground surface. A thick layer of dark very stiff to hard clay with traces of gravel and limestone was encountered to a depth of 67 feet. Below 67 feet a layer of weathered claystone was observed until 71.5 feet where SPT refusal was reached. Coring was started at approximately 71.5 feet. A layer of claystone was encountered from 71.5 feet to 100 feet depth with RQD of 17.5%, 68% and 90%. A photograph of drilling operations while taking place at B-6 and measuring RQD of a rock sample is presented in Figure 6.4. The boring logs for Borehole-4 (B-4) are presented in Appendix **Error!**

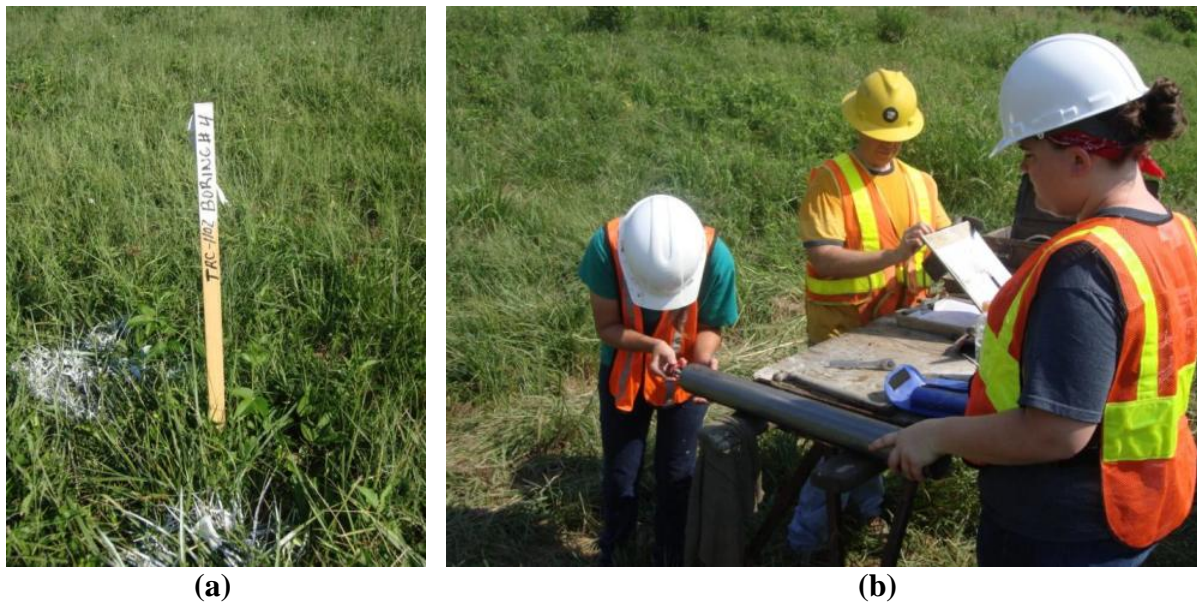
**Figure 6.5. a) Pre-drilling conditions at B-4, and b) torvane test being performed in Shelby tube soil sample .**

sandstone to a depth of 100 feet below ground surface. A photograph of the pre-drill conditions at B-4 and researchers performing torvane test at the end of a Shelby tube sample are presented in Figure 6.5. The boring logs for Borehole-4 (B-4) are presented **Error! Reference source not found.**
