# Slope Stability Monitoring Using Remote Sensing Techniques

A thesis submitted in partial fulfillment  
of the requirements for the degree of  
Master of Science in Civil Engineering

Omar A. Conte Robles  
Missouri University of Science & Technology  
Bachelor of Science in Civil Engineering, 2010

May 2012  
University of Arkansas

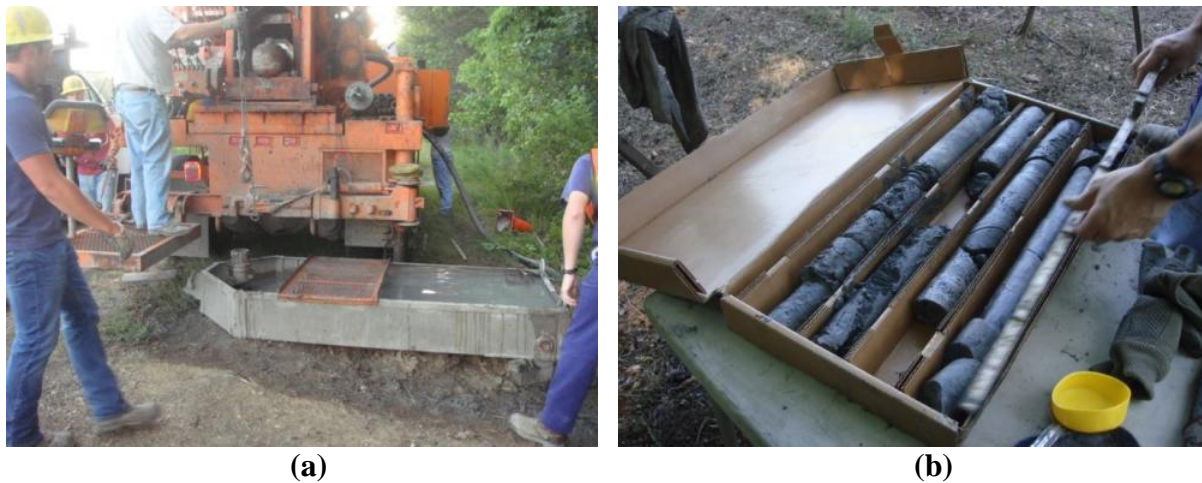
**Figure 6.6. a) Changing to rotary wash method at B-6, and b) rock sample obtained from B-6.**

thin layer of shale was observed underlain by a thick layer of sandstone with RQD values ranging from 38% to 83% until a depth of 100 feet below ground surface. A photograph of the B-6 location and a rock sample obtained from B-6 are presented in Figure 6.6. The boring logs for Borehole-4 (B-4) are presented in Appendix **Error! Reference source not found.**

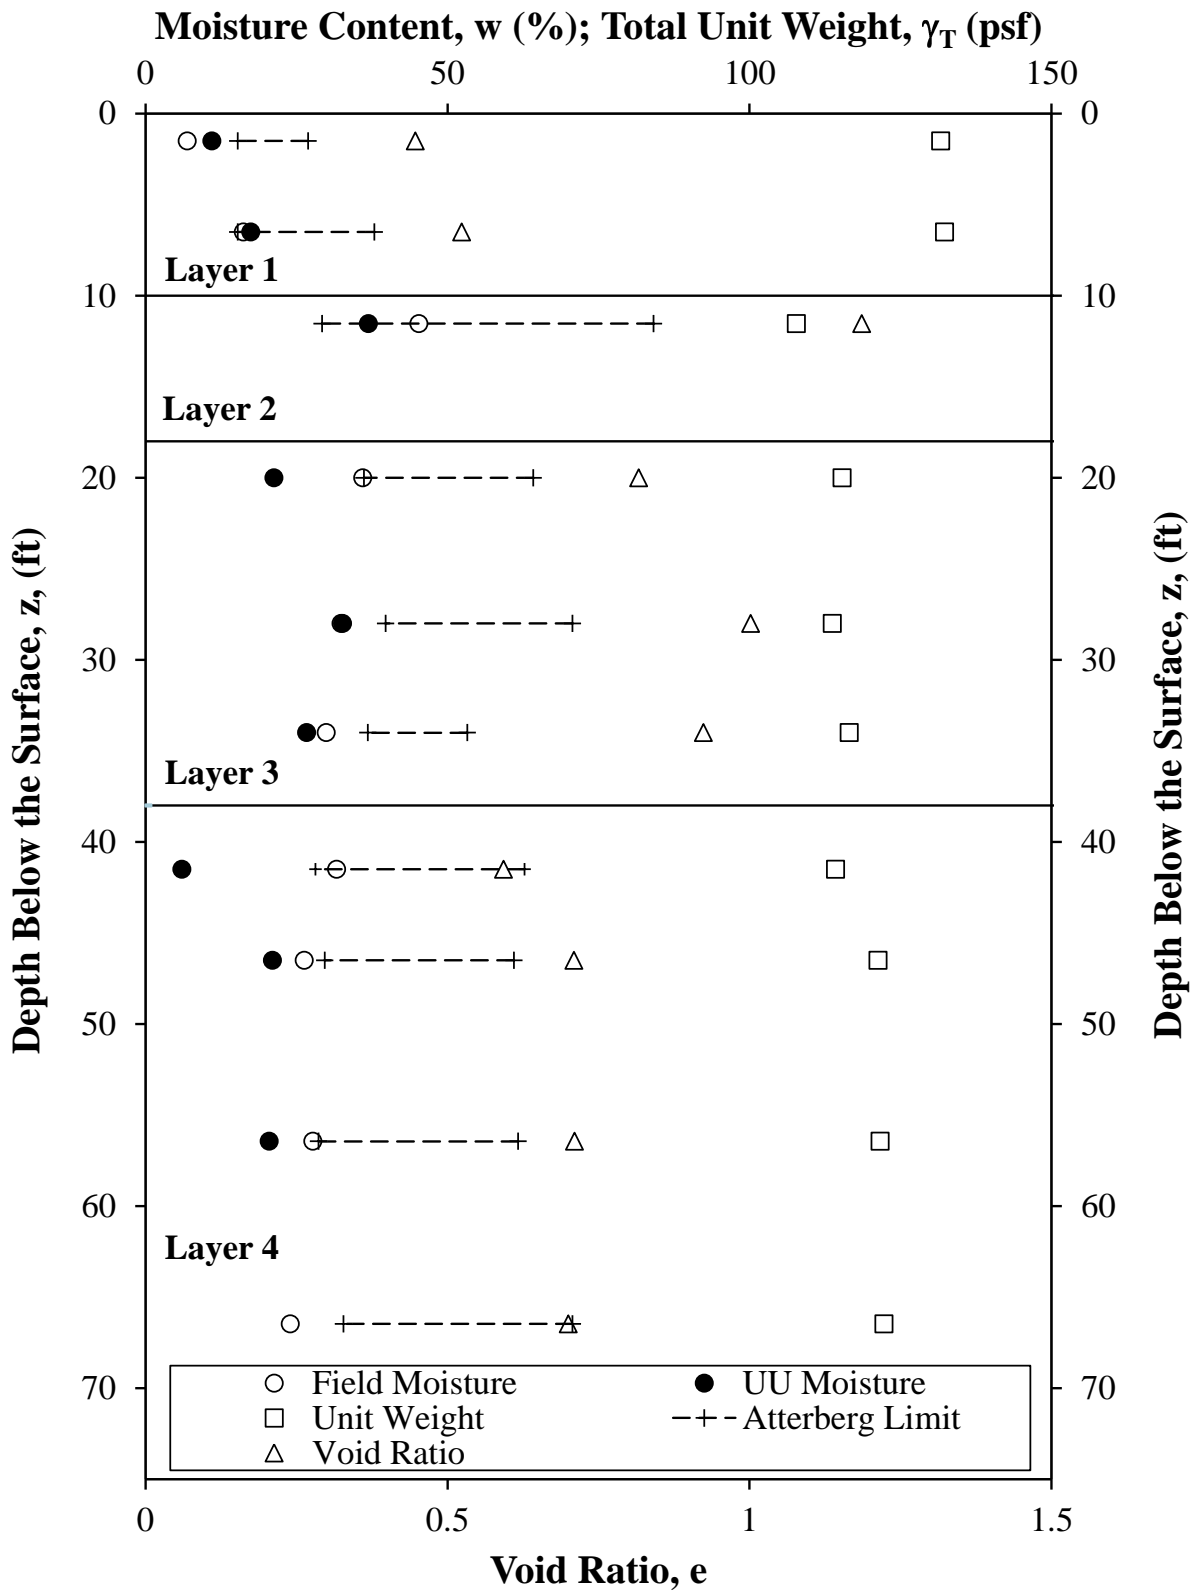
Figure 6.8. Design moisture content, unit weight and Atterberg Limits profile.

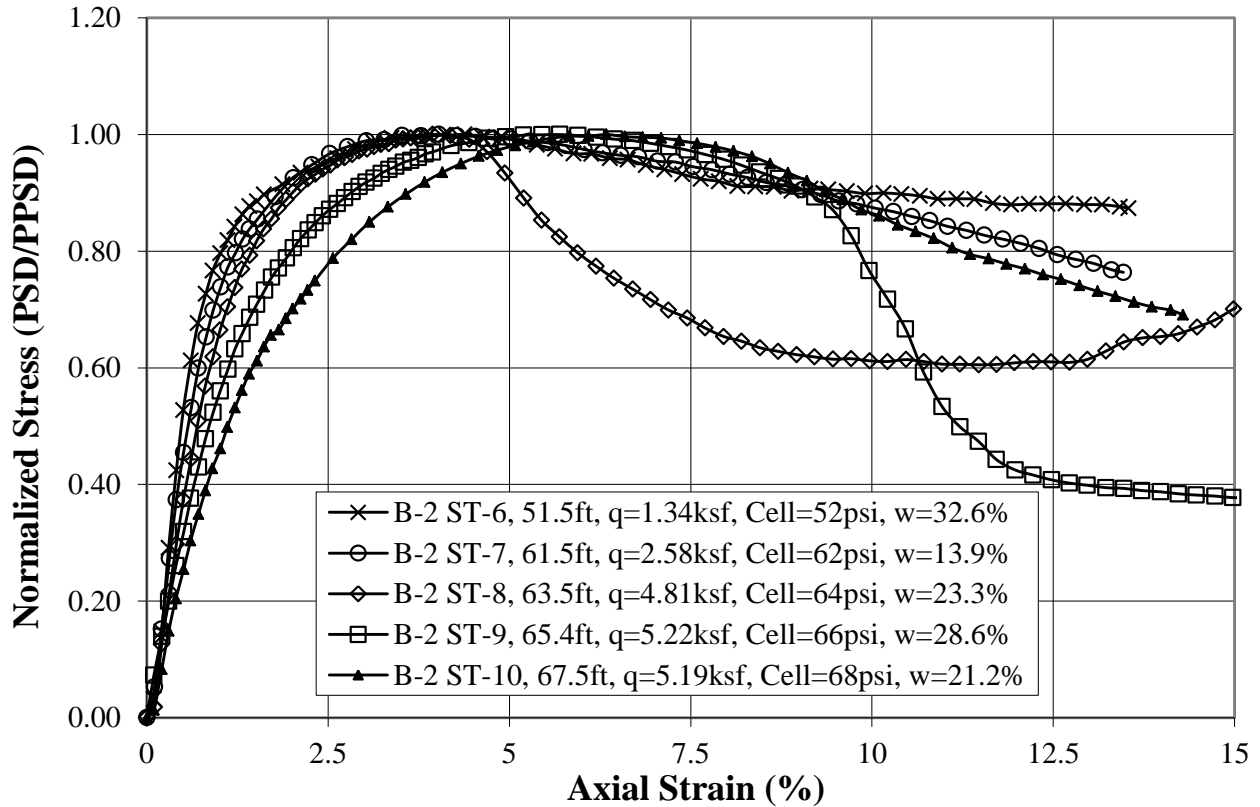
**Figure 6.9. Normalized stress-strain graph of UU test for B-2 specimens at validation site.**

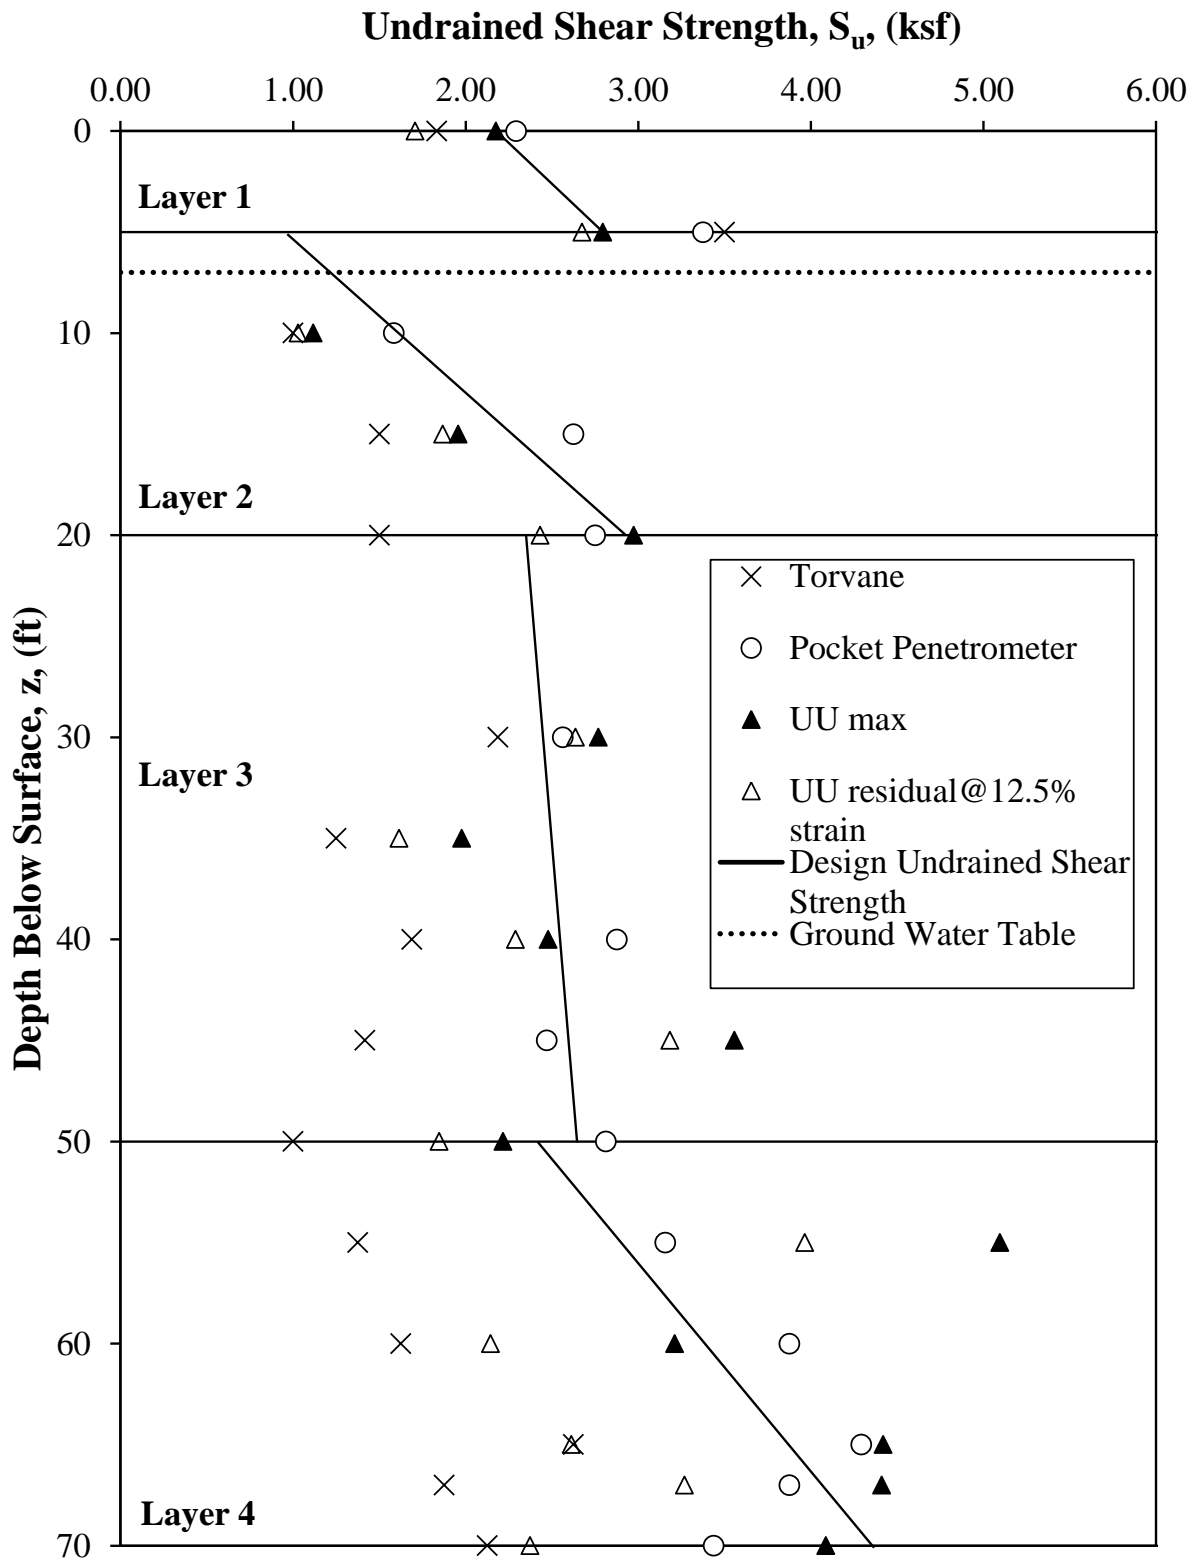
**Figure 6.10. Design strength profile for validation site near Malvern, Arkansas.**

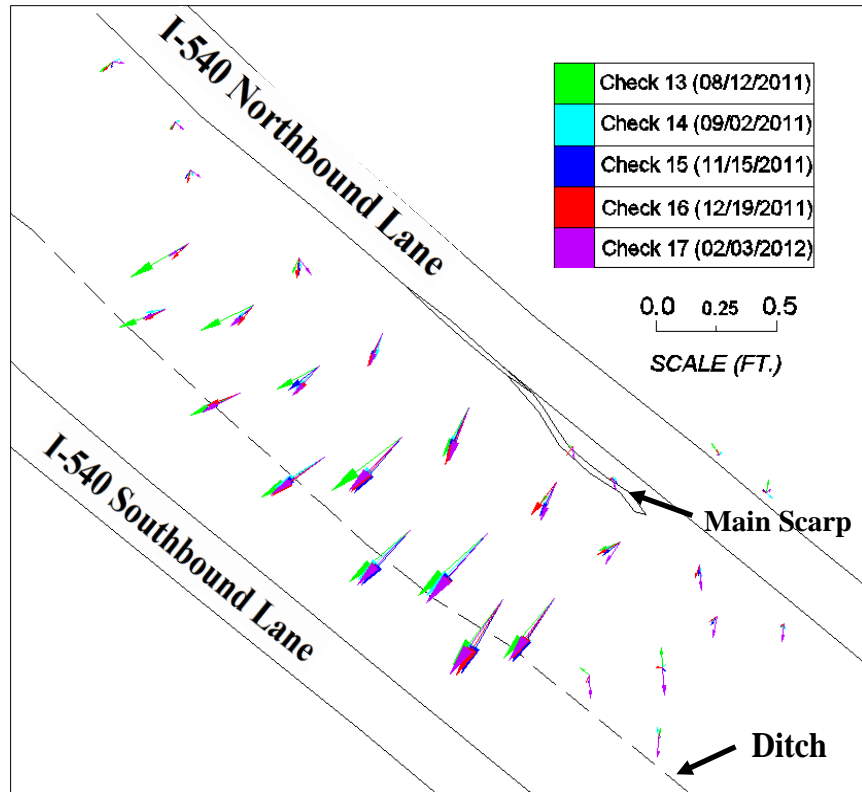
**Figure 6.17. Displacements of the last five Checks conducted at calibration site [in color].**

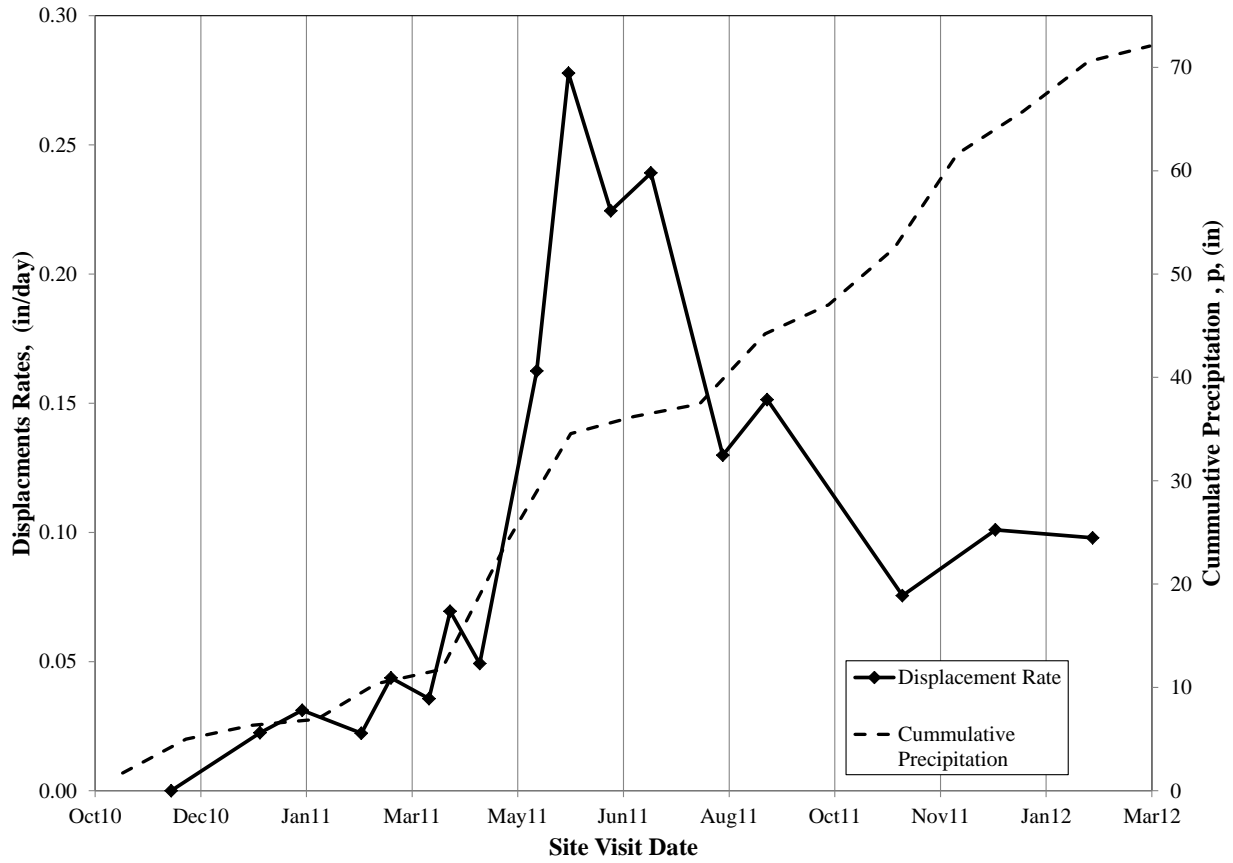
**Figure 6.18. Maximum displacement rates (horizontal) and cumulative precipitation data with time for calibration site near Chester, Arkansas.**

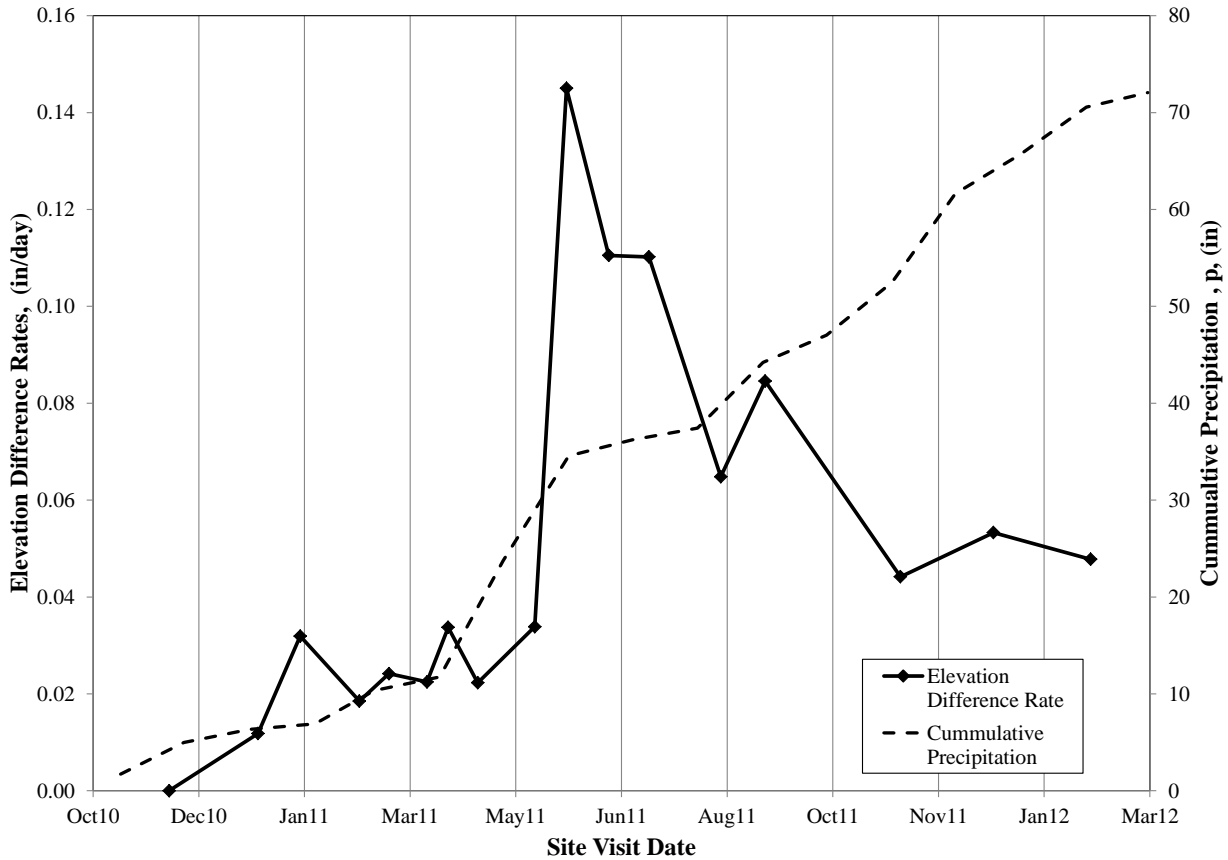
**Figure 6.19. Elevation differences rates (vertical) and cumulative precipitation data with time for calibration site near Chester, Arkansas.**

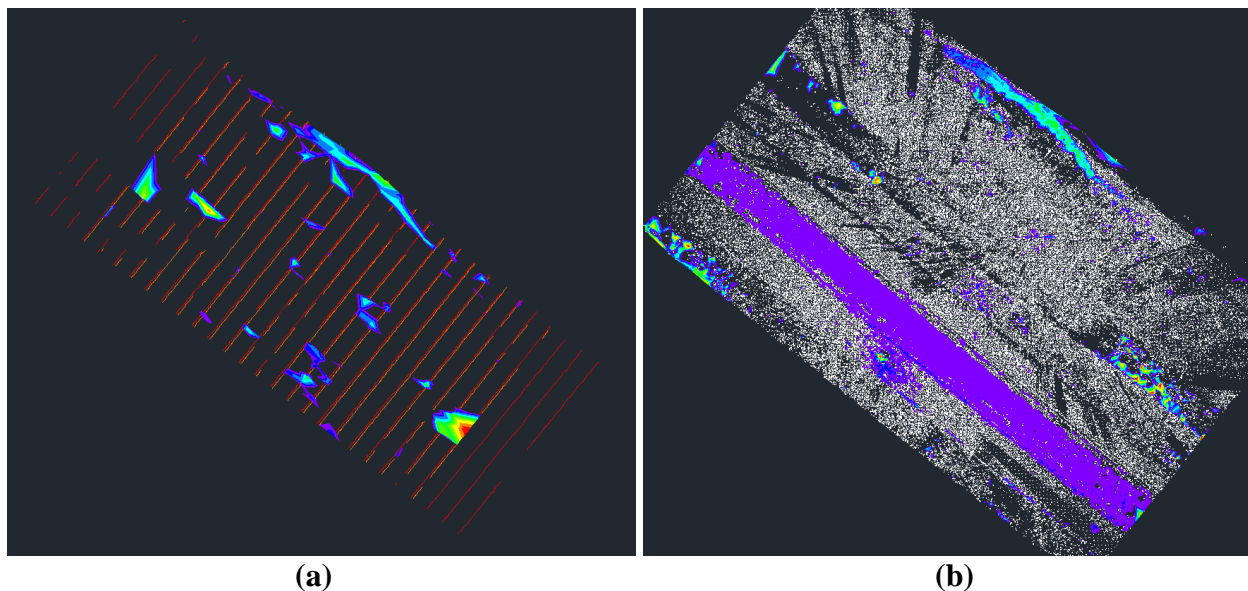
**Figure 6.22. a) Surface developed using polylines method, and b) Surface developed using bare earth correction method [in color].**

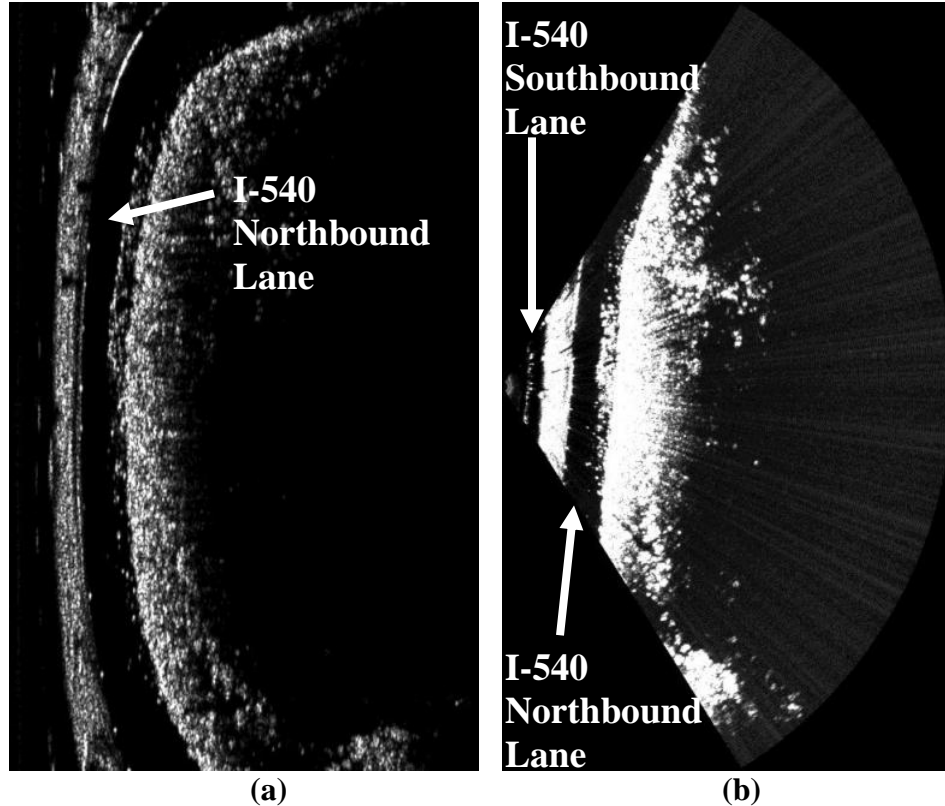
**Figure 6.26. a) MLI RADAR image obtained from southbound viewpoint in polar coordinates using 250ms chirp, and b) MLI RADAR image obtained from southbound viewpoint in rectangular coordinates using 250ms chirp.**

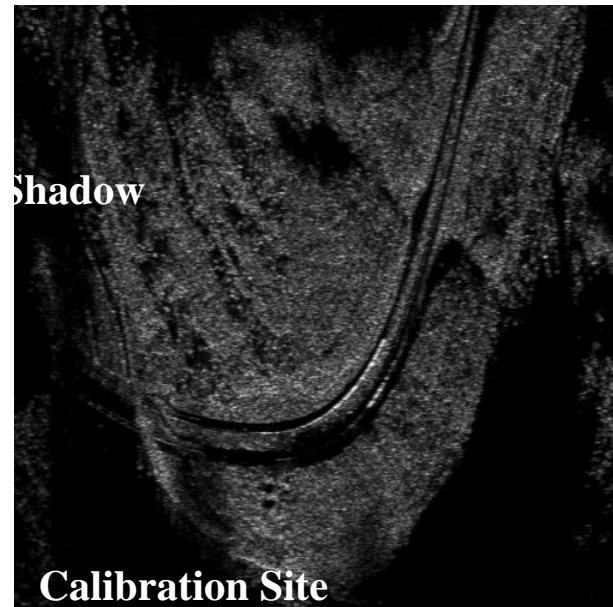
**Figure 6.27. MLI RADAR image obtained from overlook viewpoint in polar coordinates using 4ms chirp.**

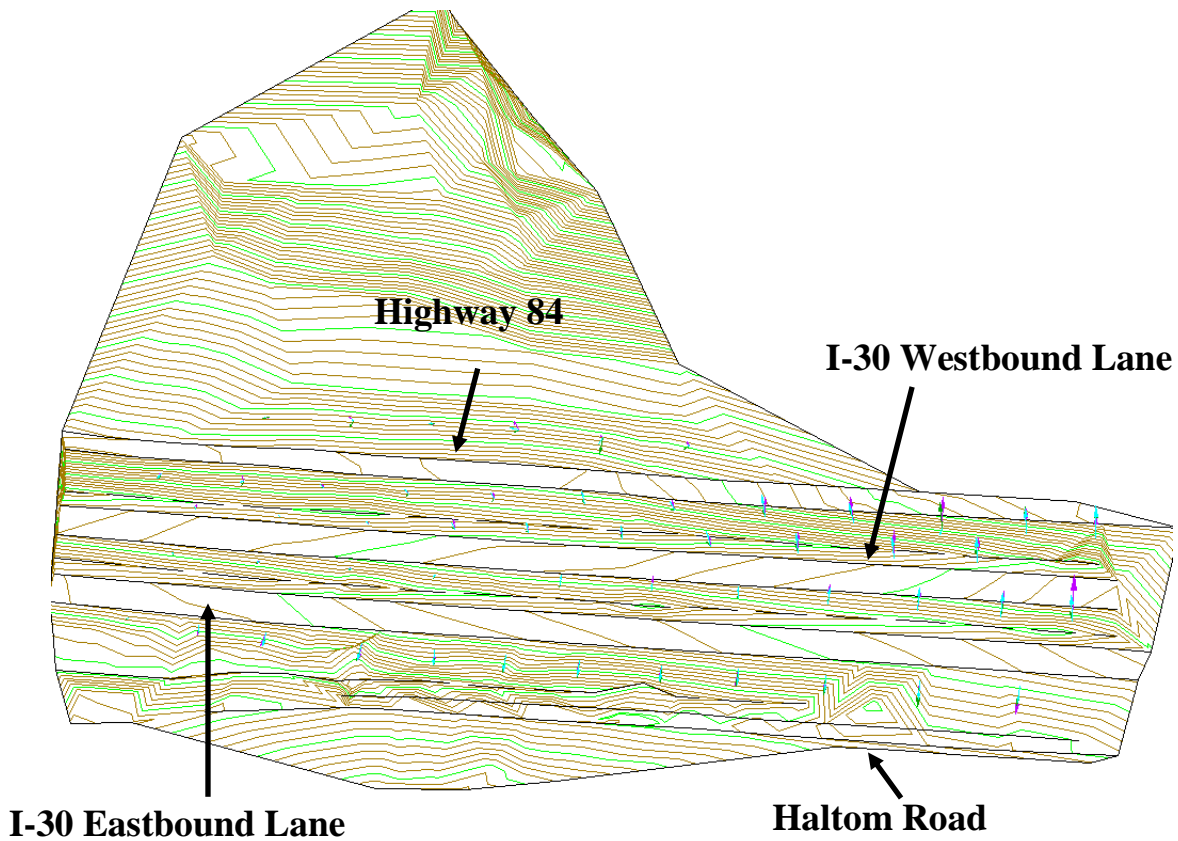
**Figure 6.29. Recorded displacement (at the monuments) and digital elevation model of the validation site obtained using the total station.**

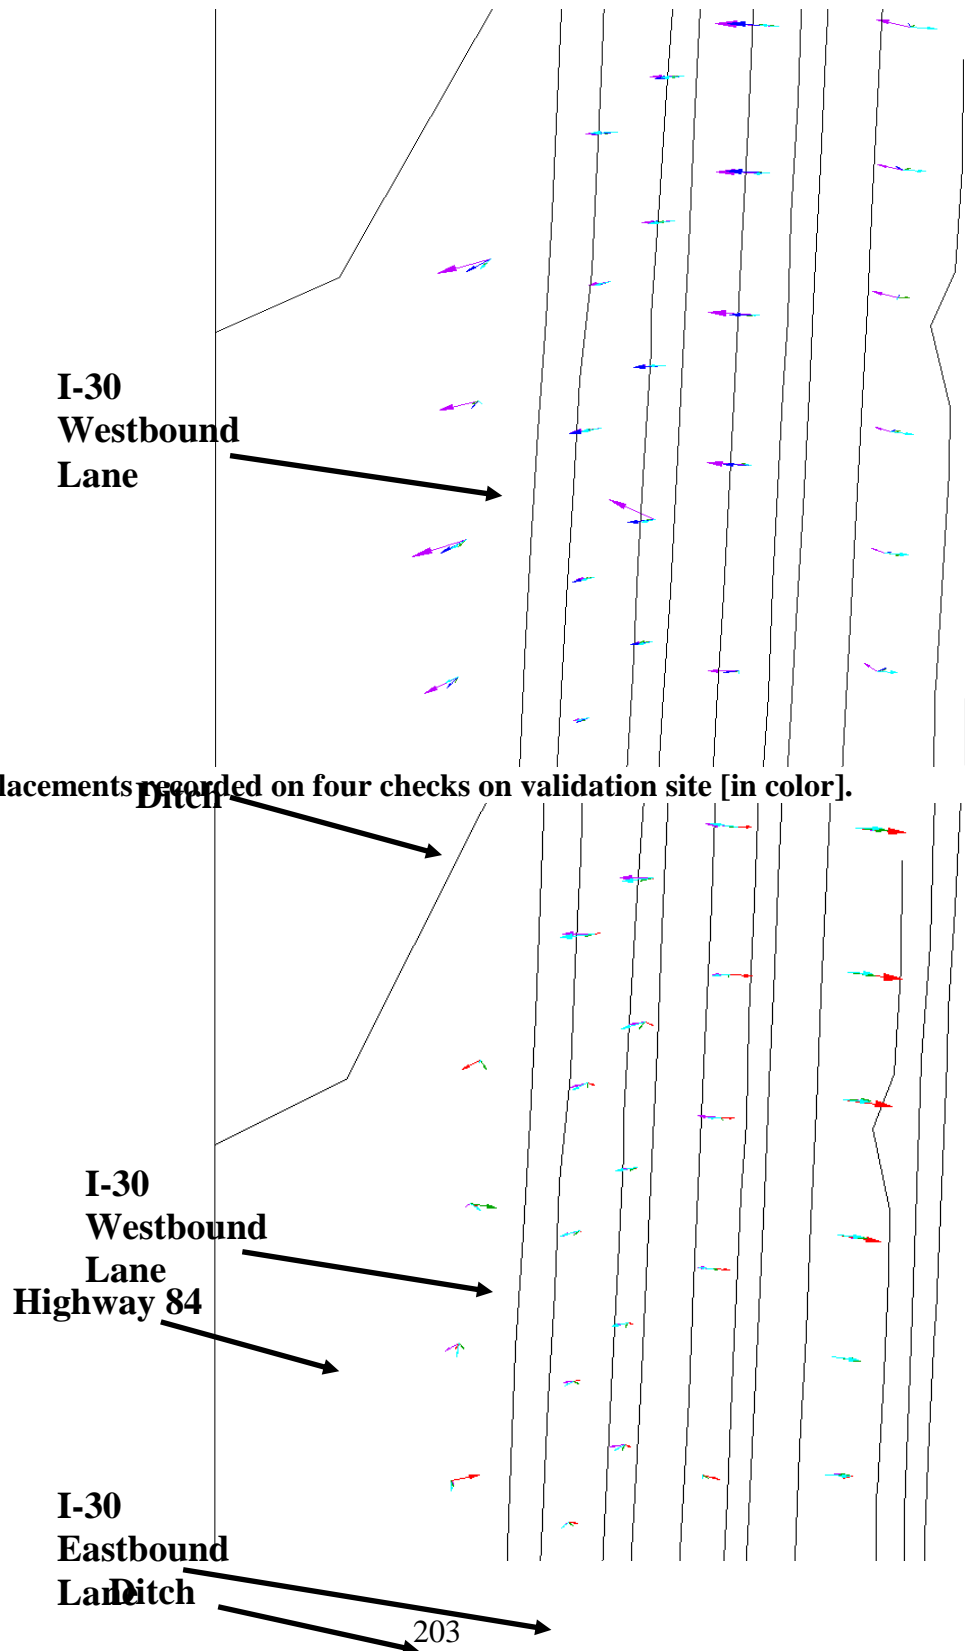
Figure 6.32. Displacements recorded on four checks on validation site [in color].

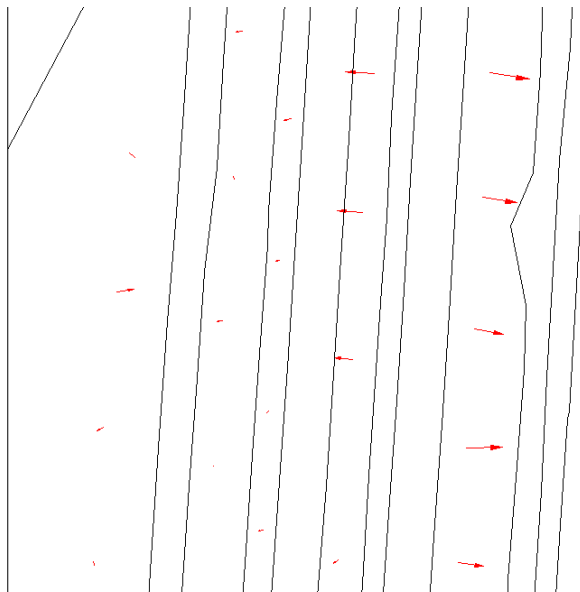
**Figure 6.35. Comparison of displacements obtained from control point 1000 and control point 1029 for validation site near Malvern, Arkansas.**

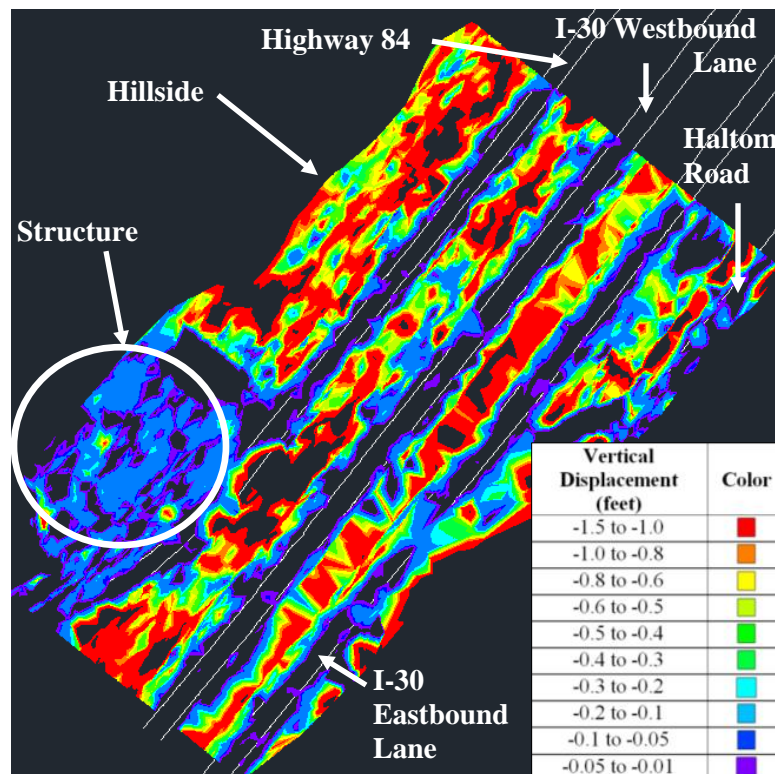
Figure 6.36. Volume surface (050311-120211) obtained using polylines method at the validation site [in color].
