The Marked Tree Site: Evaluation of Geosynthetic Reinforcements in Flexible Pavements

A thesis submitted in partial fulfillment
of the requirements for the degree of
Master of Science in Civil Engineering

December 2011
University of Arkansas

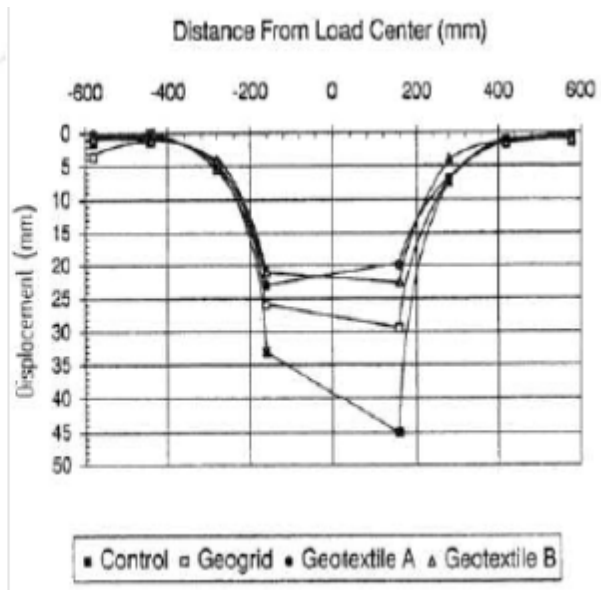
Figure 2.4. Permanent displacement profile at 800 cycles (Al-Qadi et al. 1994).

via Al-Qadi et al. (1994). As observed in Figure 2.4, the control was the poorest performing section after 800 loading cycles were applied, but the geotextiles unexpectedly outperformed the geogrid.

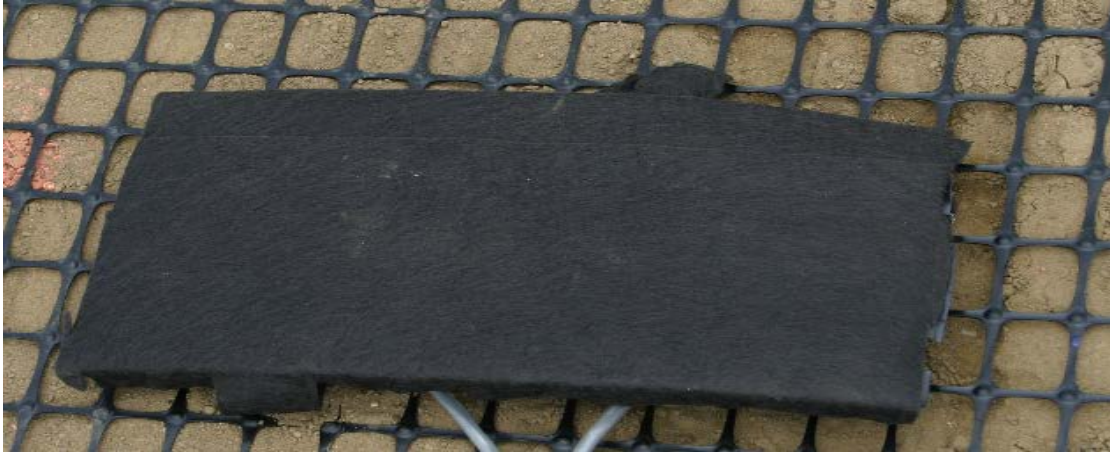
Figure 3.13. Geogrid strain gage protection, strip drain (Howard 2006).

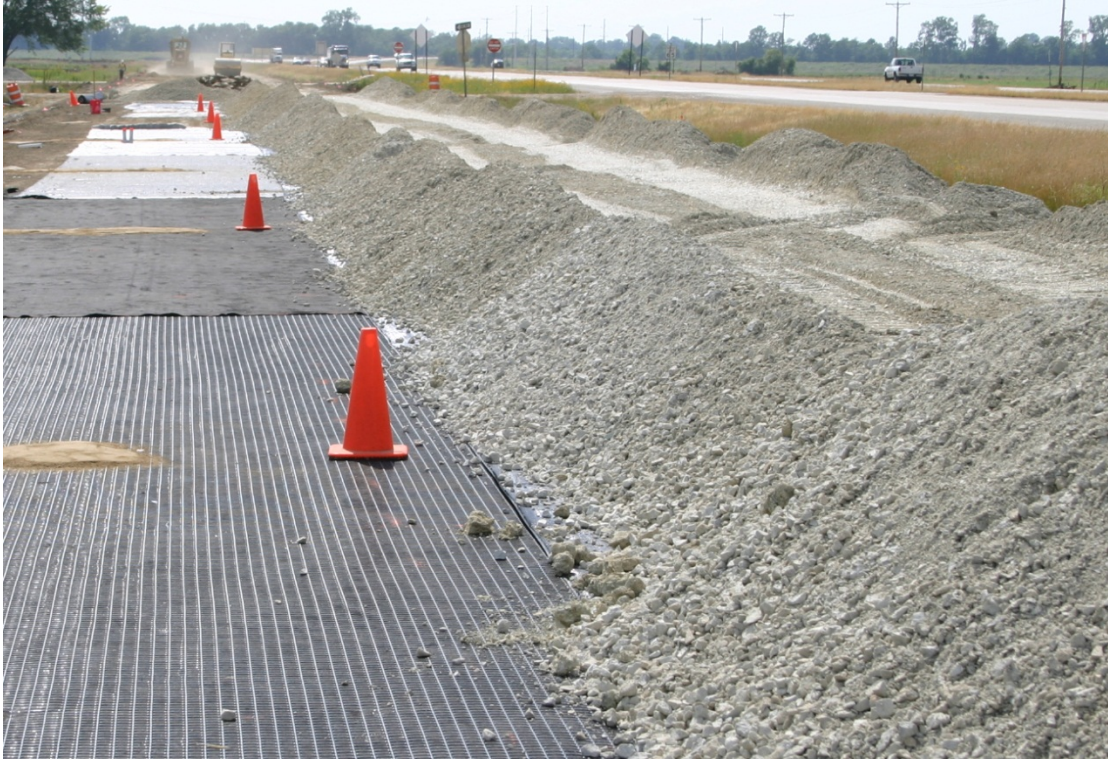
Figure 3.17. Base course placement on non-instrumented lane (Howard 2006).

lanes (Figure 3.17). Once sufficient material was present along the entire test section, aggregate was laterally bladed onto the test sections as shown in Figure 3.18. Until aggregate covered the instrumented test sections, all sensitive areas were continuously marked with fluorescent paint and/or traffic cones. This process was carefully observed and no movement of the geosynthetics occurred. After compaction of the first lift of crushed stone, the contractor proceeded as normal to bring the entire test section to the appropriate grade and density (Howard 2006).

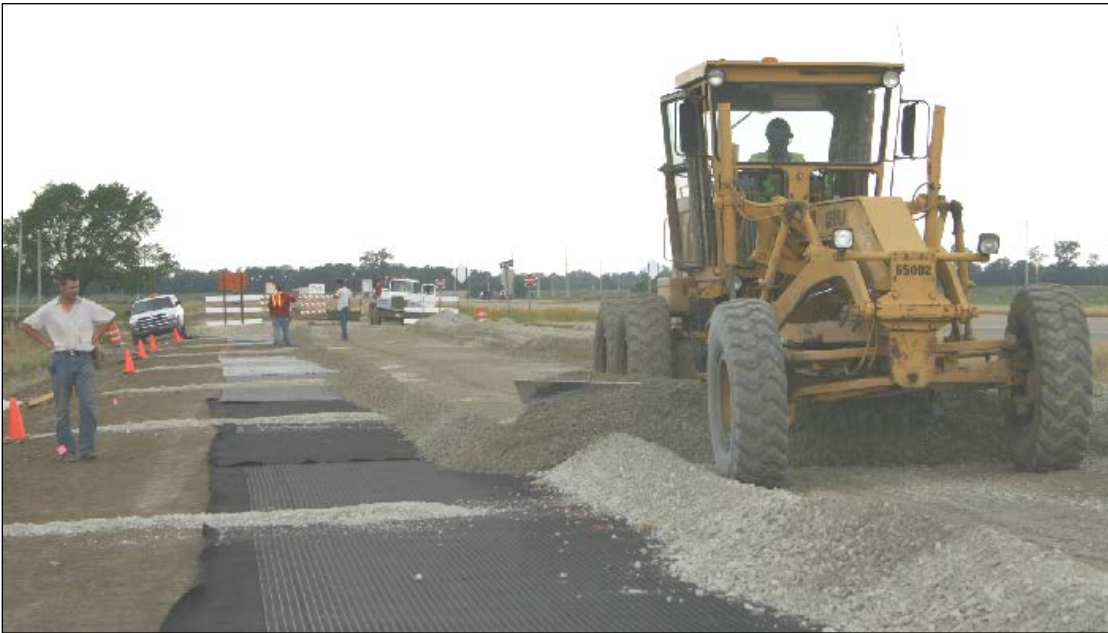
Figure 3.18. Lateral placement of crushed limestone on geosynthetics (Howard 2006).

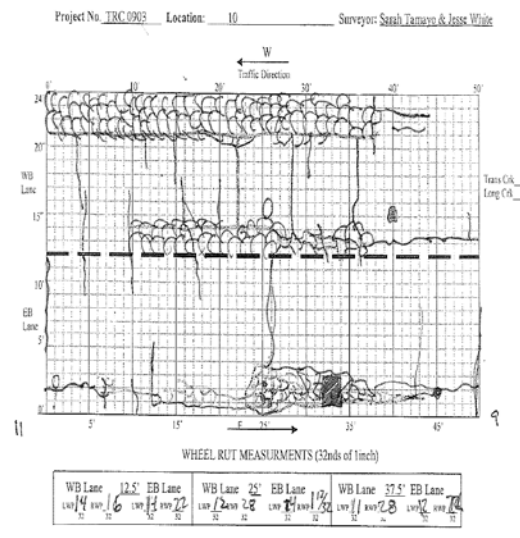
Figure 4.5. Section 10 April 2011 distress survey.

The distress survey for Section 10 for each date is presented in Figures 4.4 and 4.5 as an example of where the rut depth and cracking data were derived from. These distress surveys also show the growth of the pavement cracking over time within Section 10 (the poorest performing test section). Note that the alligator cracking in the eastbound lane began at the center of the test section in the righthand (outside) wheel path where the instrumentation was installed during

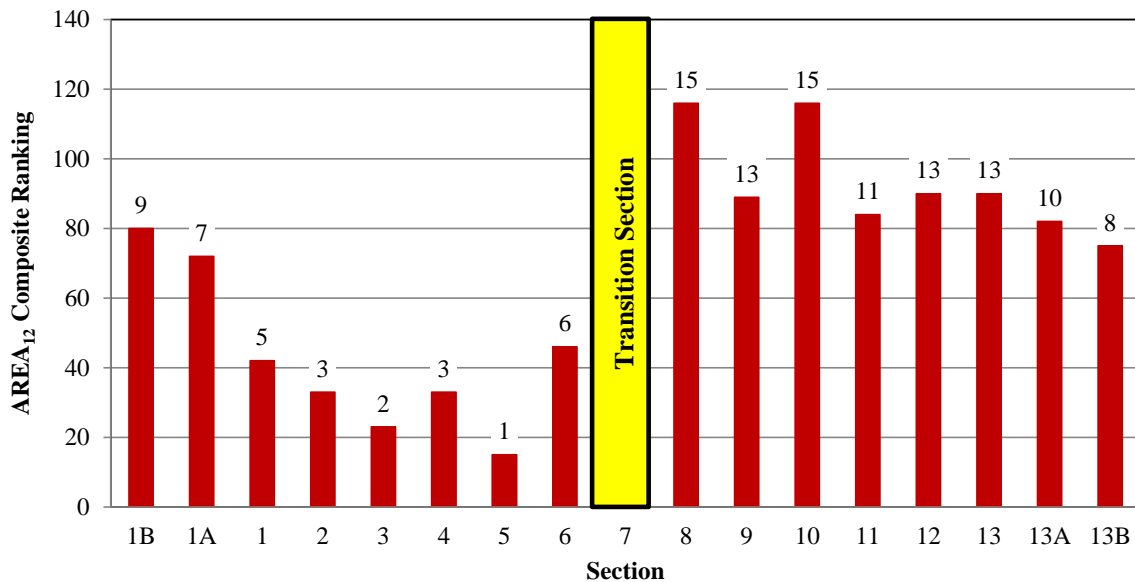
Figure 5.5. AREA₁₂ composite rankings from eight FWD tests conducted at the Marked Tree site.

The composite rankings were calculated by summing the total deflected area and the AREA12 values from each test date and ranking the sums accordingly.

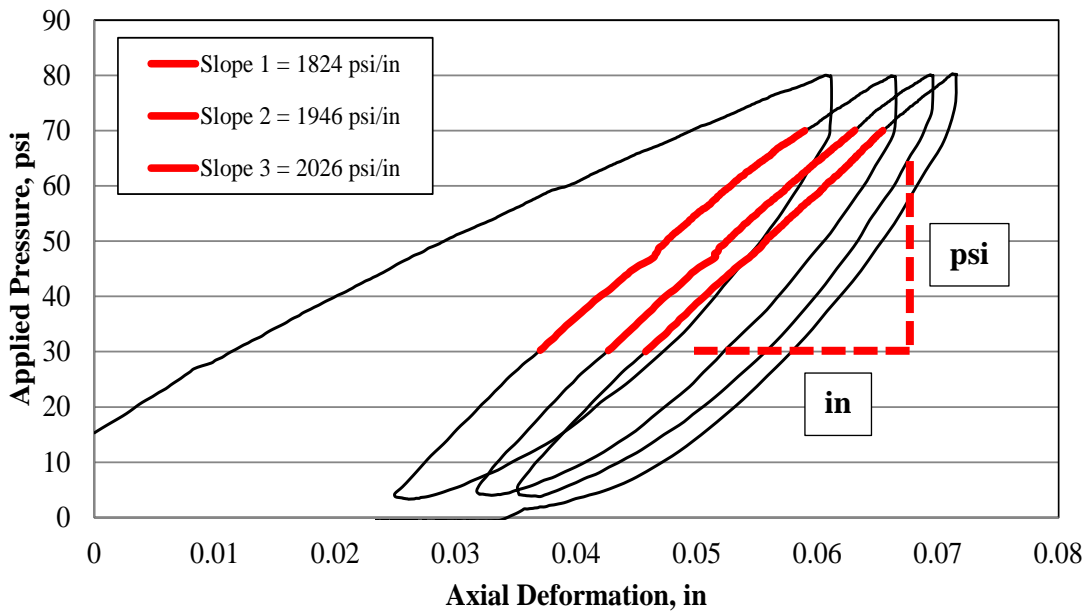
Figure 5.9. Typical PLT response curve for a 6-in (15.2 cm) base section (Section 13B).

The global stiffness values were calculated by averaging the three slopes of the loading portion of the response curves from approximately 30 psi to 70 psi (206 – 482 kPa). The slopes

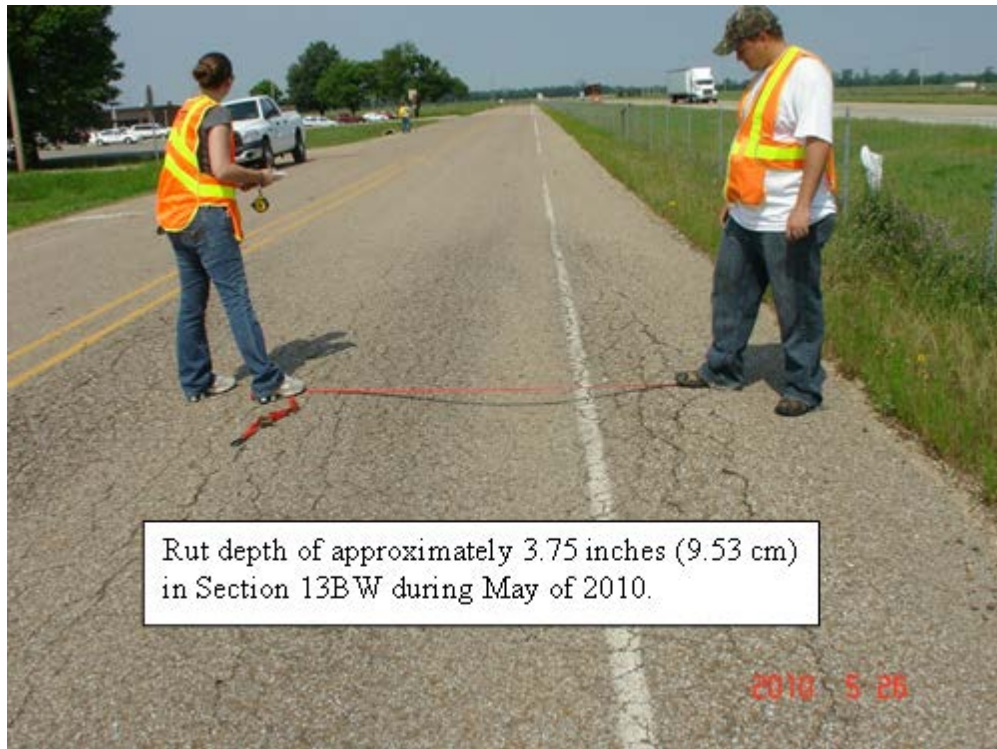
Figure 6.1. Rut depth exceeding 3 inches (7.6 cm) in Section 13BW during May 2010.

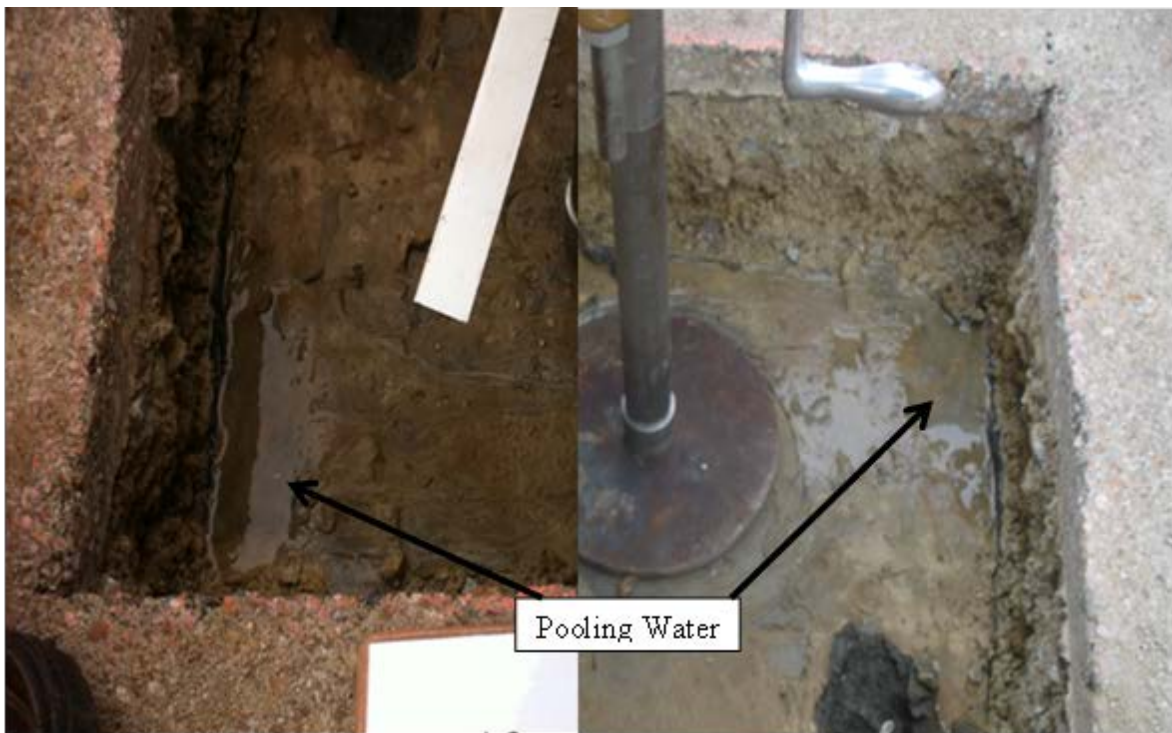
Figure 6.15. Pooling water on subgrade of Section 13W in October 2010.

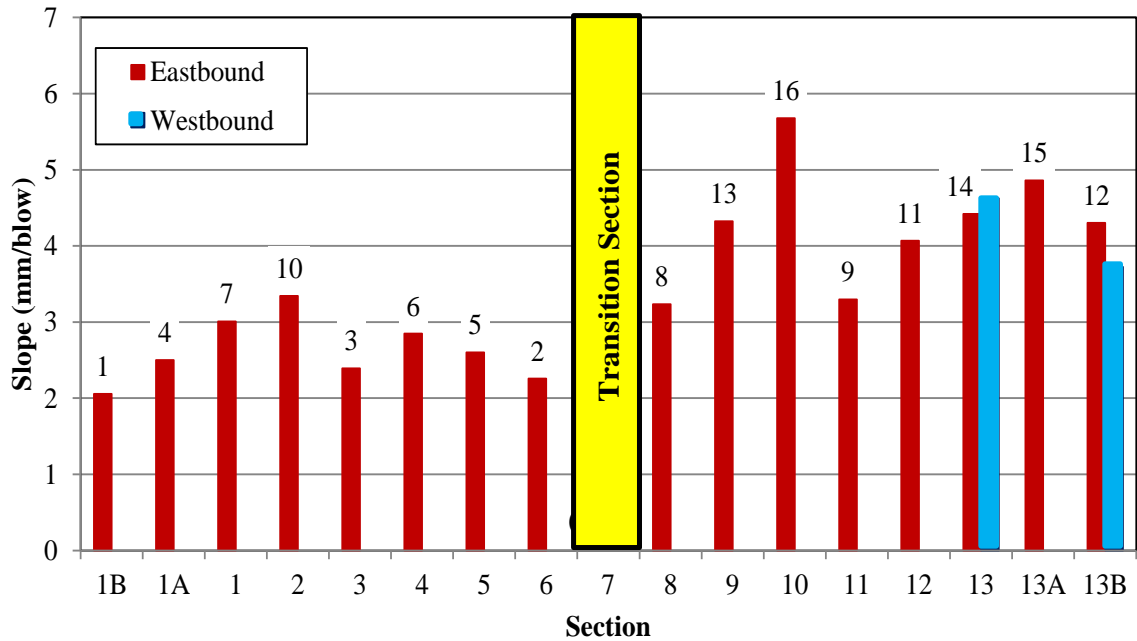
Figure 6.30. Layer 2 (bottom of base) slopes calculated from DCP testing during the October 2010 Marked Tree site visit.

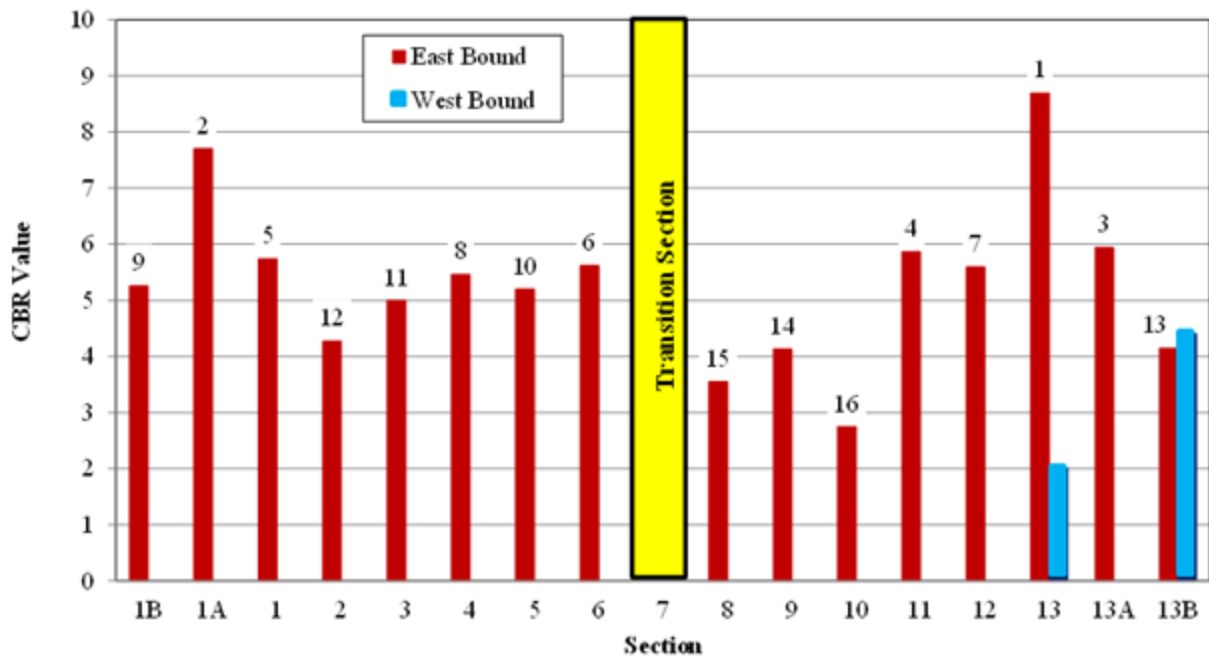
Figure 6.34. In-situ subgrade CBR values from the Marked Tree site during the October 2010 site visit.
