Mitigation of Alkali-Silica Reaction (ASR) in an Interstate Median Barrier

A thesis submitted in partial fulfillment
of the requirements for the degree of
Master of Science in Civil Engineering

August 2014
University of Arkansas

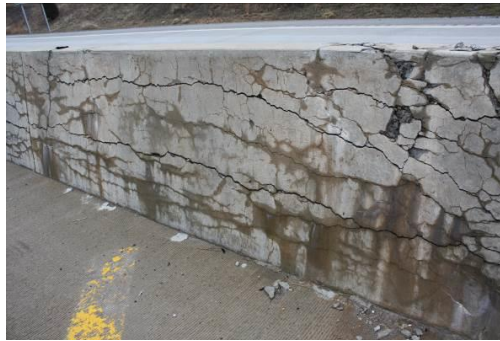
Figure 1.2. Example of ASR symptoms such as map cracking, cracks parallel to restraint, gel exudation, and surface discoloration. Picture used with permission from Richard Deschenes.

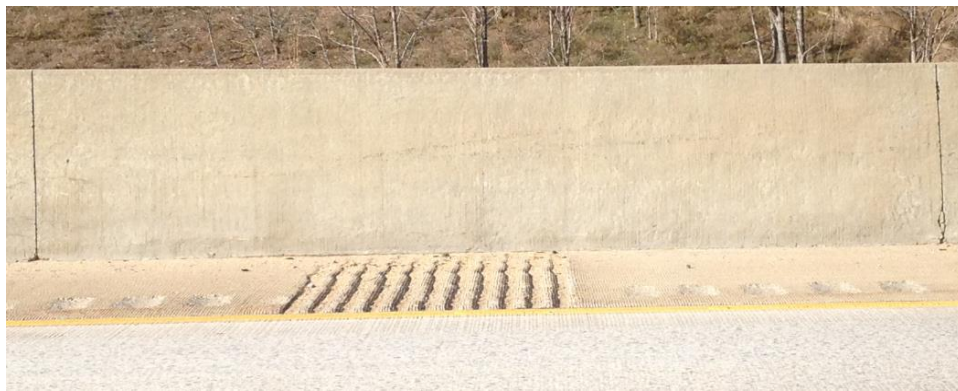
Figure 2.1. A median barrier section which exhibits minimal damage, (e.g. 3no visible map cracking). Picture used with permission from Richard Deschenes.

The three damage levels were categorized as minimal, moderate, or severe damage. The minimal damage level included sections which exhibited no visible cracking or minimal map cracking, as shown in Figure 2.1. The moderate damage level included sections which exhibited moderate map cracking and/or longitudinal cracks, as shown in Figure 2.2. Severe damage included sections which exhibited severe map cracking, longitudinal cracks (greater than 2 mm), crushing at the joints, and/or alkali-silica gel exudation and precipitation near cracks. A typical section with severe damage is shown in Figure 2.3.

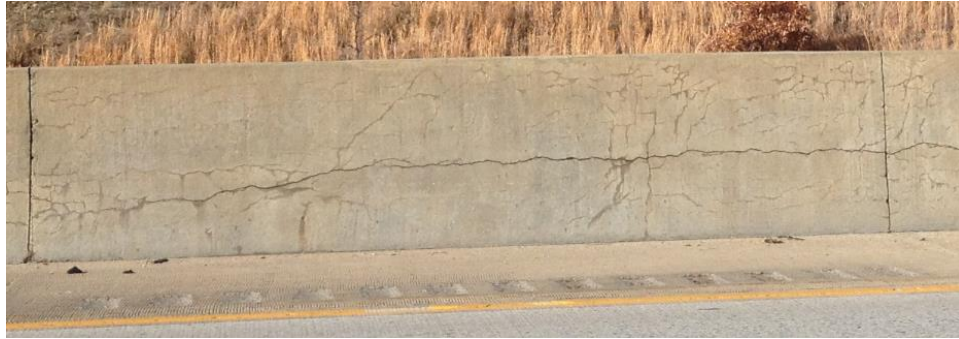
Figure 2.2. A typical median barrier section which exhibits moderate damage, (e.g. moderate visible map cracking, and a longitudinal crack along the full length of the section). Picture used with permission from Richard Deschenes.

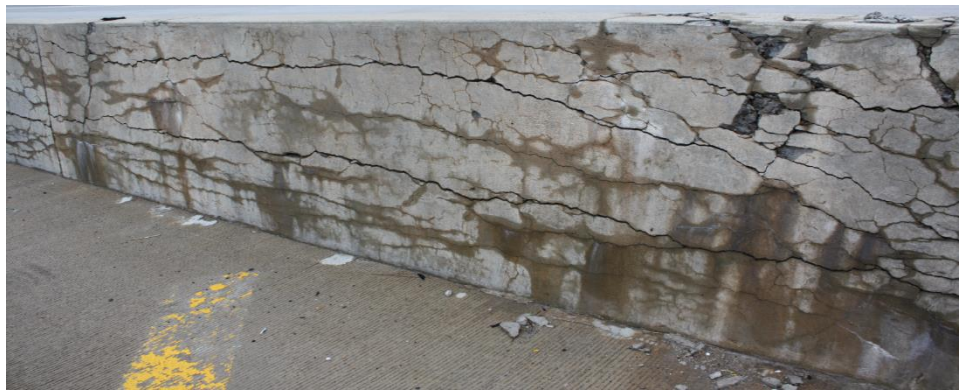
Figure 2.3. A typical median barrier section which exhibits severe damage, (e.g. severe map cracking, longitudinal cracks, crushing at the joints, and visible alkali-silica gel exudation). Picture used with permission from Richard Deschenes.

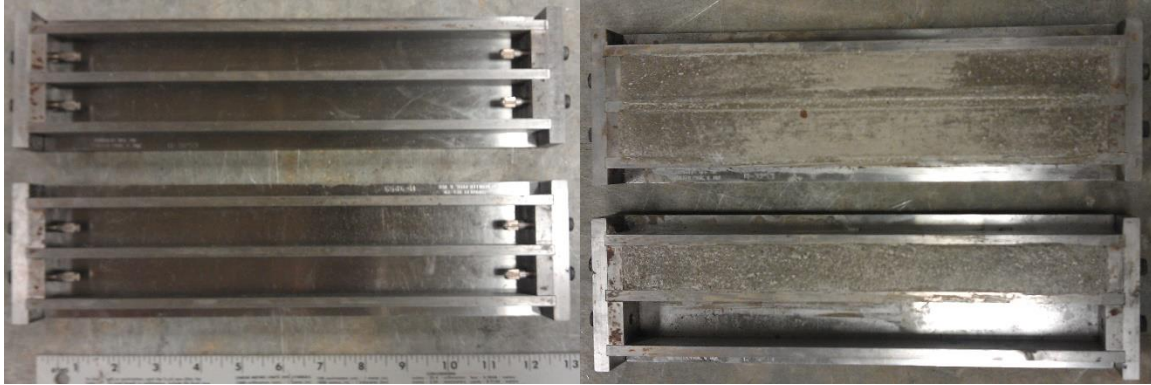
Figure 2.4. Mortar-Bar mold with gage studs (left) and mortar-bar mold with three mortar-bars (right). Picture used with permission from Richard Deschenes.

The standard batch produced enough mortar for three mortar-bars with standard dimensions of 25 x 25 x 285 mm (1 x 1 x 11.25 in). The mortar bars were cured for 24 hours in an environmental chamber with ambient temperature of 23 ± 2 degree Celsius and 95 percent relative humidity. The mortar-bar molds are displayed in Figure 2.4 (left), and typical cured mortar-bars are displayed in Figure 2.4 (right).

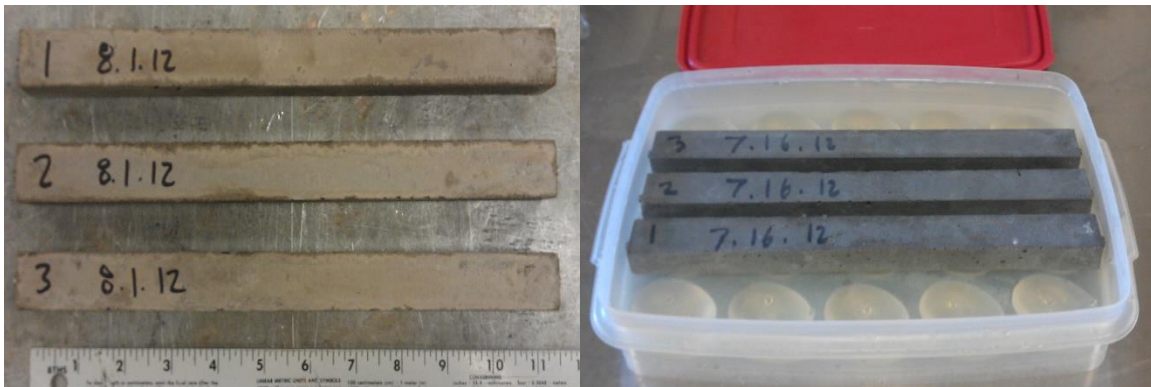
Figure 2.5. Mortar-bars (left) and mortar-bar in storage container (right). Picture used with permission from Richard Deschenes.

The mortar bars were removed from the molds after 24 hours of curing. The mortar-bars were then placed in 80 degrees Celsius water for 24 hours. A typical set of cured mortar bars are displayed in Figure 2.5 (left), and a typical set of mortar-bars in the storage containers are displayed in Figure 2.5 (right).

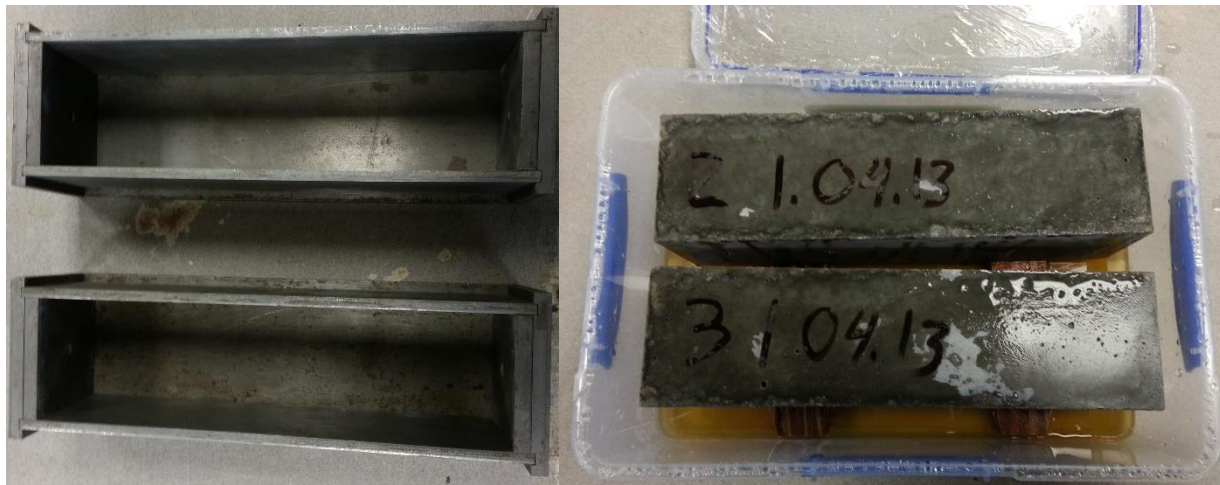
Figure 2.6. Typical CPT prism molds (left), and storage containers (right). Picture used with permission from Richard Deschenes.

used for storage had dimensions of 225 x 300 x 112 mm (9 x 12 x 4.5 in.) with a water tight cover. The prisms were elevated 25 mm (1 inch) from the bottom of the container with small blocks of wood, and then 12.5 mm (1/2 inch) of water was placed in the bottom of the container. The containers were sealed and placed in a water bath to maintain a temperature of 38 degrees Celsius.

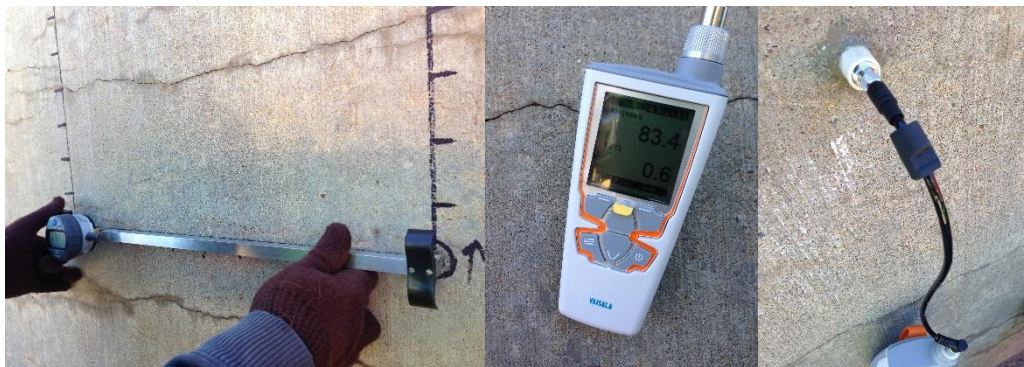
Figure 2.9. DEMEC gage during length-change measurement (left), portable humidity indicator (center), and humidity probe inserted into a humidity port (right). Pictures used with permission from Richard Deschenes.

allowed to equilibrate with the concrete for 30 minutes. The probe was left in the port until there was less than ± 1 percent change in internal relative humidity over a five minute period, but no less than 15 minutes total time. Ideally, one hour was required to allow the conditions within the port to reach equilibrium with the concrete. However, time was limited and only 30 minutes was available to measure each median barrier section. In addition, because the ports were sealed before measurements were taken; the ambient conditions within the port were already in equilibrium with the concrete. Once the humidity probe was inserted into the port and the temperature of the probe reached equilibrium with the concrete no additional time was required for equilibrium to occur. After the probe temperature reached equilibrium with the concrete, subsequent sections took less time because no additional time for equilibrium conditions was required. The portable humidity indicator and humidity probe are shown in Figure 2.9 (center) and Figure 2.9 (right), respectively.

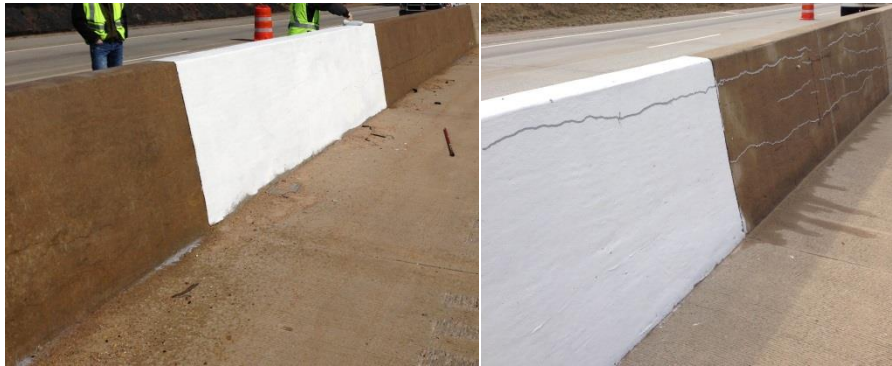
Figure 2.10. Application of surface treatment (left) and crack sealant (right). Pictures used with permission from Richard Deschenes.

single application of silane and then an additional application of silane six months later. A typical application of surface treatments is shown in Figure 2.10 (left). To ensure the correct application rate, the required amount of each respective treatment for a single section was measured and then applied to the section. The sections were allowed to dry for 24 hours, and then initial length-change and internal relative humidity were measured. Several of the moderately and severely damaged sections exhibited wide cracks (> 2 mm) which were sealed with silicon sealant to prevent excess moisture from entering the concrete. The silicon crack sealant is shown as applied in Figure 2.10 (right).

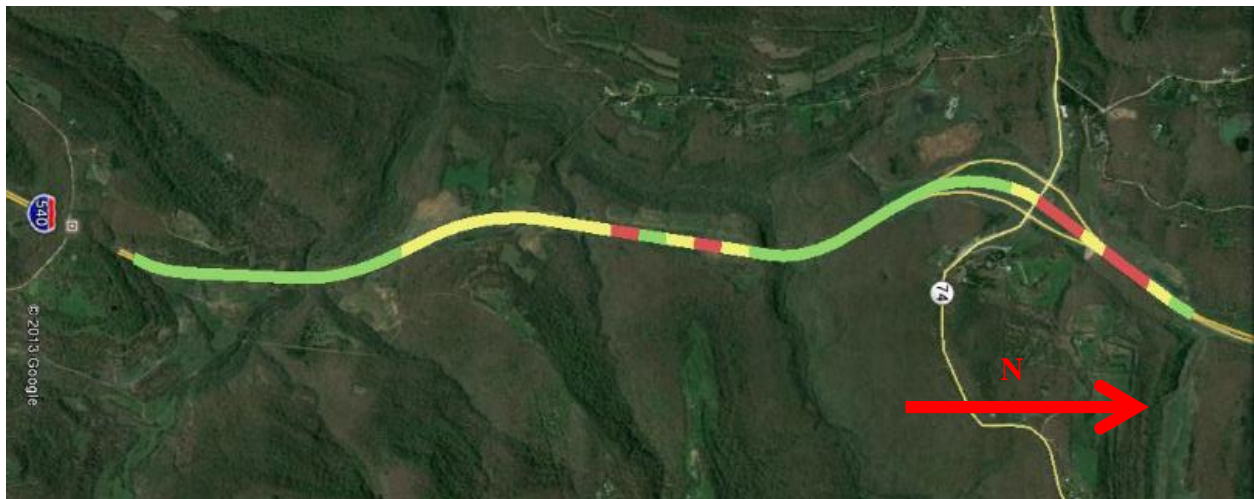
Figure 3.1. Median barrier damage level along Interstate 49. Figure produced in Google Earth.

Damaged Sections (Miles)			
Minimal	Moderate	Severe	Total
2.3	1.40	0.7	4.40

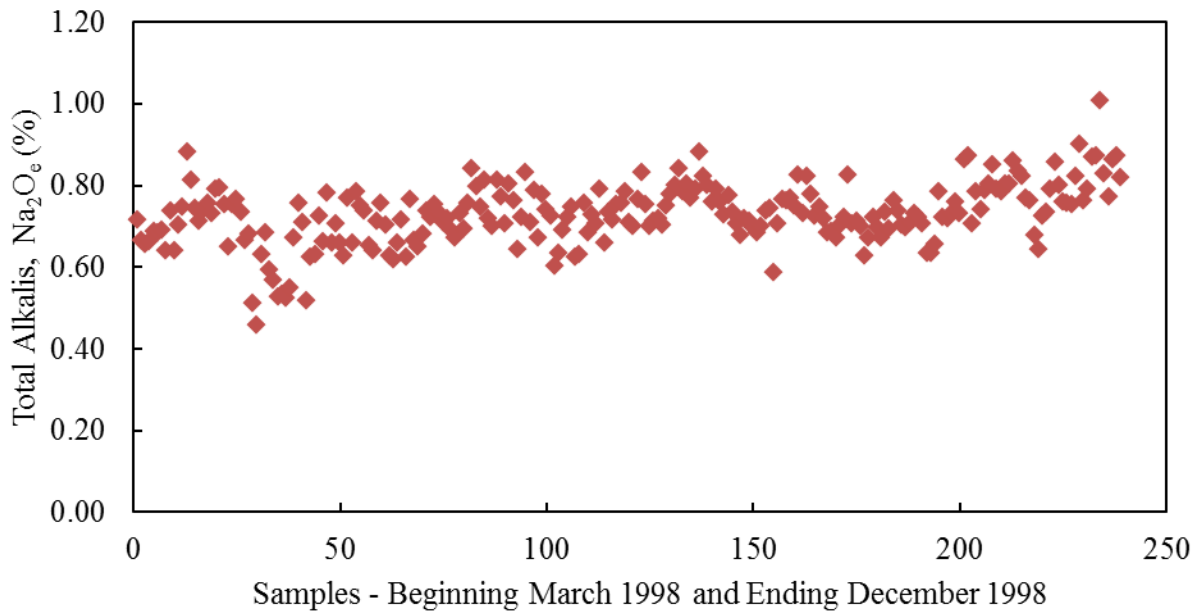
Figure 3.2. Cement alkali content (Na_2O_e) with respect to time.

Limited documentation from the construction of the median barrier was available at the start of the research program. However, information was available on the sources of aggregate, cement, and fly ash. Cement and fly ash chemistry were recovered from the original manufacturers. As discussed earlier, the fine aggregate was obtained from the Arkansas River in Van Buren, AR. The coarse aggregate was acquired from the limestone quarry in West Fork, AR. The cement was obtained from Pryor, Oklahoma and the Class C fly ash from Muskogee, Oklahoma. The cement alkali levels in percent Na_2O_e , for the cement used in the median barrier are summarized in Figure 3.2.

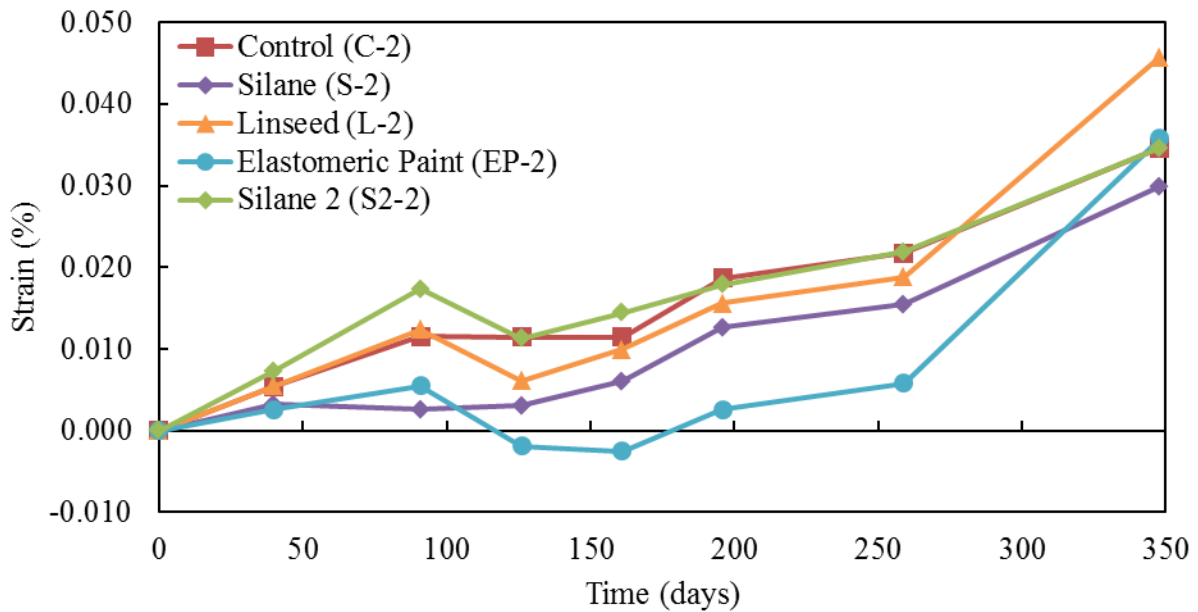
Figure 3.8. Temperature normalized vertical strain (%) with respect to time (days) results for median barrier sections which exhibit moderate damage.

reduction in strain between 91 and 259 days; however, the increase in strain between 259 days and one year was larger than that of section C-2. Section L-2 exhibited a similar large increase in strain between 259 days and one-year, and exhibited the greatest strain at one-year. The increase in strain for sections EP-2 and L-2 may be attributed to freezing and thawing damage which occurred during the winter. However, sections C-2, S-2 and S2-2 did not exhibit the same level of strain between 259 days and one year. Therefore, the silane may have provided some benefit as compared to the other treatments. Silane did not provide a benefit as compared to the untreated section C-2. Section S-2 exhibited lower strain than that of section C-2 throughout the duration of monitoring, and the strain in section S-2 was lower than that of section C-2 between 40 and 161 days. The strain remained lower than that of section C-2 due in part to the low strains which occurred soon after treatment.

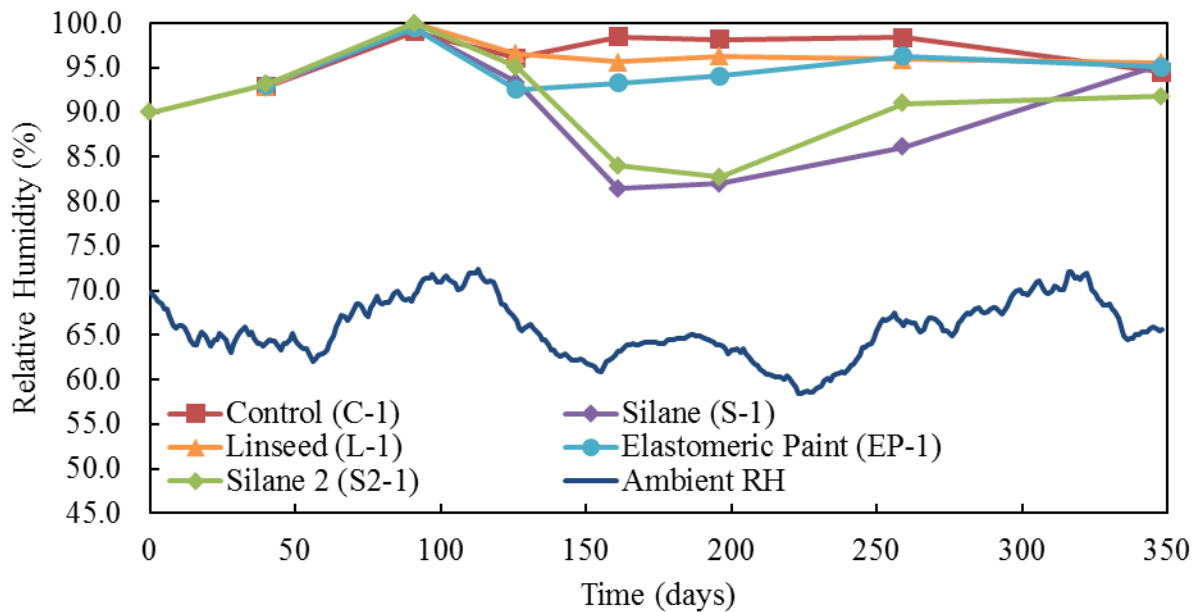
Figure 3.12. Internal relative humidity (%) with respect to time (days) results for median barrier sections which exhibit minimal damage.

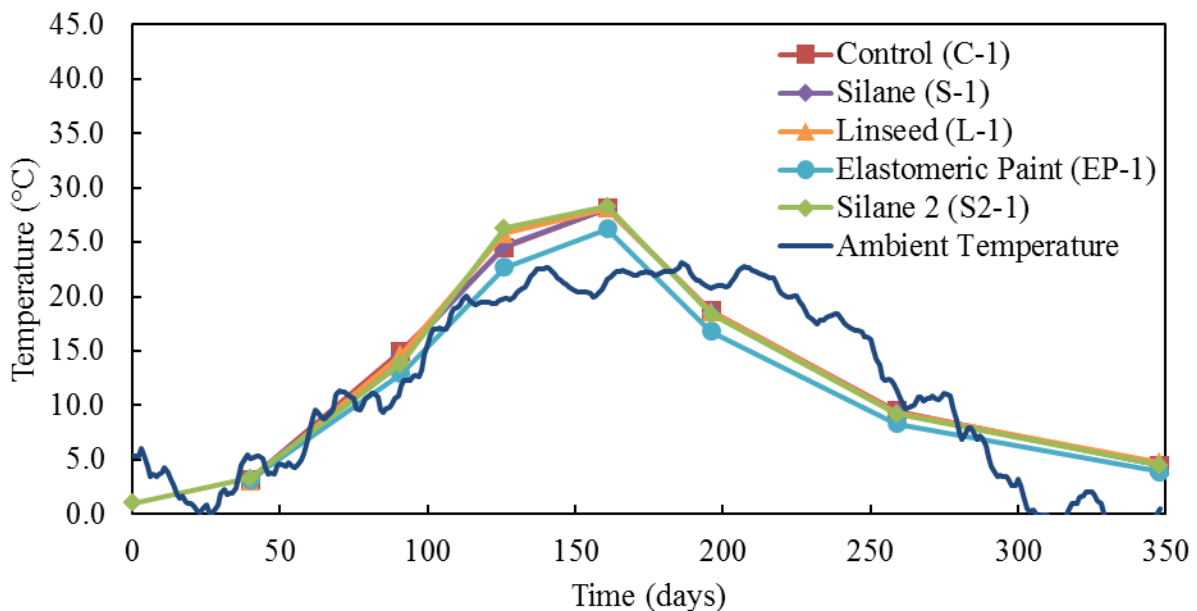
Figure 3.13. Internal temperature (°C) with respect to time (days) results for median barrier sections which exhibit minimal damage.

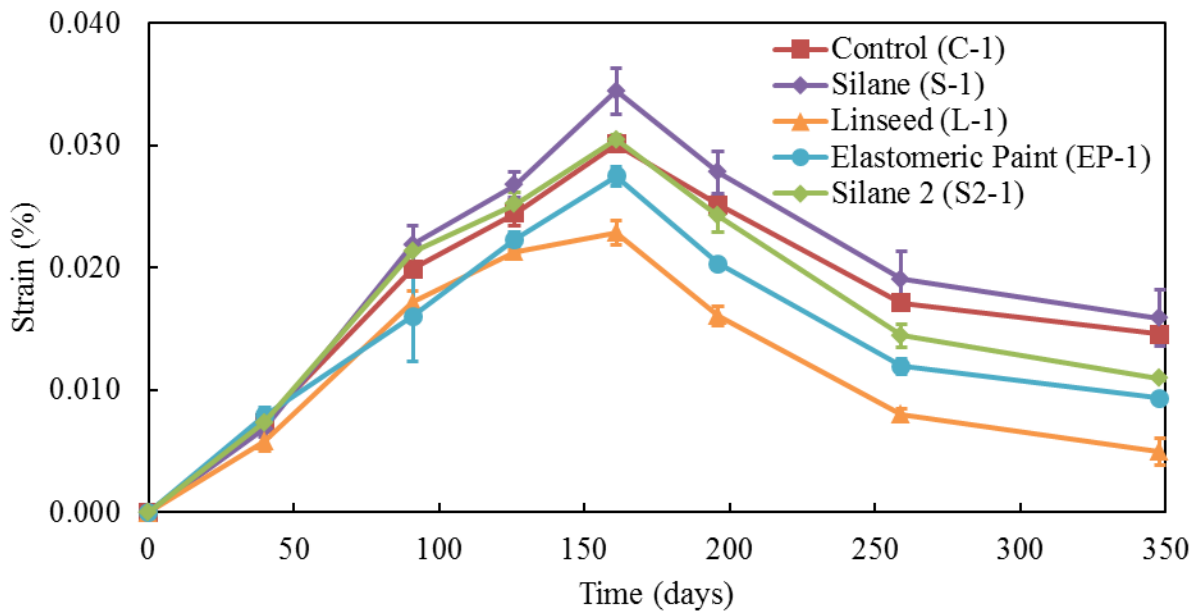
Figure A1.4. Raw vertical strain (%) with respect to time (days) results for median barrier sections which exhibit minimal damage. Error bars represent standard error between two sides of length-change grid.
