# CHARACTERIZATION OF UNKNOWN BRIDGE FOUNDATIONS

# **CHARACTERIZATION OF UNKNOWN BRIDGE FOUNDATIONS**

The National Bridge Inventory (NBI) recognized 86,133 bridges in the United States have no foundation data on record in 2003. It is evident that an unknown percentage of the 86,133 bridges identified by NBI with missing foundation data could also be highly vulnerable to scouring induced by water flow coupled with erodible soils. Conventional excavation, coring and boring excavations to identify unknown bridge foundation depths and types are deemed to be expensive, destructive, and limited in their application to the unknown foundation problem. Many surface and borehole nondestructive testing (NDT) technologies have been developed for this purpose. Three economical proven technique (Sonic Echo/Impulse Response (SE/IR), Parallel Seismic (PS) methods, and Induction Field (IF)) were selected for this study. The study focuses more on SE/IR method since it is the most inexpensive and quick method.

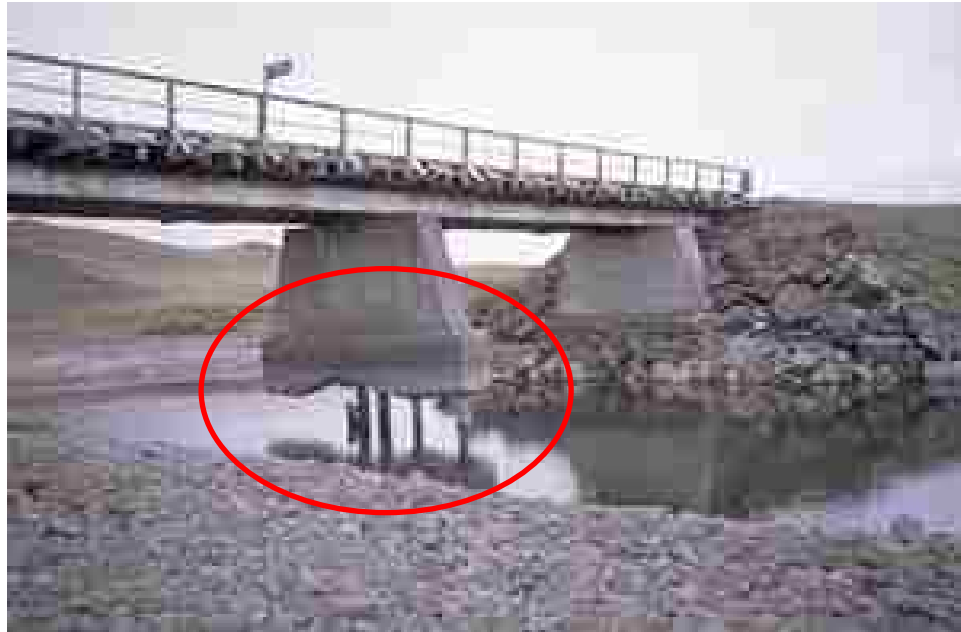
**Figure 2. Complete Loss of Support under a Bridge Pier (3)**

Conventional excavation, coring and boring excavations to determine unknown bridge foundation depths and types are deemed to be expensive, destructive and limited in their application to the unknown foundation problem (2). There is therefore a real need to research and develop lower cost nondestructive testing (NDT) methods to provide foundation depth and type data on unknown bridge foundations to aid in evaluating scour safety.

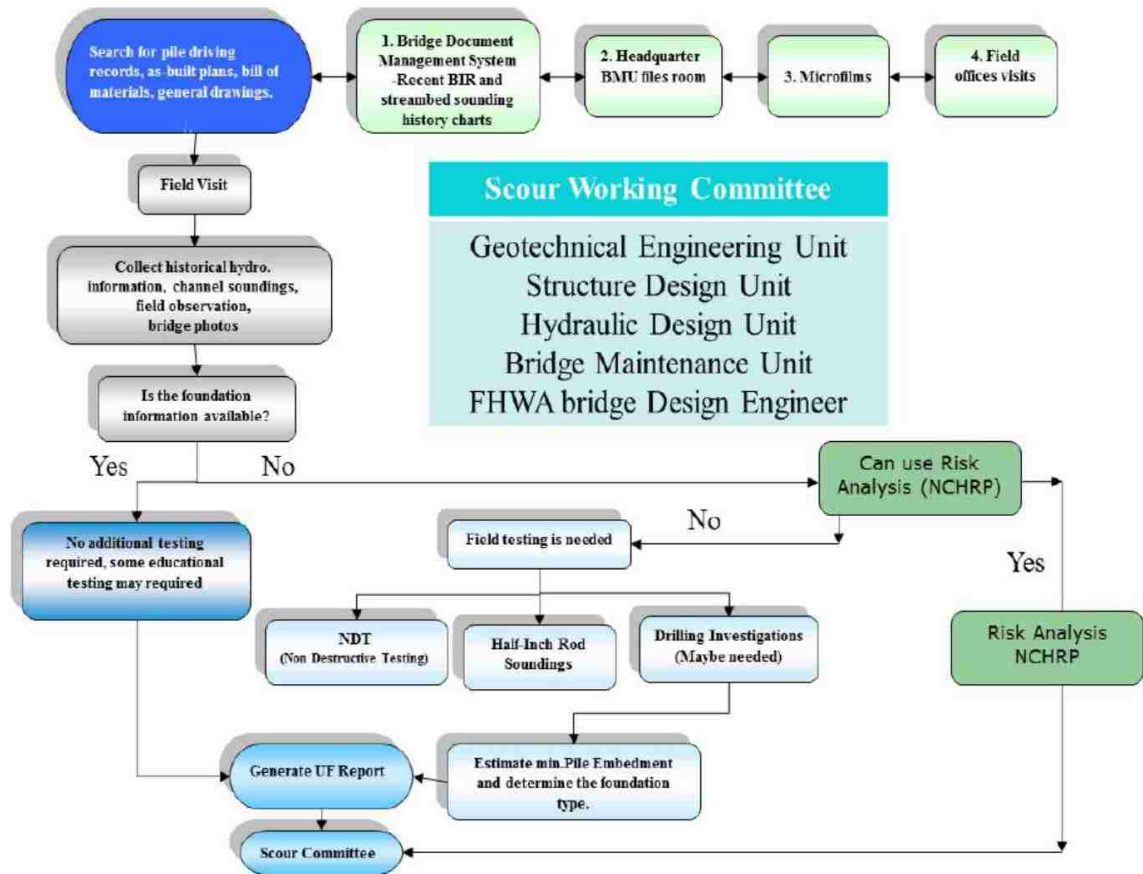
**Figure 3. Flowchart for North Carolina Unknown Bridge Foundation Process (17)**

Figure 3 shows the unknown foundation process developed at North Carolina DOT for UBF in their bridge management system in 2005. The use of the risk-based management guidelines for scour was suggested in 2010 to evaluate remaining low-risk bridges with unknown foundation in North Carolina. The review of all unknown foundation bridges was completed in 2012.

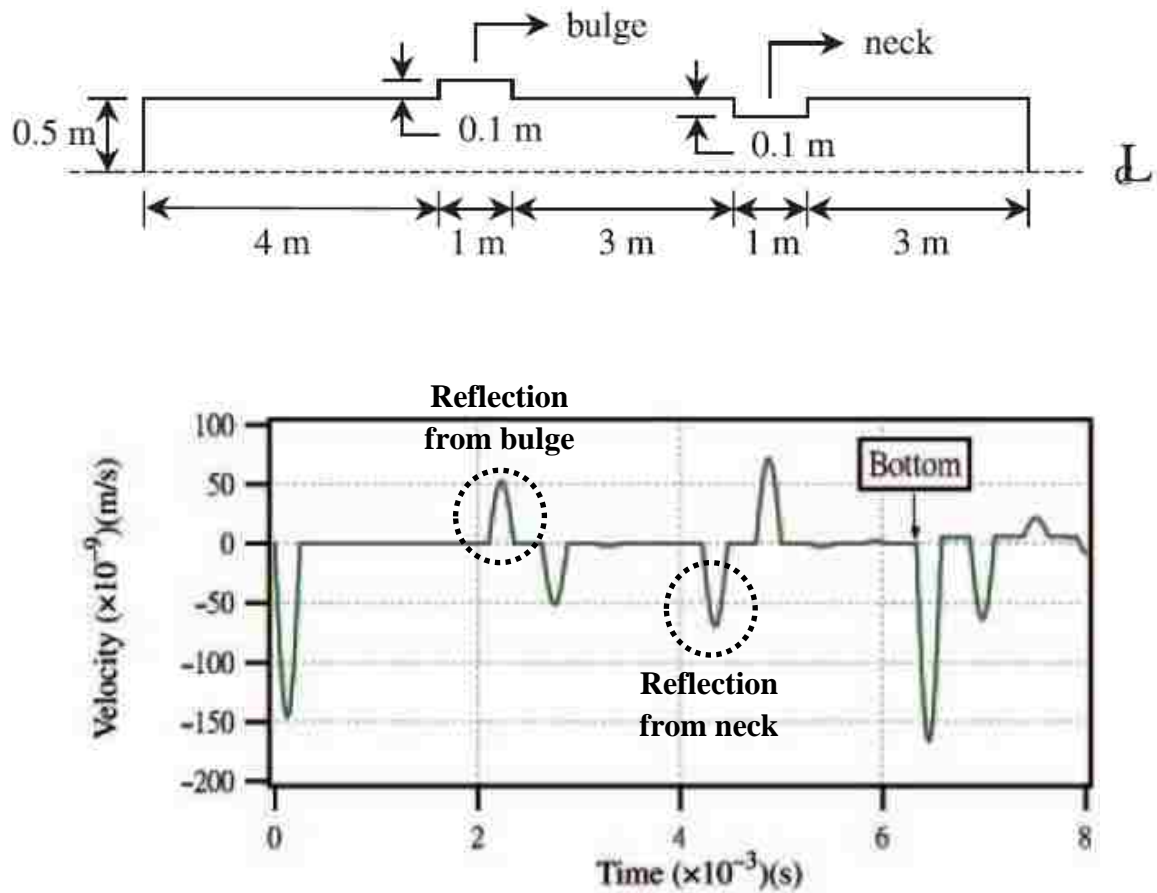
**Figure 9. Velocity Graph of a Defective Pile with a Bulge and a Neck (30)**

defects with sizes greater than 10–30% and 45% can be identifiable by SE and IR analyses, respectively (29). An example of a defective pile with a bulge and a neck and the corresponding velocity signal is indicated in Figure 9 (30).

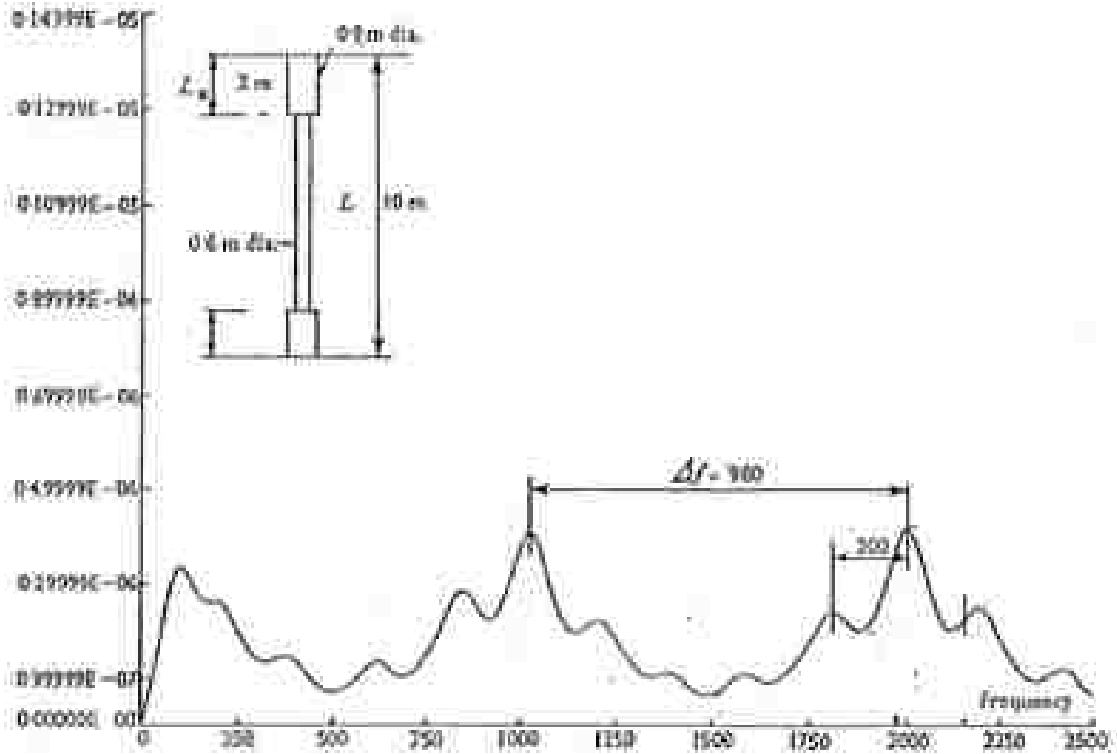
**Figure 10. An Example of a Mobility Graph with Impedance Change in the Pile (31)**

The impedance change along a pile also produces oscillation on the mobility graph. An example of a mobility graph affected by impedance change along a pile is shown in Figure 10 (31). The  $\Delta f = 200$  Hz corresponds to the reflection from the pile bottom, whereas the  $\Delta f = 980$  Hz corresponds to the cross-section change at 2 m below the pile top.

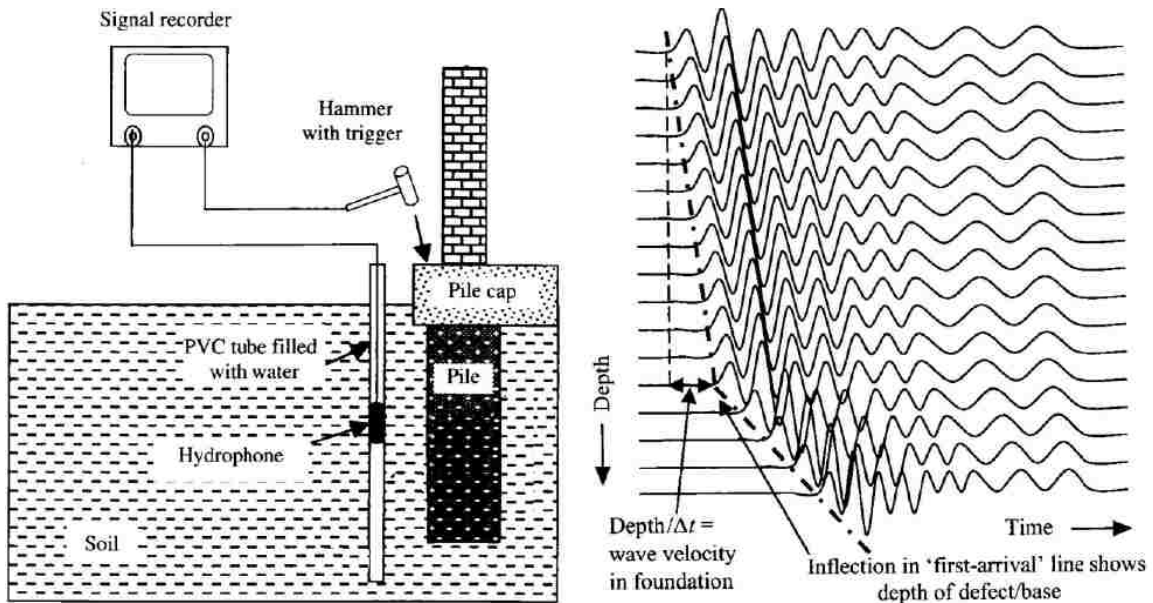
**Figure 11. Typical Setup and Test Data of PS Test (12)**

A newly developed combined Parallel Seismic and Cone Penetration Test (PS/CPT) system allows collecting soil data and conducting a PS test simultaneously during a CPT test. The new combined technique has a great advantage over conventional PS tests since no borehole is required (35). Olson et al. (36) presented details of the principles and operations of the combined (CPT+PS) system.

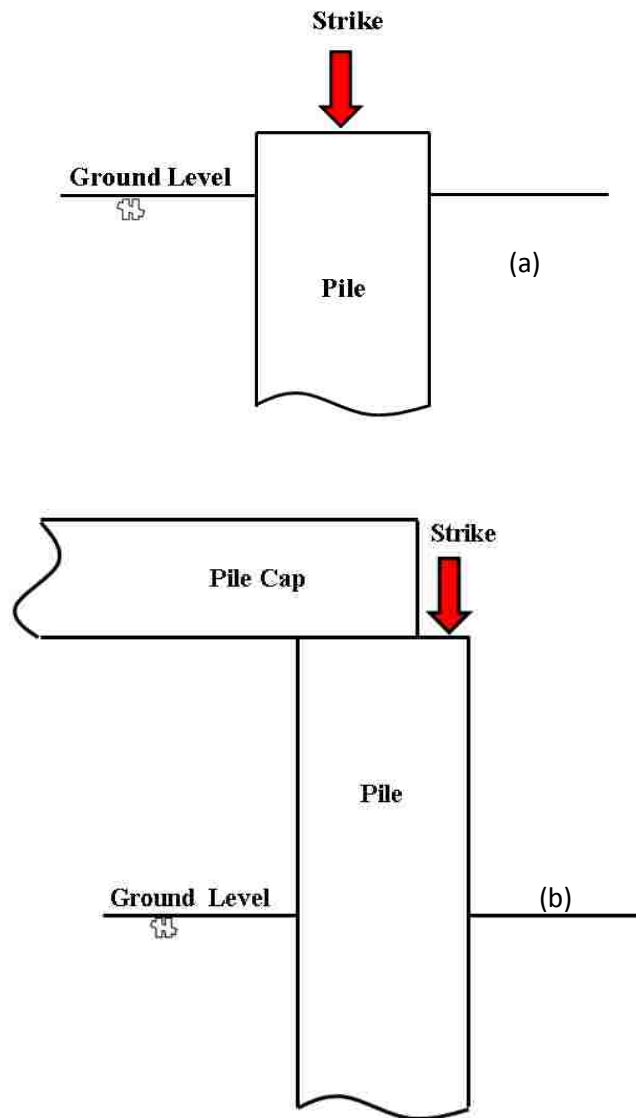
**Figure 13. Vertical Striking on Piles with Accessible Top**

**Striking Setup for Piles with Accessible Top** When either the entire or a portion of the pile top is accessible, a vertical strike can be applied on the top surface of the pile as shown in Figure 13. In this case, the longitudinal P-waves travelling down the pile is generated directly.

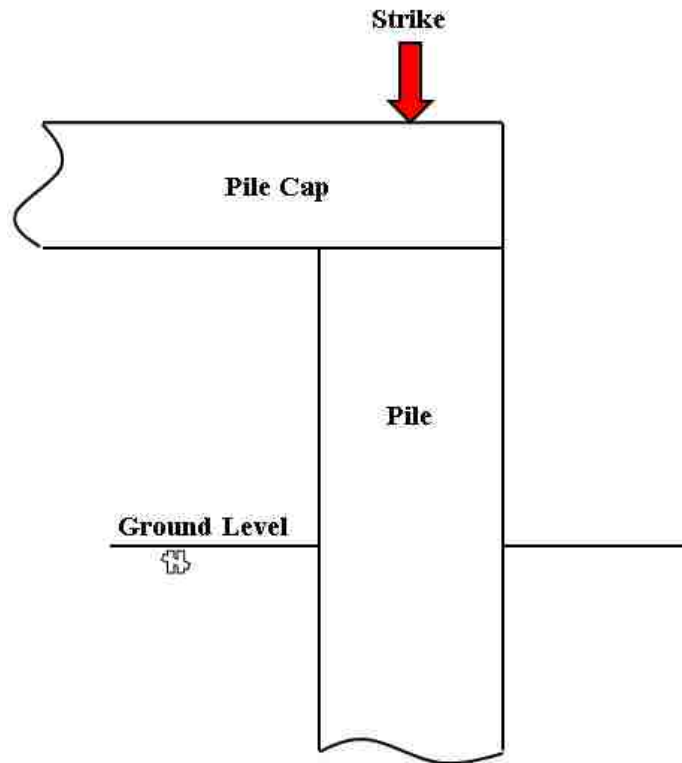
**Figure 14. Vertical Striking on the Top Surface of Pile Cap**

**Setup for Striking on Piles with Inaccessible Top** For piles with inaccessible top, the longitudinal wave can be generated by striking other parts of the foundation as shown in Figures 14 to 19. When the superstructure is not placed exactly atop the pile, longitudinal waves can be produced by striking the top surface of the pile cap as indicated in Figure 14. If the presence of the girders on the top of the pile cap does not allow striking on the pile cap top surface, other options indicated in Figures 15 to 19 can be applied.

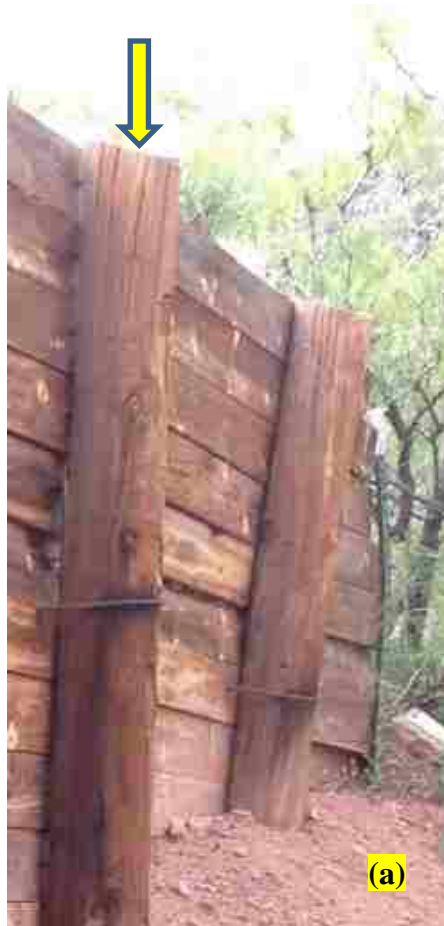
A successful SE/IR test is strongly affected by the source location. Therefore, proper striking methods should be selected to obtain interpretable results. Based on the SE/IR tests setup introduction presented in the previous section, proper practical source locations are indicated in Figure 23. Such striking methods can be used depending on the accessibility of the pile top. These source locations were extensively utilized in the field. They are prioritized based on the quality of the produced data and the preferred options are discussed later.

**Figure 23. Proper Practical Source Locations, (a) Striking on top of the test pile (b), Downward striking on Point B (top of the pile cap directly above the test pile), C (top of the pile cap next to the test pile) and upward striking on Point A (bottom of the pile cap next to the test pile), (c) Striking on top surface of a block tightly attached onto the test pile**

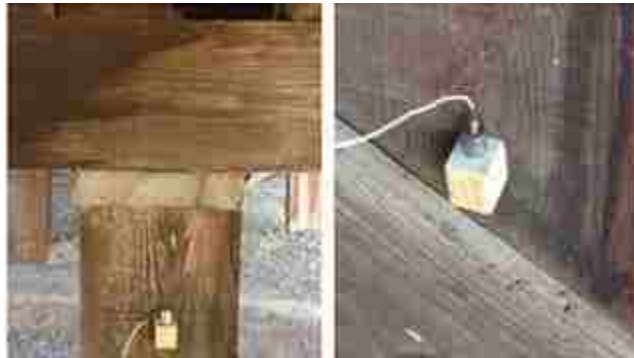
**Figure 26. Accelerometers Mounted on a Pile by Wooden Blocks.**

The sensor (accelerometer) can be placed atop the wing piles. If the pile top is inaccessible, the accelerometers will be mounted on wooden blocks attached onto the side of the test pile with nails, screws, or glue. The dimensions of the wooden blocks used in this project can be found in Figure 22. Examples of accelerometer attachment to the pile surface is indicated in Figure 26. If two accelerometers are used, the second accelerometer should be placed far away from the first accelerometer as possible.

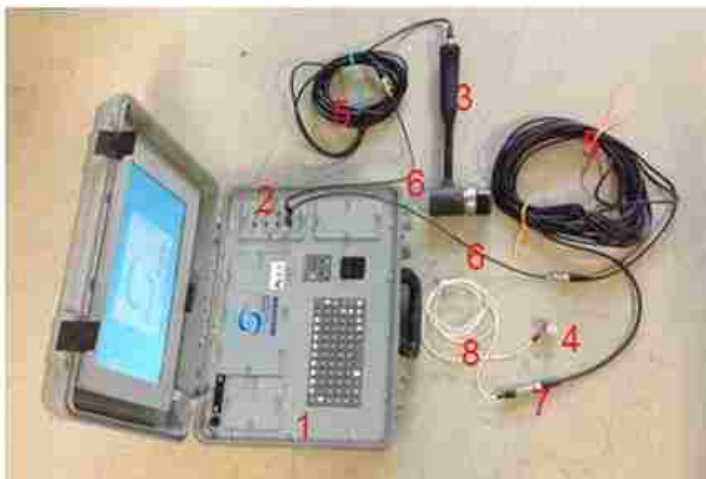
**Figure 27. SE/IR Test Equipment**

The equipment utilized for conducting SE/IR tests should be assembled as indicated in Figure 27. Four different hammer tips are available as shown in Figure 28.

1. Olson Freedom Data PC
2. Input Module
3. Impulse Hammer
4. Accelerometer
5. BNC Cable
6. BNC to 4 Pin Adapter Cable
7. Female-Female BNC Adapter
8. Microdot to BNC Cable

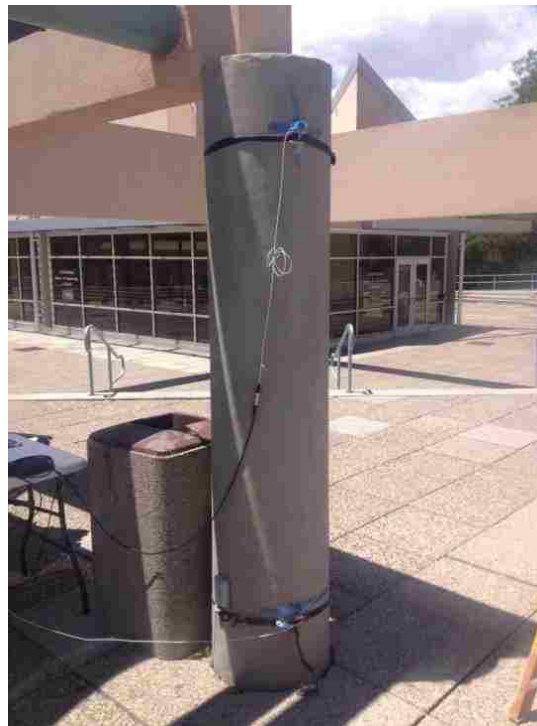
**Figure 37. The Reinforced Concrete Column of Centennial Library on UNM Campus**

Twelve SE tests were conducted on a reinforced concrete column on UNM campus shown in Figure 37. The column is one of the 3-story columns of the Centennial Engineering Library on UNM campus. The total length of the column is 43 ft. Only the top 7.5 ft of the column is visible as shown in the photo.

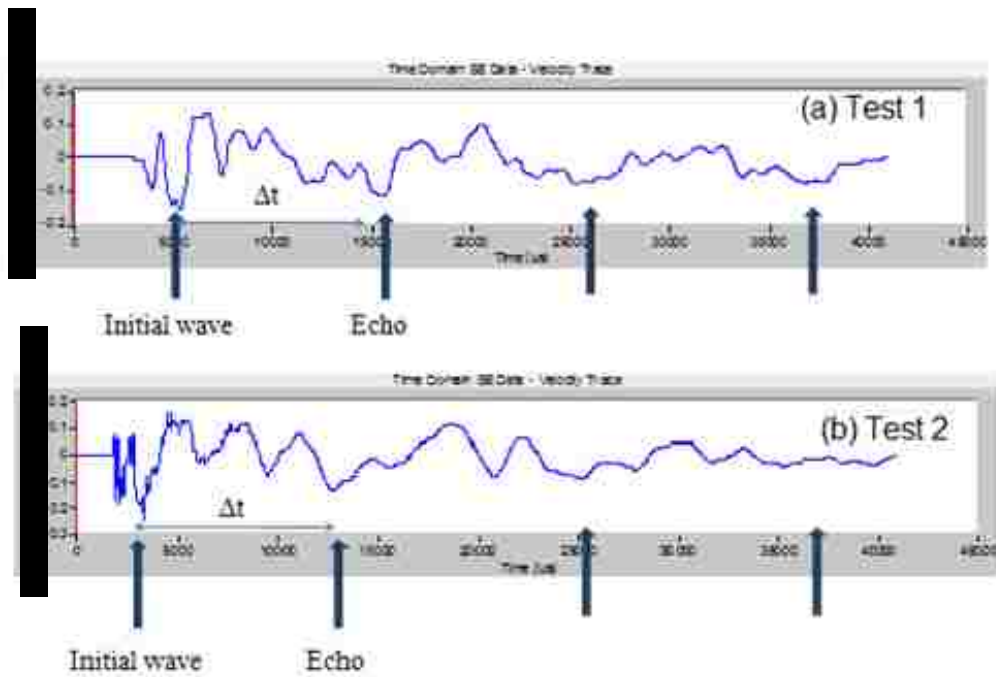
**Figure 39. Velocity Graphs for Tests 1 and 2 on the Concrete Column of Centennial Library on UNM Campus**

**Results of Vertical Striking with Hard Tip** The velocity graphs obtained from the accelerometer in Tests 1 and 2 are depicted in Figure 39. Although high frequency noise at the beginning was clearly observed in Figure 39b, the impulse and echoes were identifiable as shown as arrows in the figure. When the accelerometer was placed at least 1 ft away from the source, the high frequencies at the beginning disappeared. Therefore, accelerometers are recommended to be placed at least 1 ft from the source.

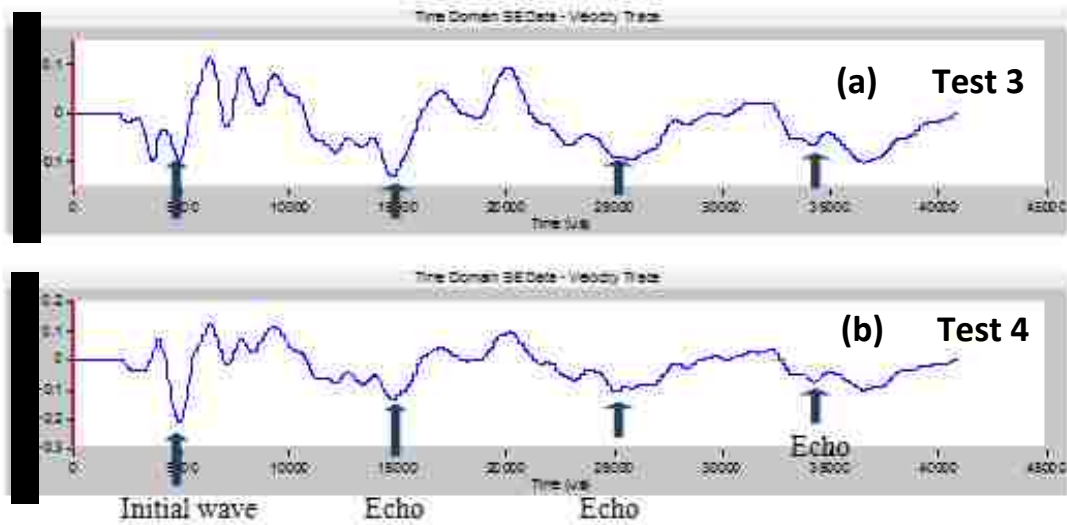
**Figure 40. Velocity Graphs for Tests 3 and 4 on the Concrete Column of Centennial Library on UNM Campus**

**Results of Vertical Striking with Medium-hard Tip** SE tests were repeated using a medium-hard tip. The velocity graphs for Tests 3 and 4 are shown in Figure 40. There are no high frequencies at the beginning of the velocity graphs. The time differences between the impulse and echo are similar to tests conducted by the hard tip (see Figure 39).  $\Delta t$  is still 10 ms and the calculated length is 50 ft.

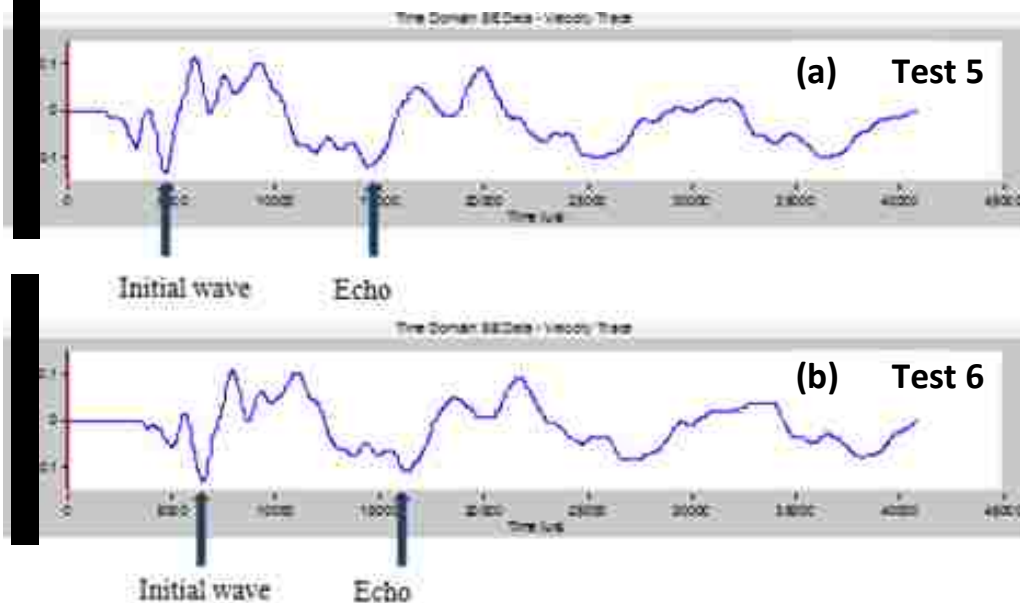
**Figure 41. Velocity Graphs for Tests 5 and 6 on the Concrete Column of Centennial Library on UNM Campus**

**Results of Vertical Striking with Medium-soft Tip** Medium-soft tip was used and the obtained velocity graphs are shown in Figure 41. Again, the results are similar to the velocity graphs using medium-hard tip (see Figure 40). In addition, no high frequency content can be found as seen in the velocity graph of hard tip (Figure 39b).  $\Delta t$  is still 10 ms and the calculated length is 50 ft.

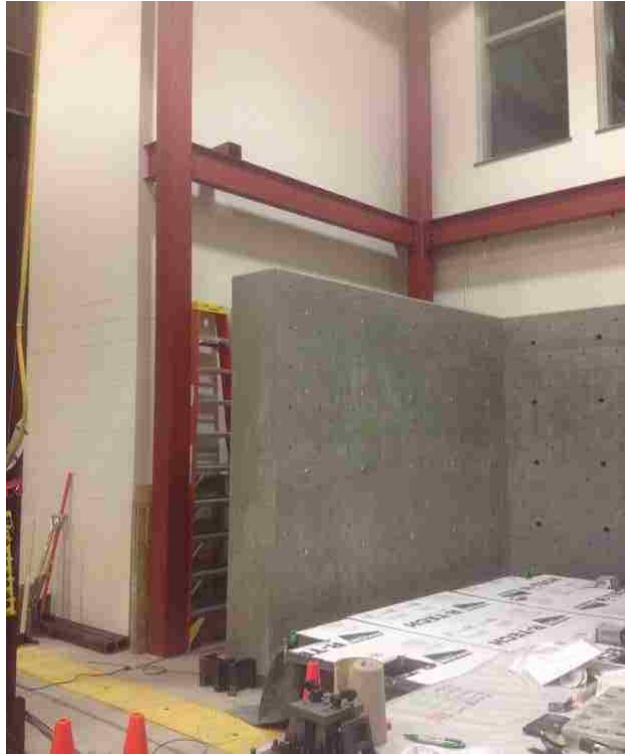
Figure 43. The Reinforced Concrete Wall in the Structural Lab

Since there are similarities in relative dimensions between a pier wall foundation and the reinforced concrete strong-wall at the Structural Lab of the Department of Civil Engineering at UNM (Figure 43), SE tests were conducted in the lab to study the applicability of the method on non-slender foundations. SE tests were carried out using vertical and horizontal striking with hard, medium-hard, medium-soft and soft hammer tips. Figure 44 shows the source (A~D) and the accelerometer locations (E, F and G). The accelerometer was mounted vertically on Points E, F or G. Wooden blocks were utilized to mount the accelerometers at Points F and G. Figure 49 shows the setup of one SE test.

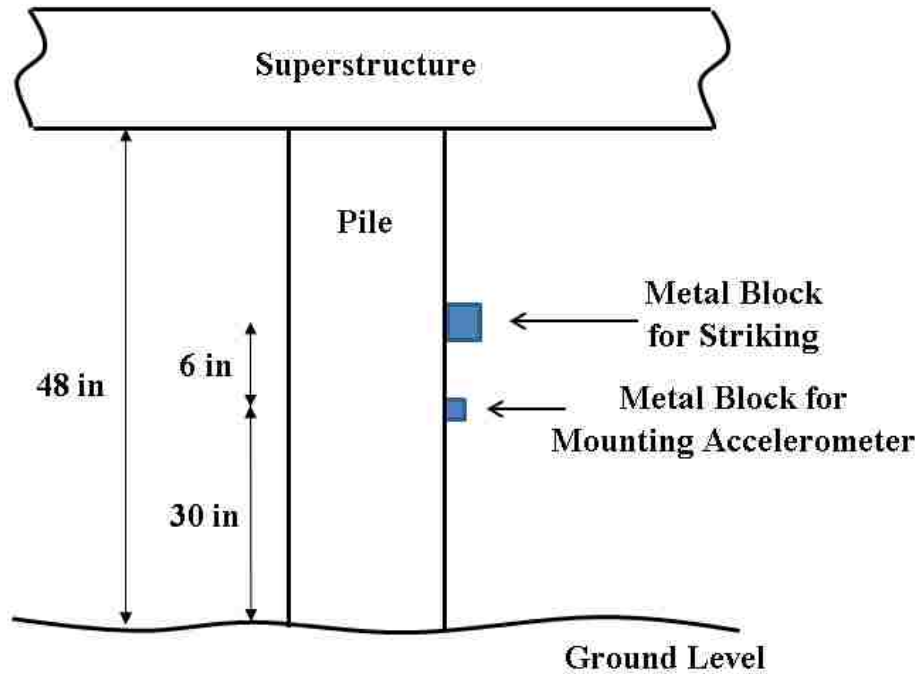
**Figure 51. SE Tests Setup for the Santo Domingo Bridge Piles (Not to Scale)**

Six SE tests were performed on Pile 7-F and seven on Pile 8-E. The test setup is shown in Figure 51. Although horizontal striking did not result in interpretable velocity signals in preliminary tests, it was decided to examine if horizontal striking on the side of a pile could produce useful result in the field. Vertical striking on a metal block was used on Pile 8-E as the source. The metal block used for vertical striking was attached to the pile surface tightly. The accelerometer was attached vertically on a metal block attached to the pile. The specifications of SE tests are indicated in Table 8.

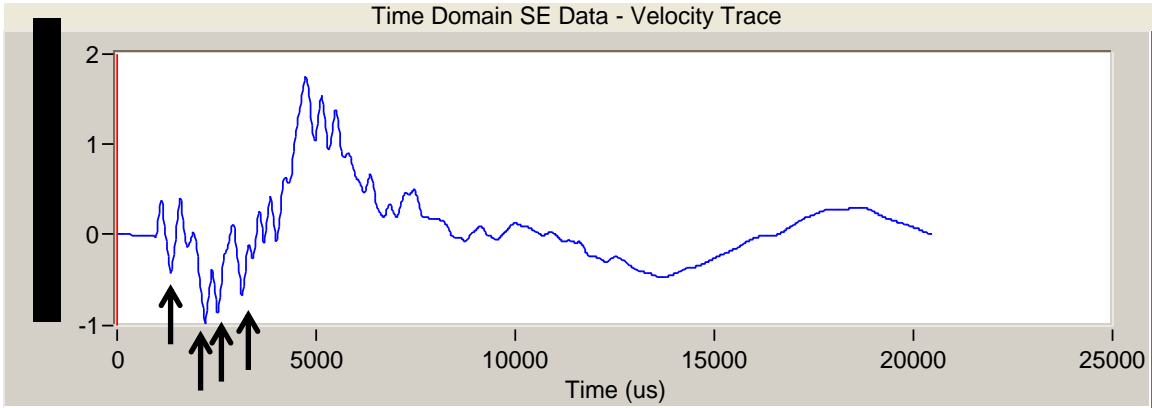
**Figure 52. Velocity Graph from the Accelerometer (Pile 7-F)**

Tests 1 to 6 were performed on Pile 7-F with horizontal striking. The results were not useful and the length of the pile could not be determined. A typical velocity graph (Test 1) is shown in Figure 52. The arrows in the figure indicate the high frequency vibrations. These high frequencies may be due to the reflections of impedance change in the pile or may relate to the lateral vibration of the pile. Reflections from the pile toe were not found.

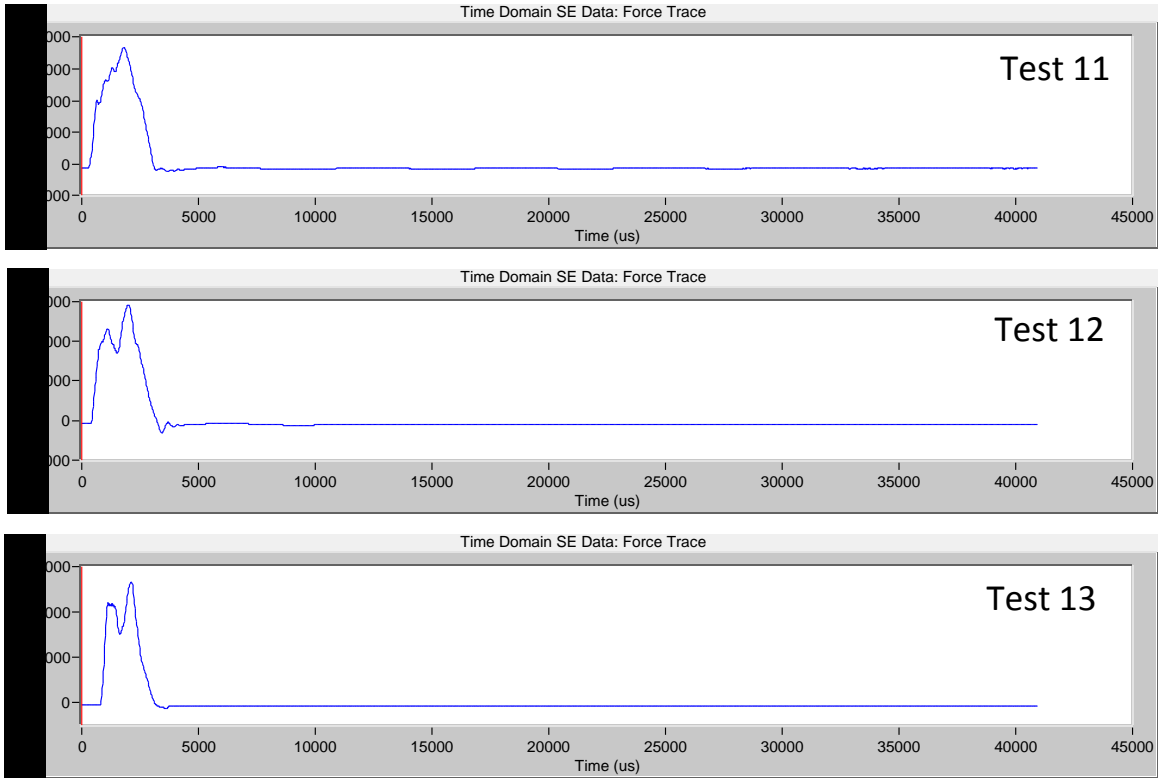
**Figure 78. Initial Impulse from the Hammer's Force Sensor (Wooden block, Hard-tip)**

*SE Tests Performed with Wooden Striking Block and Hard tip Hammer* SE tests were conducted by hard hammer tips in Tests 11 to 13. Since the source was applied manually, the only difference between Tests 11 to 13 was the difference between their input energies and impulse shapes (Figure 78). These source signal graphs show more regular

shapes compared to sources produced by aluminum blocks (Figure 72). The corresponding velocity graphs for Tests 11 to 13 are indicated in Figures 79 to 81 respectively.

that of hard tip (see Figure 78). The corresponding velocity graphs obtained from Accelerometer 1 and 2 are shown in Figures 83 to 85 for Tests 14 to 16 respectively.

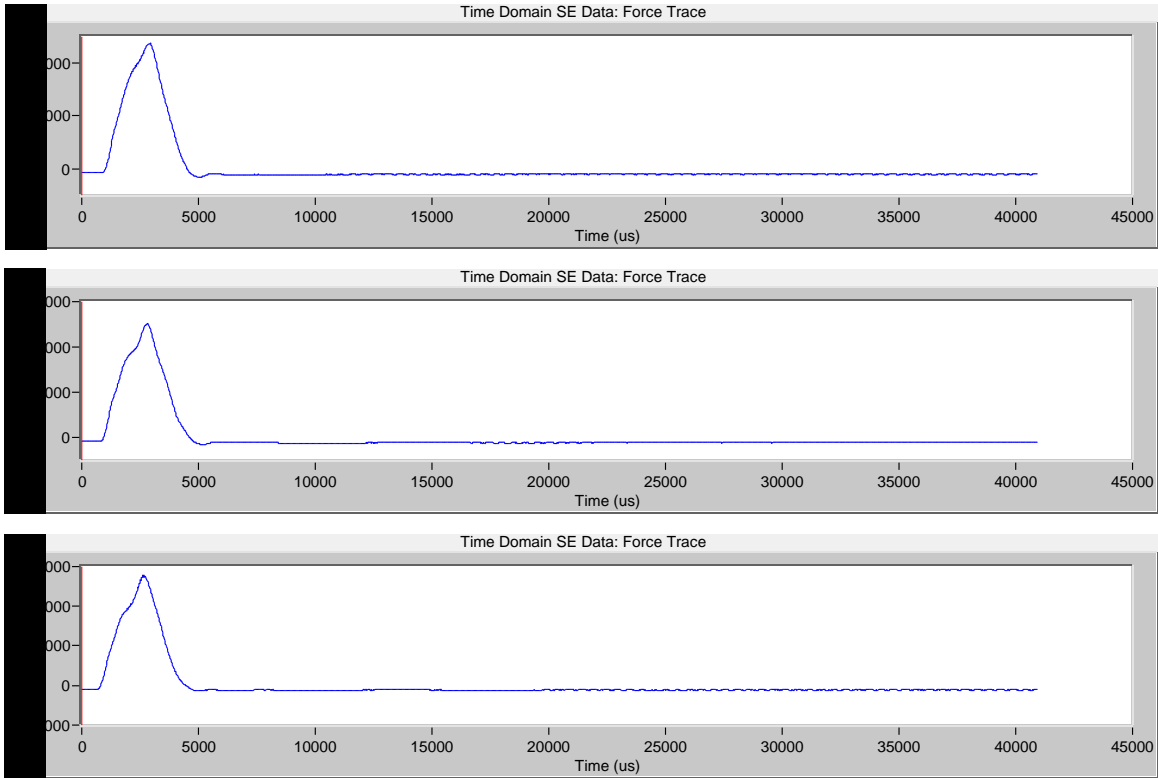
**Figure 82. Initial Hammer Impulses (Wooden blocks, Medium-hard-tip)**

Three SE tests were conducted with medium-hard tip hammer in Tests 14 to 16. The source signals in Tests 14 to 16 are shown in Figure 82; the shape of the source signal is better

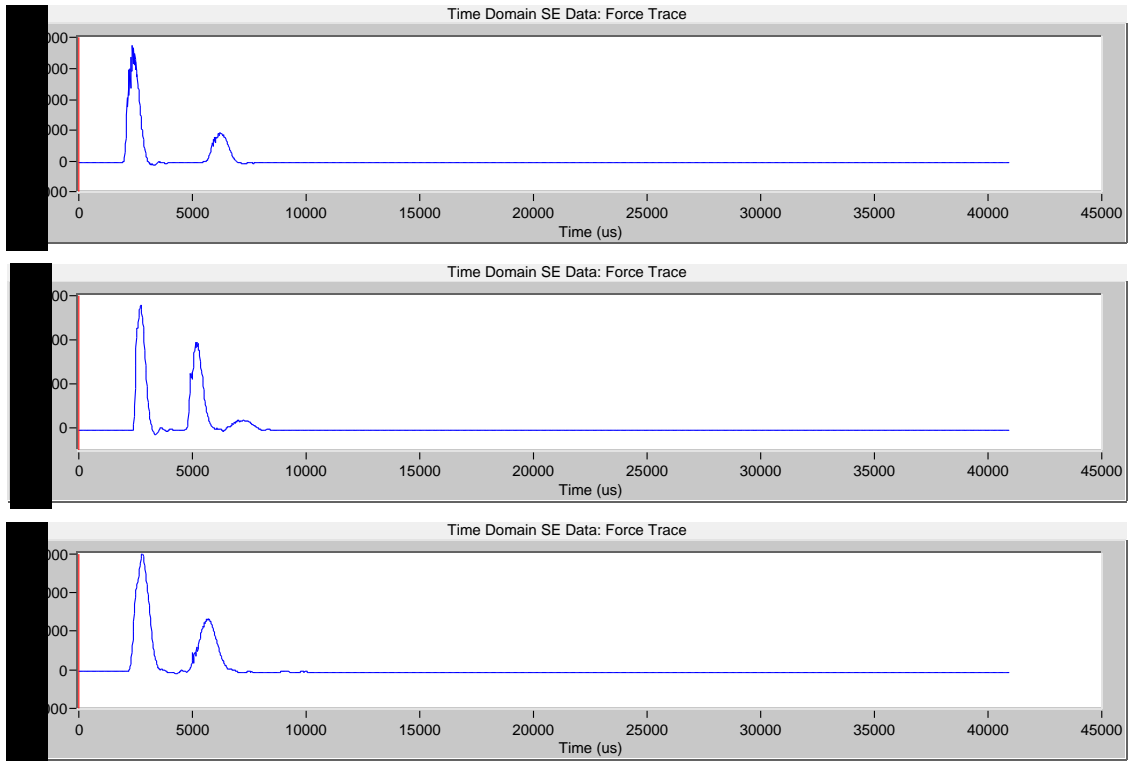
**Figure 86. Impulse Signals Generated by Striking the Aluminum Block with Hard Hammer Tips (Tests 17 to 19)**

*SE/IR Tests Performed with Aluminum Striking Block* In Tests 17 to 19, different energies were imparted into the piles by striking an aluminum block attached to the side of the pile with hard hammer tip. As shown in Figure 86 the impulse graphs show multiple peaks similar to the previous observations of Pile 1 (see Figure 72).

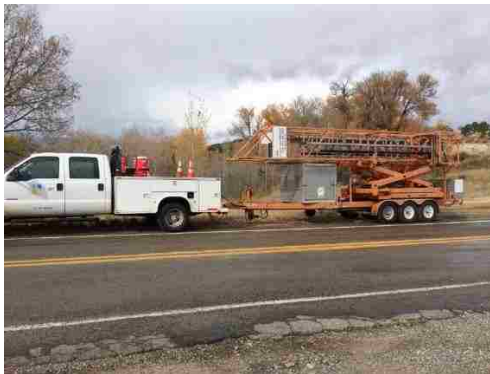
**Figure 96. Mobile Scaffold from NMDOT District 4**

A trailer-mounted inspection platform (mobile scaffold) from NMDOT District 4 was arranged at the second visit to explore the feasibility of conducting SE tests on piles with the help of the inspection platform. Figure 96 shows the mobile scaffold that was used for attaching the blocks for accelerometer and for striking. Figure 97 shows NMDOT staff preparing the scaffold to conduct SE tests.

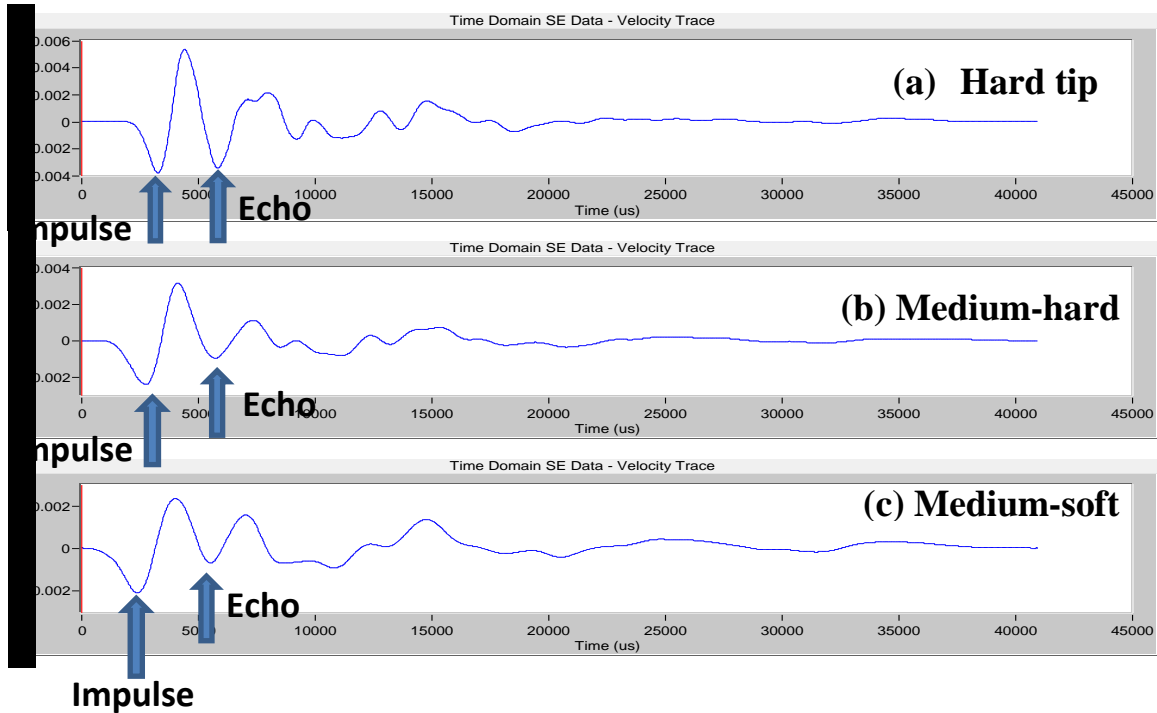
**Figure 102. Velocity Graphs of Pile E with Different Hammer Tips (Tests 10 to 12)**

**SE Tests on Pile 8** Three SE tests (10 to 12) were conducted on Pile 8 with hard, medium-hard and medium-soft hammer tips again. The top edge of the pile was accessible; therefore, the source was applied by striking the top surface. Due to the size of the pile, the accelerometer was mounted 1 ft below the top of the pile. The velocity graphs are shown in Figure 102. Recognizable impulse and echo were found in all three velocity graphs. Unlike the SE test on Pile 1, the result of medium-soft tip was acceptable when striking at the top of the pile. The estimated pile lengths are listed in Table 26.

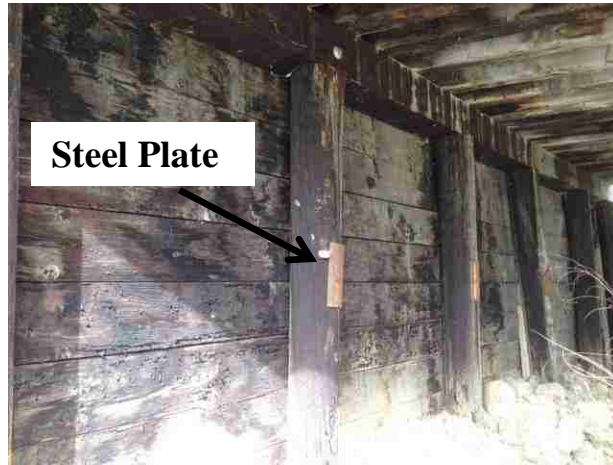
**Figure 103. A Steel Plate Attached to Pile 10**

**SE Tests on Pile 10** Two SE tests (13 and 14) were conducted on Pile 10 with hard tip. Since the top was accessible, Test 13 was performed by striking the top surface of the pile. A ½ in thick steel plate was attached on this pile as shown in Figure 103 that could be used as the striking block. The steel plate was connected to the pile with thick metal bolts but the contact was loose. There was also a gap between the steel plate and the pile. In Test 14, the source was applied by vertical striking at the edge of the steel plate. The accelerometer was mounted 40 inches below the top of the pile.

Figure 104 shows the velocity graphs of these two tests. Good result was found for vertical striking at the top (Test 13).  $\Delta t = 2.92$  ms and the estimated pile length is 22.5 ft. Poor results of striking the steel plate were found which might be due to the poor coupling between the steel plate and pile. Energy transmitted only through the steel bolts and a

complex source signal was created due to the vibration of the plate. Thus, mounting the striking block on a pile tightly and securely is very essential to yield good results.

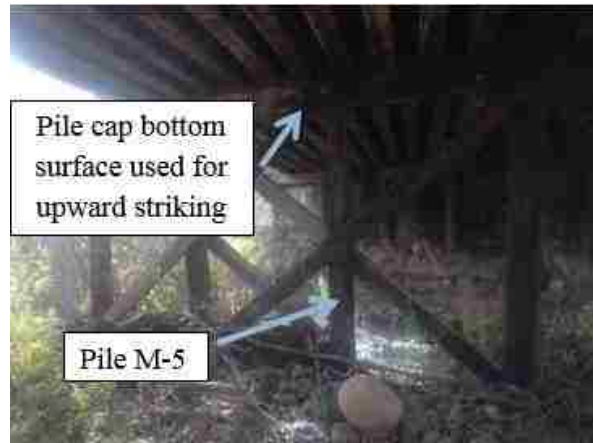
**Figure 105. Photo of Pile M-5 and the Pile Cap**

**SE Tests on Piles M-5** Twenty-one SE tests were performed on this pile. Two accelerometers were mounted on the wooden blocks attached to the side of the test pile. As mentioned before, when the top of either pile or pile cap are inaccessible, upward striking on the pile cap next to the test pile can be used as the alternative mean to produce longitudinal waves along the test pile. Figure 105 shows the locations of striking on the pile cap. Upward striking on pile cap will produce a strong tensile wave accompanied by a weak reflected compression wave. The source of some SE tests was also applied through

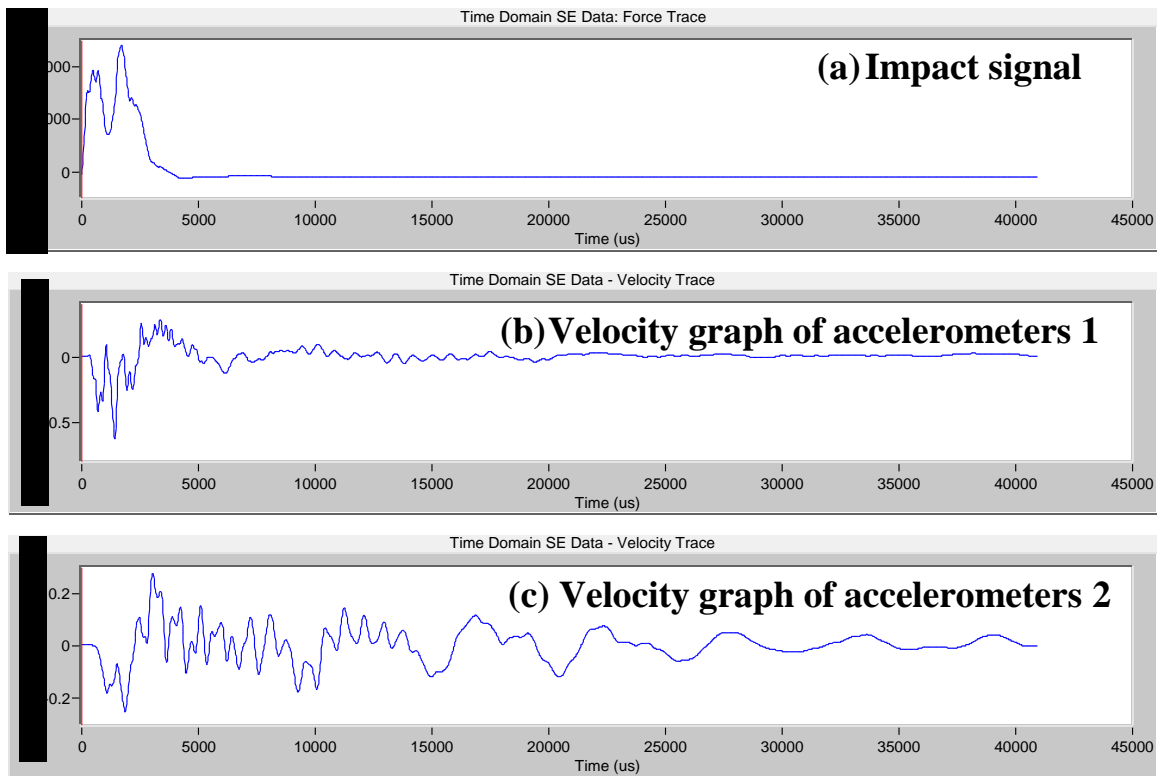
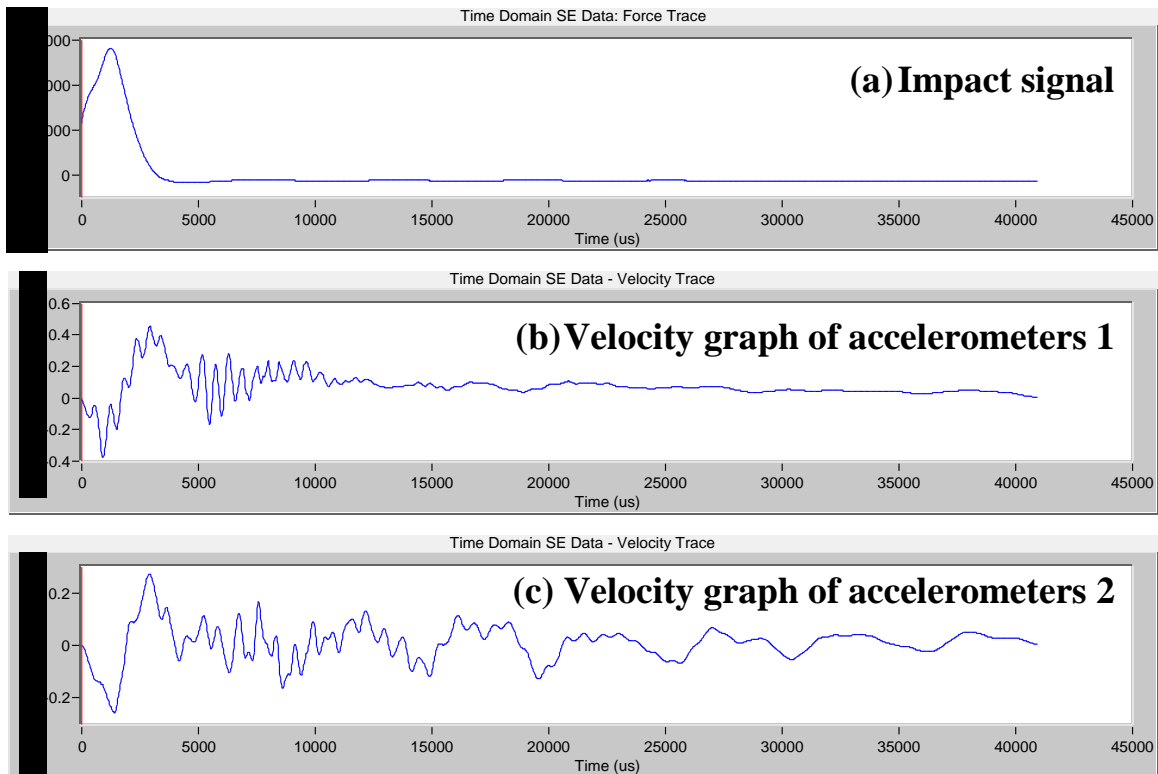
- Care must be taken on mounting the striking block onto the test pile. Clean and clear source signal may not be generated due to imperfect coupling between the block and pile surface. The result also depends on the hammer tip as shown in Figures 107 and 108 Multiple peaks in the impact signal were found while using a hard tip (see Figure 107a). These peaks interfered with the determination of the echo in the velocity graph (see Figures 107b and 107c). When a softer hammer tip was used, the multiple peaks disappeared for the accelerometer mounted farther from the source (see Figure 108a).

**Figure 107. Impact Signal and Velocity Graphs using a Hard Tip**

**Figure 108. Impact Signal and Velocity Graphs Using a Medium-soft Tip**

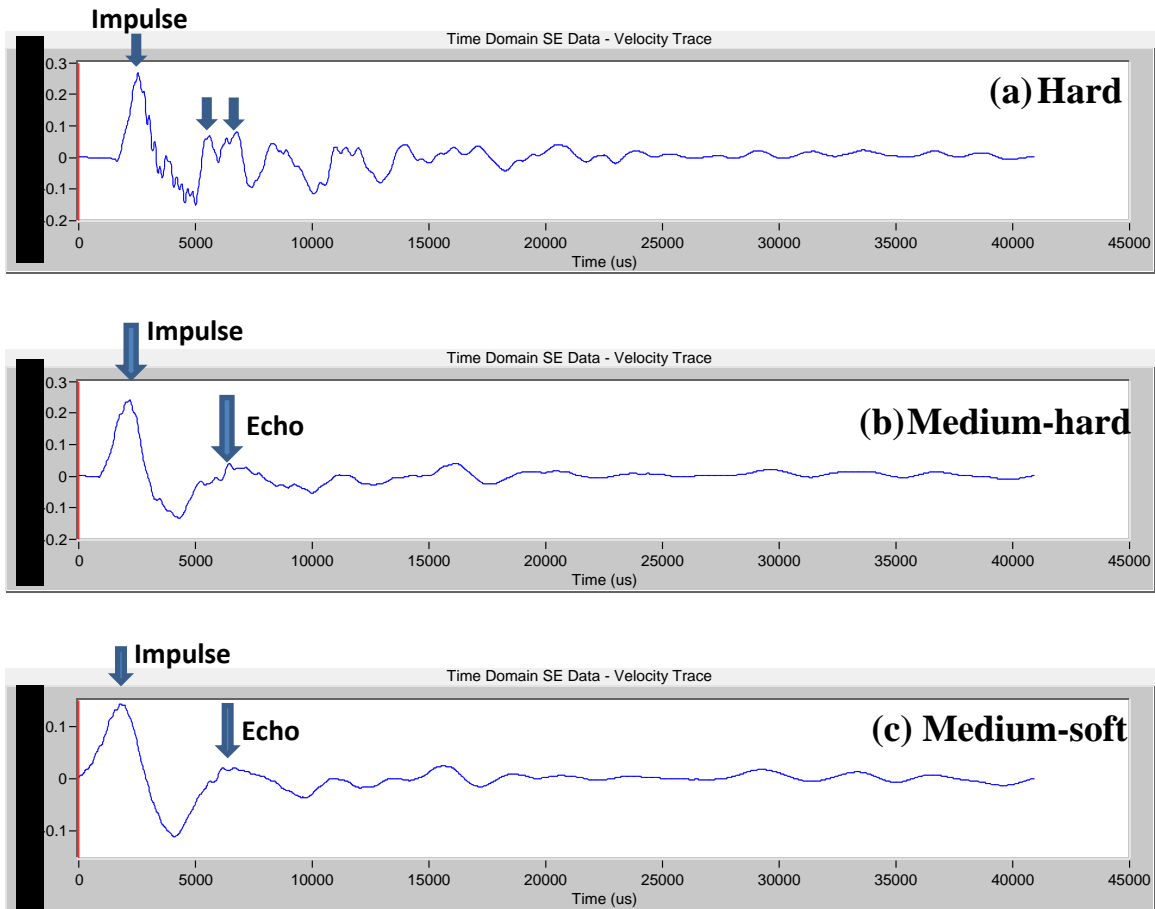
**Figure 109. Velocity Graphs for Various Hammer Tips Conducted on Pile M-5**

- In general, all hammer tips produced good results when there was good coupling between the striking block and the pile. However, upward striking with hard hammer tip did not produce good velocity graphs (Tests 5, 9 and 11). Figure 109 shows three SE tests with three different hammer tips. As shown in Figure 109a, there are two echoes with similar magnitudes which made it difficult to select the correct echo. High frequency vibrations were seen in the velocity graph for hard tip but not for medium-hard and medium soft tips. The softer tips produced waves with lower frequencies that resulted in better data for this particular pile.

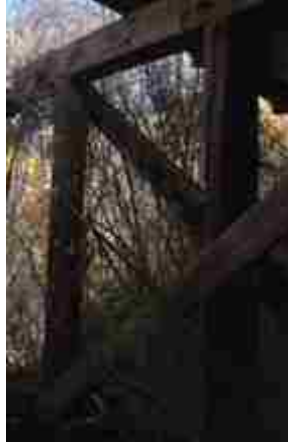
**Figure 111. Exterior Pile M-7 and the Pile Cap**

The results of the SE tests on Pile M-7 obtained from both accelerometers are also shown in Table 29. This result is more consistent than those of Pile M-5 (see Table 28). First, striking on the pile cap directly above the pile produced excellent results. Second, there is no interference of reflections from superstructure. As shown in Figure 111, Pile M-7 is the exterior pile with only a pile cap above the pile. There is no superstructure above the pile cap. When the source is applied by upward striking at the pile cap, the generated up-going tension wave is reflected from the cap as a down-going compression wave. More complicated superstructures produce more complicated velocity graphs. This is the reason that the results of Pile M-5 is less consistent than Pile M-7. Once again, the results show that upward striking on pile cap next to the test pile is acceptable.

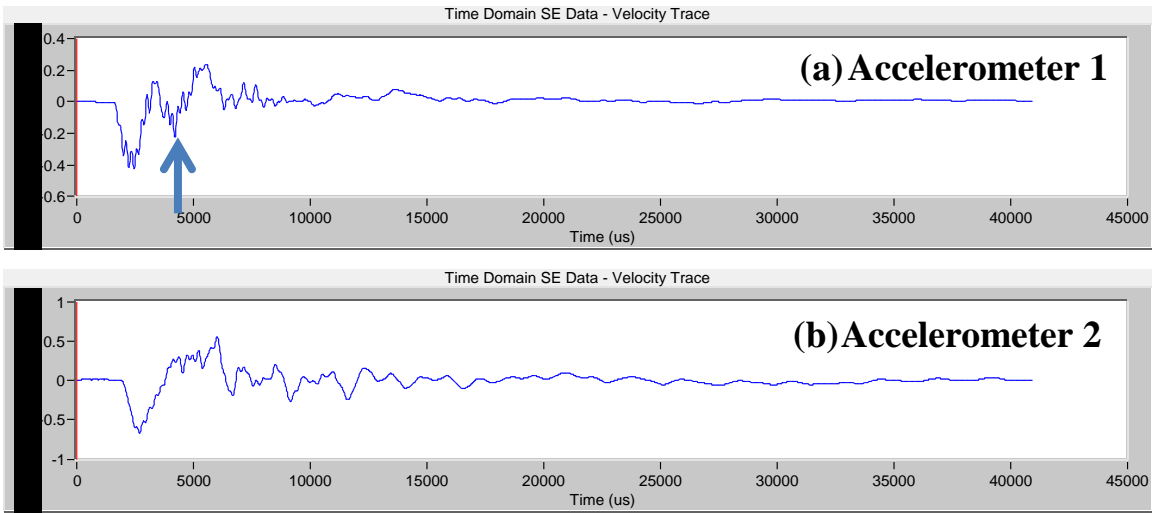
**Figure 113. Velocity Graphs Obtained from Accelerometers 1 and 2 (Test 19)**

or the noise due to the running water (river current hits the pile constantly) hinders the determination of the echo from the pile toe. The velocity graphs received from the two sensors were very different and typical velocity graphs are shown in Figures 113 and 114. The arrows on the graphs of the Accelerometer 1 (closer to pile top) show a reflection from an impedance change but the echo did not appear in Accelerometer 2 (close to the ground level). Therefore, the echoes shown in Figures 113a and 114a are not considered as the echoes from the pile toe.
