# CHARACTERIZATION OF UNKNOWN BRIDGE FOUNDATIONS

# **CHARACTERIZATION OF UNKNOWN BRIDGE FOUNDATIONS**

The National Bridge Inventory (NBI) recognized 86,133 bridges in the United States have no foundation data on record in 2003. It is evident that an unknown percentage of the 86,133 bridges identified by NBI with missing foundation data could also be highly vulnerable to scouring induced by water flow coupled with erodible soils. Conventional excavation, coring and boring excavations to identify unknown bridge foundation depths and types are deemed to be expensive, destructive, and limited in their application to the unknown foundation problem. Many surface and borehole nondestructive testing (NDT) technologies have been developed for this purpose. Three economical proven technique (Sonic Echo/Impulse Response (SE/IR), Parallel Seismic (PS) methods, and Induction Field (IF)) were selected for this study. The study focuses more on SE/IR method since it is the most inexpensive and quick method.

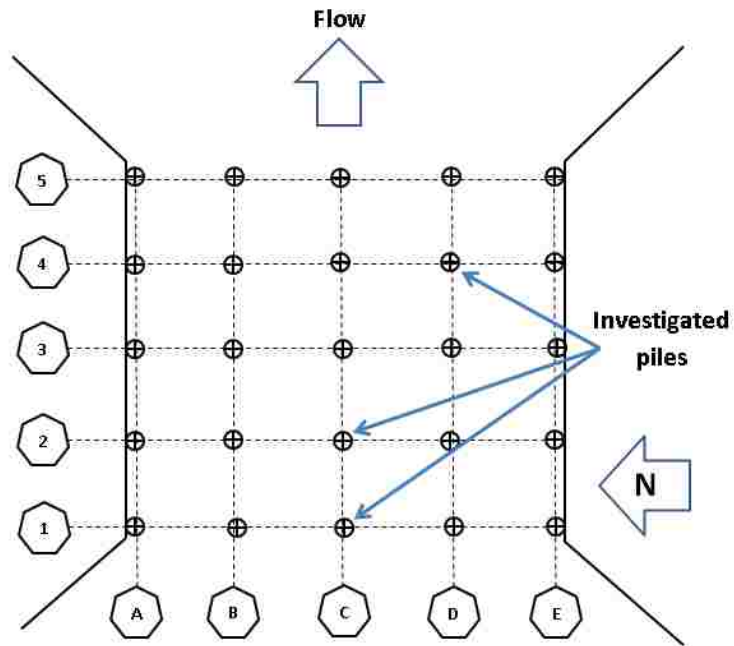
**Figure 117. Foundation Plan and Investigated Piles of Bridge No. 1676**

The foundation plan and the investigated piles are indicated in Figure 117. SE tests were performed on three timber piles indicated in the figure. The SE tests were done with four different hammer tips including hard, medium-hard, medium-soft, and soft. Two accelerometers were attached to the side of the piles as shown in Figure 118. The wooden blocks were glued onto the pile surface.

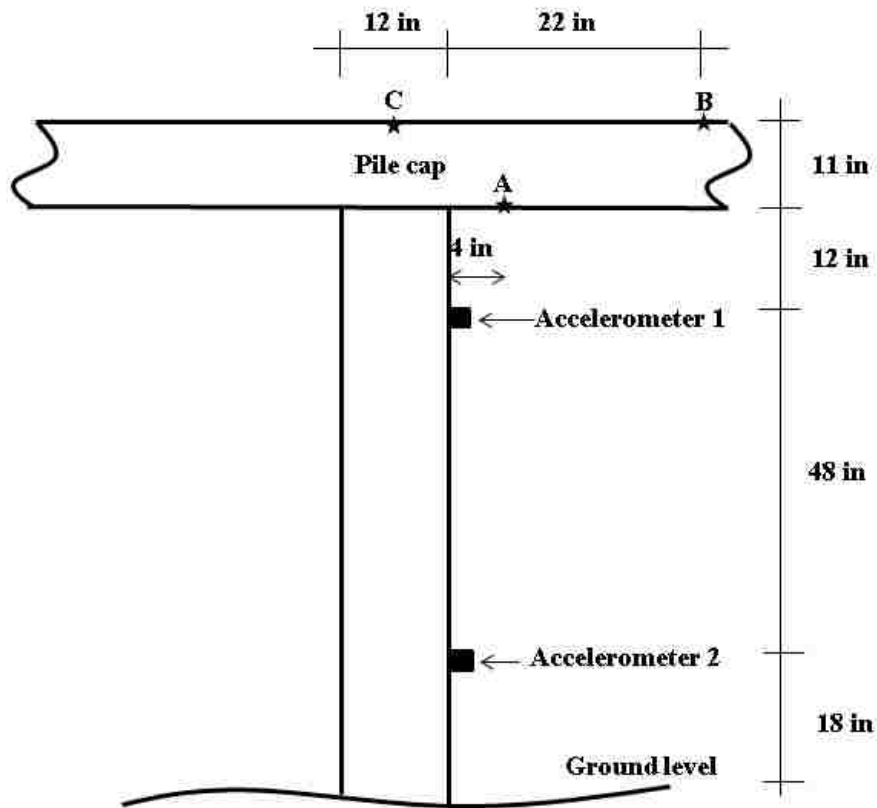
**Figure 121. SE/IR Setup for Pile C-2**

**SE/IR Tests on Pile C-2 (SE Analysis)** Twelve SE/IR tests were conducted on Pile C-2 with different hammer tips. The source was created by downward striking on pile cap above the pile, downward striking on the pile cap near the pile, and upward striking on the pile cap near the pile. Figure 121 shows the source (Points A, B, and C) and receiver locations and Table 36 lists the specifications of these SE/IR tests.

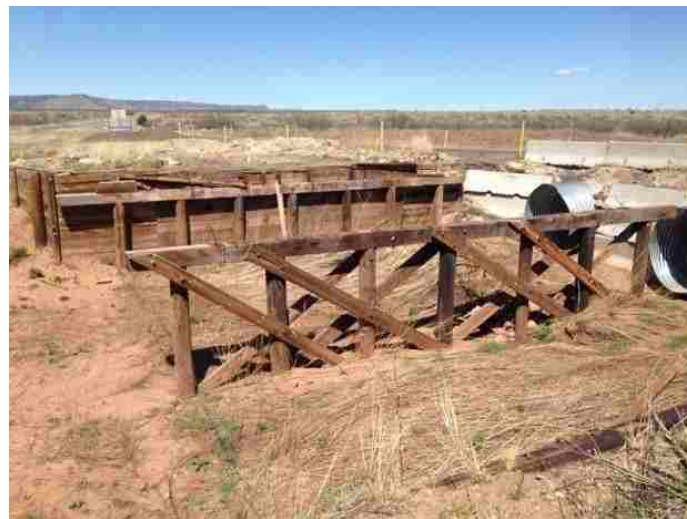
**Figure 124. Photo of the Partially Dismantled Bridge near Route 419**

The partially dismantled bridge (Bridge No. 6253) is located 64 miles east of Las Vegas. The bridge was used to be on Route 419 (coordinates 34.211303, -106.921087). Figure 123 shows the location of the bridge. Route 419 was realigned and the bridge was no longer in service. The superstructure of the bridge was removed when the research team arrived at the site. Only pile caps and round timber piles were presented as shown in Figure 124.

This site was selected because the piles are going to be pulled out. The actual pile length finally become known which enables the research team to verify the results of nondestructive tests. SE/IR tests were conducted on five piles as shown in Figure 125. Since the findings were very similar to the conclusions of previous bridges on timber piles the results are not elaborated here. The results including the embedment pile lengths and the total pile lengths are listed in Table 44.

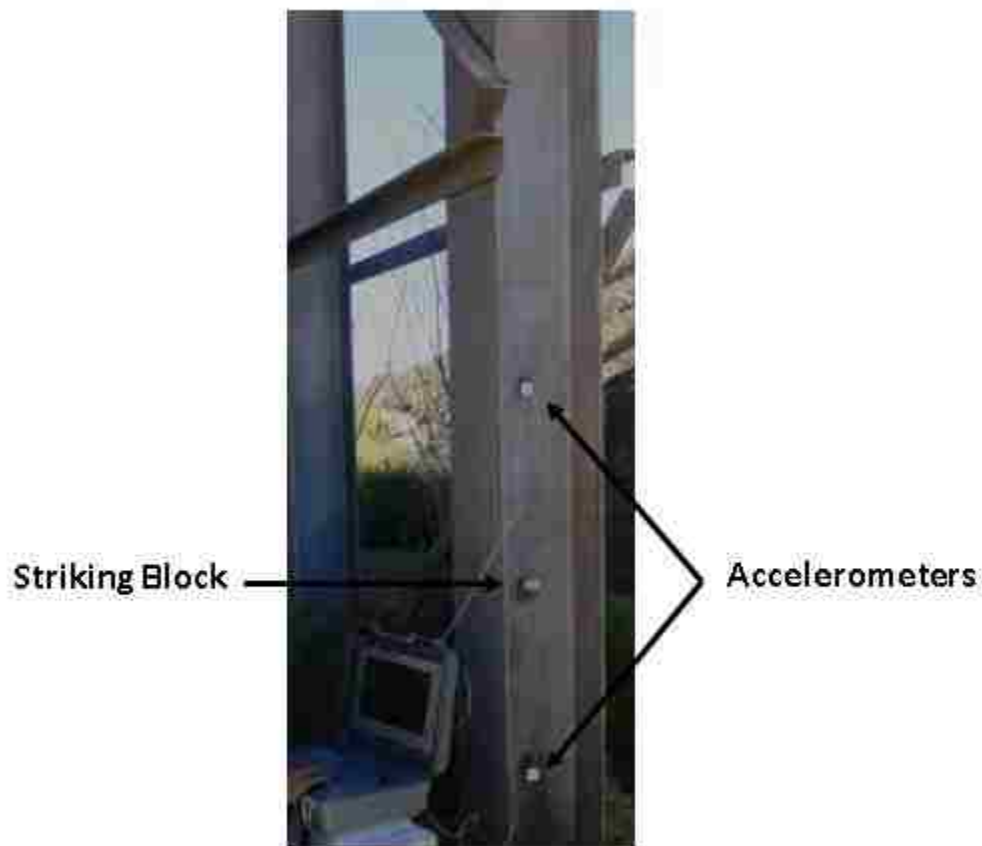
**Figure 128. SE Test Setup for a H-pile of Bridge No. 7480**

Holes had been predrilled by NMDOT engineers. Metal blocks for striking and mounting accelerometer were attached onto the web of the H-pile with bolts. Two accelerometers were used. A nonconventional SE test setup is shown in Figure 128. The source (hammer striking) was between two accelerometers. Although numerous SE tests of different setups were performed on different piles, none of the results were successful.

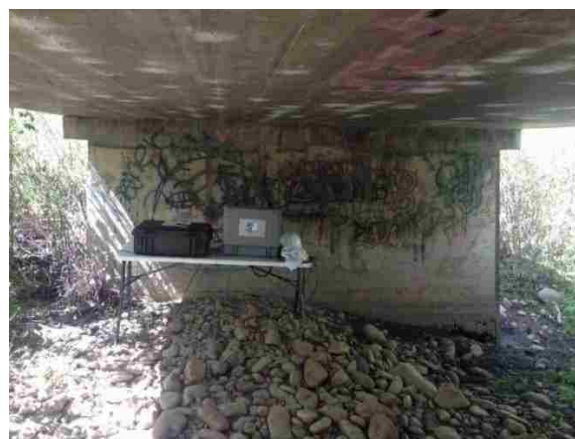
**Figure 132. Side View of One of the Piers**

In addition to the NDT tests performed on timber piles, the research team decided to conduct SE tests on concrete piers. Bridge No. 5899 in District 5 was selected for testing since there are three intermediate concrete piers. The bridge is located 66 miles north of Santa Fe on NM 111 crossing over the Rio Vallecitos as shown in Figure 130. The coordinates of the bridge are 36.49485, -106.1124972. The street and aerial views of the bridge are shown in Figure 131. The bridge is a 4-span concrete bridge supported by three intermediate concrete piers. The side view of one of the piers is indicated in Figure 132.

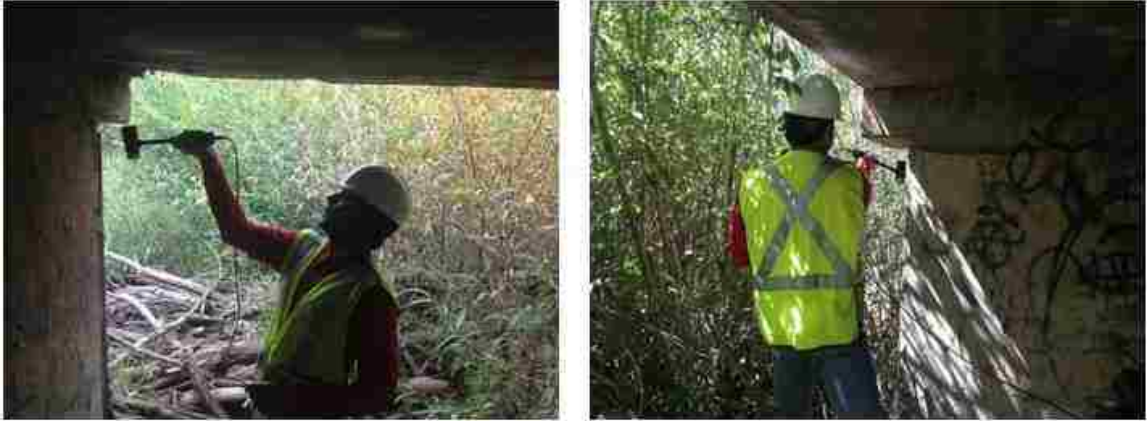
**Figure 135. Upward Striking on the Pile Cap and on the Bridge Deck**

**SE/IR Tests at South Side of Pier 2 by SE Analysis** Twenty SE/IR tests were conducted at the south side of Pier 2. The source was applied on five different points with three different hammer tips. The strikes were the horizontal striking on the south (or west) side of the pier wall, upward striking on the pile cap (or on the bottom of the bridge deck), and vertical downward striking on the bridge deck above the pier wall. Figure 135 shows the application of upward striking on the pile cap and on the bottom surface of the bridge deck. Table 49 shows the used hammer tips and the location and direction of the hammer strike for each test at the south side of Pier 2. Table 50 shows the results of SE tests conducted at the south side of Pier 2. Similar to Pier 1, horizontal striking (Tests 1-3 and 9-11) did not produce useful data and consequently the pier length was not determined. The length of the pier was determined from SE tests of all vertical striking. The average length of Pier 2 at the south side is 26.8 ft.

Upward striking on the pile cap and bridge deck were simulated in the numerical model shown in Figure 219 ( $d = 7\text{m}$ ). In Model M22 an upward strike on pier cap at Point C was applied, whereas the strike was applied at Point D in Model M23 (see Figure 133).

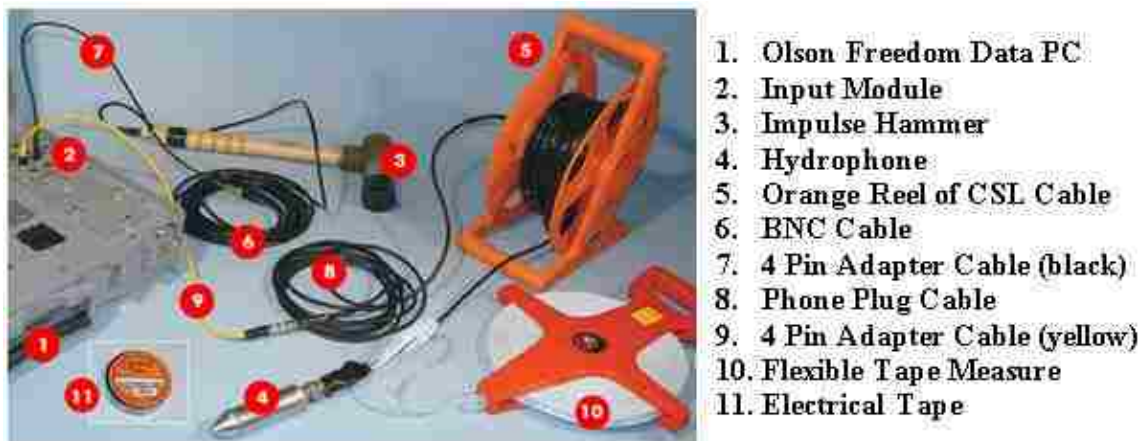
Figure 138. PS Equipment

Figure 138 shows the required equipment for conducting a PS test. The assembled equipment is shown in the figure. Engineers should follow the user manual of the equipment to assemble the device.

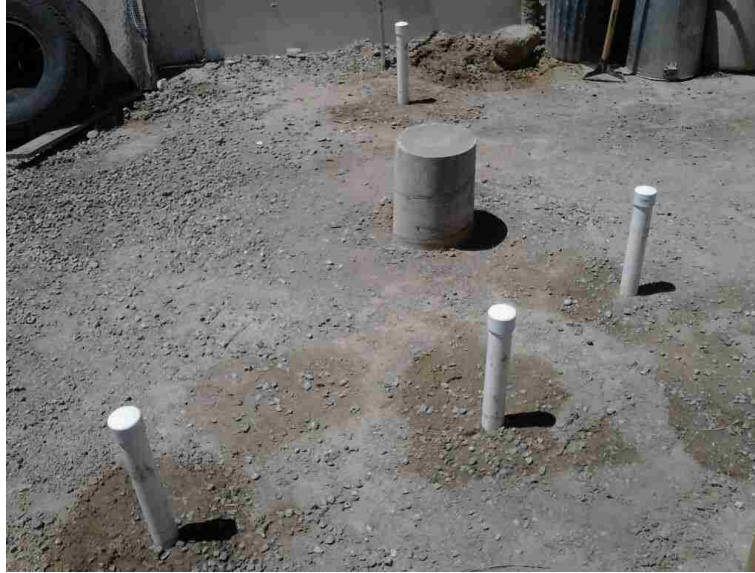
**Figure 141. Configuration of the PS Testbed**

Initial PS tests were conducted at a test site off UNM campus to examine the capability of the equipment. The soil of the test site is silty clay with gravel. A 10-in diameter and 3-ft long reinforced concrete cylinder (pier) was installed at the test site. The PS test setup is shown in Figure 141. The depth of the concrete cylinder is 2 feet below ground. Four 2-in PVC pipes, each 5-ft in length, were installed at various distances from the center of the pile. The PVC pipes were then filled with water. PS tests were conducted by lowering a hydrophone into each of the pipes and impacting the center of the concrete pier with a hammer. The data were collected from each of the pipes at intervals of 1 foot starting at the ground level.

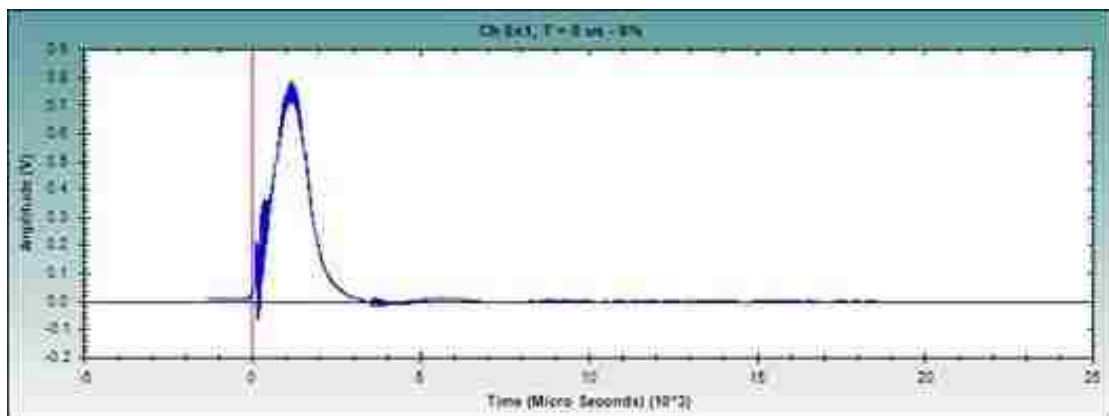
**Figure 142. Duration and Amplitude of the Source Generated by a Hammer**

Figure 142 shows the signal generated by the hammer. Figure 143 shows the received signals when the hydrophone is at the ground level and four feet below grade. The distance between the borehole and the concrete cylinder is 2 ft. Comparing Figures 143a and 143b, a delay in arrival time was observed as expected. Figure 143a shows a peak at 8  $\mu\text{s}$  while Figure 143b shows a peak at 9  $\mu\text{s}$ . The 1<sup>st</sup> valleys in Figures 143a and 143b were found at 11  $\mu\text{s}$  and 13  $\mu\text{s}$ , respectively.

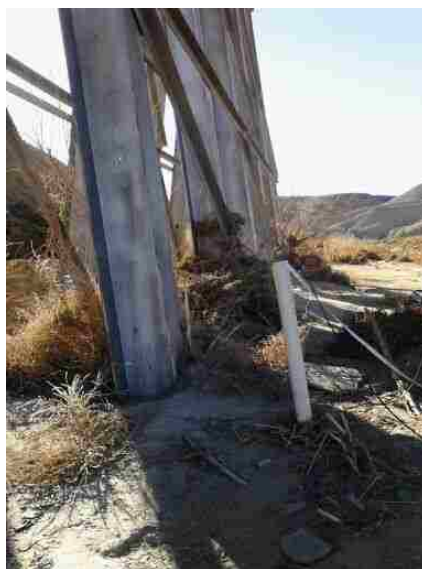
**Figure 145. An Aligned PVC Pipe and the Adjacent Pile**

Two-inch inner diameter PVC casings were placed in each boring with a water tight cap at the base and a removable cap at the top of the tube. The spacing between the PVC tube and the hole was backfilled with existing soil. Figure 145 shows a PVC pipe with its adjacent pile. Table 59 provides a summary of the depths for each borehole.

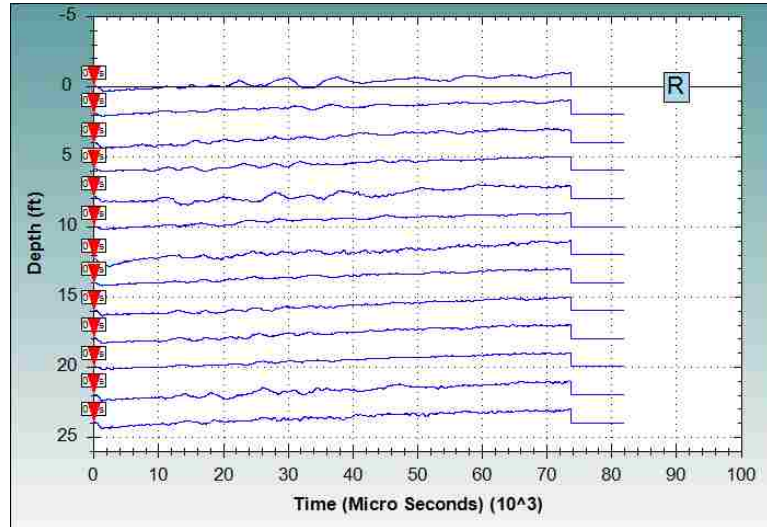
**Figure 146. PS Test Result in a Dry Hole**

holes and the obtained poor result is shown in Figure 146. The hydrophone could not record good signals without the water coupling.

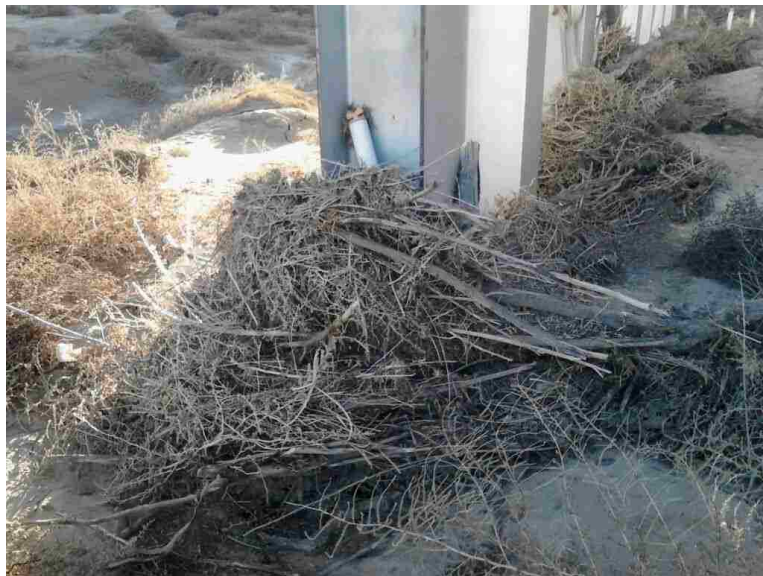
**Figure 147. Destroyed Pipe (B-06)**

The second problem was the damage of one installed PVC tube. As shown in Figure 147, the PVC pipe at B-06 was destroyed due to the movement of debris from flooding. Therefore, conducting PS test was also impossible at this borehole.

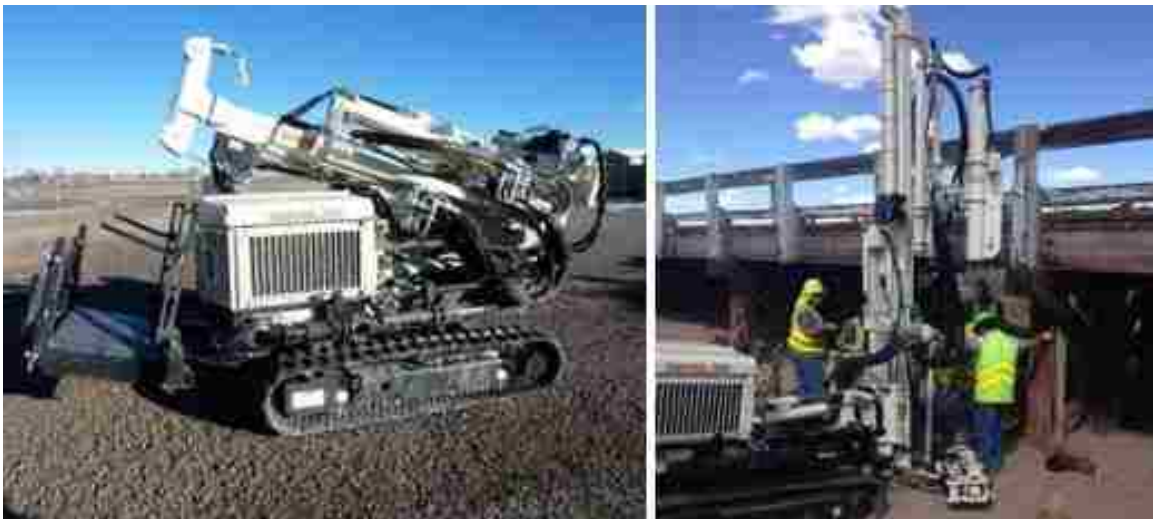
**Figure 163. Geoprobe Model 7822DT- Low Headroom Drill Rig**

Conventional PS tests were conducted on two timber piles at Bridge No. 1676. The location and foundation plan of the bridge are shown in Figures 115 and 117 respectively. The test piles were Pile B-1 and C-1. Two test borings were drilled adjacent to the timber piles by NMDOT using the Geoprobe 7822DT (purchased during this project). The plan view of the location of the boreholes is indicated in Figure 162. The low headroom drill rig and the drilling operation are shown in Figure 163.

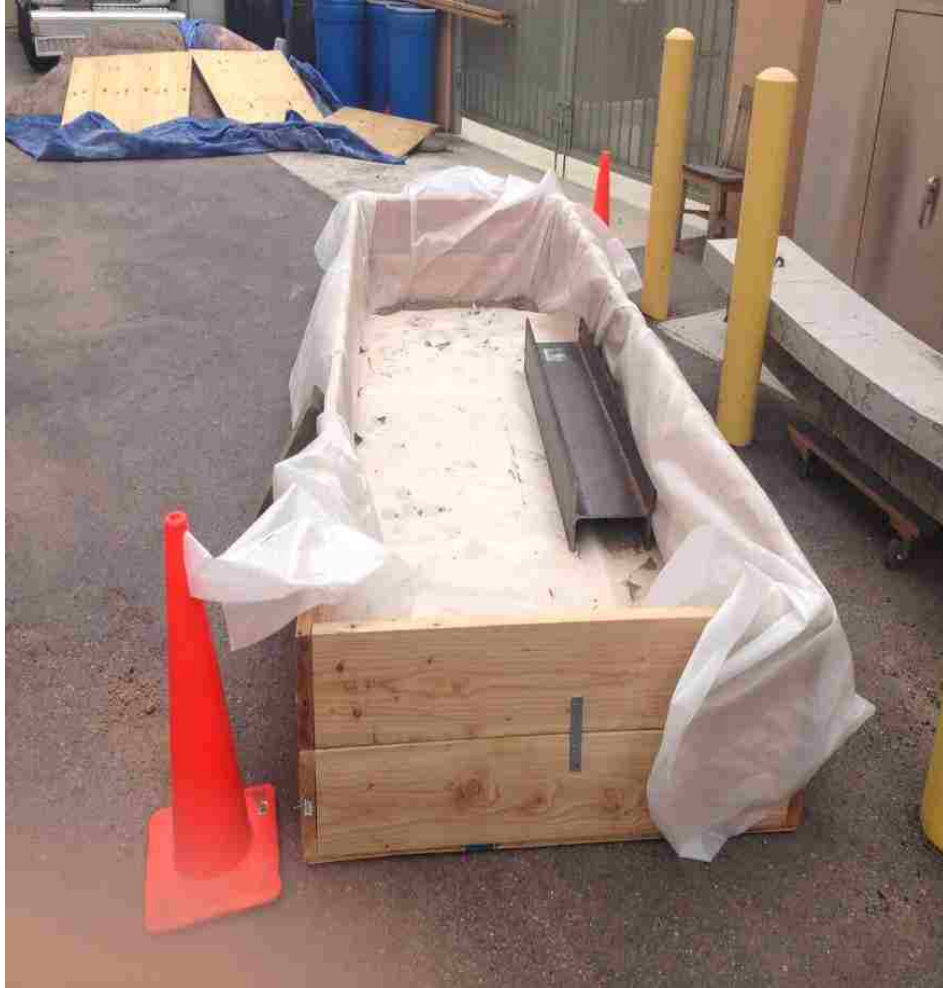
**Figure 180. Test Configuration with Steel Beam and Wooden Box**

The first testbed contained a metal I-beam placed horizontally in a wooden box full of soil as shown in Figure 180. A metal beam buried in a wood box filled with soil was a suitable prototype of a real steel foundation of a bridge. The dimensions of the wooden box were 12 ft × 4 ft × 18 in. The I-beam was 5 ft long, 12 in depth and an 8 in flange width. The preliminary tests were supposed to be conducted in the structural lab at UNM. However, during conducting the IF tests in the structural lab, it was revealed that the test could not be conducted on the concrete floor due to the presence of steel reinforcement. The testbed was therefore moved outdoor on an asphalt paved driveway as shown in Figure 180. Before recording the data, three PVC tubes were placed horizontally at a distance of 1, 1.5 and 2 ft respectively from the steel beam.

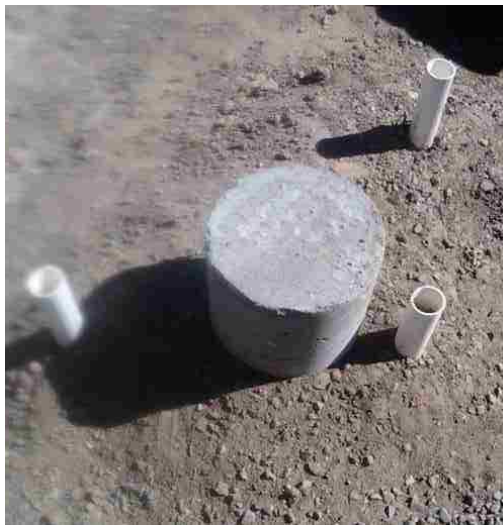
Figure 184. Layout of the Concrete Pier and Boreholes

A three-foot deep by one-foot diameter hole was excavated. A four-foot long, one-foot diameter reinforced concrete pier was cast in place at the test site. The pier was reinforced with 5-#5 vertical rebar and #3 ties at 6 in, as shown in Figure 183. There was 3 in clear cover to the outside of the #3 ties. Three two-inch diameter holes were then bored 6-ft into the ground. The boreholes run parallel to the concrete pier located distances of 6, 12, and 18 in from the outside edge of the pier as can be seen in Figure 184. A 2-in diameter PVC pipe was inserted in the holes to a depth of 3 ft below the bottom of the pier as shown in Figure 185. The LITE was assembled and calibrated. The Probe was inserted into the

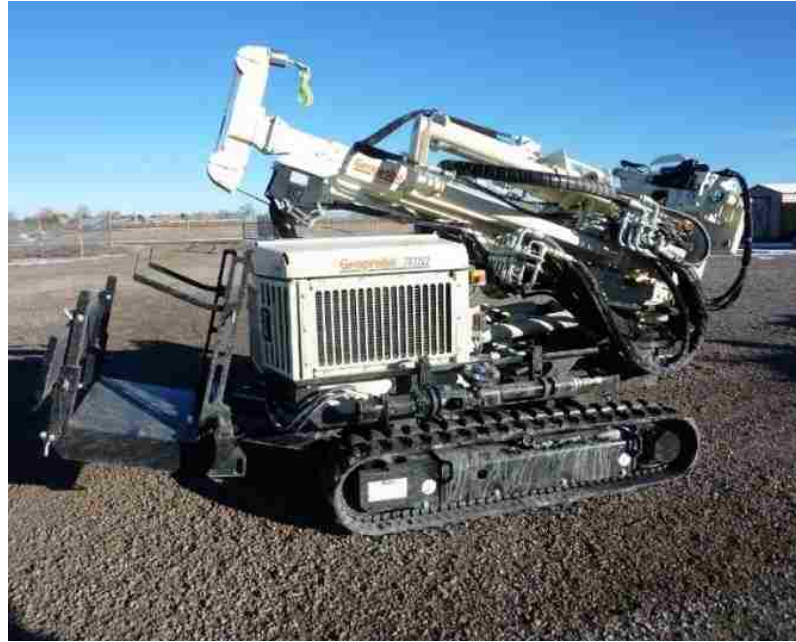
**Figure A1. Geoprobe 7822DT-Low Headroom Drill Rig**

A bridge deck may have several variables that affect the quality of the test result. The clearance below the bridge deck is very important for PS and IF methods. Special drilling equipment (Geoprobe 7822DT) shown in Figure A1 may be required for low clearance bridges. Connections between the superstructure and the substructure determine the extent of traffic noise that is transmitted through the structure itself to the foundation, affecting the SE/IR and PS tests. PS and IF methods require drilling a hole with a depth at least 15 ft beyond the expected depth within the certain distance from the foundation. The foundation design is based on the subsurface conditions and the anticipated structural loads which depend on the length and width of the span. Historical standard bridge designs in New Mexico can be consulted to estimate the expected pile depth. If the piles are in soils, presumed resistance of soils can be used to roughly estimate the pile length.

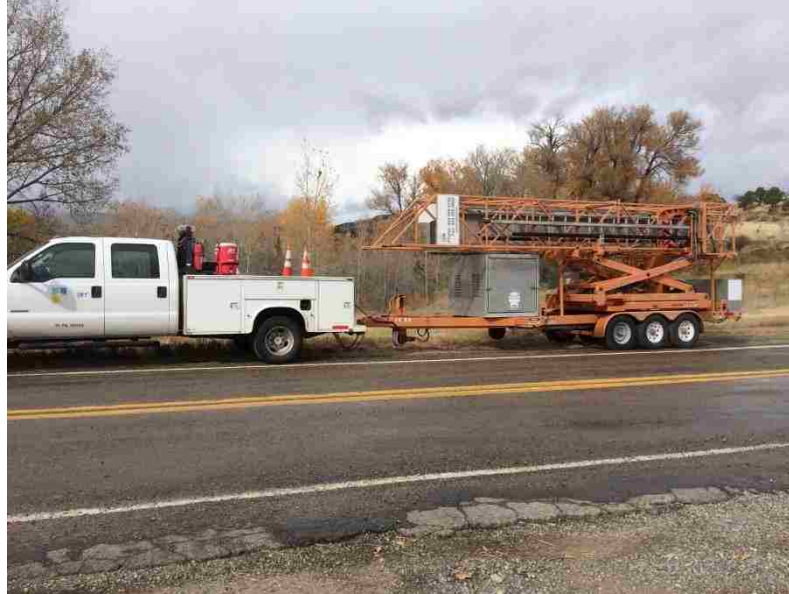
**Figure A2. Mobile Scaffold (NMDOT District 4)**

Seasonal weather fluctuations may affect the access of substructure. These impacts could be associated with variations in the water levels and flow velocities under a bridge. The running water may require the mobilization of a scaffold as shown in Figure A2.

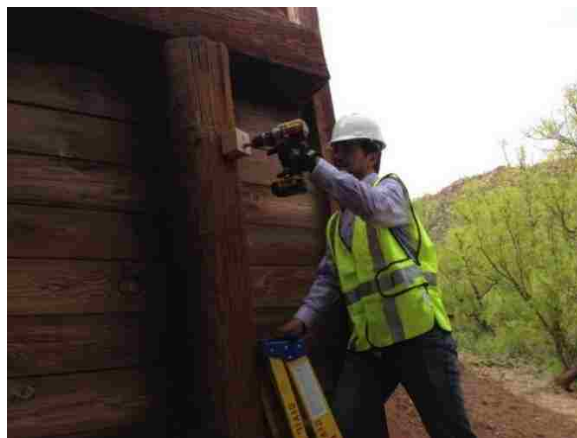
**Figure A13. Attaching the Striking Block on the Test Pile**

When a striking block is employed, the block should be properly secured by nails and screws to prevent any detachment during striking (see Figure A13). The dimensions of a striking block used in this project are shown in Figure A14. The only requirement of the dimensions of the striking block is that they must be greater than the size of the hammer. The striking block is located between the first accelerometer and the top of the pile. The hammer should not touch the pile during striking.

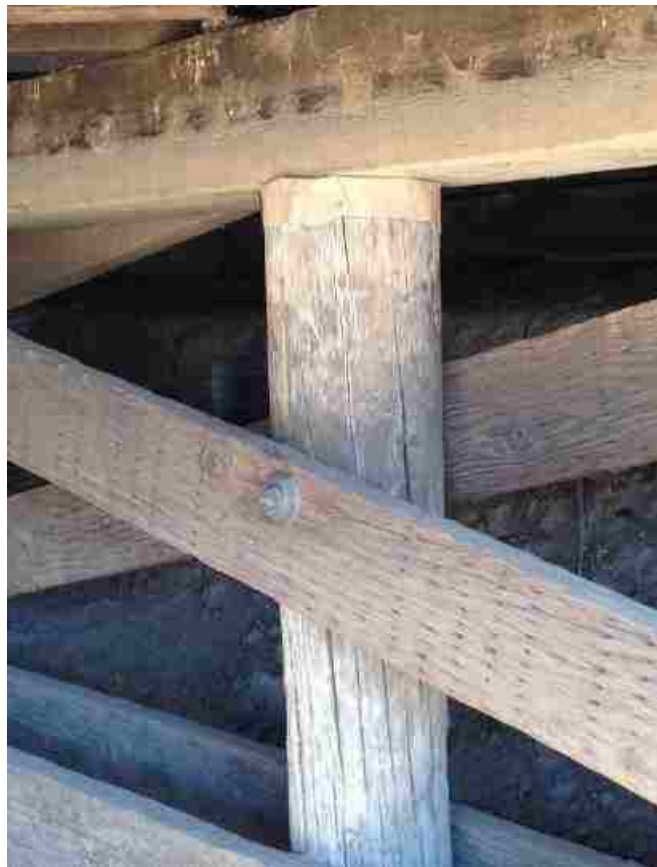
**Figure A15. Diagonals and a Bolt**

If Options 1 to 3 cannot be applied, good results have been obtained by striking on the existing bolt (see Figure A15).

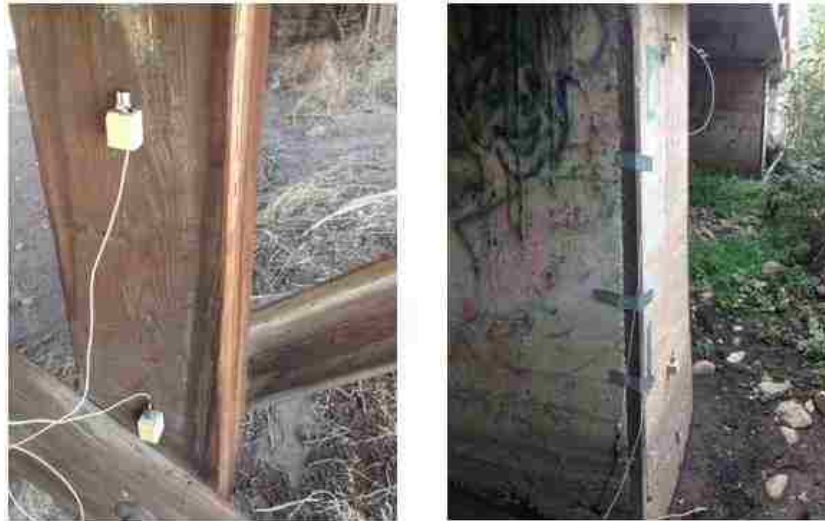
**Figure A19. Two Accelerometers Mounted on the Side of the Substructure**

Good results have been obtained during this project when the accelerometer was placed 1-2 ft from the source. Therefore, it is recommended to place the first accelerometer 1-2 ft below the source (the striking point). The second accelerometer should be placed far away from the first accelerometer as possible (at least 2 ft). The locations of the sensors should be recorded for future data interpretation. Figure A19 shows the two accelerometers mounted on the side of the substructure. If two accelerometers are used two velocity graphs are obtained with a single hammer blow. Also, the propagated wave velocity can be estimated from the first arrival times at the two accelerometers. An example of the

calculation of the propagated wave velocity will be presented later in this report. The project findings indicate that the calculated length based on the velocity graph from the first accelerometer was more consistent than that from the second accelerometer.

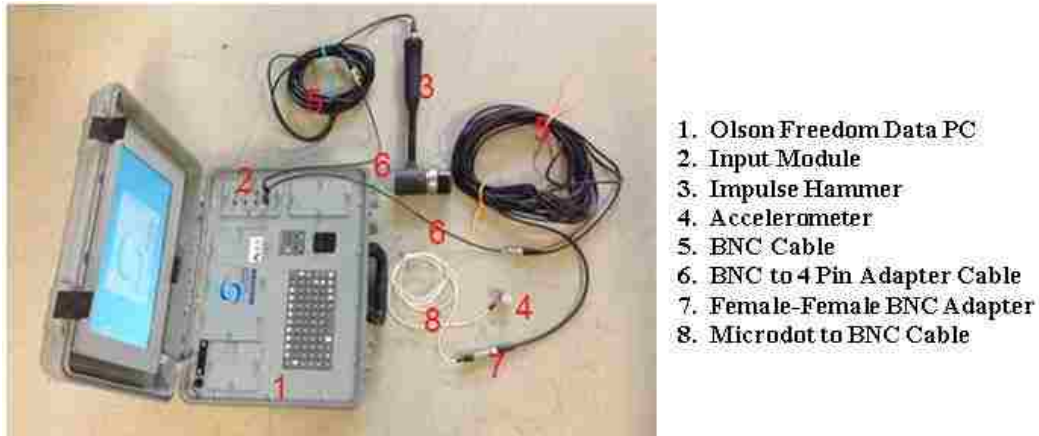
**Figure A21. SE/IR Test Equipment**

The equipment used for conducting SE/IR tests should be assembled as indicated in Figure A21.

In addition to the parts shown in Figure A21, the following items should also be brought to the site:

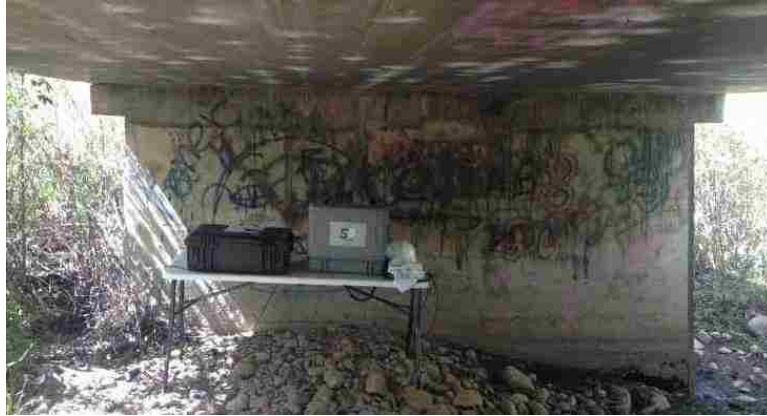
**Figure A22. SE/IR Equipment Placement near a Test Pier Wall**

The equipment should be assembled on a flat surface close to the test pile. Figure A22 shows the SE/IR equipment on top of a table near the pier wall. There should not be any problem when the table is less than 45 ft from the substructure since the cables are 50 ft long.
