An Engineered Fit-For-Purpose Polymer Nanocomposite Seal Repair Material for Wellbores

DISSERTATION

Doctor of Philosophy

The University of New Mexico
Albuquerque, New Mexico

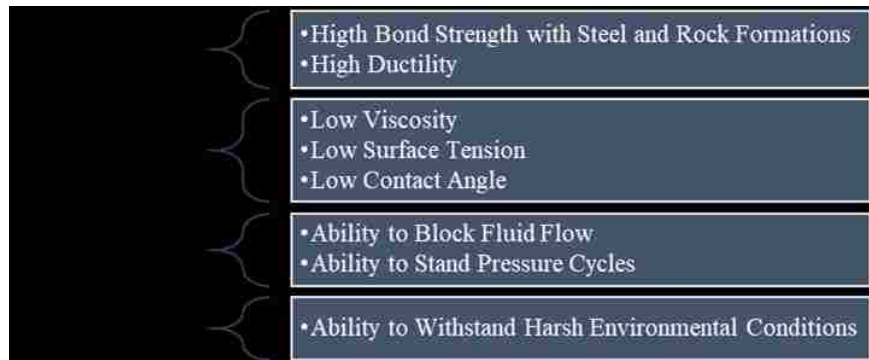
Figure 1.1: Summary of the desired properties of wellbore seal repair material.

The desired properties of wellbore seal repair material are summarized in Figure 1.1. High bond strength and ductility are required to allow the seal repair material to

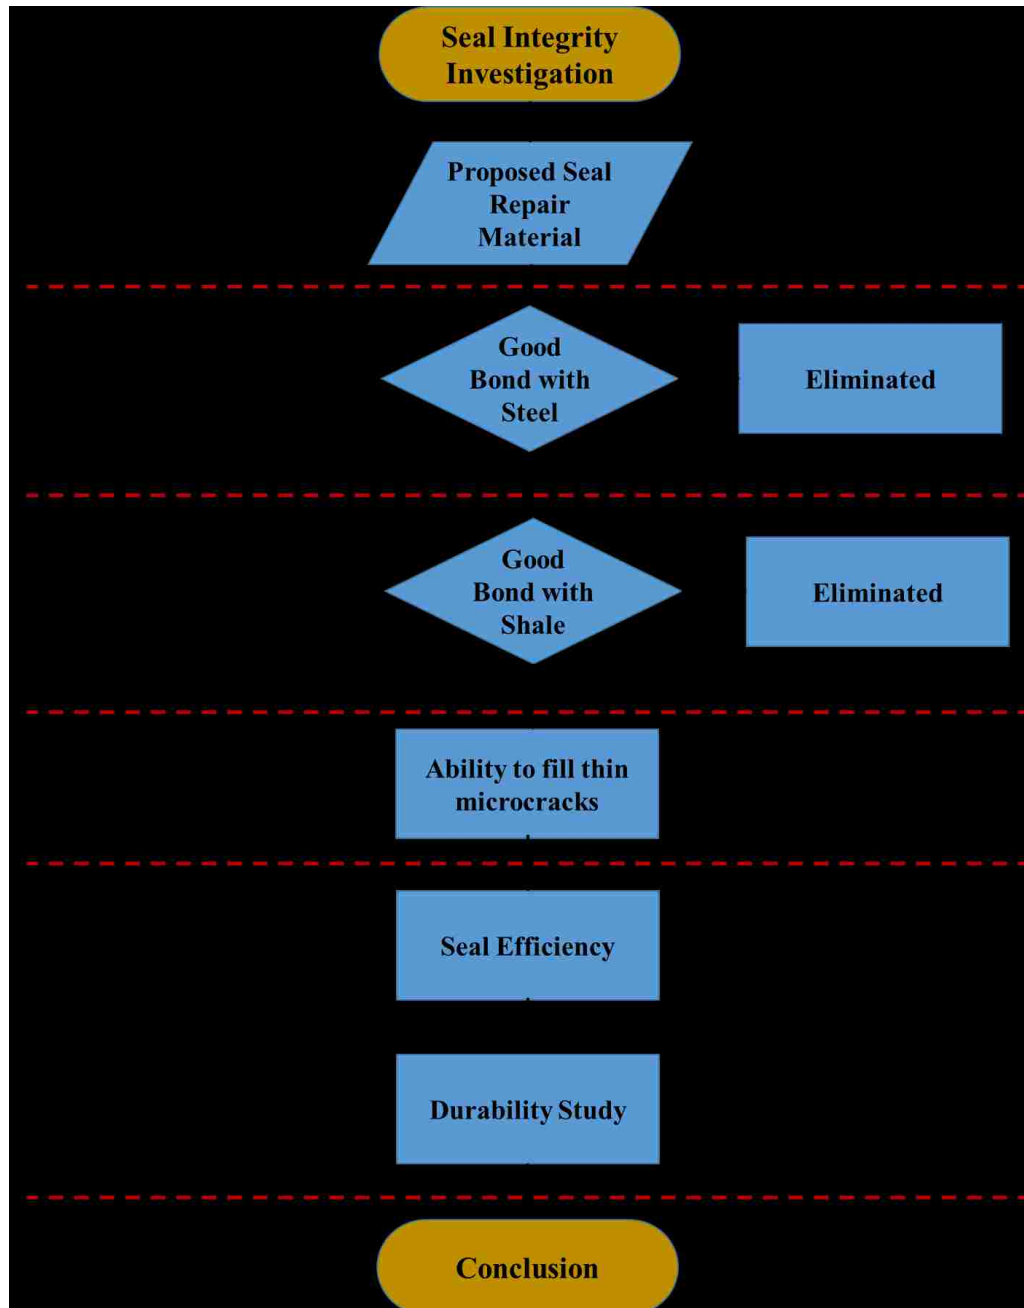
Figure 1.2: Flowchart summarizes the elimination process adopted in the investigation.

The design process of the seal repair material (selection of polymer and incorporated nano particles) follows an elimination process of four phases summarized in Figure 1.2. First, the bond strength with steel, and flowability of the proposed polymer cement nanocomposites (PCNC) were investigated. Next, in Phase II the bond strength with shale of the selected polymer nanocomposites in Phase I was investigated. In Phase III, the ability of selected polymer nanocomposites to fill thin microcracks (30 μm) was then investigated. Finally, a performance study that includes examining the efficiency of seal repair material to the seal cement-steel interface, and the ability to withstand the wellbores' extreme environmental conditions was conducted in Phase IV. In all the

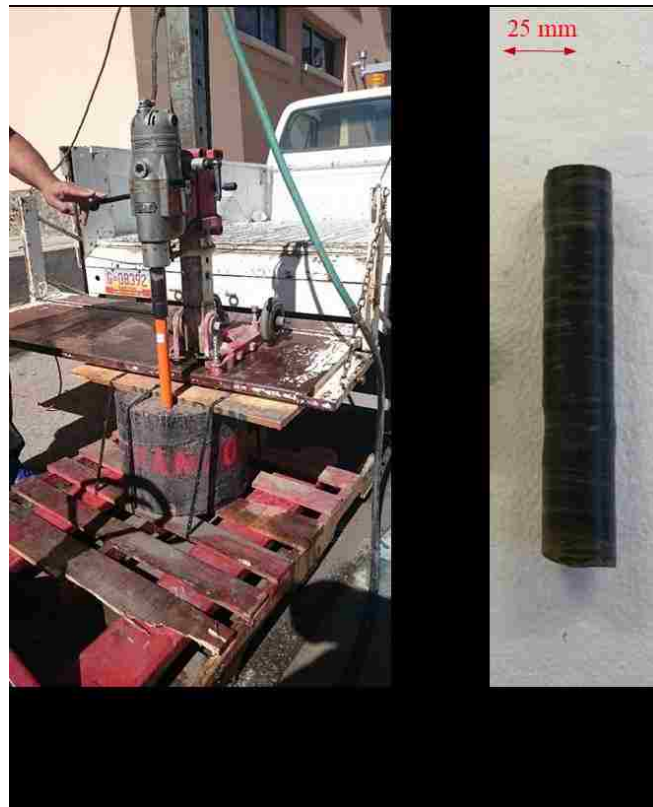
Figure 3.1: (a) Coring process of Mancos shale and (b) Mancos shale core.

The shale used in this investigation is Mancos Shale, sourced from TerraTek shown in Figure (3.1).

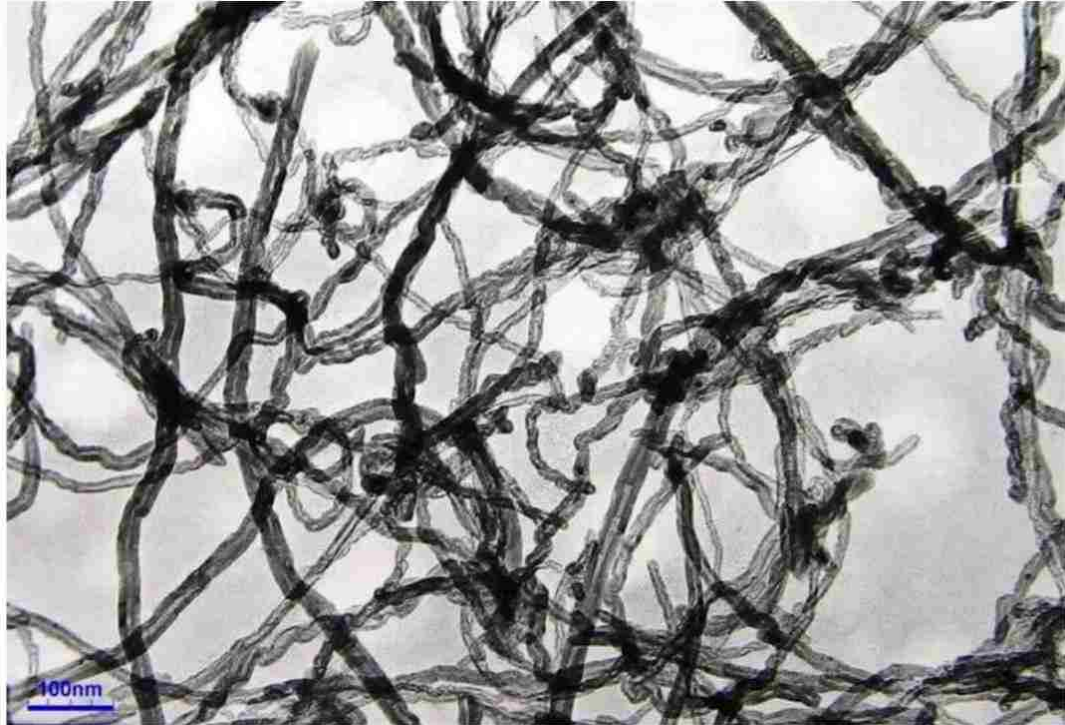
Figure 3.2: Transmission electron microscope (TEM) images of MWCNTs.

Functionalized Multi-Walled Carbon Nano-Tubes (MWCNTs) were added to produce the nanocomposite. The MWCNTs have an outer diameter (OD) of 20–30 nm, inner diameter (ID) of 5–10 nm and length of 10–30 μm . The bulk density of the MWCNTs is 0.21 g/cm^3 and the specific surface area is 110 m^2/g . The functionalization of MWCNTs was performed by the manufacturer. A typical functionalization process is carried out in two steps as reported by Zhu et al. and Osorio et al. (Zhu et al. 2003, Osorio et al. 2008). First, a mixture of nonorganic acids such as sulfuric, nitric, and/or hydrochloric acids is added and stirred with the nanotubes under elevated temperature. The role of the aggressive mixture of acids is to create a defect on the surface of the nanotubes. The acids addition is followed by base such as ammonium hydroxide. The base is expected to neutralize the acidity and impregnate the carboxylic functional group on the nanotubes. Figure 3.2 shows Transmission electron microscope (TEM) images of MWCNTs.

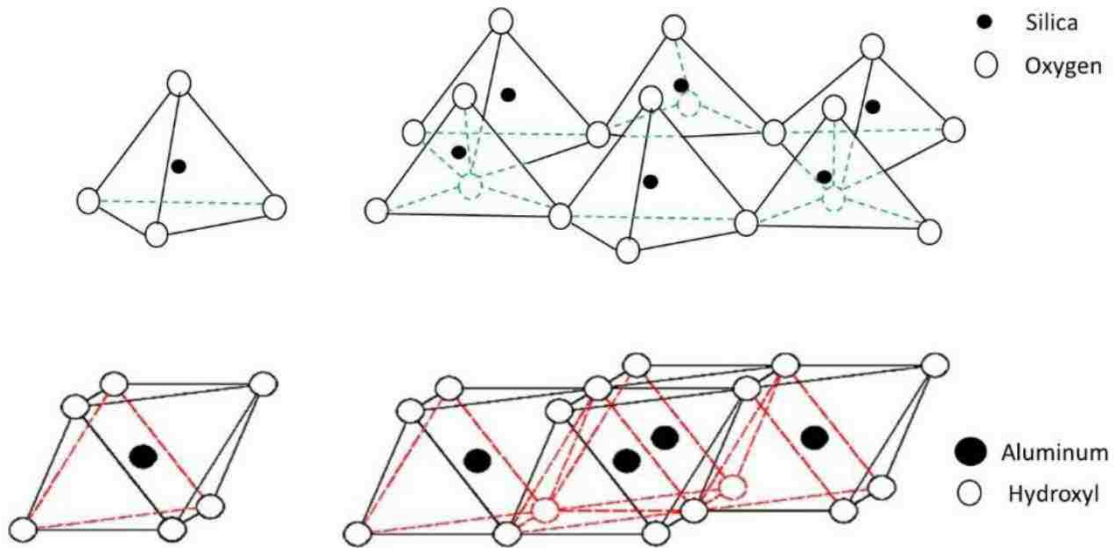
Figure 3.3: Structure of a silica tetrahedral sheet (up), and an alumina octahedral sheet (down) (McLaren and Cameron 1996).

$\text{Al}(\text{OH})_3$ - sheets (McLaren and Cameron 1996) as shown in Figure 3.3. In montmorillonite (2:1 type phyllosilicates), each layer is composed of one octahedral alumina sheet sandwiched between two tetrahedral silica sheets (Uddin 2008).

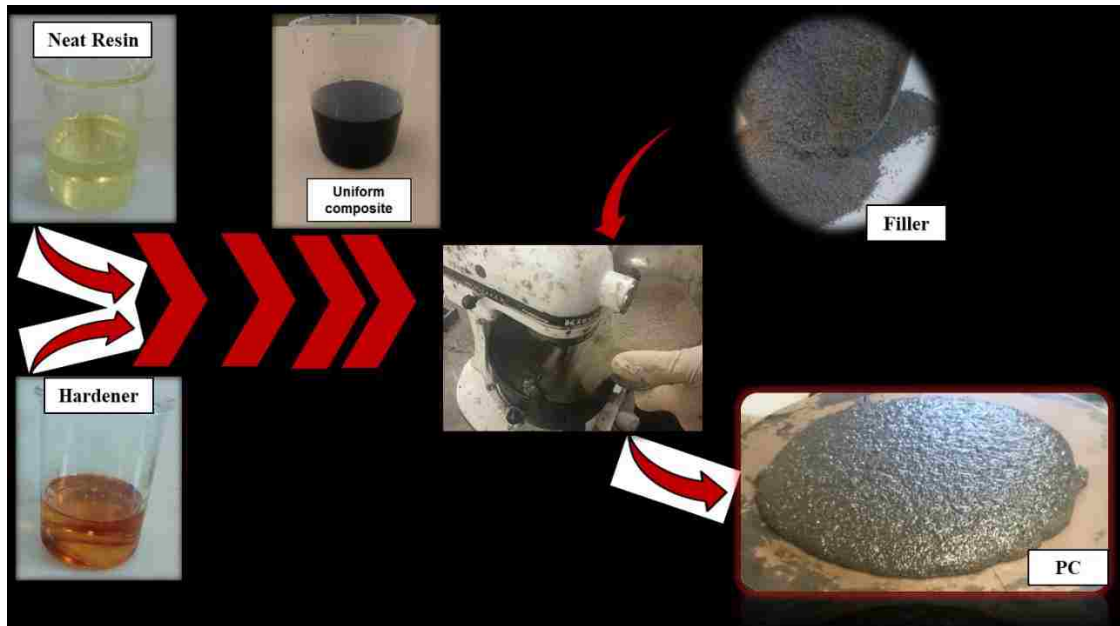
Figure 3.6: Schematic of mixing procedure of polymer-cement nanocomposites.

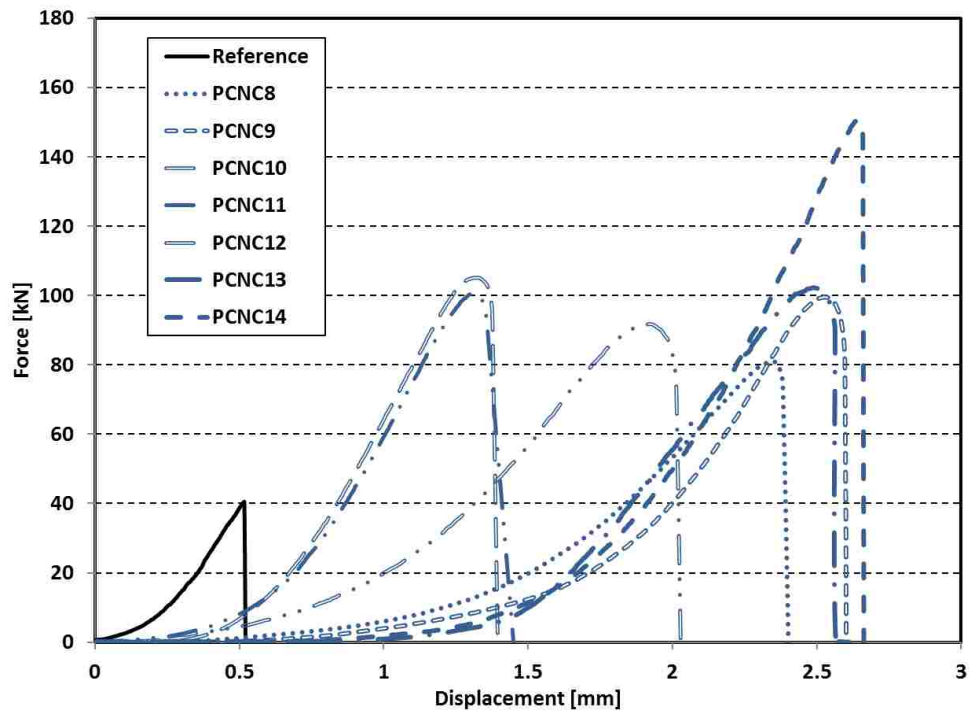
Figure 3.10: Load-displacement curves of reference microfine cement material and Novolac epoxy cement nanocomposites.

Load-displacement data from the slant shear tests for the Polysulfide Siloxane epoxy cement nanocomposites in Figure 3.9 and Novolac epoxy cement nanocomposites in Figure 3.10. Load-displacement response of the reference microfine cement material is also shown in Figure 3.9 and Figure 3.10.

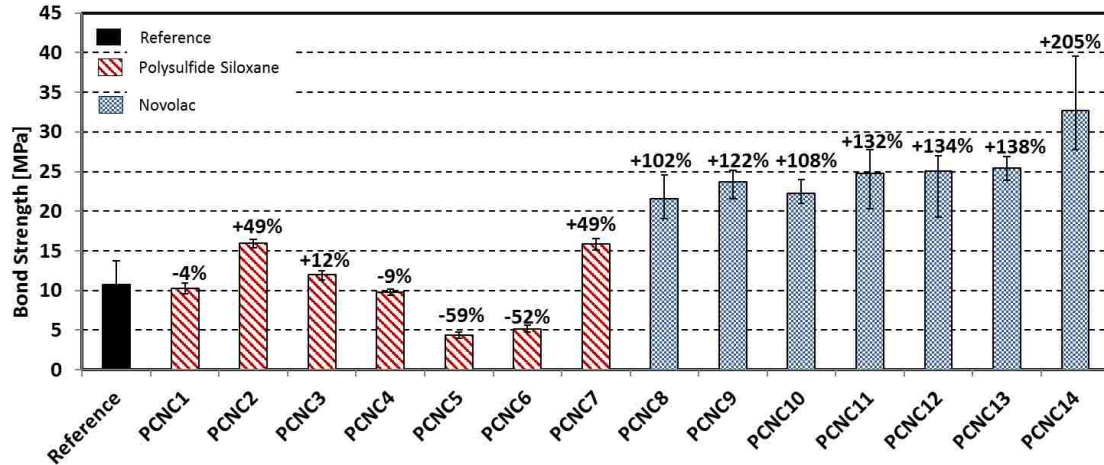
Figure 3.11: Mean bond strength for reference microfine cement material and all fourteen polymer cement nanocomposites.

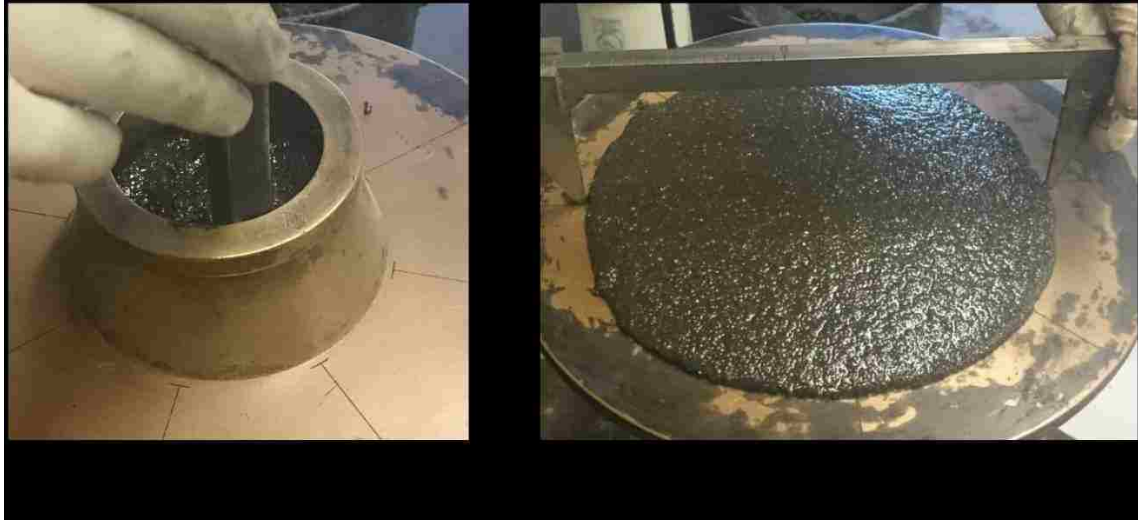
Figure 3.12: (a) Filling the flowability cone (b) taking readings using test caliber.

the flowability of the slurry. Figure 3.12 shows filling of the flowability cone and reading of flowability with the test caliber.

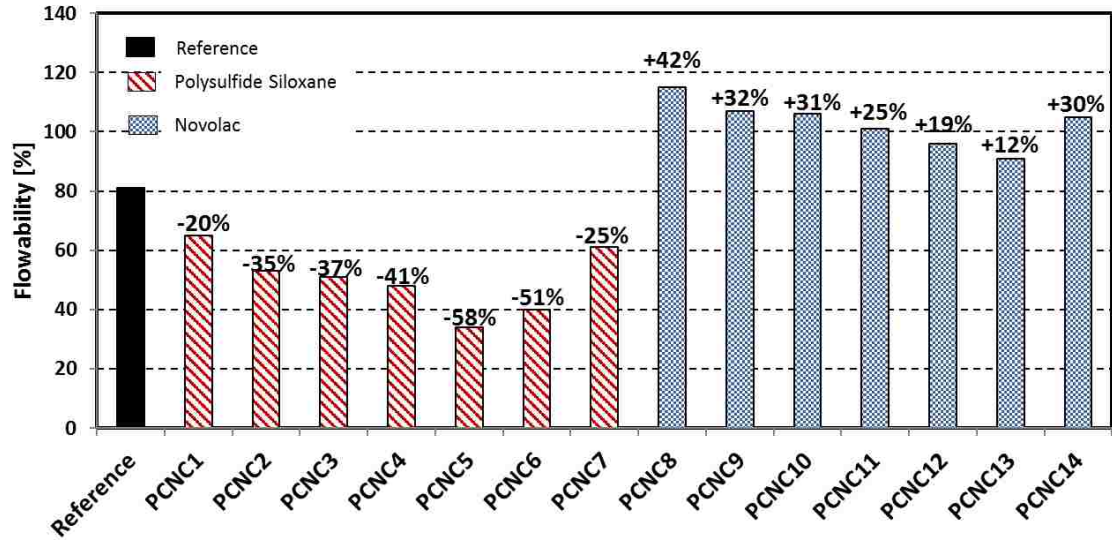
Figure 3.13: Flowability results for the reference microfine cement material and all fourteen polymer nanocomposites.

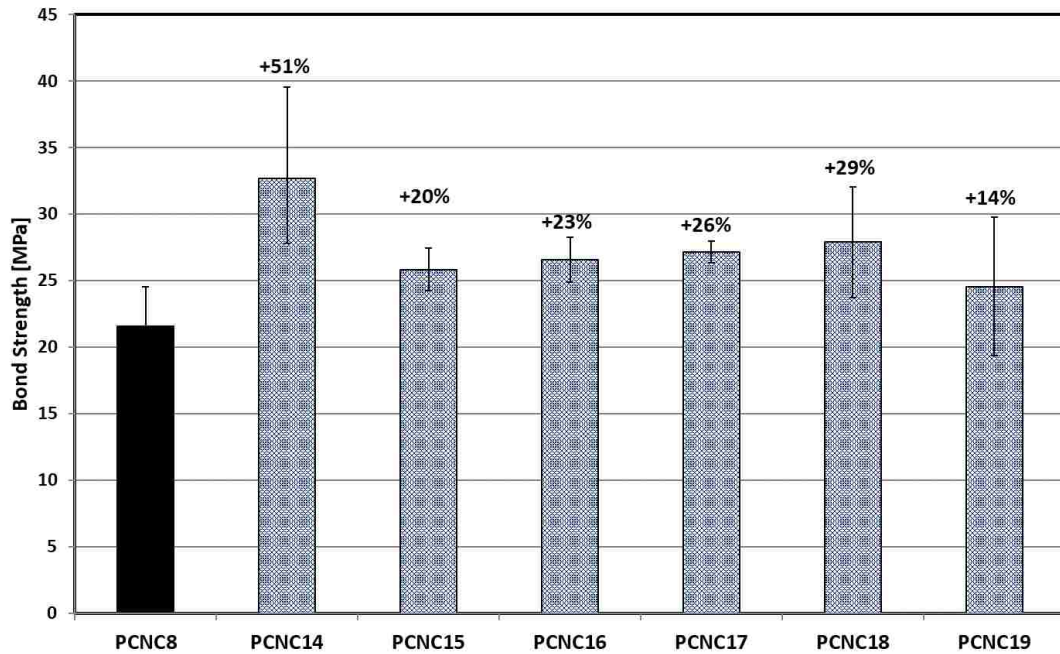
Figure 3.14: Mean bond strength for all Novolac epoxy PCNC.

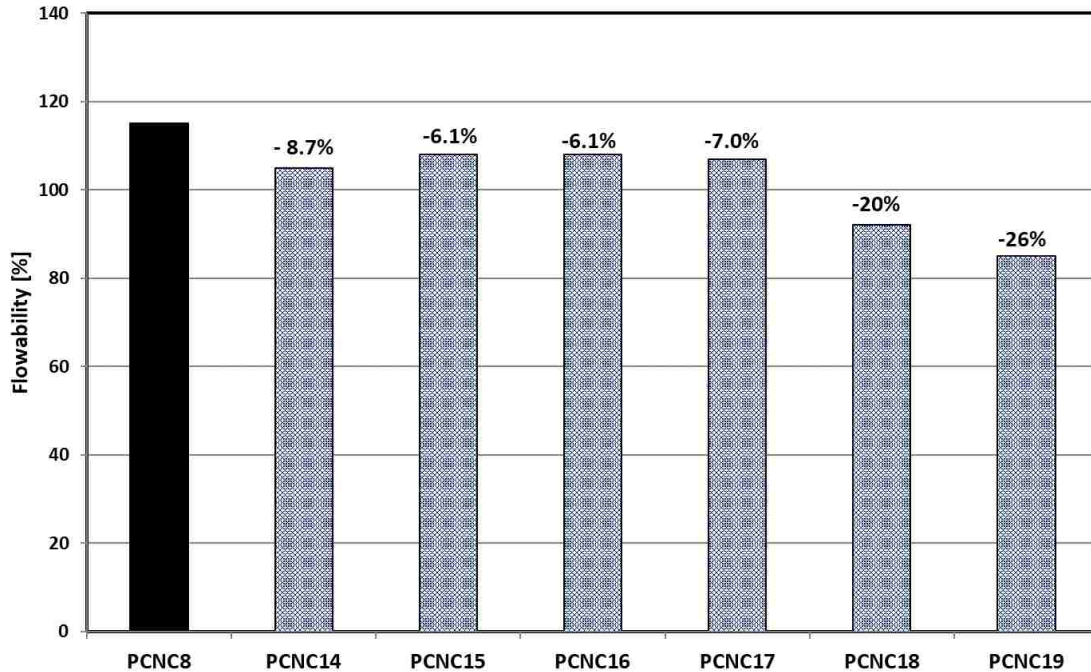
Figure 3.15: Flowability results for all Novolac epoxy PCNC.

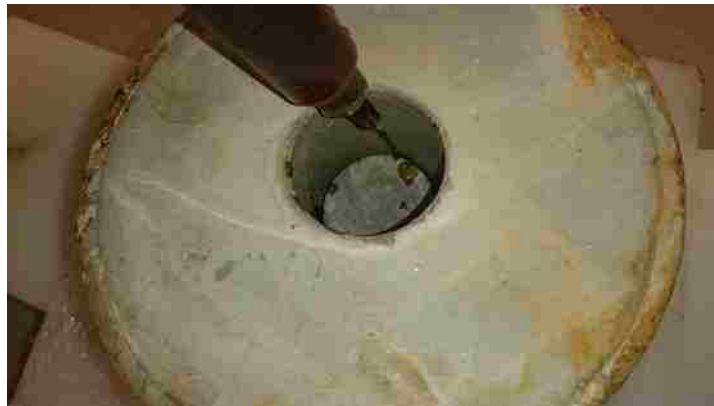
Figure 3.17: Placing seal repair material at the cement-shale microannulus.

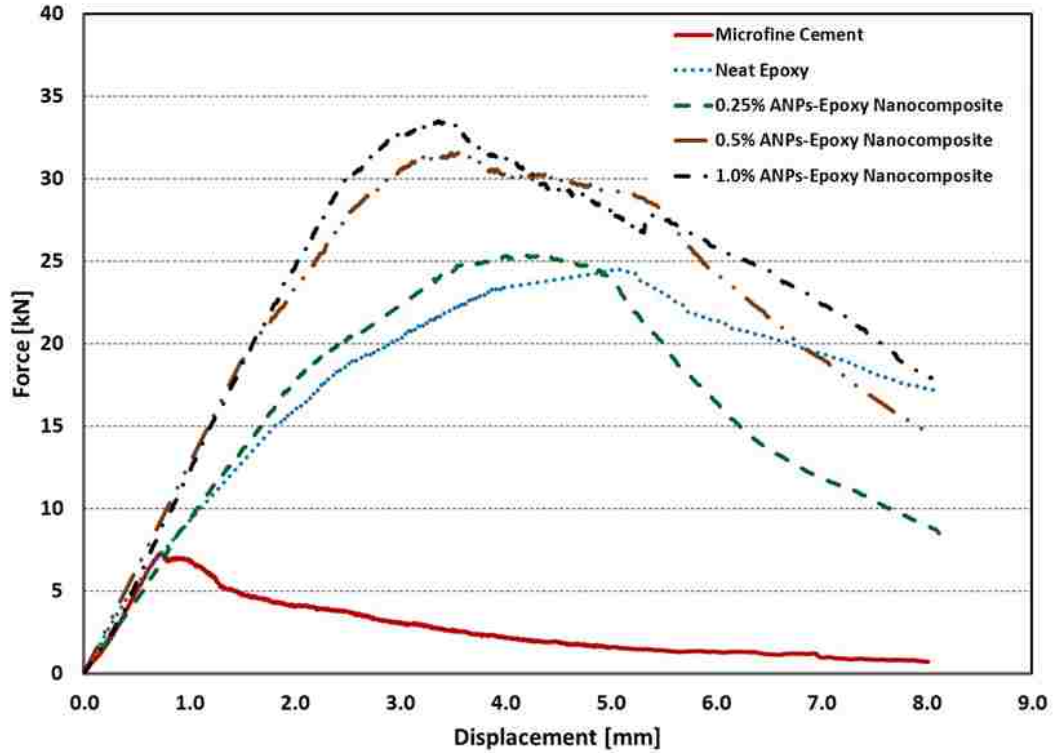
Figure 3.19: Median load-displacement curves of specimens sealed with microfine cement and epoxy-based materials.

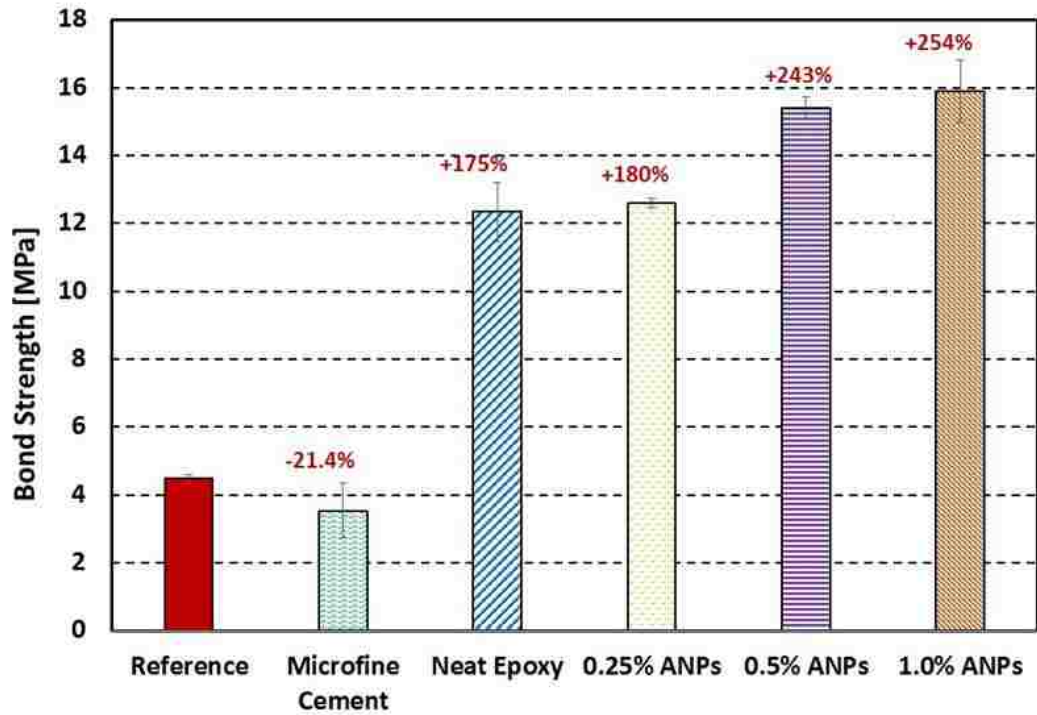
Figure 3.20: The bond strength of the reference case and all seal repair materials.

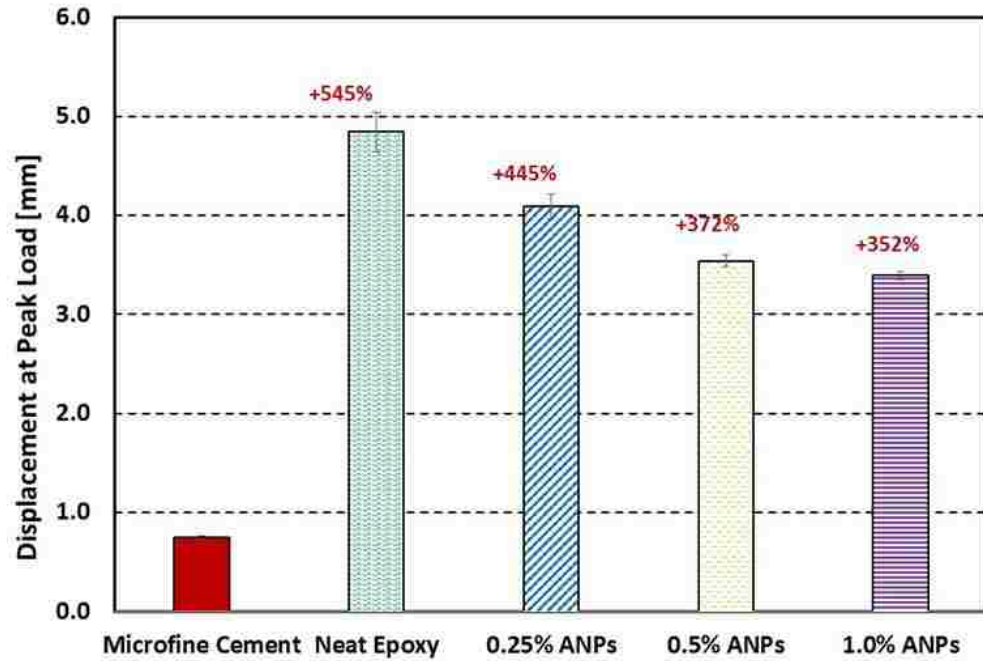
Figure 3.21: Displacement at peak load of the microfine cement and all ANPs-epoxy nanocomposites

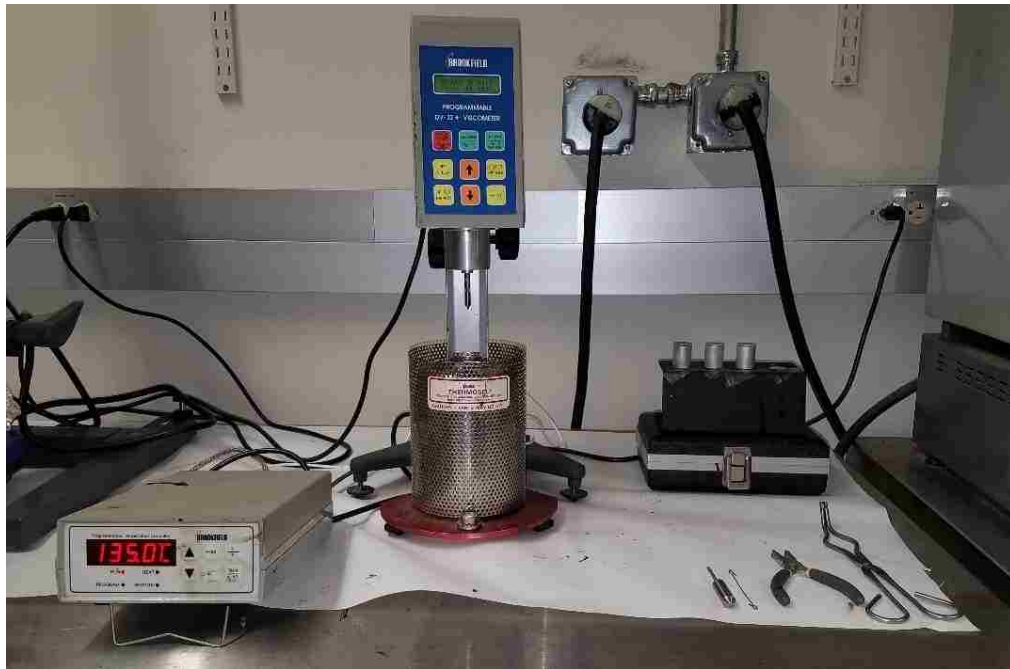
Figure 3.23: Rotational Viscometer.

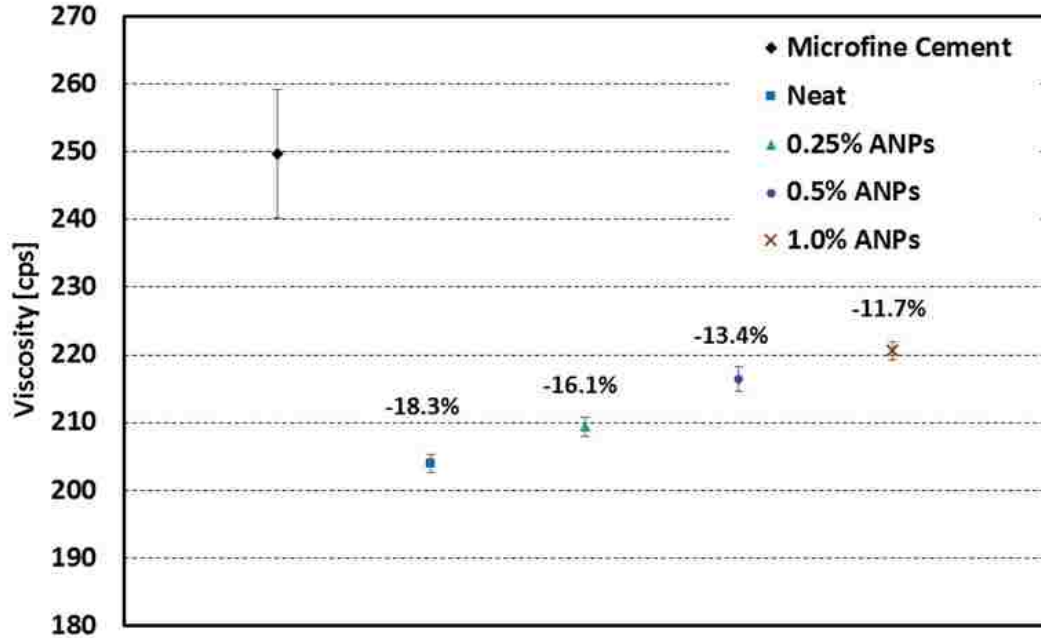
Figure 3.24: Comparison of the viscosity between polymer nanocomposites incorporating 0% (Neat) 0.25%, 0.5%, and 1.0% ANPs and microfine cement.

difference in viscosity of ANPs-epoxy nanocomposites was significantly different than that of microfine cement.

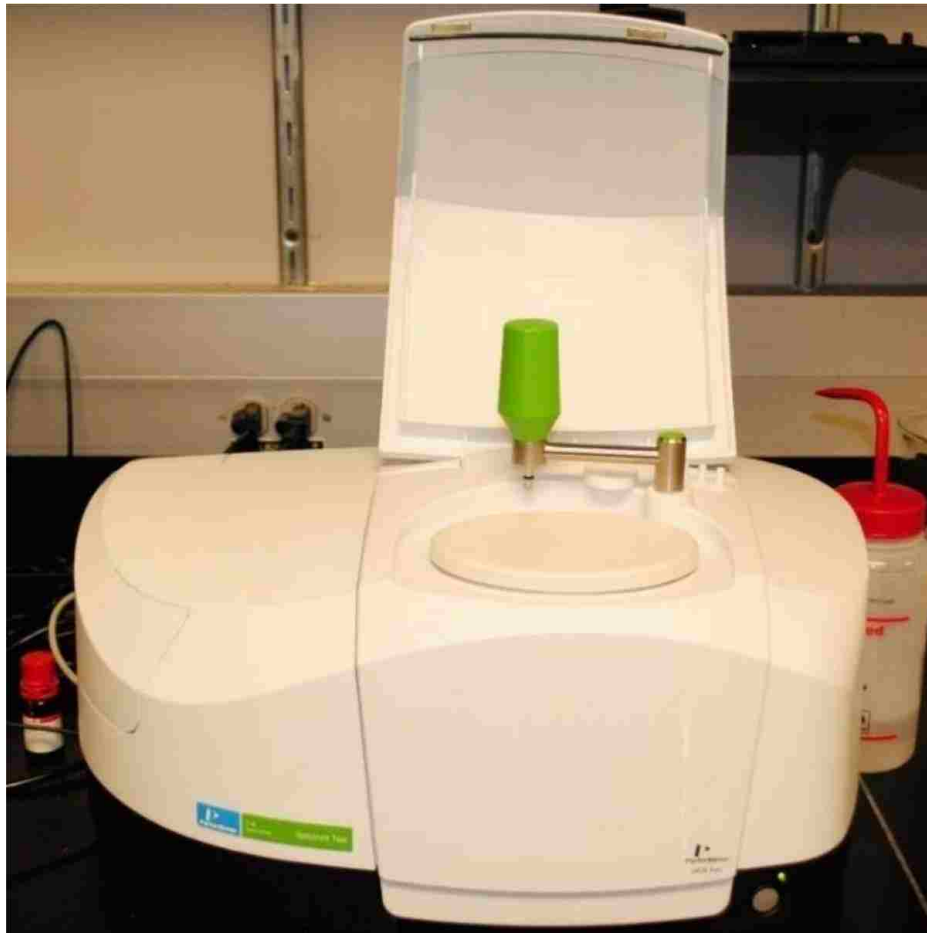
Figure 3.28: PerkinElmer FTIR machine.

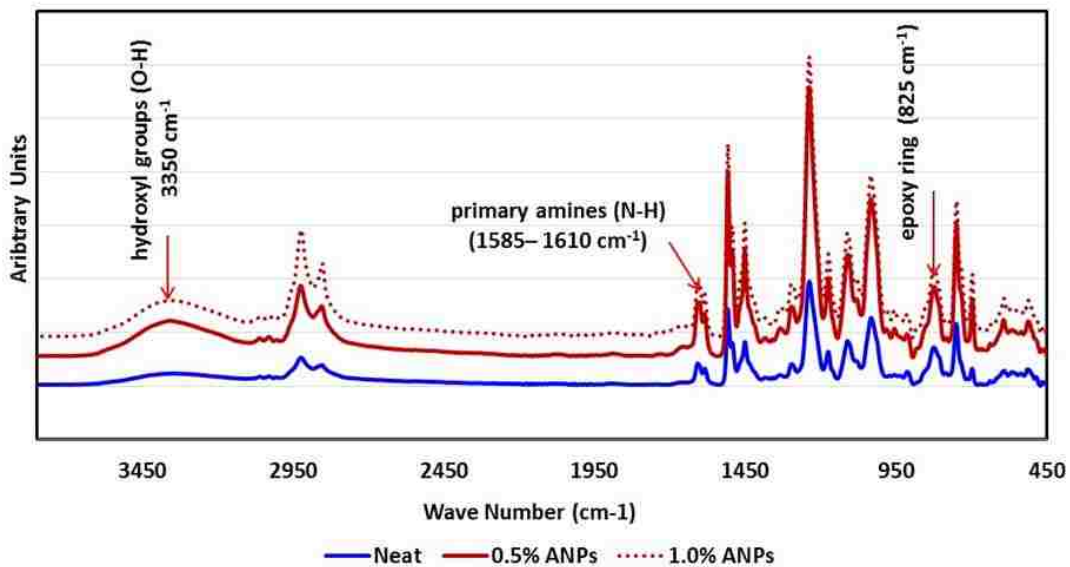
Figure 3.29: FTIR spectra of neat epoxy and epoxy incorporating 0.5 and 1.0 % ANPs showing the significant changes appearing in the spectra using ANPs compared to the neat epoxy.

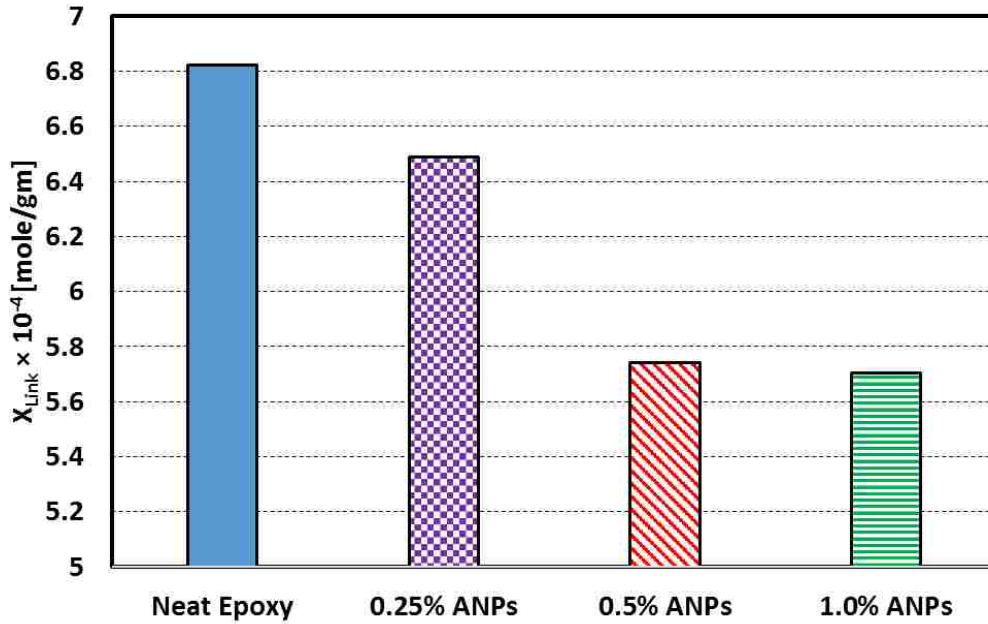
Figure 3.31: X_{link} : A measure of the degree of crosslinking for neat epoxy, 0.25% ANPs-epoxy nanocomposite, 0.5% ANPs-epoxy nanocomposite, and 1.0% ANPs-epoxy nanocomposite.

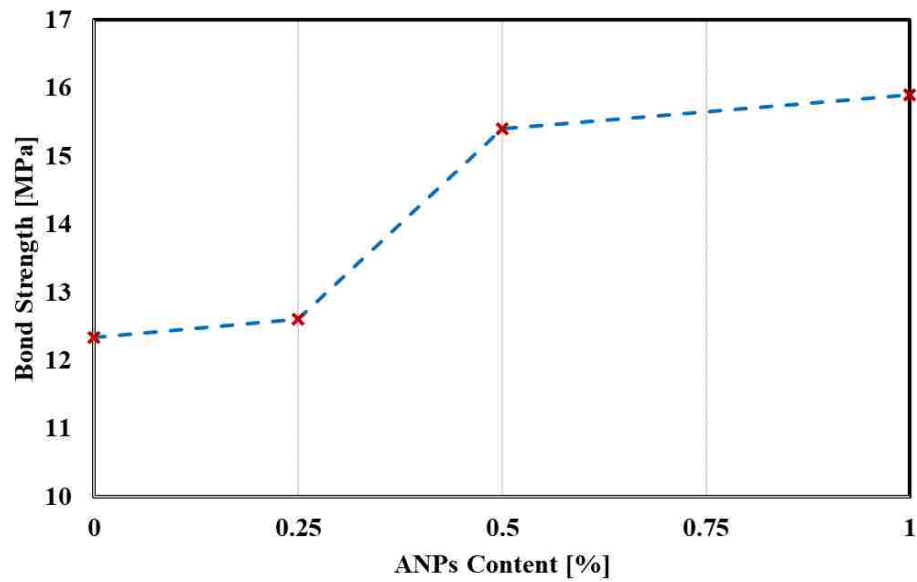
Figure 3.32: The relation between the bond strength and the content of ANPs in polymer nanocomposites.

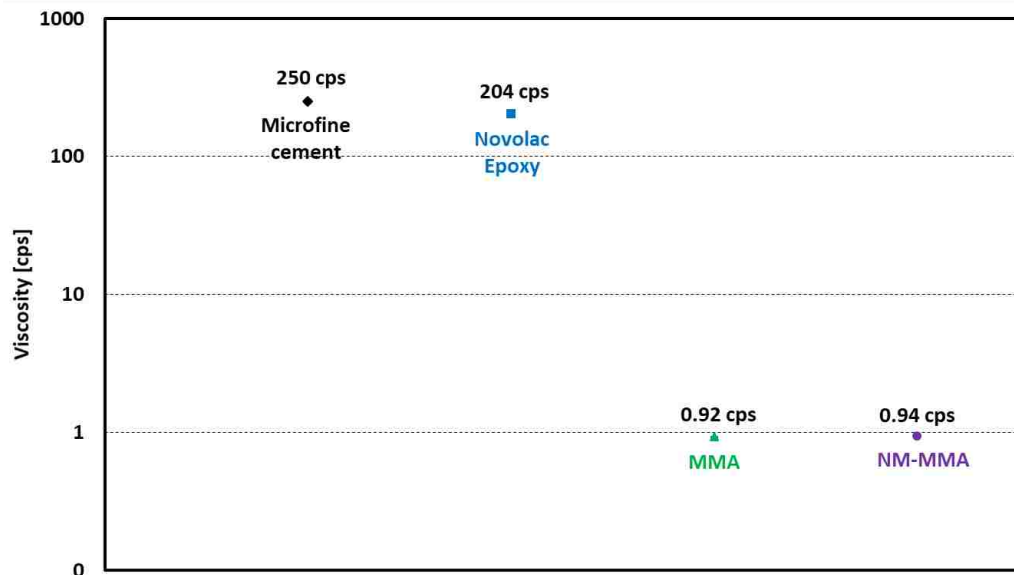
Figure 3.33: Viscosity measurements of all seal repair materials: Log scale is used to enable display with order of magnitude change in viscosity.

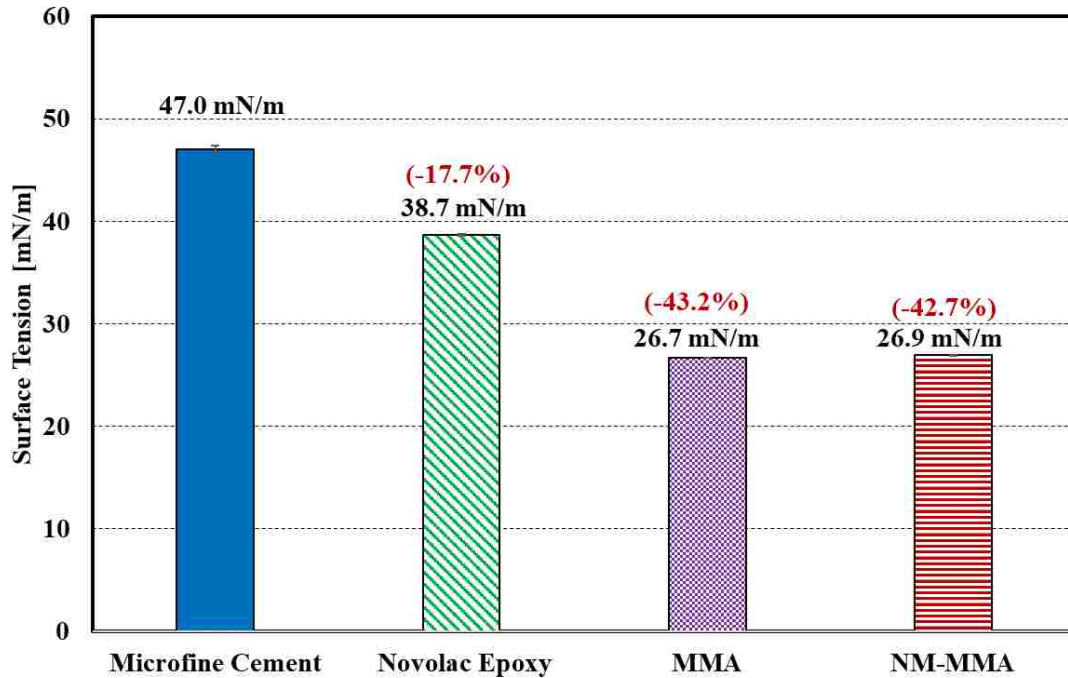
Figure 3.35: Surface tension seal repair materials: % above the bars represents the difference of Penetrability Index of seal repair material compared with microfine cement.

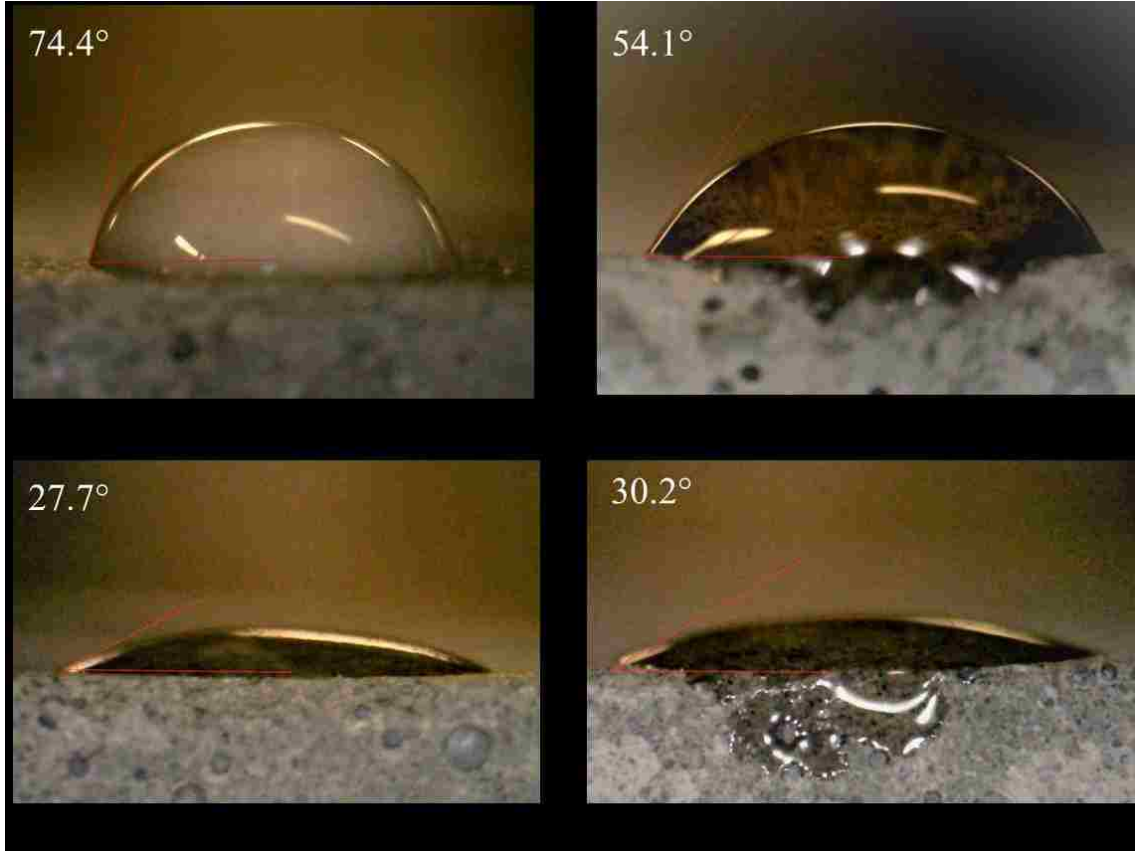
Figure 3.36: Contact angle measurements for (a) Microfine cement, (b) Novolac epoxy, (c) MMA, and (d) NM-MMA.

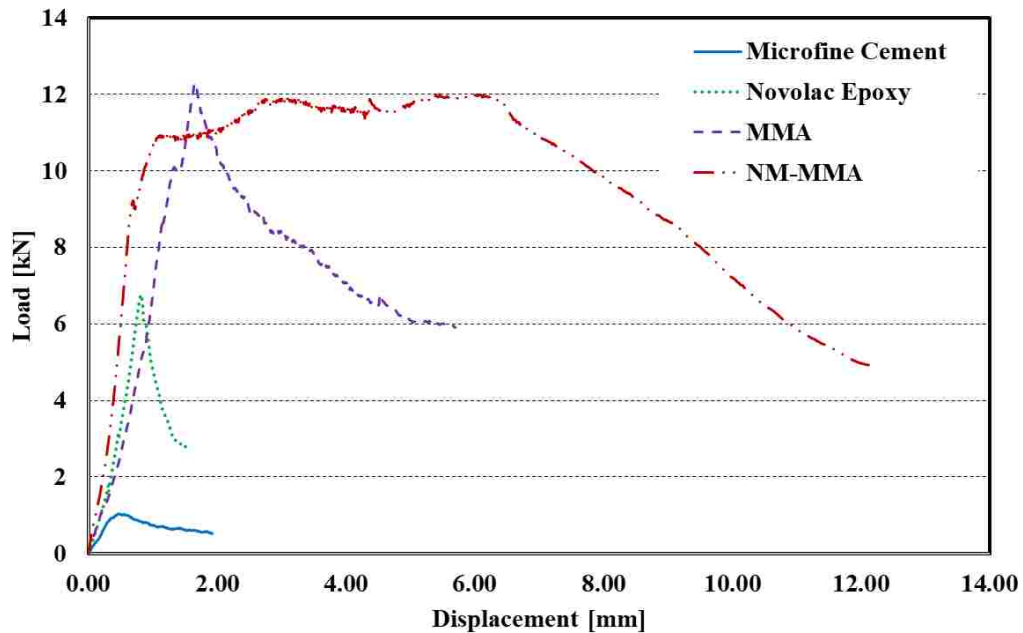
Figure 3.39: Median load-displacement curves of specimens sealed with microfine cement, Novolac epoxy, MMA, and NM-MMA polymer nanocomposite.

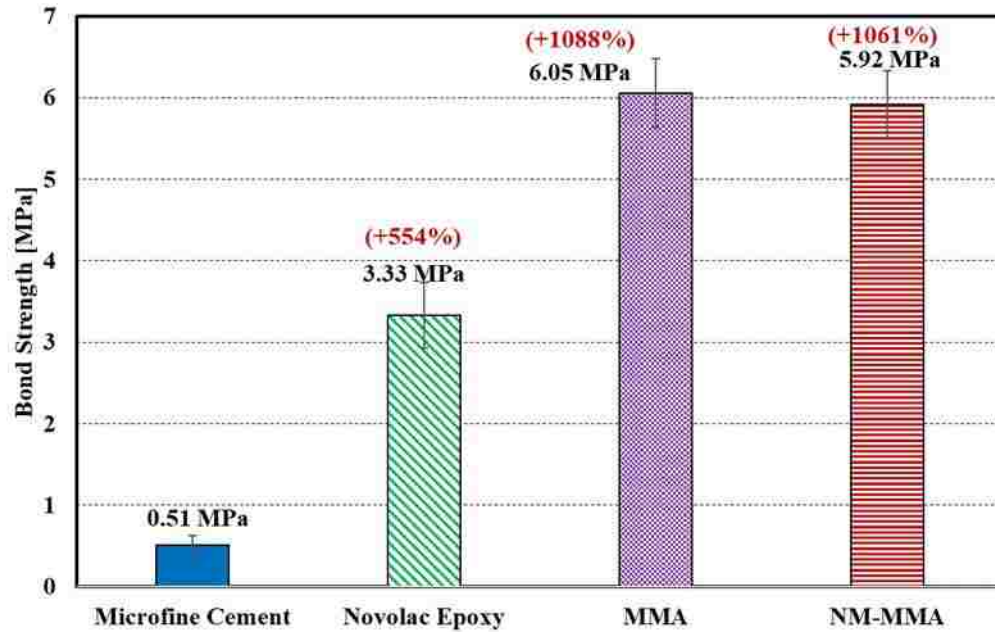
Figure 3.40: The apparent bond strength of all seal repair materials; % above the bars represents the difference of bond strength of seal repair material compared with microfine cement currently used in the field.

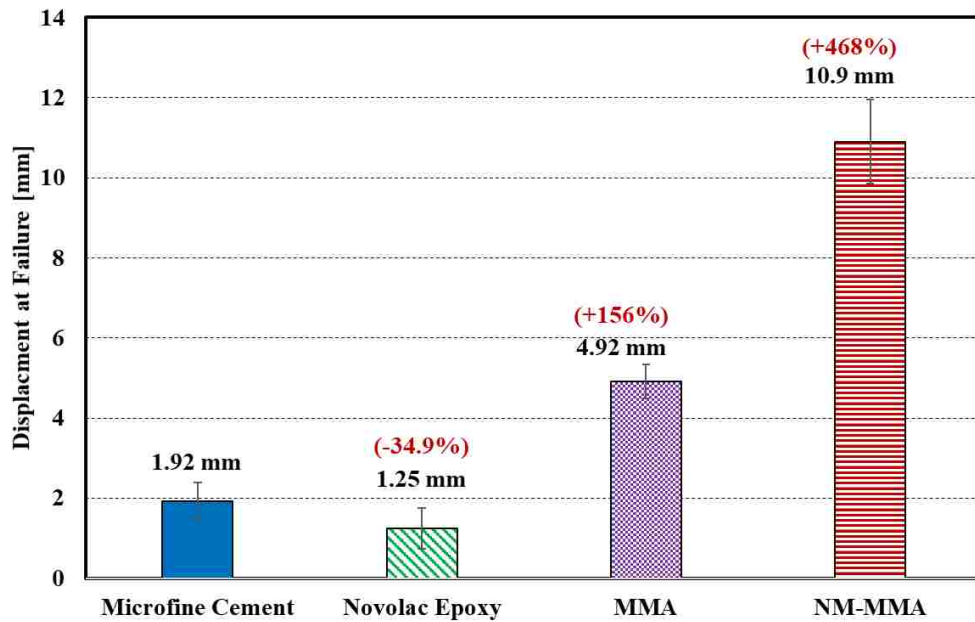
Figure 3.41: Displacement at failure of all seal repair materials; % above the bars represents the difference of bond strength of seal repair material compared with microfine cement.

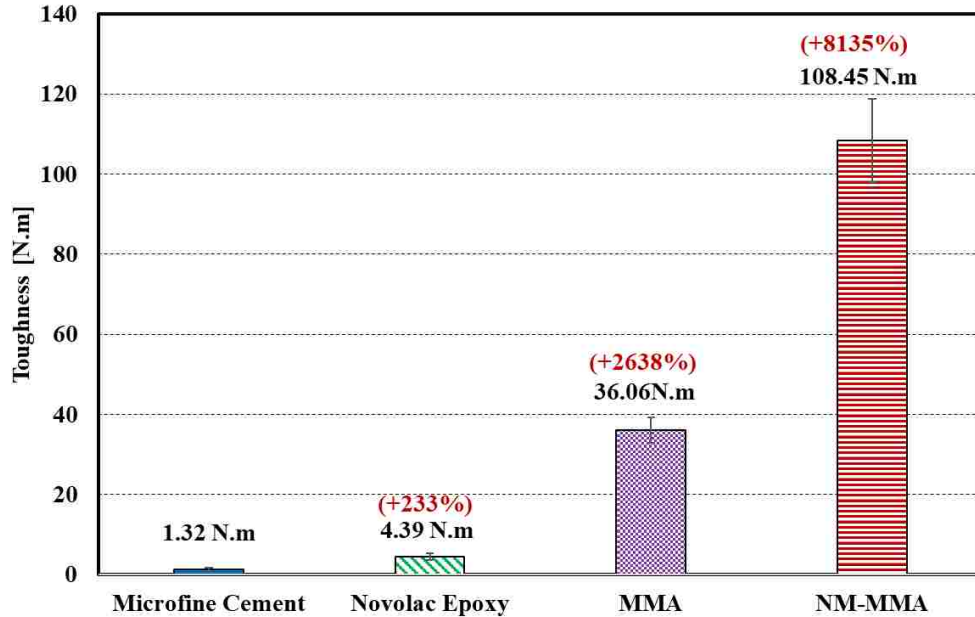
Figure 3.42: Toughness of all seal repair materials; % above the bars represents the difference of bond strength of seal repair material compared with microfine cement.

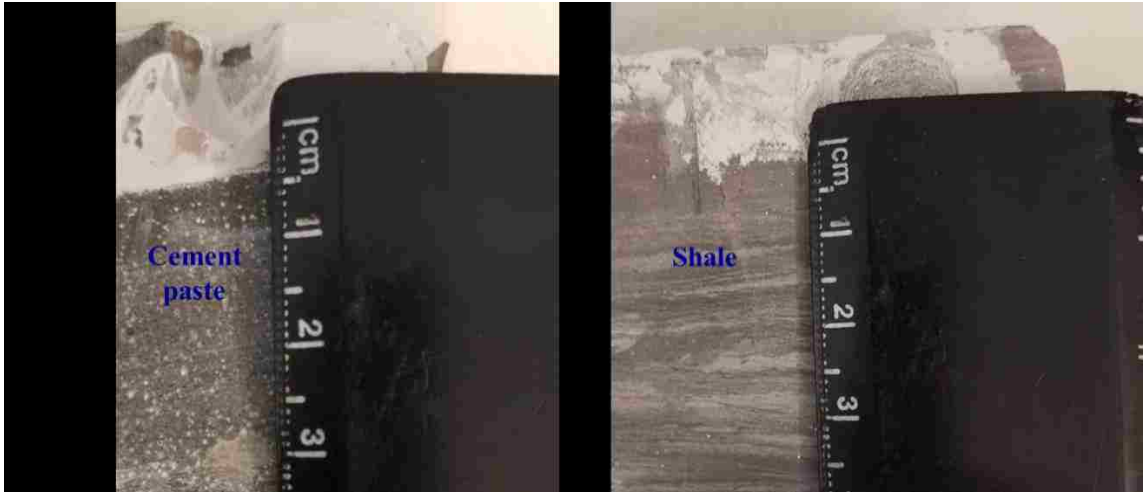
Figure 3.43: Microscopic images of cement-shale interface sealed with microfine cement with two different sides showing depth of microfine cement penetration of cement paste and shale sides.

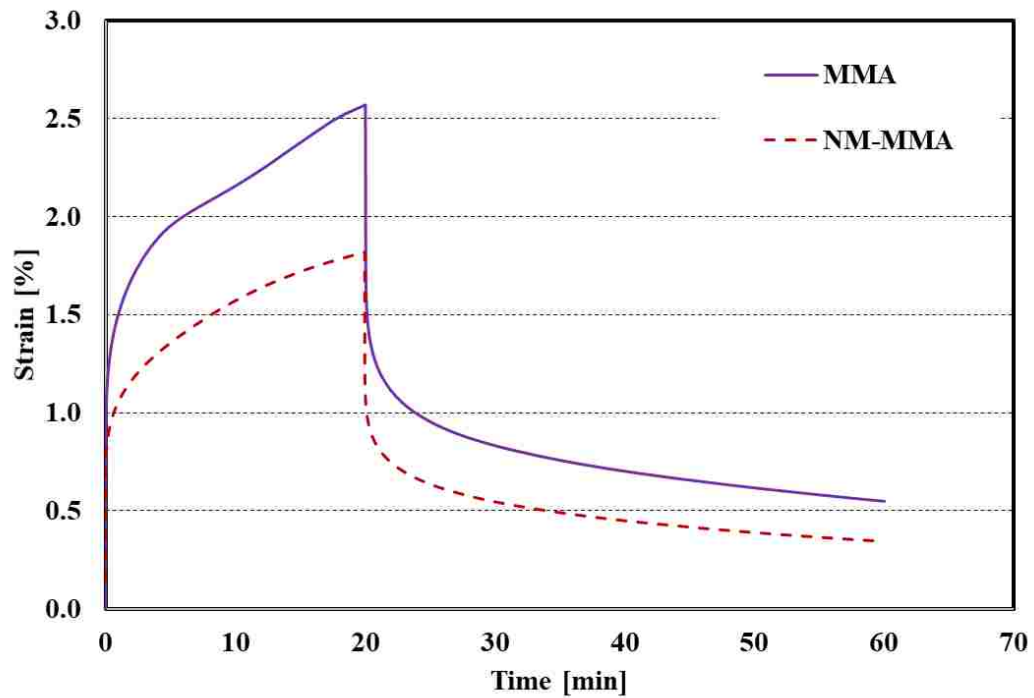
Figure 3.46: The viscoelastic behavior of MMA and NM-MMA obtained from creep test.

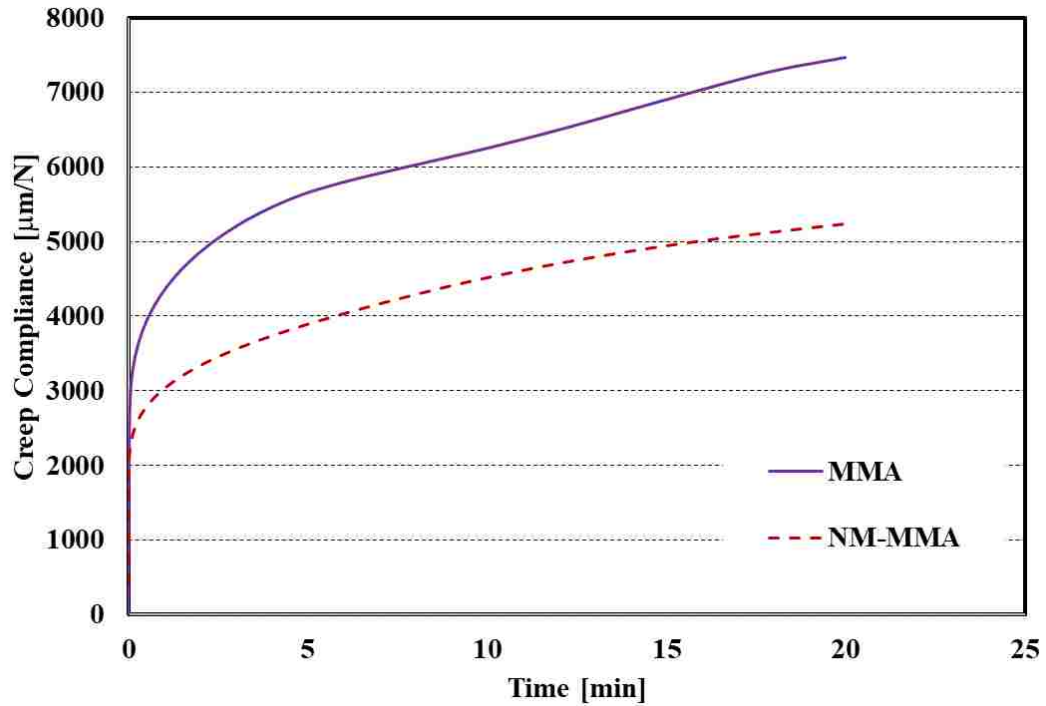
Figure 3.47: Creep Compliance of MMA and NM-MMA calculated from equation 3.7.
