An Engineered Fit-For-Purpose Polymer Nanocomposite Seal Repair Material for Wellbores

DISSERTATION

Doctor of Philosophy

The University of New Mexico
Albuquerque, New Mexico

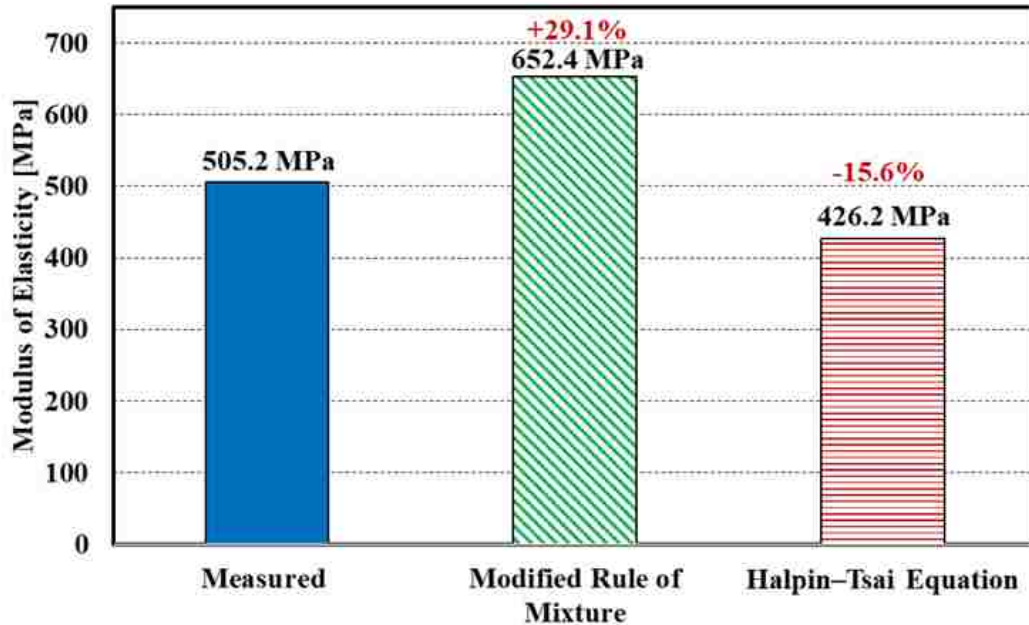
Figure 3.48: The estimated modulus of elasticity of NM-MMA using modified rule of mixture and Halpin–Tsai method compared to the measured value; % above the bars represents the difference of estimated modulus of elasticity compared with measured value..

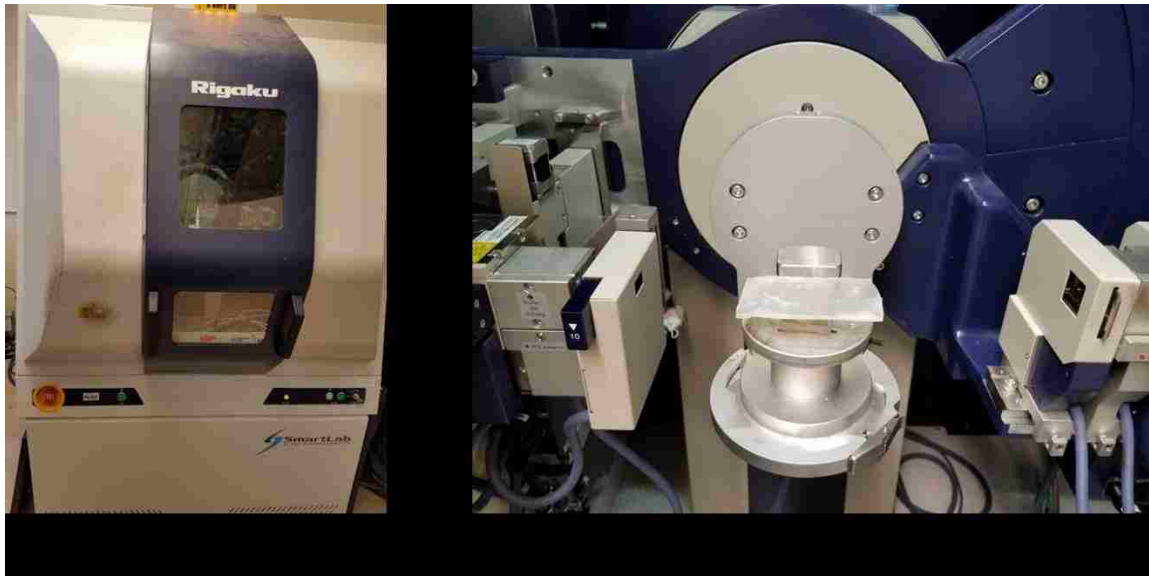
Figure 3.49: (a) Rigaku SmartLab XRD machine and (b) MMA sample on XRD sample holder.

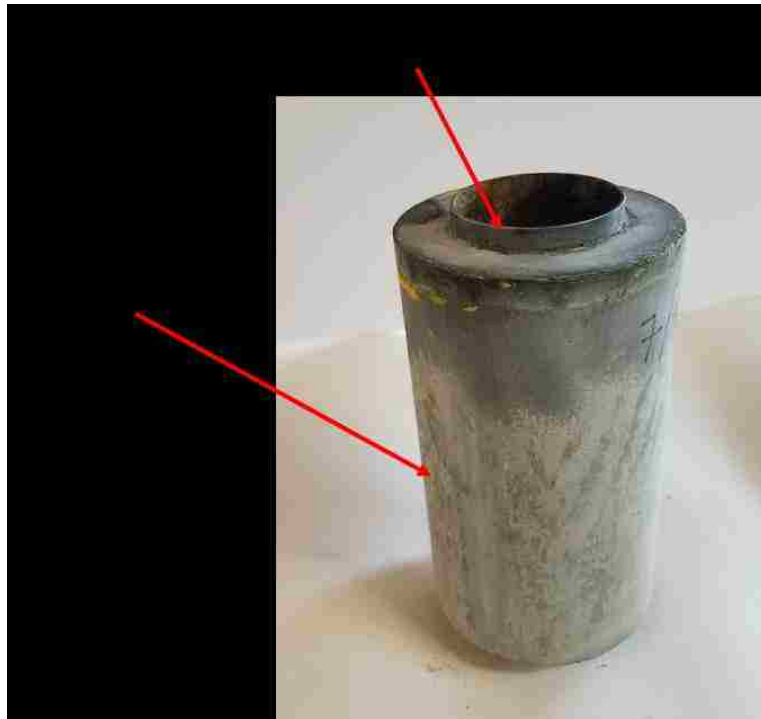
Figure 3.51: Integrated seal test specimen.

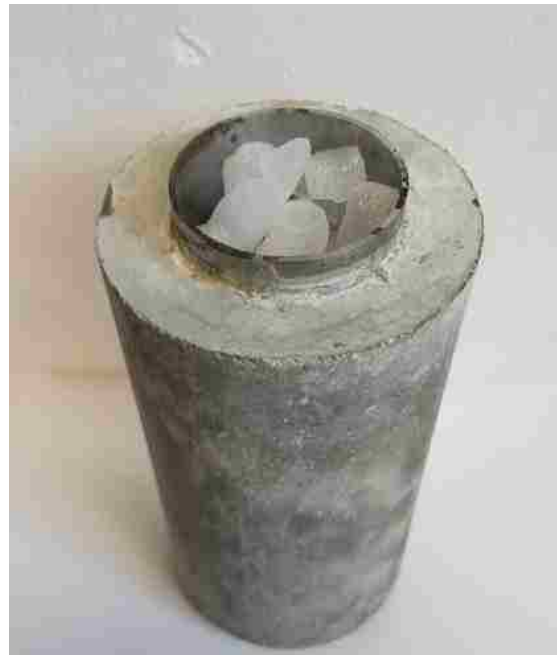
Figure 3.52: Debonding steel casing from the cement sheath using dry ice.

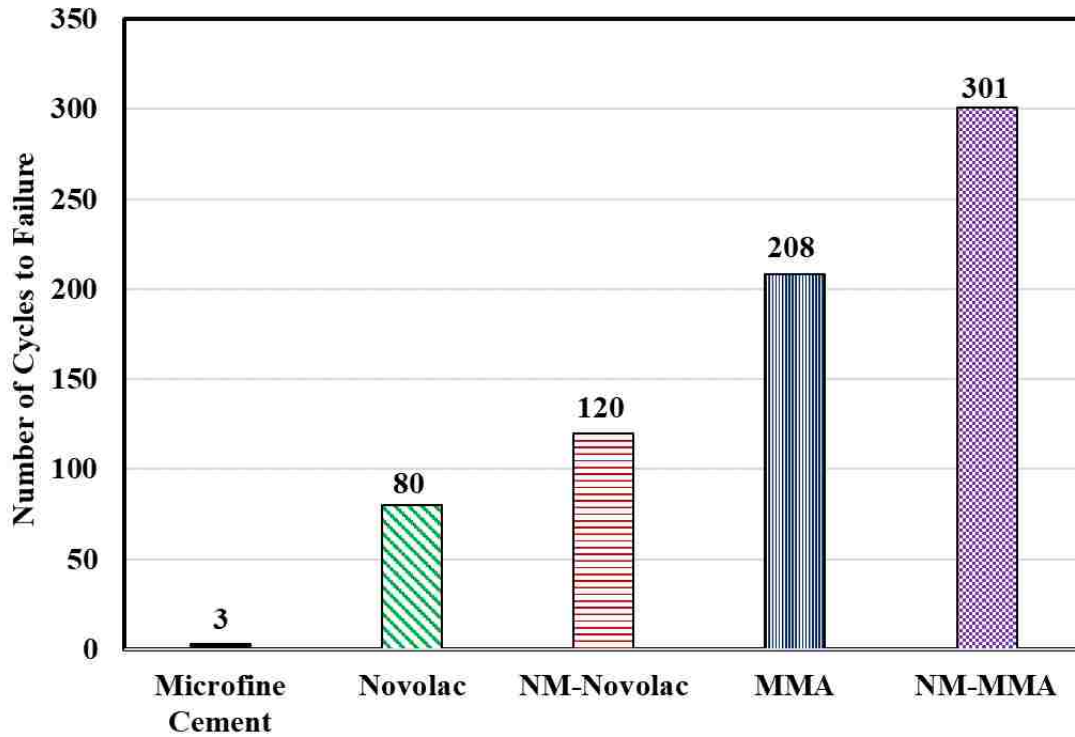
Figure 3.58: Number of casing pressure cycles applied until failure of seal integrity of sealed specimens.

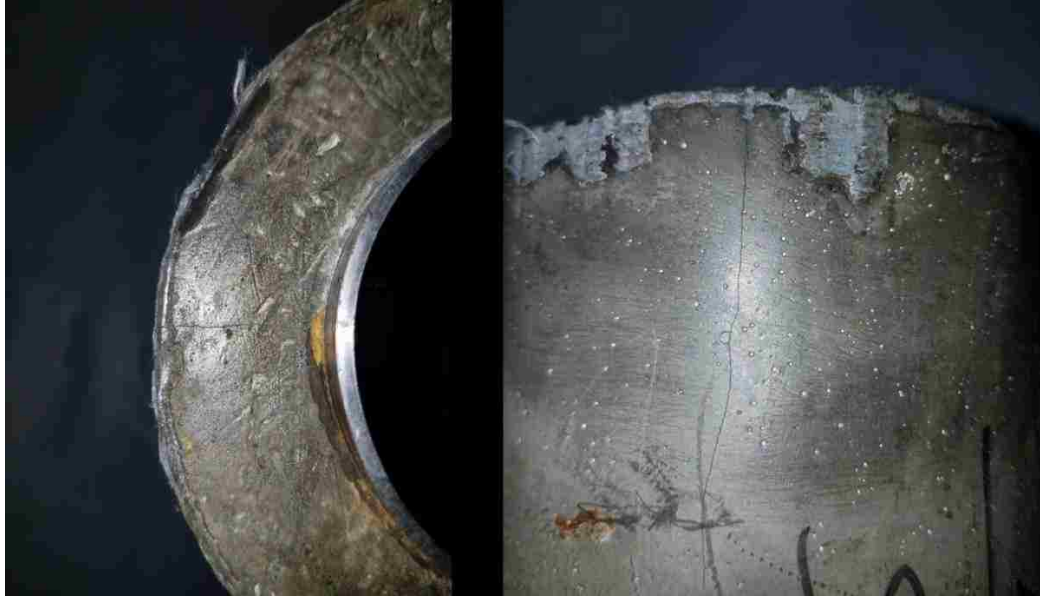
Figure 3.59: Post cyclic test integrated seal specimen sealed with MMA showing a single longitudinal crack in the cement sheath.

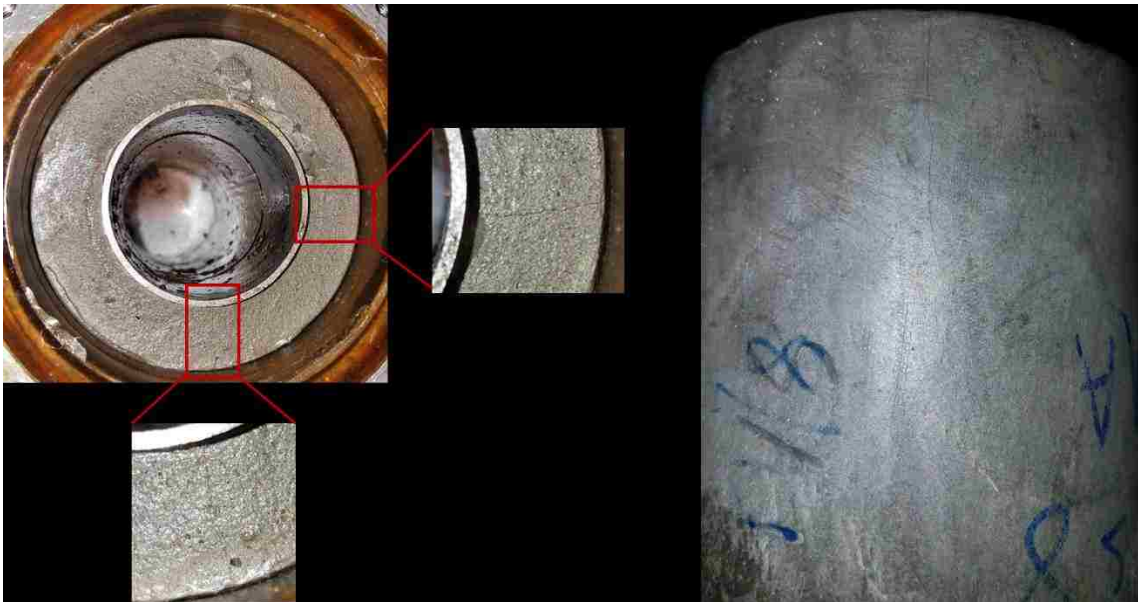
Figure 3.60: Post cyclic test integrated seal specimen sealed with NM-MMA showing two longitudinal cracks in the cement sheath.

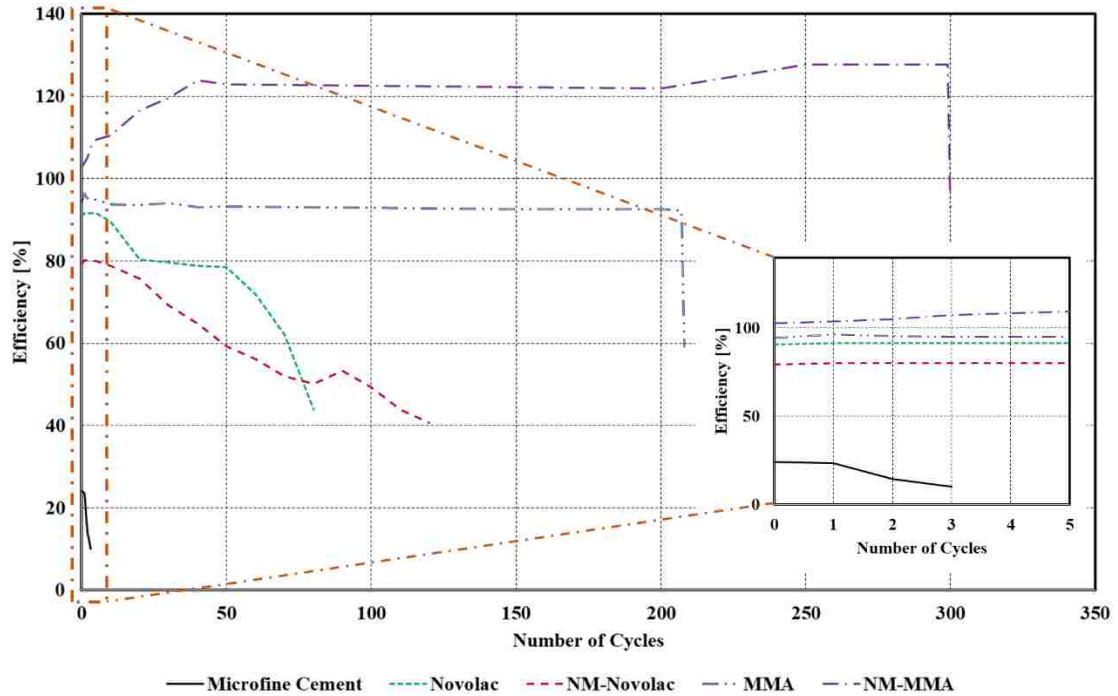
Figure 3.61: Change of seal efficiency of seal repair materials with number of casing pressure cycles.

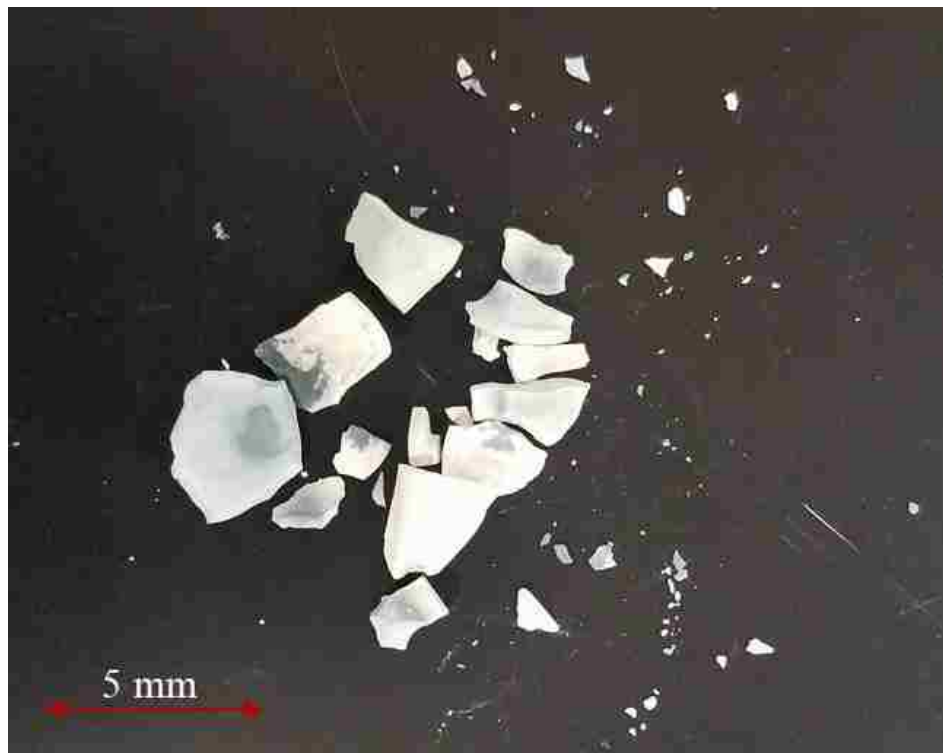
Figure 3.65: Microfine cement fractions falling apart due to harsh environmental conditions.
