PRACTICAL CONSIDERATIONS IN DETERMINING TIMBER PILE DEPTH USING THE SONIC ECHO METHOD

THESIS

The University of New Mexico
Albuquerque, New Mexico

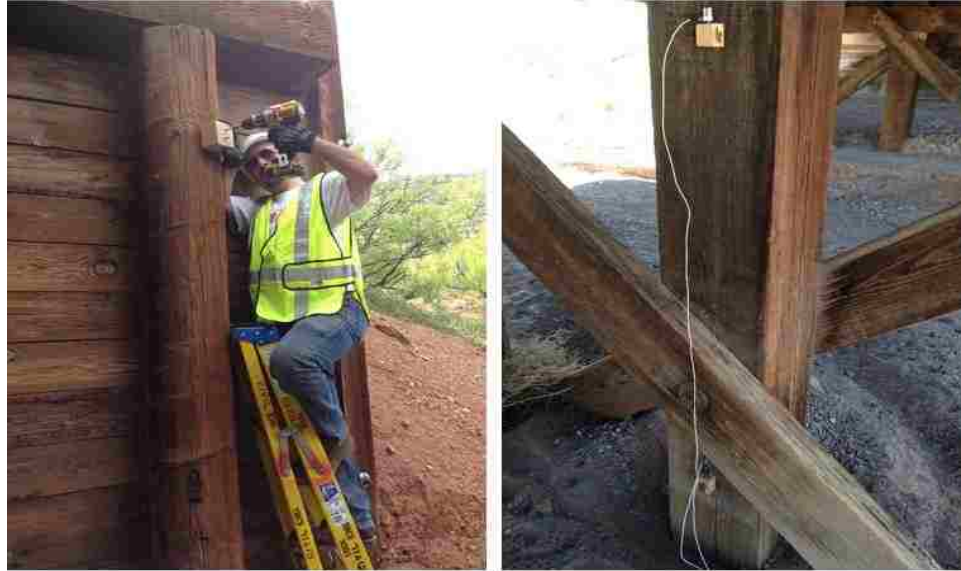
In using the first method, a square wooden block with 4 inches X 4 inches dimensions is used to create the impact. It must be coupled to the pile side with an adhesive material (epoxy) or anchor bolts (anchor bolts are recommended). Another wooden block with 2 inches X 2 inches dimensions is used to attach the accelerometer on top of it. It is recommended to attach the accelerometer as near to the top edge of the pile as possible, using an adhesive material (epoxy) as shown in Figure 3-1.

Figure 3-1: Mounting the Wooden Blocks and Attaching the Accelerometers

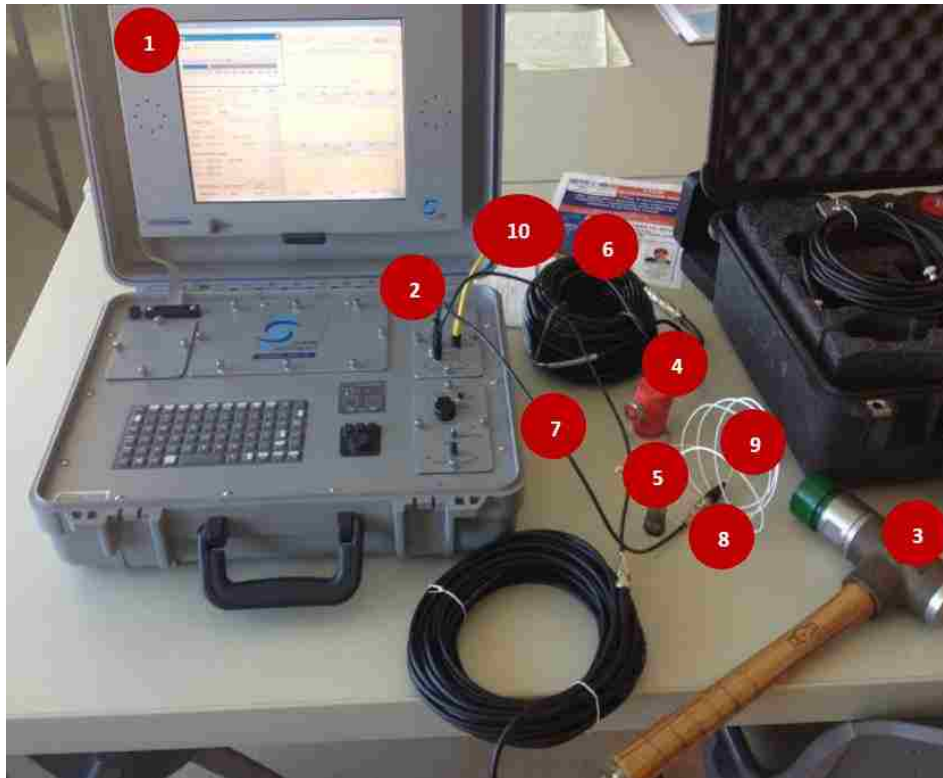
Two types of motion sensors that are used in the SE test are accelerometers or geophones. They exhibit different properties in their high and low frequency ranges. The accelerometer represents more truthful results in the high frequencies, while geophones have low frequency range and there is no need for calculating an integration constant. Empirically, all bridges were tested using accelerometers instead of geophones, because geophones weigh more than accelerometers, which makes the attachment process more difficult (Rausche et al., 1992). The Olson Freedom Data PC system consists of basic components, including a platform for data acquisition, analysis and display. A processor depicts the sonic pulse in both a time domain and a frequency domain on an analog oscilloscope. This acceleration is digitally integrated to the velocity traces, which are then easier to interpret (Hertlein & Davis, 2007). Figure 3-3 provides a list of all the equipment, hardware components, and software used in conducting a SE test.

Figure 3-3: Equipment and Hardware Components Used for SE Test

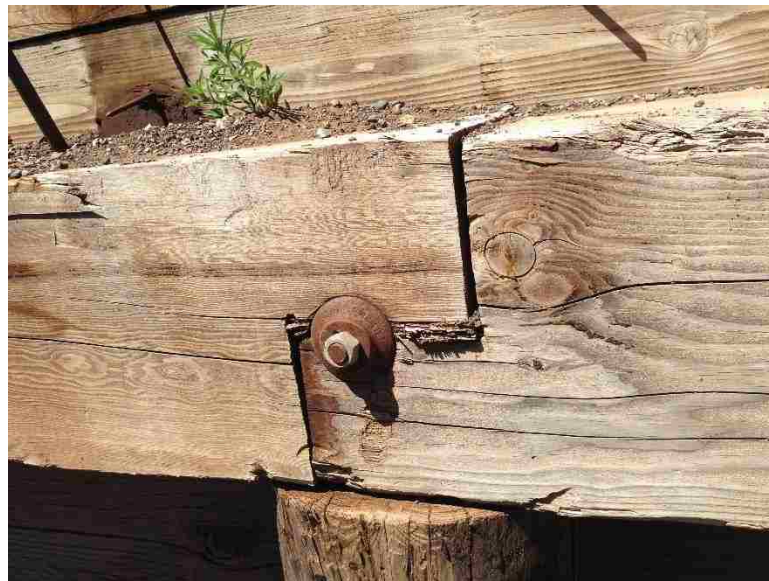
Alternative approaches were used to estimate the sound wave velocity for timber bridge that has joints in the girder, as shown in Figure 3-11.

Figure 3-11: The Joined Girder of Timber Bridge

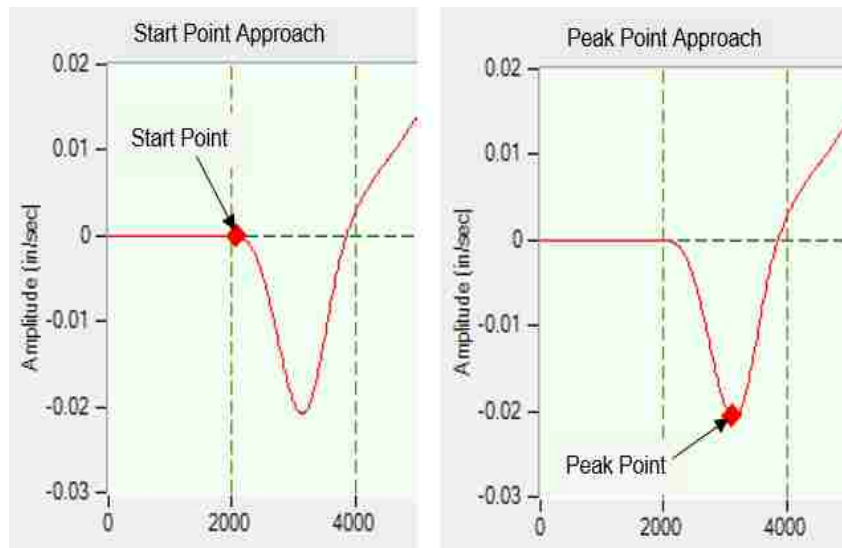
1, then another known distance to arrive at accelerometer 2. The accelerometer senses the signal at a specific time, which is called the start point, as shown in Figure 3-12. Each velocity trace that is obtained from each accelerometer has different start points. The differences between the start points of each graph represents the time need for the propagated wave to travel the distance between the accelerometers. The times are tabulated for every 60 μ s into velocity traces, which allows human error if the start point is selected inaccurately. Instead, the peak point of impulse may be selected as another alternative approach to estimate the wave velocity as shown in Figure 3-12. However, the average of propagated wave velocity into Bridge #1676 piles that are estimated using the start point approach equals 15672 ft./sec, while it equals 14927 ft./sec when the peak points approach is used.

Figure 3-12: Alternative Approaches Used for Estimating the Wave Velocity

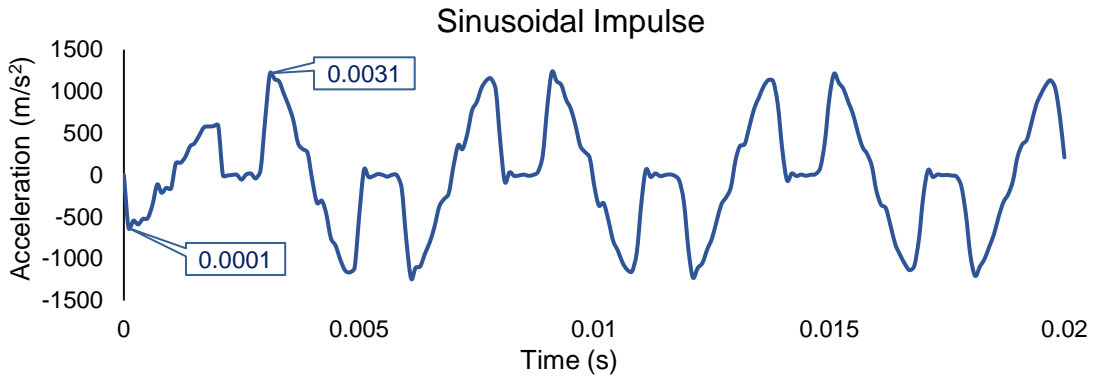
studied; these were sinusoidal, rectangular, and triangular impulses. Figures 4-7 to 4-12 show the acceleration and velocity responses of sinusoidal, rectangular, and triangular impulses, respectively:

Figure 4-7: Acceleration History Response of Node #3901-Sinusoidal Load Shape

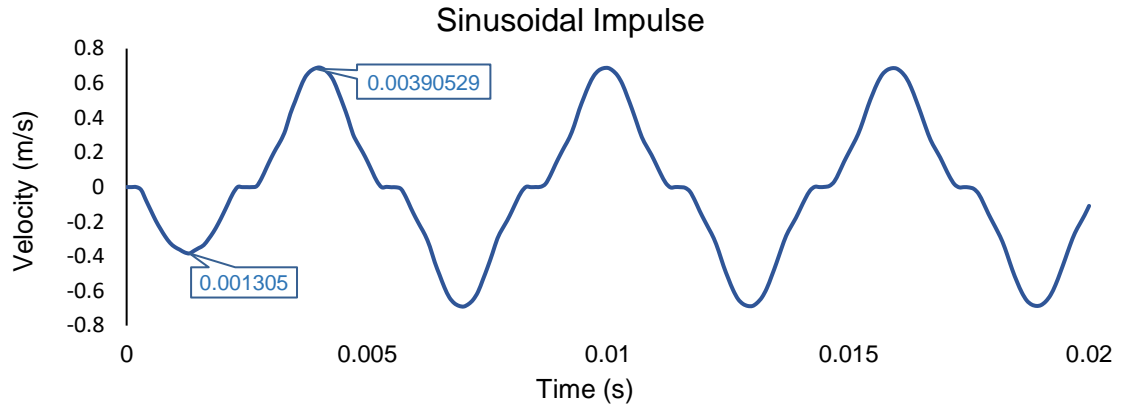
Figure 4-10: Velocity History Response of Node #3901- Sinusoidal Load Shape

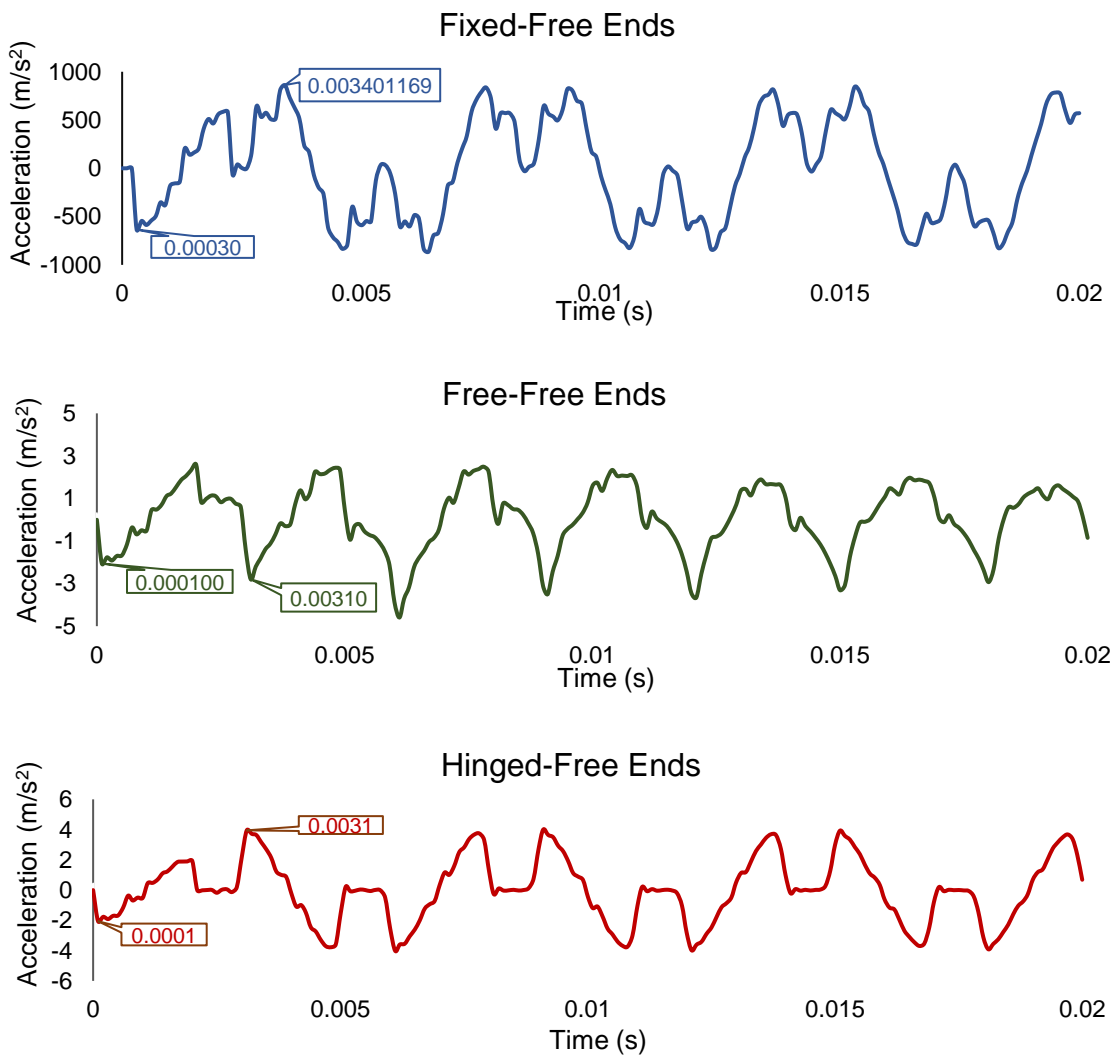
Different boundaries were tested for the column pile model to investigate the influences of boundary conditions on the time lapse of the stress wave as well as the acceleration and velocity traces. Three types of boundary conditions were studied. The first case involved fixed-free ends. In the second case free-free ends were used while node #2629 was fixed to ensure stability of the pile. And the third case used hinged-free ends. Figures 4-13 and 4-14 show the acceleration and velocity responses, respectively, of node #3901:

Figure 4-13: Acceleration History Responses of Node #3901 With Different Boundaries

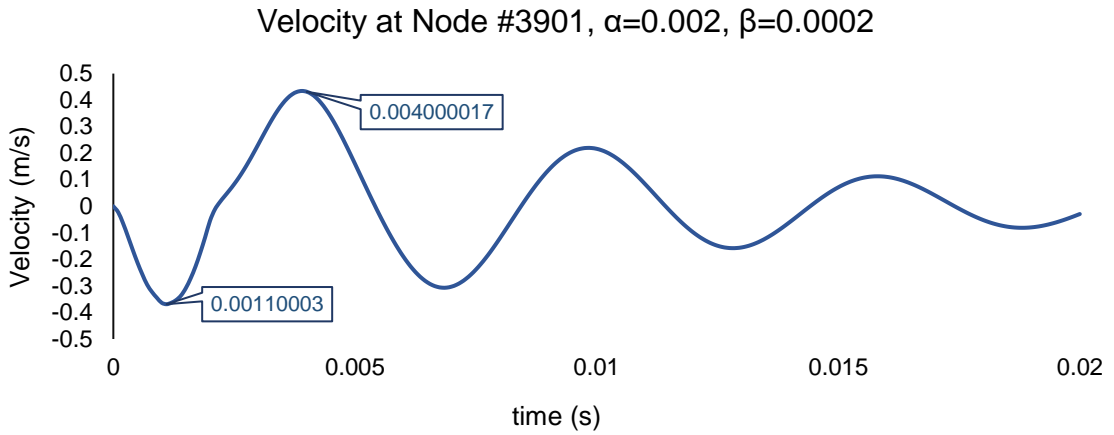
Figure 4-16: Velocity History Response of Node #3901 $\alpha=0.002$, $\beta=0.0002$

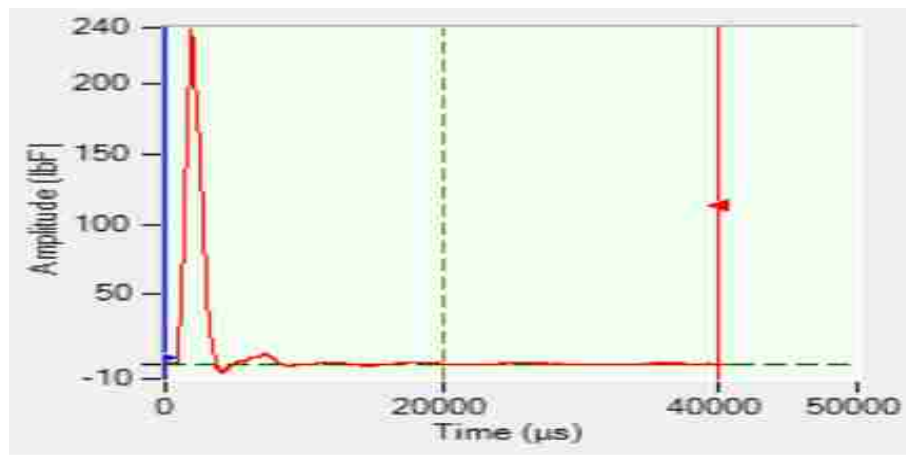
Figure 5-41: Typical Impulse Graph- Shows One Clear Peak

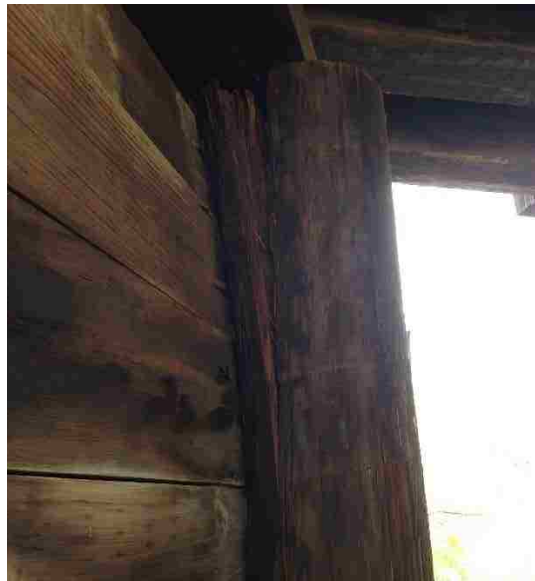
Figure 5-50: Longitudinal Crack Along Pile 14
