# TREE ROOT ENCROACHMENT ON LEVEE DRAINAGE SYSTEM

**TREE ROOT ENCROACHMENT ON LEVEE DRAINAGE SYSTEM**

Master of Science in Civil Engineering

The University of New Mexico  
Albuquerque, New Mexico

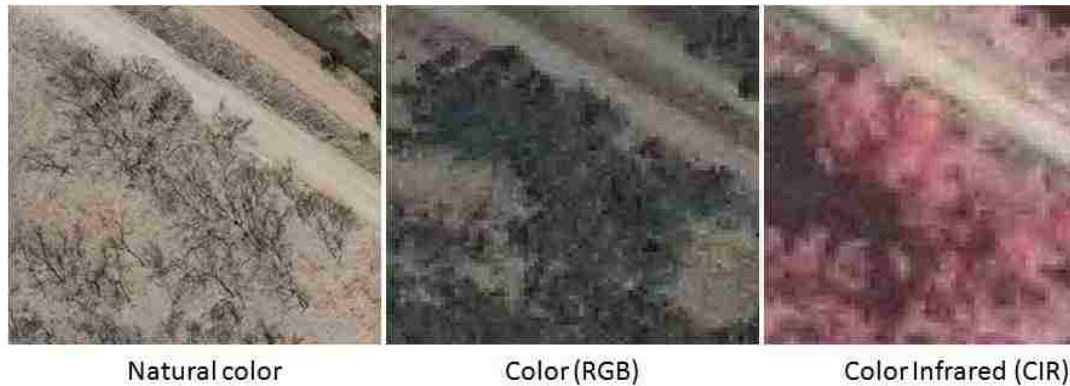
Three different types of aerial photographs were used to measure the tree crown sizes: Natural color, RGB (Red, Green, Blue), and CIR (Color Infrared) as shown in Figure 2.3.

**Figure 2.3 Aerial photographs**

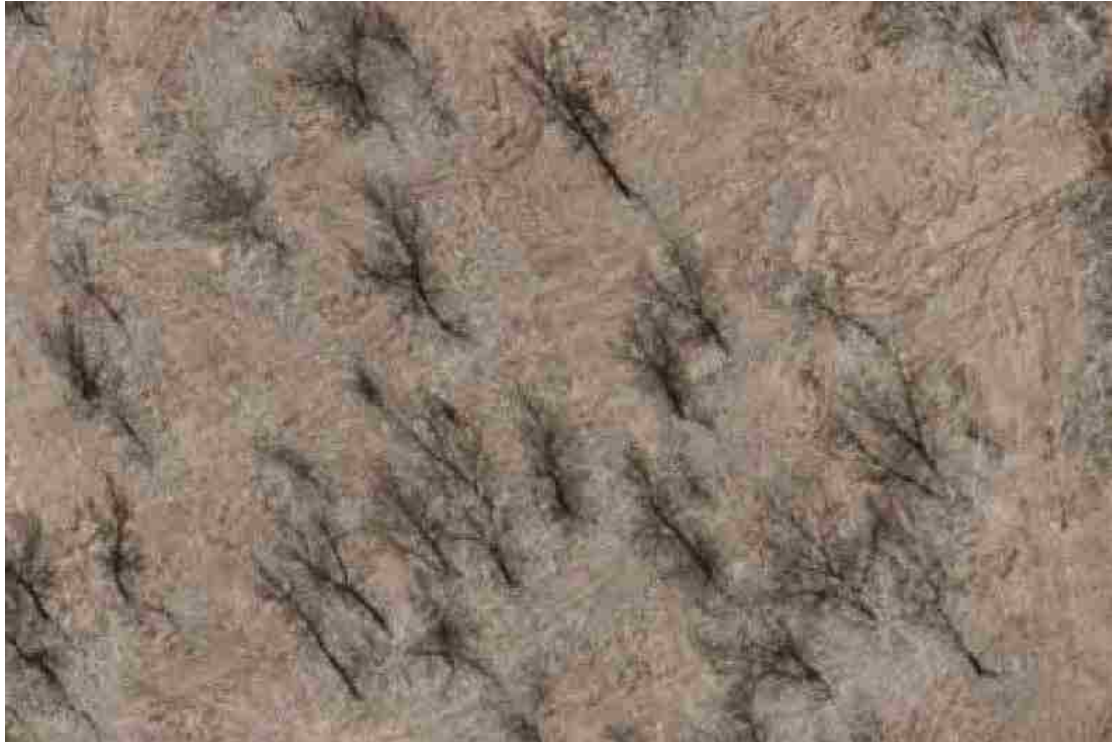
The photographs that depict color digital aerial photographs were acquired in the spring of 2008 prior to leaf-out conditions. The Bernalillo County GIS Program provides high-resolution (2.54 cm x 2.54 cm) aerial photography with natural color to public with no charge. Although the natural color images have good resolutions, it appears as though camera tilts have not been removed. As shown in Figure 2.4, some trees appear to be overturned due to the camera tilt effect. Also, it is difficult to measure crown size on those images as they were collected during the leaf-off season.

**Figure 2.4 Natural color aerial photography. Note that the trees seem to be inclined as camera tilts have not been removed.**

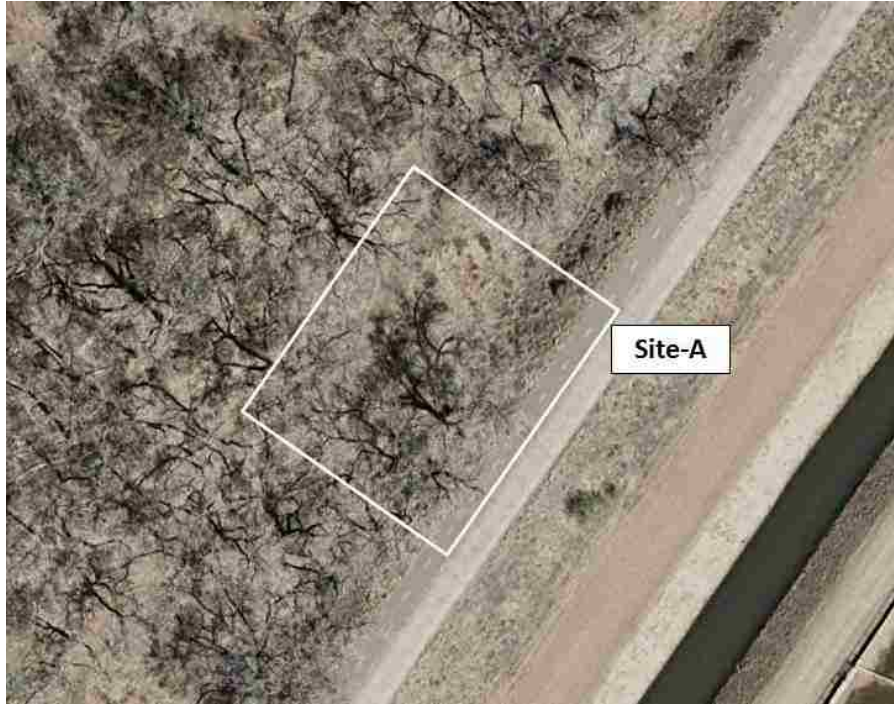
At Site-A (Figure 2.6), which is covered mostly with cottonwoods and willows, it was very difficult to measure individual tree crown sizes due to its complex vegetation community. On the vegetation map (Figure 2.7), it appears as though most understory species grow underneath the cottonwood crowns. However, as the vegetation map was created with average crown size, the actual vegetation coverage and crown shape are not

**Figure 2.6 Natural color aerial photograph for Site-A**

identical to the vegetation map. At Site-A, three cottonwood trees were found in the field measurements, and they had complex crown shapes rather than simple circles. In reality, understory species such as willows were not completely overlaid by cottonwood crown. Siberian elm is not discussed here as it is minority species.

Even though willows are visible on the aerial photographs, the resolution of the photographs was not fine enough to measure small willow crowns. As the field measurement indicates, the average crown size for willow is 0.64 m (Table 2.1). The natural color aerial photography has resolution of 2.54 cm. Despite the fact that the average crown size is larger than the resolution, the photography has camera tilts which make measurement more difficult. In contrast, resolution of RGB and CIR photography was too coarse for the measurement of willow crown size. Consequently, none of the photography was appropriate for the GIS-based crown size measurement for Site-A.

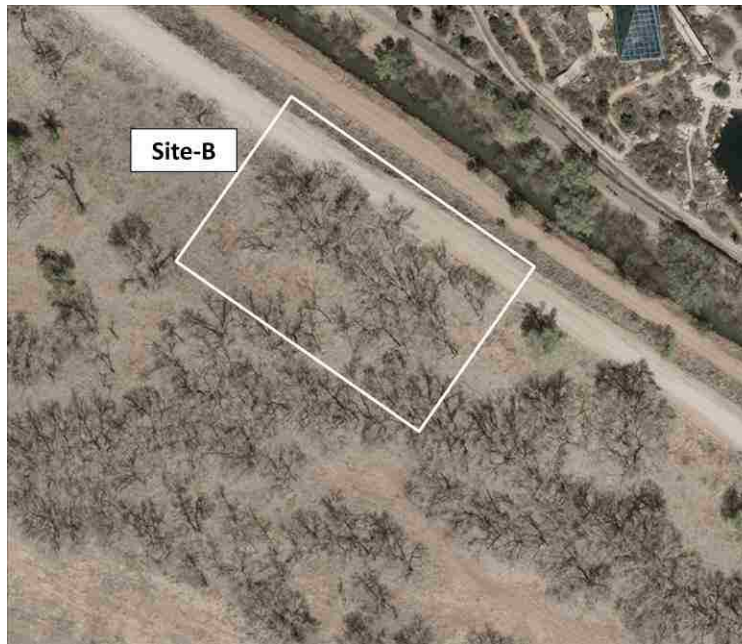
In contrast to Site-A, Site-B has simple vegetation community with cottonwood and fewer understory species. Understory species are mostly found underneath the cottonwood crowns; thus those understory plants are not visible on the aerial photography. Tree crown sizes were measured on the aerial photography with the ArcGIS measurement tool. In the field measurements, 8 cottonwoods were found in total. Table 2.3 shows the comparison of two measurement methods. The GIS-based average crown radius was 1.22 m larger than that of field measurement. It appears as though shade and camera tilts made it difficult to distinguish the edges of tree crowns. The difference in estimated tree crown size resulted in a 2.13 m difference of the horizontal extent of root system. Although small cottonwoods were not detected on the GIS-based measurement it is more important to understand the root systems of larger trees as they would be

Figure 2.8 Natural color aerial photographs for Site-B

expected to be larger, and likely have a greater horizontal extent. Thus, at this site, the GIS-based measurements provided a reasonable estimate of tree crown radius. Using equation 2.2, four cottonwoods have root systems that reach the levee.

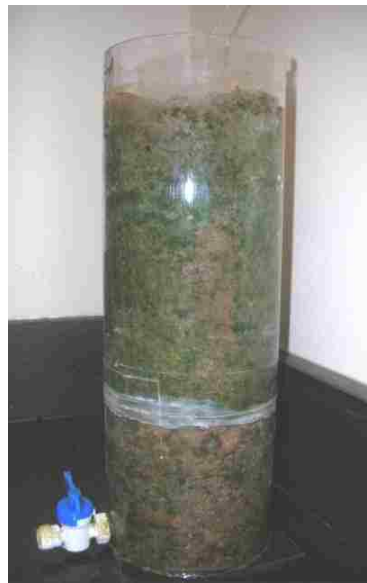
**Figure3.2 Photograph of experimental column**

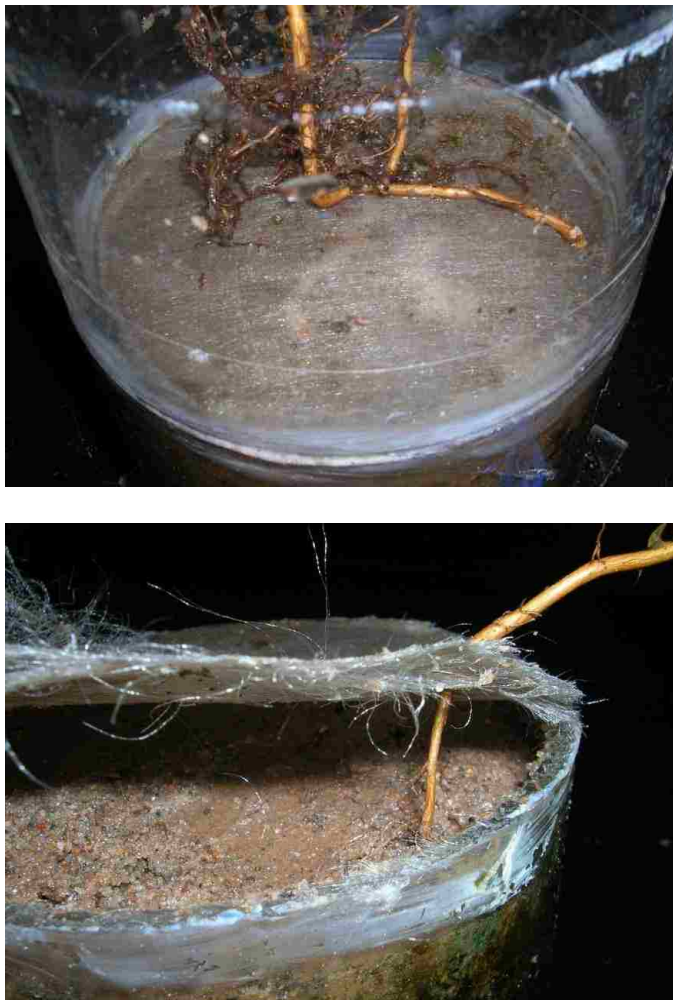
Even though the water table was lowered to create air gap, roots can continue growing through gap in response to gravitropism and thereby breaking through the root barriers. The estimated total root lengths seemed to be unrelated to the drainage material or root barriers. After bridging the gap to the water table, root proliferation generated a full root system and equalized root growth in upper and lower chambers.

**Figure 3.4 Photograph of root growth through geotextile**

\*The drainage material was sand, and the root barrier was the 4 oz geotextile.

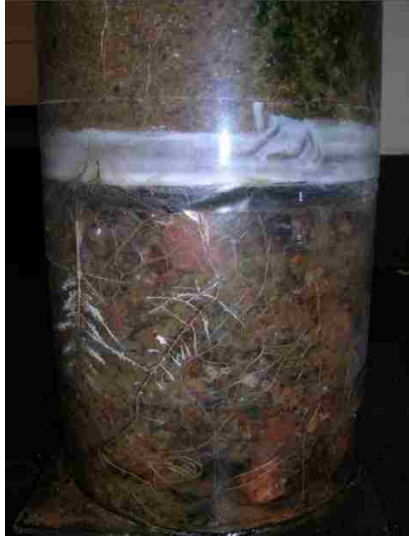
The second reason for low survivability is that some roots did not grow into lower columns. In many columns, some roots grew between the root barrier and the column wall (Figure 3.9). As willow roots are much finer than cottonwood, some root found a small gap along the column wall and the root barrier. When the columns were built, 30 cm of acrylic columns were first cut into two pieces to insert the root barriers, and they

**Figure 3.9** Picture of root system grow found outside of the column

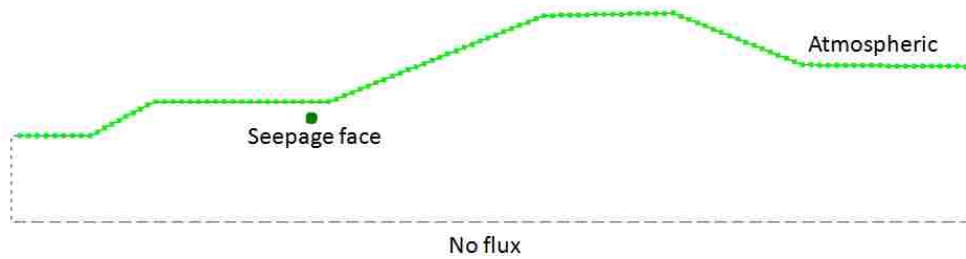
**Figure 4.8 Boundary condition for ambient condition**

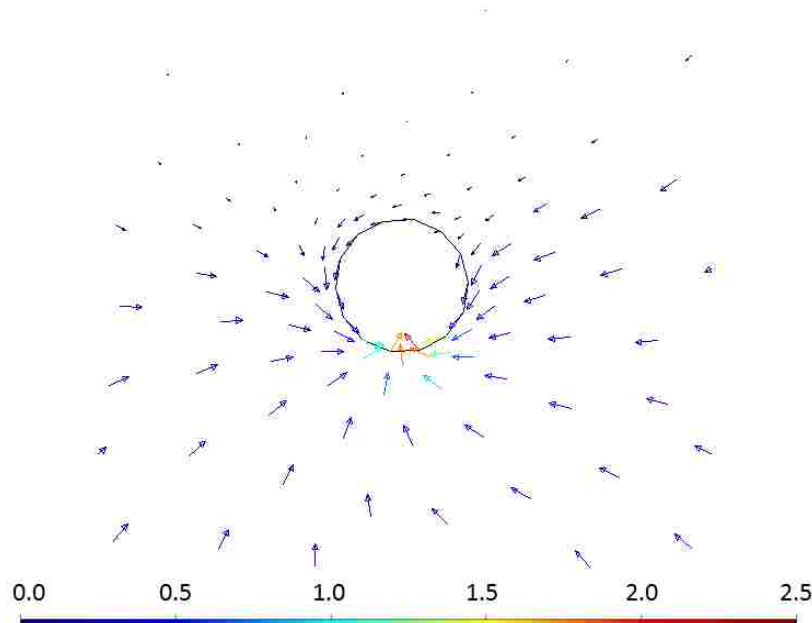
**Figure 4.15 Water flow velocity near toe drain, day=30, m/day**

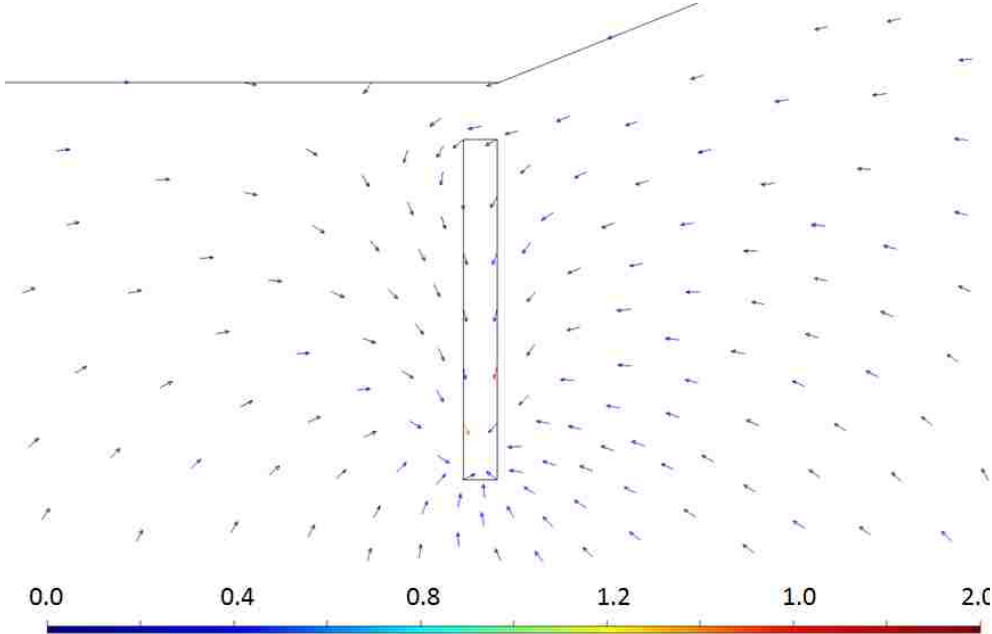
Figure 4.17 shows the result of the simulation with the geocomposite edge drain when the riverside is flooded. With the geocomposite edge drain, the drainage area did not have as great of moisture content as did the model with the conventional toe drain. The drainage area refers to the area on the right side of the edge drain which is filled with coarse drainage materials (gravels). The bottom of the drainage area has water content of approximately 0.35, while water content of the same area was about 0.4 in the levee with the toe drain system. As shown in Figure 4.18, water is drained through the entire seepage face.

Figure 4.18 Water flow velocity near edge drain, day=30, m/day

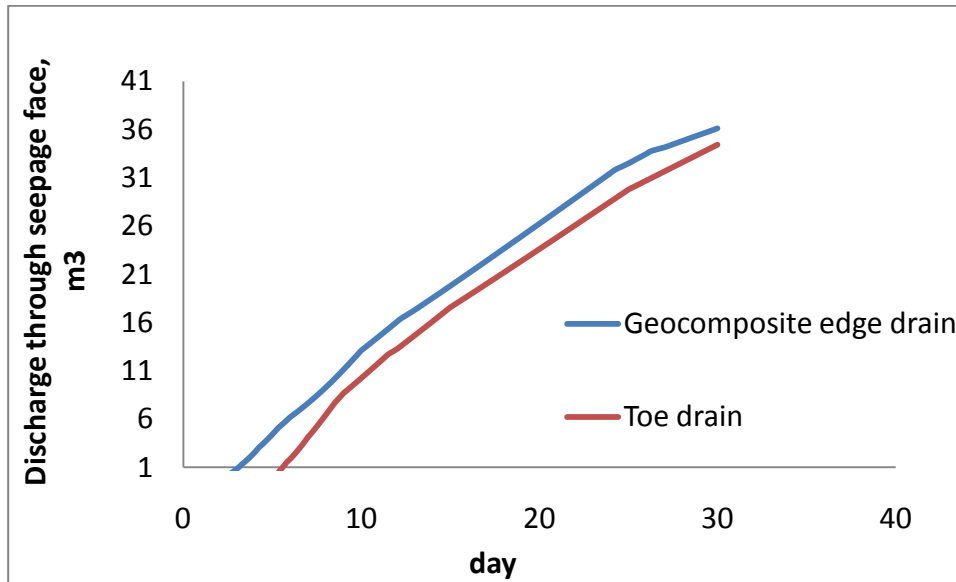
In these simulations, the geocomposite edge drain could remove excess water from the levee slightly faster than the conventional toe drain (Figure 4.20).

**Figure 4.20 Cumulative discharge through the seepage faces**

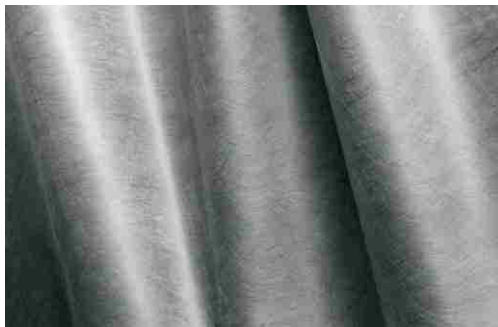
Material: nonwoven polypropylene geotextile fabric, water permeable

**Figure A-1 Geotextile**

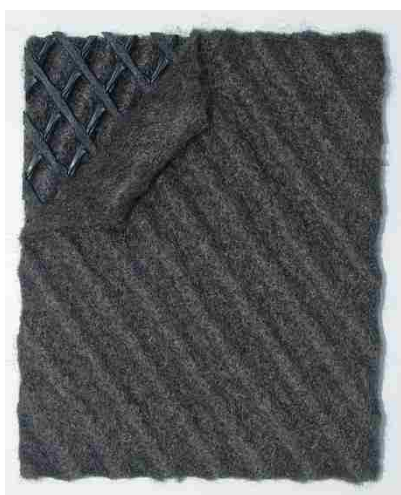
Material: The geotextile is bonded to the geonet with a hot knife application allowing for high bond strength without the reduction of transmissivity values of other processes

**Figure A-2 Geocomposite**

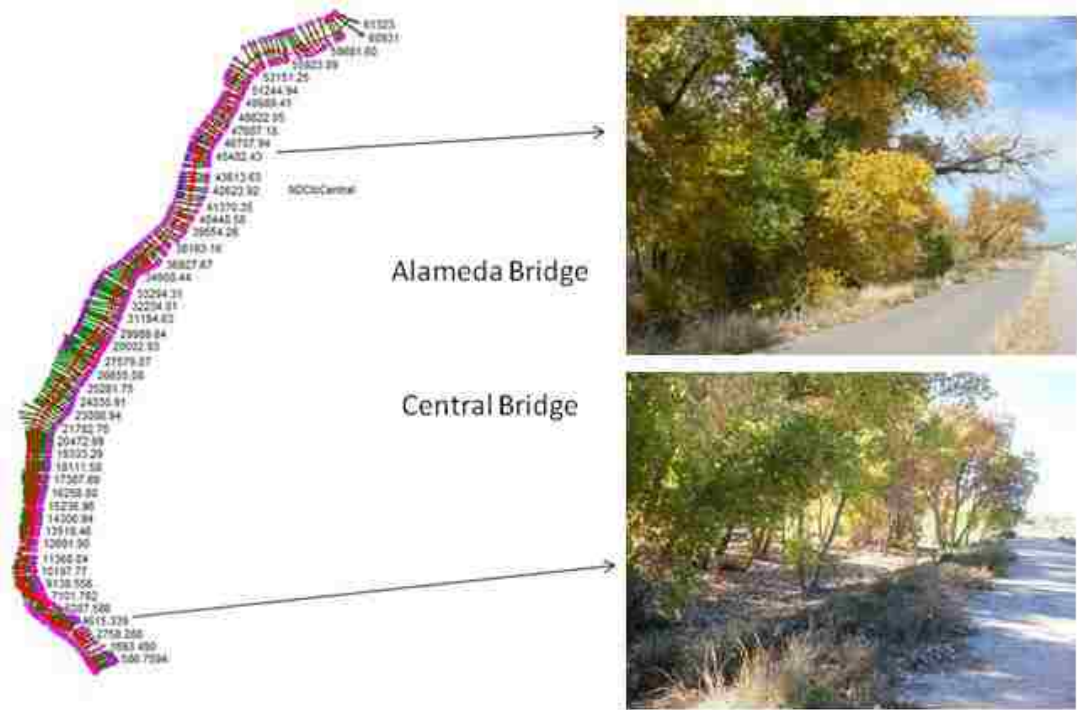
**Figure D- 2 Cross sections**

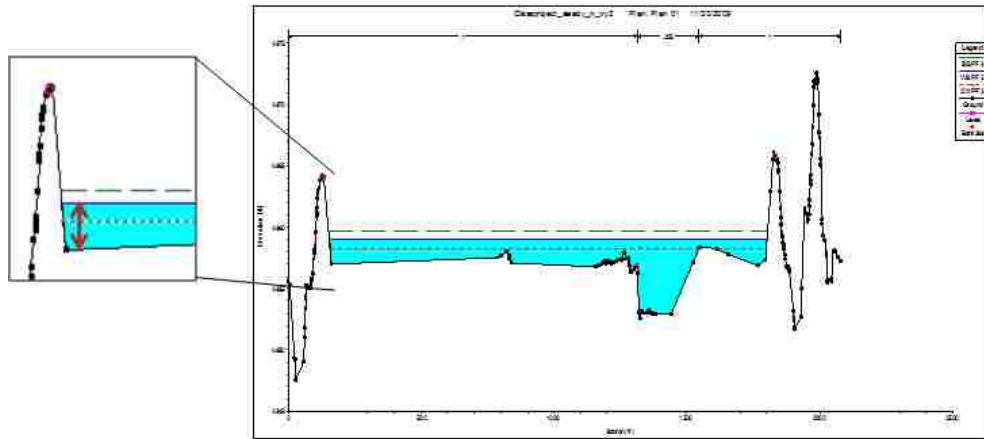
side of the main channel was very similar, it was measured at only right side.

**Figure D-3 Flood depth measurement**

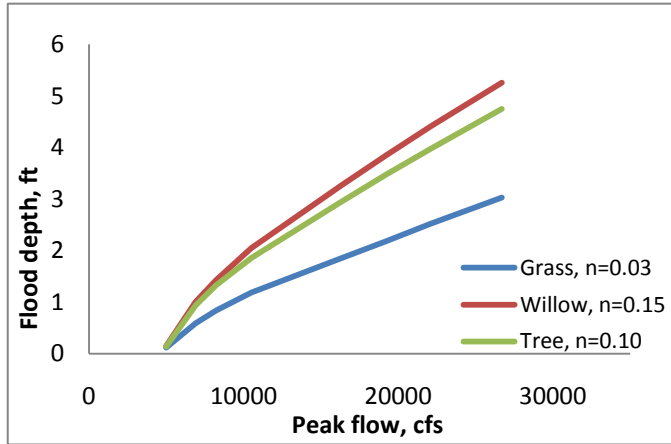
riparian corridor is covered thoroughly with tree. If it is covered with grass, instead of trees, the maximum flood depth would decrease to approximately 1 ft.

**Figure D-4 Flood depth at the central cross**
