# Manufacturing and Preliminary Testing of a Subscale Suspension Boat

A Thesis

in Candidacy for the Degree of Master of Science

in Mechanical Engineering

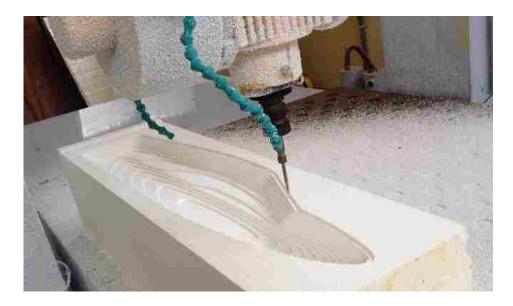
Fig 2.3 EPS mold where rough milling has been completed and finish

milling has just begun.

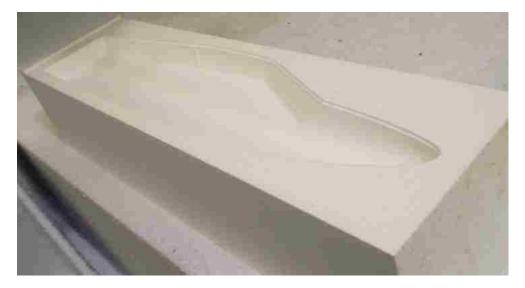
Fig 2.4 EPS mold with offset error. The error was fixed before the final

molds were machined.

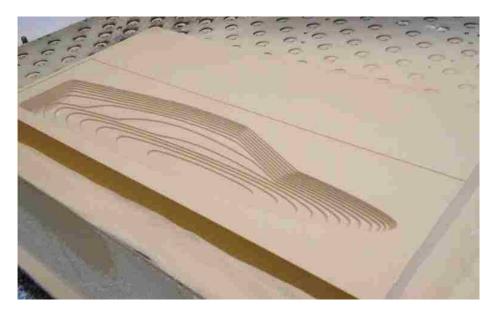
Fig 2.5 Rough milling completed on General Plastic tooling board

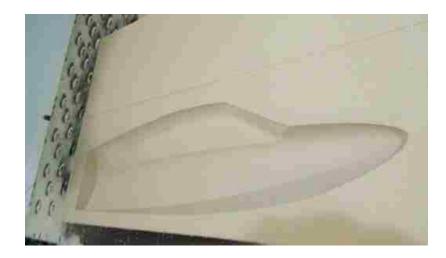
Fig 2.6 Finishing-milling completed on General Plastic tooling board

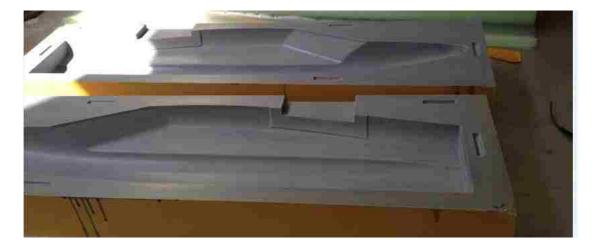
Fig 2.7 Finished molds.

Epoxy was brushed onto the molds in order to get a strong and stiff surface. Before brushing, cleaning the mold is necessary in case contaminant roughs the mold. The mold was thoroughly wiped by acetone. Epoxy (MGS L285 and H287) was mixed properly and then a small amount of blue chalk was added. The blue chalk helps gauging the thickness of the epoxy coat. The epoxy was gently spread with a squeegee and the redundant resin was wiped off with paper towels to make sure there was a uniform thin layer of epoxy on the mold surfaces. The epoxy was left to cure for 8 hours. After it cured, the surfaces were sanded with 1000 grit sand paper and cleaned with acetone. The same procedure was repeated twice to make a good mold surface.

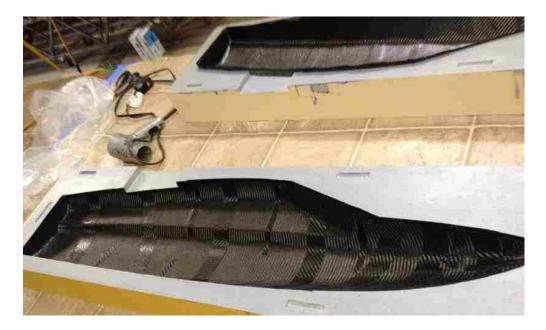
Fig 2.10 First layer laid as well as local reinforcements

Fig 2.10 shows the local reinforcements between layer one and layer two. The wide strips were the reinforcement strips which formed a strong web frame. The narrow strips were used to prevent cover slots cut to fit curvature surfaces.

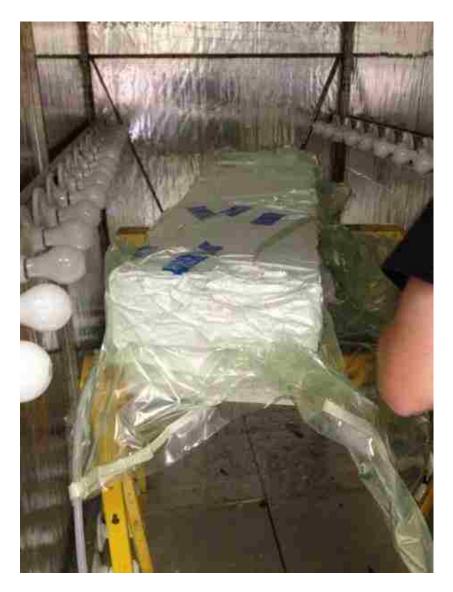
After closing the molds, the outside of the mold was wrapped with breather and envelope bagged. The envelope vacuum bag was sealed to the internal bag to allow atmospheric pressure into the latter. The sealed mold is shown in Fig. 2.12.

Fig 2.12 Vacuumed molds inside the oven, ready to be cured

The envelope bag was checked to be sealed perfectly before going into the oven. Because the pump was continuously working throughout the heating procedure, a high-temperature Teflon vacuum hose was used inside the oven. Outside the oven a less expensive nylon tube was used. The part was cured at 85+/-5 C for 24 hours.

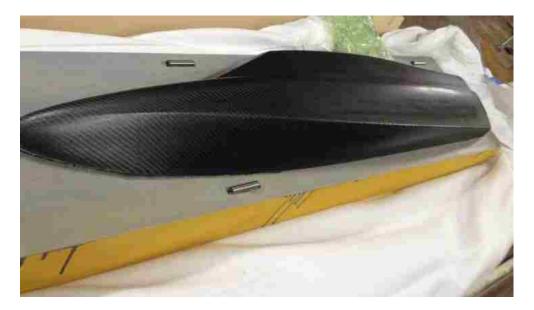
After getting rid of all the redundant materials, a carbon fiber hull was successfully made, Fig. 2.13.

Fig 2.13 Hull still in one of the mold halves.

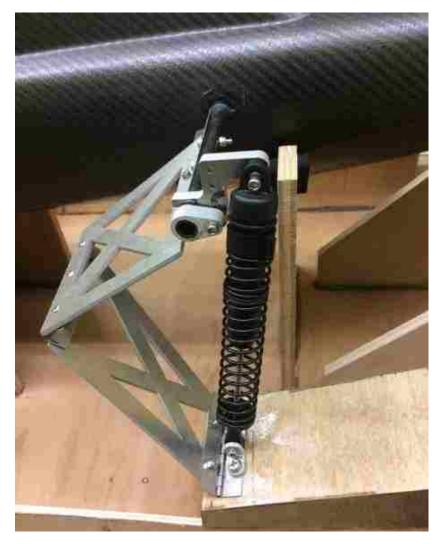
Fig 3.6 Shock assembly

The shocks were connected onto the sponsons and the center fuselage, Fig. 3.6. The springs used were chosen to provide the designed attitude of the boat when running.

The full stroke was 45 mm, 30% stroke was 13.5 mm. The spring rate of the spring was 1570 N/m. During operation of the suspension boat, the weight is carried near the transoms of the four sponsons. The weight on each sponson in this configuration is approximately 2.5kg. So the spring will shrink 15.6mm, which is acceptable.

When the boat was tested, it was found that the damping factor of the shocks were too large. The solution was to reduce the amount of shock oil inside the shock and to use a lighter (lower viscosity) shock oil (Mugen super silicone shock oil #200).

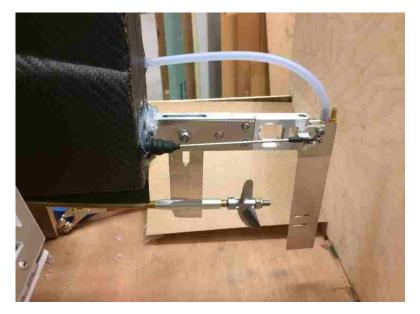
A strut and rudder assembly was purchased from a hobby shop (Fig 4.1). A skeg was attached at the bottom of the strut. The strut is attached to the transom of the

Fig 4.1 Strut and rudder

While moving, due to dynamic pressure, water flowed into the hole drilled on the rudder. A silicon tube transported the water from the rudder (Fig 4.1) and sent it into ESC. From there, he water exiting the ESC was then sent into the motor

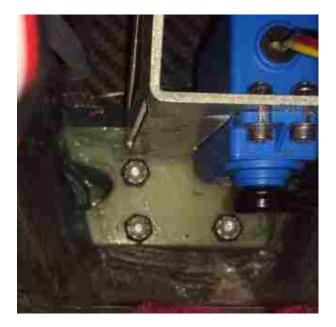
hull by four screws. In order to strengthen the transom, a piece of G-10 board was bonded on the inside of the transom as shown in Fig 4.2. The screw holes were sealed with silicon. The rudder is rectangular (32mm×125mm). In water tests, the boat displayed poor maneuverability, which will be discussed in later sections.

Fig 4.2 G-10 reinforcement

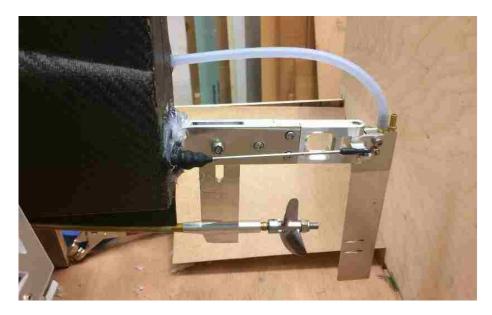
Fig 4.6 Servo linkage

The servo was installed on an aluminum shelf which was attached to the rear carbon fiber tube and the transom (Fig 4.5). The servo arm was connected to the rudder by a steel rod with a ball linkage (Fig 4.6). A rubber bellow was bonded on transom to make the hole where the rod goes out water-proof.

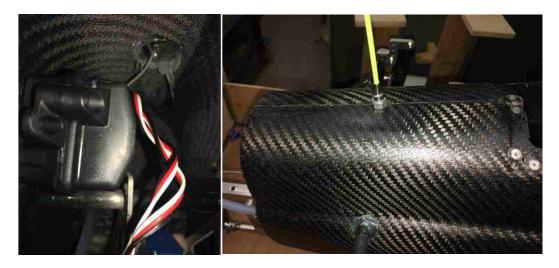
The receiver was used to receive signals from the transmitter and deliver them to the ESC and the rudder. It delivers pulse width modulated (PWM) signals to the servo and the ESC to control the direction and speed of the boat. The receiver was installed on the roof of the boat and the antenna went out of the roof in a plastic tube (Fig 4.7).

Fig 4.7a Receiver

Fig 4.7b Antenna

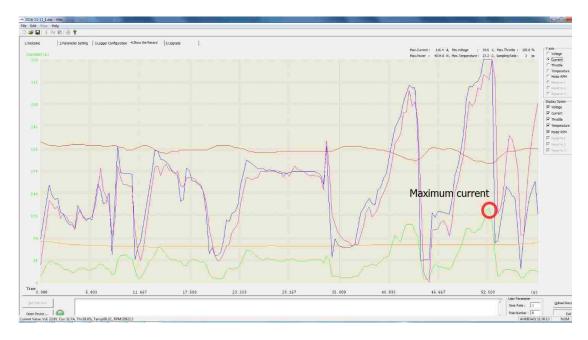
The data collected by the ESC are shown in Fig 5.1. In which the data were represented in different colors (Red – Voltage, Green – Current, Blue – Throttle, Yellow – Temperature, Pink – Motor RPM). General data are shown as Table 5.1

Fig 5.1 Comprehensive data

Max Current (A)	116
Max Power (W)	3030
Min Voltage (V)	34.6
Max Temperature (C)	27
Max Throttle (%)	100
Max Motor RPM	22300

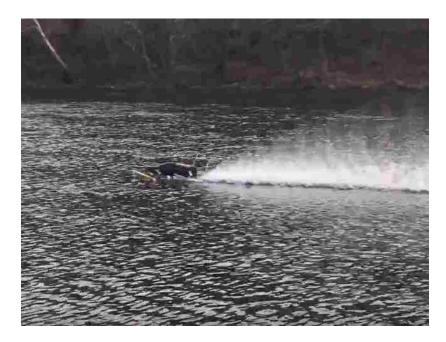
From the video it appears that when the boat was running at full throttle the front sponsons were up in the air, which indicates that it may be beneficial to move the center of gravity forward (Fig 5.3).

Fig 5.3 A screenshot from testing video. Note lack of spray and wake from the left

front sponson.

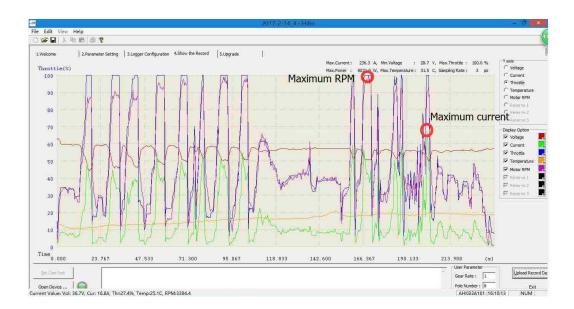
The data collected by the ESC are shown as Fig 5.4. In which the data were represented in different colors (Red – Voltage, Green – Current, Blue – Throttle, Yellow – Temperature, Pink – Motor RPM). General data are shown in Table 5.3

Fig 5.4 Comprehensive data

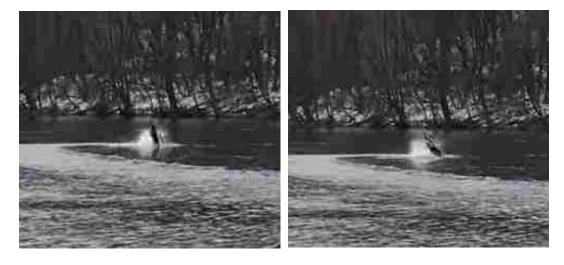
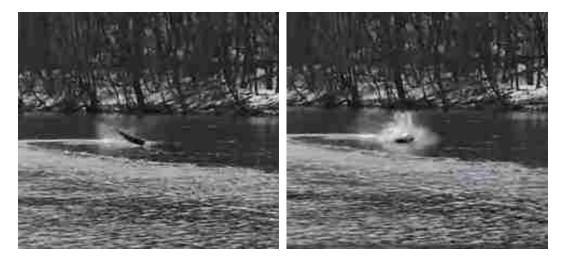
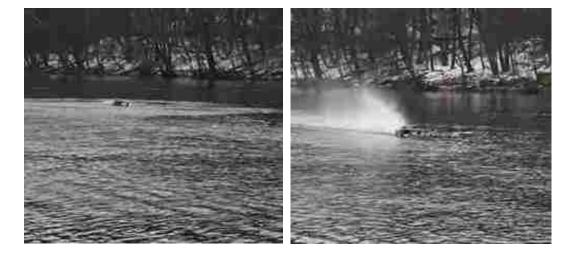
During the third test, when the boat was launching with a full throttle, the high pitch moment flipped the boat upside down (Fig 5.6), smashed on to the water, and broke the front reinforcing rod. However, the boat flipped back and still finished two full throttle dashes.

The boat rolled over quite a few times without damage. However, during the last run it flipped over backwards and broke a suspension strut. Everything else has held up well on the boat.

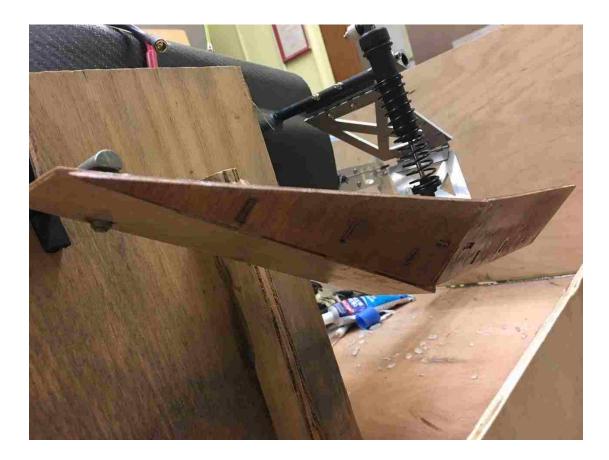
2) Installing deflectors on the side of the rear sponsons. When the boat is making a turn, the intent is that the deflectors will help the rear of the boat to slide sideways (Fig 6.2).

Fig 6.2 Deflectors on the rear sponsons
