# Laboratory Fatigue Evaluation of a Full Scale Steel Orthotropic Bridge Deck with Round Bottom Ribs and Fitted Floor Beams

A Thesis

Structural Engineering

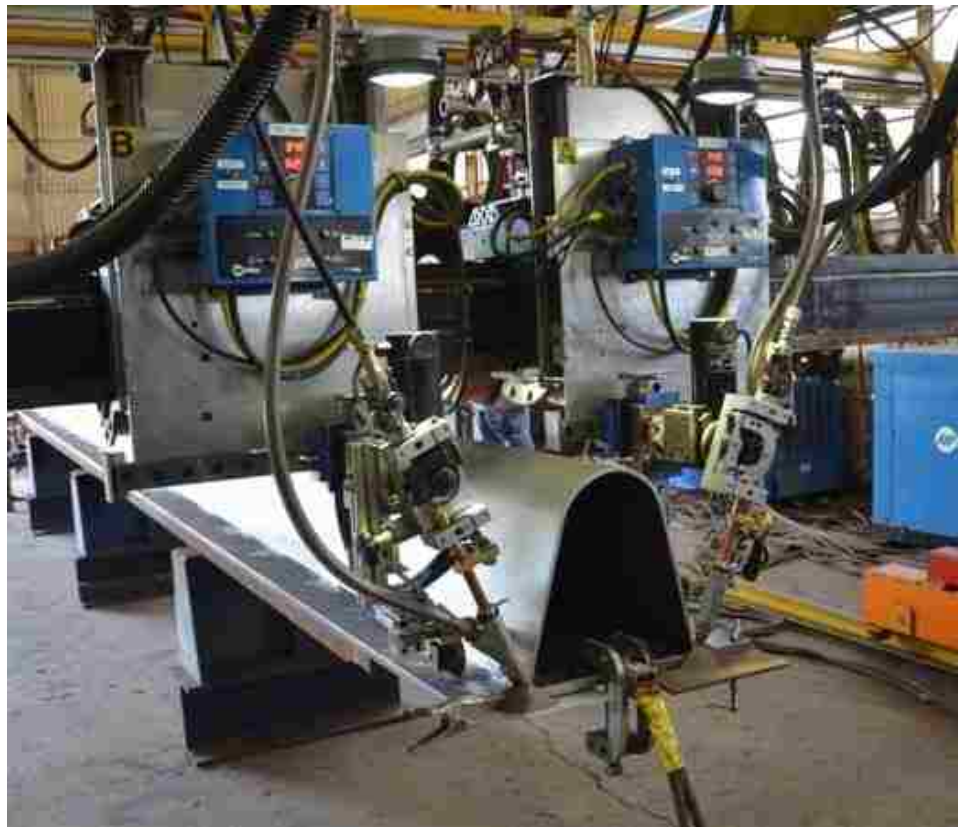
**Figure 98** Rib-to-deck plate welding procedure (not showing prototype deck fabrication)

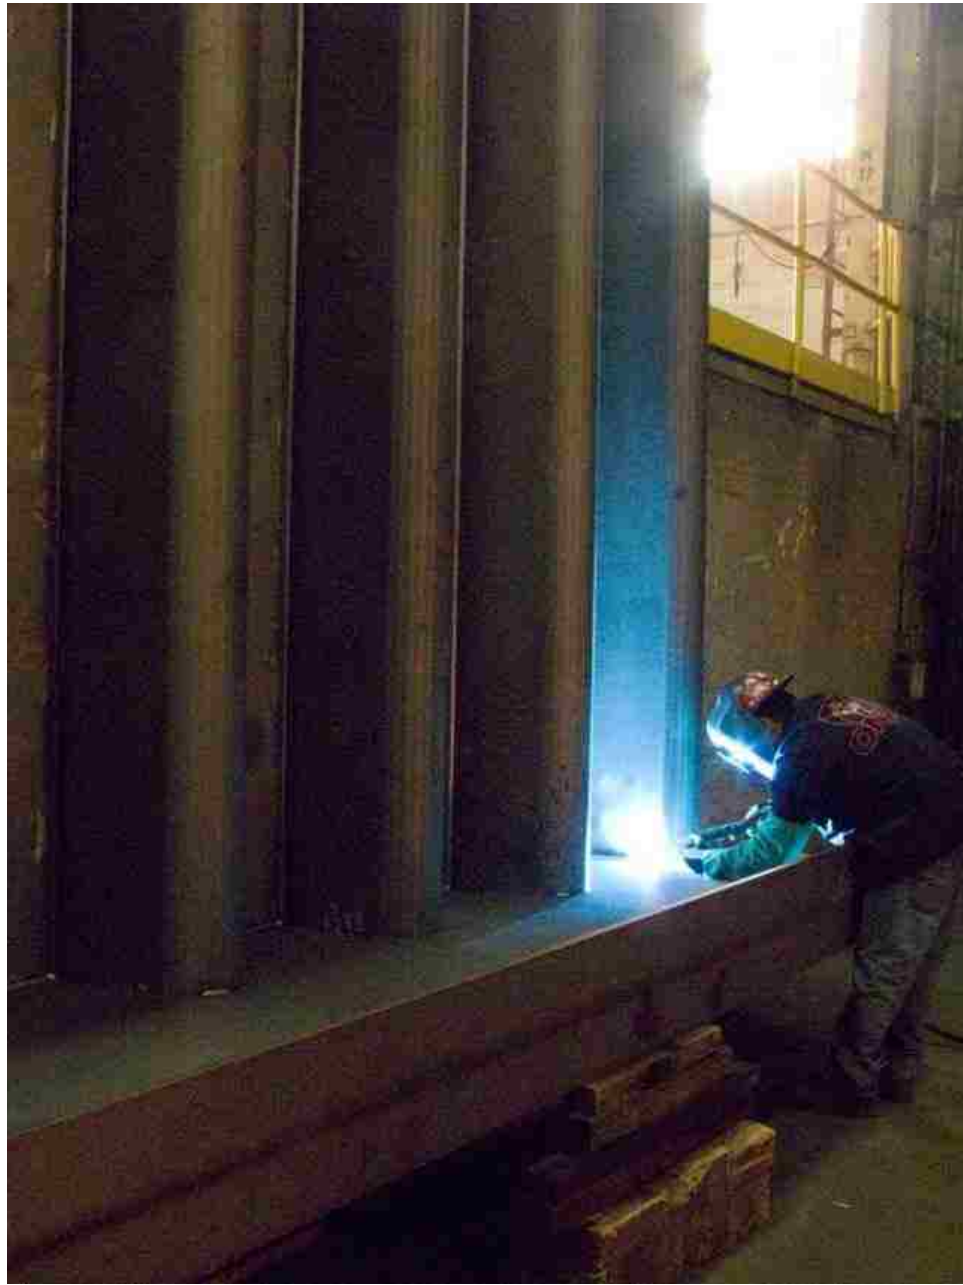
**Figure 101 Rib-to-floor beam welding in 2F position**

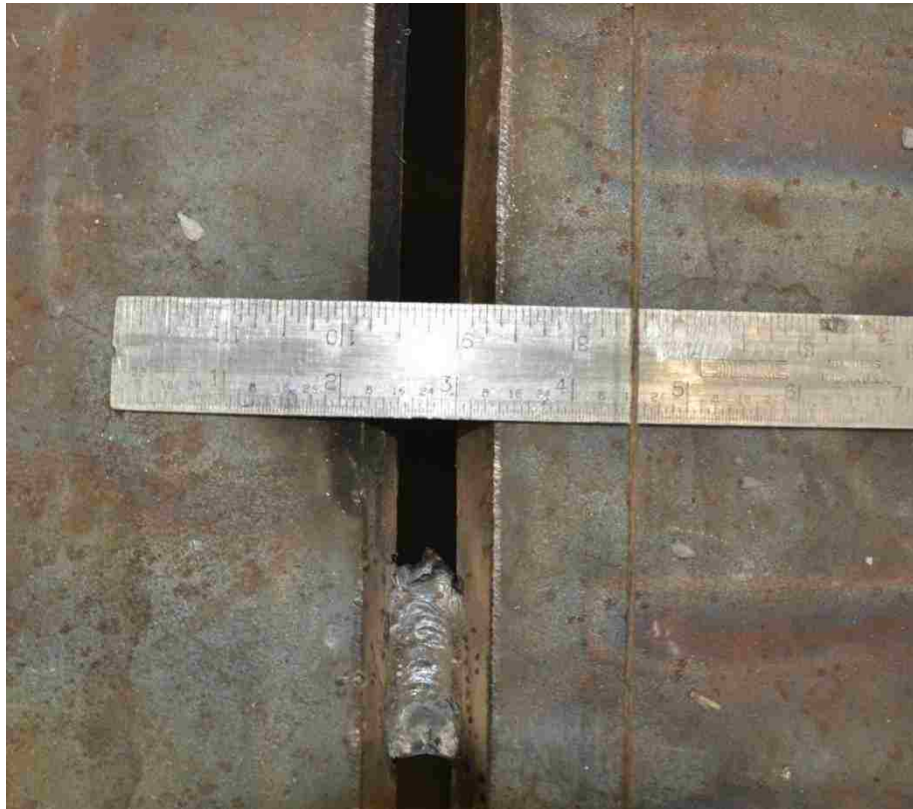
**Figure 111** Maximum root gap of 1/2 in.

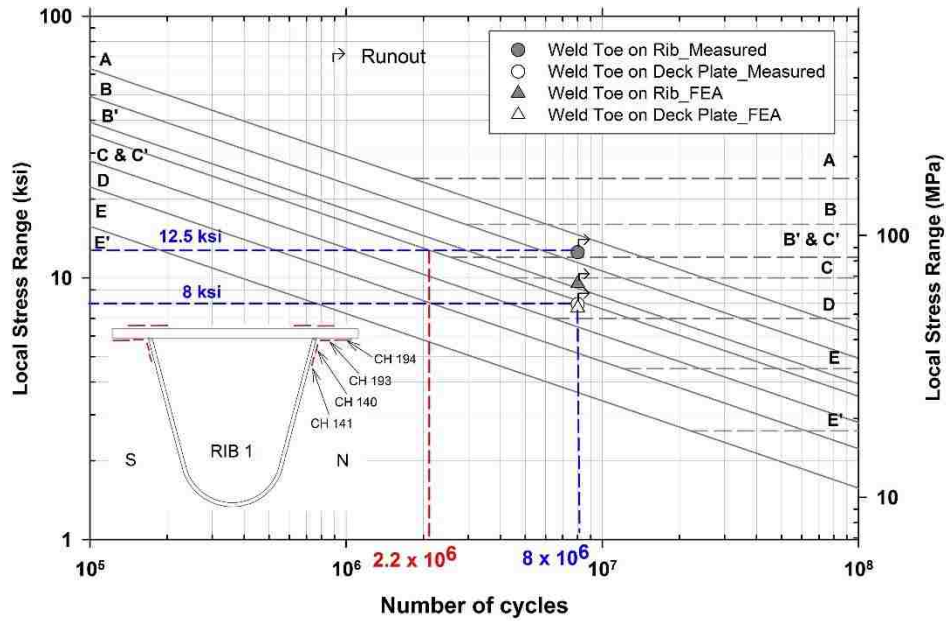
Figure 217 Assessment of fatigue performance of rib-to-deck plate connection at section Z-Z
