Investigation of the impact of environmental conditions on field welding of precast concrete connections

Investigation of the Impact of Environmental Conditions
on Field Welding of Precast Concrete Connections

A Thesis

Master of Science

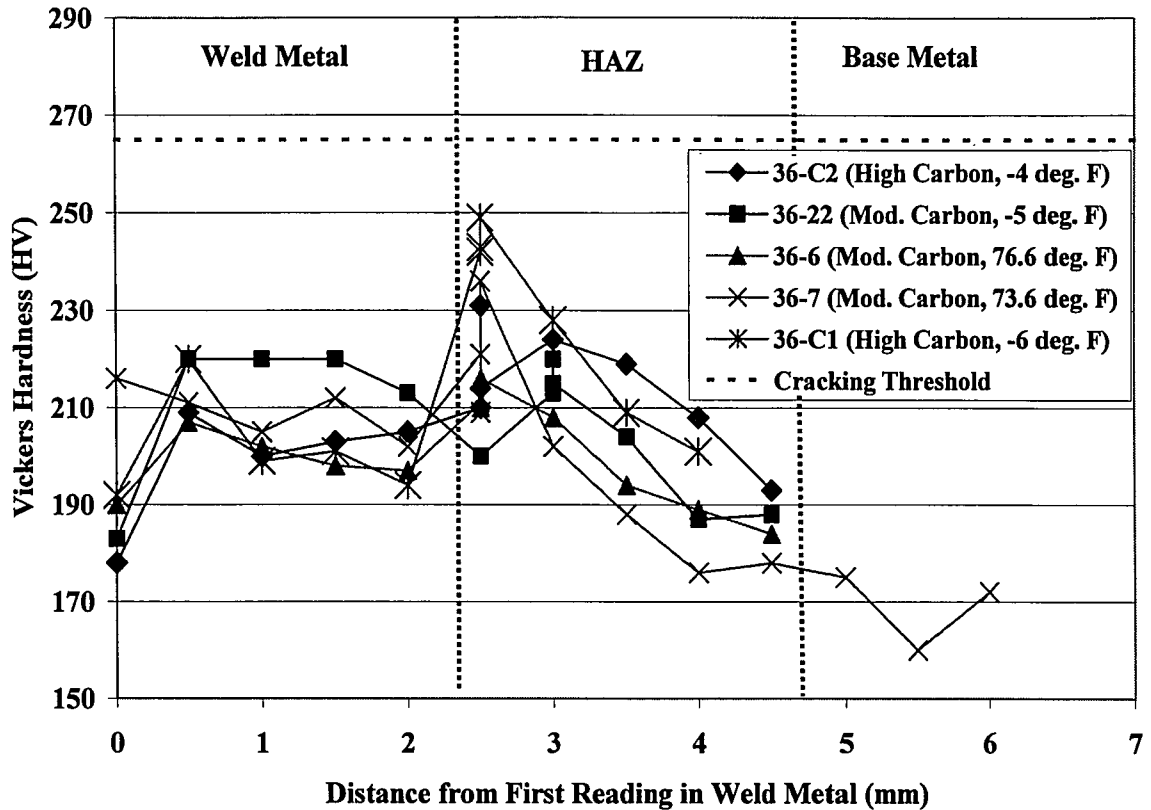
Figure 4.47: Plot of Vickers Hardness From Microhardness Tests

The values from the hardness measurements for all five specimens listed above are depicted graphically in Figure 4.47. The approximate crack-susceptibility threshold of 265 HV is indicated on the figure, as well as the approximate zones (weld metal, HAZ, and base metal) for the tested specimens.
