Horizontal shear capacity of composite concrete beams without interface ties

A Thesis

Structural Engineering

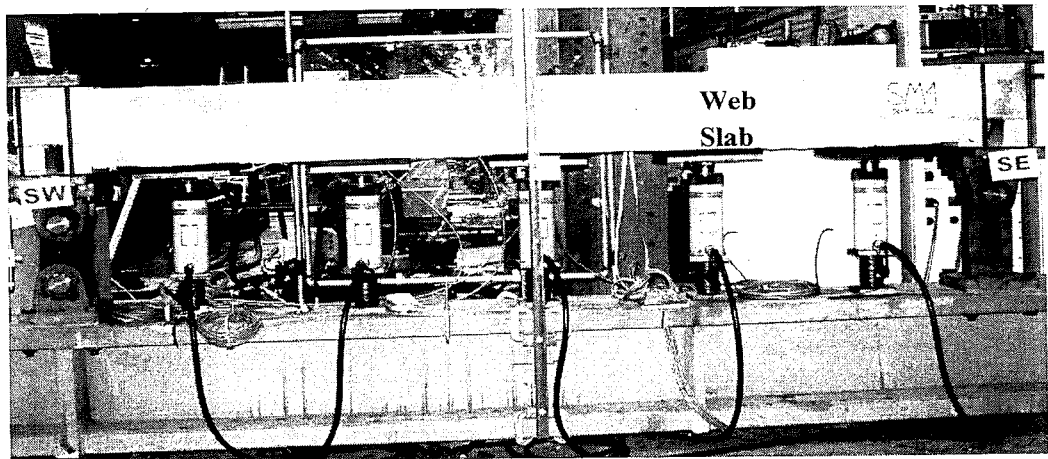
Figure 5-7: Five Point Load Configuration

The beams were inverted and placed in a simply supported self-reacting test setup. Two or five equal loads were then applied at a quasi-static rate to the specimens through the use of thirty ton jacks serviced by a single hydraulic pump (Figure 5-7 and Figure 5-8). The applied load was paused every five kips in order to inspect the beam and the composite interface. The test was stopped once the specimen failed.

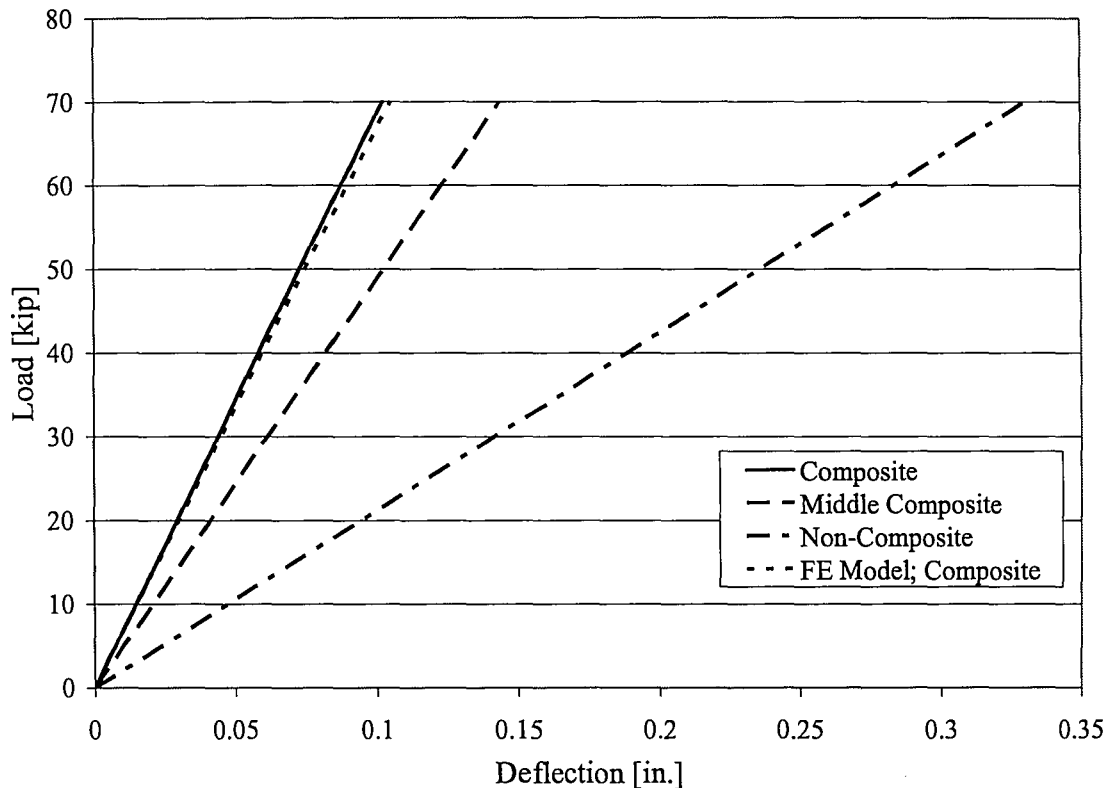
Figure 9-3: Calculated Composite, Middle Composite, and Non-Composite Deflection
