Evaluation of an Enhanced Steel Orthotropic Bridge Deck for Temporary Interstate Applications

A Thesis

Structural Engineering

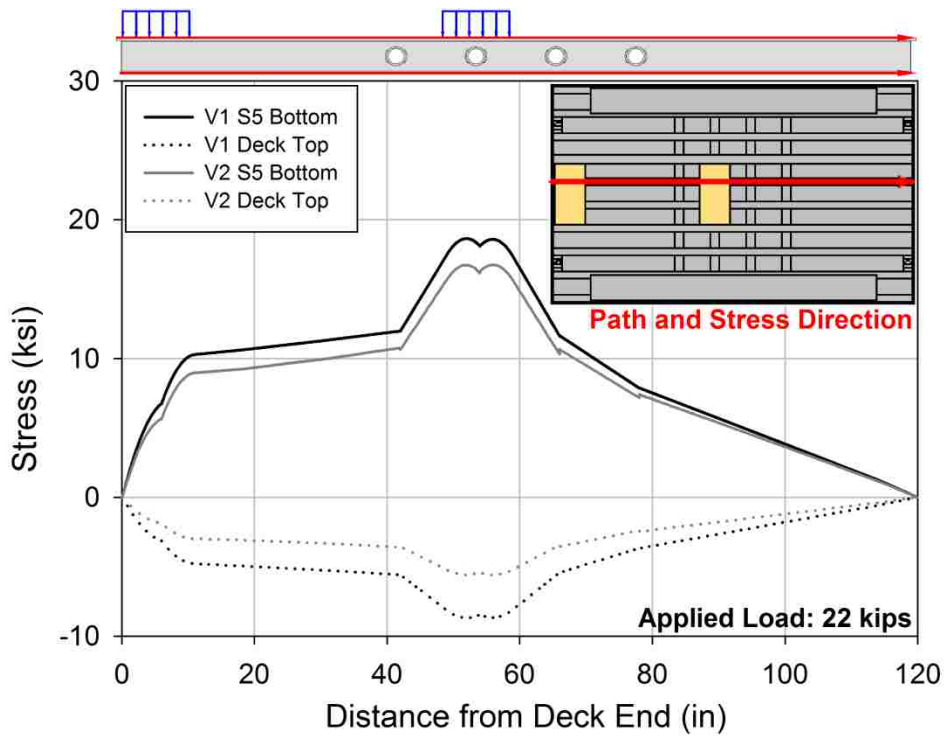
Figure 22. V1 and V2 grillage stress along top and bottom of S5

The stresses along the bottom soffit of the stringer and at the top of the deck plate along the centerline of S5 are presented in Figure 22. Along the bottom of S5, the stresses found in the V1 grillage analysis were reduced by 10% to 15% in the V2 grillage analysis. The largest stress reduction occurred between the interior and exterior load pad.

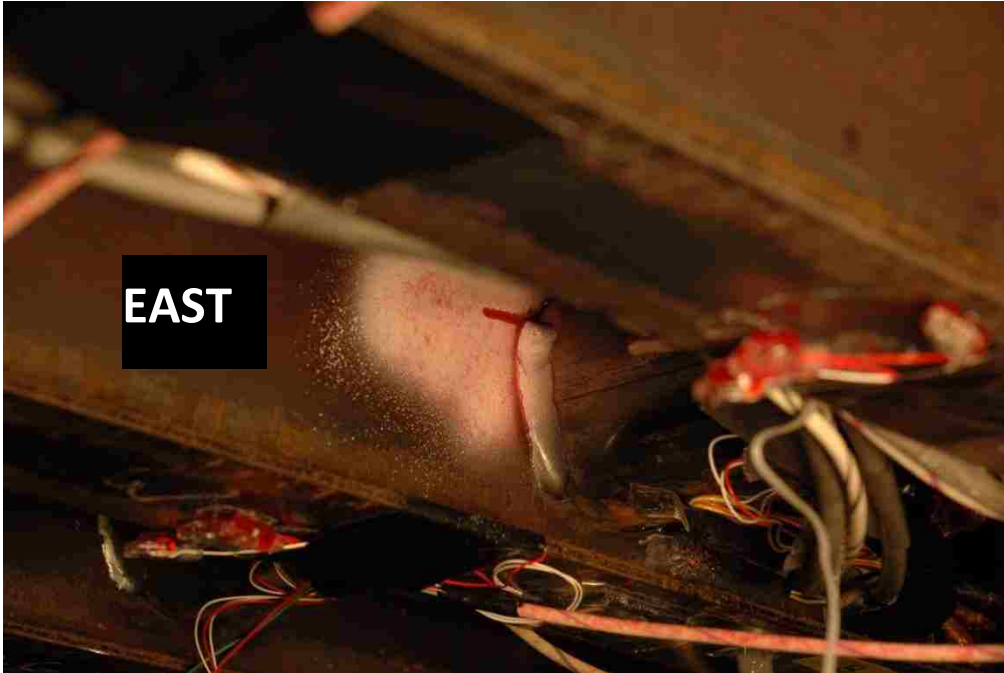
Figure 60. Specimen #1, crack at the east weld of the S5-T2 intersection

On May 23, at approximately 8.0 million cycles, the fatigue test was halted as cracks were discovered at several stringer-to-tube connections. These cracks are described in Section 5.1.1, and shown in Figures 60–64.

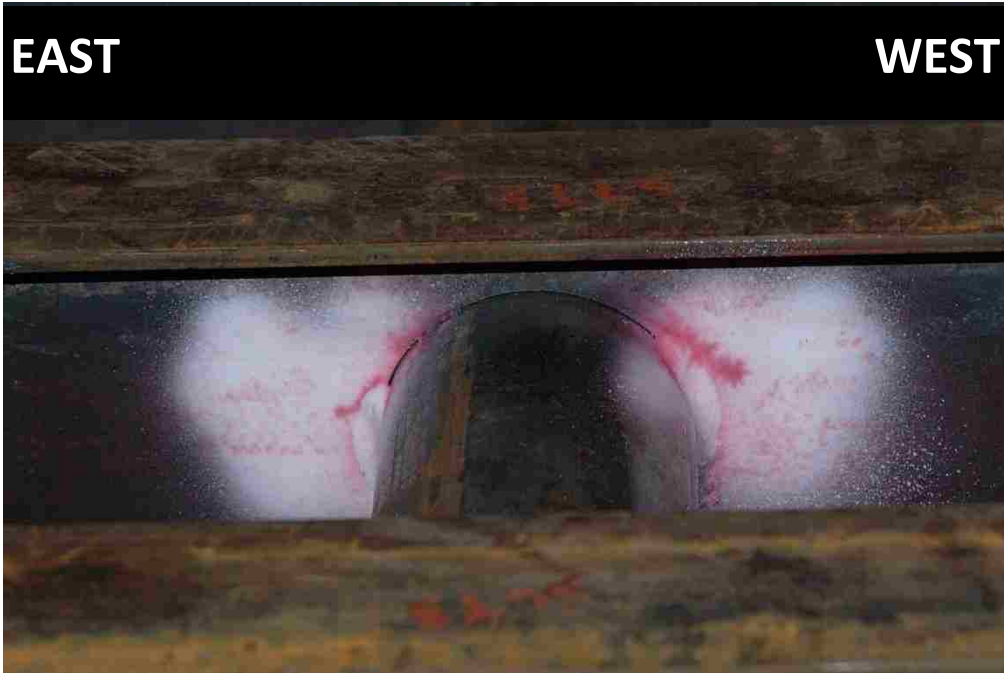
Figure 62. Specimen #1, cracks at S7-T3 intersection, shown with dye penetrant

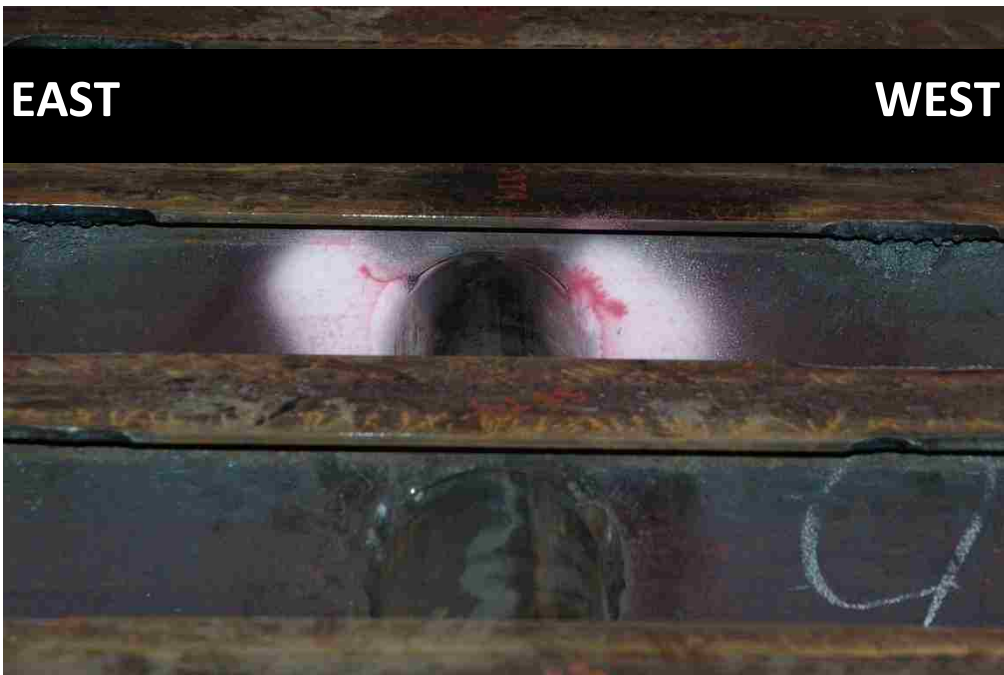
Figure 63. Specimen #1, cracks at S9-T4 intersection, shown with dye penetrant

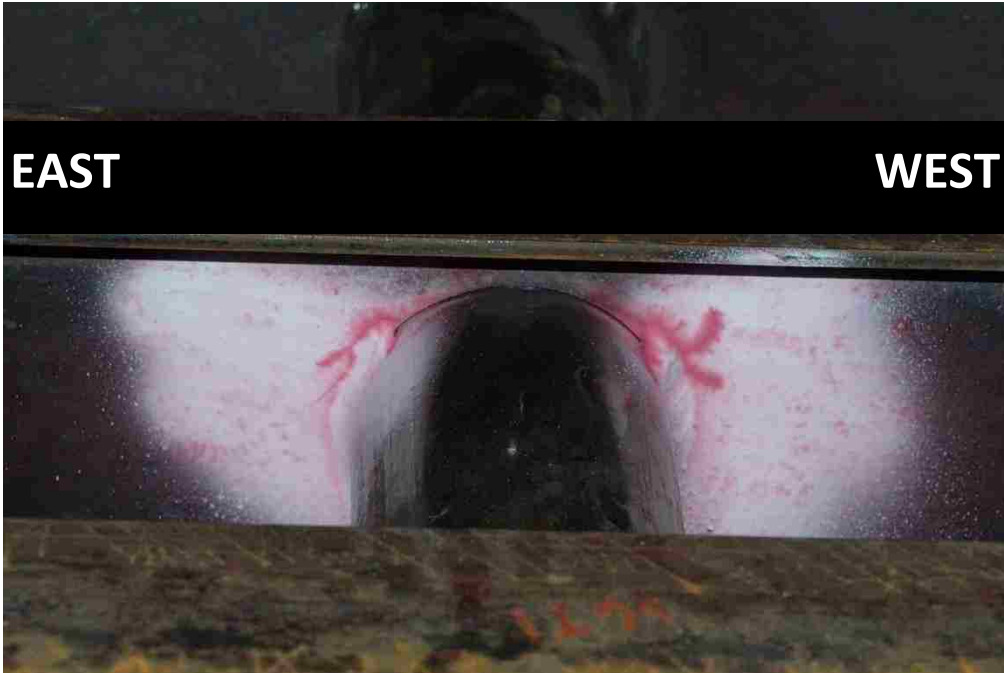
Figure 64. Specimen #1, cracks at S7-T1 intersection, shown with dye penetrant

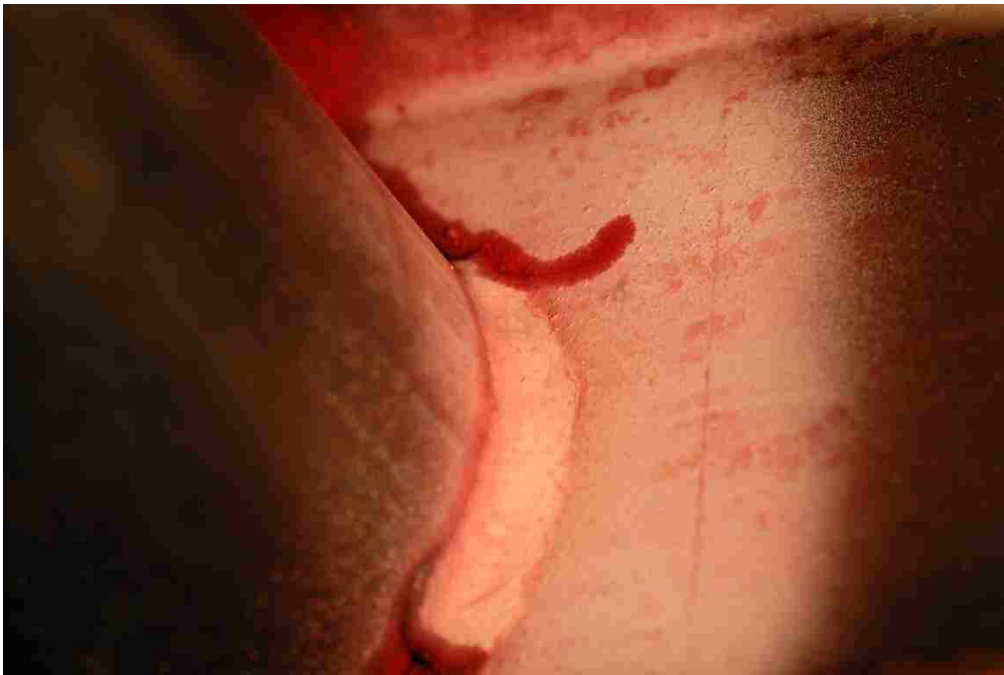
Figure 65. Specimen #2, crack at west weld of the S9-T1 intersection

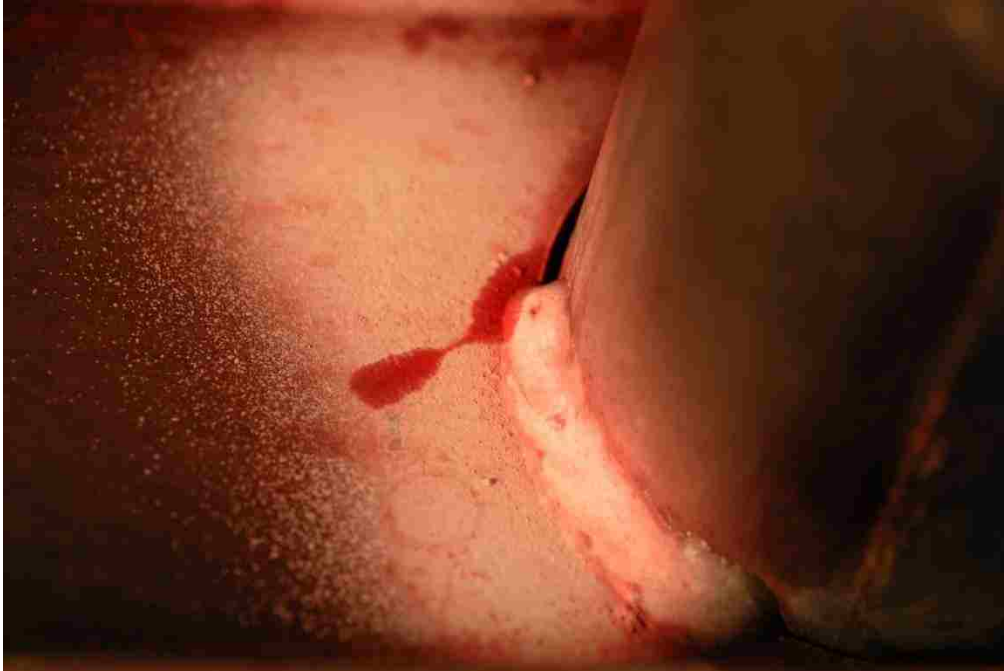
Figure 66. Specimen #2, crack at east weld of the S9-T1 intersection

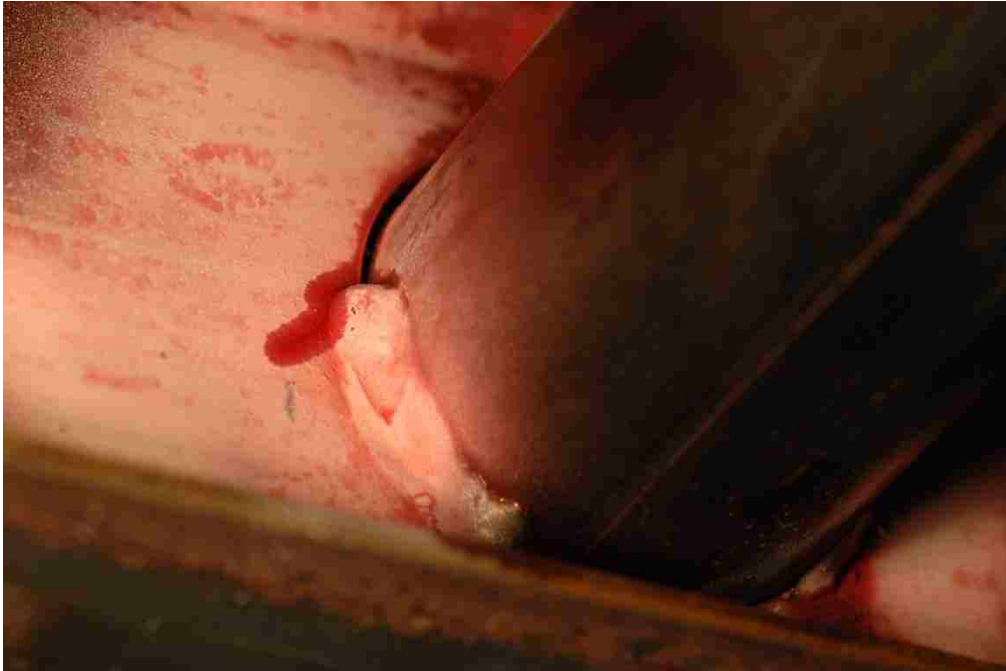
Figure 68. Specimen #2, crack at east weld of the S8-T1 intersection
