# Localized Damage Detection in Structures: A Statistics Based Algorithm Using a Densely Clustered Sensor Network

Elizabeth L. Labuz  
*Lehigh University*

Master of Science

Structural Engineering

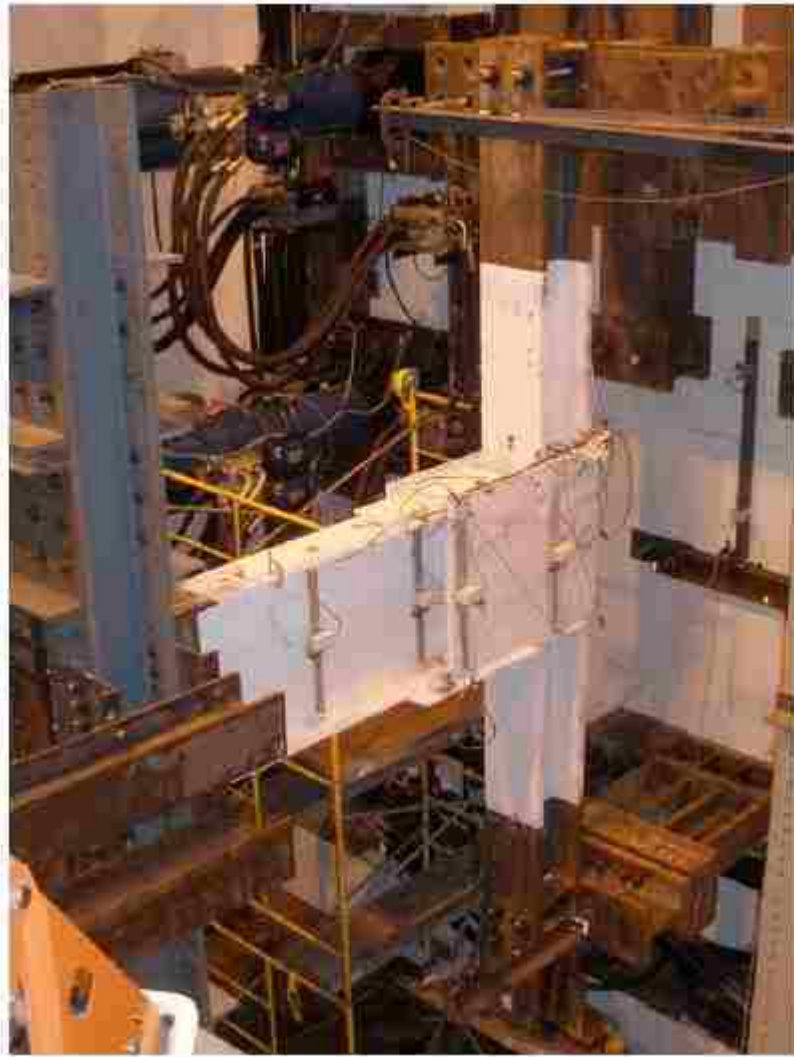
**Figure 5.1. Typical experimental test setup at Lehigh's ATLSS Center**

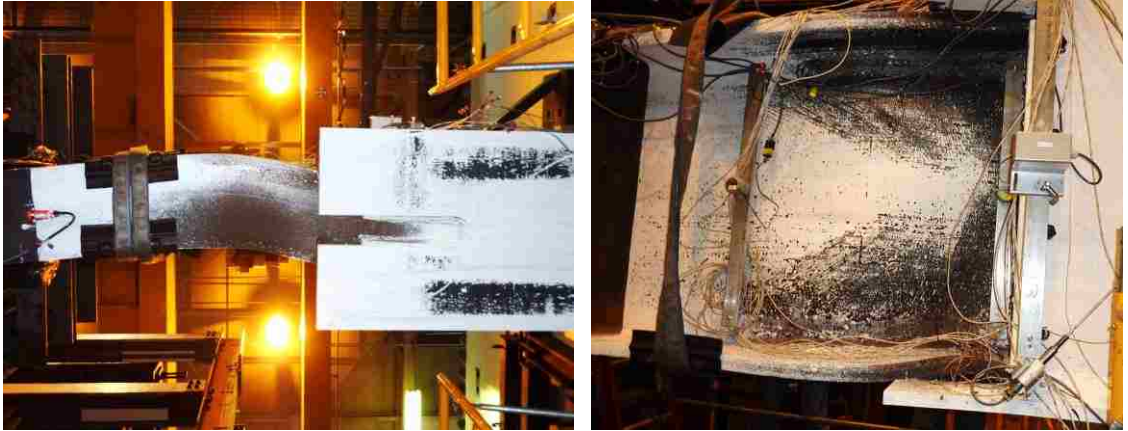
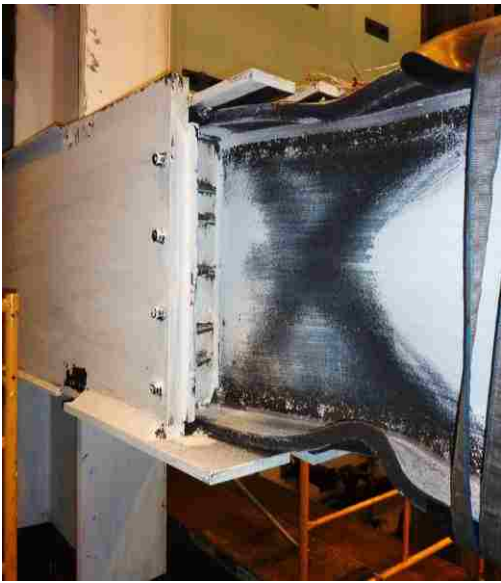
**Figure 5.7. Photos from Test A Damage Class 7**

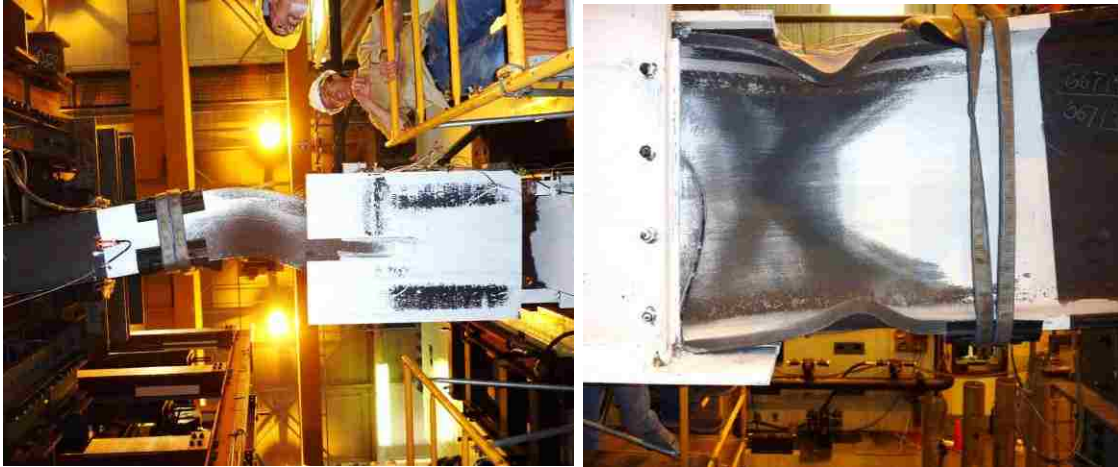
**Figure 5.8. Photos from Test A Damage Class 8**
