## Re-evaluation of Acceptance Testing Criteria for Structural Masonry Using the Prism Test Method

RE-EVALUATION OF ACCEPTANCE TESTING CRITERIA FOR STRUCTURAL  
MASONRY USING THE PRISM TEST METHOD

A thesis submitted in partial fulfillment  
of the requirements of the

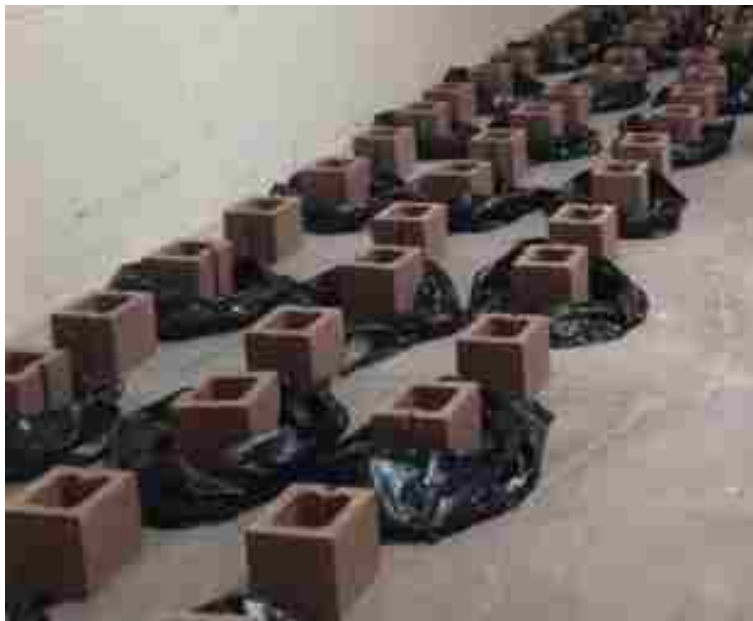
**Figure 2- Blocks laid in order for prism construction**

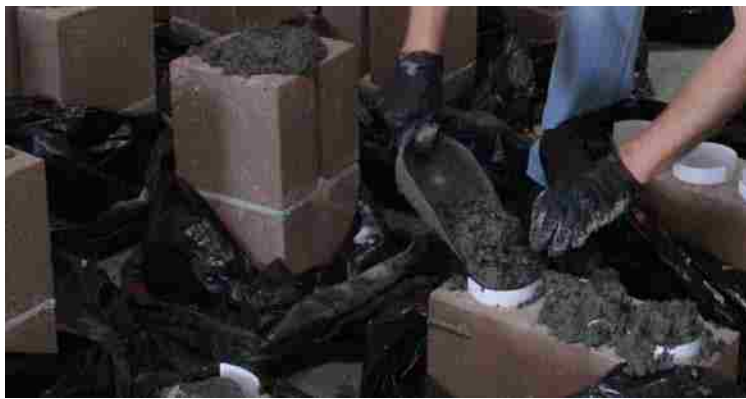
**Figure 3- Placement of Grout**

Once the cylindrical grout specimens were cast and rodded for consolidation, the prism specimens were then filled using the same conveyance method. Once grouted, the prisms were consolidated using a hand-held mechanical vibrator with a  $\frac{3}{4}$ " vibrating end; approximately 3 minutes after the initial consolidation, grout in the prism specimens was consolidated using the same tool a second time. Upon completion of the second consolidation, the top surface of the masonry prisms was struck to produce a raised grout surface of approximately  $\frac{1}{4}$ " above the top of the block to allow for grout shrinkage during curing. Upon finishing the top surface, both the grout and prism test specimens were sealed in bags for curing.

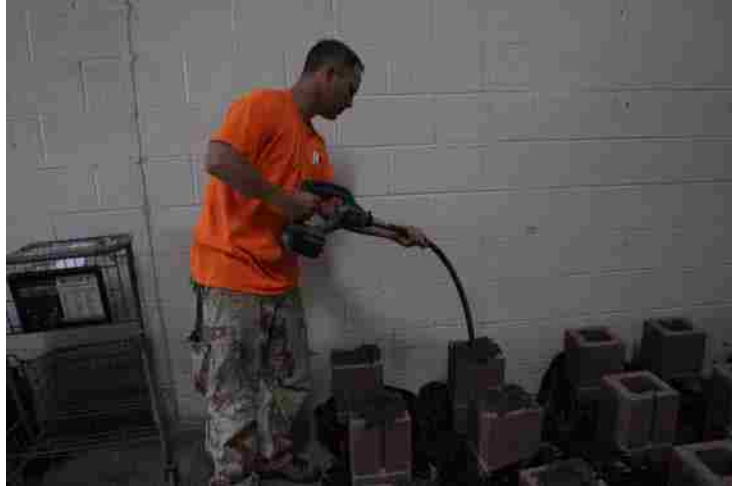
**Figure 4- Consolidation of Grout**

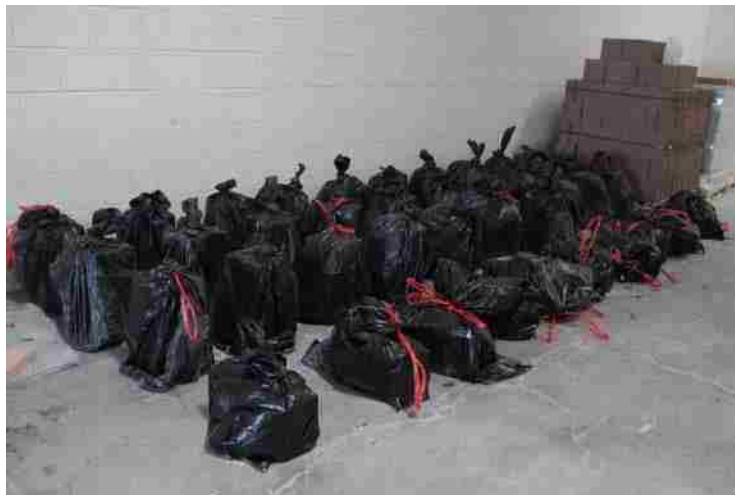
**Figure 5- Curing of Specimens**

After 26 days of curing in the moisture and temperature-controlled warehouse, grout samples were removed from the bags and broken free from the CMU molds and lining. The top and bottom surfaces of the grout cylinders were cut smooth using a large diameter wet-saw. On the 27<sup>th</sup> day, after having been cut and dried, grout samples were capped using molten sulfur compound. Similarly, after 26 days of curing, prism samples were removed from the bags.

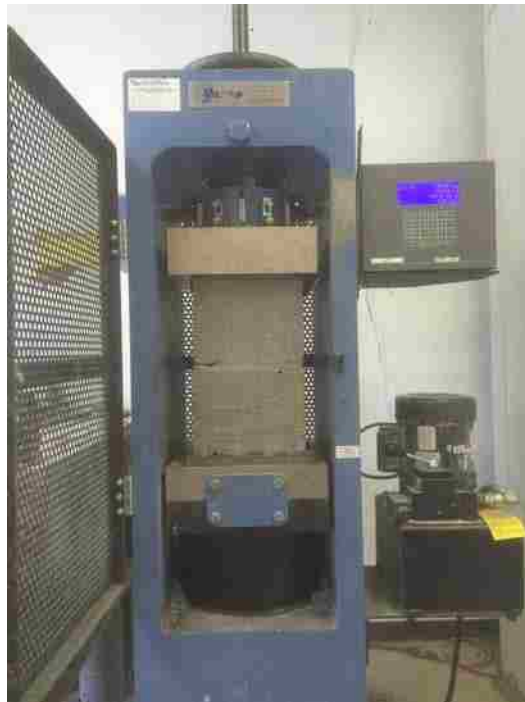
**Figure 6- Example of Prism Testing in Compression Machine**

caused by varying correction factors. On the 27<sup>th</sup> day, after being cut and dried, prisms were capped using the molten sulfur compound. Grout and prism samples were tested in uniaxial compression on the 28<sup>th</sup> day from initial casting, using a 500K Gilson compression machine with the Gilson-provided top platens, bottom platens and spacers (3 inch steel top and bottom platens used for prisms to ensure even load application and no platen deformation, as required).

Compressive strength values were reported to the whole unit as displayed by the digital data display on the compression testing machine. For the sake of reducing rounding effect in the data set, the ASTM recommendation for rounding to the nearest 5 PSI or 10 PSI (depending on the specific material being testing and the ASTM being referenced) was not used in the research reporting.

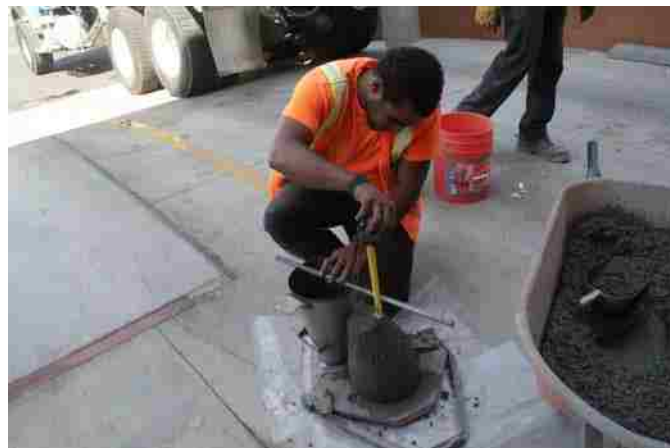
**Figure 7- Slump Measurement by ACI Technician**

Ready-mix grout delivery was the first major variable explored in this research. This was anticipated although certainly not expected to the degree encountered. In an effort to replicate field-constructed conditions for the prism samples, ready-mix concrete trucks with grout batched using conventional batching equipment, scales, and computers were used to produce the grout materials. Variability in the delivered slump of the grout batches was significant; for the first mix, a 4500 PSI design, a slump of 5 inches was ordered and a 3.75 inch slump was measured once the material arrived at the research site. For the second batch, which was a 2500 PSI design, a slump of 5 inches was ordered and a slump of 4 inches was measured at the research site. For the third batch, which was a 4500 PSI design, a slump of 7 inches was ordered and the material arrived with a slump that could not be measured in accordance with applicable ASTM for vertical slump due to three consecutive failed slump tests due to material falling off of the plate; however, for sake of reporting for this research, a 10” slump is reported. All slump tests were conducted by the same technician possessing the American Concrete Institute’s Field Technician Level 1 certification in accordance with industry standards.

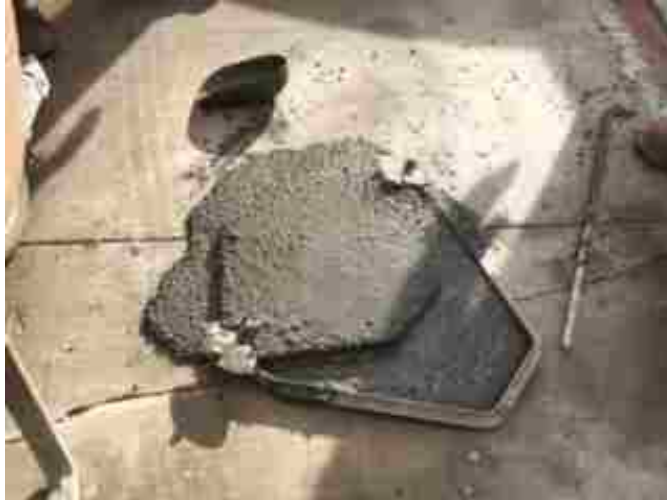
**Figure 8- “Invalid” Slump Test Due to Very High Slump Flow**

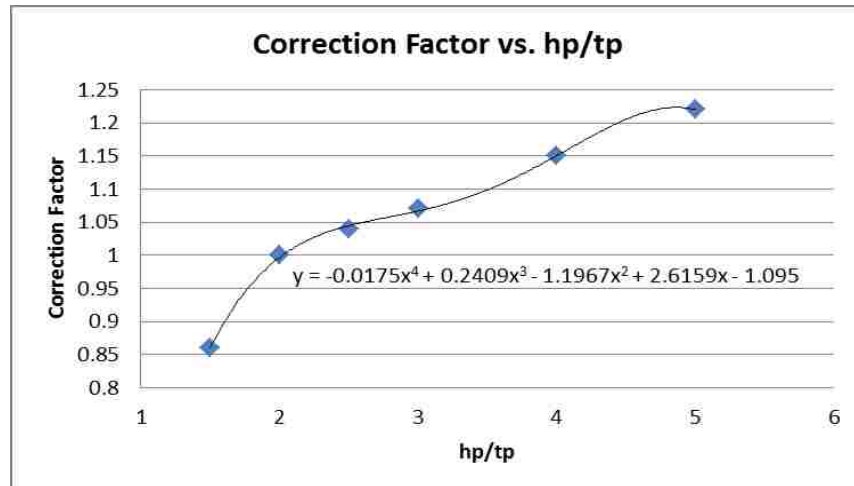
Prism linear interpolation for correction factors:

**Figure 10 - Linear Interpolation Graph for Prisms**

<b>Prism Correction Factor Table from ASTM C1314</b>						
hp/tp	1.5	2	2.5	3	4	5
Correction	0.86	1	1.04	1.07	1.15	1.22
