Study of composite wind turbine spars

A Thesis

Master of Science

Mechanical Engineering

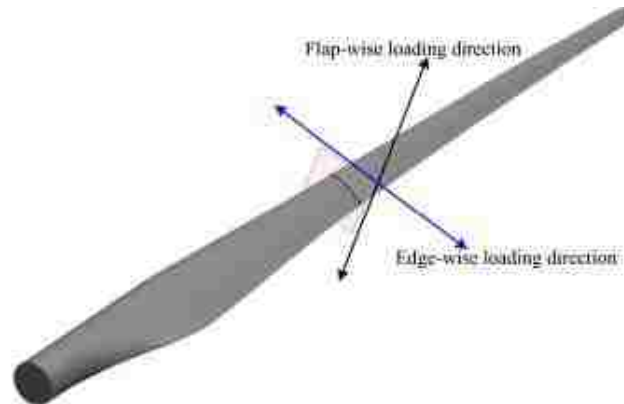
Figure 1: Wind turbine blade showing flapwise and edgewise loading directions

These flapwise loadings in turn produce bending loads along the length of the spar. It is of critical importance that these bending loads do not impart structural damage to the blades. Flapwise loading is mainly carried by a composite beam structure, or spar, inside the shell of the blade. A typical spar consists of spar caps or flanges, which carry axial loads and bending moments, and webs which carry shear and torsion. Fibers in the

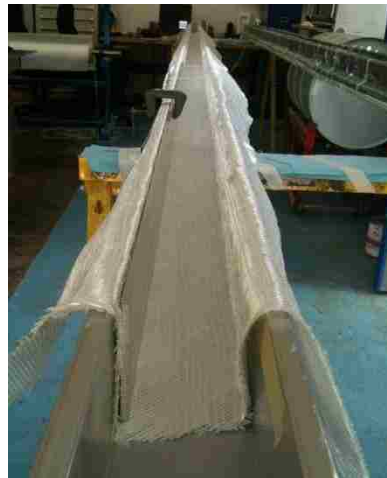
Figure 5: Layer of DB240($\pm 45^\circ$) on aluminum extrusion for inner half

- a. One layer of DB240 ($\pm 45^\circ$) running along the whole length of the beam was laid directly on the mold for webs and flange as shown in *Fig.5*.

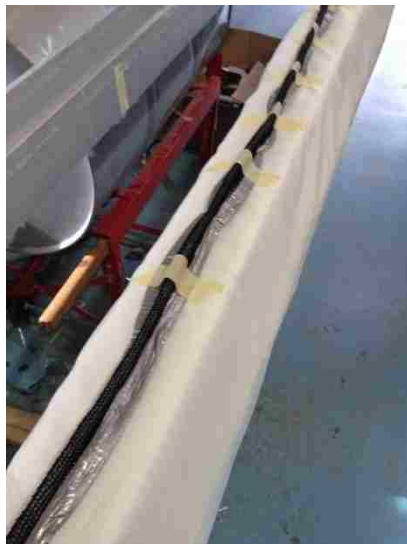
Figure 7: Peel Ply and distribution medium on aluminum extrusion for outer half

- d. Six layers of DB240 ($\pm 45^\circ$) reinforcements in the center covering both webs and the flange were laid to supposedly provide extra strength needed to counter buckling and stress concentration due to the holes needed for pinned end support. Lengths were 350 mm, 300 mm, 250 mm, 200 mm, 150 mm and 100 mm.
- e. Three layers of DB240 reinforcements ($\pm 45^\circ$) centered at ± 2500 mm from the center covering both webs and the flange were also laid due to same above stated reason. Lengths were 200 mm, 150 mm and 100 mm.
- f. One layer of peel-ply was laid on the whole length of the beam covering both webs and the flange. Extra width of peel-ply material was used to make it easier to manage corners and wrinkles while vacuuming. Peel-ply impregnated with release agent helps in easy separation of laminate and vacuum bag after infusion as shown in *Fig.7*.

- g. A perforated distribution medium covering flange only was laid on top of peel-ply as shown in *Fig.7*. Spiral pipes were placed in the middle of the distribution medium that ran along the length of the spar to assist in resin transfer during the infusion process. Spiral pipes were placed almost 1” higher from the surface to prevent any contact with the spar.
- h. One breather cloth folded into three layers was taped underneath the beam in order to provide a continuous passage for the air inside the bag while vacuuming.
- i. The aluminum extrusion along with laminates were then put inside a vacuum bag and sealed at both ends with bag sealant tape as seen in *Fig.8*.
- j. A small hole was made in the bag on one side of aluminum extrusion at the bottom and a vacuum pump pipe was connected to the breather with help of sealant.

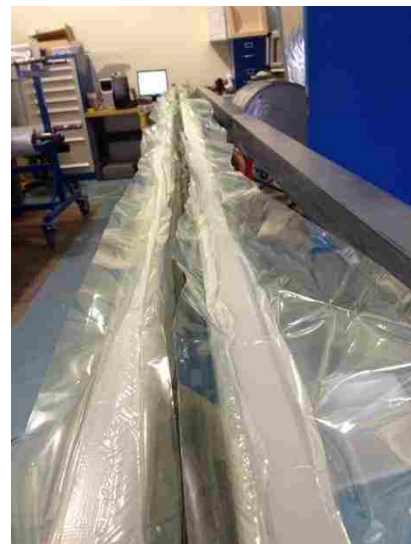
Figure 8: Vacuum bag covering aluminum extrusion of inner half

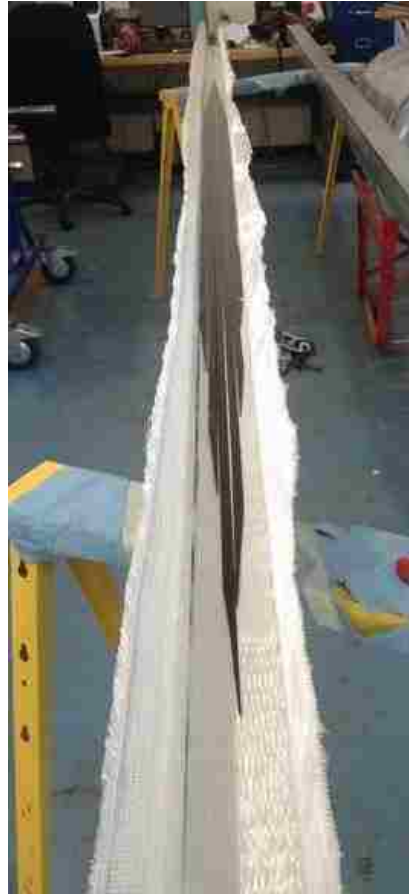
Figure 9: Layup of carbon fiber pultrusions on flange for inner half

- f. Carbon pultrusions were added in the flange section with the intention to provide additional strength, and in particular stiffness, against flapwise bending loads in three spars as shown in *Fig.9*.

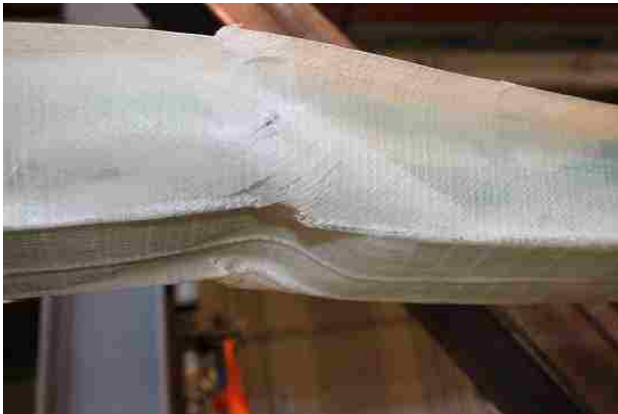
Figure 11: Buckling in webs and deformed compression flange

Of the seven spars that were tested, most failed early on the application of load and ultimately produced buckling in shear webs [Fig.11and12]. Damages incurred on spars after the application of load may have forced webs to deflect in out of plane direction. Since the two halves were connected through shear webs, it seemed that first five spars with thin webs construction could not sustain the stresses induced due to bending and failed at loads much lower than design load. Furthermore, it was noted from earlier research that if multiple layers are added together with each layer oriented in various preferred directions, material will become preferentially strong in that direction. Hence shear webs in last two spars were reinforced with additional layers of glass fiber ($\pm 45^\circ$, symmetric) in an attempt to avoid buckling failure.

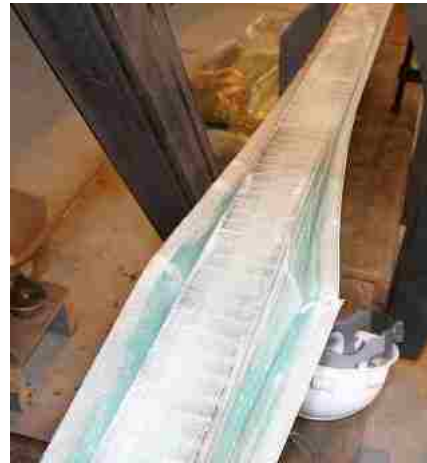
Figure 12: Debonded webs

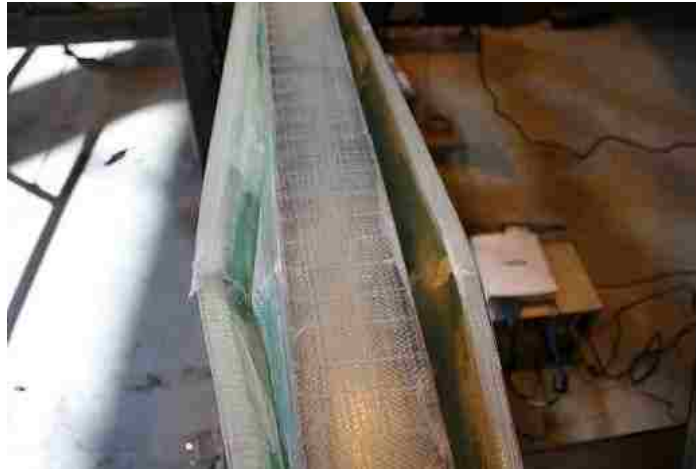
Figure 13: Debonding of shear webs

All spars suffered from severe damage in the adhesive layer bonding between shear webs. These adhesive failures may have led to the final failure of the spar, or they may have occurred for example after shear buckling of the webs. These failures can be further categorized as cohesive shear failure and adhesive shear failure [16]. Damage in adhesive layer was observed at different places in all spars.

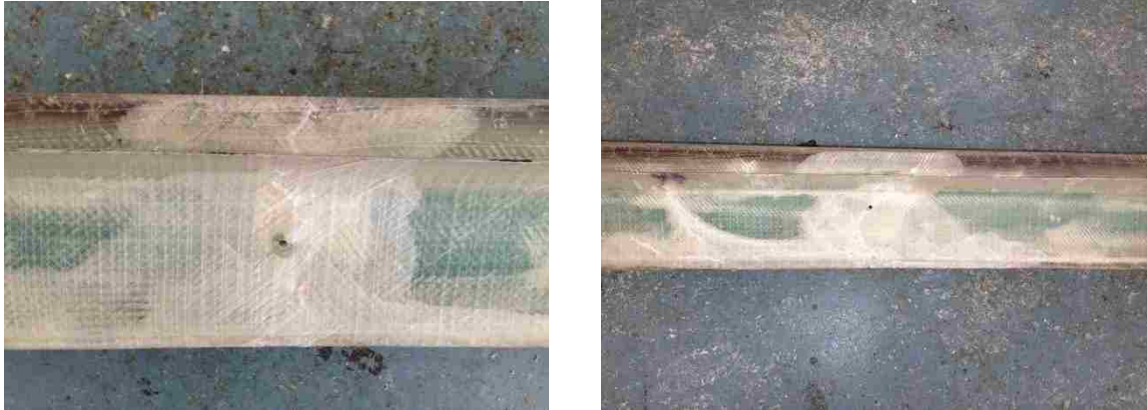
Figure 14: Crack passing through rivet hole

Adhesive-riveted joints were used except in first spar which may have resulted in extra strength between webs of inner and outer halves under bending. Cracks were seen around rivet/ pin holes which may have been produced or propagated due to stress concentration. Also, use carbon fiber pultrusions with untreated surface may create serious potential of stress concentration [9].

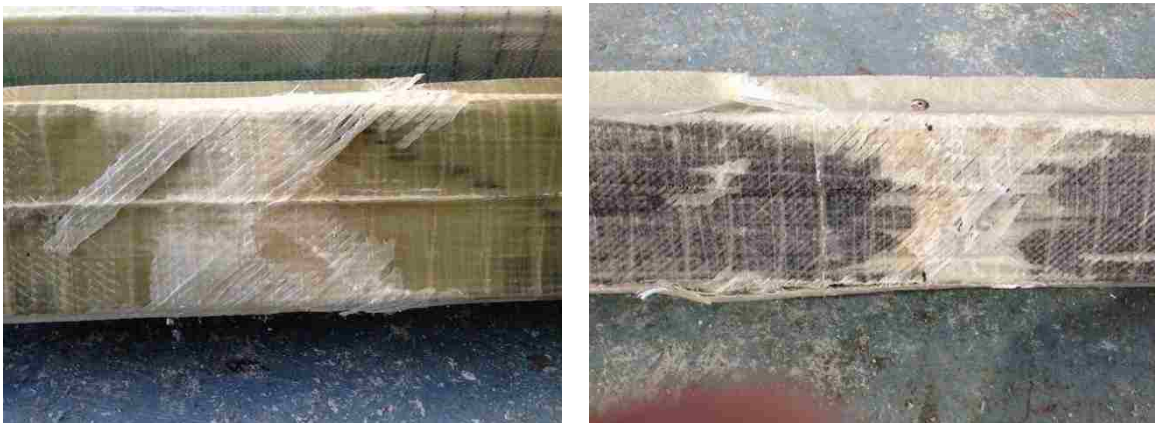
Figure 15: Delamination of plies in shear webs & compression flange

The flanges were subjected to tension and compression. Severe damage in terms of delamination was observed after final failure. The delaminations may have occurred directly after the final failure. Delamination and debonding of plies in shear webs were also observed especially near rivet holes.

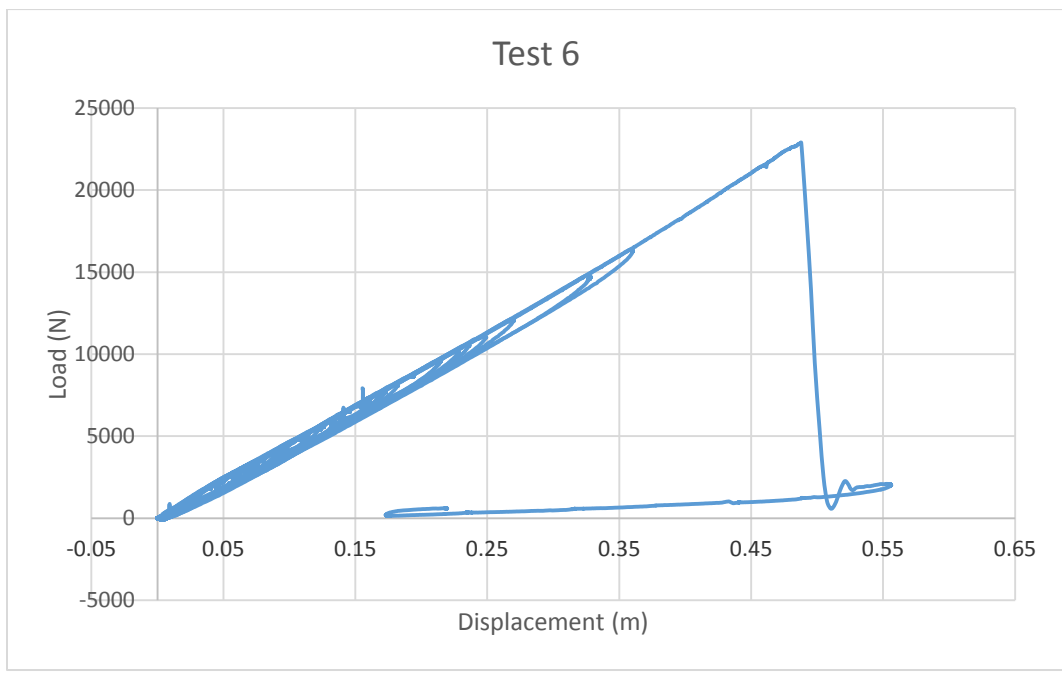
*Figure 22: both halves glass fiber reinforced
both halves with thicker webs*

Above charts represents the amount of center deflection of spars with respective stepwise load increments. Sixth spar test exhibited the most optimum result as it took load that was closest to design load before failure. It may be inferred from empirical results that additional reinforcement of shear webs may have played a very critical role against buckling, although it cannot be said with confidence that the failure of sixth spar was due to compression or shear. Moreover, use of carbon fiber pultrusion in the flanges of fifth and seventh spar may have contributed in additional strength and stiffness but full potential of carbon fiber reinforcements could not be tested since these spars failed earlier than design load limit.

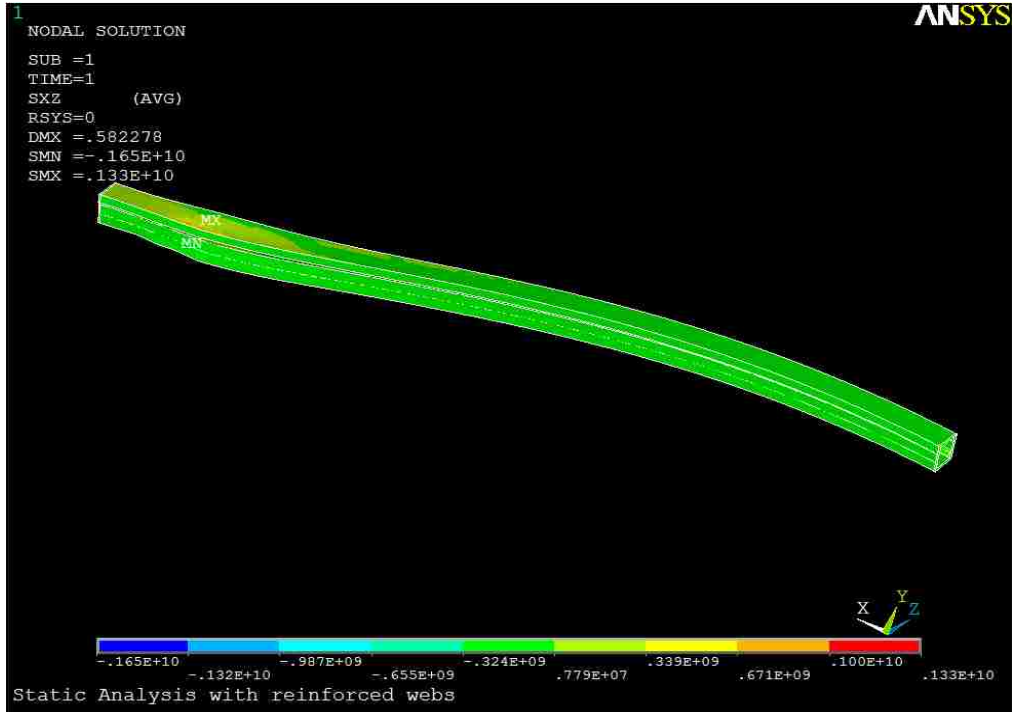
Figure 25: Shear stresses in xz-plane at maximum displacement

Linear elastic static analyses are represented by *Fig. 24, 25, 26 and 27*. Model was setup such that one end of the structure was fixed in y and z translation and x and y rotations and load was applied on the other end with fixed translations in x and z and fixed rotations in x and y. As mentioned earlier, symmetry condition was used in results extraction to minimize computational time and load required to analyze the results. Maximum displacement on the application of design load can be observed in *Fig.24*.

Analysis showed maximum stress and maximum strain in shear webs rather than flanges which indicate that spar may fail in buckling. Thus buckling analysis became necessary to find the effective failure modes in the spar.

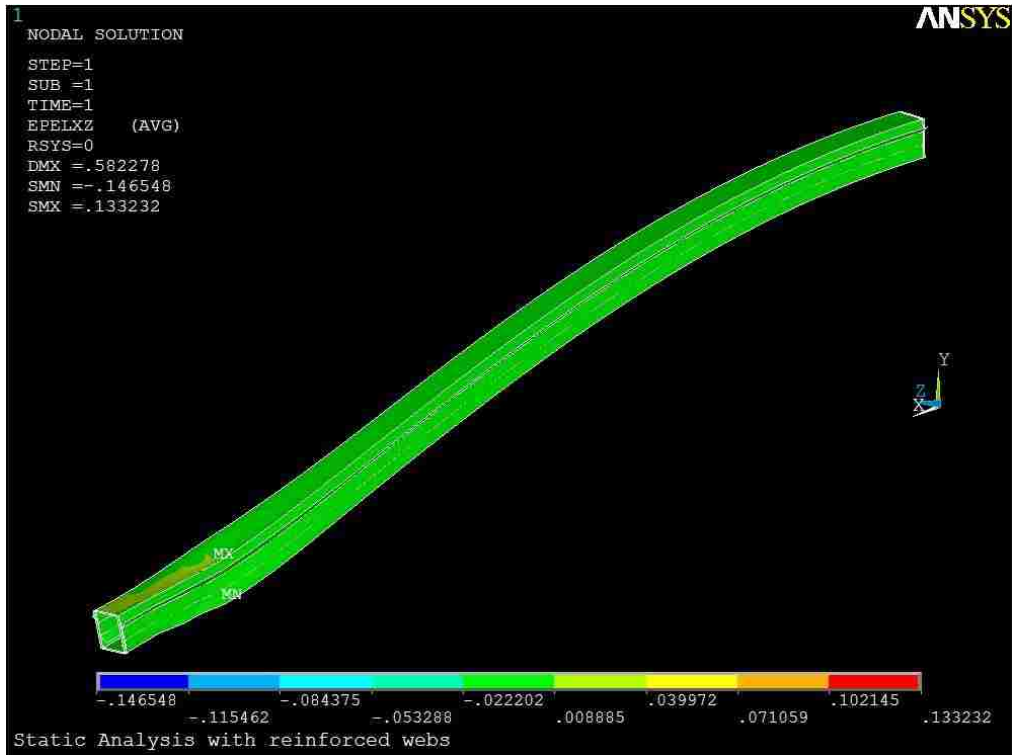
Figure 26: Strains in xz-plane at maximum displacement

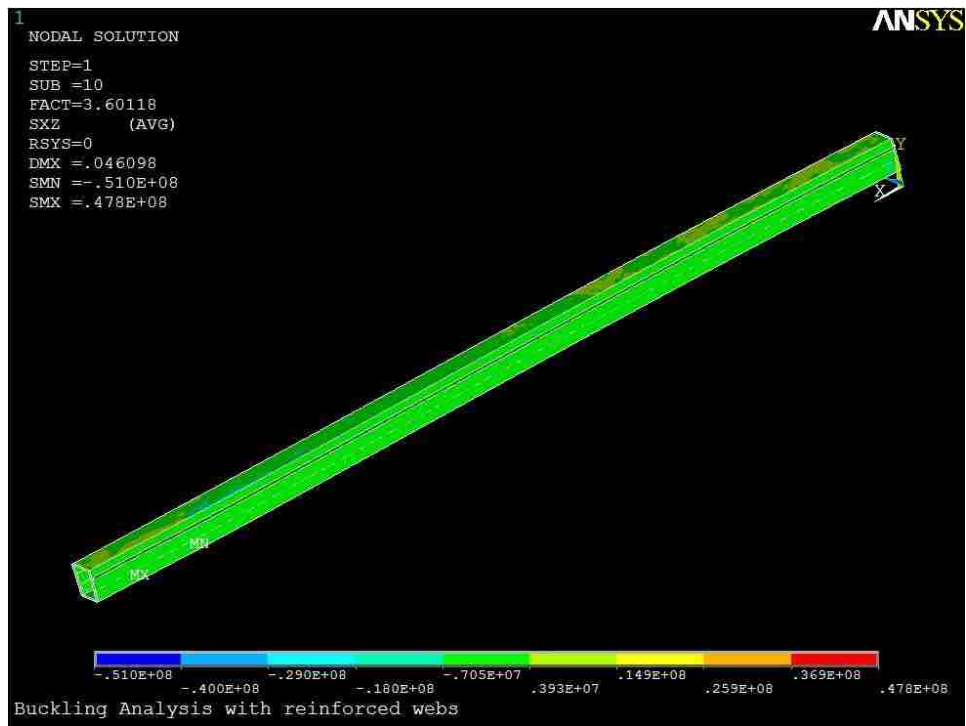
Figure 29: Shear stresses in xz-plane for reinforced webs

Figure 30: Strains in xz-plane for reinforced webs

Spars models with thin and reinforced webs were subjected to *eigenvalue buckling analysis* as shown in *Fig.27~30*. Models were loaded with same amount of force as in static analysis and same boundary conditions were applied. Objective was to analyze results where eigenvalue is closest to 1. Results obtained indicated that buckling strength was approximately one-third in the spars with thin webs.

Buckling may still have been the dominant failure mode in both cases i.e. with thin webs [*Fig.27 and Fig.28*] and also with thick webs [*Fig.29 and Fig.30*] but with much reduced effect in the later.
