Failure Mechanisms of the Protective Coatings for the Hot Stamping Applications

A Thesis

The Degree of Master of Applied Science

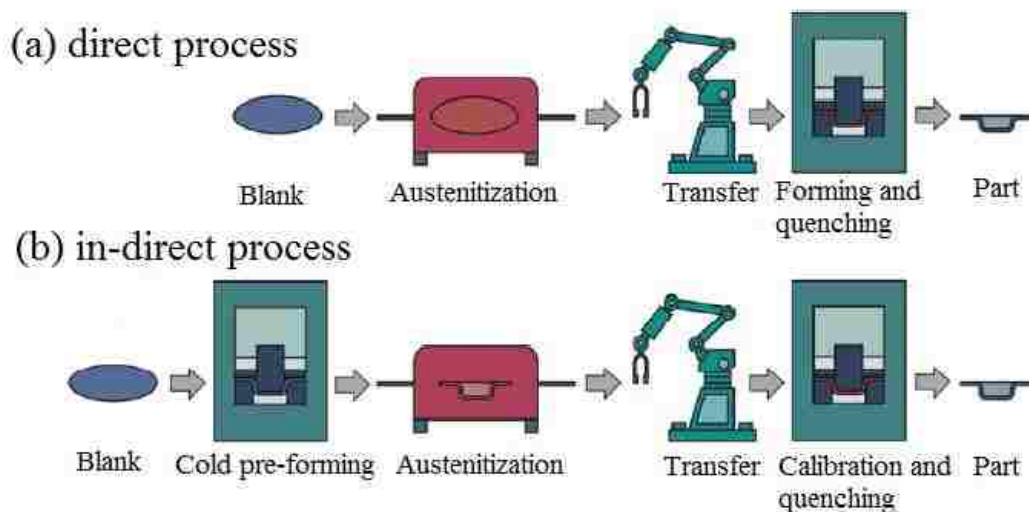
Figure 2.1 Setup illustration of the (a) direct; and (b) indirect hot stamping processes [22].

- 1) Indirect process: the blank is formed, trimmed, and pierced in cold condition. It is later heated and quenched in a die to get high strength properties;
- 2) Direct process: the unformed blank is heated in a furnace, formed in hot condition, and quenched in the die to achieve the required properties.

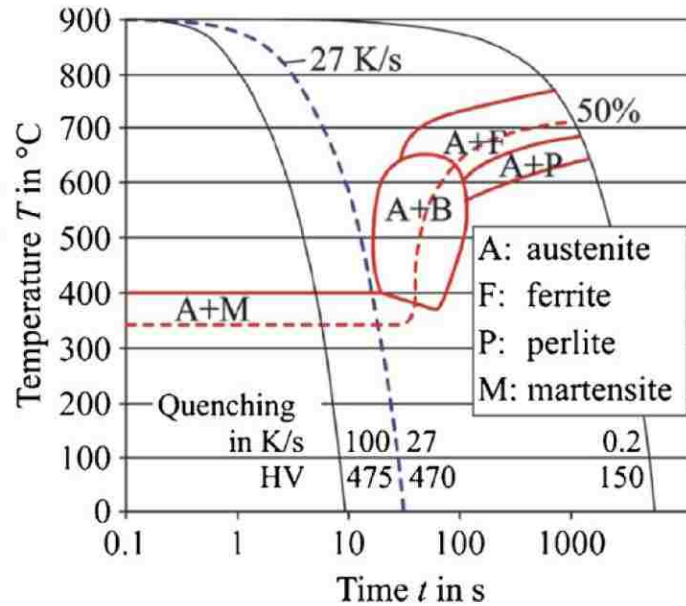
Figure 2.3 CCT diagram of 22MnB5, showing the martensitic transformation at a temperature of around 400°C with a minimum cooling rate of 27K/s [32].

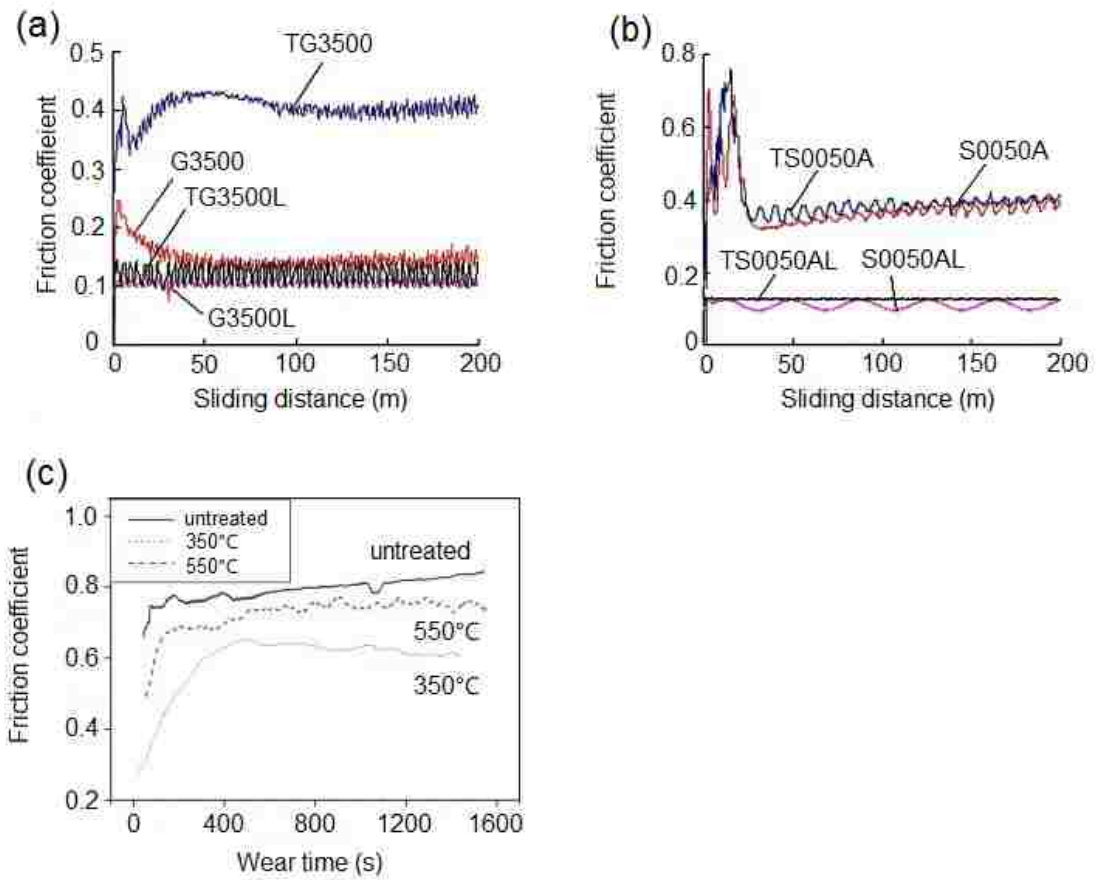
Figure 2.12 (a) Tribological behaviours without (with) lubricants of treated/untreated TG3500 (L)/G3500 (L) and TS0050A(L)/S0050A(L) samples [54]; (b) Friction coefficient of the untreated and nitrided AISI 420 steel samples [48].

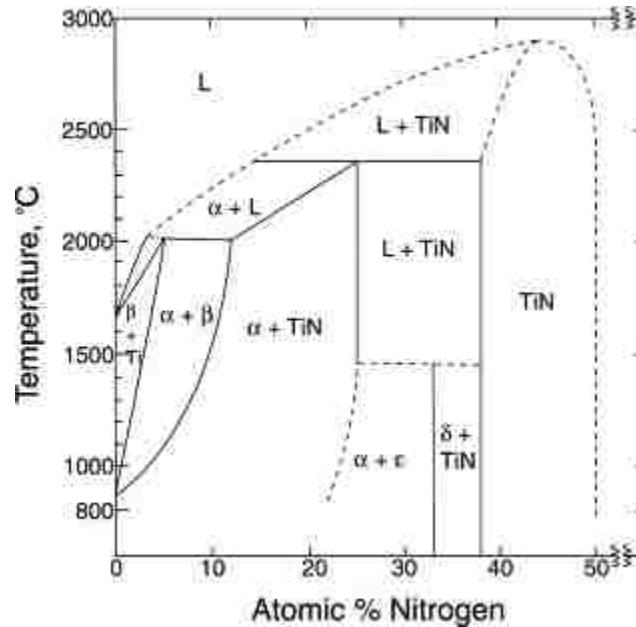
Figure 2.13 Equilibrium phase diagram of Ti-N binary system [59].

Of the transition metal nitrides, processing techniques, properties, and applications of titanium nitride (TiN) have been extensively investigated [60-63]. Titanium nitride crystallizes in the B1 NaCl structure and exists a solid solution containing nitrogen in the range 37.5-50 at. % as shown in Figure 2.13 [59].

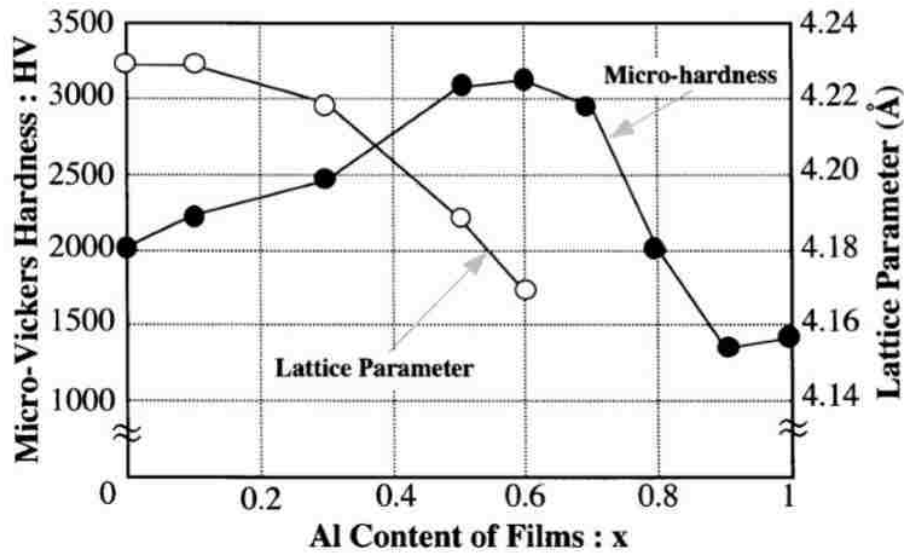
Figure 2.15 Changes in lattice parameter and micro-hardness of $Ti_{1-x}Al_xN$ films with $x=0, 0.1, 0.3, 0.5, 0.6, 0.7, 0.8, 0.9, 1.0$, respectively. The hardness and lattice parameter of TiN film were ~ 2000 HV and 4.23 \AA , respectively. With the addition of Al into Ti-based targets, the micro-hardness gradually increased up to ~ 3200 HV at $x=0.6$ and rapidly decreased to ~ 1400 HV at $x=0.9$ [65].

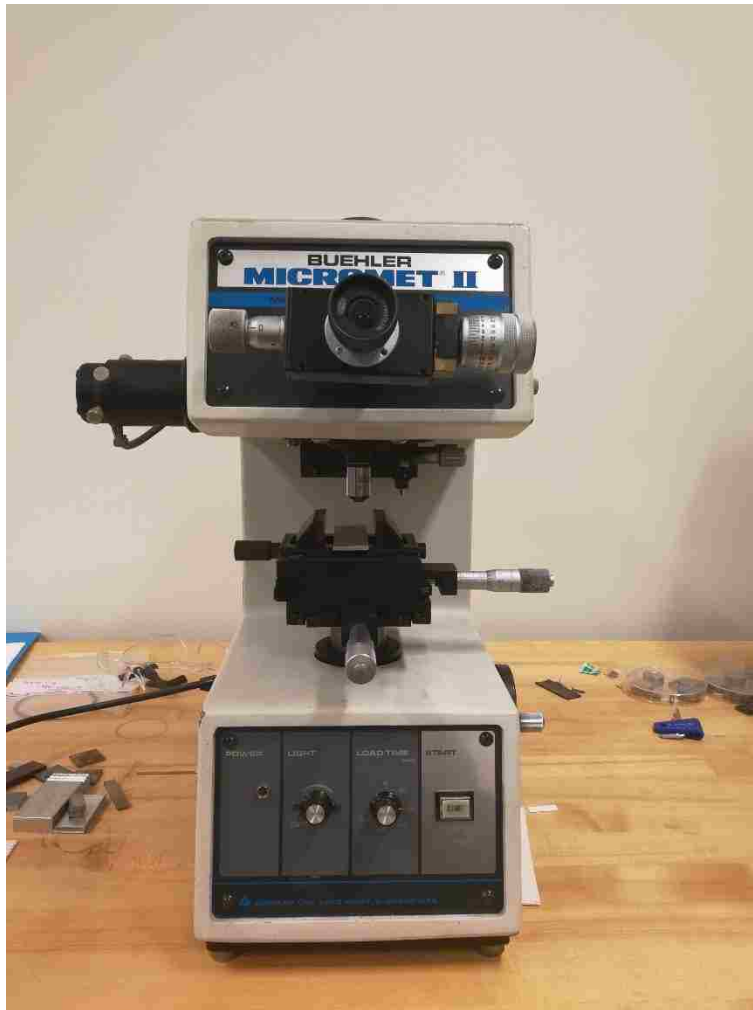
Figure 3.3 Buehler MicroMet II micro-hardness tester.

Metallographic sections were examined using an optical microscope (Figure 3.2.a) and a scanning electron microscope equipped with an EDS detector (FEI Quanta 200 FEG, Figure 3.2.b). The surface hardness of all modified surfaces was measured by a microhardness tester (Figure 3.3) with indentation load 0.0981 N. Meanwhile, for the nitrided iron/steels, the hardness profiles were also determined with indentation load 0.245 N.

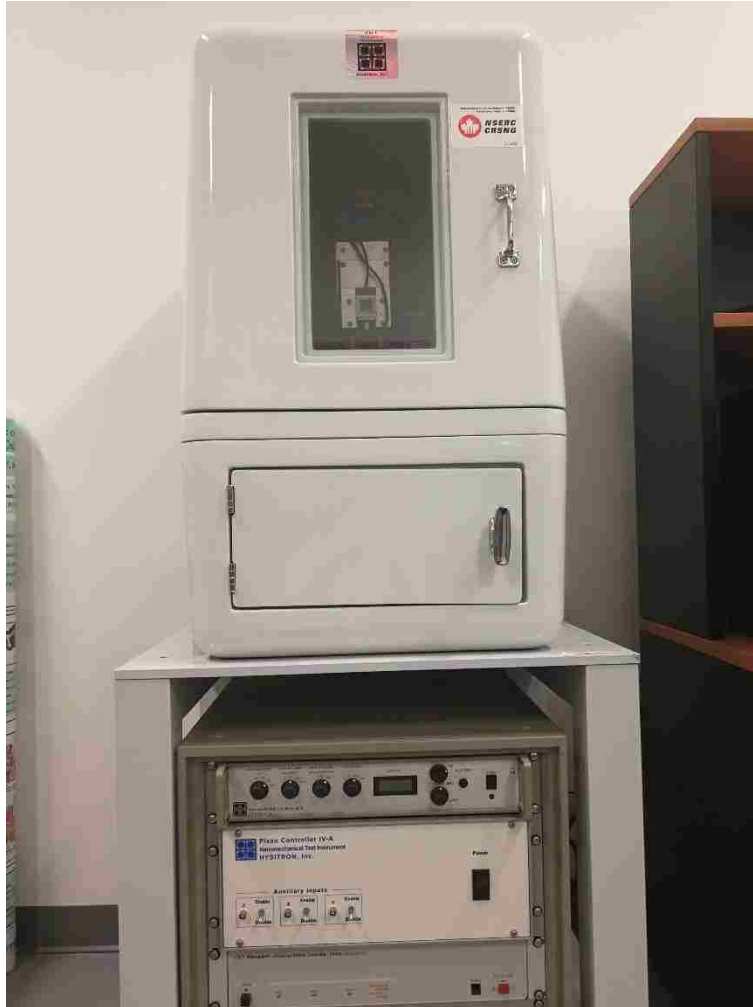
Figure 3.4 Hysitron nanoindentation machine.

The elastic modulus was measured by Hysitron nanoindentation machine (Figure 3.4) with a load of 2500 μN .

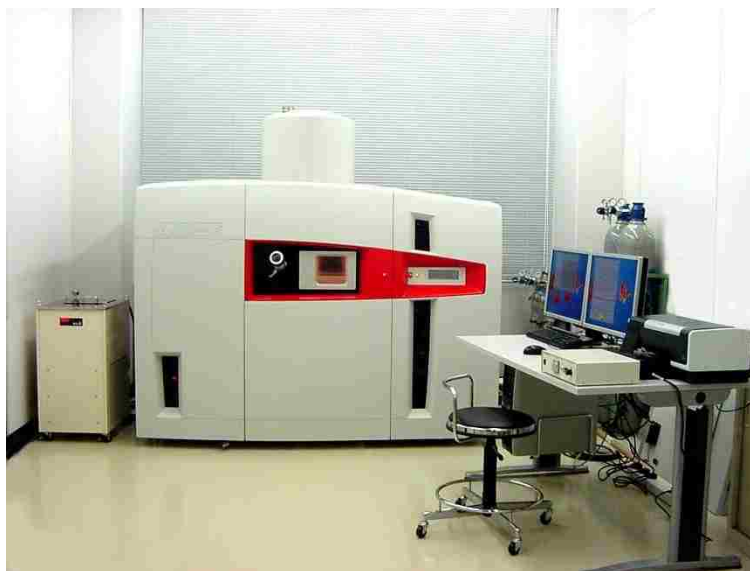
Figure 3.8 Kratos AXIS NOVA X-ray photoelectron spectroscopy.

X-ray photoelectron spectroscopy (XPS, Kratos AXIS NOVA, Figure 3.8) analysis was also carried on the duplex treatment samples to figure out the possible evolution of the surface properties at elevated temperature. The XPS analyses were carried out with a monochromatic Al K(alpha) source (15mA, 14kV), which can probe the surface of the sample to a depth of 5-7 nanometers. The instrument work function was calibrated to give a binding energy (BE) of 83.96 eV for the Au 4f7/2 line for metallic gold, and the spectrometer dispersion was adjusted to give a BE of 932.62 eV for the Cu 2p3/2 line of metallic copper. Specimens were electrically isolated during the analyses, and the Kratos charge neutralizer system was used on all specimens.

Away from the wear track, survey scan analyses were carried out with an analysis area of 300 x 700 microns and a pass energy of 160 eV, and then high-resolution analyses were carried out with a pass energy of 20 eV. Inside the wear track, analysis area with a size of 400 x 400

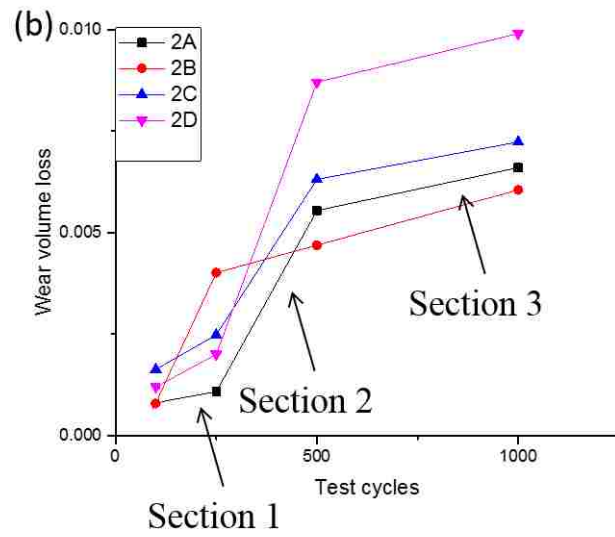
Figure 4.2 Wear volume loss vs. test cycles curves for nitrided die materials (a) D6510, and (b) S0050A.

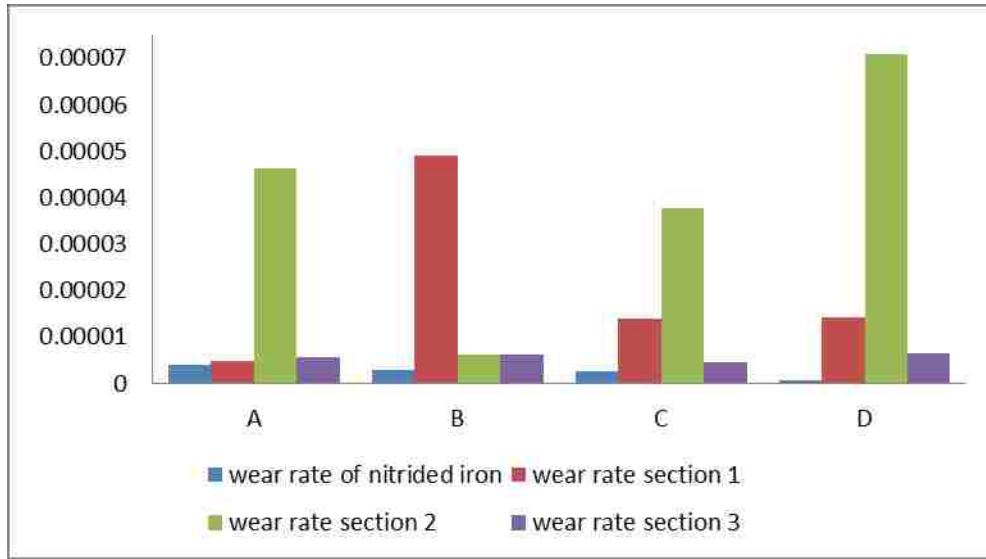
Figure 4.3 Wear rate plots for the nitrided irons and all three sections of the nitrided steels.
