**Investigation of Plasma Electrolytic Oxidation (PEO) Coated Bores in Internal
Combustion Engines**

A Thesis
Submitted to the Faculty of Graduate Studies
through the Department of Mechanical, Automotive, and Materials Engineering
in Partial Fulfillment of the Requirements for
the Degree of Master of Applied Science
at the University of Windsor

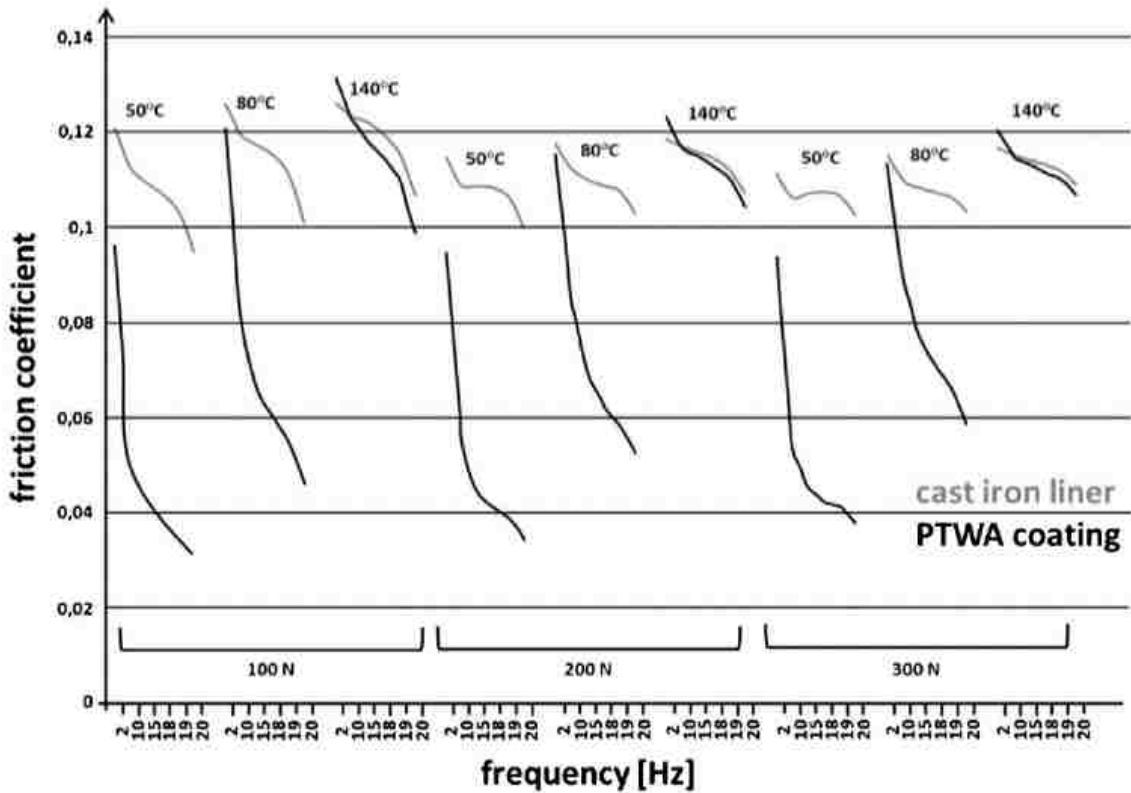
Figure 8: PTWA - Tribology Test - Cameron Plint TE77 - COF vs. Frequency vs. Lubricant Temperature [8]

Figure 8 displays a tribological comparison in terms of coefficient of friction between PTWA coated bores and cast iron liners, under varying conditions of sliding frequency and lubricant temperature. The comparison clearly shows the significant decrease in coefficient of friction when using PTWA coated bores.

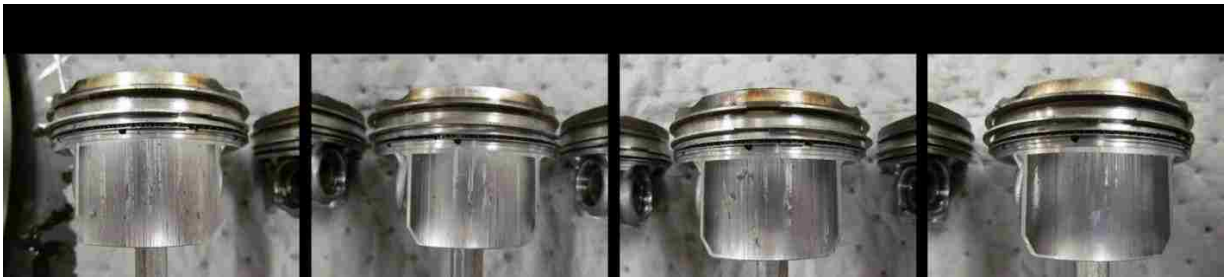
Figure 49: Dynamometer 1 - Engine 2599 – Teardown - Piston Skirts - Major Thrust Side

Visual inspection of the piston skirts revealed severe scuffing on the major thrust sides of the pistons as shown in Figure 49. The scuffing completely wore off the graphite-based Nanofriks1 coating leaving large scoring marks in the direction of piston travel. The galling that had occurred on the major thrust side of the piston skirts could have accelerated wear of the bore walls by aggressively ploughing the sliding interface causing surface profile changes in the form of scratches and through contamination of the oil.

Although the major thrust side piston skirts experienced the most severe scuffing as shown in Figure 49, there was still detrimental wear that had occurred on the minor thrust sides as is visible in Figure 50. The polishing off of the piston skirt coating was beginning to occur as is visible on the bottom of the minor thrust side piston skirts. This type of wear does not normally occur in standard production engines, especially at such an early period in engine operation of only 9.54 test hours.

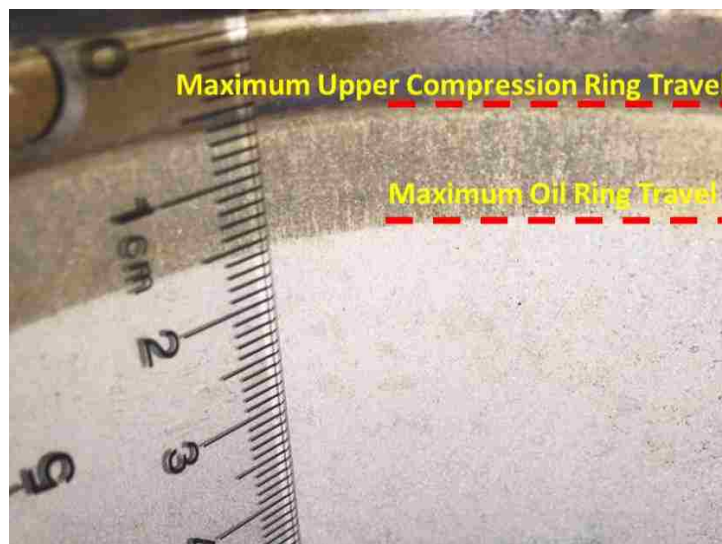
Figure 59: Dynamometer 2 - Engine 2633 - Cylinder 1 - Back – Piston Ring Travel Schematic

Visually, it seemed that cylinders 1 and 2 did not experience any detrimental wear. Profilometry was used to determine the quantity and severity of microscopic wear and depression by wear that had occurred in these cylinders. The variation in color towards the top of the stroke was only due to the bore wall being exposed to different sliding surfaces or none at all, as seen in Figure 59.

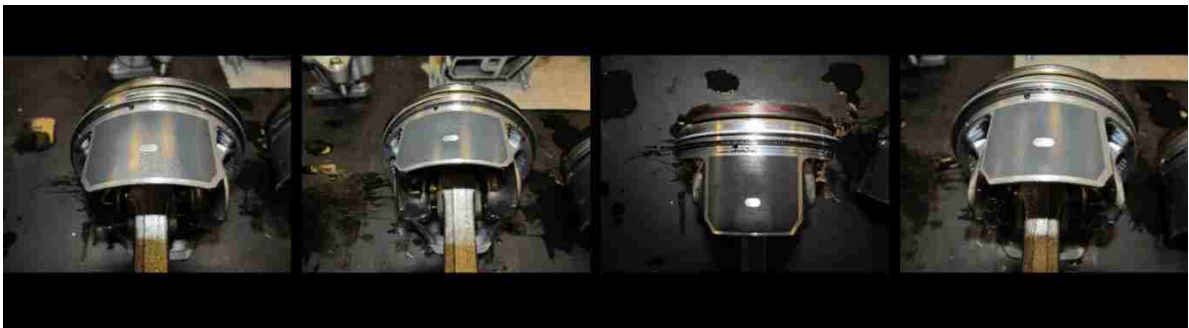
Figure 63: Dynamometer 2 - Engine 2633 - Teardown - Piston Skirts - Cylinders 1 & 2

The piston skirts for cylinder 1 and 2 did not experience any significant wear and stayed completely intact with the exception of slight discoloration towards the center of the skirt on both the major and minor thrust sides as shown in Figure 63.

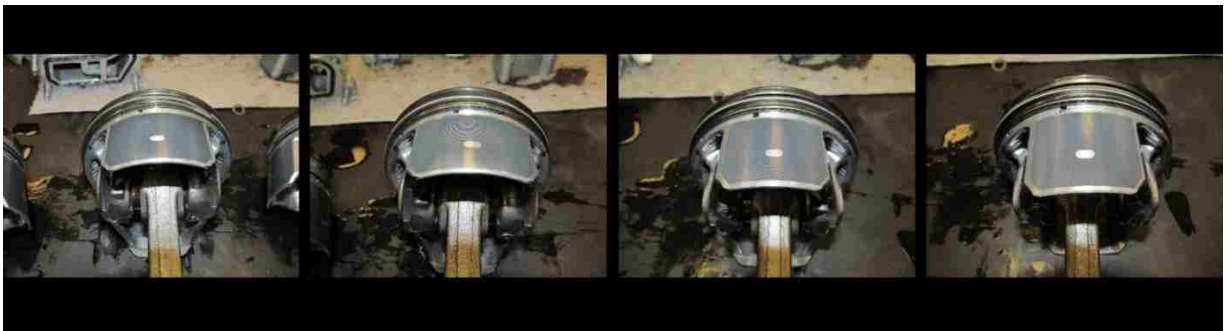
Figure 71: Dynamometer 2 - Engine 2633 - Teardown - Piston Skirts - Cylinders 3 & 4

The piston skirts for cylinders 3 and 4 did not experience any unfavorable wear on either the major or minor thrust sides, despite the severe wear on the cylinder bores as pictured in Figure 71.

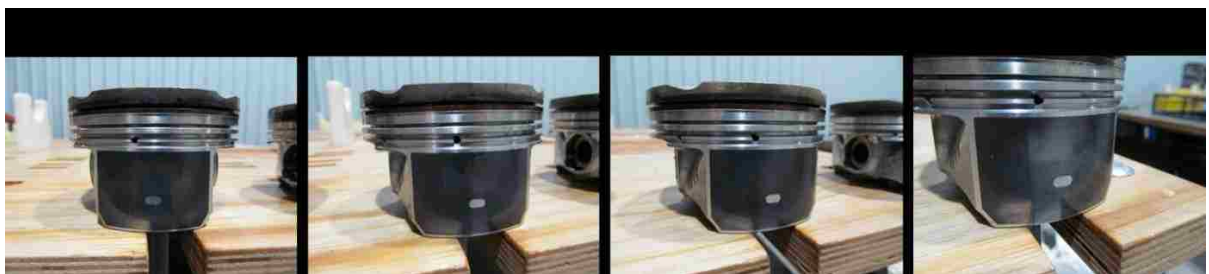
Figure 90: Dynamometer 3 - Engine 2595 - Teardown - Piston Skirts - Major Thrust Side

The piston skirts experienced acute wear, mostly on the major thrust side. On the major thrust side, there was noticeable discoloration at the bottom of the Nanofriks1 coated piston skirts as pictured in Figure 90. In addition to the discoloration, piston 1 and 2 major thrust sides, which experienced the largest piston to bore clearances, had faint linear marks in the direction of piston travel extending over the entire piston skirt. Moreover, piston 4, which experienced the smallest bore clearance, had the piston skirt coating polished off at the bottom edge on the major thrust side.

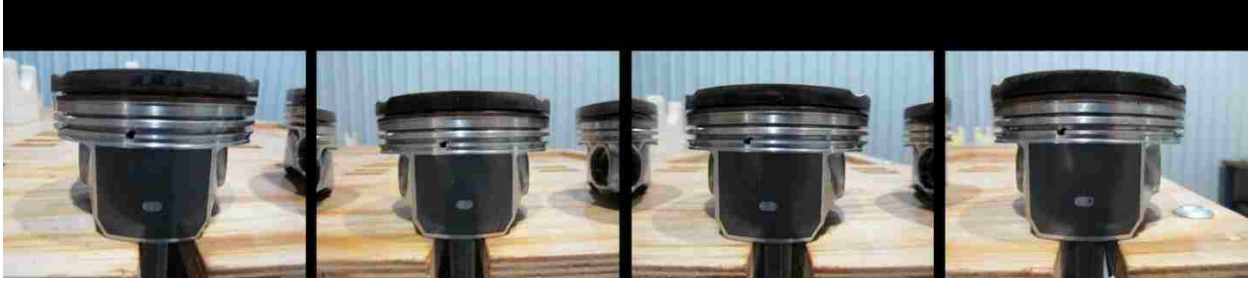
Figure 91: Dynamometer 3 - Engine 2595 - Teardown - Piston Skirts - Minor Thrust Side

The minor thrust side of all pistons experienced little to no wear as seen in Figure 91. Pistons 2 and 4 had faint linear markings on their minor thrust sides.

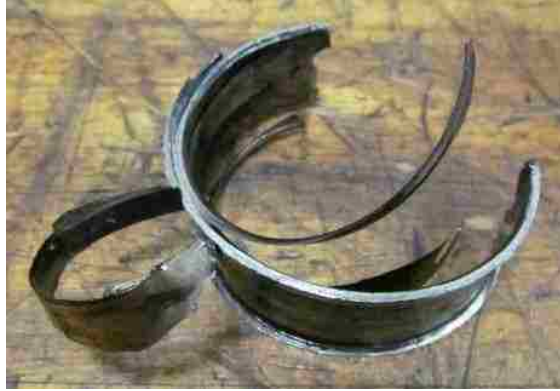
Figure 101: Dynamometer 4 - Engine 2595R - Journal Bearing - Cylinder 4

The reason for failure was assumed to be engine parts or engine assembly and not due to the coated bores as there was not enough significant wear on the bore walls to cause such a failure. Journal bearings associated with cylinders 1 and 4 were destroyed. The destroyed journal bearing associated with cylinder 4 is pictured in Figure 101. Cylinders 1 and 4 had also shown the most significant wear by visual inspection. It is assumed that the journal bearings fragmented into their respective cylinders consequently affecting the PEO coated bore surfaces.

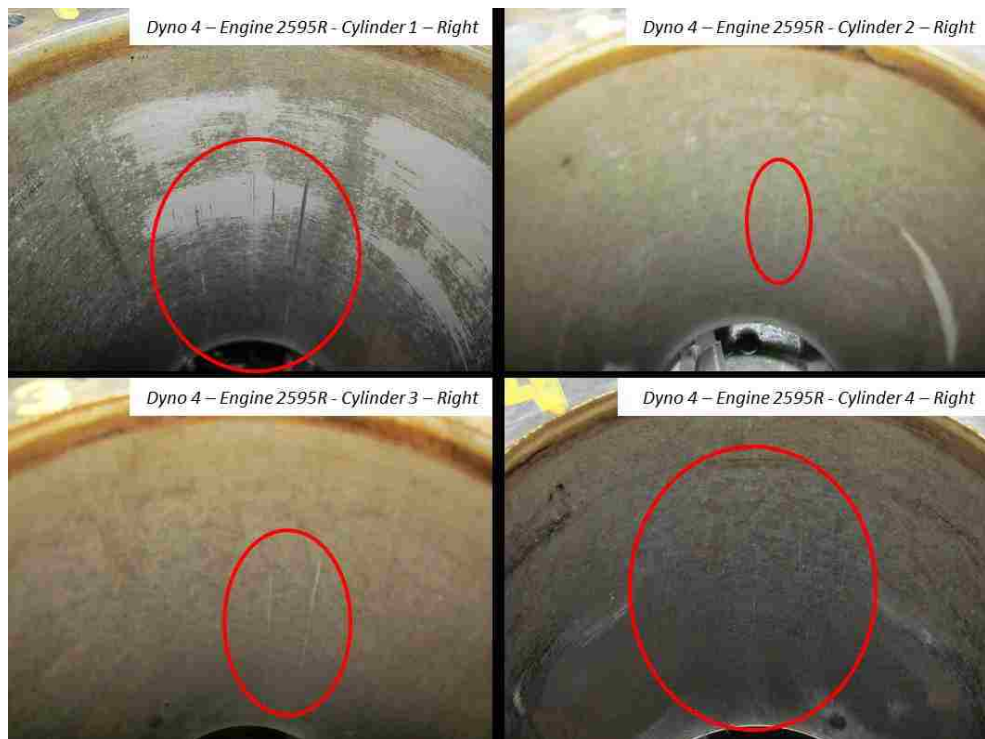
Figure 103: Dynamometer 4 - Engine 2595R - Teardown - Cylinders – Wear Marks – Major Thrust Side

Each cylinder was subjected to various levels of wear during this dynamometer test. Cylinder 1 experienced the worst wear with delaminating PEO coating. In addition to PEO coating wear, scratch marks were visible on the major thrust side following direction of piston travel as seen in Figure 103. Cylinder 2 was subjected to minimal wear, mostly occurring by delamination at TDC of each bore on their minor thrust sides as pictured in Figure 102. Cylinder 3 had also experienced relatively minimal wear with delamination occurring at TDC on its minor thrust side, in addition to the onset of scratch marks located on the major thrust side in the direction of piston travel. Cylinder 4 began seeing linear markings and discoloration parallel to piston travel on the major and minor thrust sides which indicated piston slap occurring.

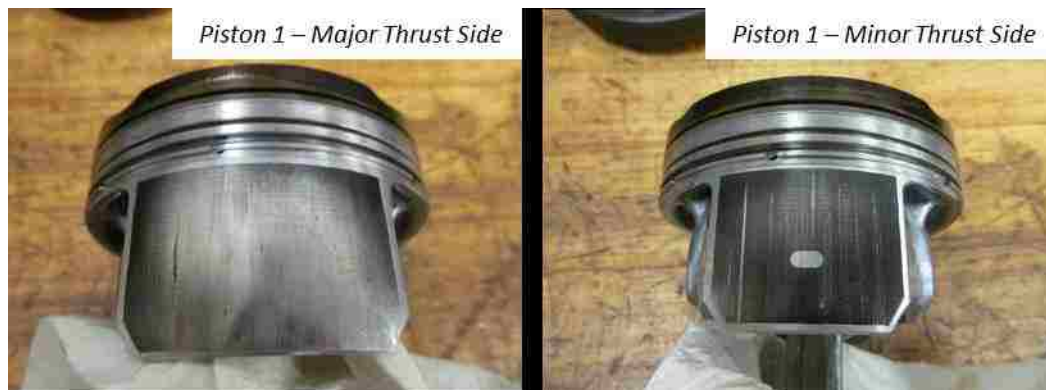
Figure 108: Dynamometer 4 - Engine 2595R - Teardown - Piston Skirts - Piston 1

The piston skirts in this engine trial experienced varying levels of wear, closely correlating to the quantity and severity visible on their respective bore counter surfaces. Cylinder 1 major thrust side skirt coating was polished off while the minor thrust side was mostly intact with the exception of linear markings along the entire skirt face as pictured in Figure 108.

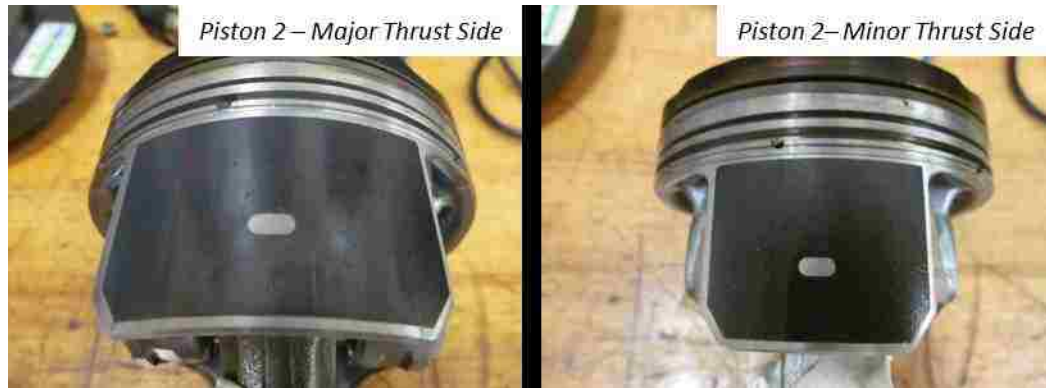
Figure 109: Dynamometer 4 - Engine 2595R - Teardown - Piston Skirts - Piston 2

Pistons 2 and 3 experienced similar wear. Both the major and minor thrust side coatings were unaffected by any wear with the exception of faint scratch marks along the skirt faces as shown in Figure 109 and Figure 110.

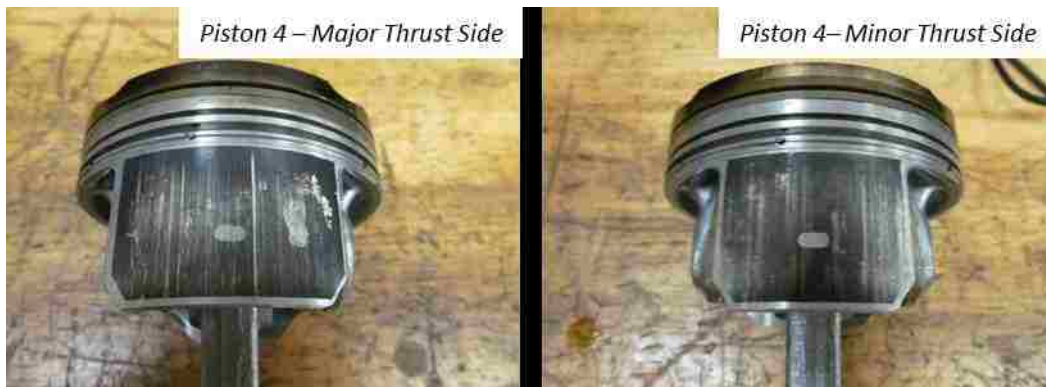
Figure 111: Dynamometer 4 - Engine 2595R - Teardown - Piston Skirts - Piston 4

Piston 4 experienced severe wear on both the major and minor thrust side piston skirts, visible in Figure 111. Substantial longitudinal linear wear marks covered the surface of the skirt in addition to the visible fading of the skirt coating concentrated towards the center of the skirts, distinguishable by the color variation.

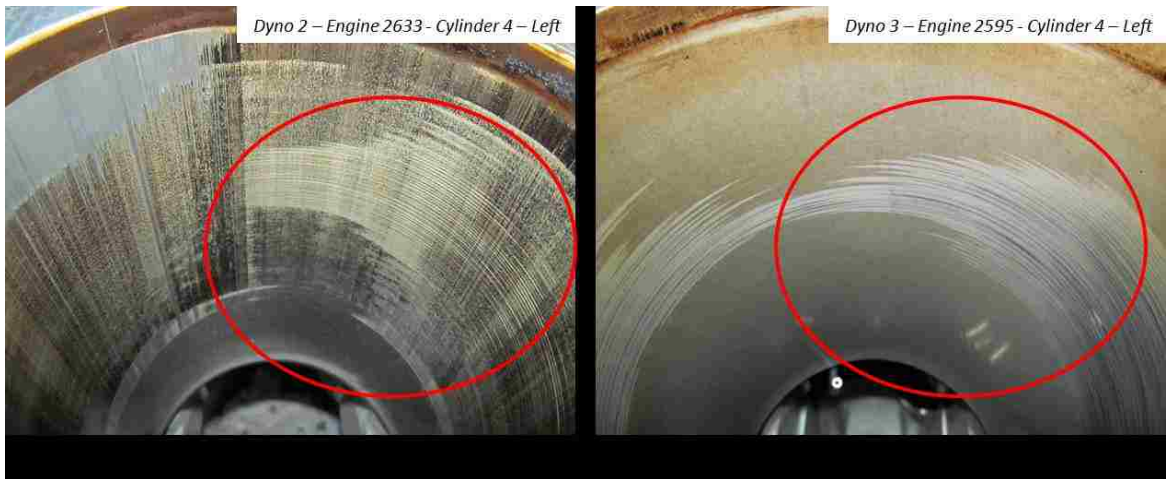
Figure 117: Discussion - Ring Flutter Wear – Comparison Between Engine Trials 2 & 3

Engine trial 3 provided additional data to support the claim of lower clearance distances increasing wear. All cylinders in engine trial 3 had the same wear type, denoted as “Ring Flutter” in this study, as well as cylinder 4 in engine trial 2. A visible comparison between the similar wear patterns over two different engine trials is seen in Figure 117. The common controlling parameter between these sets of cylinders was the bore size and clearance distance being $87.509\ \text{mm} - 87.520\ \text{mm}$.

Additionally, all cylinders in engine trial 3 possessed the same controlling parameters with the exception of clearance distance. Cylinder 4 had a combined clearance total of $13\ \mu\text{m}$, much smaller than the next smallest clearance total in the same engine trial which occurred in cylinder 3 and had a total combined clearance of $23\ \mu\text{m}$. A post-test visual inspection of

the bores revealed a significantly larger area of the cylinder bore covered by the ring flutter phenomenon, and with more aluminum substrate exposed. In addition to the greater ring flutter region, the depth of each wear mark was more severe in cylinder 4 than the rest of the cylinders with peak to valley heights being consistently large and reaching values up to 9 μm in height. Moreover, the piston in cylinder 4 experienced a different wear with the piston skirt coating being polished off on the bottom end of the major thrust side. This comparison between engines of similar clearance distance as well as individual cylinders with different clearance distances suggests that the ring flutter phenomenon occurs due to small clearance distances. The severity of ring flutter wear is enhanced as the clearance distances become smaller until eventual scuffing due to extremely small clearances creating high contact pressure on the bores, as seen in engine trial 1.
