Mechanical and Material Characterization of Mining Wheels for Enhanced Safety

A Thesis

Submitted to the Faculty of Graduate Studies
through the Department of Engineering Materials
in Partial Fulfillment of the Requirements for
the Degree of Master of Applied Science
at the University of Windsor

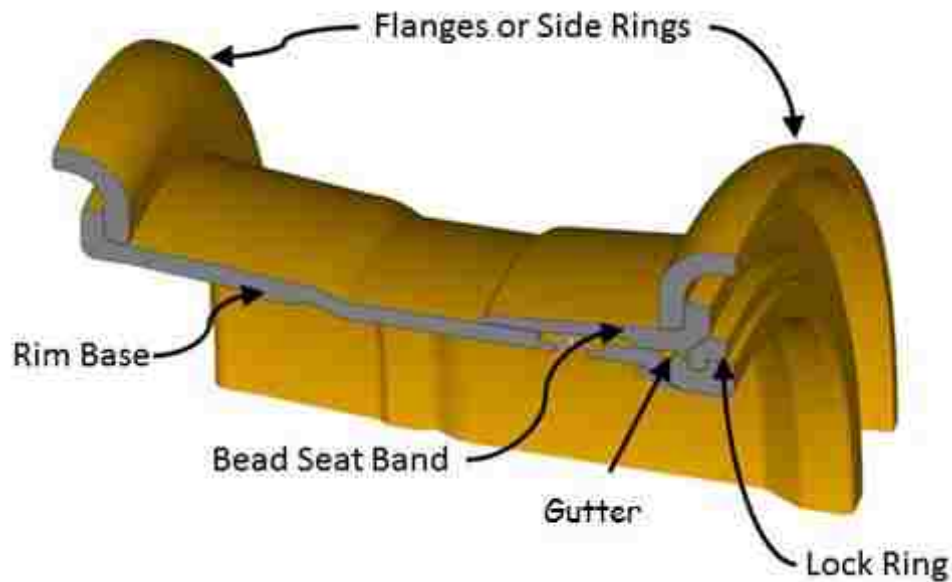
Figure 1.1: Cross-sectional view of a five-piece wheel assembly [7]

A typical multi-piece wheel, Figure 1.1, is manufactured using high-strength low-alloy (HSLA) structural steel. The design consists of a rim base, a mounting disc, a front flange, a rear flange, a split lock ring, and a bead seat band. Based on the expected function of the wheel (e.g. loading, tire size), certain components are sometimes combined into one forged or machined component. These wheels are used in place of single piece rims when their corresponding tires are too stiff to be mounted, using conventional methods, without becoming damaged [2]. Such is the case for heavy

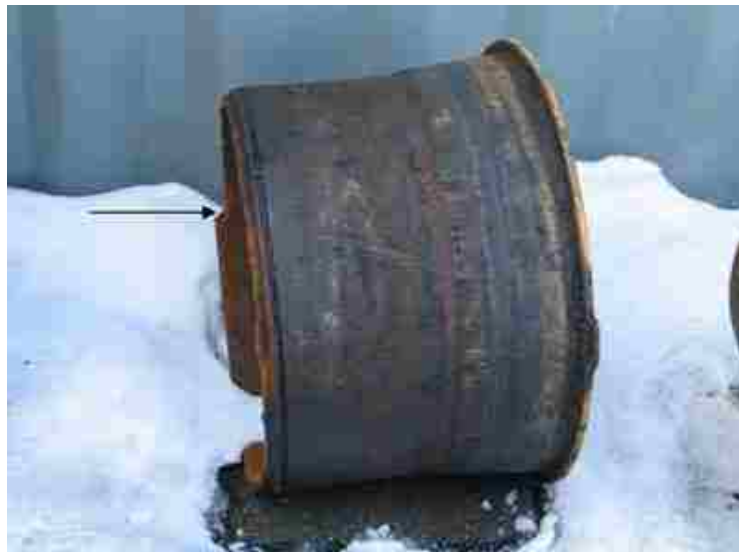
Figure 2.1: 2007, Massachusetts, USA wheel failure. Black arrow indicates failure region [4].

A multi-piece split rim failure occurred while a mechanic was changing the tire of a container handler vehicle (Figure 2.1) in 2007, in Massachusetts, USA. Upon failure, wheel components were propelled away from the vehicle, striking, and fatally injuring, the mechanic. The incident occurred due to a variety of factors, including improper tire handling procedures and mechanical failure of the gutter region of the wheel due to material degradation, resulting in fatigue cracks within the gutter. Recommendations from the incident involved better handling procedures, in addition to more vigorous wheel component structural integrity examinations [4].

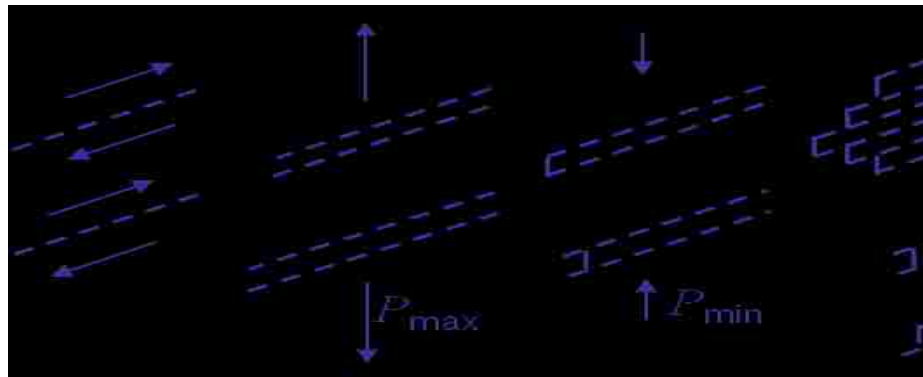
Figure 2.2: Stages of slip band development during fatigue initiation

Over several cycles of slip step generation, slip bands develop. Dislocation gliding takes place along these bands in an effort to minimize energy. Slip and dislocation gliding continues in this way until an obstacle is reached, at which point dislocation pileup occurs. Eventually, with a high enough dislocation density, the obstacle may be overcome through dislocation climb, jog, cross-slip or similar mechanisms [16]. This process repeats itself over the course of many cycles, due to the continued preference of dislocation motion along the low energy slip bands. The result of this activity creates persistent slip bands (PSB), as illustrated in Figure 2.2.

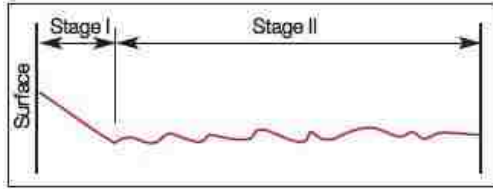
Figure 2.3: Fatigue crack growth direction [17]

In the first stage of crack propagation, fatigue micro-cracks move along shear planes, and thus have a tendency to be angled at 45° (Figure 2.3) relative to the surface (in the case of crack initiation at the surface). During this stage, cracks propagate freely until microstructural barriers are encountered (e.g. grain boundaries, inclusions, sufficiently hard material phases). The cracks then lose energy and decelerate if they are able to overcome the crack barrier, or they become arrested if sufficient energy is unavailable to overcome the obstacle. Knowledge of this behaviour has allowed material engineers to prolong the first stage of crack propagation by use of grain refiners within the material, and shot-peening to the material surface [13].

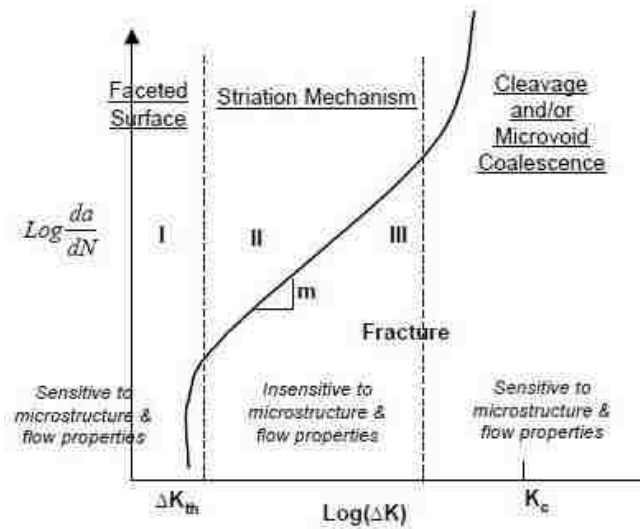
Figure 2.4: Fatigue crack growth as a function of crack propagation stage [17]

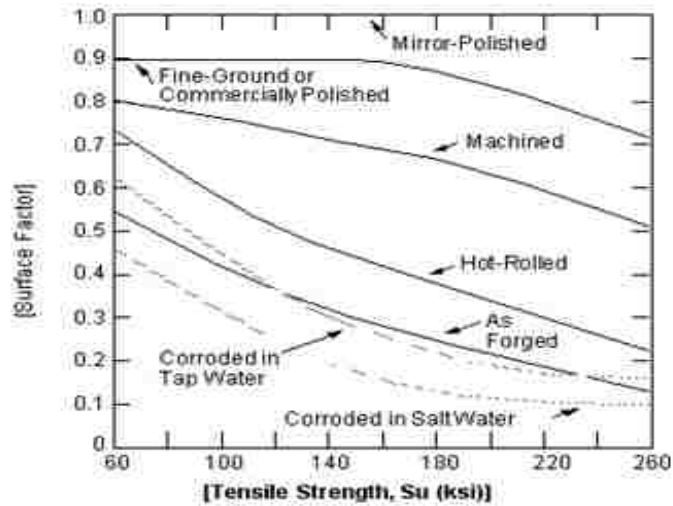
Figure 2.5: Fatigue surface factors for surface conditions as a function of material UTS [22]

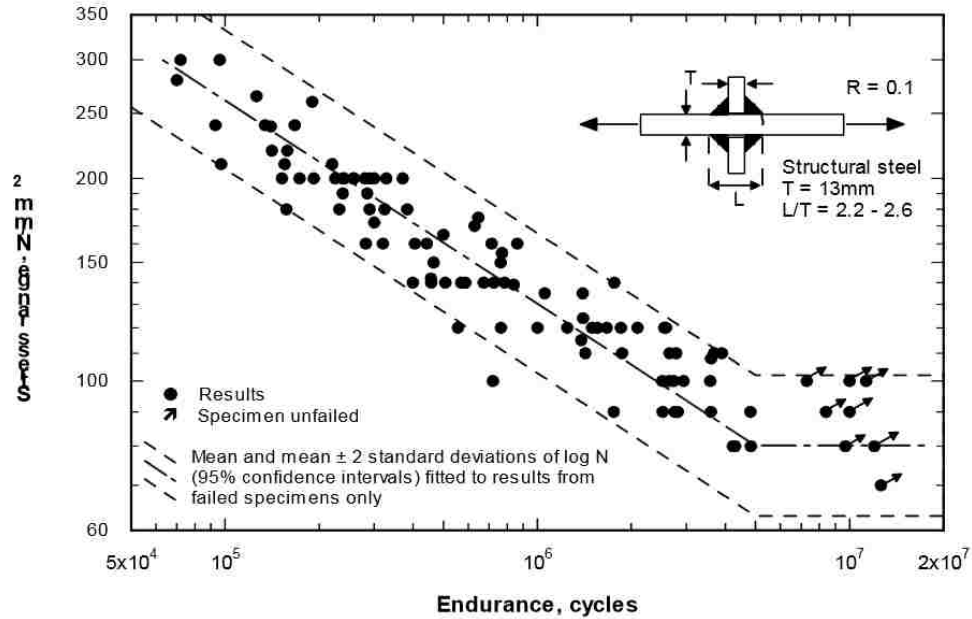
Figure 2.6: Sample S-N plot demonstrating application of confidence bands [34]

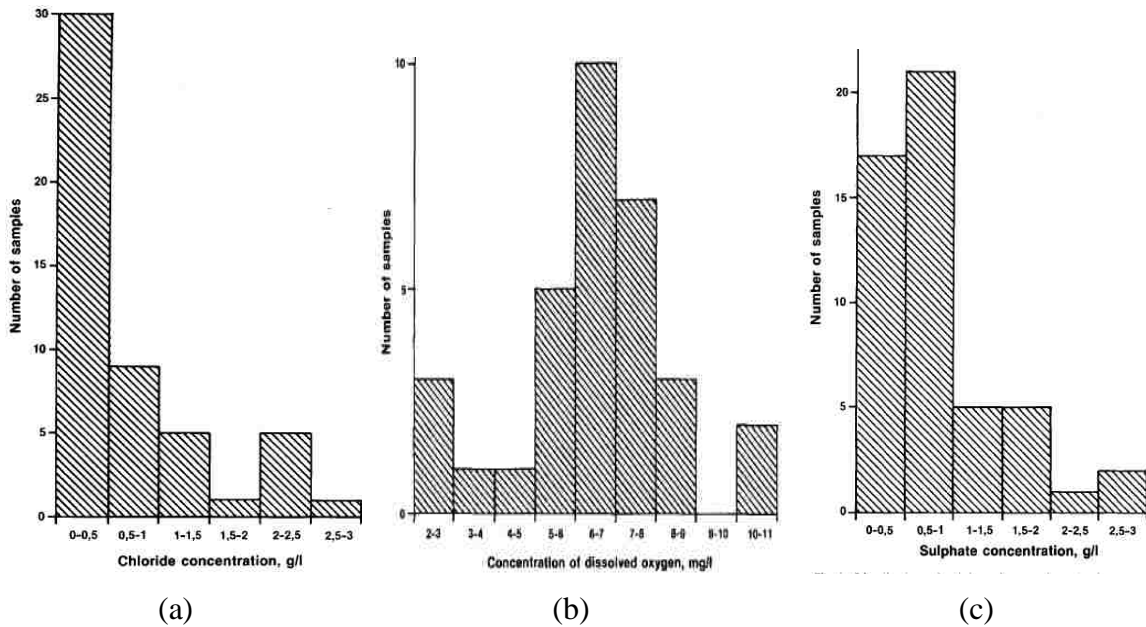
Figure 2.8: (a) Chloride, (b) oxygen and (c) sulfate levels in the ground water of a South African gold mine [38]

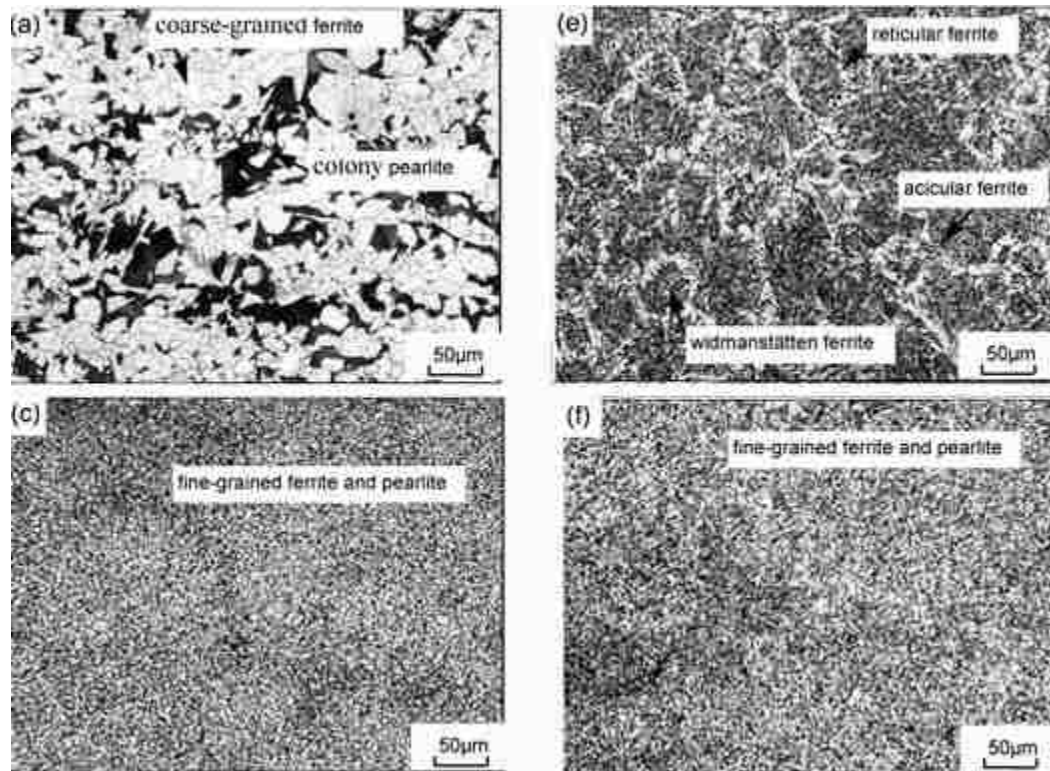
Figure 2.12: Microstructure of Q345 for different heat treatments: (a) base metal zone, (c) recrystallized zone, (e) fusion zone, (f) weld metal zone [53]

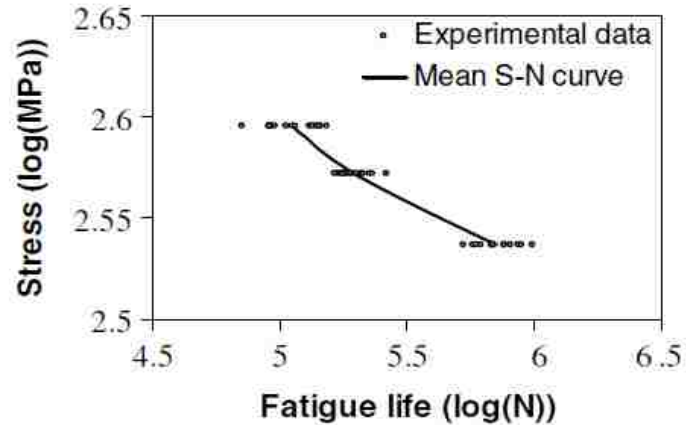
Figure 2.13: High-cycle fatigue life of a 16Mn steel [55]

Fatigue data on 16Mn steel is discussed by Liu and Mahadevan [55]. Stress amplitudes presented were 394 MPa, 373 MPa, and 344 MPa. The associated $\log(N)$ fatigue lives were stated as 5.05 (112,201 cycles), 5.29 (194,948 cycles), and 5.85 (707,945 cycles), respectively. Figure 2.13 shows the fatigue life of the 16Mn steel tested.

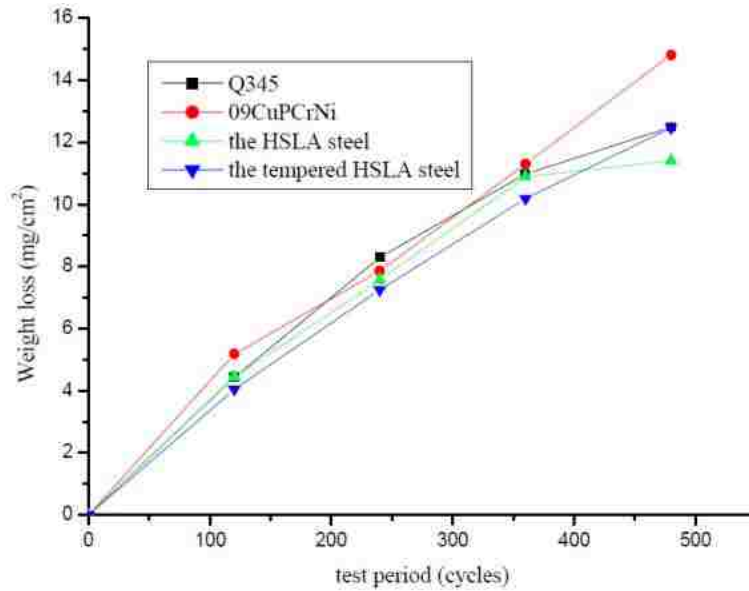
Figure 2.14: Mass-loss corrosion behaviour of Q345 and other HSLA steels after wet/dry cyclic corrosion testing [57]

minutes in the drying condition. Testing lasted for 480 hours, with intermittent pauses to weigh specimens. Results from corrosion testing found the Q345 steel had a mass-loss of approximately $12.5 \text{ mg}\cdot\text{cm}^{-2}$ after 480 hours. Figure 2.14 shows a plot of the mass-loss behaviour of all steels tested as a function of testing time.

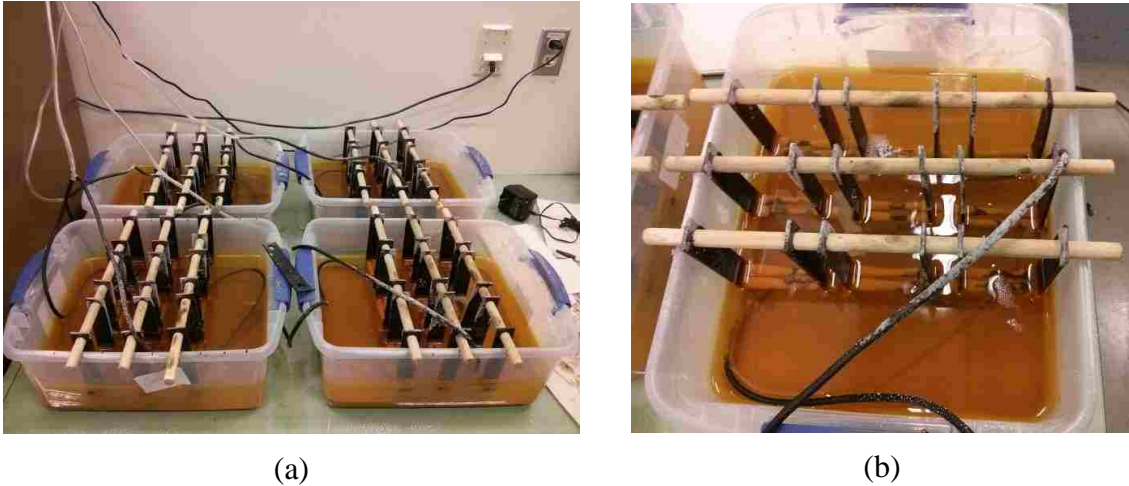
Figure 3.1: Accelerated corrosion test setup: (a) all corrosion containers, and (b) top view of one corrosion container

From recommendations made in ASTM G31, pre-corroded fatigue and tensile specimens were polished using 120-grit silicon carbide paper, and cleaned using an acetone solution prior to corrosion testing. Test specimens were individually suspended in the NaCl solution, avoiding contact with other specimens. Specimens were suspended using non-reactive polycarbonate mounting strips. The corrosion solution was contained in non-reactive polypropylene containers. A container was used for each wheel component tested. Figure 3.1 shows the test setup.

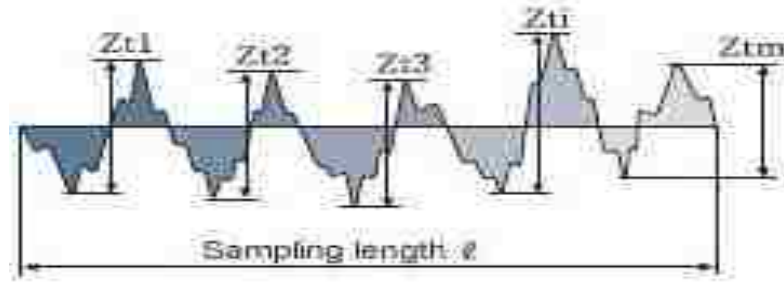
Figure 3.2: Roughness profile with equally spaced roughness readings for calculation of R_z

The level of surface corrosion was evaluated based on surface roughness. A Mitutoyo SurfTest SJ-201 contact surface profilometer was used to measure surface roughness. With this tool, a diamond stylus is moved vertically in contact with a sample, and then moved laterally across the sample over a predefined distance and contact force. The surface roughness profile is generated over the duration of this process. Surface roughness values such as the arithmetic average roughness (R_a), and the surface roughness depth (R_z) are then automatically calculated from the surface profile. R_a roughness represents the mean surface roughness from the generated surface profile. R_z roughness represents the surface roughness depth as taken from a local maximum peak to a local minimum valley. The R_z value is calculated from the mean of five sampling lengths over the total length of the surface roughness profile. Figure 3.2 shows an example surface roughness profile, with five equally spaced sample readings for calculation of the R_z surface roughness.

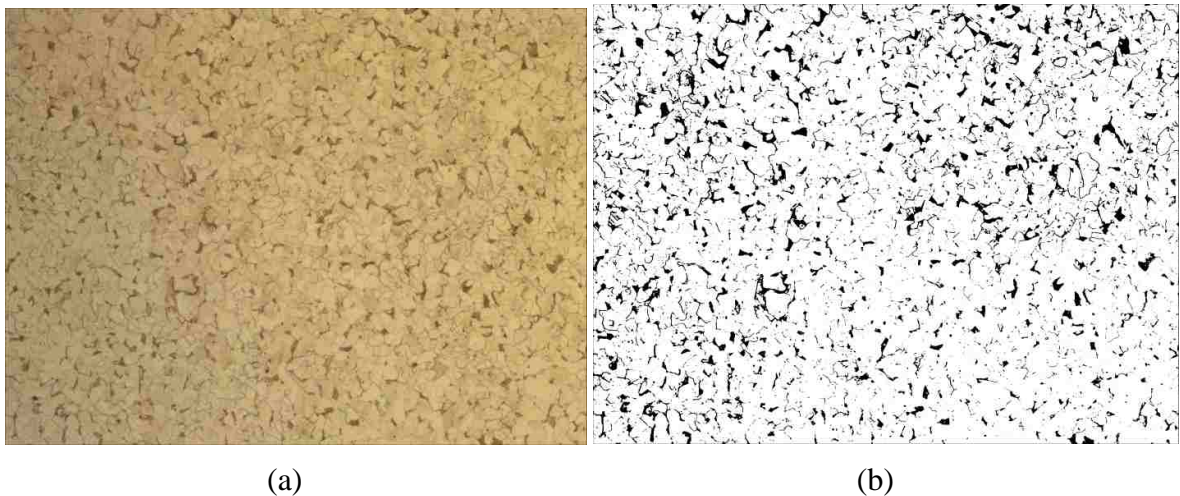
Figure 3.3: (a) 100x micrograph of specimen extracted from the flange, (b) binary image of (a) created using ImageJ

Calculation of area fractions of ferrite and pearlite were performed using ImageJ [60], a public domain Java image processing program. Using ImageJ, micrographs were converted to binary black and white images, with black areas representing pearlite and light areas representing ferrite. Following conversion, the software automatically calculated area fractions of black and white areas. Sometimes, further preprocessing of an image was necessary prior to analysis to remove shadows and other artifacts which might artificially influence area fraction calculations. Figure 3.3 shows an example conversion of a micrograph from colour into binary using ImageJ.

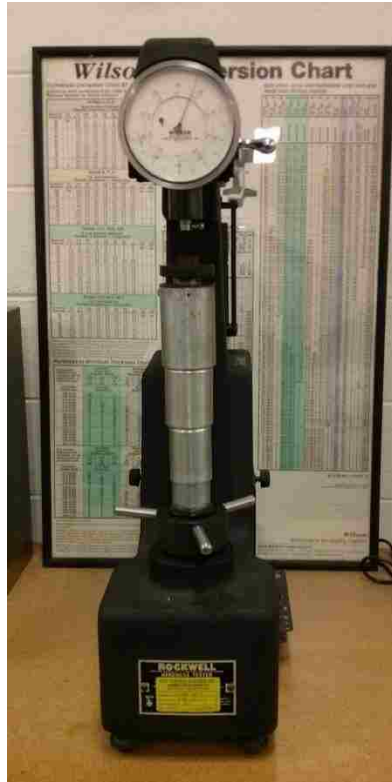
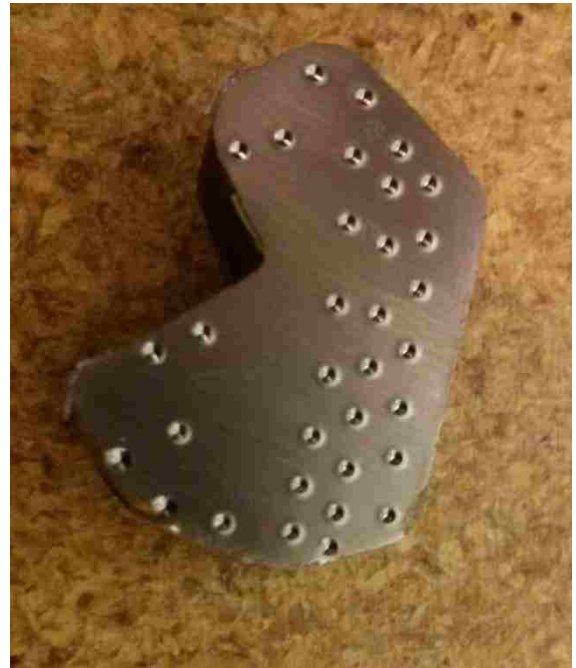
Cross-sectional hardness testing was done using a Wilson Rockwell hardness tester. The machine was verified in accordance with ASTM E18 [62], which details standard testing methods for Rockwell hardness testing of metallic materials. Rockwell B measurements were taken using a 1.588 mm steel sphere with a 100 kgf load. Measurements were recorded across the thickness of each wheel component at intervals of 3-4 mm. Measurements were performed three times at each depth, and average values were used to plot hardness as a function of component depth. Surfaces for all hardness testing samples were machined to be flat, i.e., parallel with the sample mounting surface of the Wilson machine. Furthermore, they were ground up to 600-grit to remove any surface irregularities that might affect hardness testing. Figure 3.4 shows the testing setup with a tested lock ring sample.

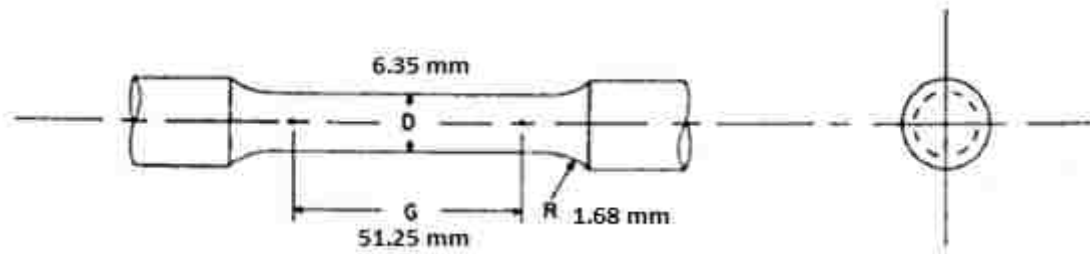
Figure 3.5: Tensile specimen geometry with gauge length, G, of 51.25 mm, fillet radius, R, of 1.68 mm, and gauge diameter of 6.35 mm

A reduced-size, round tensile specimen geometry was used for all tensile tests, in accordance with ASTM E8/E8M [63]. This geometry was selected based on wheel component dimensions, which prevented extraction of sufficient material for manufacture of standard-sized specimens. Overall, tensile specimens had a diameter of 6.35 mm, a fillet radius of 1.68 mm, a holding diameter of 9.52 mm, a gauge length of 51.25 mm, and a total length of 105.41 mm. Figure 3.5 shows the specimen geometry with relevant dimensions.

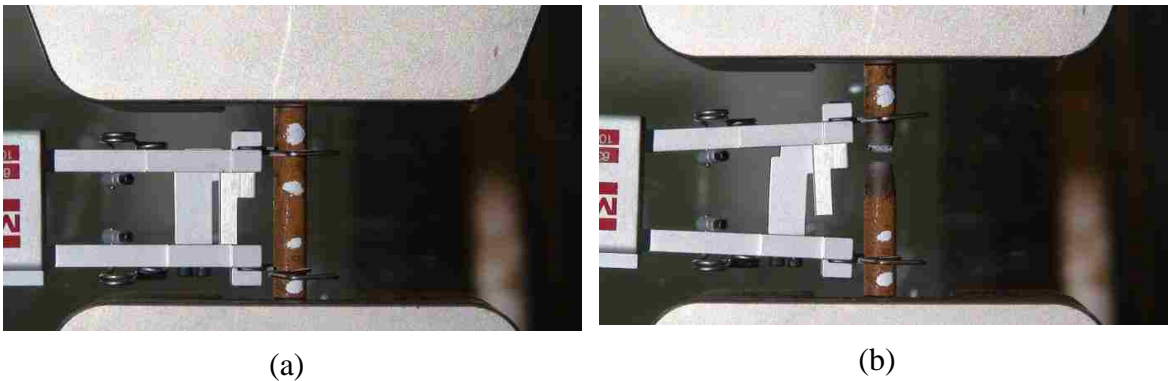
Figure 3.6: Tensile testing of pre-corrosion tensile specimen equipped with extensometer for strain tracking: (a) before testing), and (b) after testing

During testing, an extensometer was placed on the gauge region of the specimens to track specimen strain. Data output from the testing machine computer included the 0.2% offset yield strength, modulus of elasticity, tensile strength, and percent elongation to failure. Additionally, load-elongation measurements were recorded. As a precautionary check, all load-elongation data was processed using suitable software, to ensure testing values output from the MTS computer were accurate. Figure 3.6 shows the test setup with application of the extensometer onto a pre-corroded tensile specimen.

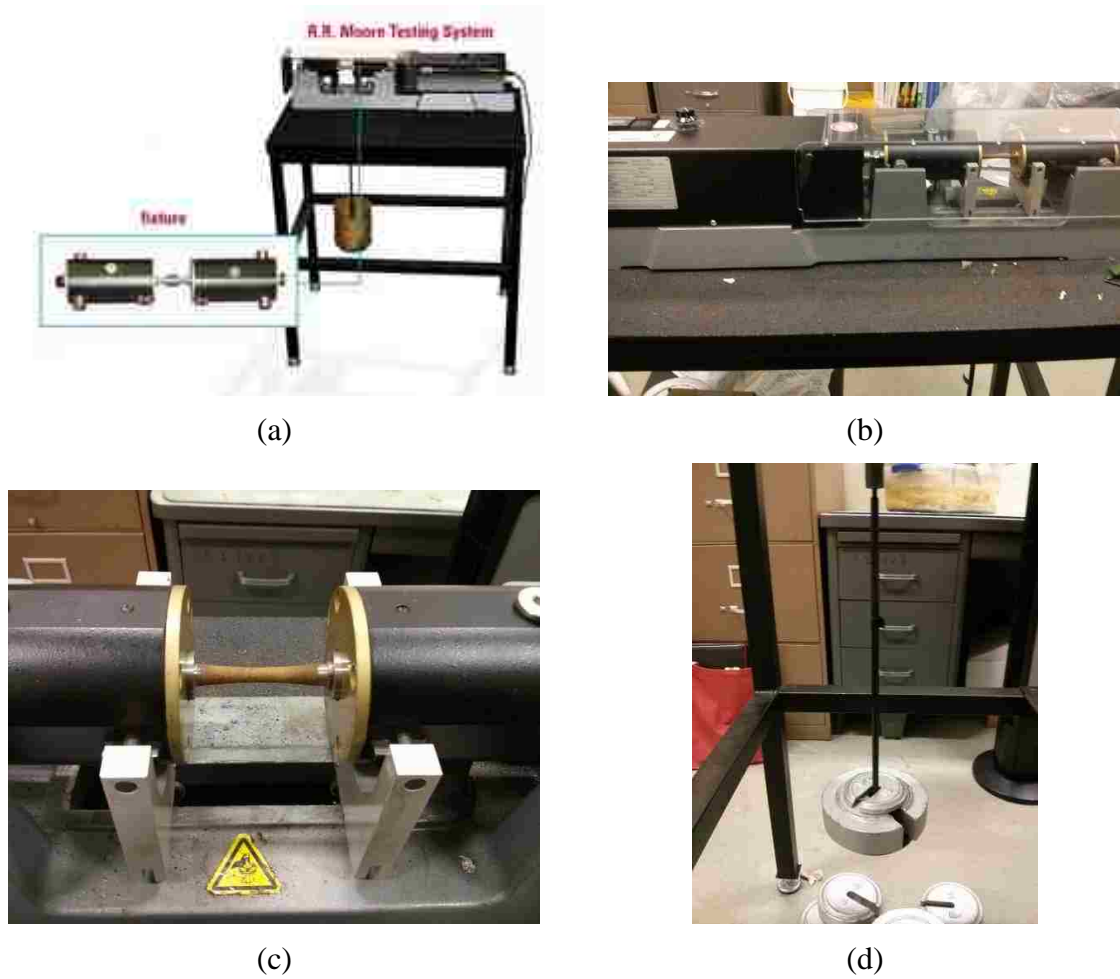
Figure 3.7: (a) Instron illustration of RR Moore system, (b) RR Moore machine in operation, (c) up close image of image machine with pre-corroded specimen, and (d) weights used to adjust specimen stress

Stress-based fatigue testing was conducted on an Instron R.R. Moore rotating-bending fatigue testing machine. Figure 3.7 shows the machine under operation. Testing was performed under ambient atmospheric conditions. The R.R. Moore machine was operated at frequencies ranging from 83 hz to 117 hz (5000 rpm to 7000 rpm). Specific operating frequencies were adjusted for each specimen and loading condition in an effort to minimize machine vibration. Machine vibration would become an issue if operating frequencies approached machine resonant frequencies, which are influenced by loading and specimen imperfections, e.g., non-uniform specimen mass distribution.

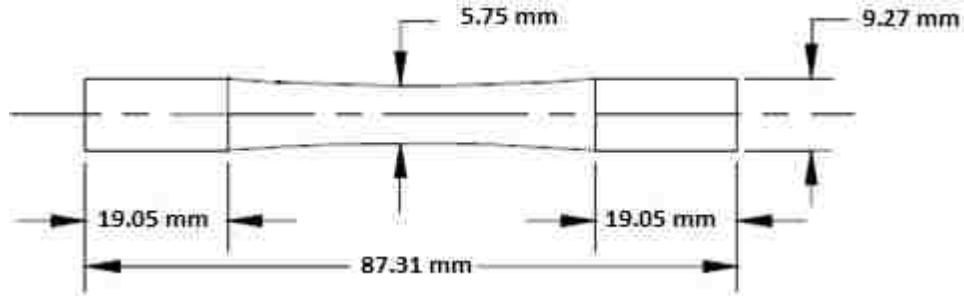
Figure 3.8: Fatigue specimen geometry and dimensions

approximately 5.75 mm, an hourglass section length of 49.21 mm, and a total length of 87.31 mm. Surface area of the fatigue specimen was approximately 23.19 cm².

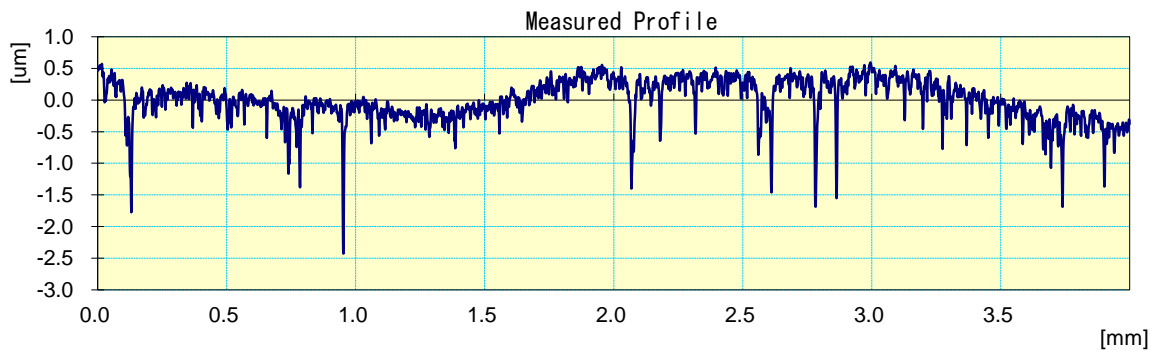
Figure 3.9: Sample roughness profile of fully ground Rim Base fatigue specimen

Fatigue specimens were ground using a drill press operated at 1500 rpm. Fatigue specimens were mounted on the drill press and ground using progressively finer silicon carbide grit papers, ranging in grit from 120-grit to 600-grit. A minimum of three minutes was allocated to grinding for each grit paper for each specimen. Following grinding, the surface roughness of one or two fatigue specimens was measured in an effort to maintain some degree of quality control during the grinding process. Overall, fatigue surface roughness was maintained at or below 0.4 μm , measured using R_a roughness, described in section 3.3.2. A sample roughness profile of a fully ground Rim Base fatigue specimen is included in Figure 3.9.

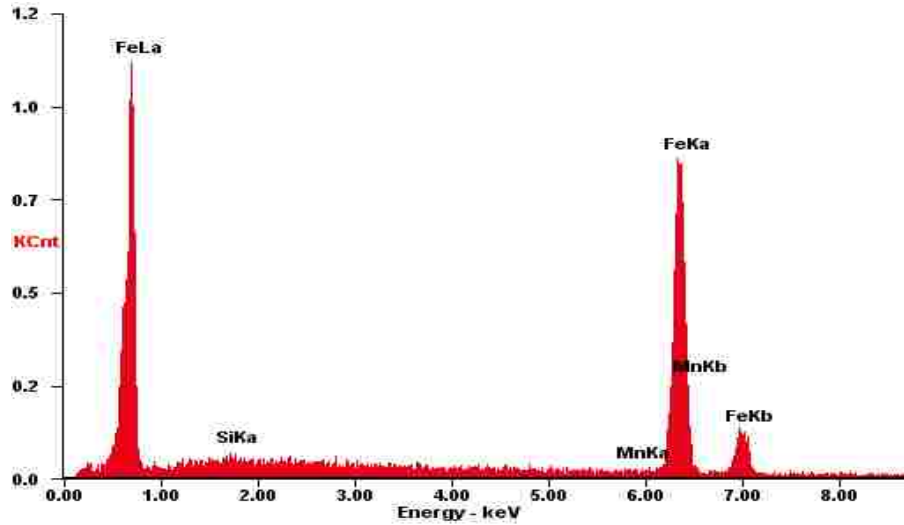
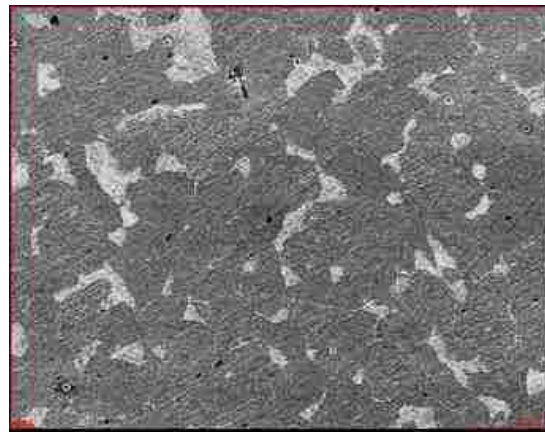
The HSLA structural steel used in fabrication of all wheel components is known as Q345 or 16Mn. Alloying elements in this steel are carbon, manganese, silicon, phosphor, vanadium, and sulfur. To verify that all components of the five-piece wheels in this study were fabricated using the Q345/16Mn alloy, energy dispersive spectroscopy analysis was conducted on steel samples extracted from all components. Elements quantified using the EDS technique were iron, manganese, and silicon. Other alloying elements were too low in concentration to be accurately detected using EDS analysis. Corrections in measurements were made to include a nominal Carbon content of 0.2 wt%, consistent with the Q345 alloy.

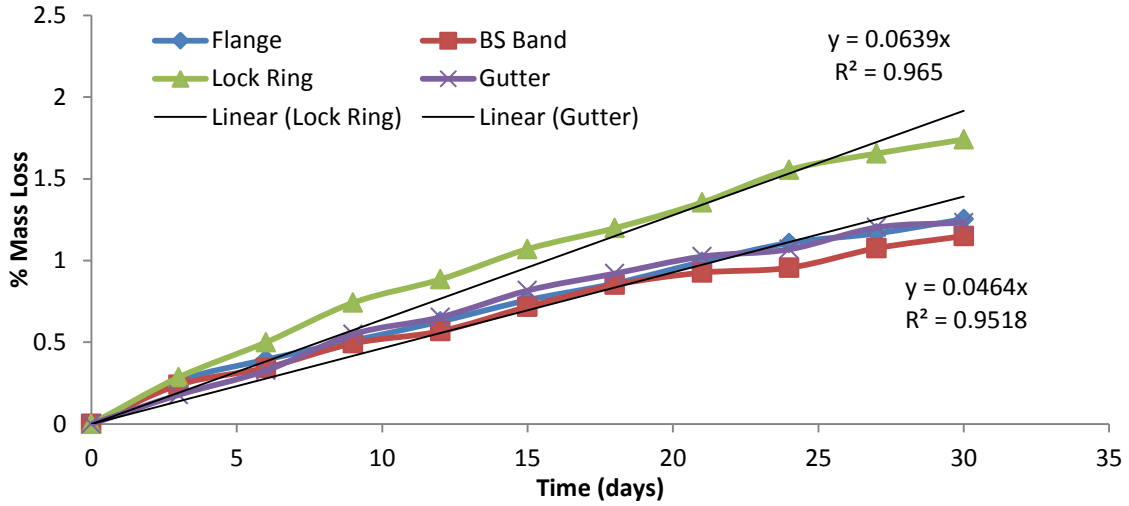
Figure 4.2: Percent mass-loss over time of fatigue specimens submerged in 3.5 wt% NaCl solution

The mass-loss of two fatigue specimens per wheel component was recorded over the duration of submerged corrosion testing. Results from mass-loss tracking are included in Figure 4.2. The average mass-loss of the two tracked fatigue specimens for each wheel condition was used for plotting purposes. In Figure 4.2, mass-loss is displayed as percent mass-loss, which was calculated using Equation (4.1). As can be seen from Figure 4.2, mass-loss measurements are consistent for the Flange, BS Band and Gutter. Mass-loss measurements are higher for the Lock Ring, with an increase in percent mass-loss of approximately 41% relative to the BS Band after 30 days of submerged corrosion testing, calculated using Equation (4.1).

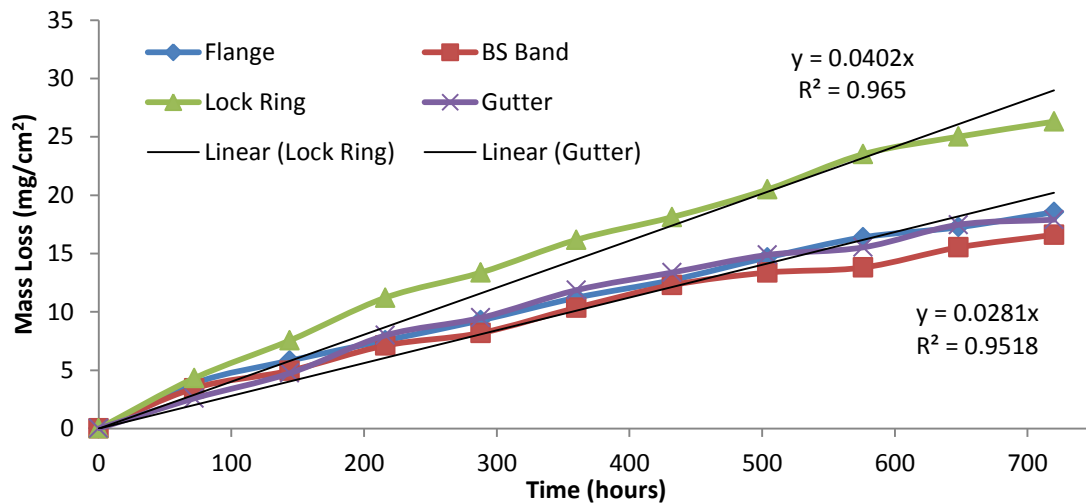
Figure 4.3: Surface area mass-loss over time of fatigue specimens submerged in 3.5 wt% NaCl solution

To compare the mass-loss of Q345 under fully submerged corrosion testing with data in the literature, Equation (3.2) was used. In this equation, mass-loss is calculated as the difference in initial and final specimen mass divided by specimen surface area. This method of reporting mass loss is commonly used in the literature for corrosion tracking. Figure 4.2 is re-plotted as Figure 4.3, using Equation (3.2). In Figure 4.3 it can be seen that the surface area mass-loss (SAML) rates as a function of hours for the Lock Ring and Gutter regions are 0.0402 and 0.0281, respectively, measured in $\text{mg}\cdot\text{cm}^{-2}\cdot\text{hrs}^{-1}$. Converted to days, these rates become 0.9648 and 0.6744, respectively, measured in units of $\text{mg}\cdot\text{cm}^{-2}\cdot\text{day}^{-1}$.

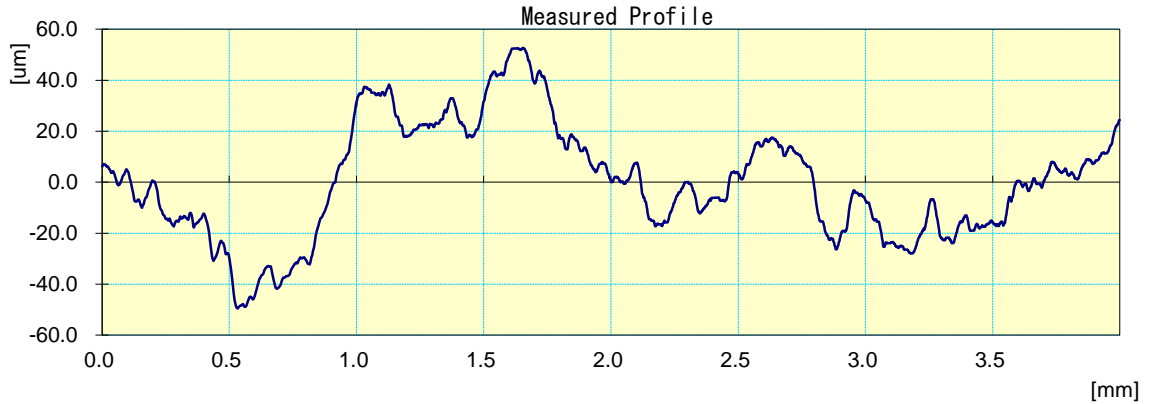
Figure 4.4: Surface roughness profile of pre-corroded fatigue specimen

component. From the two figures, it can be seen that the two roughness profiles are of the same magnitude. Furthermore, qualitatively, the two profiles have similar shapes.

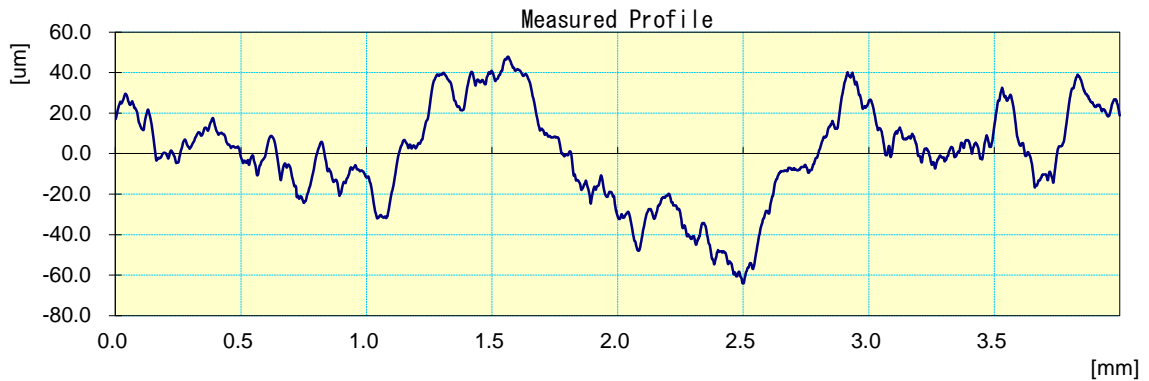
Figure 4.5: Surface roughness profile of in-service corroded wheel component

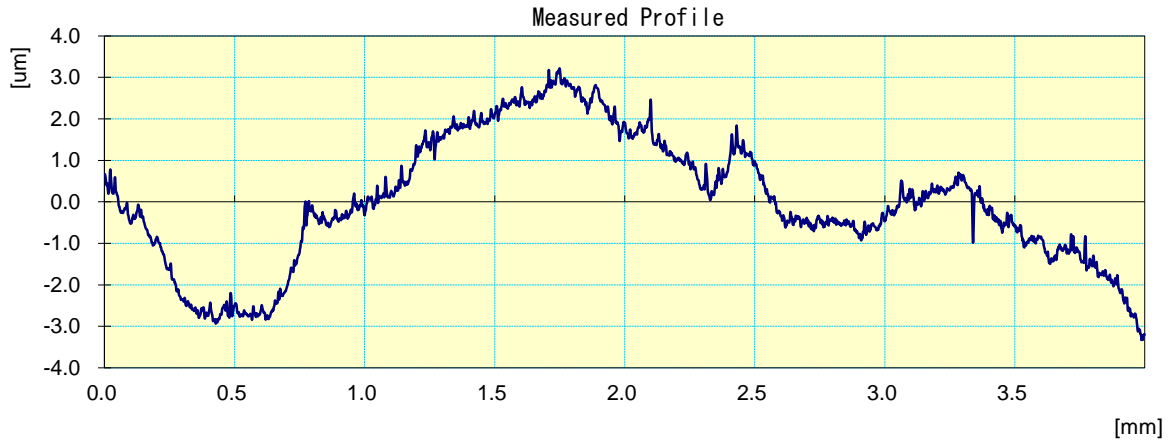
Figure 4.6: Roughness profile of new painted flange

Surface roughness measurements were also taken of new wheel components. A sample roughness profile taken from a new painted flange is presented in Figure 4.6. From the profile, it can be seen that the roughness measurements range from approximately $-3.0 \mu\text{m}$ to $3.0 \mu\text{m}$. In contrast, worn wheel and pre-corroded specimen roughness measurements ranged in values from approximately $-60.0 \mu\text{m}$ to $60.0 \mu\text{m}$ as shown in Figure 4.4 and Figure 4.5. The new wheel roughness range is approximately 20 times lower than that of the measured worn wheel, and is representative of the overall degradation that occurs to in service wheels exposed to wear and corrosion. This degradation in surface roughness is detrimental to the high-cycle fatigue behaviour of wheels, as discussed in section 2.2. The R_a and R_z roughness values for the new wheel profile of Figure 4.6 are $1.02 \mu\text{m}$ and $4.67 \mu\text{m}$, respectively. A summary of all roughness values discussed in this section is included in Table 4.3.

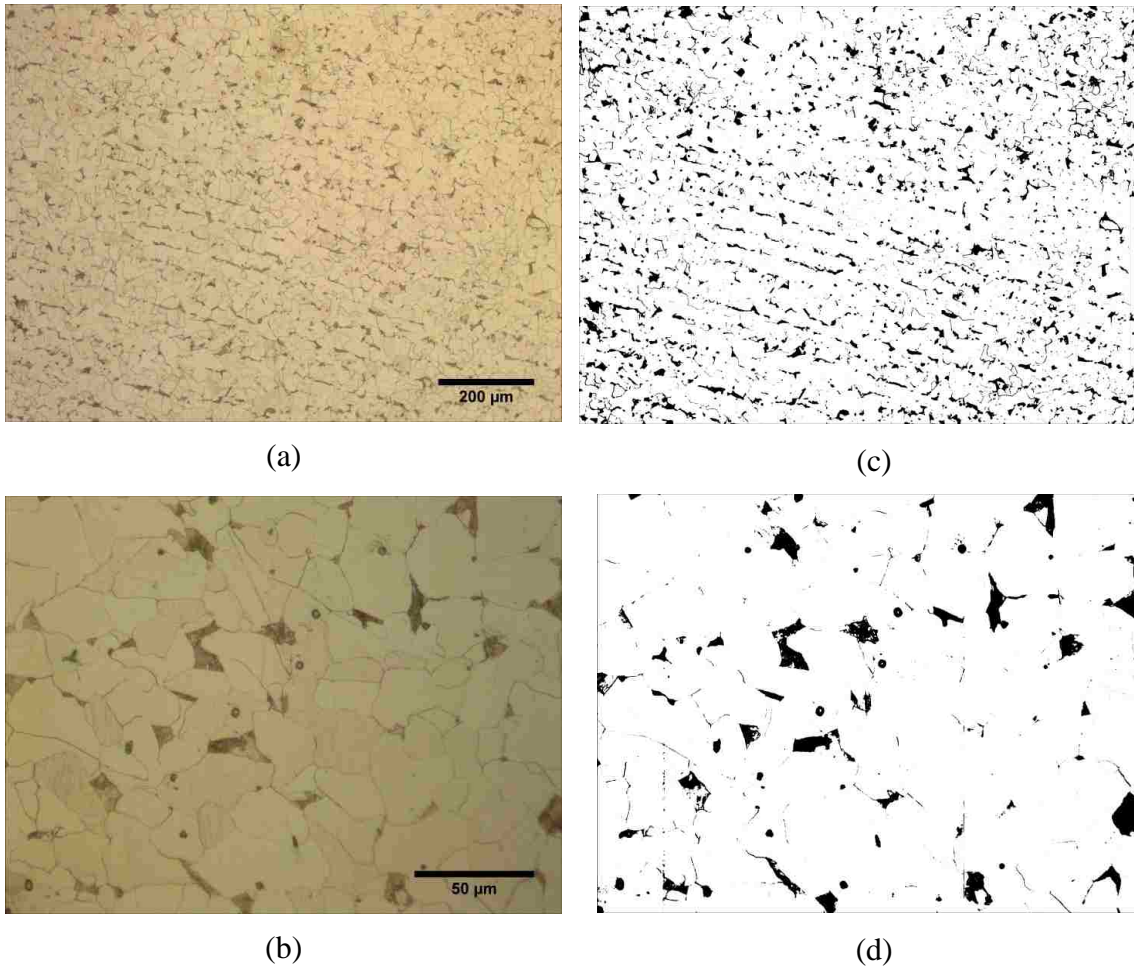
Figure 4.7: Micrographs of Rim Base at (a) 100x, (b) 500x, and in binary at (c) 100x, (d) 500x

Low and high magnification micrographs taken from material samples of each component are included in Figure 4.7 - Figure 4.11. In each figure, colour micrographs are included, as well as black and white micrographs. The black and white micrographs were used to evaluate area fractions of ferrite and pearlite in each microstructure.

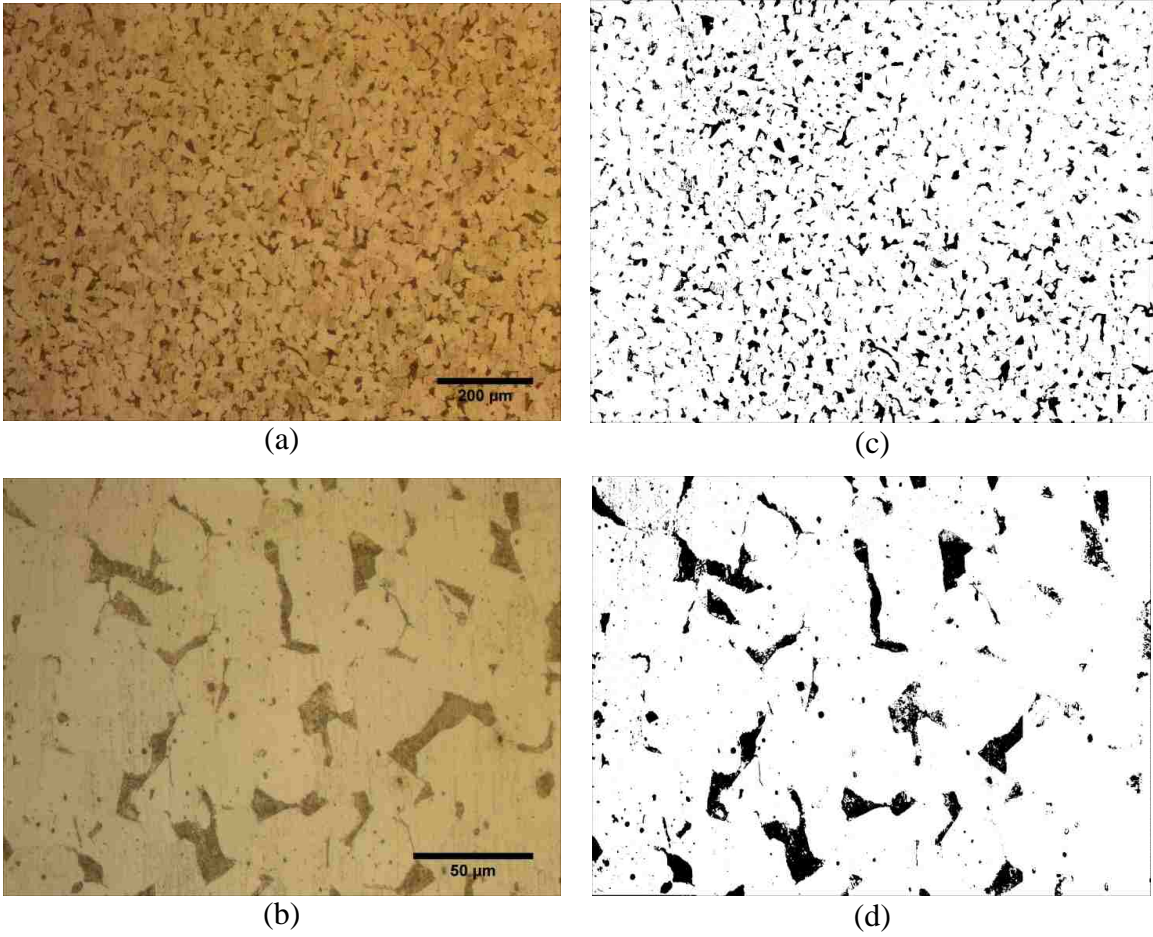
Figure 4.8: Micrographs of BS Band at (a) 100x, (b) 500x, and in binary at (c) 100x, (d) 500x

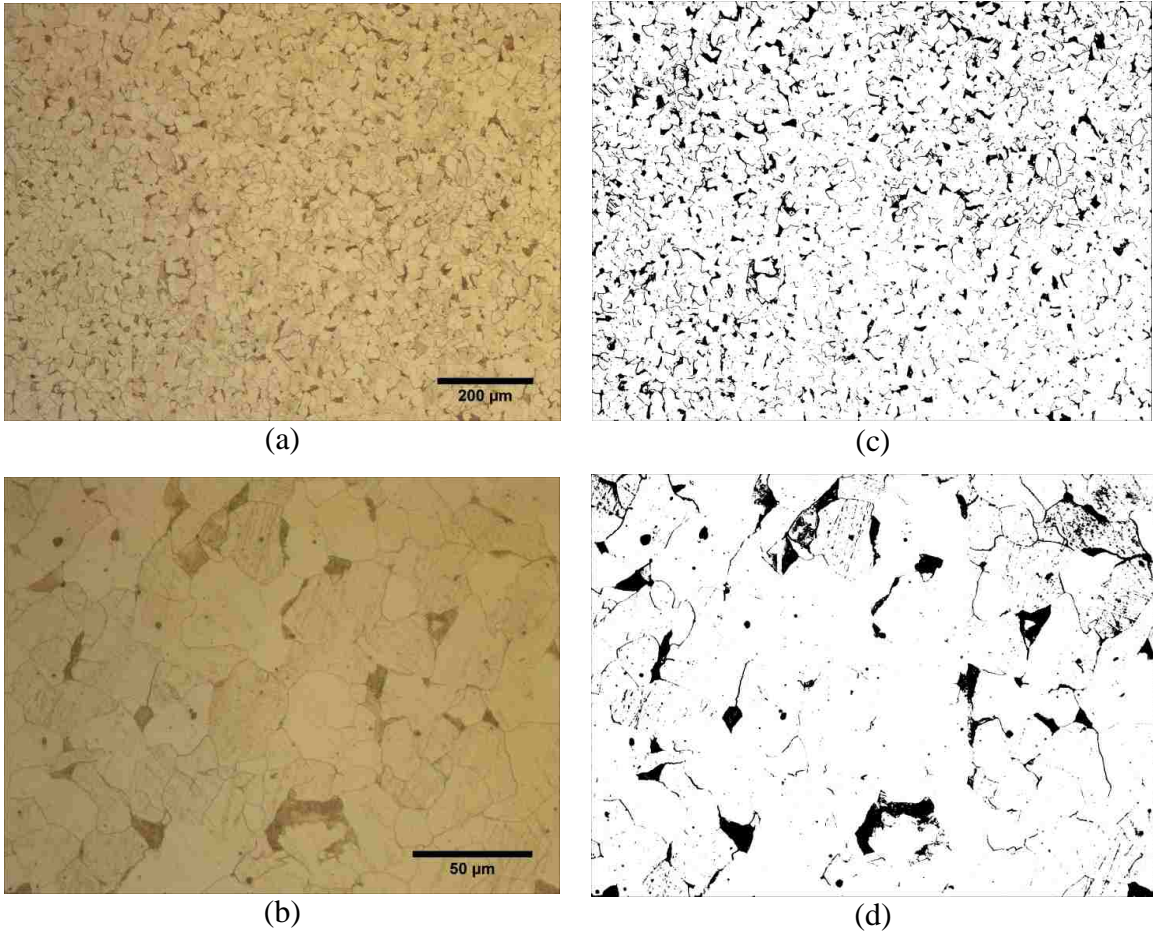
Figure 4.9: Micrographs of Flange at (a) 100x, (b) 500x, and in binary at (c) 100x, (d) 500x

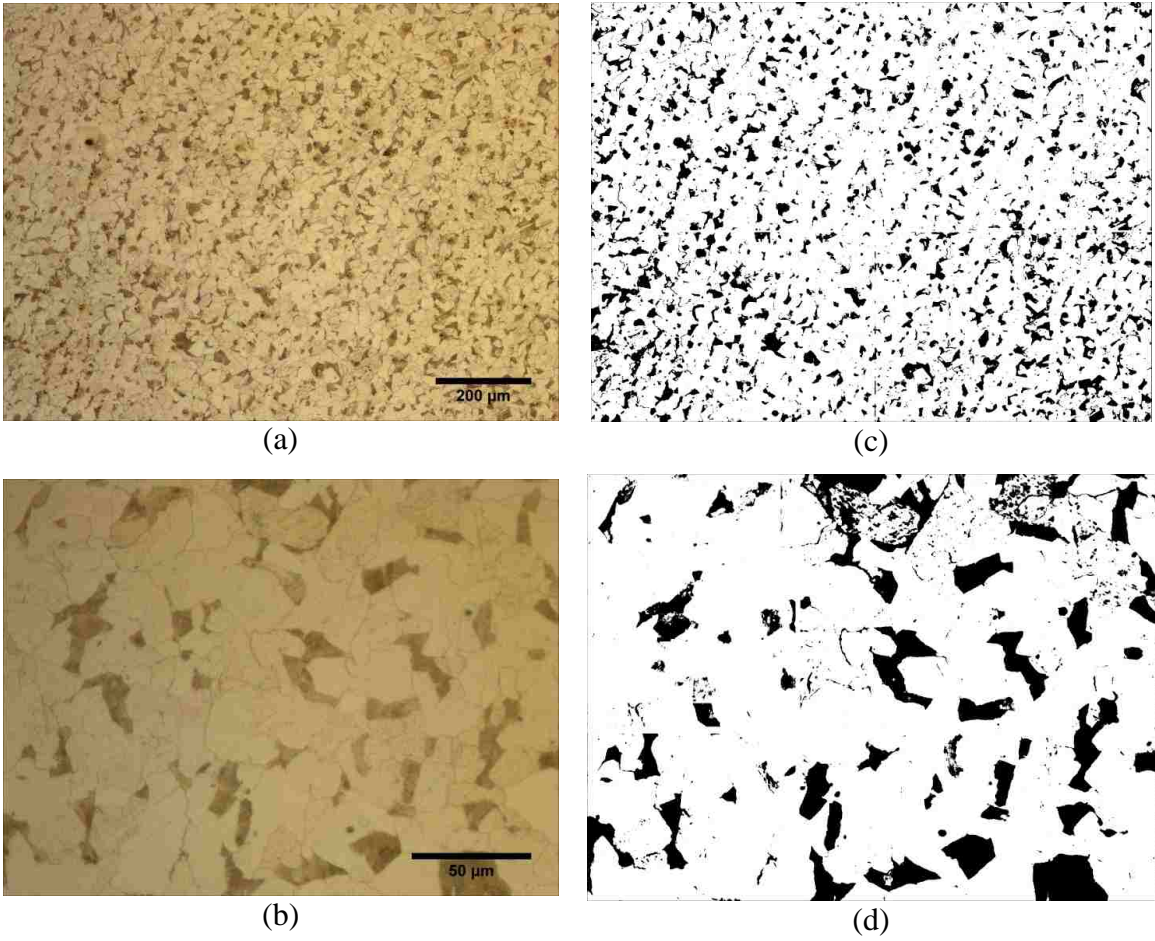
Figure 4.10: Micrographs of Gutter at (a) 100x, (b) 500x, and in binary at (c) 100x, (d) 500x

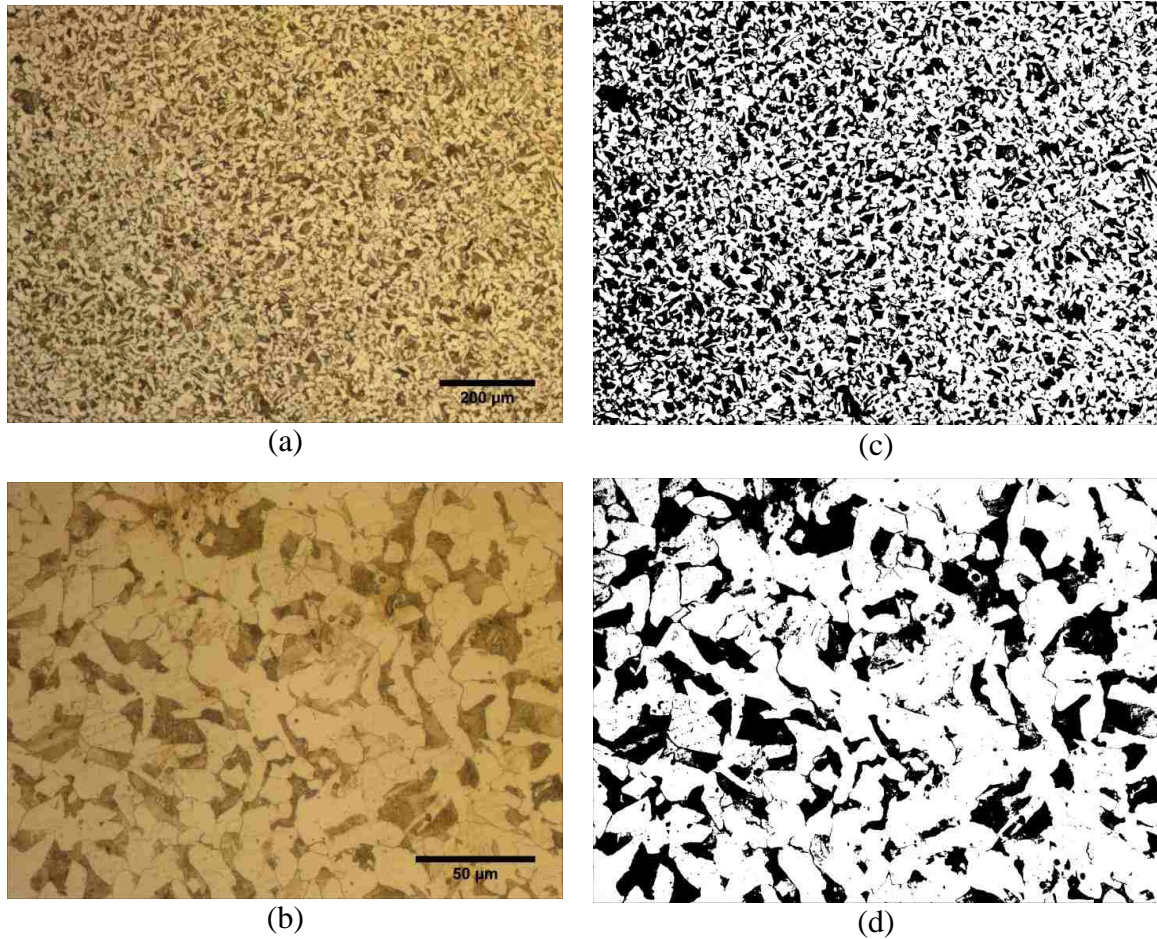
Figure 4.11: Micrographs of Lock Ring at (a) 100x, (b) 500x, and in binary at (c) 100x, (d) 500x
