Mechanical and Material Characterization of Mining Wheels for Enhanced Safety

A Thesis

Submitted to the Faculty of Graduate Studies
through the Department of Engineering Materials
in Partial Fulfillment of the Requirements for
the Degree of Master of Applied Science
at the University of Windsor

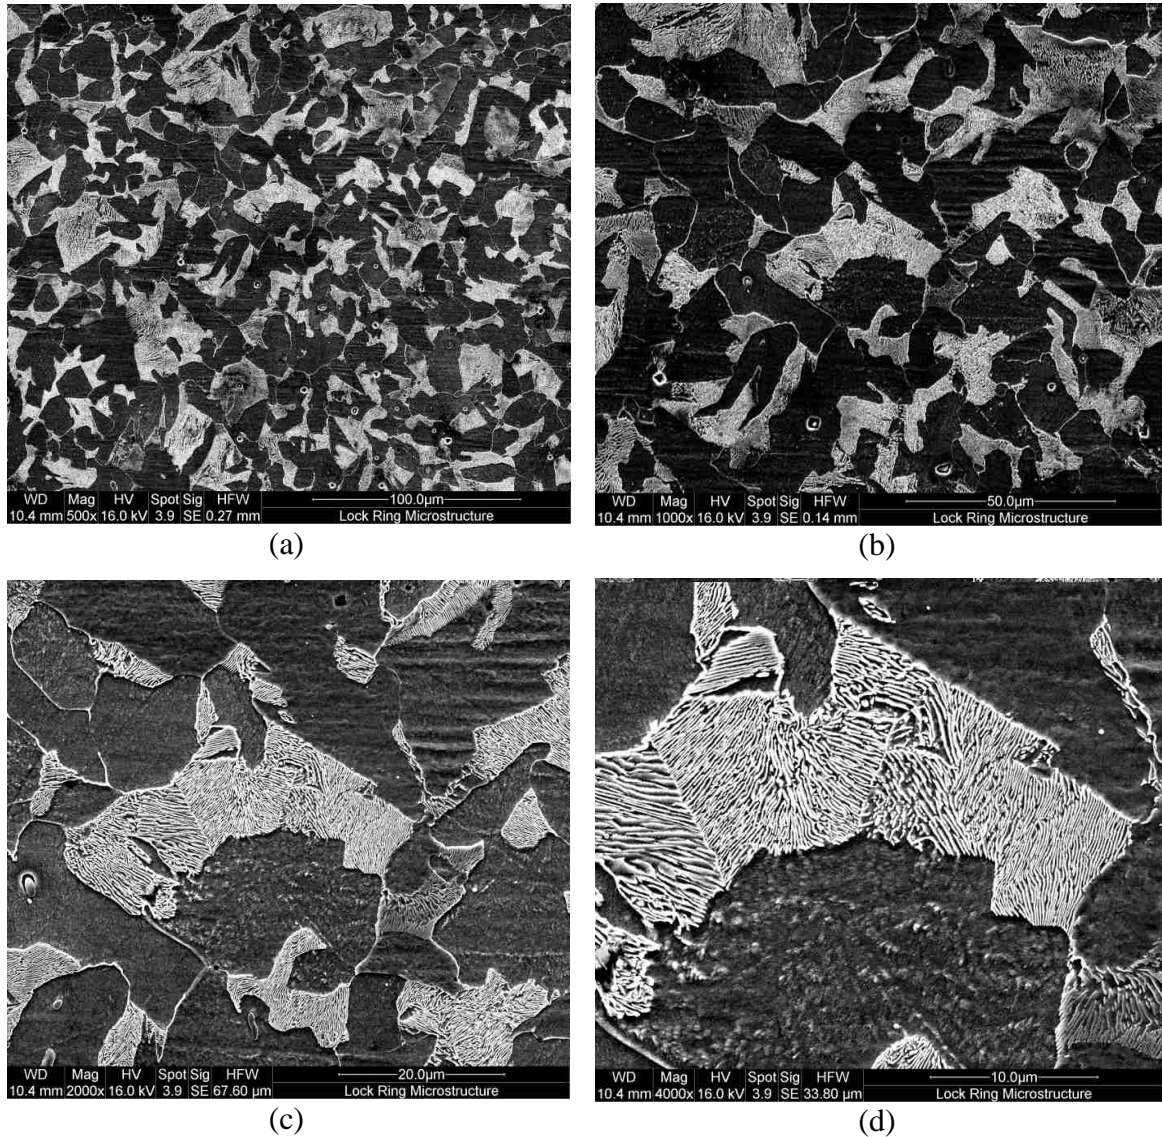
Figure 4.12: SEM micrographs of Lock Ring (a) 500x, (b) 1000x, (c) 2000x, and (d) 4000x

Figure 4.12 shows the Lock Ring sample evaluated under low and high magnifications using a scanning electron microscope. From the high magnification SEM micrographs, it can be seen that the unresolved consist of a lamellar (layered) type microstructure. This is the typical microstructure of pearlite. The layers are thin phases of ferrite, and cementite, the two phases present in low-carbon steels. The pearlite microstructure is much stronger and harder than the ferrite phase. This strength increase is attributable to the presence of the hard cementite phase, and the small layer spacing. The presence of pearlite in steel should improve yield and UTS properties, but reduce ductility. The presence of pearlite in the microstructure is consistent with the work of other microstructural studies of the Q345 alloy [52] - [54]. SEM analysis conducted on other wheel components also found the unresolved regions to be pearlite; however, micrographs of these components have been omitted to avoid repetition.

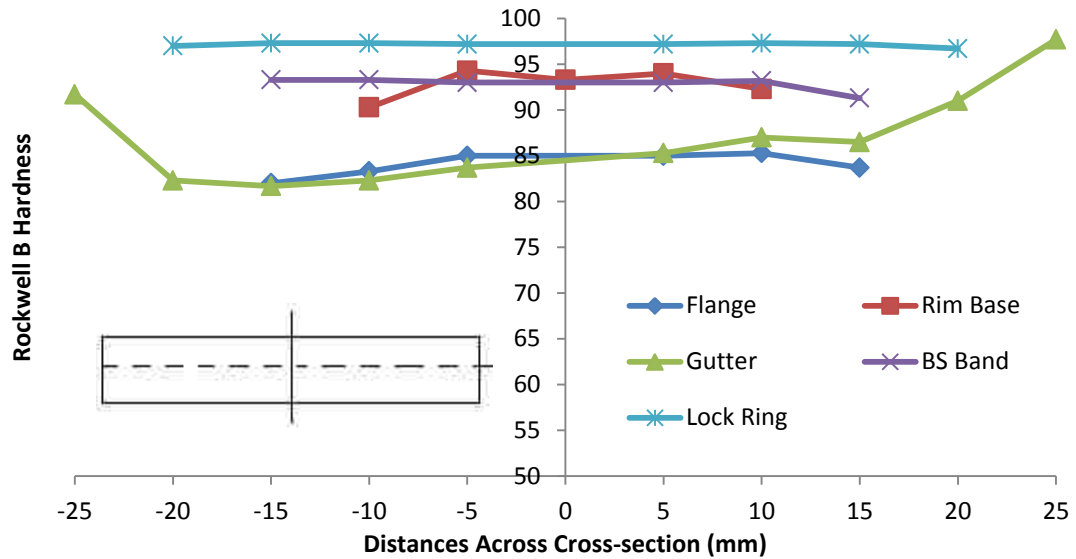
Figure 4.13: Component HRB hardness as a function of depth

Similar trends in Gutter region hardness were also reported in the work of Zhang & Fleek [11], discussed in section 2.1.2. In their work, surface hardness readings were near 99 HRB, consistent with the findings of the present hardness testing (~97 HRB). Conversely, core hardness readings in their work were near 90 HRB, while core hardness readings of the Gutter in this study were closer to 80 HRB, as shown in Figure 4.13. Overall, variations in Gutter region hardness are indicative that fatigue and tensile specimens will be more representative of the Gutter core than the Gutter surface.

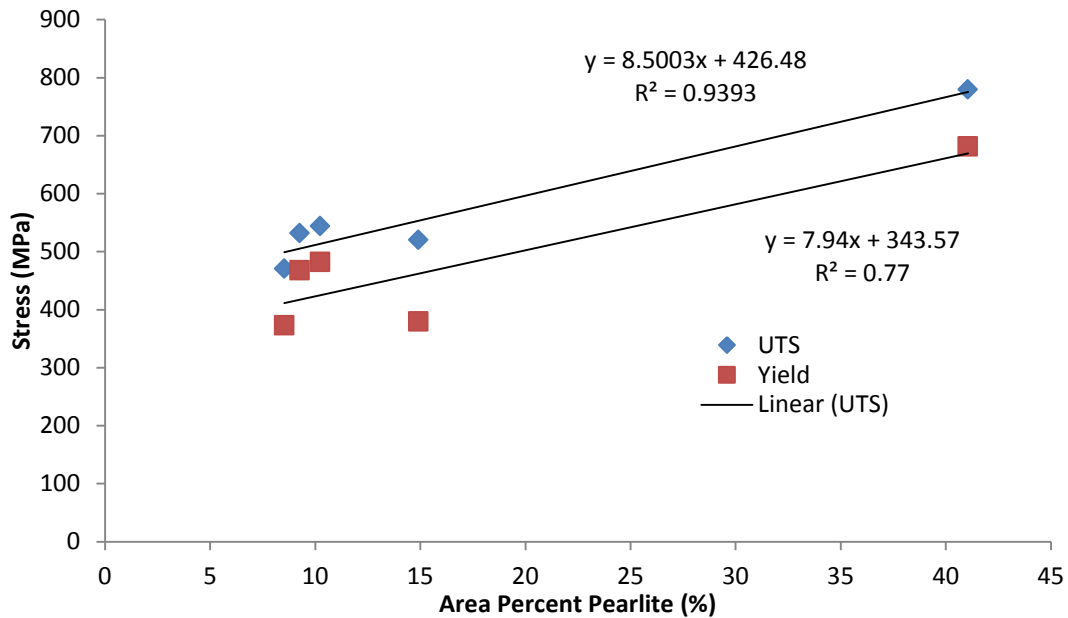
Figure 4.14: Yield strength and ultimate tensile strength as a function of pearlite content for as-extracted wheel component tensile testing

relationship with the pearlite content in the alloy, for the ranges observed in this work. To verify if this relationship is truly linear, a wider range of pearlite contents should be examined in future work. The tensile properties of pearlite fractions between extreme values should also be evaluated.

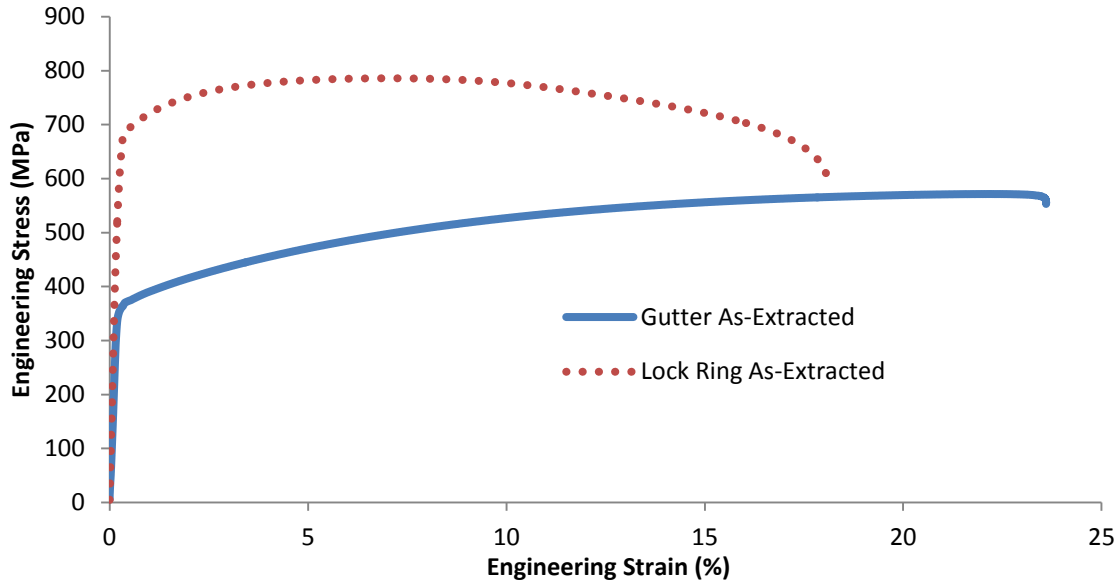
Figure 4.15: Engineering stress-strain behaviour of as-extracted specimens from the Lock Ring and the Gutter

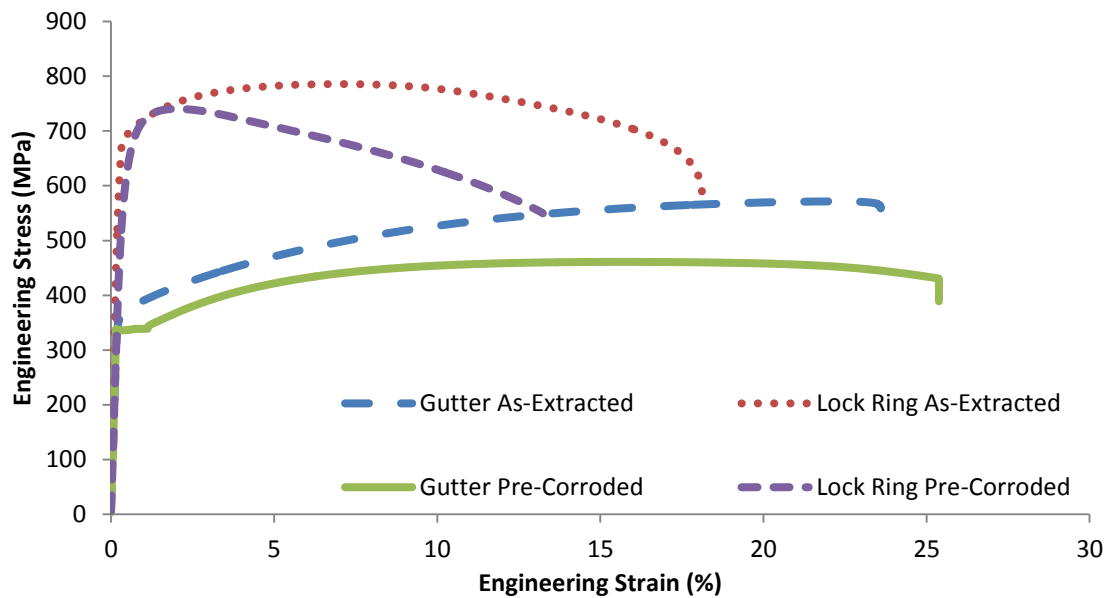
Figure 4.16: As-extracted and pre-corroded stress-strain curves of Lock Ring and Gutter specimens

Pre-corroded stress-strain curves of the two components reflect the data presented in Table 4.7 and Table 4.8, showing minimal changes in YS and UTS values between the two specimen conditions. On the other hand, the pre-corroded Lock Ring specimen shows a decrease of 27% in total elongation before failure, while the pre-corroded Gutter specimen only shows a 7.6% decrease in total elongation. These decreases in total elongation may be associated with corrosion; however, they should not play a great role in fatigue performance, which has a stronger dependence on UTS than maximum percent elongation.

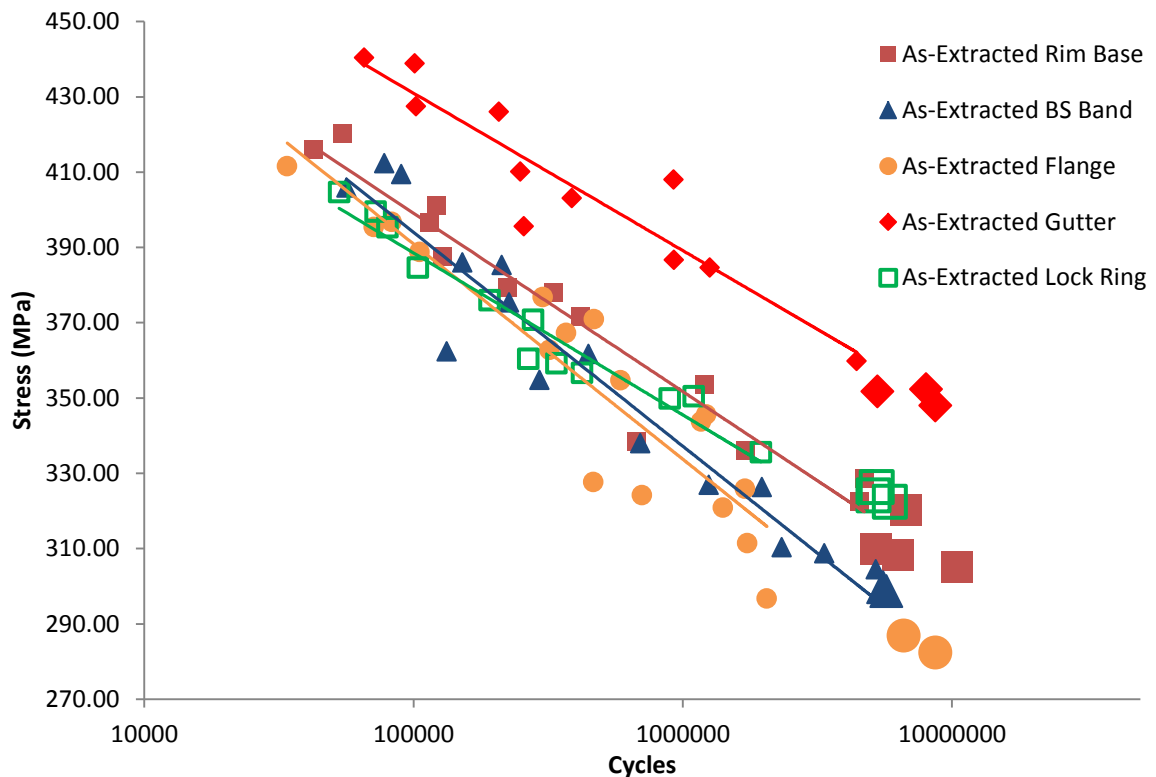
Figure 4.17: High-cycle fatigue behaviour of as-extracted specimens from all wheel components

Results from fatigue testing of specimens in the as-extracted condition are plotted on an S-N curve, in Figure 4.17. The larger data points correspond to fatigue specimens that did not fail after 5,000,000 cycles or more, and provide a rough estimate of the endurance limit for each fatigue dataset.

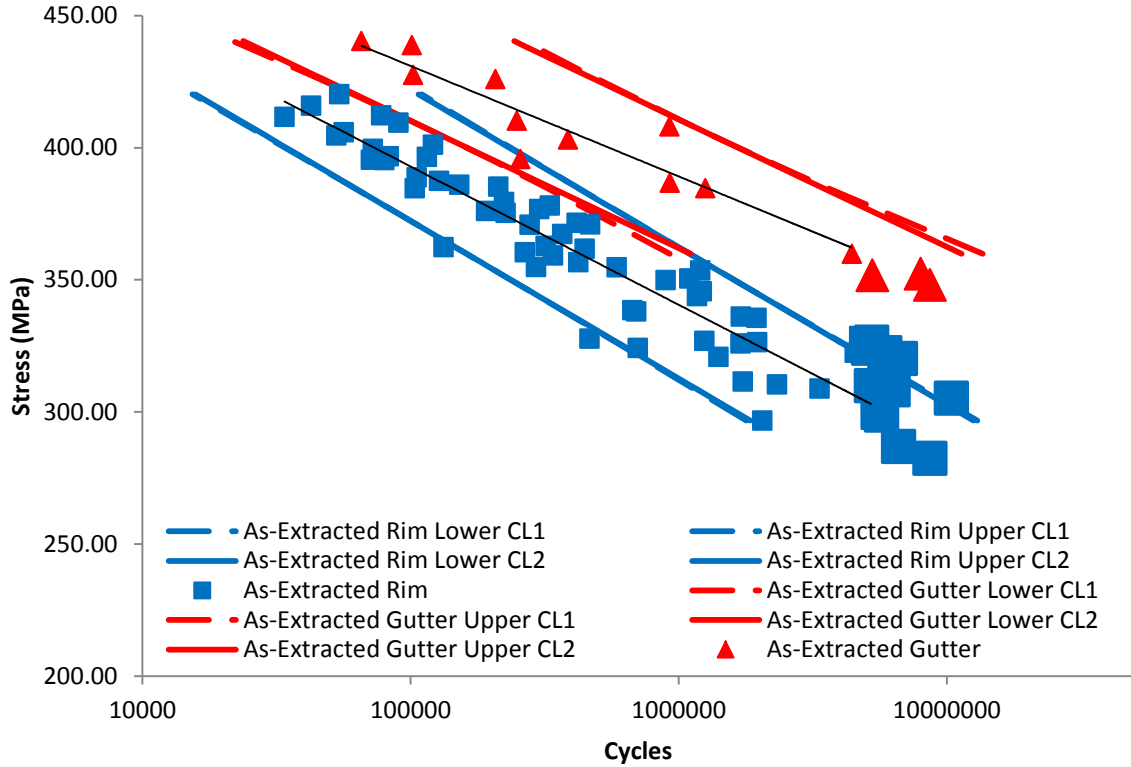
Figure 4.18: As-extracted fatigue data with upper and lower confidence bands

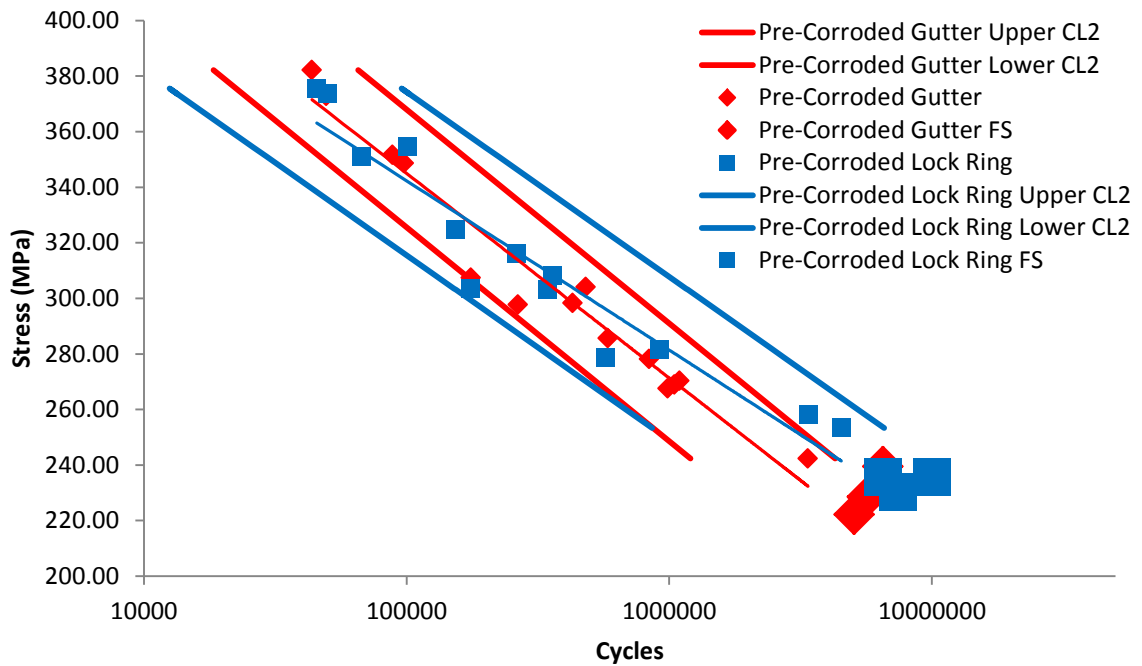
Figure 4.19: S-N fatigue behaviour of pre-corroded Lock Ring and Gutter datasets

Pre-corroded fatigue results from Lock Ring and Gutter specimens are included as S-N curves in Figure 4.19. Base 10 log-linear fits using Equation (4.2) are included for both datasets. Additionally, upper and lower confidence limits, generated using Equation (3.3) are also included. Results from statistical analysis of each dataset, consistent with the procedures of sections 2.3 and 4.6.1, are included in Table 4.12. Results include reliability and dataset classification, per ASTM E739 [31]. Equations describing each dataset are also included.

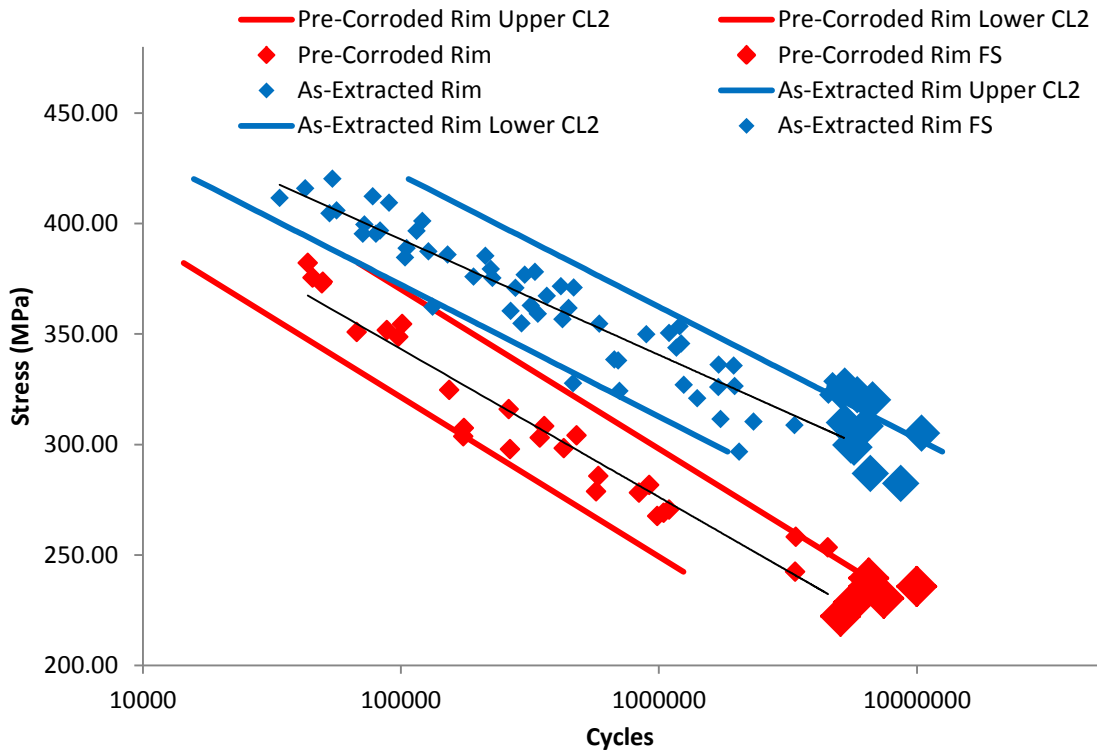
Figure 4.20: S-N curves of as-extracted and pre-corroded 'Rim' fatigue datasets

replications and the large number of data points in each dataset, both datasets fall under the classification of “Reliability”, highlighting the reliability of the data.

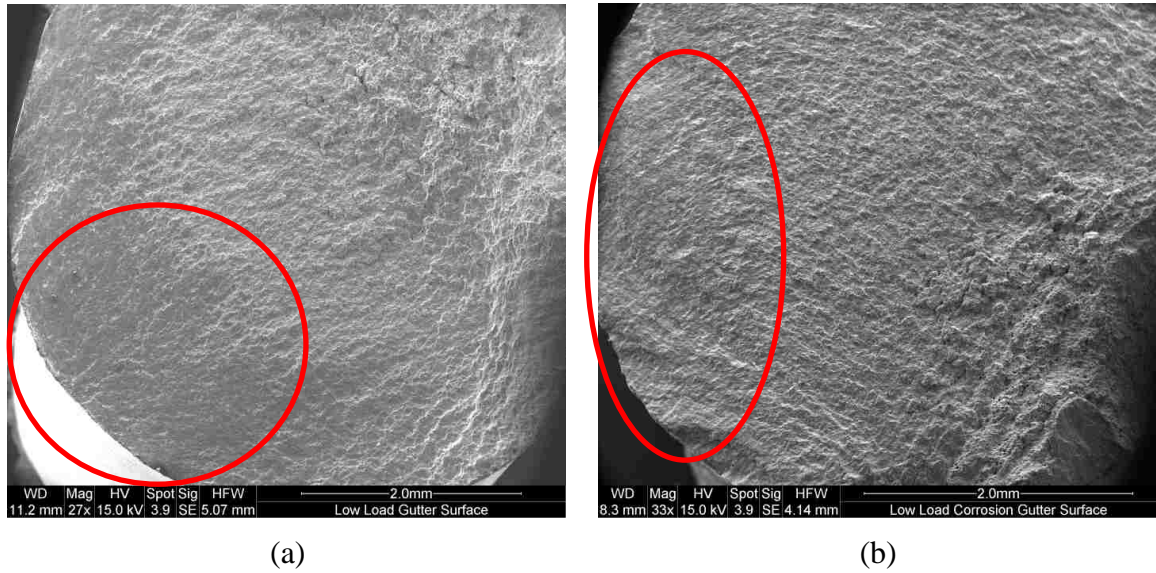
Figure 4.21: Fracture surfaces of low-load Gutter fatigue specimens (a) as-extracted and (b) pre-corroded

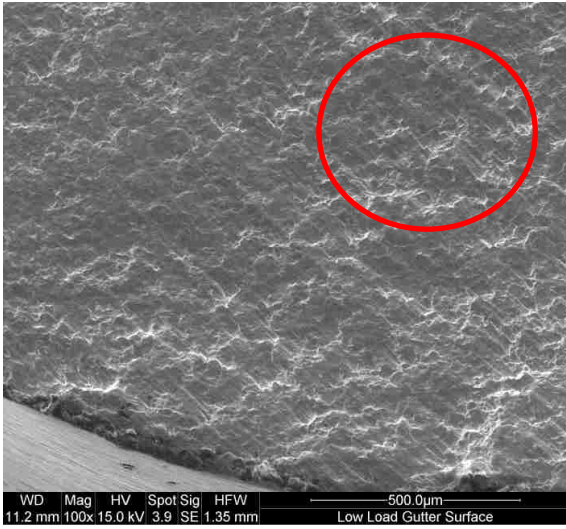
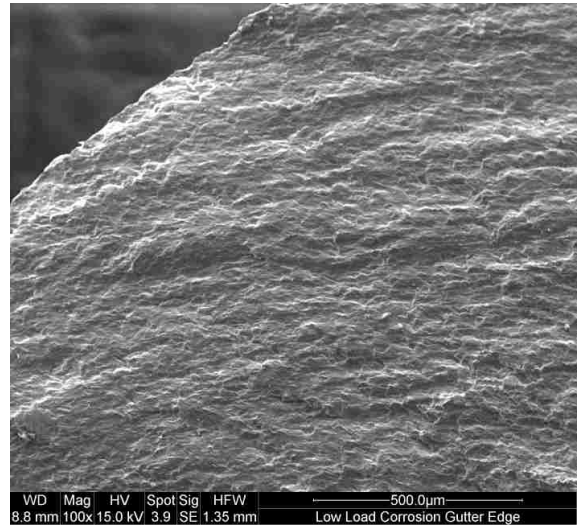
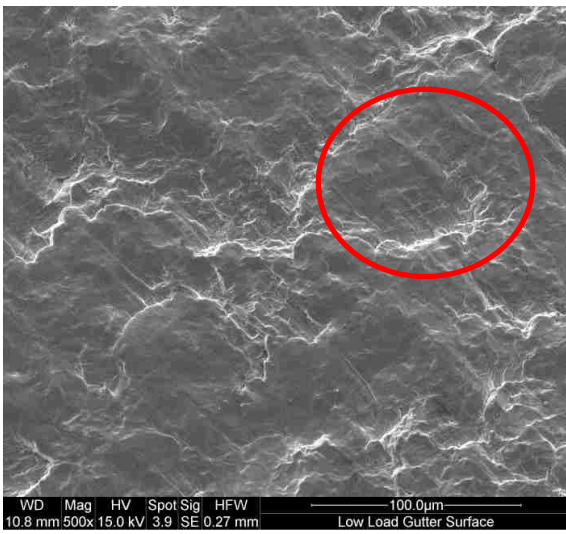
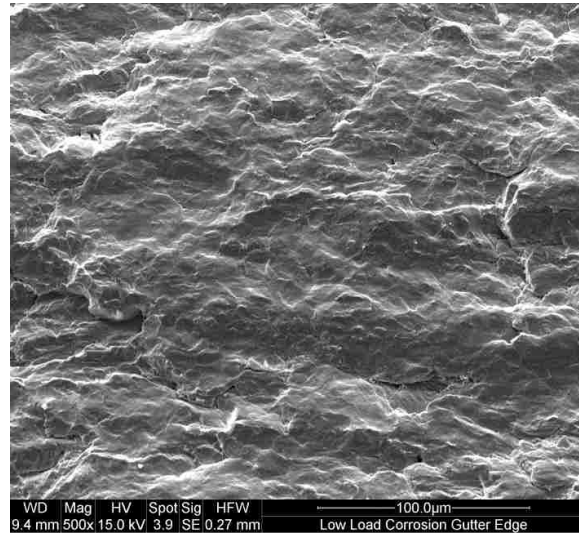
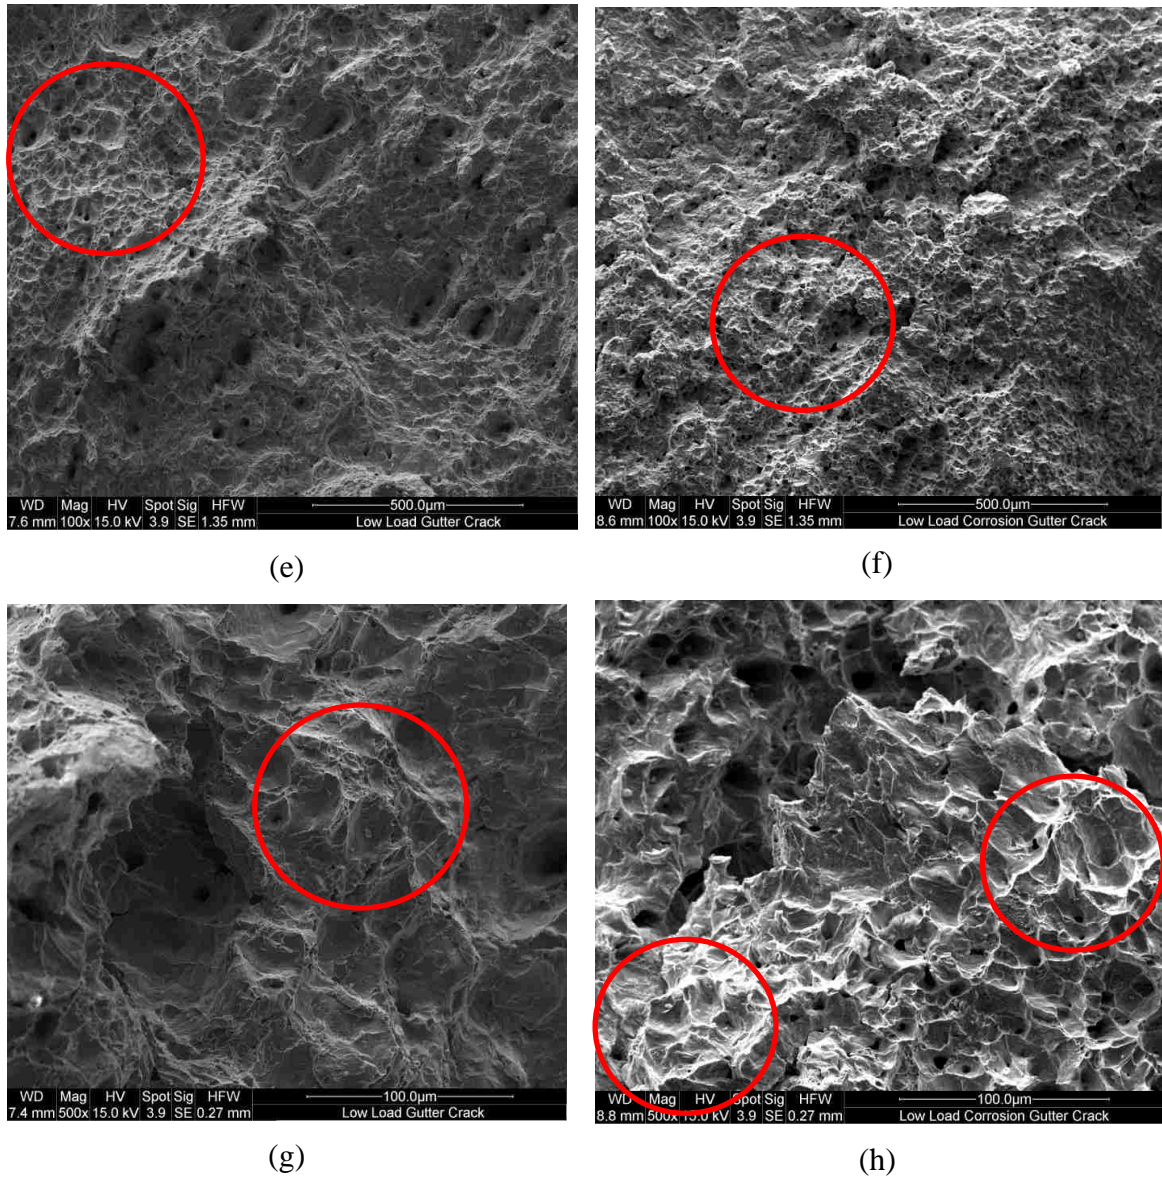
Figure 4.22: Higher magnification SEM fractographs of low-load Gutter fatigue specimens in the (left) as-extracted and (right) pre-corroded conditions. From top to bottom: (a,b) 100x, (c,d) 500x fatigue initiation zone; (e,f) 100x, (g,h) 500x fatigue failure zone.

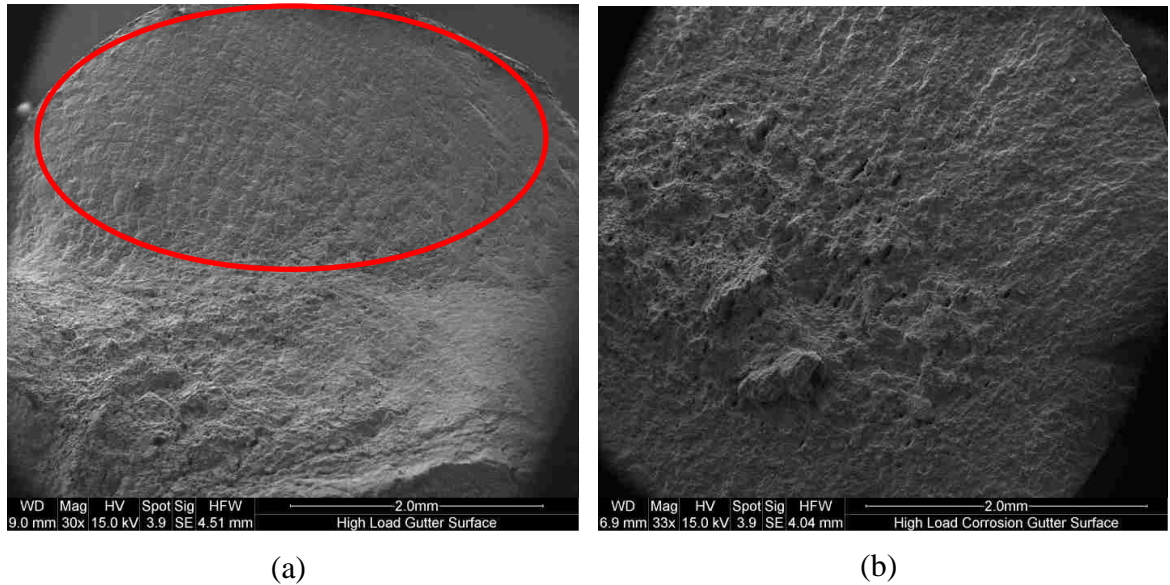
Figure 4.23: Fracture surfaces of high-load Gutter fatigue specimens (a) as-extracted and (b) pre-corroded
