2011

### The Effect of Sliding Contact Friction on Surface Quality of Aluminum Sheet Products

A Thesis  
Submitted to the Faculty of Graduate Studies  
through Engineering Materials  
in Partial Fulfillment of the Requirements for  
the Degree of Master of Applied Science at the  
University of Windsor

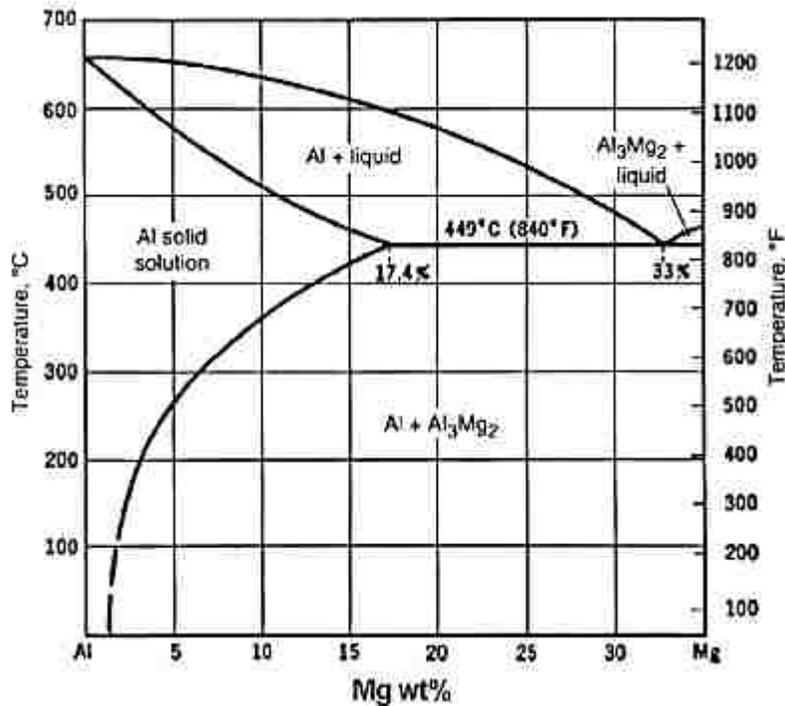
Figure 1 Phase diagram of binary Al-Mg system. The magnesium concentration is in wt. % [6]

Magnesium has a high solubility in aluminum up to 17.4 wt. %, and as shown on, the Al-Mg phase diagram (Figure 1), it undergoes precipitation hardening for it possesses a positively sloping solvus. Commercially however, this is not the case as the formation of the required second-phase precipitates ( $\text{Al}_3\text{Mg}_2$ ) is difficult, and therefore they cannot be heat-treated [6]

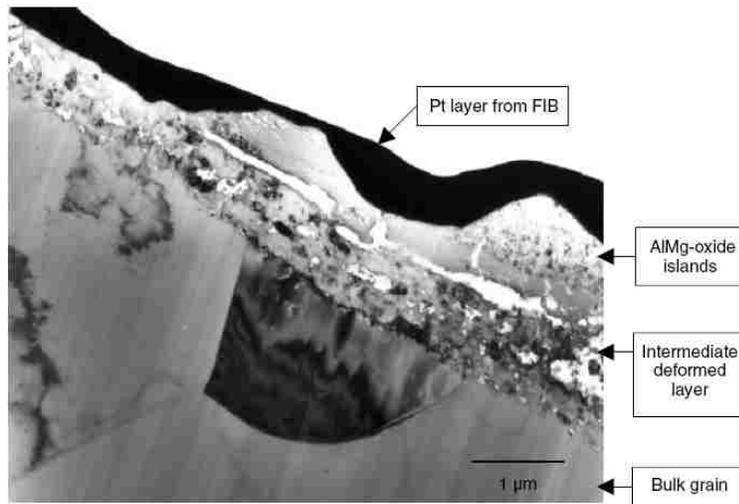
**Figure 2 Bright-field TEM analysis of the near-surface of a cross-section of hot rolled and annealed AlMg0.5 [30]**

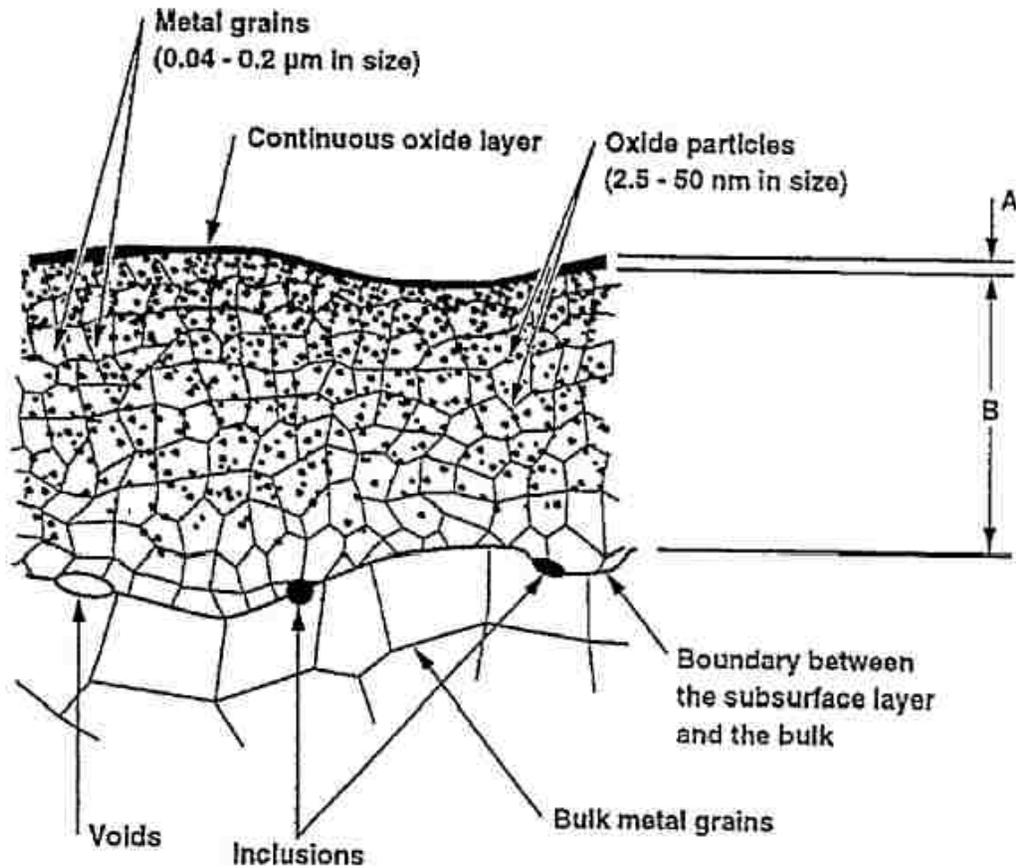
Figure 3 Schematic representation of subsurface layer containing microcrystalline oxides mixed with small grained material and covered with a continuous surface oxide. A represents the surface oxide layer and B represents the subsurface ultrafine grained layer [21]

(iii) The holes are covered over with thin metal layers during the continuing rolling process which leads to a *shingled* surface appearance.

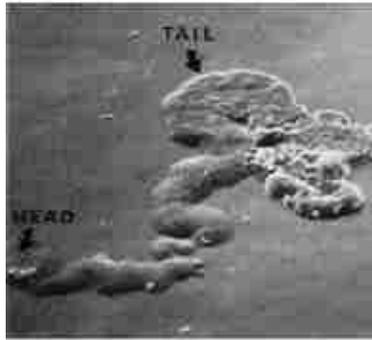
Figure 4 Advancing head and cracked tail section of a filiform cell [29]

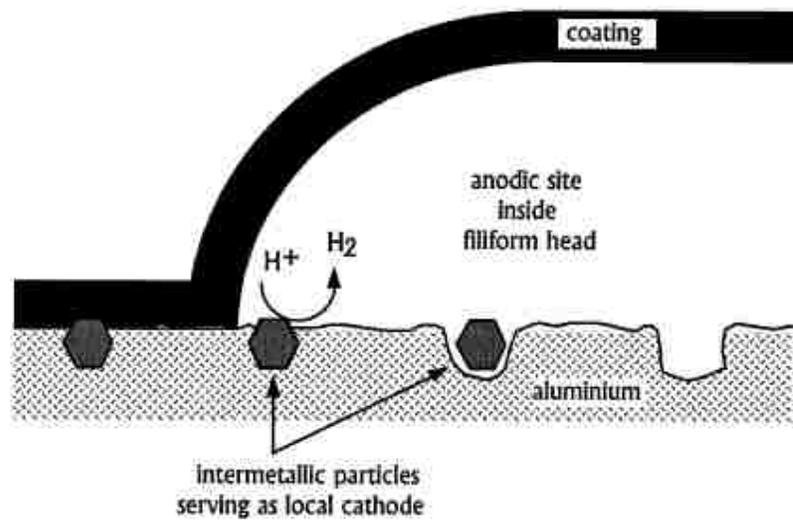
Figure 5 Effects of intermetallic particles on the propagation behaviour of filiform filaments [49]

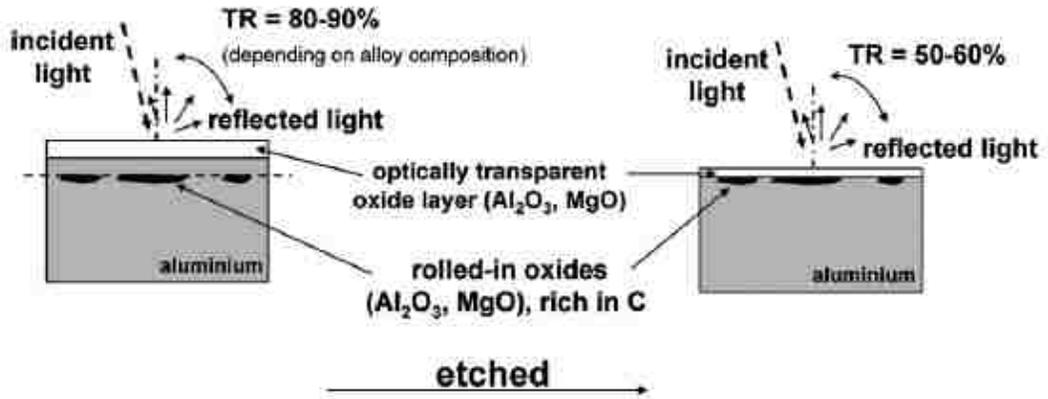
Figure 6 Schematic of the influence of the rolled-in oxides on the Total Reflectance (TR) [31]

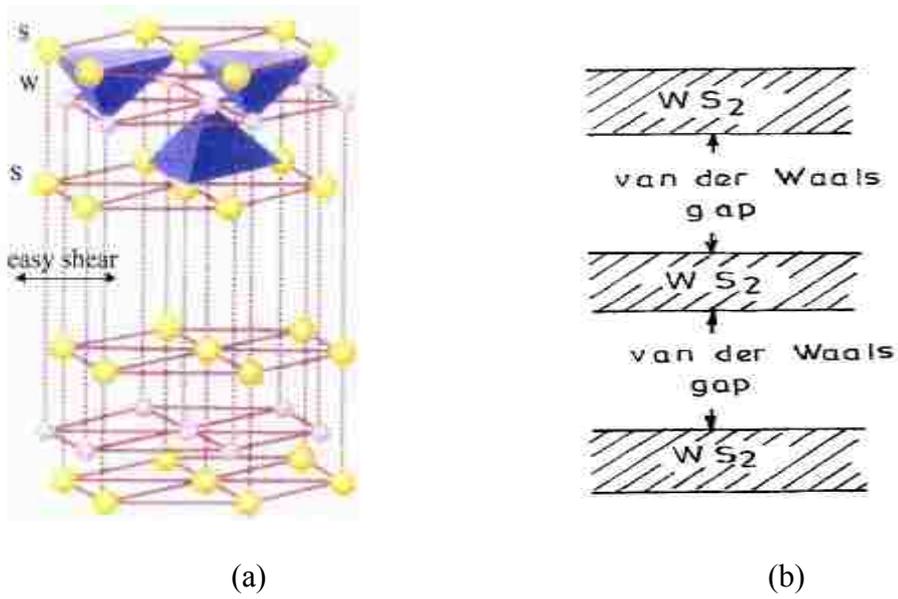
Figure 7 (a) Crystal structure of hexagonal 2H- $\text{WS}_2$  with easy shear direction [82], (b) structure showing stacking of layers [84]

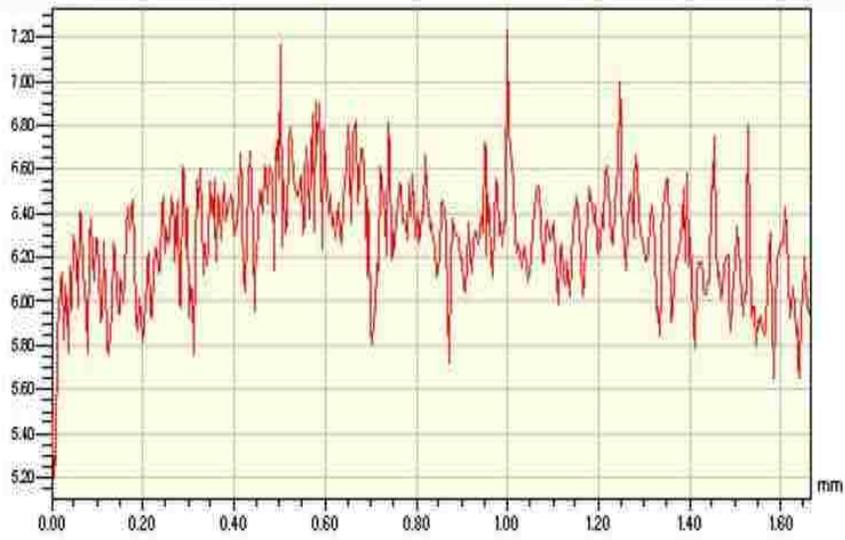
Rq	0.26 $\mu\text{m}$
Ra	0.20 $\mu\text{m}$
Rt	2.03 $\mu\text{m}$
Rp	7.23 $\mu\text{m}$
Rv	5.20 $\mu\text{m}$

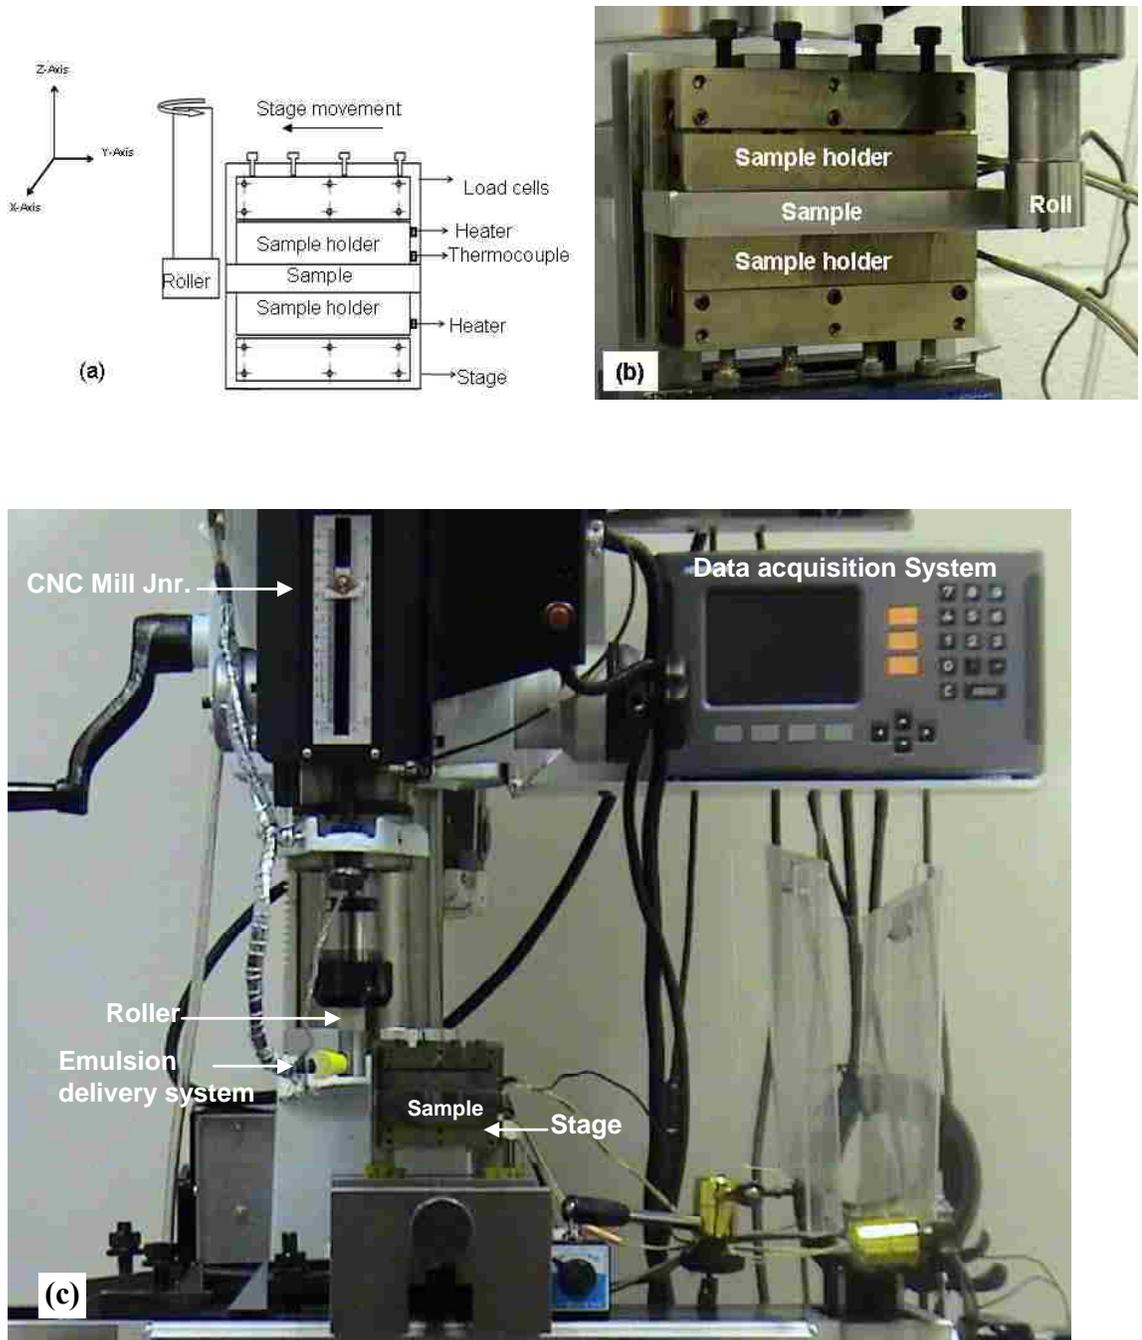
**Figure 10 (a) Schematic of the front and top view of laboratory experimental setup with the arrows showing the direction of motion; (b) image of the experimental setup (c) general view of the CNC Mill with stage and sample**

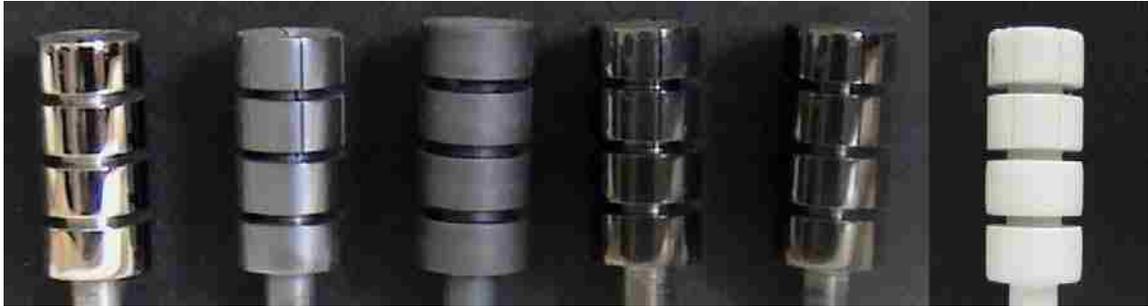
Figure 11 Picture showing the pins used in the order from left to right: the uncoated pin, the S.B. WS2 coated pin, the A.S. WS2 coated pin, the TB 40 coated pin, the TB 41 coated pin, and lastly the BN coated pin

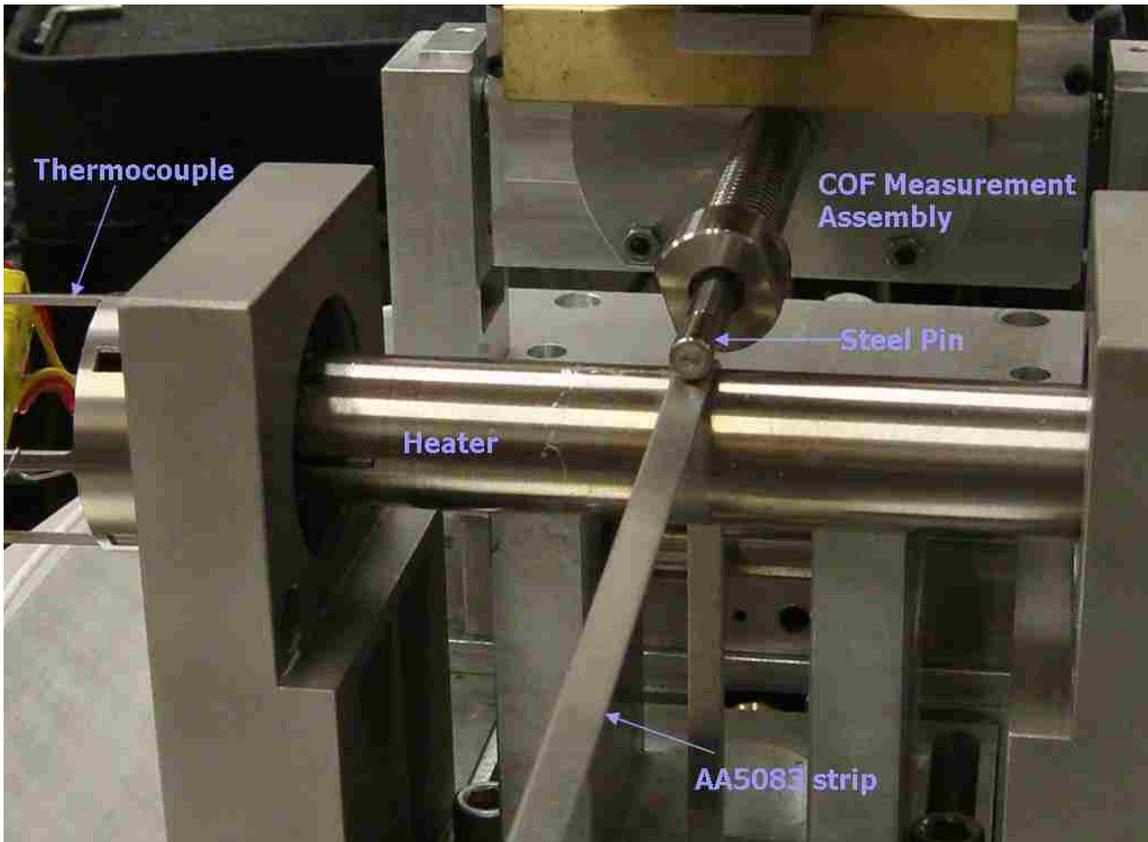
Figure 12 Experimental set-up for the high temperature tribometer designed to simulate hot forming operations

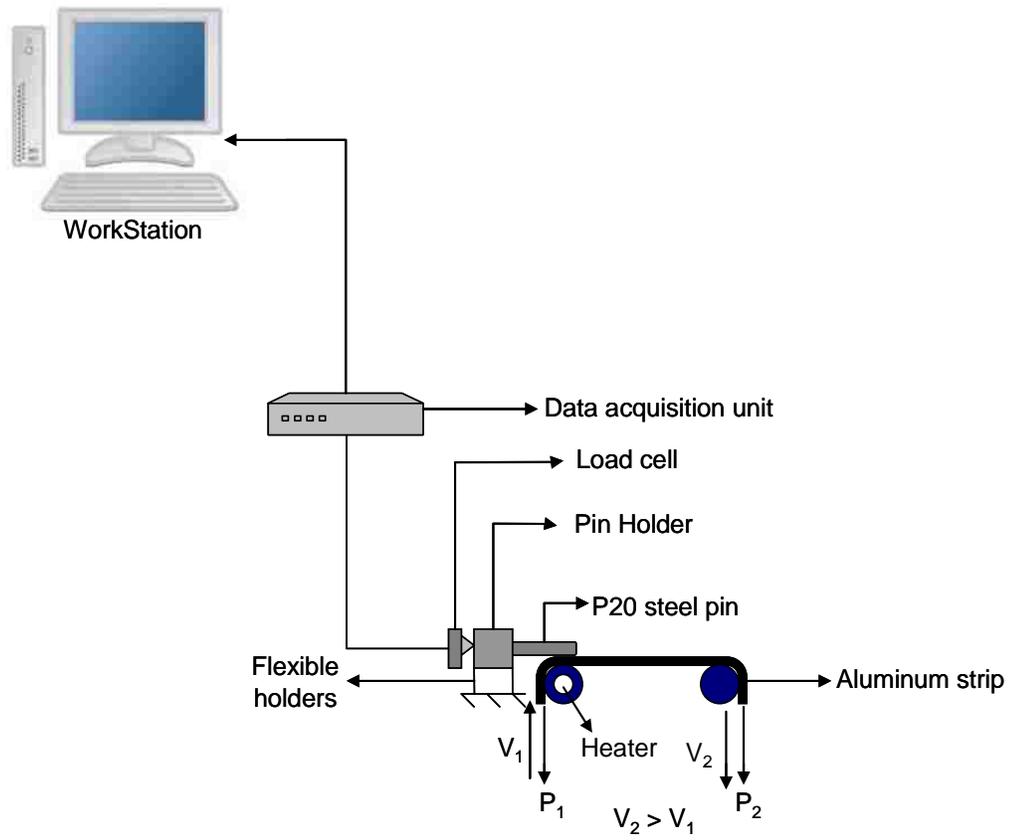
Figure 13 A Schematic diagram of the coefficient of friction measurement

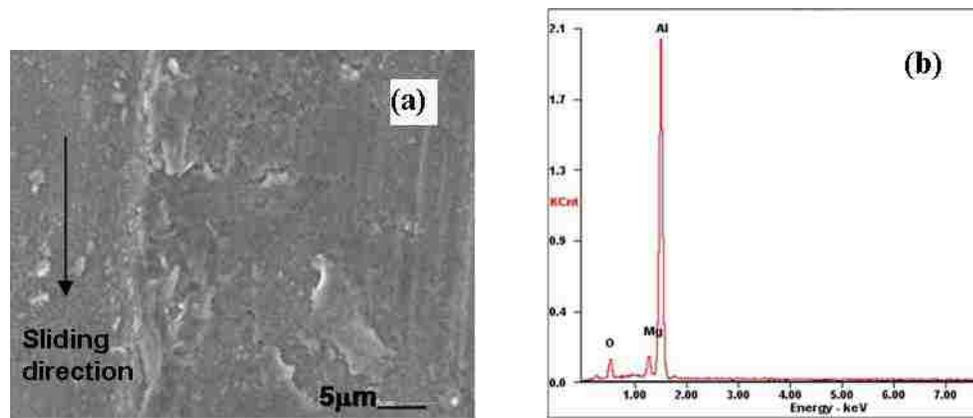
**Figure 14 (a) SEM image from the surface of an AA3104 sample rolled by industrial reversing mill (before rolling with tandem mills), (b) EDS analysis from the surface shows oxygen**

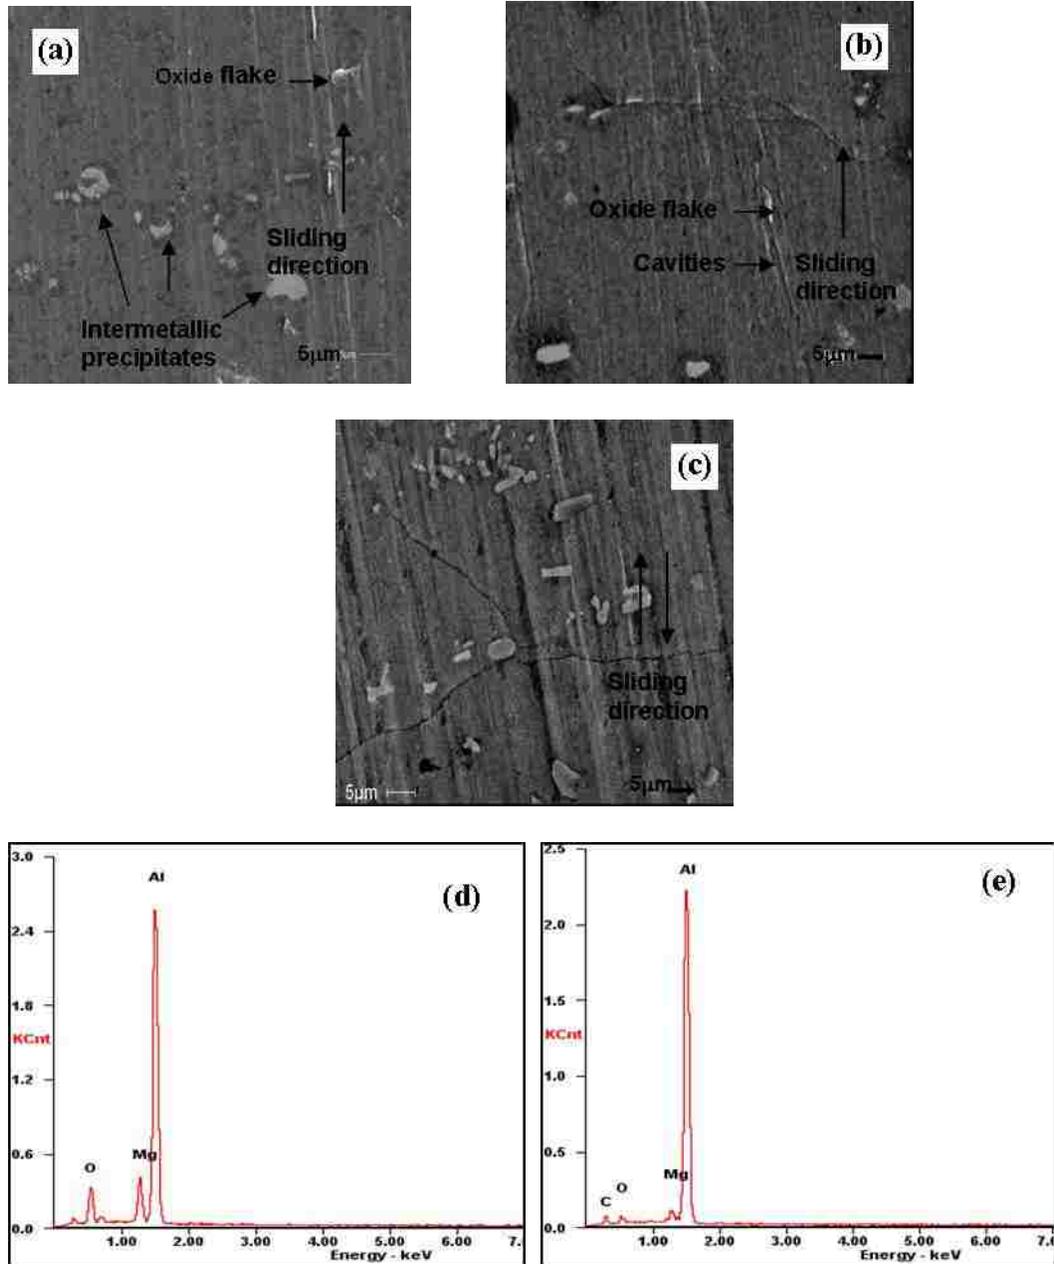
Figure 15 AA3104 surface hot rolled at 753 K and with forward slip 1%, (a) SEM image from the surface after 1 pass, (b) SEM image from the surface after 2 passes in the same direction, (c) SEM from the surface after 2 passes in opposite directions, (d) EDS analysis from the flakes observed and (e) EDS analysis from the bulk surface

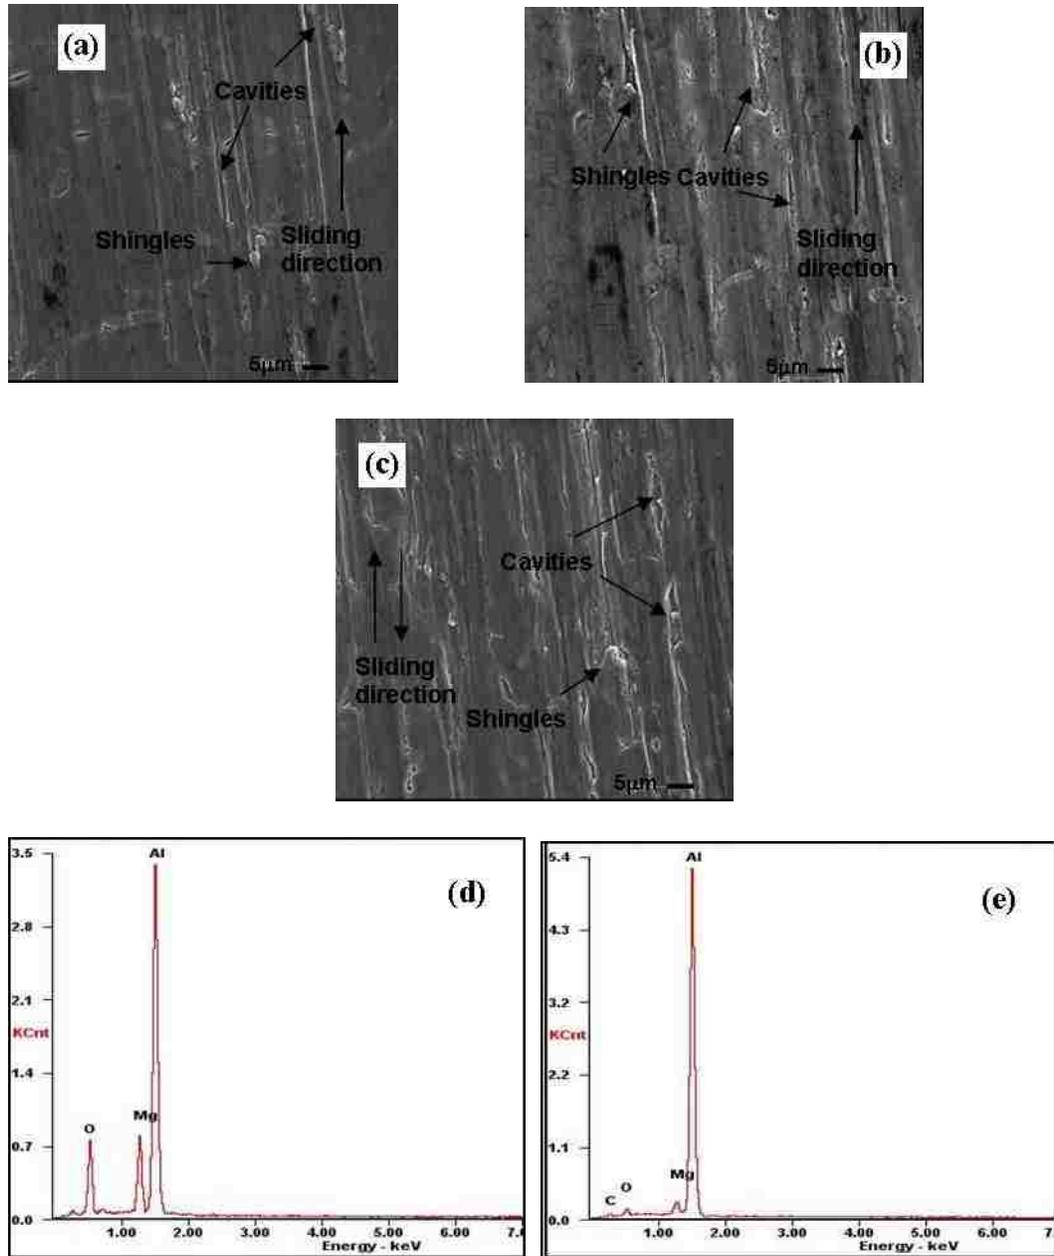
Figure 16 AA3104 surface hot rolled at 753 K and with forward slip 6.5%, (a) SEM image from the surface after 1 pass, (b) SEM image from the surface after 2 passes in the same direction, (c) SEM from the surface after 2 passes in opposite directions, (d) EDS analysis from the shingles observed and (e) EDS analysis from, the bulk surface

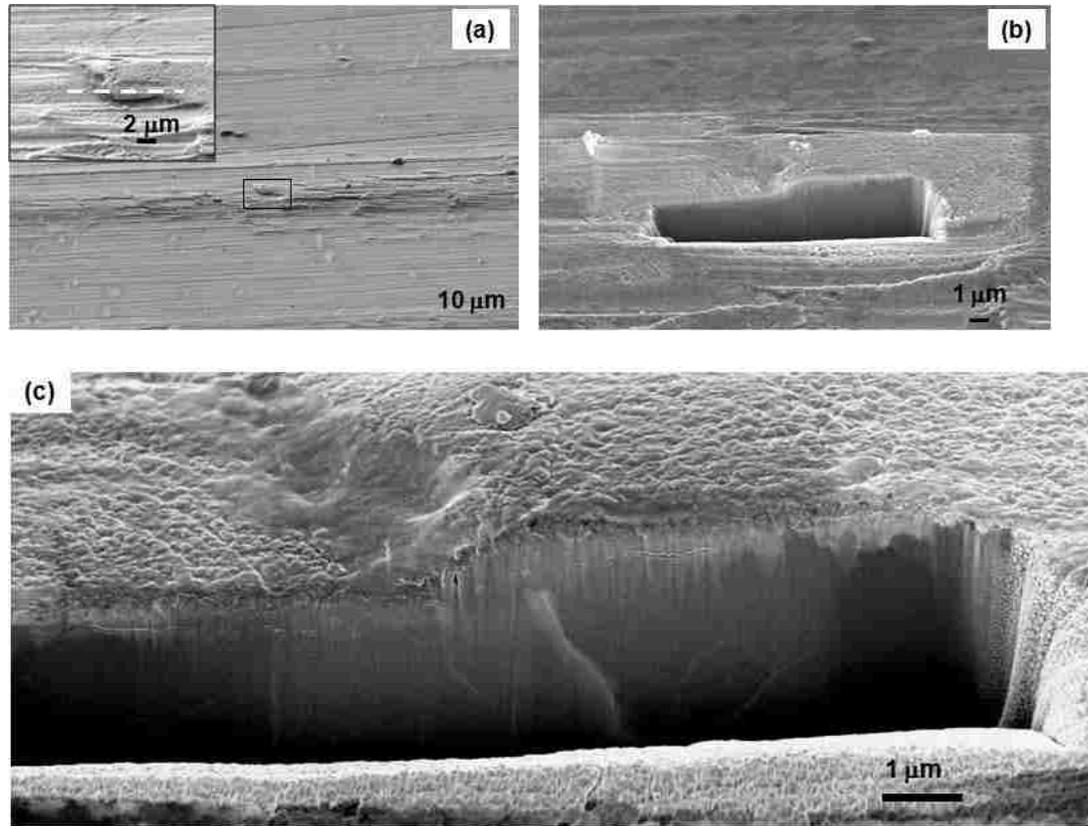
**Figure 17 SEM image from the AA3104 surface hot rolled in 1 pass at 753 K and with 12% forward slip, (a) localized shear deformations in the form of shingles, the inserted image magnifies the area in the bracket, (b) low magnification image of the trench after FIB milling the surface was platinum coated first in order to avoid damaging due to exposure to ion beam, (c) cracks formed beneath and parallel to the surface**

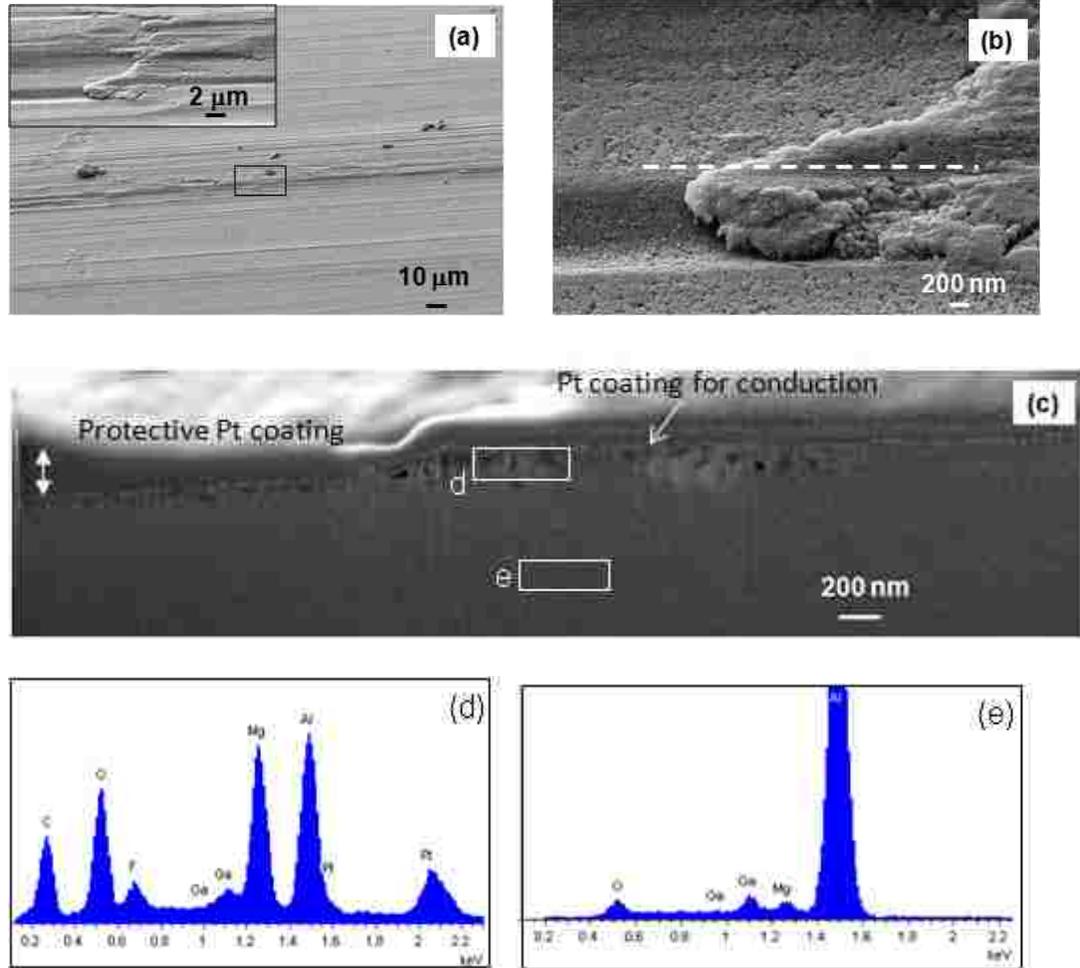
Figure 18 AA3104 surface hot rolled in 1 pass at 753 K and with forward slip 12%, (a) SEM image from the locally deformed areas with the inserted image magnifying the area of interest, (b) the FIB milling is performed along the dashed line, (c) the cross-section shows voids and defects in the near surface area, (d) EDS analysis from the area marked as d; the elements Pt and Ga from the protective coating and the ion source respectively, and (e) EDS analysis from the area marked as e (bulk material)

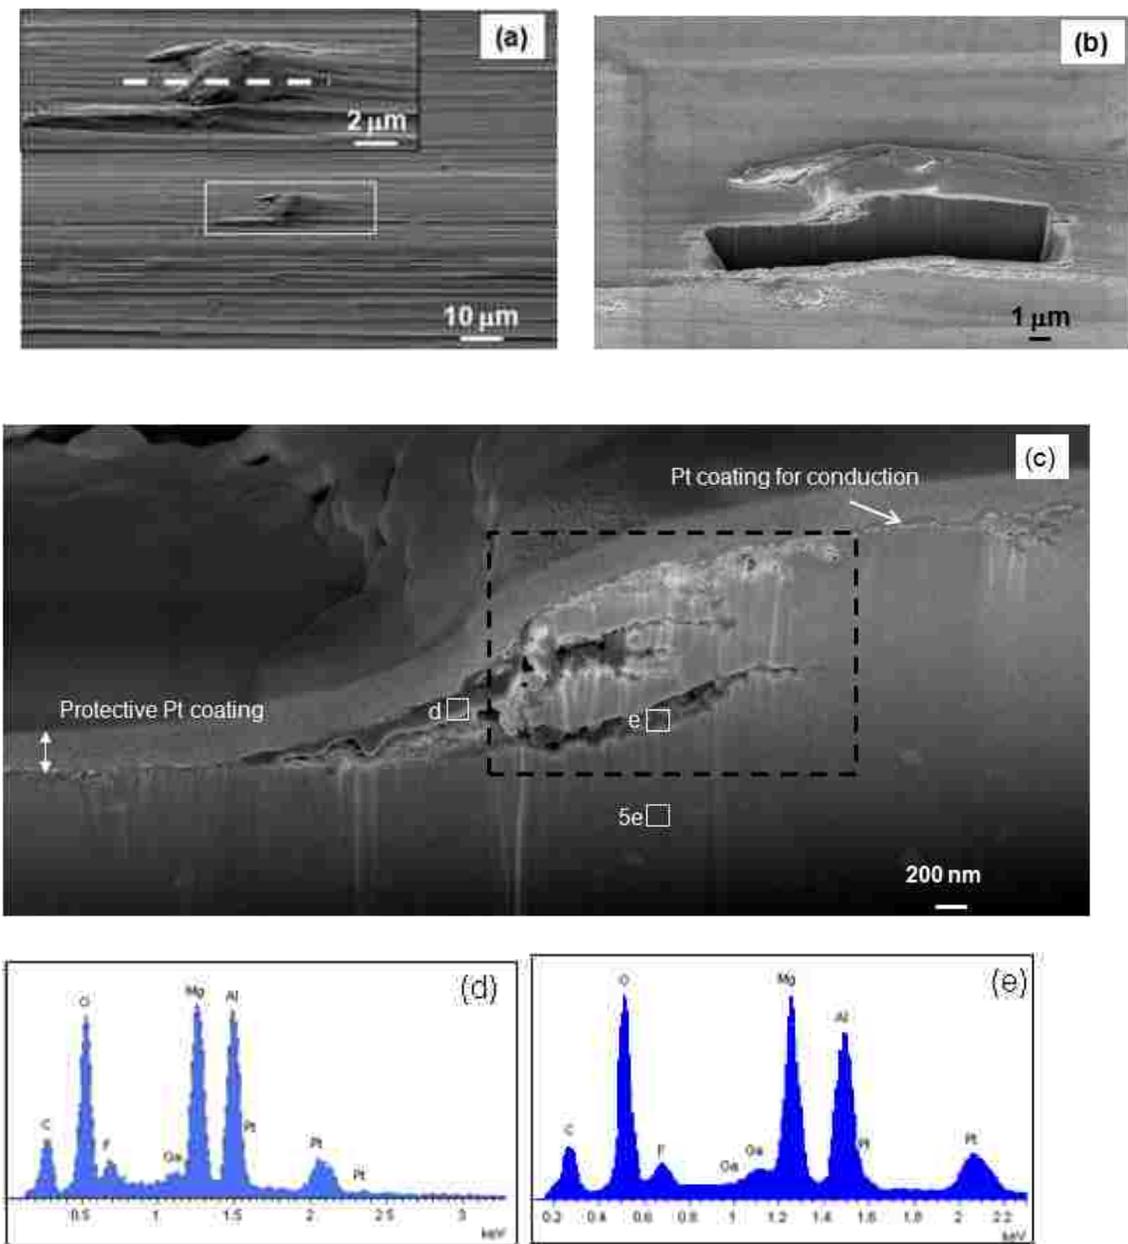
Figure 19 Evolution of AA3104 surface hot rolled in 2 passes in the same direction at 753 K and with 12% forward slip, (a) SEM image, (b) FIB milling performed along the dashed line in (a), (c) the cross-section shows voids and defects on the surface of the dimple and layered features (marked by dashed line), (d) EDS analysis of the area marked as d in (c), and (e) EDS analysis of the area marked as e in (c)

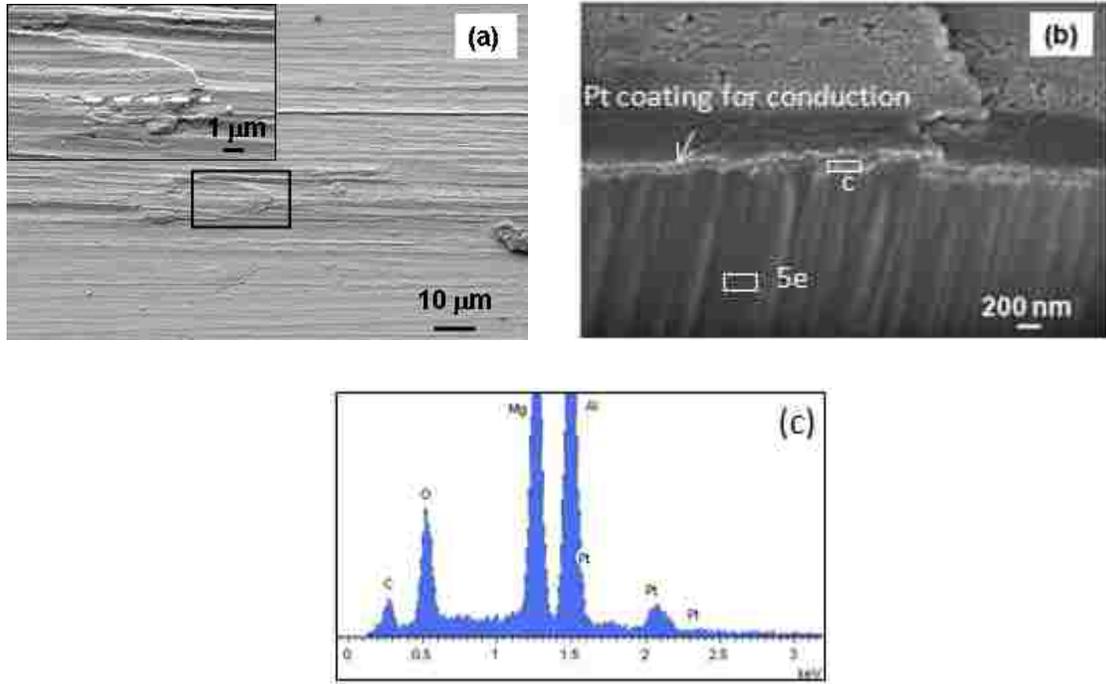
**Figure 20 Evolution of AA3104 surface hot rolled in 2 passes (forward-reverse) at 753 K with 12% forward slip of (a) SEM image showing shingles, (b) the cross-section along the dashed line in (a) shows a layer formed on the rolled surface, and (c) EDS analysis of the area marked in (b)**

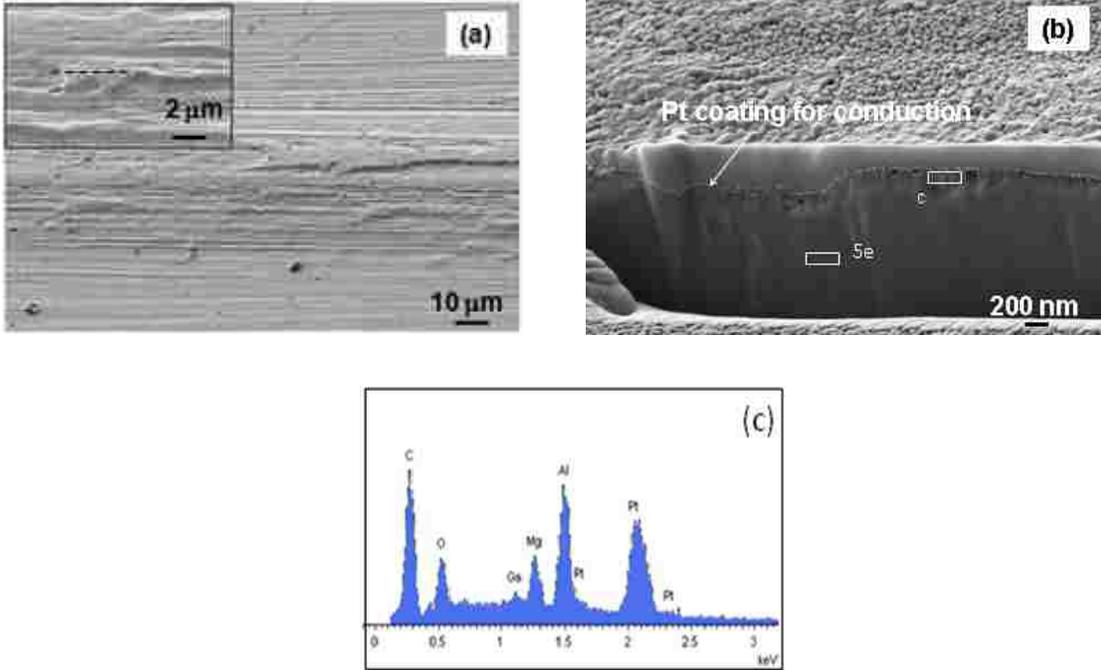
Figure 21 Evolution of AA3104 surface hot rolled in 1 pass at 753 K and with forward speed of -1%, (a) SEM image showing surface smearing, (b) the cross-section along the dashed line in (a) shows a layer formed on the rolled surface, and (c) EDS analysis of the area c marked in (b)

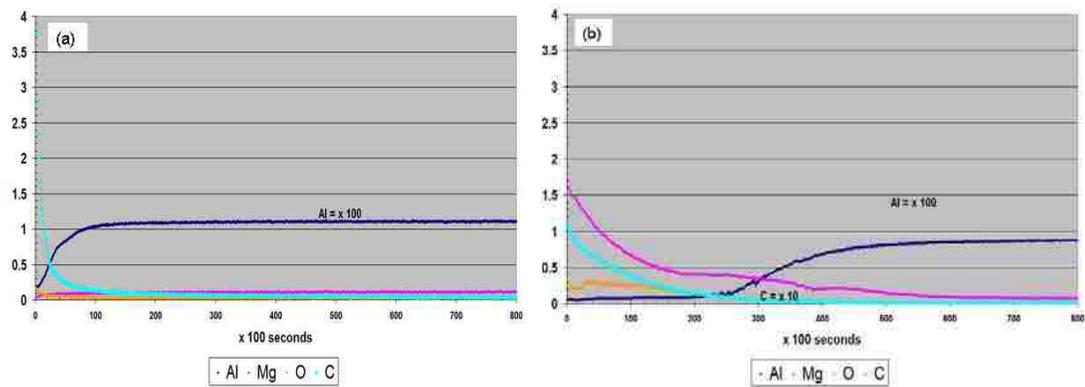
Figure 22 (a) GDOES depth profile analysis from the surface of an as polished sample, (b) GDOES depth profile analysis from the surface of a sample polished and heated to 753 K for 840s.

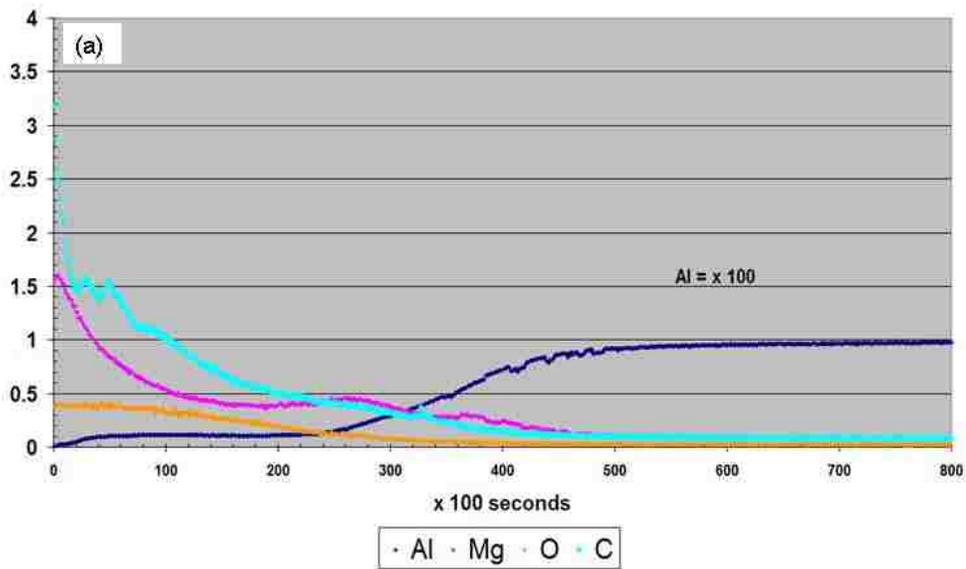
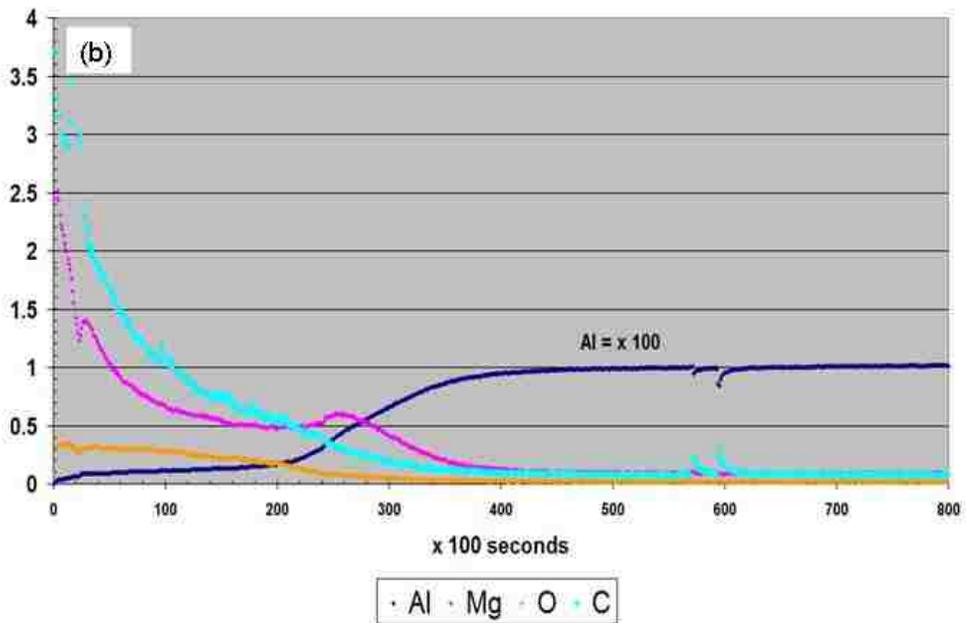
Figure 23 Elemental signal strength as a function of sputter time using GDOES, (a) forward speed 12%, 1 Pass, (b) forward speed 12%, 2 passes in the same rolling direction.

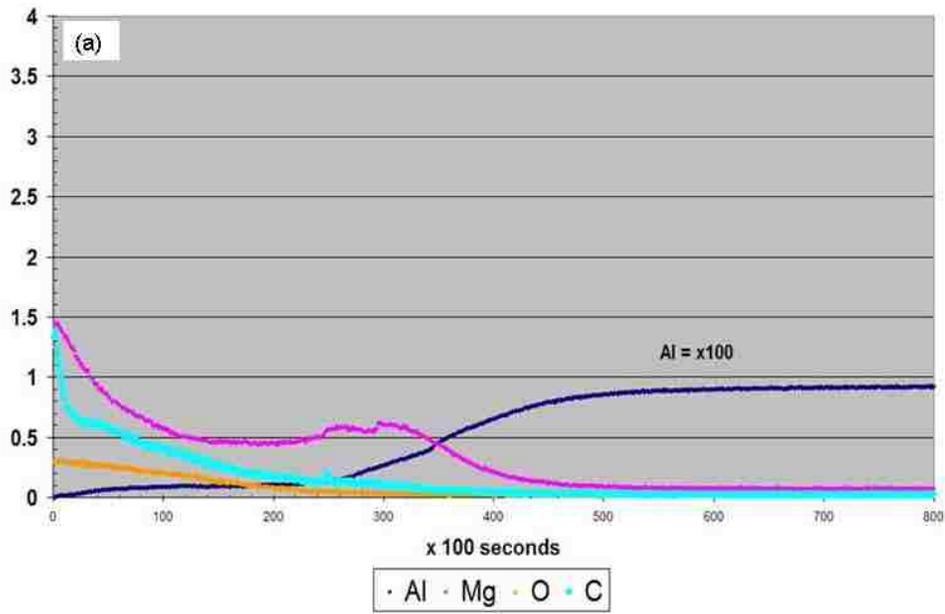
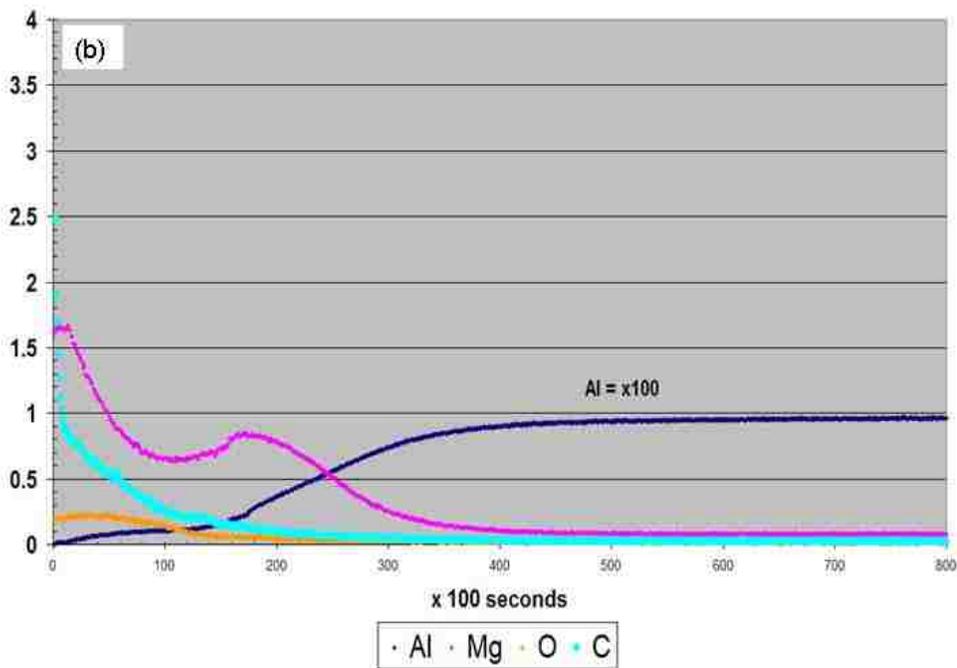
Figure 24 Elemental signal strength as a function of sputter time using GDOES, (a) forward speed - 1%, 1 Pass, and (b) forward speed -1%, 2 passes in the same rolling direction.

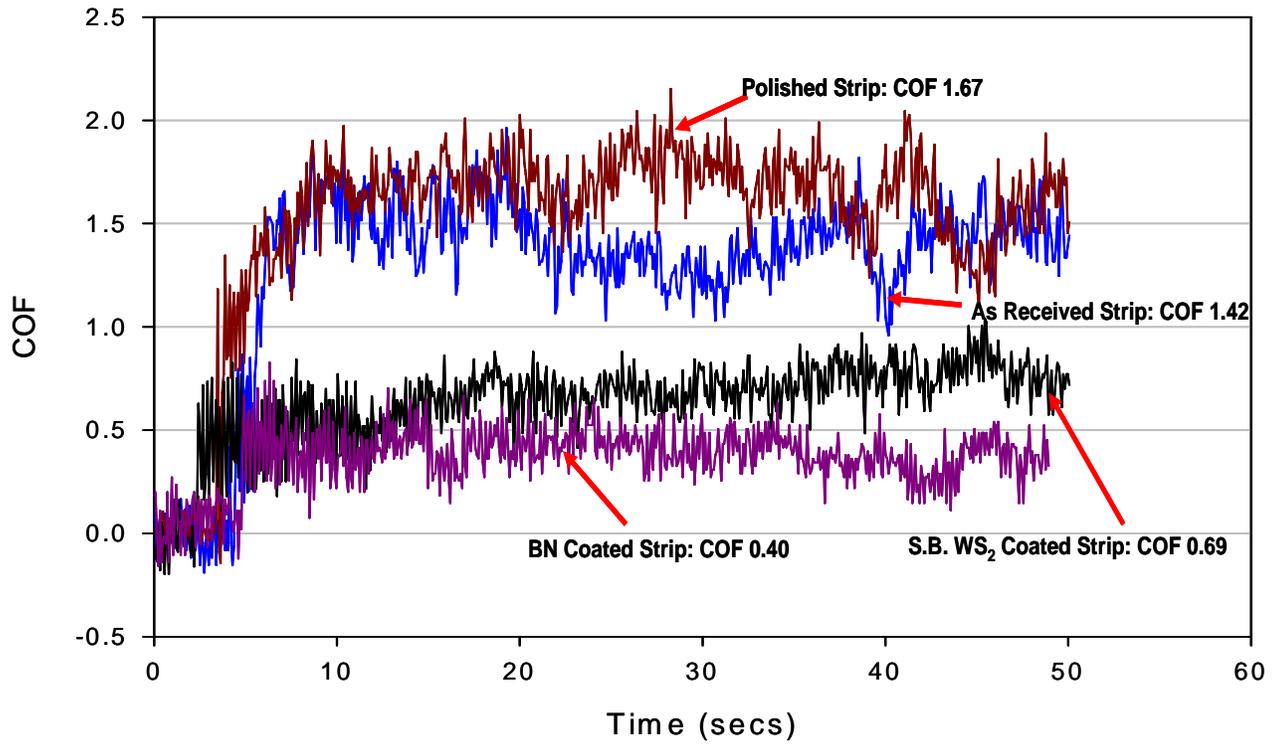
**Figure 25 COF-Time curves for the polished uncoated P20 steel pin against the various surface conditions of the AA5083 aluminum strip**

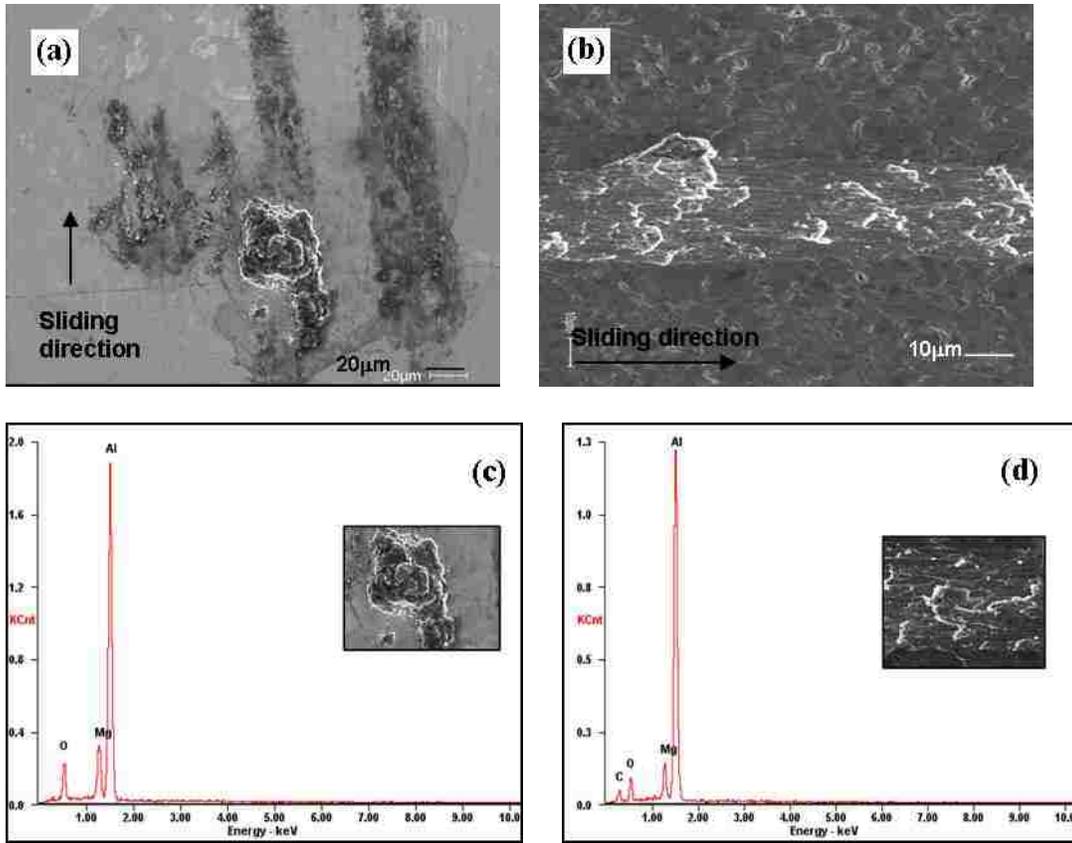
Figure 26 Polished uncoated pin against the polished strip, (a) SEM of polished uncoated pin surface, (b) SEM of polished strip surface, (c) EDS of material adhesion on uncoated pin surface, and (d) EDS of wear track of polished strip

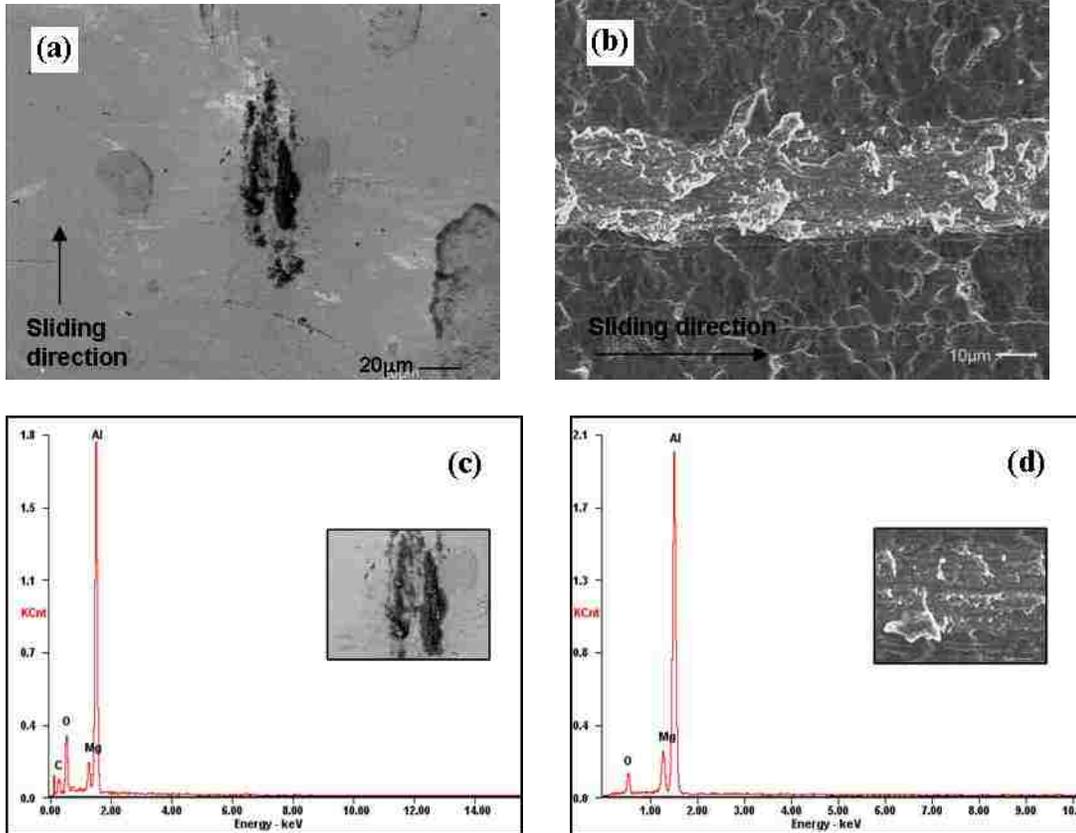
Figure 27 Polished uncoated pin against the as-received strip, (a) SEM of as-received uncoated pin surface, (b) SEM of as-received strip surface, (c) EDS of material adhesion on uncoated pin surface, and (d) EDS of wear track of as-received strip
