2011

### The Effect of Sliding Contact Friction on Surface Quality of Aluminum Sheet Products

A Thesis  
Submitted to the Faculty of Graduate Studies  
through Engineering Materials  
in Partial Fulfillment of the Requirements for  
the Degree of Master of Applied Science at the  
University of Windsor

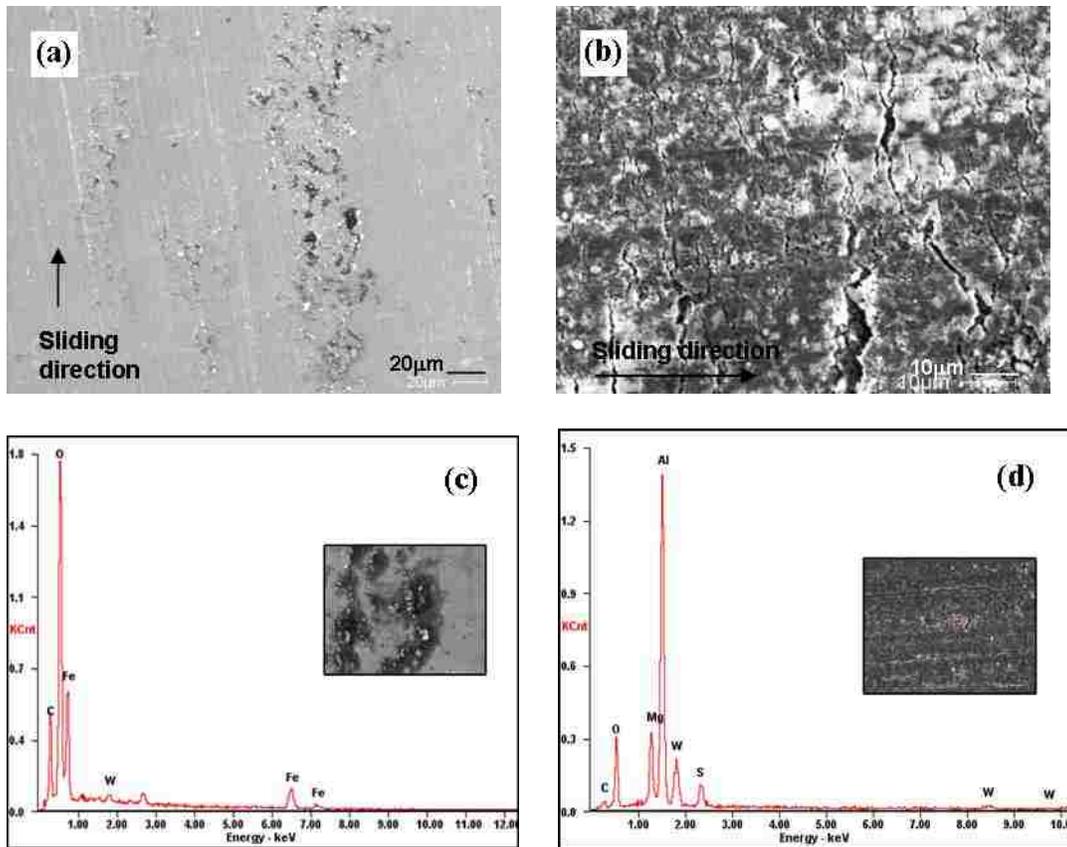
Figure 28 Polished uncoated pin against the WS<sub>2</sub> coated strip, (a) SEM of as-received uncoated pin surface, (b) SEM of S.B. WS<sub>2</sub> coated strip surface, (c) EDS of material adhesion on uncoated pin surface, and (d) EDS of wear track of S.B. WS<sub>2</sub> strip

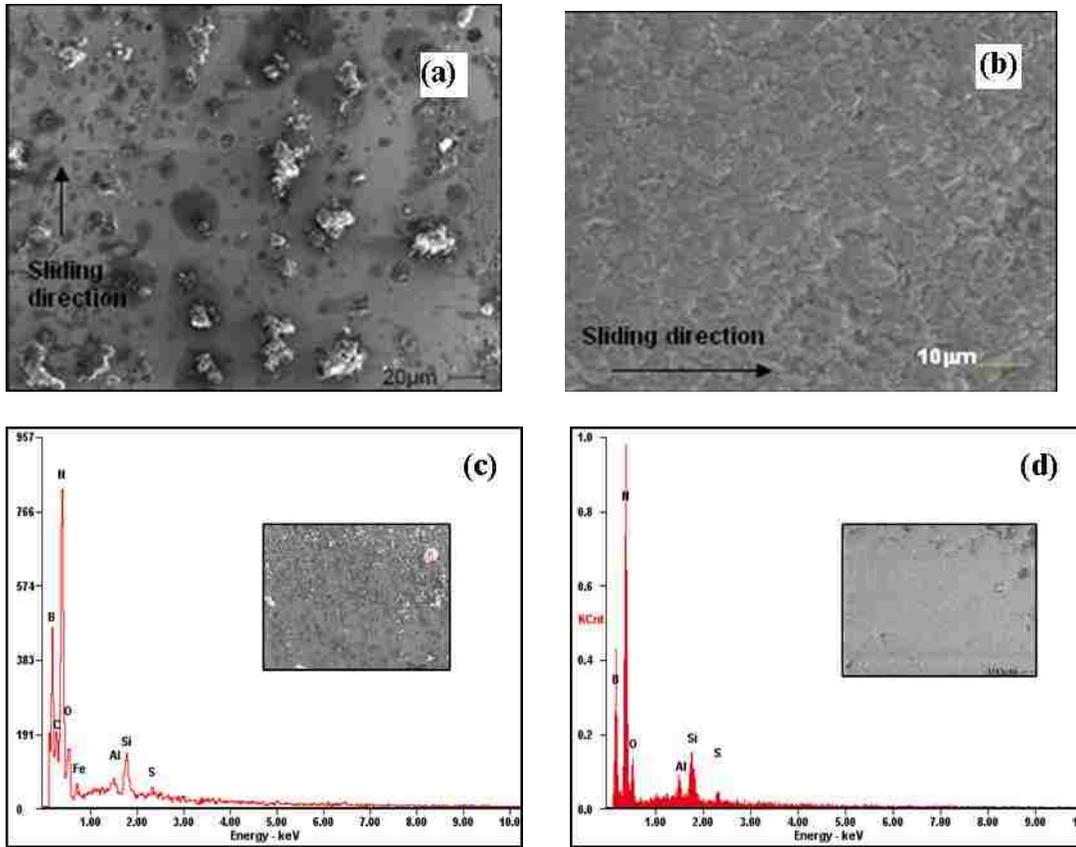
Figure 29 Polished uncoated pin against the BN coated strip, (a) SEM of as-received uncoated pin surface, (b) SEM of BN coated strip surface, (c) EDS of material adhesion on uncoated pin surface, and (d) EDS of wear track of BN strip

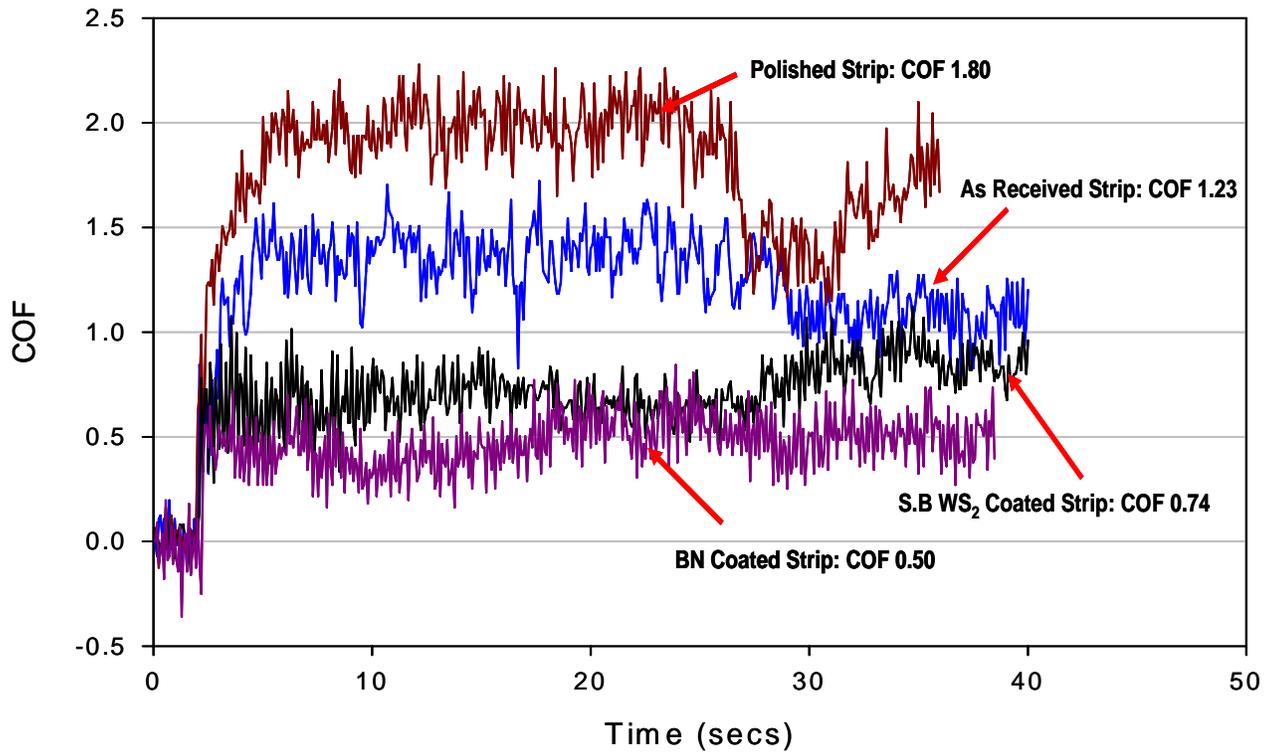
Figure 30 COF-Time curves for the S.B. WS<sub>2</sub> coated P20 steel pin against the various surface conditions of the AA5083 aluminum strip

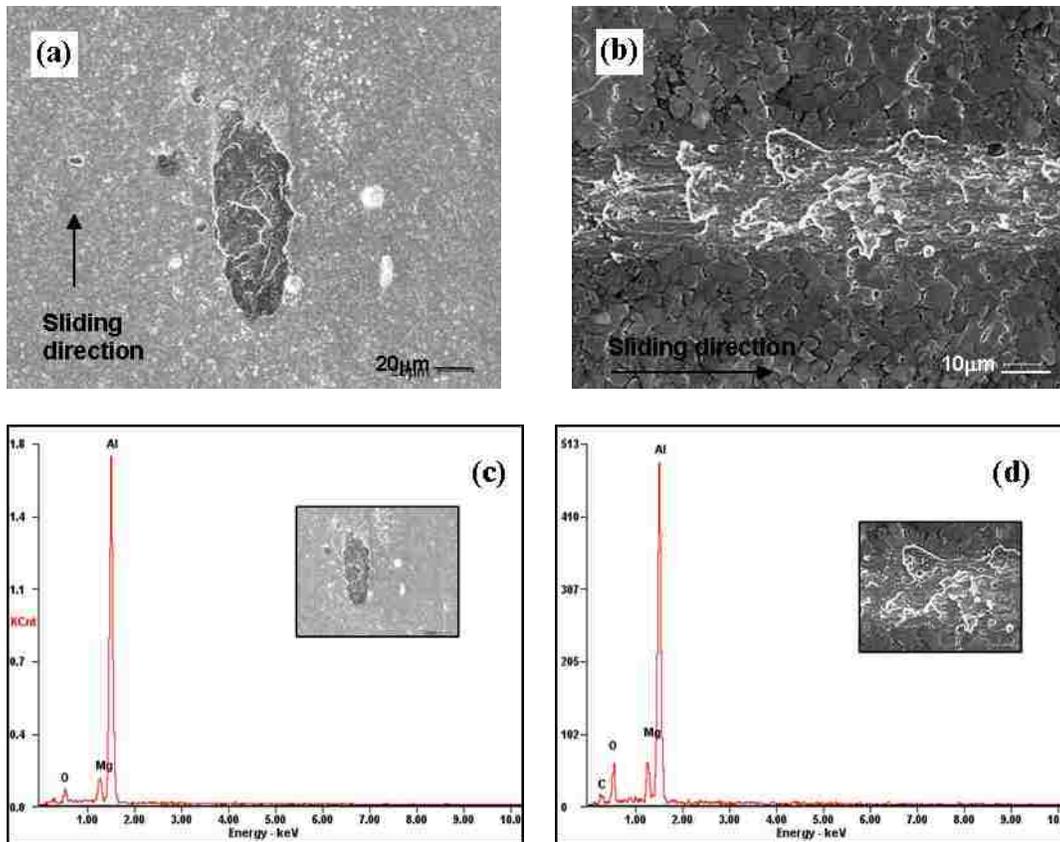
Figure 31 S.B. WS<sub>2</sub> coated pin against the polished strip, (a) SEM of S.B. WS<sub>2</sub> coated pin surface, (b) SEM of polished strip surface, (c) EDS of material adhesion on S.B. WS<sub>2</sub> coated pin surface, and (d) EDS of wear track of polished strip

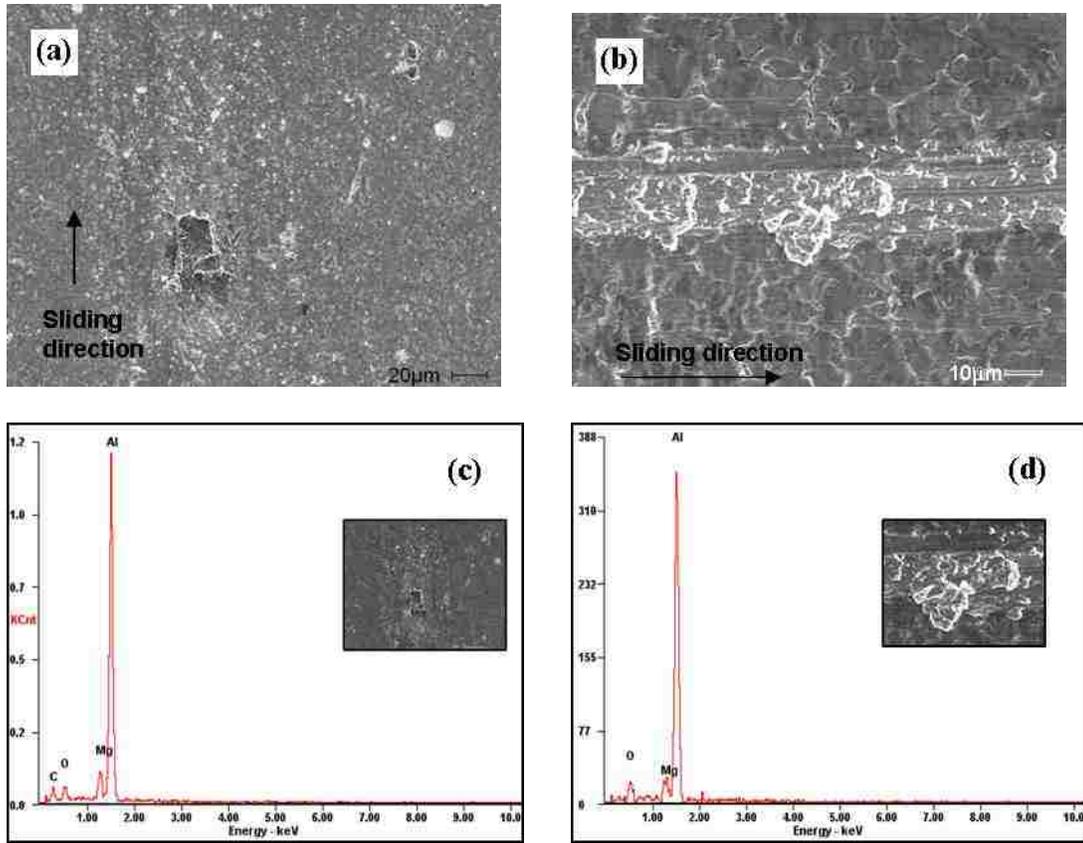
Figure 32 S.B. WS<sub>2</sub> coated pin against the as-received strip, (a) SEM of S.B. WS<sub>2</sub> coated pin surface (b) SEM of as-received strip surface, (c) EDS of material adhesion on S.B. WS<sub>2</sub> coated pin surface, and (d) EDS of wear track of as-received strip

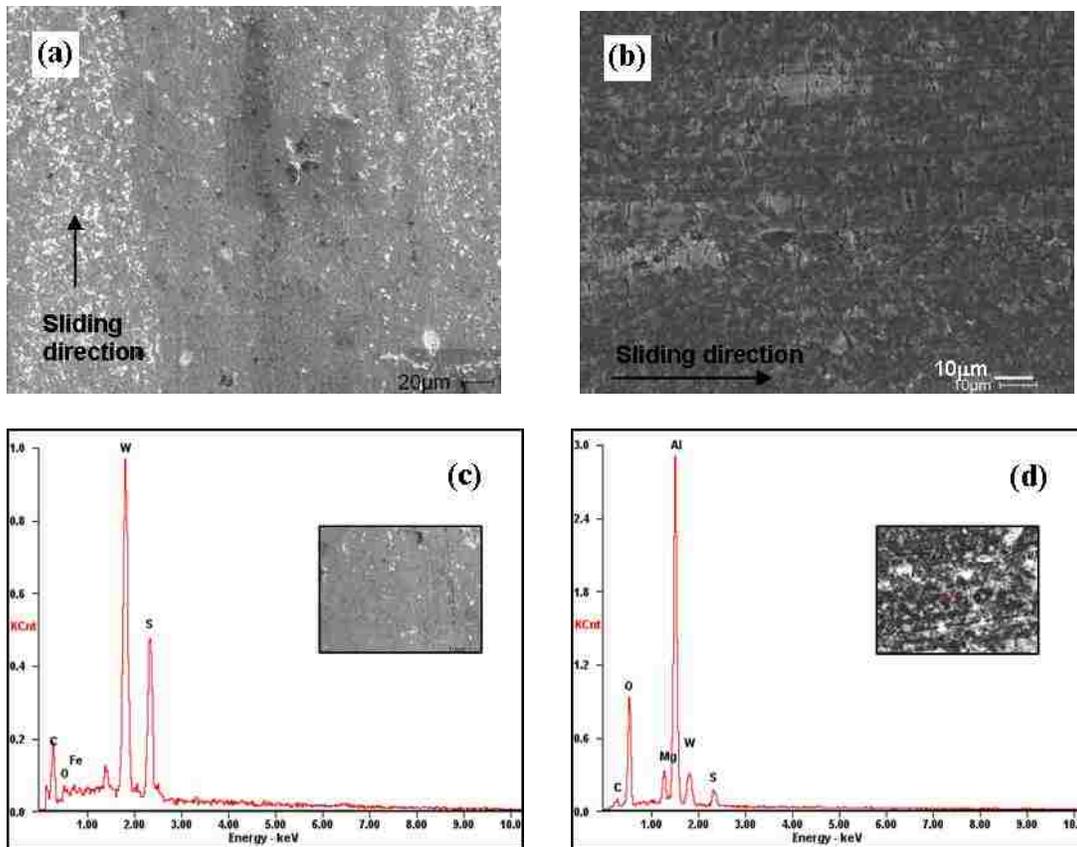
Figure 33 S.B. WS<sub>2</sub> coated pin against the S.B. WS<sub>2</sub> coated strip, (a) SEM of S.B. WS<sub>2</sub> coated pin surface, (b) SEM of S.B. WS<sub>2</sub> coated strip surface, (c) EDS of material adhesion on S.B. WS<sub>2</sub> coated pin surface, and (d) EDS of wear track of S.B. WS<sub>2</sub> strip

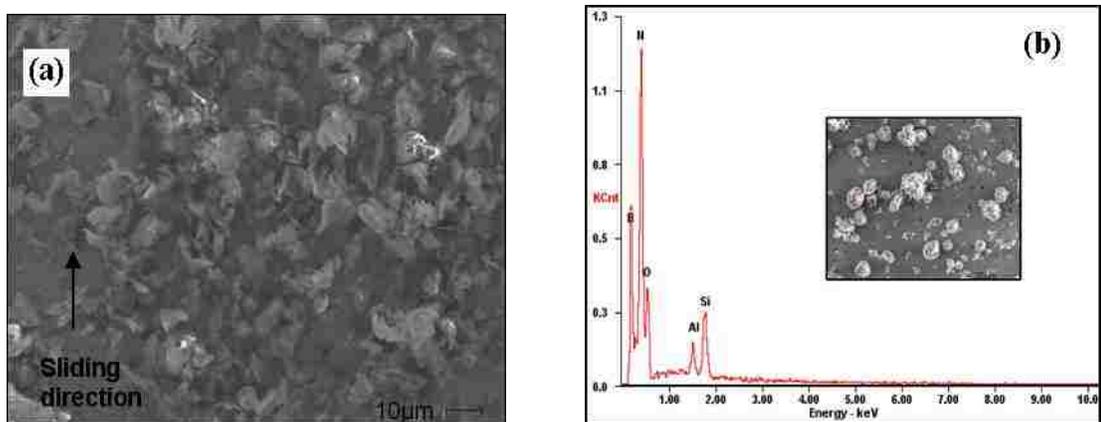
Figure 34 S.B. WS<sub>2</sub> coated pin against the BN coated strip, (a) SEM of S.B. WS<sub>2</sub> coated pin surface, and (b) EDS of material adhesion on S.B. WS<sub>2</sub> coated pin surface

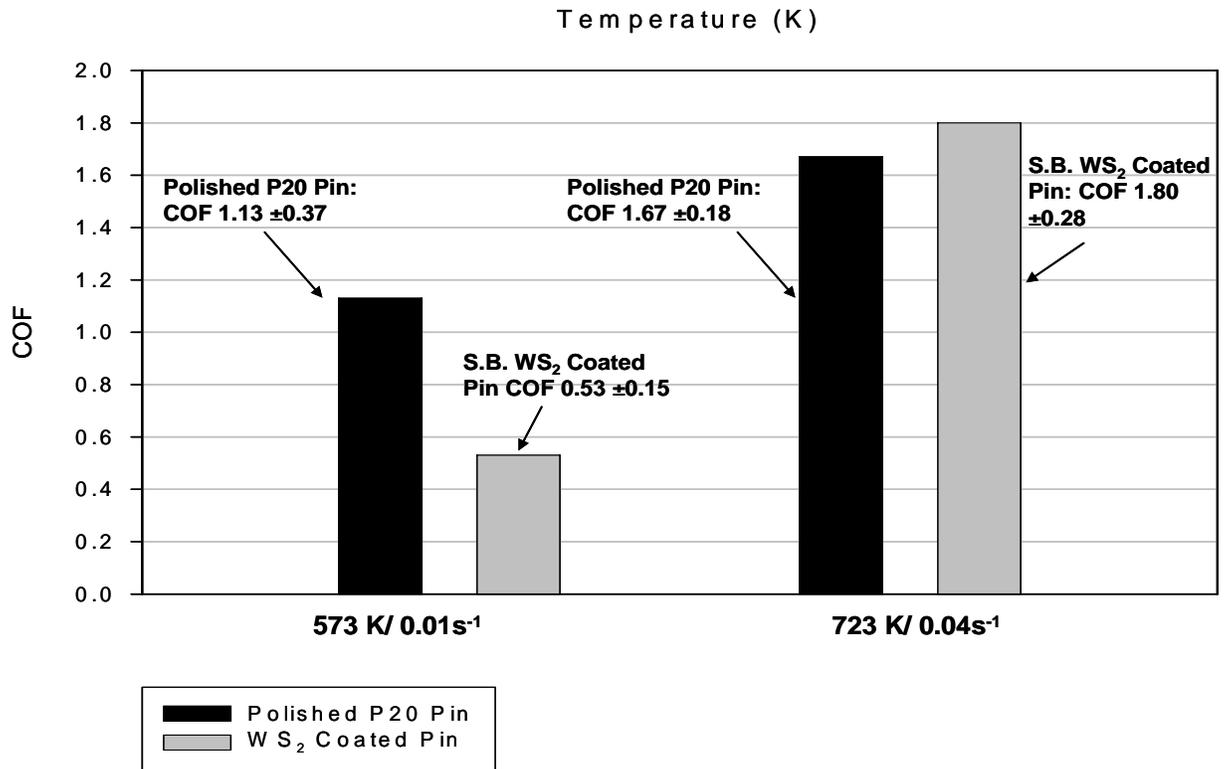
Figure 35 Histogram comparing COF of S.B. WS<sub>2</sub> coated pin against polished strip at 723 K/0.04s<sup>-1</sup> and 573 K/0.01s<sup>-1</sup> with the COF of polished uncoated pin against polished strip at 723 K/0.04s<sup>-1</sup> and 573 K/0.01s<sup>-1</sup>

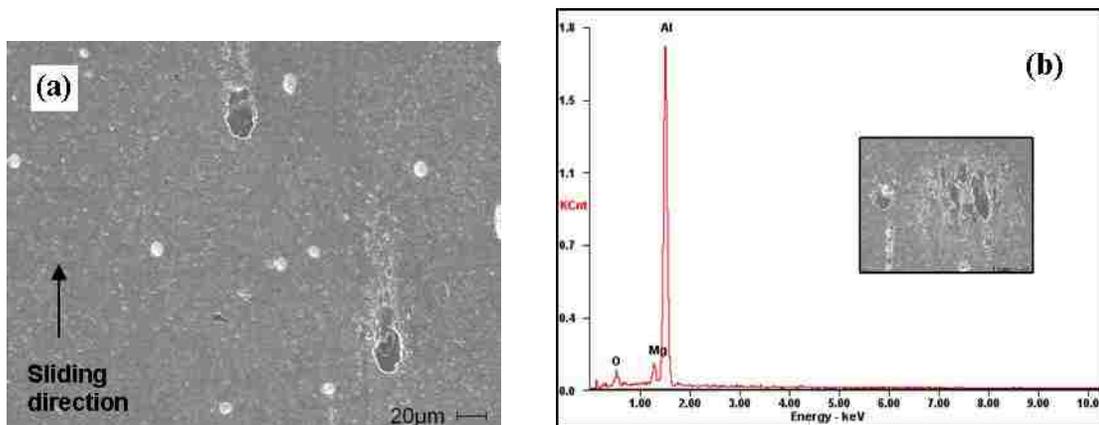
Figure 36 S.B. WS<sub>2</sub> coated pin against the polished strip at 573 K/0.01s<sup>-1</sup> (a) SEM of S.B. WS<sub>2</sub> coated pin surface, (b) EDS of material adhesion on S.B. WS<sub>2</sub> coated pin surface

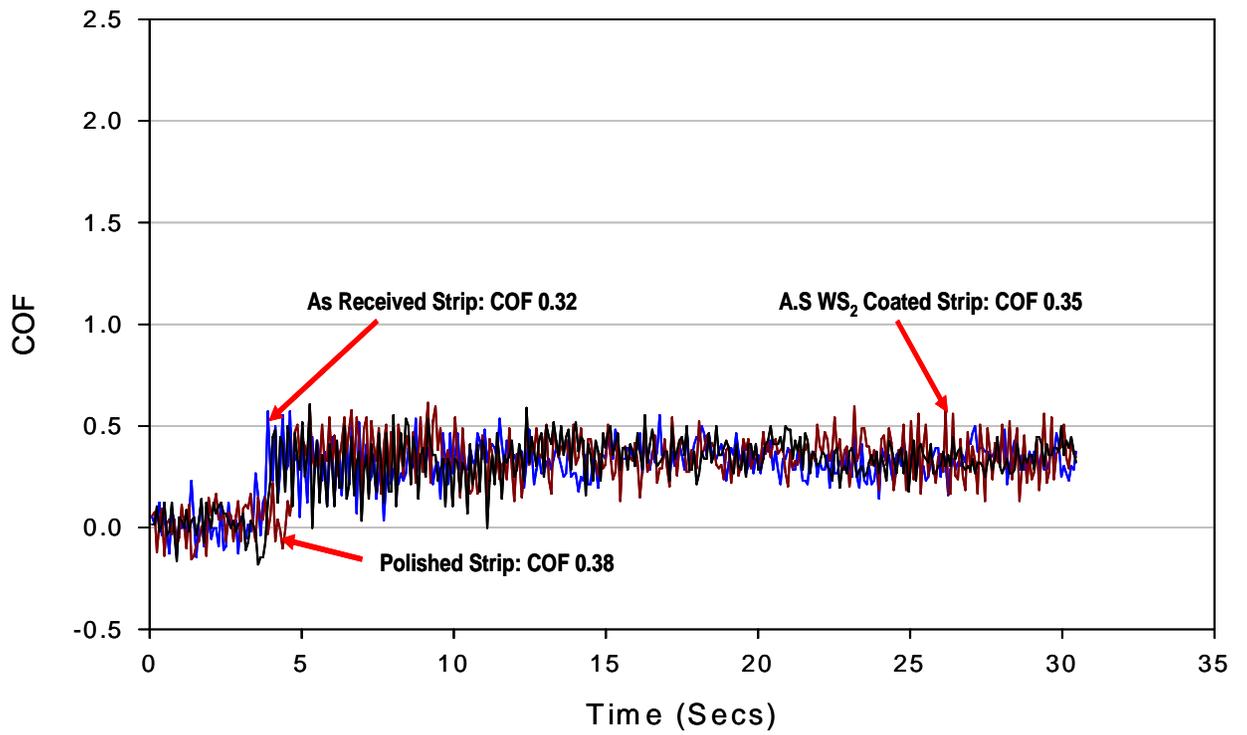
**Figure 37 COF-Time curves for the A.S. WS<sub>2</sub> coated P20 steel pin against the various surface conditions of the AA5083 aluminum strip**

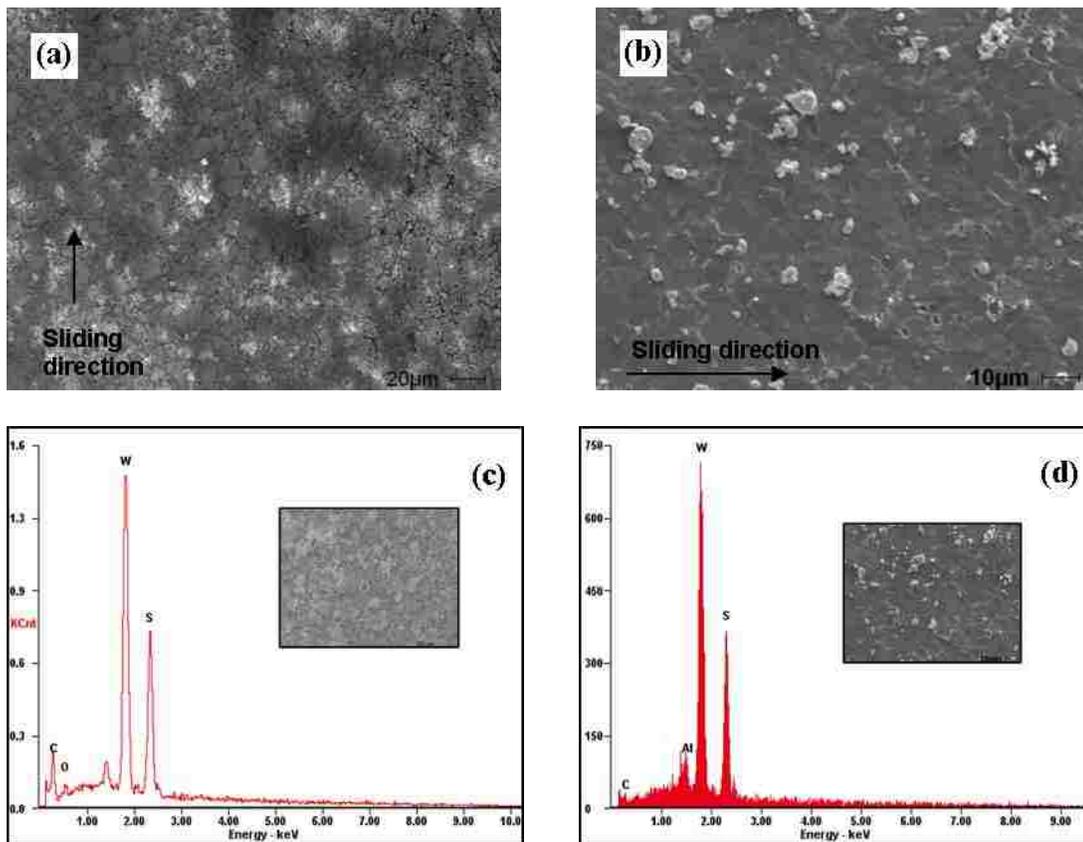
Figure 38 A.S. WS<sub>2</sub> coated pin against the polished strip, (a) SEM of A.S. WS<sub>2</sub> coated pin surface, (b) SEM of polished strip surface, (c) EDS of A.S. WS<sub>2</sub> coated pin surface, and (d) EDS of wear track of polished strip

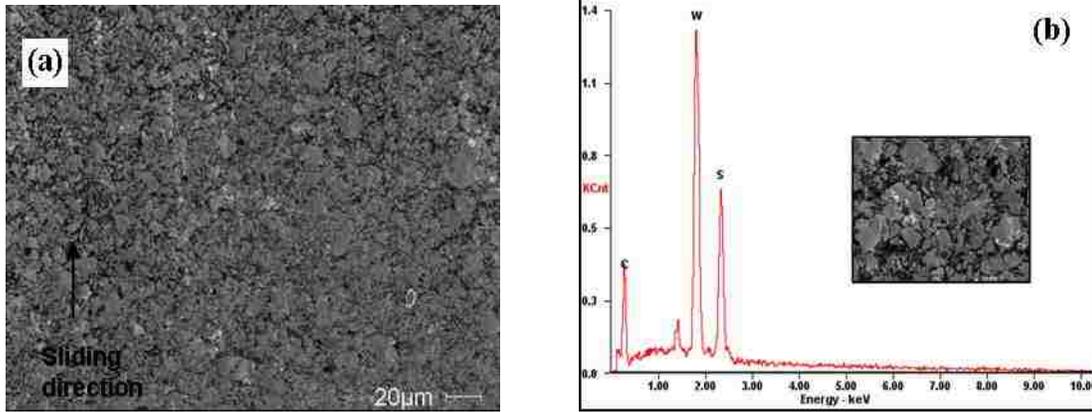
Figure 39 A.S. WS<sub>2</sub> coated pin against the as-received strip, (a) SEM of A.S. WS<sub>2</sub> coated pin surface, (b) EDS of A.S. WS<sub>2</sub> coated pin surface

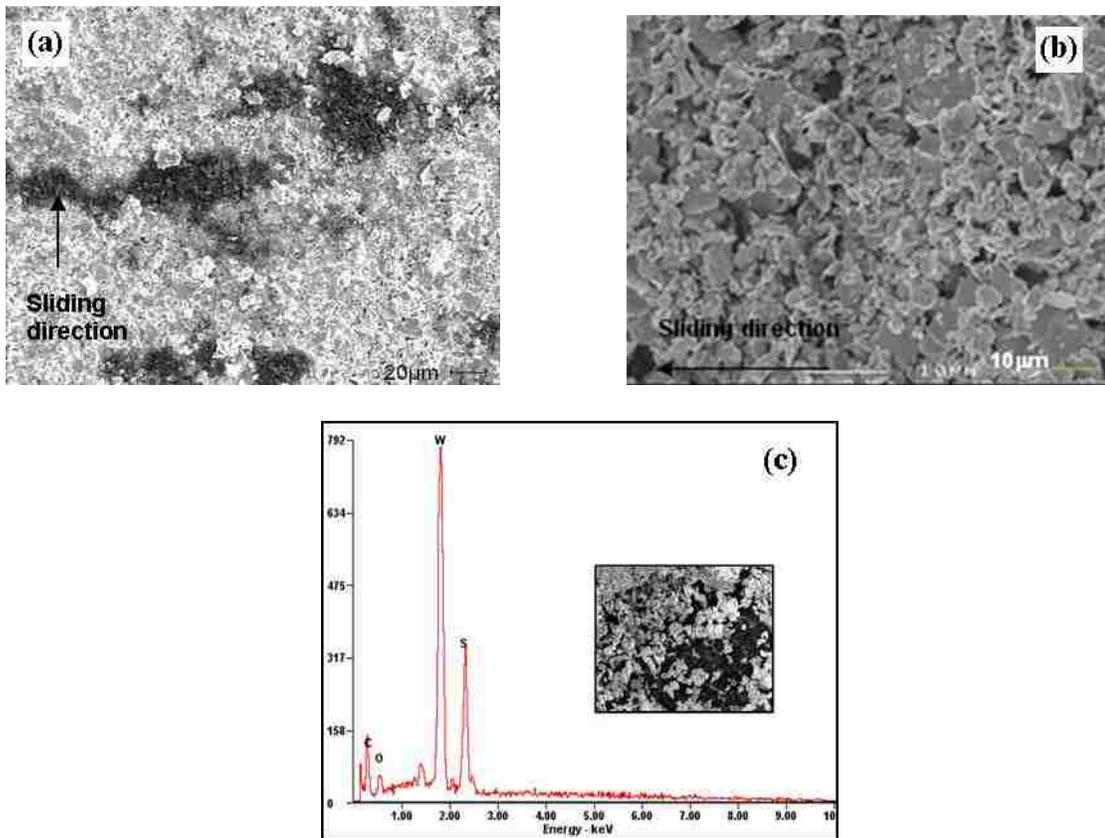
Figure 40 A.S. WS<sub>2</sub> coated pin against the A.S. WS<sub>2</sub> coated strip, (a) SEM of A.S. WS<sub>2</sub> coated pin surface, (b) SEM of A.S. WS<sub>2</sub> coated pin surface, (c) EDS of A.S. WS<sub>2</sub> coated pin surface

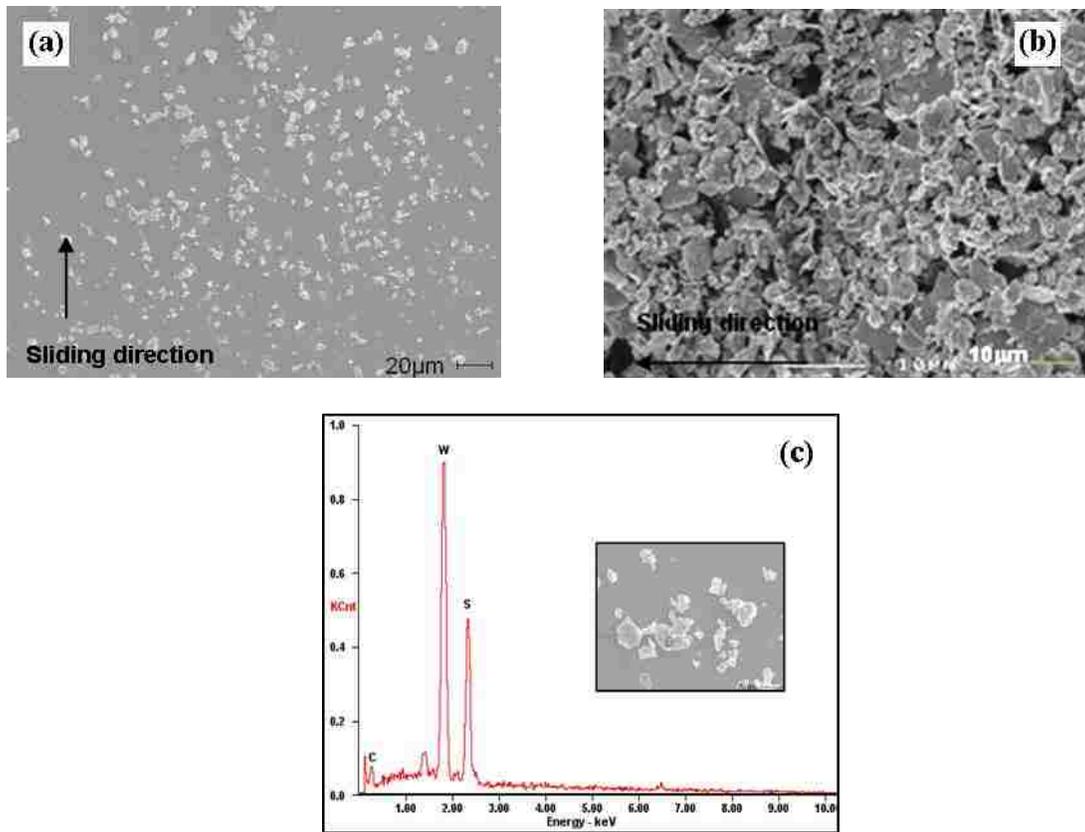
Figure 41 Polished uncoated pin against the A.S. WS<sub>2</sub> coated strip, (a) SEM of polished uncoated pin surface, (b) EDS of material transfer on polished uncoated pin surface

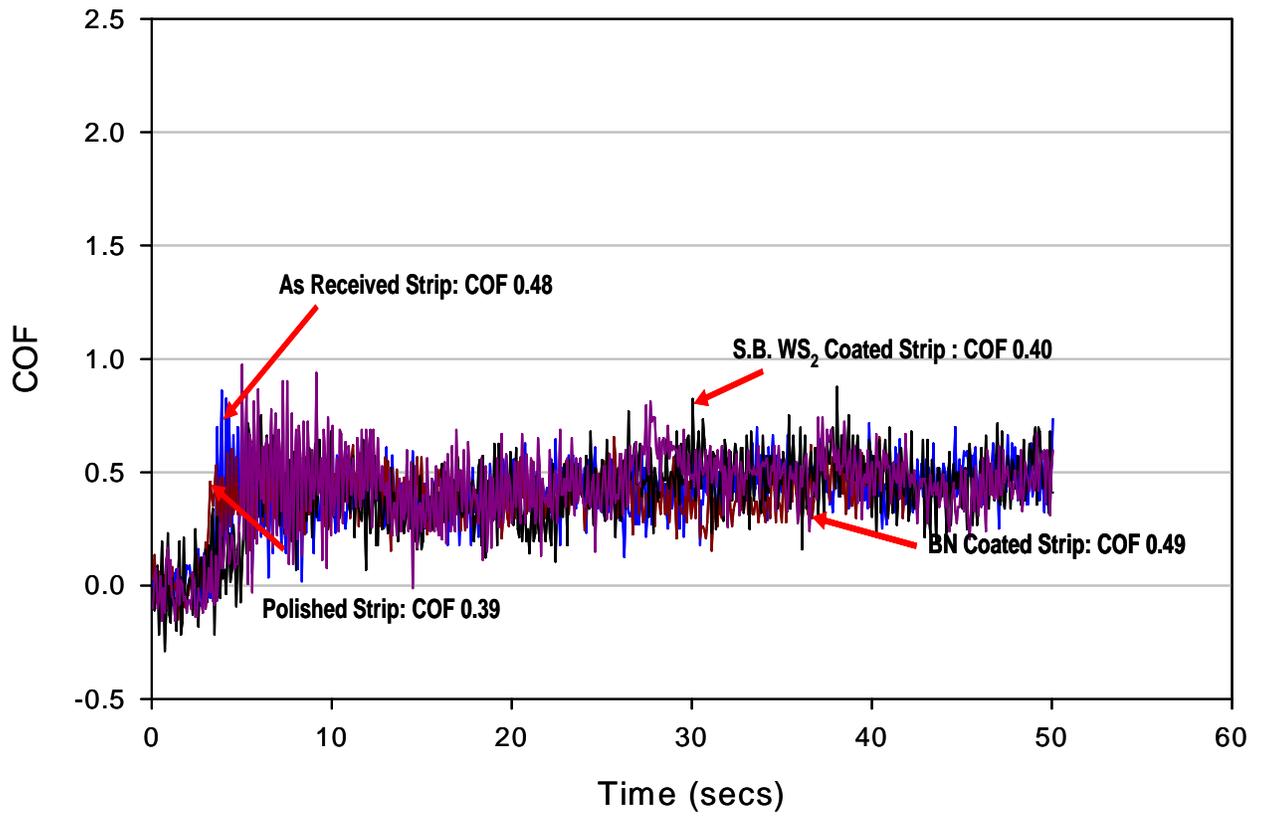
**Figure 42 COF-Time curves for the BN coated P20 steel pin against the various surface conditions of the AA5083 aluminum strip**

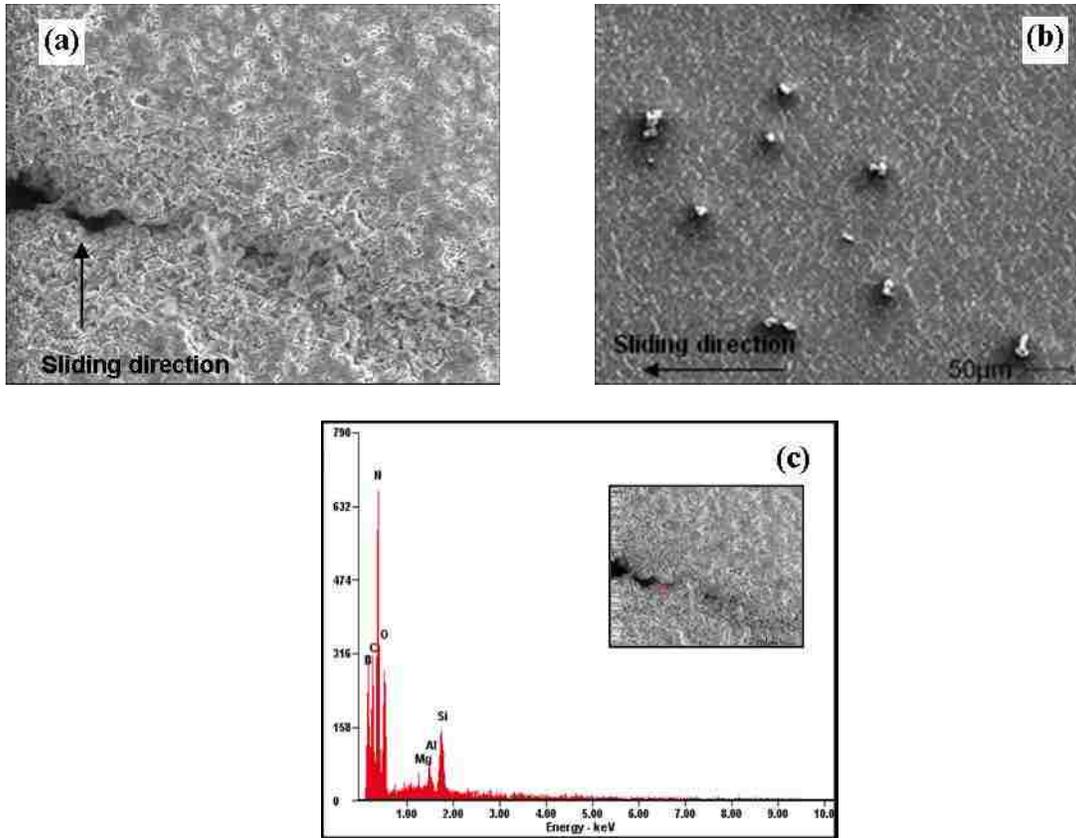
Figure 43 BN coated pin against the polished strip, (a) SEM of BN coated pin surface, (b) SEM of polished strip surface, (c) EDS of BN coated pin surface

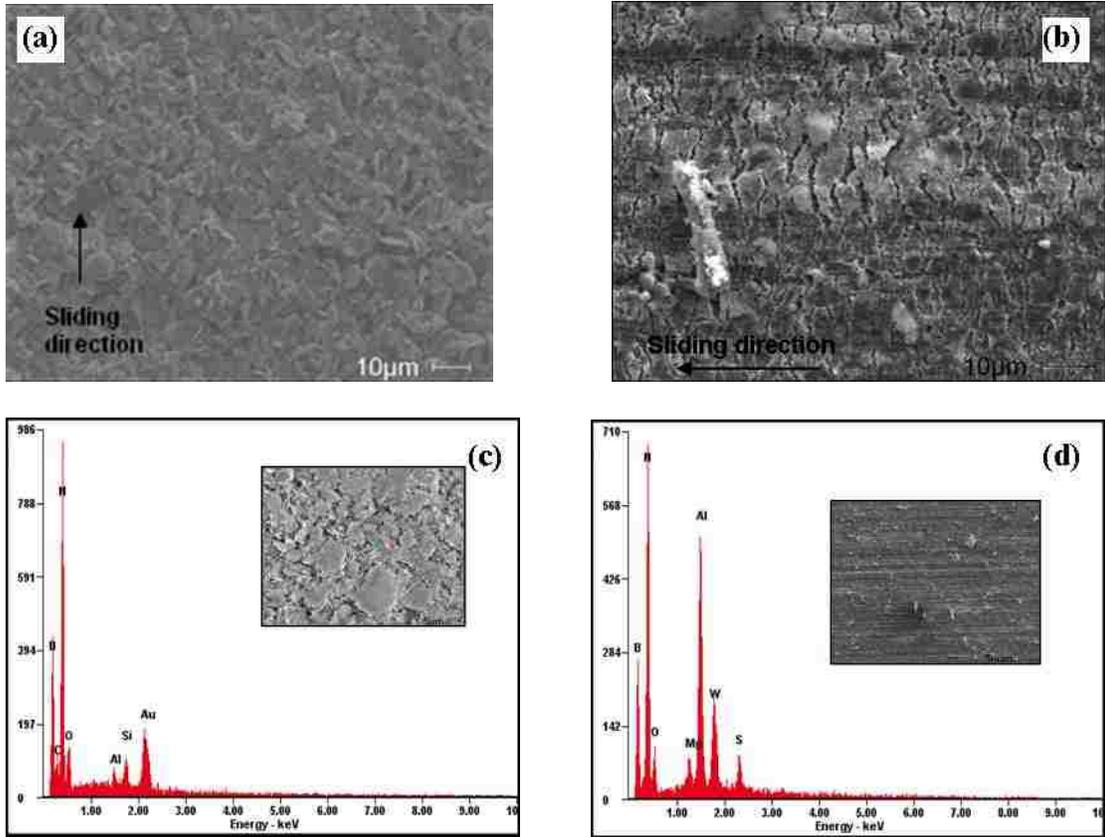
Figure 44 (a) SEM of BN coated pin surface against the as-received strip, (b) SEM of S.B. WS<sub>2</sub> coated strip surface run against BN coated pin, (c) EDS of BN coated pin run against as-received strip surface, (d) EDS of S.B. WS<sub>2</sub> coated strip run against BN coated pin surface

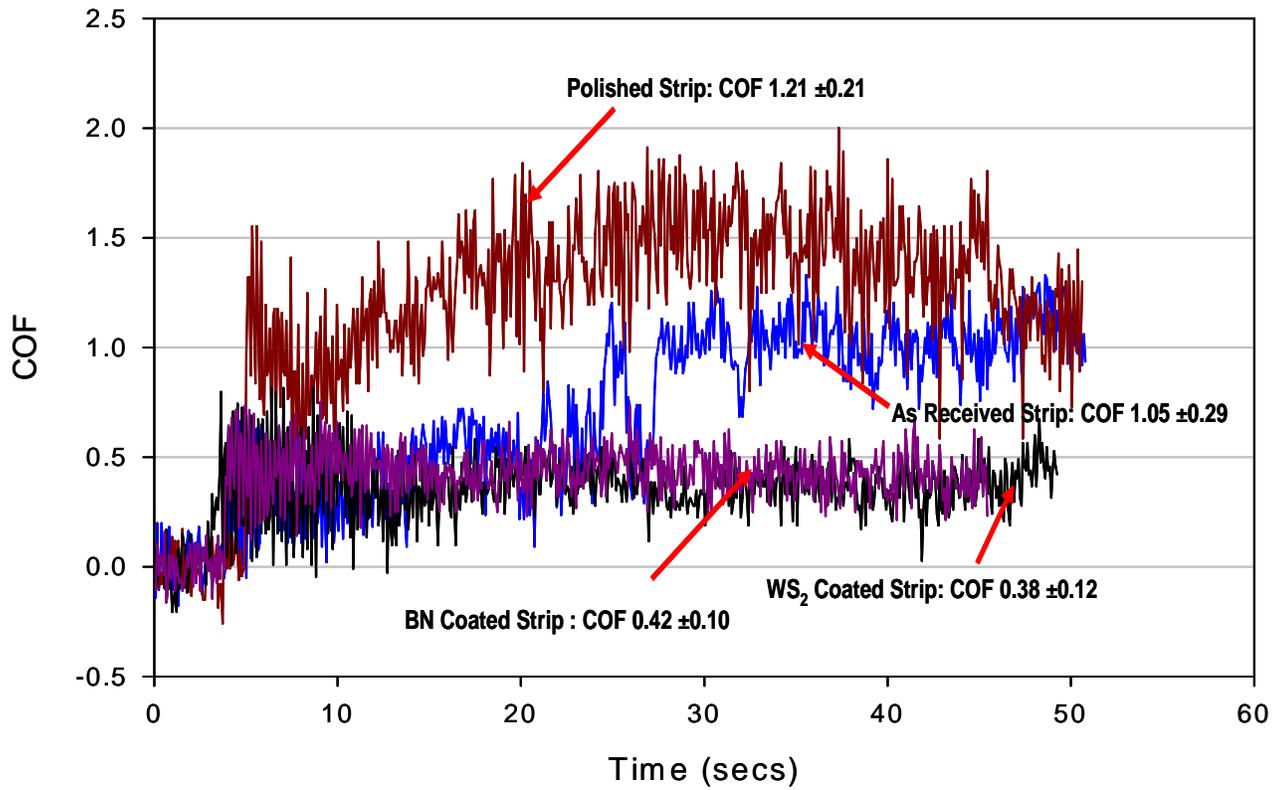
Figure 45 COF-Time curves for the DLC TB40 coated P20 steel pin against the various surface conditions of the AA5083 aluminum strip

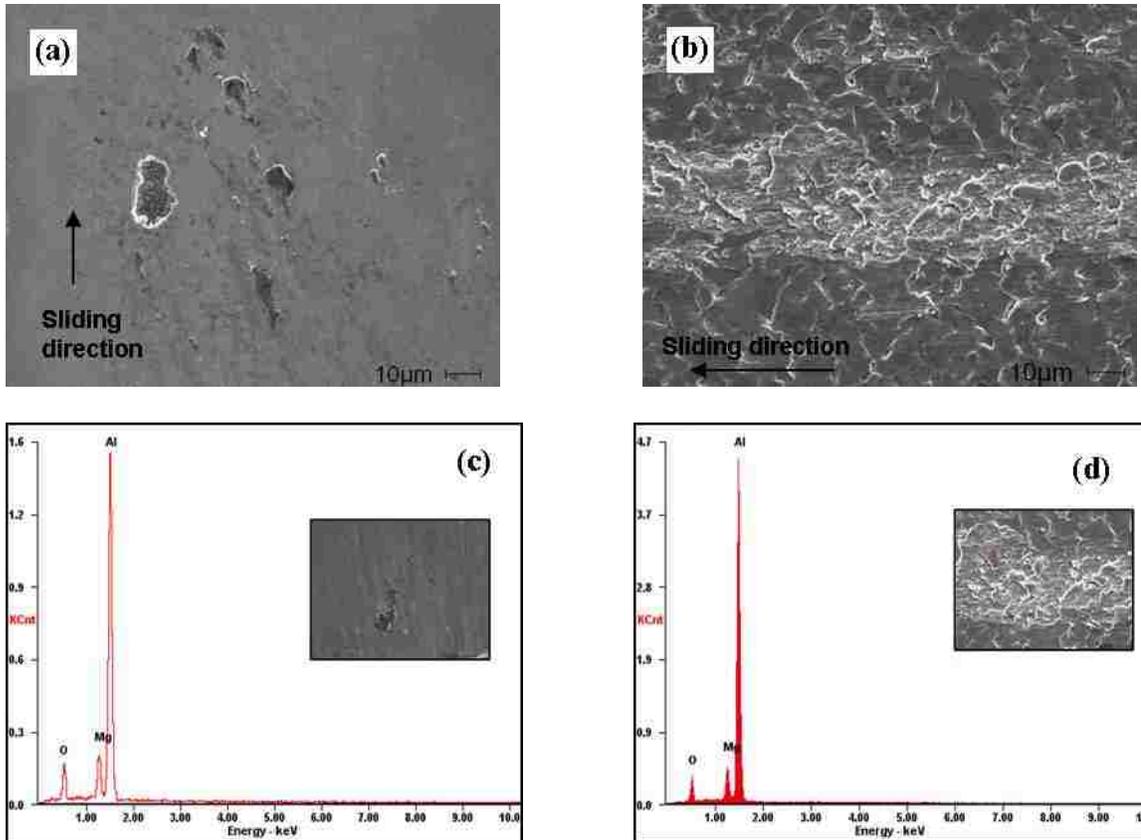
Figure 46 DLC TB40 coated pin against the polished strip, (a) SEM of TB 40 coated pin surface, (b) SEM of polished strip surface, (c) EDS of material adhesion on TB 40 coated pin surface, and (d) EDS of wear track of polished strip

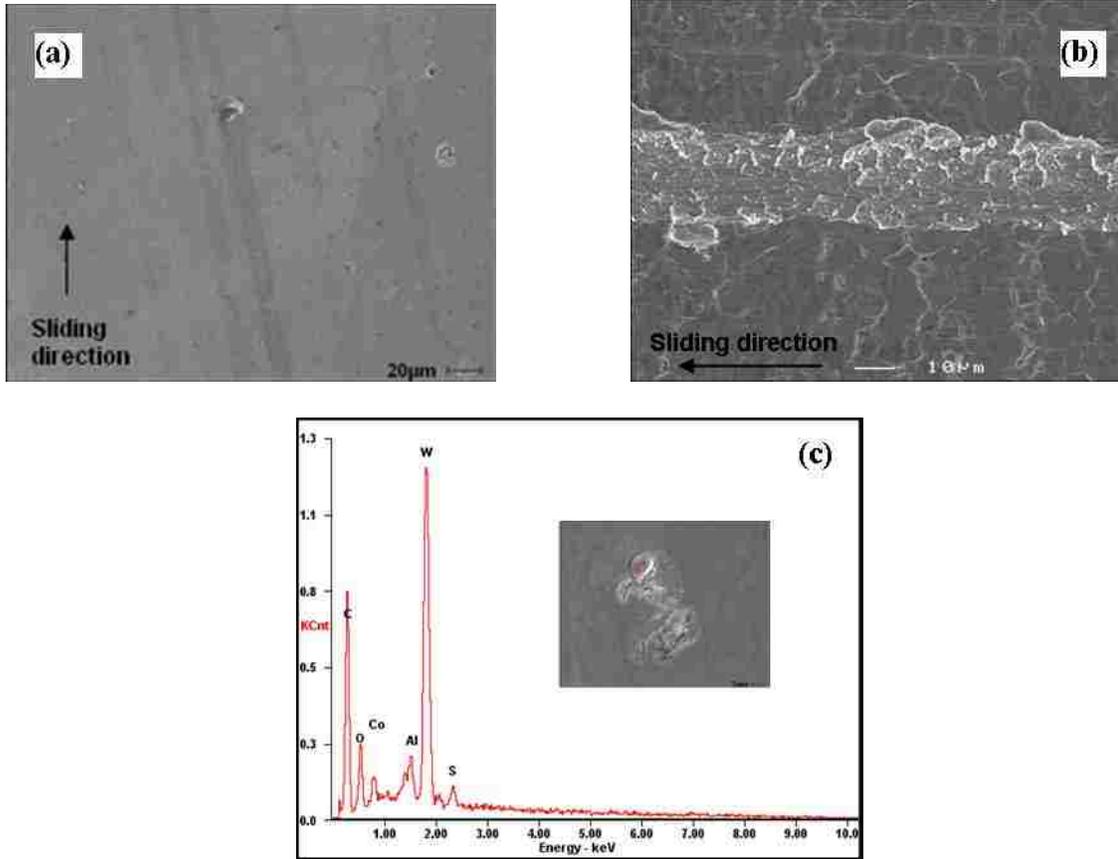
Figure 47 DLC TB40 coated pin against the as-received strip, (a) SEM of TB 40 coated pin surface, (b) SEM of as-received strip surface, (c) EDS of material adhesion on TB 40 coated pin surface

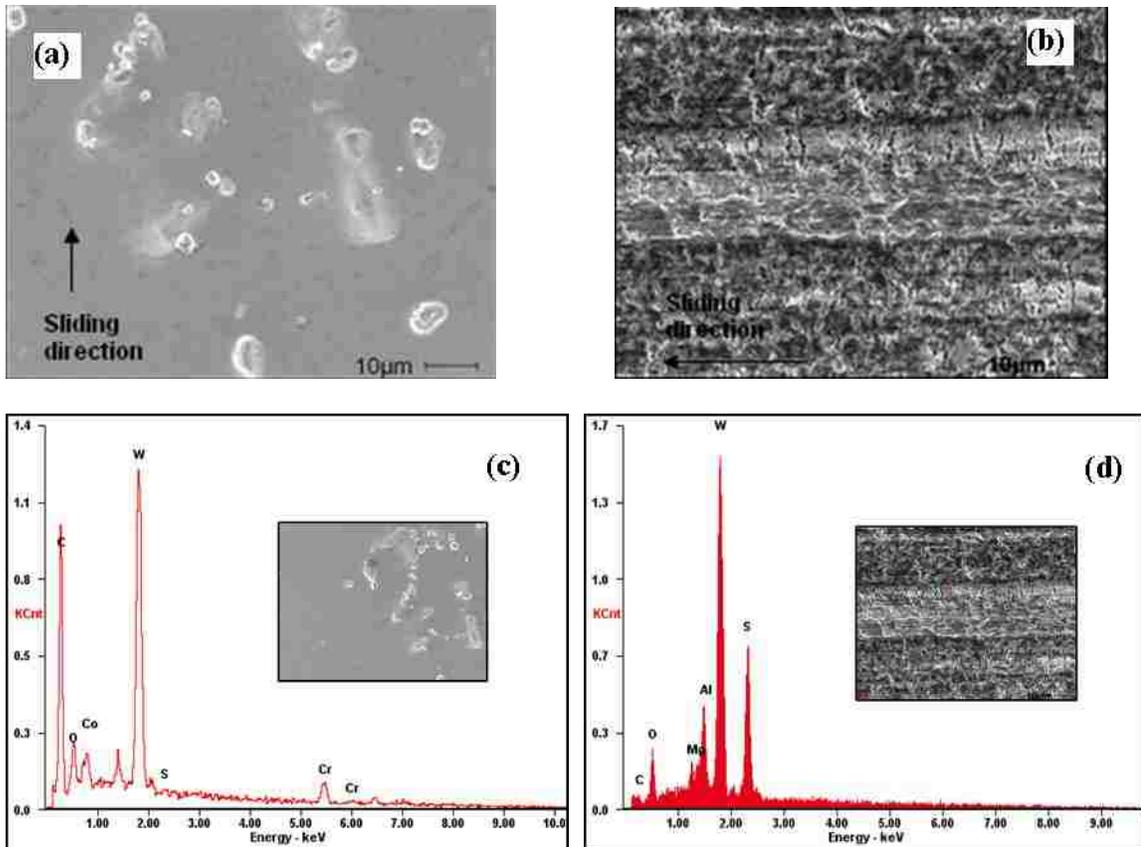
Figure 48 DLC TB40 coated pin against the S.B. WS<sub>2</sub> coated strip, (a) SEM of TB 40 coated pin surface, (b) SEM of S.B. WS<sub>2</sub> coated strip surface, (c) EDS of material adhesion on TB 40 coated pin surface, and (d) EDS of wear track of S.B. WS<sub>2</sub> coated strip

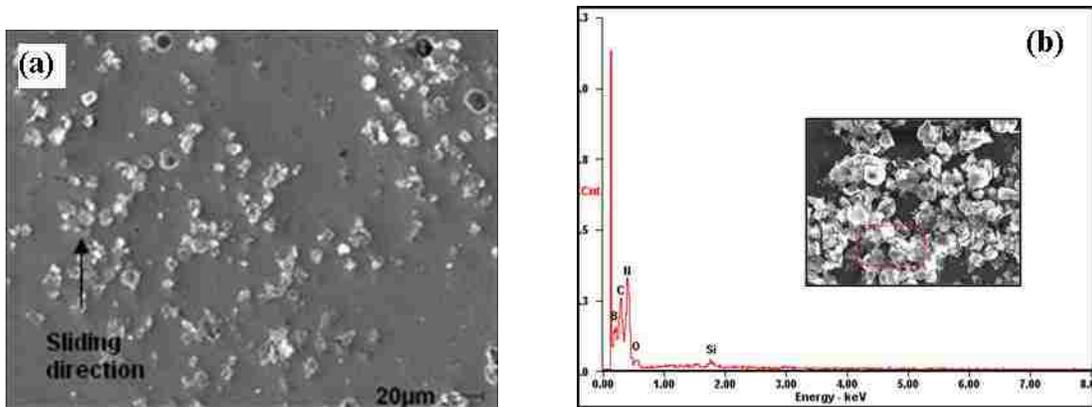
Figure 49 DLC TB40 coated pin against the BN coated strip, (a) SEM of TB 40 coated pin surface, (b) EDS of material adhesion on TB 40 coated pin surface

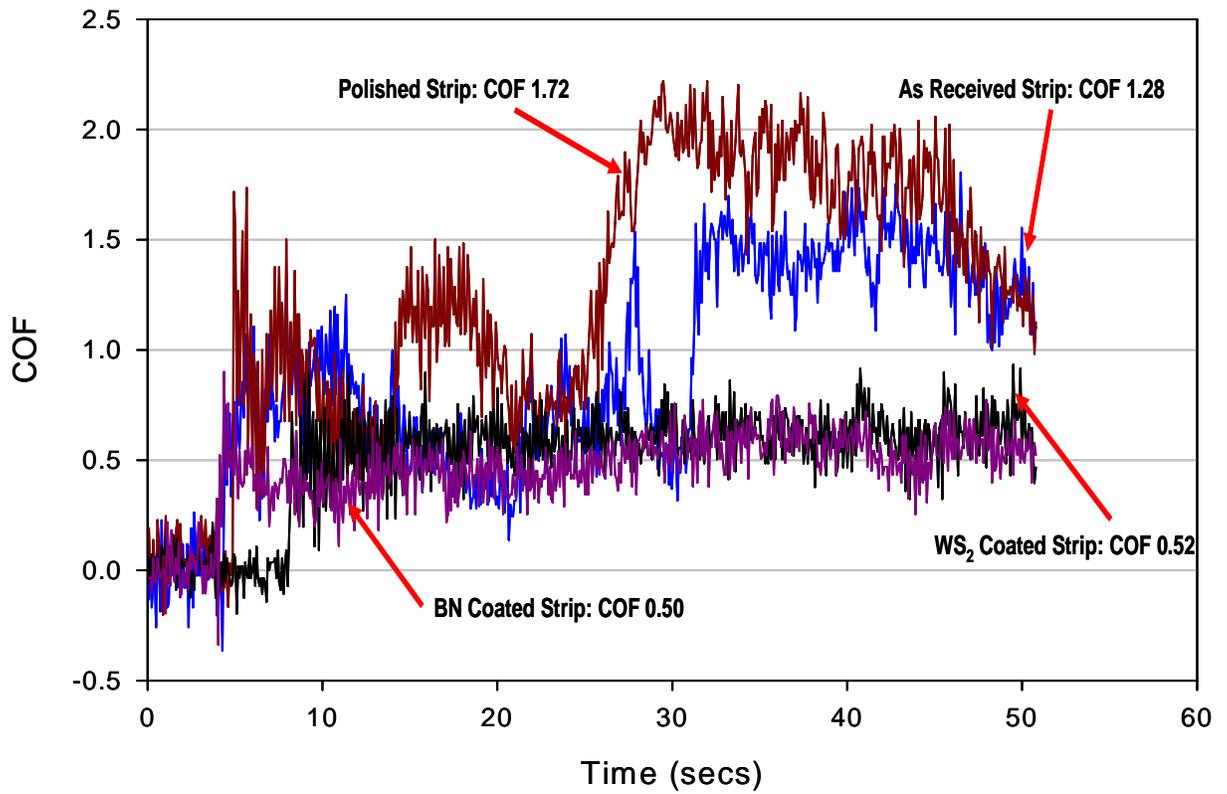
**Figure 50 COF-Time curves for TB41 coated P20 steel pin against the various surface conditions of the AA5083 aluminum strip**

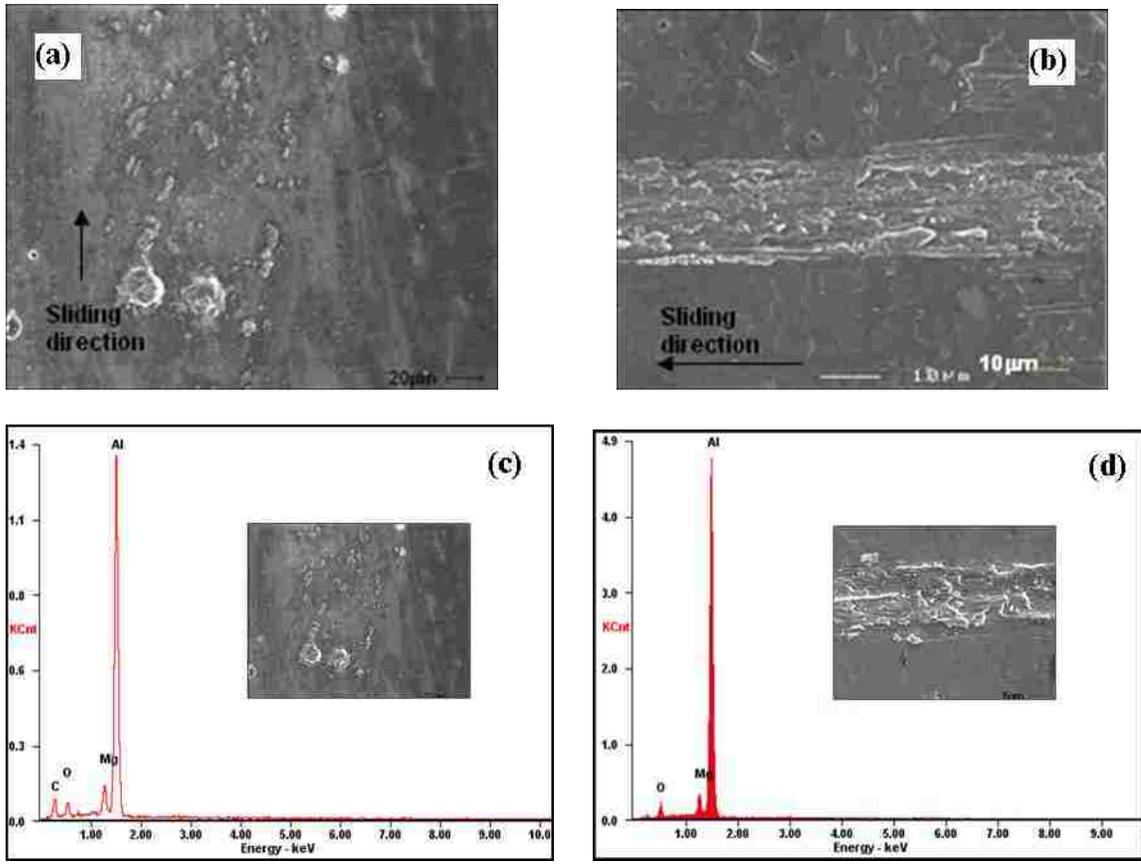
Figure 51 DLC TB41 coated pin against the polished strip, (a) SEM of TB 41 coated pin surface, (b) SEM of polished strip surface, (c) EDS of material adhesion on TB 41 coated pin surface, and (d) EDS of wear track of polished strip

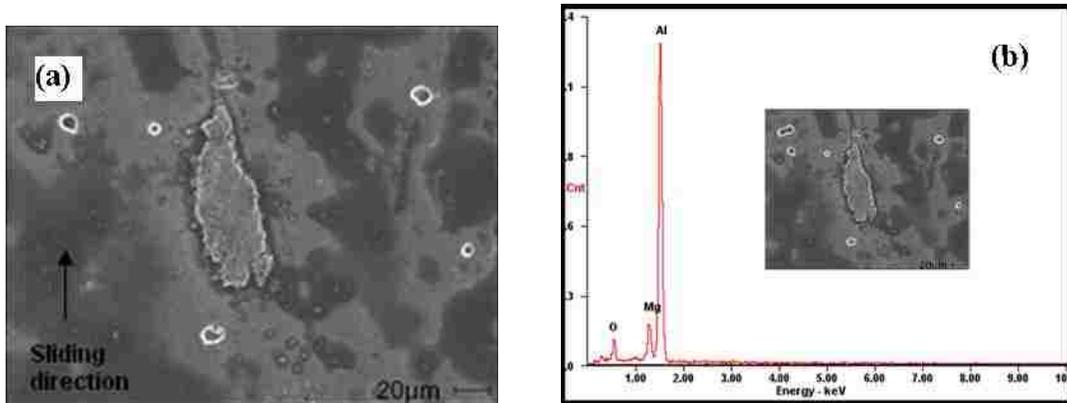
Figure 52 DLC TB41 coated pin against the as-received strip, (a) SEM of TB 41 coated pin surface, and (b) EDS of material adhesion on TB 41 coated pin surface

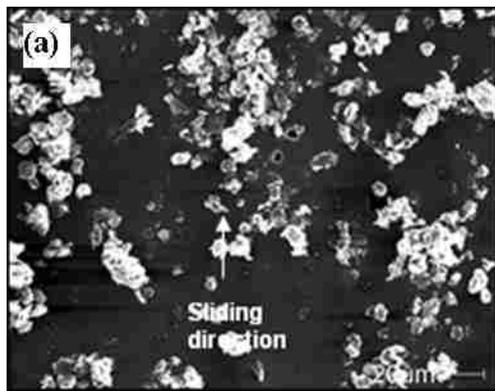
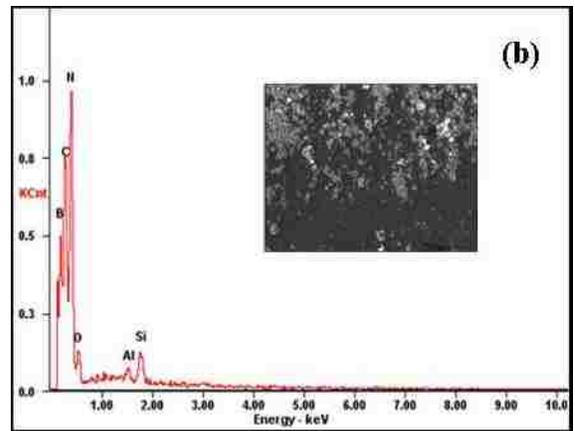
Figure 53 DLC TB41 coated pin against the BN coated strip, (a) SEM of TB 41 coated pin surface, (b) EDS of material adhesion on TB 41 coated pin surface
