2011

### The Effect of Sliding Contact Friction on Surface Quality of Aluminum Sheet Products

A Thesis  
Submitted to the Faculty of Graduate Studies  
through Engineering Materials  
in Partial Fulfillment of the Requirements for  
the Degree of Master of Applied Science at the  
University of Windsor

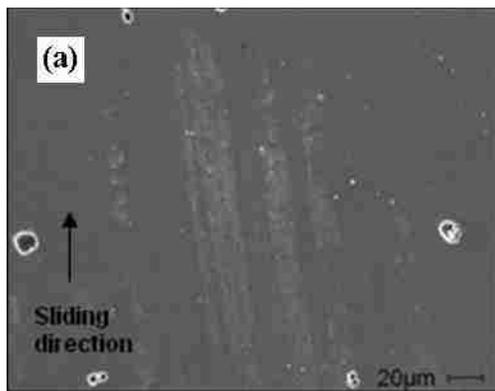
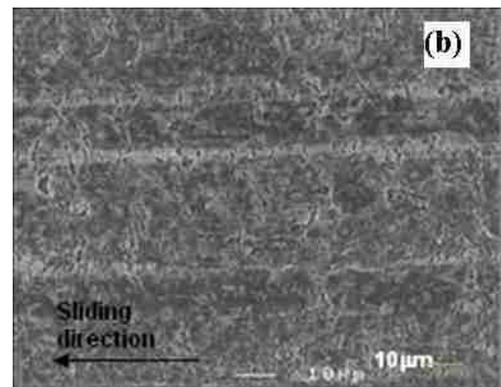
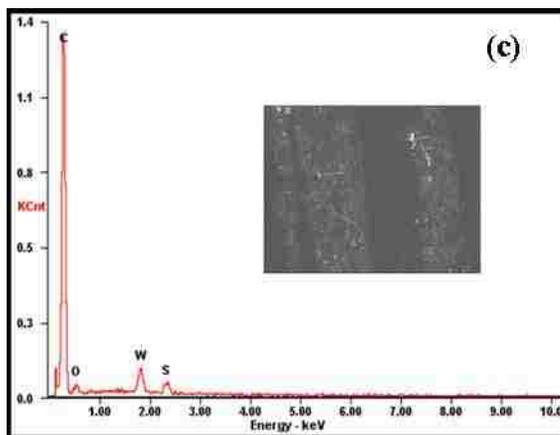
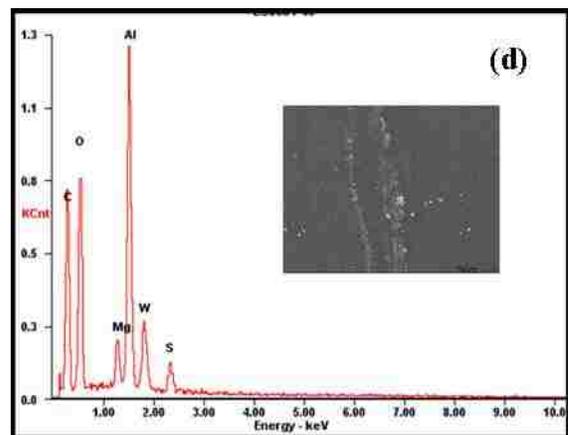
Figure 54 DLC TB41 coated pin against the S.B. WS<sub>2</sub> coated strip, (a) SEM of TB 41 coated pin surface, (b) SEM of S.B. WS<sub>2</sub> coated strip surface, (c) EDS of material adhesion on TB 41 coated pin surface, and (d) EDS of material adhesion on TB 41 coated pin surface

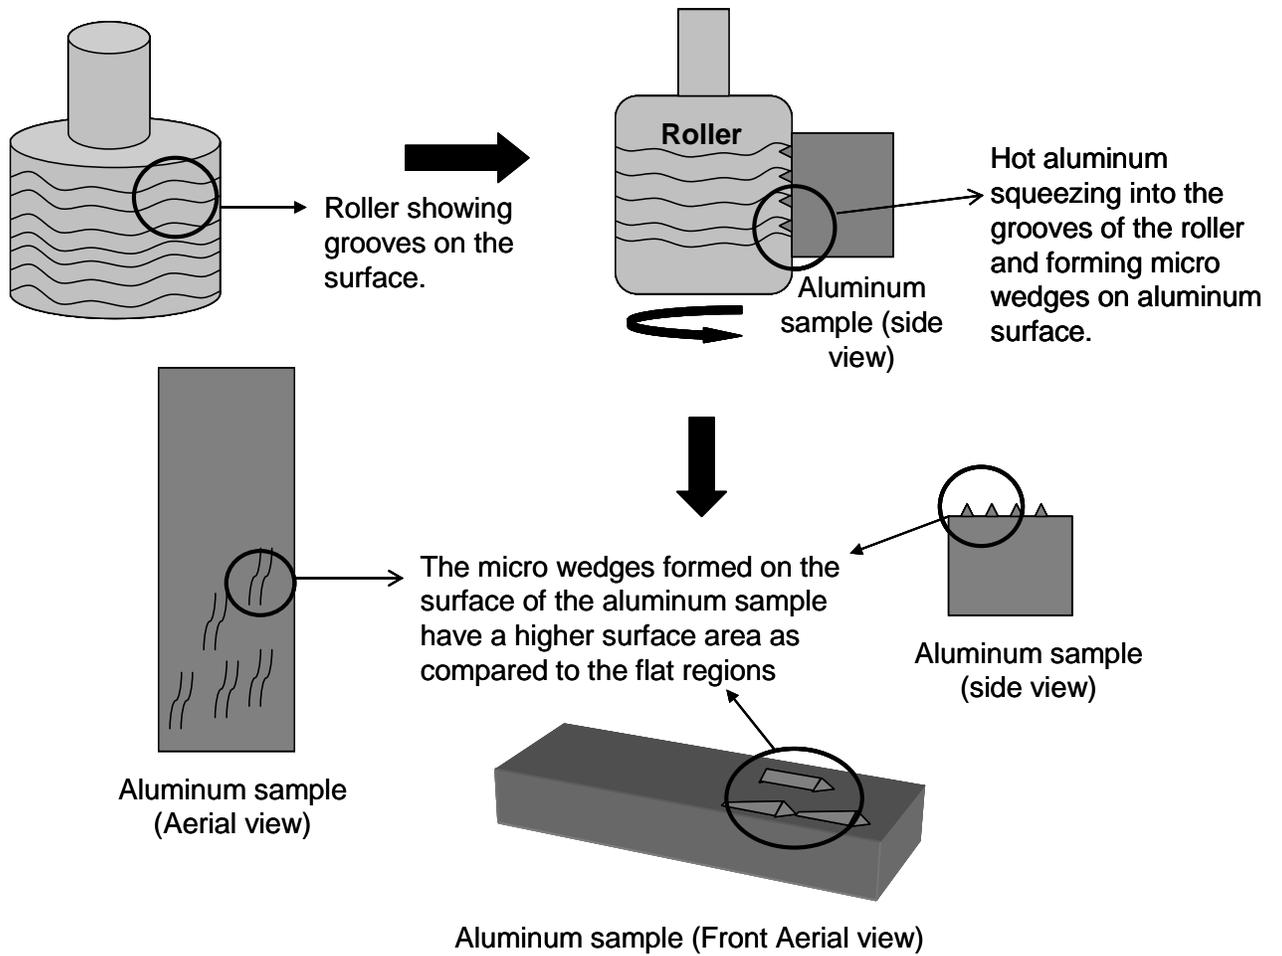
Figure 55 Formation of Microwedges on the aluminum stock rolled against the steel roll

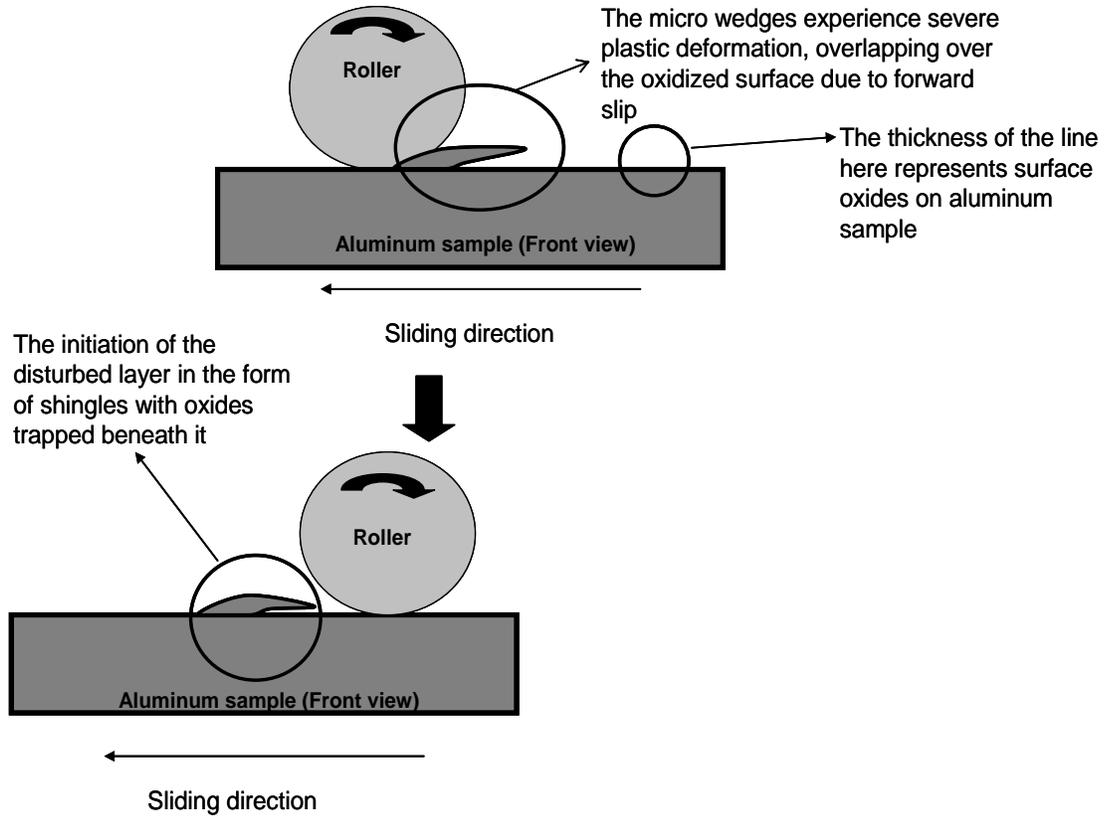
**Figure 56** The influence of the first rolling pass

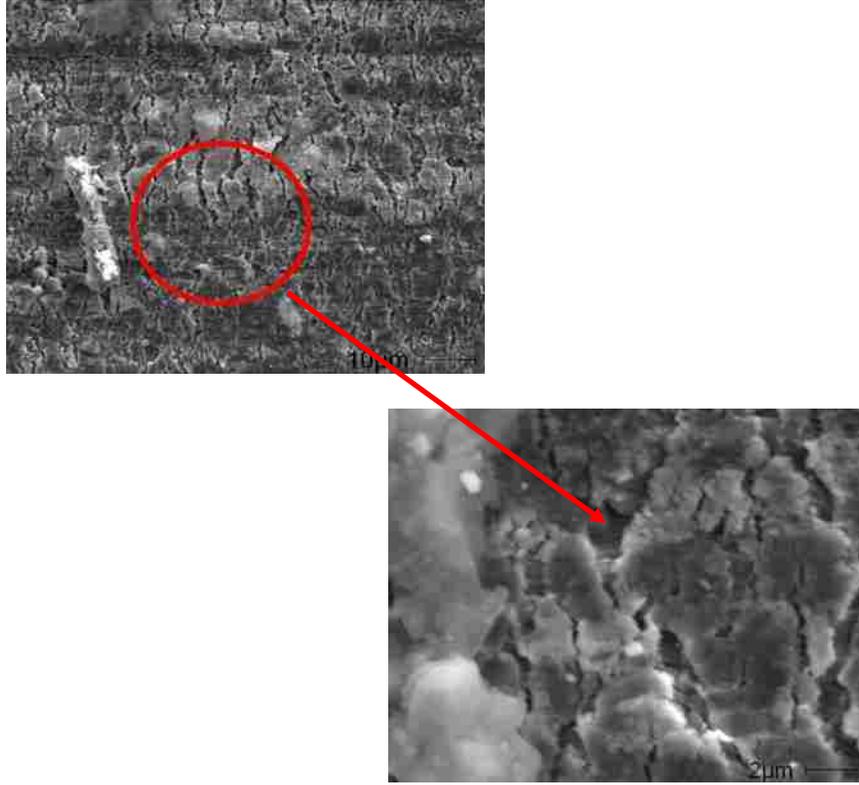
**Figure 57 SEM of the cracks on S.B. WS<sub>2</sub> coating showing the exposed AA5083 substrate**

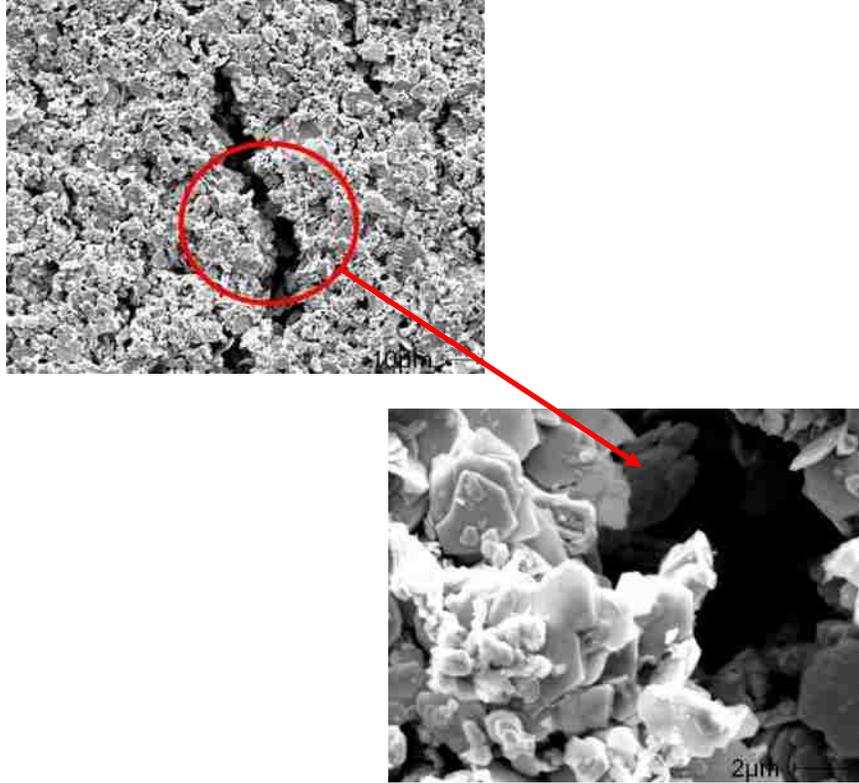
**Figure 58 SEM of the cracks on A.S. WS<sub>2</sub> coating showing no exposure of AA5083 substrate due to coating thickness**

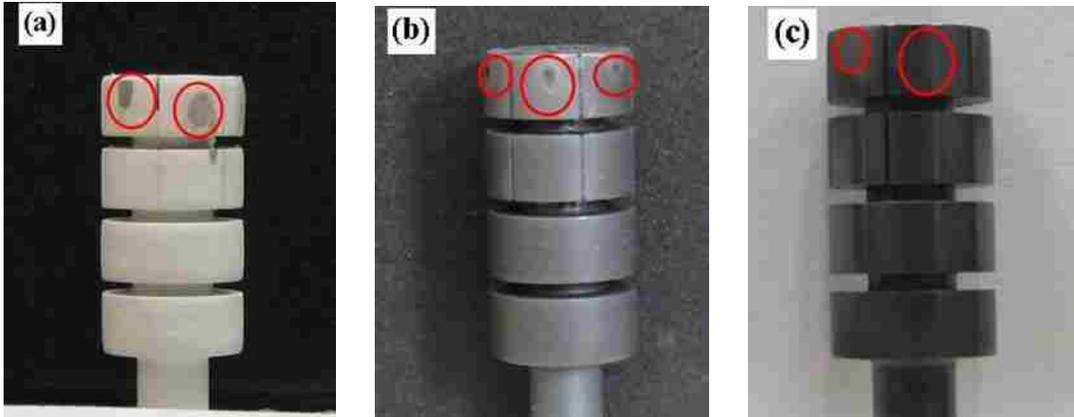
Figure 59 Pictures of the surfaces of the, (a) BN coated pin, (b) A.S. WS<sub>2</sub> coated pin, and (c) S.B. WS<sub>2</sub> coated pin after the hot forming experiment with red rings around strip contact areas showing visual coating loss

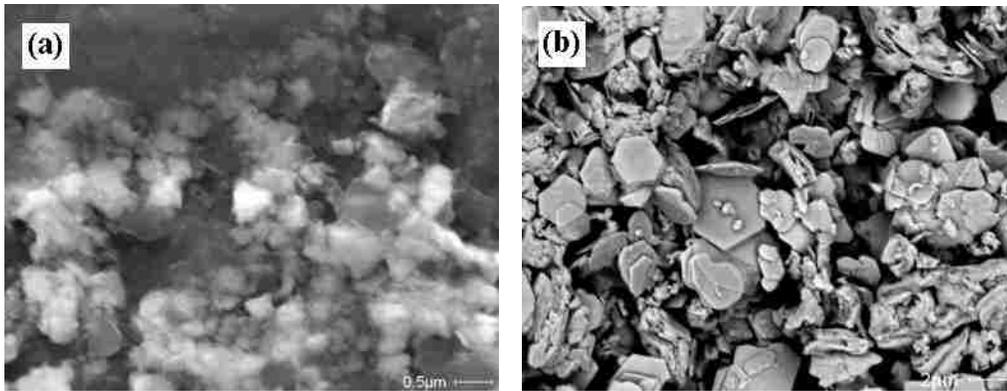
Figure 60 A Comparisons of the platelet sizes for (a) S.B. WS<sub>2</sub> coating (b) A.S. WS<sub>2</sub> coating

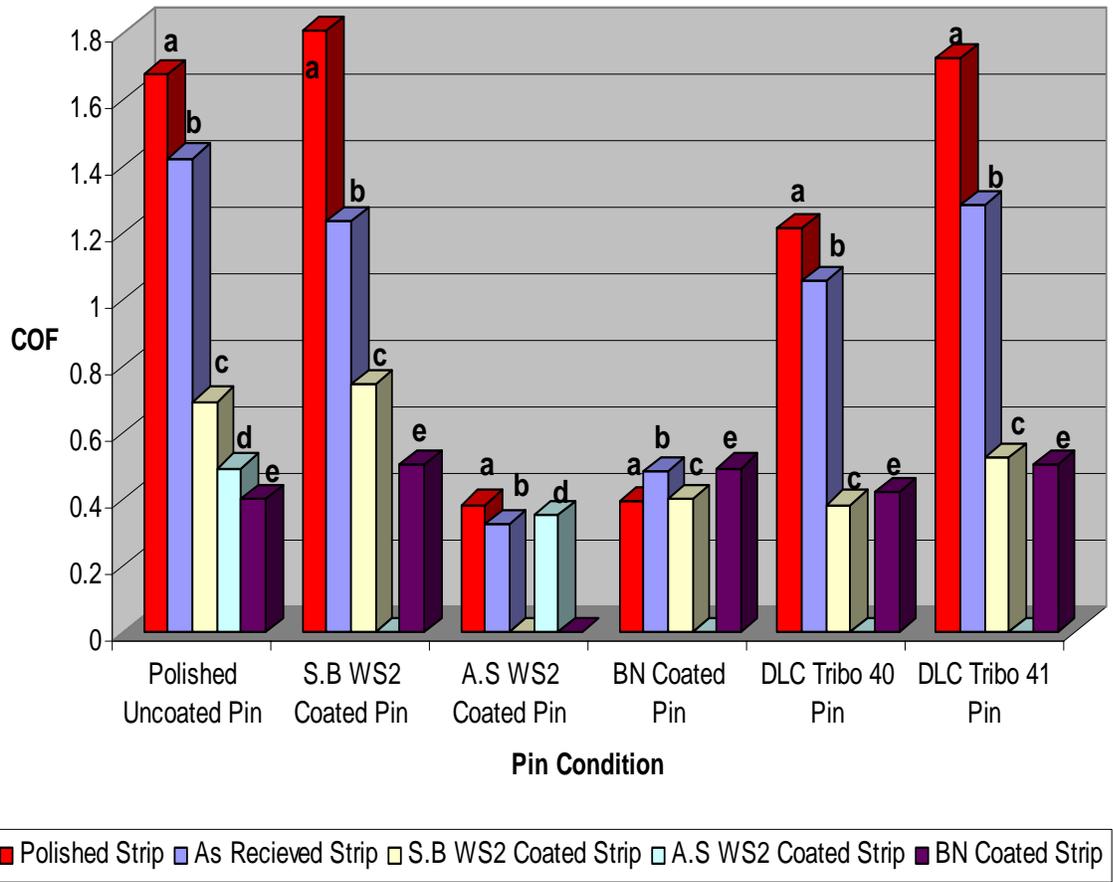
**Figure 61 Average COF Chart ; (a) depicts the polished strip, (b) as-received strip, (c) S.B. WS<sub>2</sub> coated strip, (d) A.S. WS<sub>2</sub> coated strip, (e) BN coated strip**

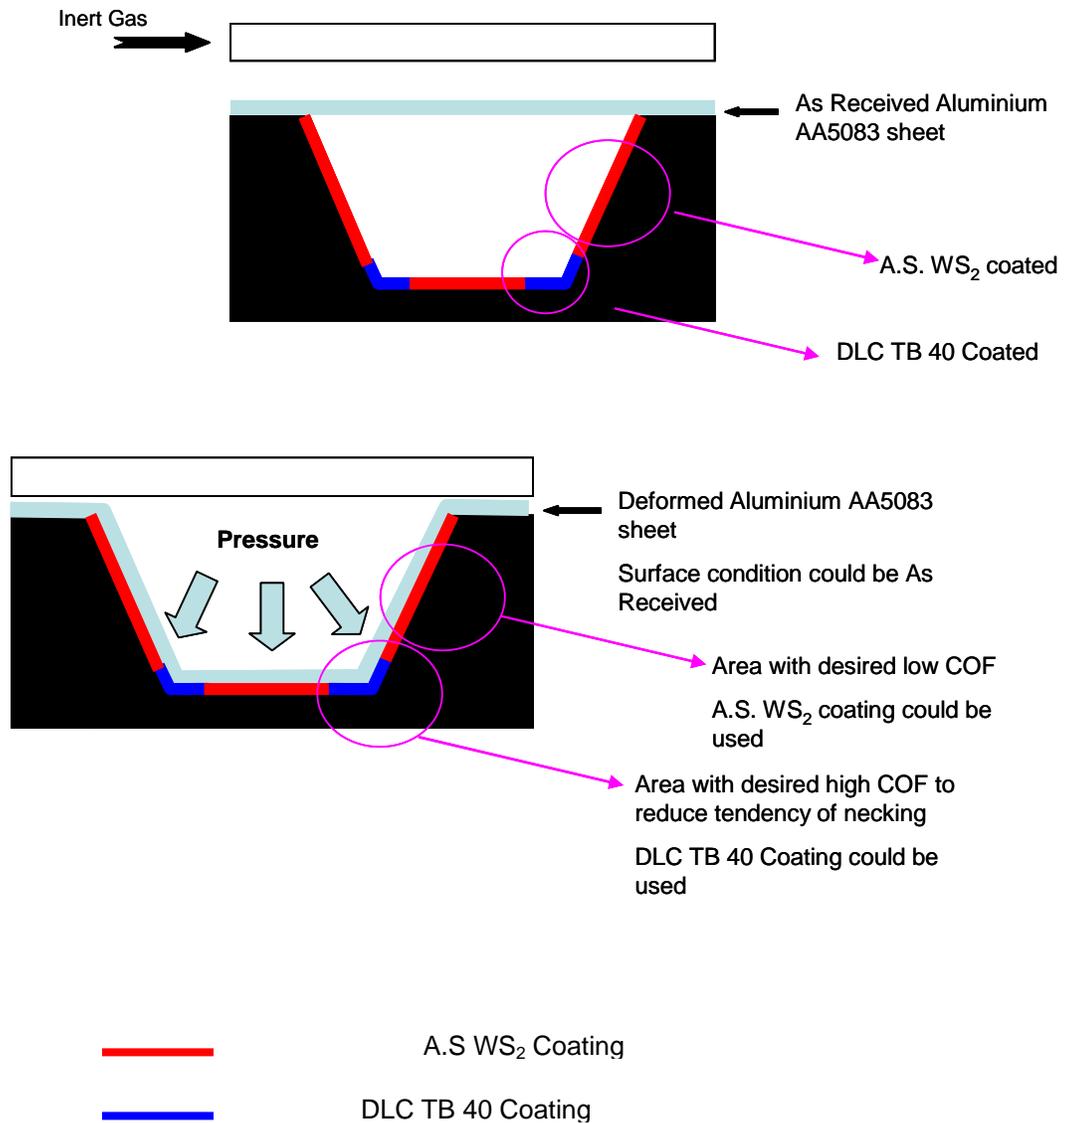
**Figure 62 A Schematic diagram displaying ways solid lubricant coatings can be combined to attain high COF at high radii areas and low COF at other areas**
