Ex Vivo Biomechanical Testing to Examine the Etiology of
Low Back Pain as a Result of Whole Body Vibration

A thesis

Master of Science in Bioengineering

University of Washington

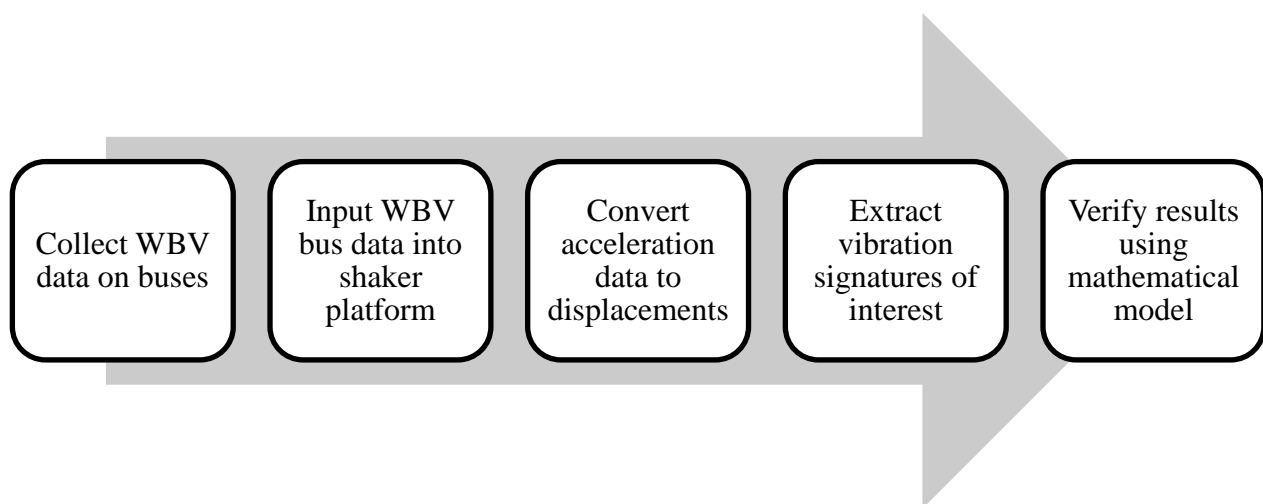
Figure 2.1 Overview of data collection and processing.

This chapter discusses the methods and protocols used in obtaining WBV signatures to be used in subsequent laboratory testing on human cadaveric specimens. Occupational WBV data was collected in King County Metro buses at the vehicle seat and floor by Ryan Blood, a Ph.D. student in the University of Washington’s Department of Environmental and Occupational Health Sciences (henceforth referred to as “Blood”). Because sternum vibration data was not collected during this initial round of data collection, the data from the buses was to be used in conjunction with a computational mathematical model to predict the response of the drivers’ sternums to vibrations. Blood later collected vibration data at drivers’ sternums using a hydraulic shaker platform using the bus data as inputs. This data was processed to extract the displacement response of individual intervertebral discs to vibrations and verified using the computational mathematical model. This extracted data was used in the laboratory experiments detailed in later chapters. An overview of the process described in this chapter is shown in Figure 2.1.

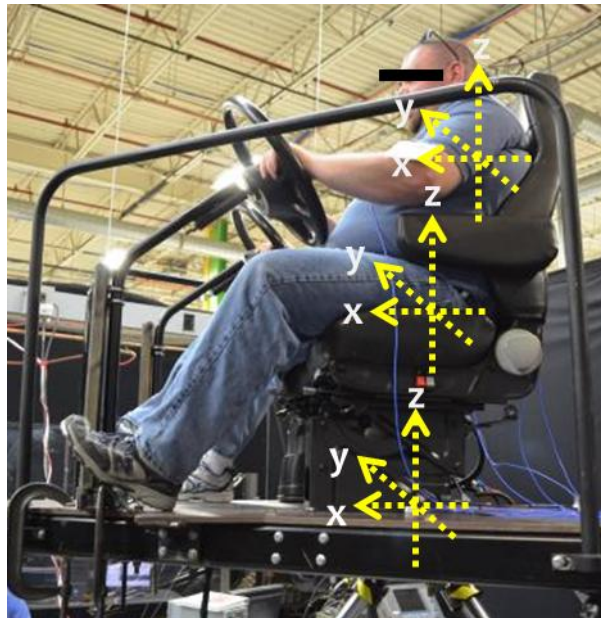
Figure 2.3 Shaker table experiment setup. Locations of arrows mark approximate placement of three accelerometers (image courtesy of Ryan Blood).

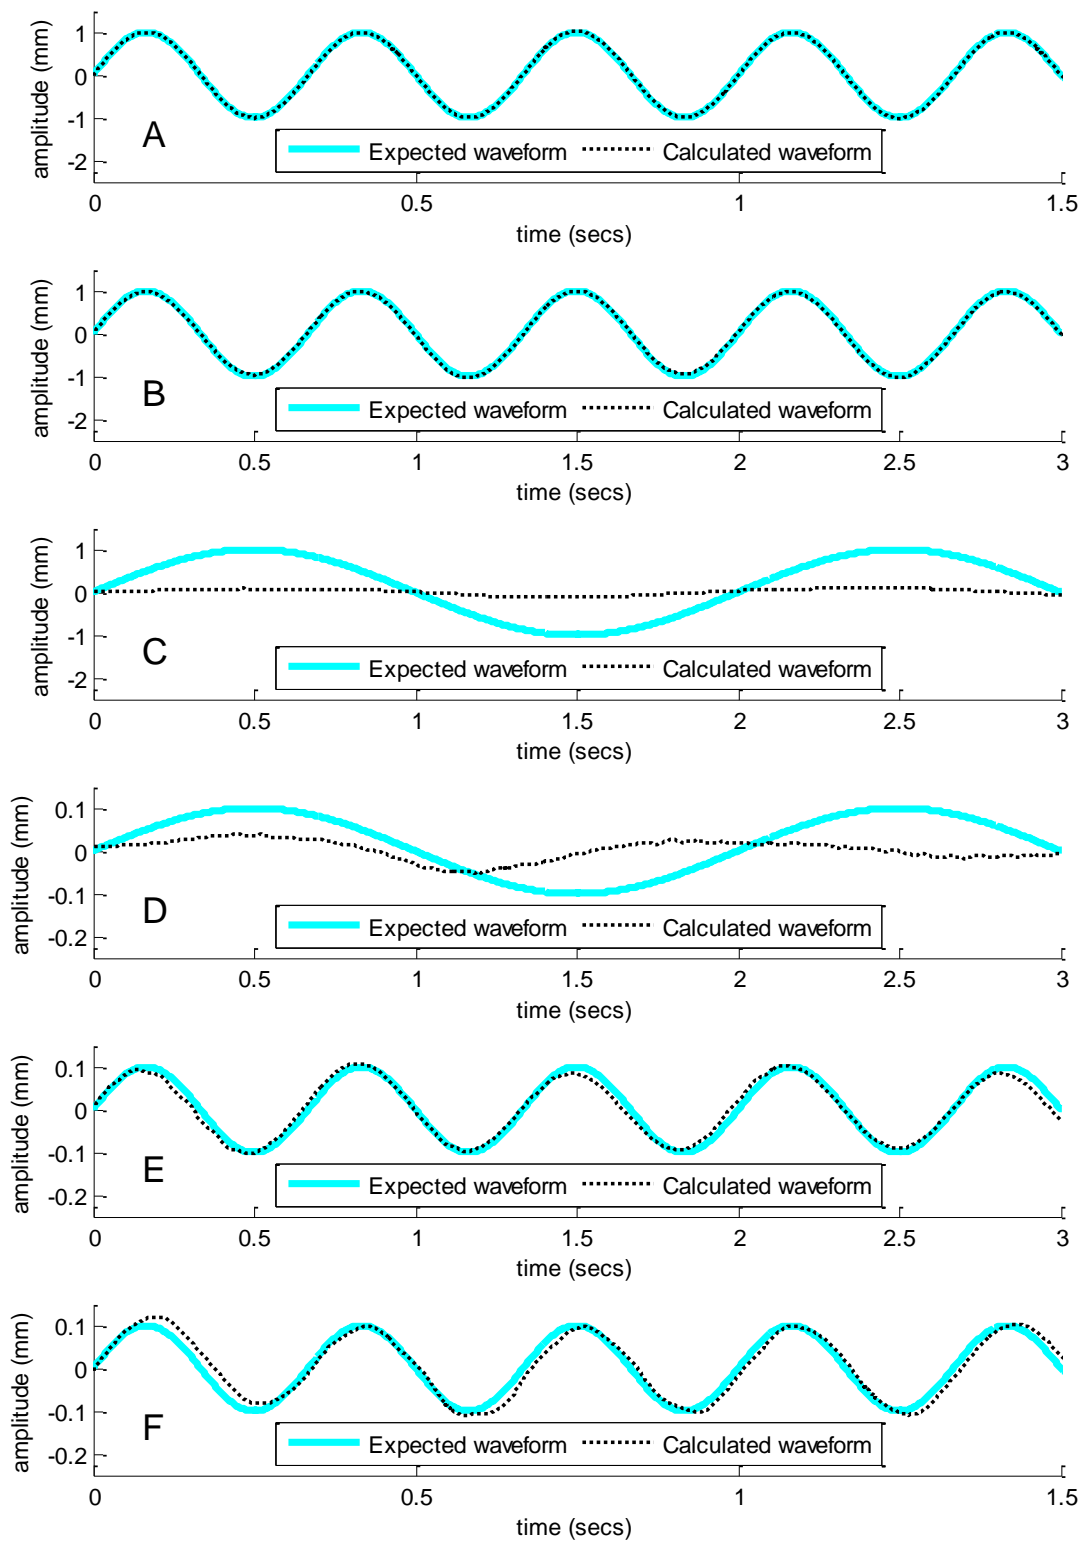
Figure 2.5 TFDI calculations and validation. A: 3 Hz, 2 mm amplitude; B: 1.5 Hz, 2 mm amplitude; C: 0.2 Hz, 2 mm amplitude; D: 0.2 Hz, 0.2 mm amplitude; E: 1.5 Hz, 0.2 mm amplitude; F: 3 Hz, 0.2 mm amplitude

Apparent from both Figure 2.5 and Table 2.5 is the accuracy of the TFDI approach in determining displacement when frequencies are within the working range of the accelerometers used (note that, as discussed previously, the working range for the accelerometers used was 0.5-1000 Hz). For both data sets with a 0.5 Hz frequency, the TFDI approach was unsuccessful in determining the amplitude of the vibrations. For only one of the two cases was the frequency detected but only with moderate success (run C - 0.5 Hz and 2 mm amplitude). This emphasizes the importance of understanding the working range for instruments used when employing the TFDI. Meanwhile, the TFDI very accurately calculated both the displacement and frequency for all other runs of data. It should be noted that the frequencies and amplitudes used in these calculations are in a similar range to those used in ex vivo experiments discussed later. Based on these results, it can be concluded that the TFDI approach allowed for an accurate calculation of displacement values from acceleration data provided the frequency content of the data of interest lies within the working range of the accelerometers used.

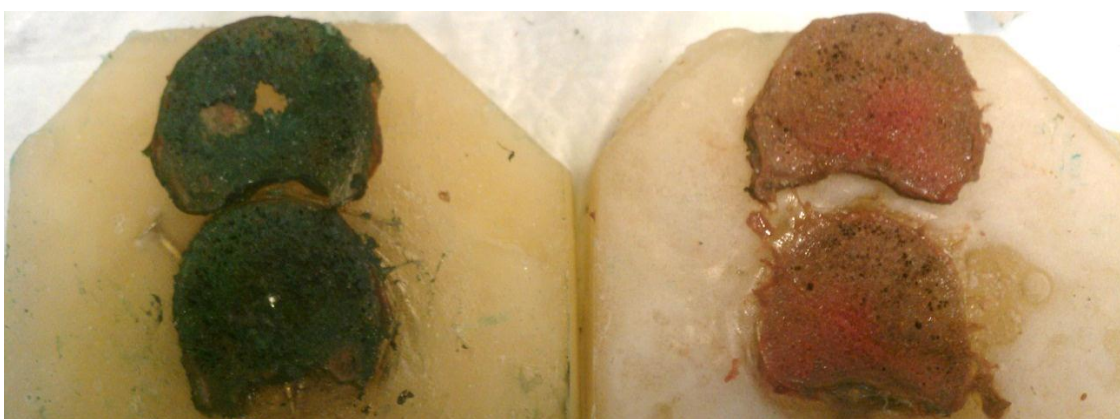
Figure 3.5 Results from second preliminary test. Note the blue-green color of the cancellous bone on the left. L1 shown on the left and T12 shown on the right. The difference in color is brought on by leaking of stain from the intervertebral disc, through the endplate fracture, and into the cancellous bone of the vertebra.

Upon dissection of the disc, damage was detected to both the intervertebral disc and one of the vertebral bodies. Small amounts of migration of the nucleus pulposus beyond the outline of the safranin-O outline were found. Additionally, an endplate fracture was found on the superior endplate of L1 (inferior of the two endplates surrounding the intervertebral disc). The idea that this fracture was brought on during cycling was supported by the fact that prior to testing and upon injecting the safranin-O and the first round of alcian blue, the disc only took a limited volume of fluid (approx. 0.4 ml total) via maximum thumb pressure. After the first 7200 cycles, however, the disc was freely accepting the alcian blue stain (approx. 1 ml was injected). This lack of ability to maintain pressure is indicative of disc damage, as discussed in section 3.2. The presence of the endplate fracture was verified by finding a region of the superior L1 endplate having been pushed into the cancellous bone of the vertebral body. This was further verified by cutting both of the FSU's vertebrae in half transversely using a bone saw. This revealed a brownish-red color to the inside of T12, as expected of cancellous vertebral bone. The inside of L1, however, was a blue-green color as brought about by leaking of stain into the cancellous bone. This contrast in color is shown in Figure 3.5.

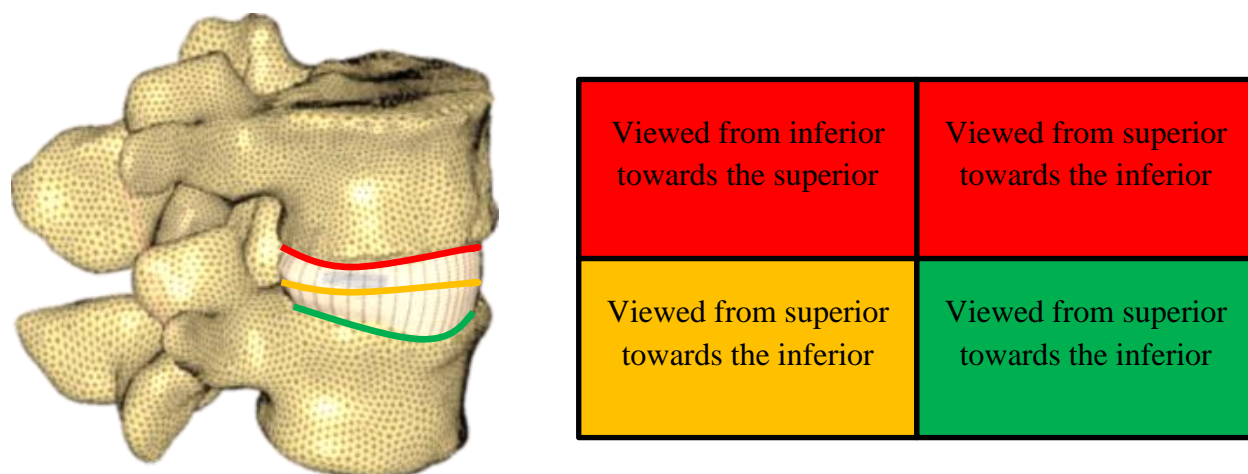
Figure 4.4 Diagram of FSU (left) and picture grid (right). Lines through intervertebral disc on FSU correspond to location of images detailed in diagram of picture grid. Views shown in picture grids correspond to those written in each section of the diagram of grid.
