Enamel coated steel reinforcement for improved durability and life-cycle performance of concrete structures: microstructure, corrosion, and deterioration

A DISSERTATION

Presented to the Faculty of the Graduate School of the
MISSOURI UNIVERSITY OF SCIENCE AND TECHNOLOGY

CIVIL ENGINEERING

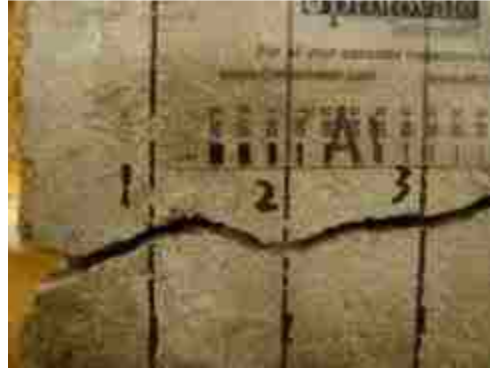
Figure 2.7 Typical corrosion-induced cracks on the concrete surface with a crack meter.

2.2.3 Crack Width Measurement. At specified corrosion levels, photos were taken on the top of each test specimen with a crack width meter as the scale as shown in Figure 2.7. The images were processed in AutoCAD 2010 to determine the widths of concrete cracks along the length of steel bars every 1.0 mm.

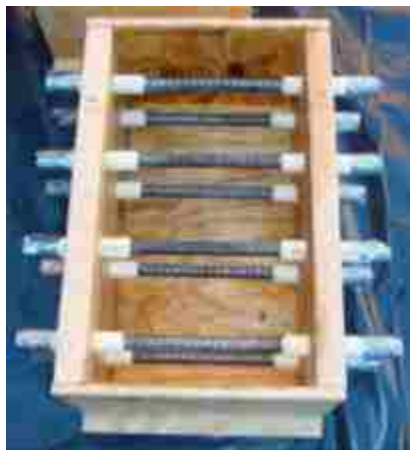
Figure 3.3 Mold to cast concrete block.

For the casting of concrete, plywood molds were built as shown in Figure 3.3. Sixteen holes with a diameter of 28.6 mm were drilled in two side plywoods at the location of steel bars. After that, silicon resins were applied to seal the void between the plywood hole and the encasement PVC pipe. Before casting, a layer of oil was applied to avoid water penetration to the plywood during and after casting of concrete.

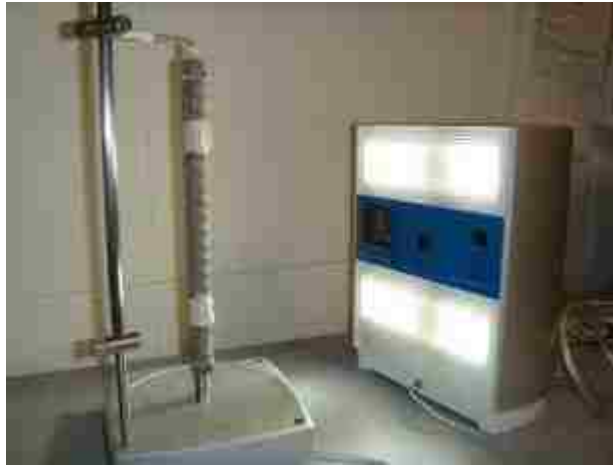
Figure 3.5 3D laser scanning of deformed steel bar.

3.2.3 3D Laser Scan. After the accelerated corrosion test, the corroded bars were taken out of the concrete specimens and then sand blasted to remove the attached concrete debris and corrosion products. After cleansing, all the surface morphology was measured using a 3D laser scanner (see Figure 3.5) to determine the remaining cross section, and the 3D coordinates of each point on the surface of the corroded rebar were acquired. Data not belonging to the corroded rebar were cleansed by ScanStudio software to get cleaner point cloud files with a higher signal-to-noise ratio of the data. The acquired 3D point cloud data were processed using ImageWare software to get the boundary of the cross sections of corroded steel rebar.

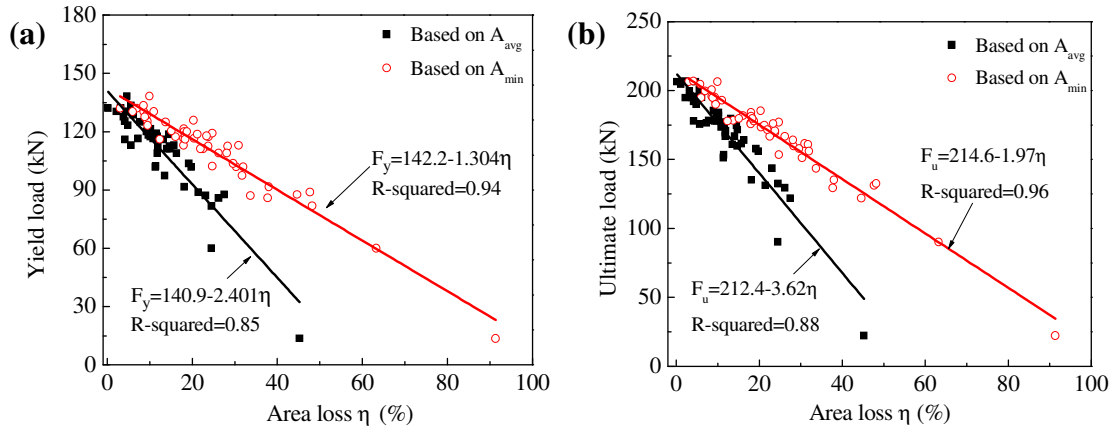
Figure 3.14 Yielding load (a) and ultimate load (b) as a function of area loss.

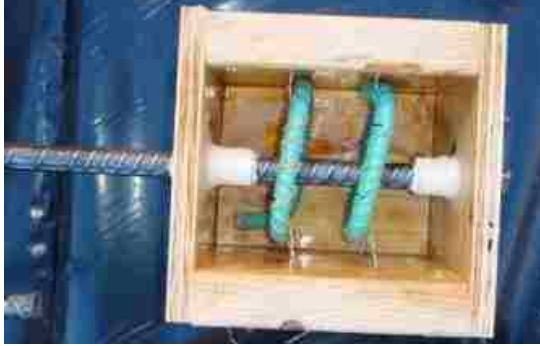
Figure 4.2 Plywood mold for pull-out specimen casting.

For the casting of concrete, formworks were constructed using 13 mm plywoods as shown in Figure 4.2. Two holes with a diameter of 28.6 mm were drilled on the two opposite side walls for bar placement at the predetermined location. Once the steel bar is in place, silicon resin was applied to seal the void between the holes and the PVC pipes. Two epoxy coated steel bar stirrups with a diameter of 12.7 mm were used as confinement. To ensure the placement of stirrups at the certain location, four plastic ties were used to mount the stirrups against the sidewalls. Before casting, a layer of oil was applied to avoid water penetration to the plywoods.

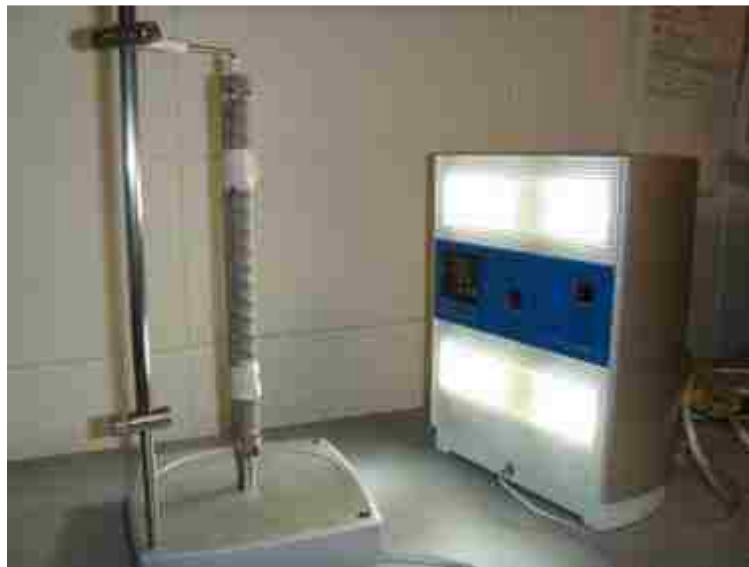
Figure 4.5 3D laser scanning of the deformed steel bar.

4.2.4 3D Laser Scan. After pullout tests, the corroded bars were taken out of the concrete specimens and cleansed with sand blaster. After cleansing, the surface morphology of the bars was measured using a 3D laser scanner to determine the residual cross section as indicated in Figure 4.5. After this operation, the 3D coordinates of each point on the surface of the corroded bar were acquired. Data not belonging to the corroded rebar were cleansed by ScanStudioHD software to give point cloud files with higher signal-to-noise ratios. The acquired 3D point cloud data were processed using ImageWare software.

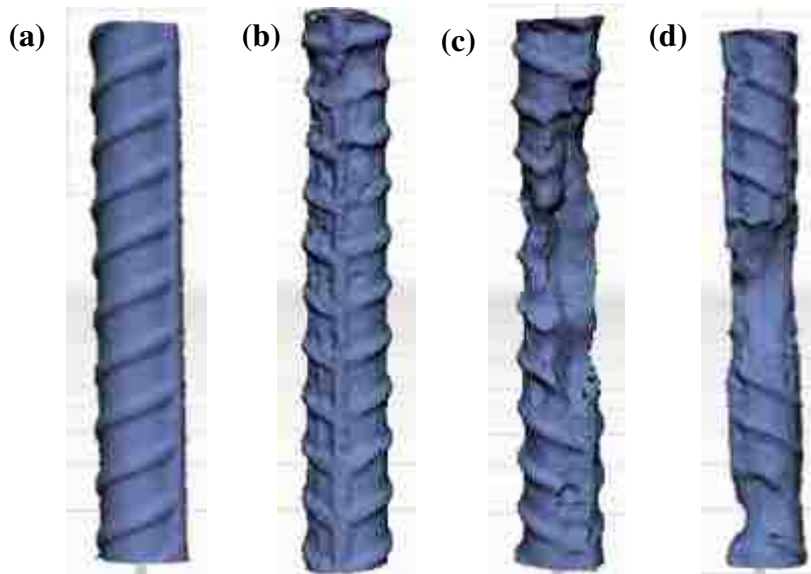
Figure 4.7 Scanned surface profiles of (a) uncorroded bar, (b) corroded bar #2, (c) corroded bar #3, and (d) corroded bar #10.

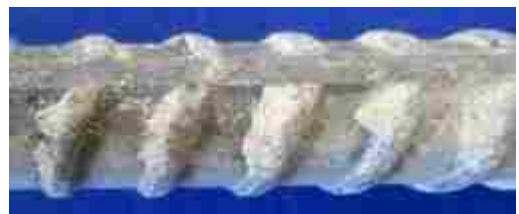
Figure 4.18 Visual observations on steel-concrete interfaces after pullout tests: (1) concrete interface, (2) steel bar surface; (a) uncorroded specimen, (b) slightly corroded specimen on ribs, (c) slightly corroded specimen on lugs, and (d) severely corroded specimen.
